BETA LAB NO.M10198, REV. 1 - Tesoro E6600 HEAT EXCHANGER "E". SUMMARY OF THE RESULTS  PART: 6600-E HEAT EXCHANGER "E", ALL PARTS DAMAGE DEPTH, AND PART 17 MOUNTS	TESORO REFINING AND MARKETING COMPANY ANACORTES REFINERY 10200 W. MARCH POINT ROAD T91WA4428 ANACORTES, WA 98221	CUSTOMER P.O. No.: 4501667904
		DATE: 3/7/2011
		PAGE 1 OF 70

**LABORATORY REPORT**

This report contains the summary of the results obtained in ten previous reports, measurements of the damage penetration on all mounts, as well as evaluation of the Part 17, mounts from weld LS1 labeled LS-1 and 17-LS1 (see layout of the mounts on Figure 1).

This report is the eleventh in a series of the reports on the failed parts ("E") of the 6600E heat exchanger "E". The LS# and CS# refer to longitudinal and circumferential weld seams respectively, while the part number refers to the chain of custody number.

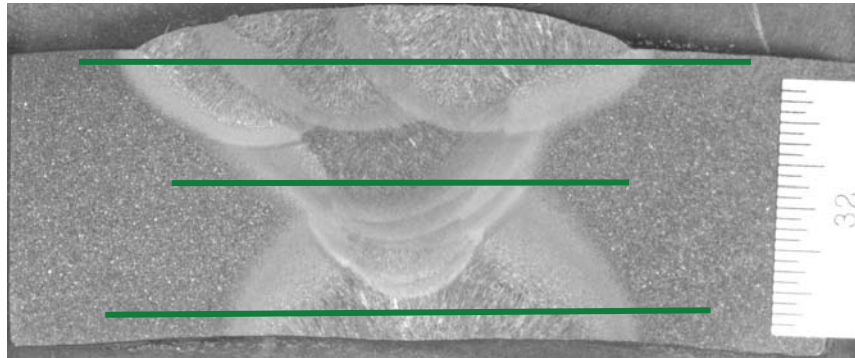
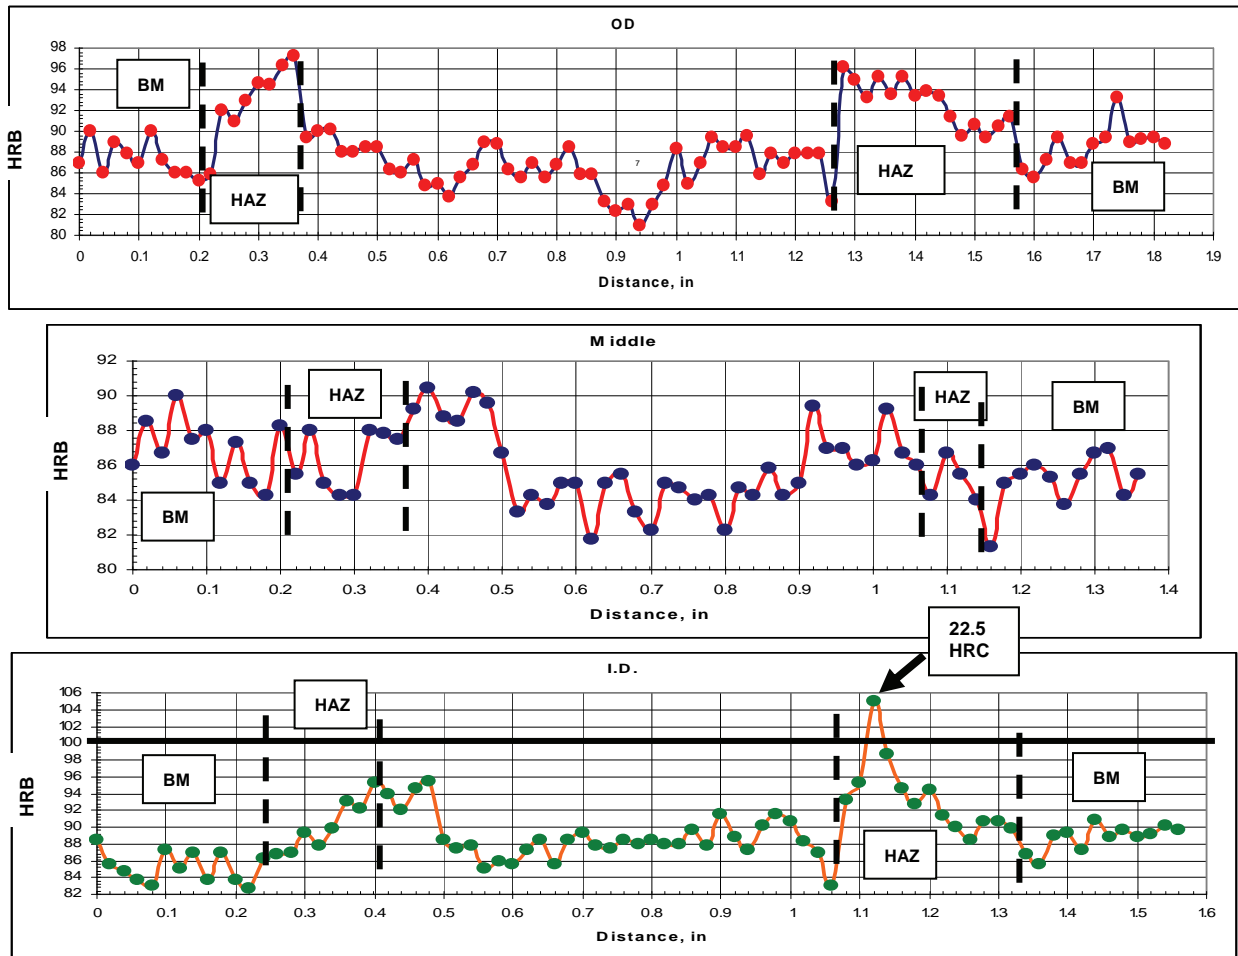
Figure 7. I.D. is on the bottom

**LABORATORY REPORT**  
**SAMPLE 17 - LS1**  
**SEMI-MICRO HARDNESS DISTRIBUTION ACROSS THE WELD**

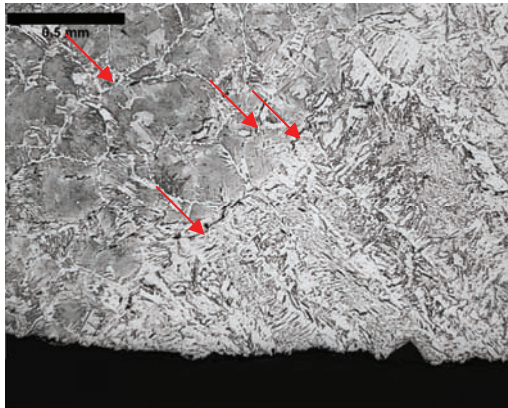
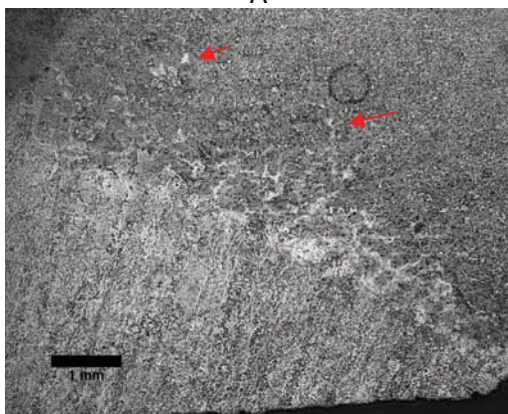
Figure 9. Definitions of the damage locations (devised by others) used in Table 11 and in the text. The locations in the base metal (BM) or in the weld metal (WM) are self-explanatory.

When the observed damage is located at the fusion line (FL) or at the 1<sup>st</sup> or 2<sup>nd</sup> grain of the CG HAZ (Coarse Grain of the Heat Affected Zone, CG everywhere in this report), it is marked as **"FL"**

It is typical to find damage beyond the FL and the 2<sup>nd</sup> grain of the CG, as it shown on the micrographs at left. The arrows at the microphotograph [B] show a spot indicative of the damage well deep in the CG, away from the FL. On microphotograph [C] the damage is in the 21<sup>st</sup> – 22<sup>nd</sup> grain inside the CG.

If this is observed, the location of the damage is defined as **"CG"**.

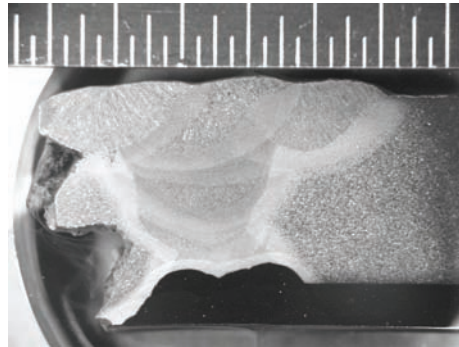
**LABORATORY REPORT  
CS4 WELD, SAMPLE 19W-M1**

Un-etched left of weld

Etched left of weld

Damage Depth, mm	
Left of the Weld	Right of the Weld
18.51	0 (Clad)

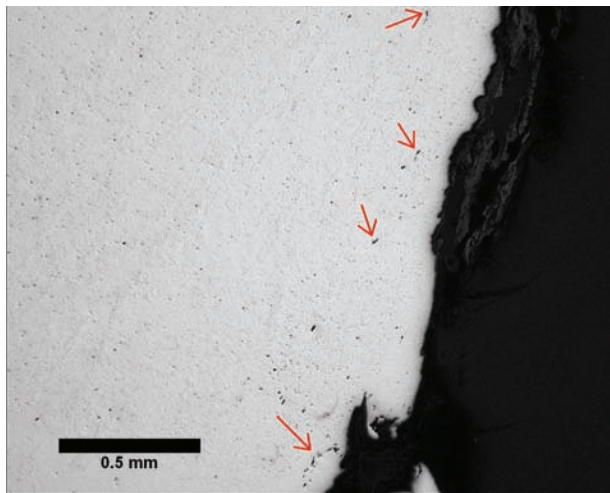
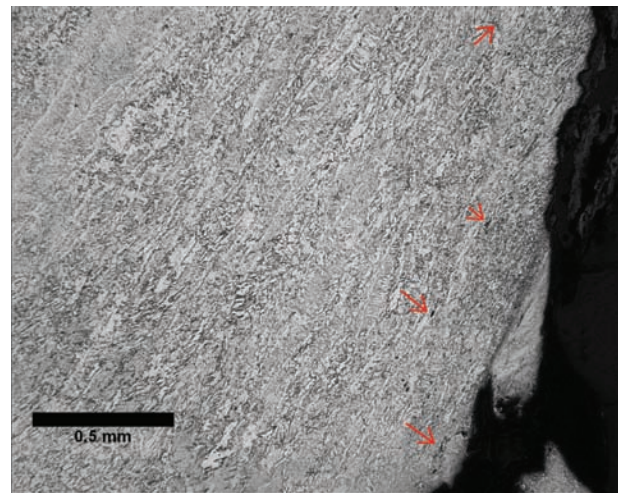
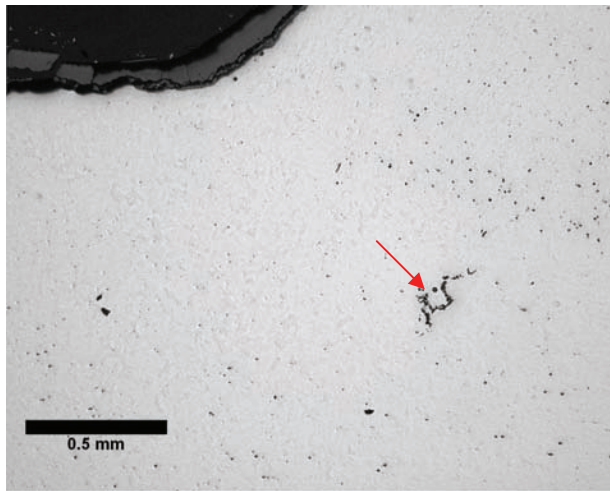
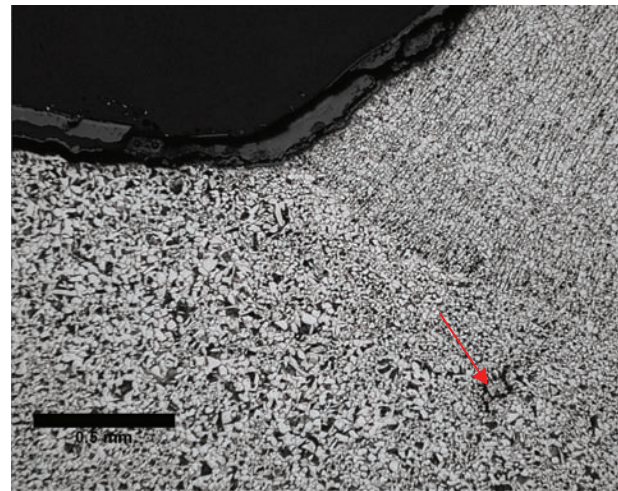
14M5

19E-m5 at fracture. Un-etched

19E-m5 at fracture. Etched

14-m5 at O.D. Un-etched.

14-m5 at O.D. Etched

Damage Depth, mm	
Left of Weld	Right of Weld
0 (Clad)	21.8

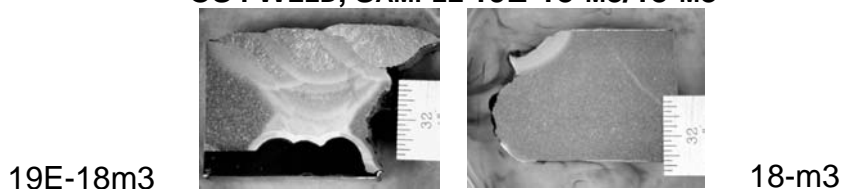
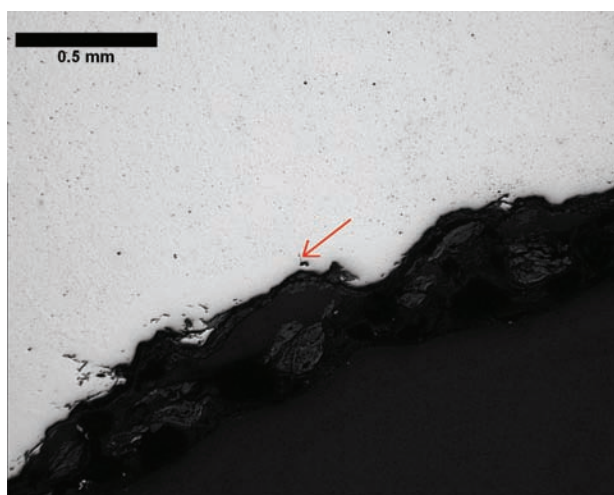
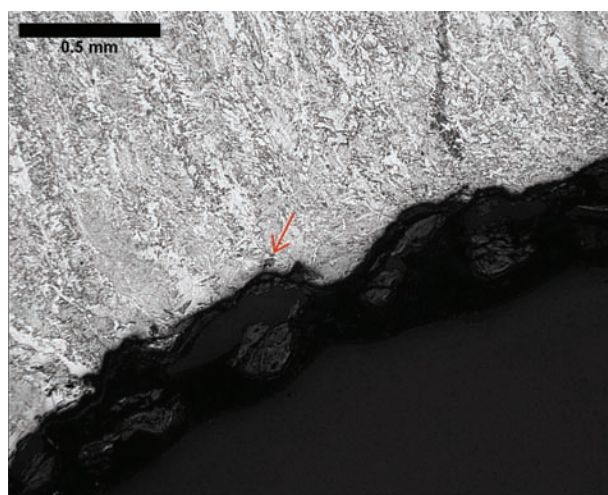
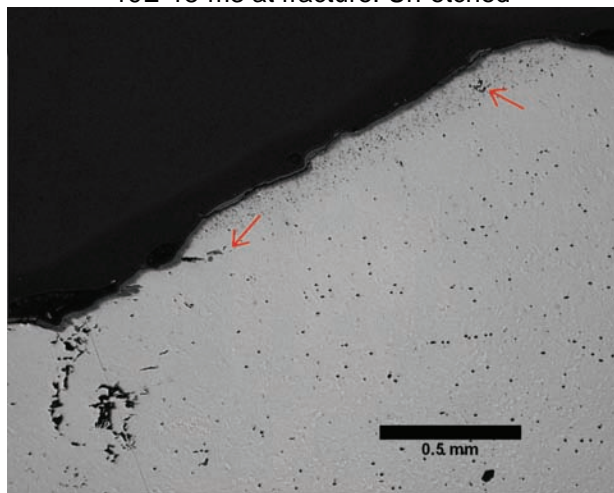
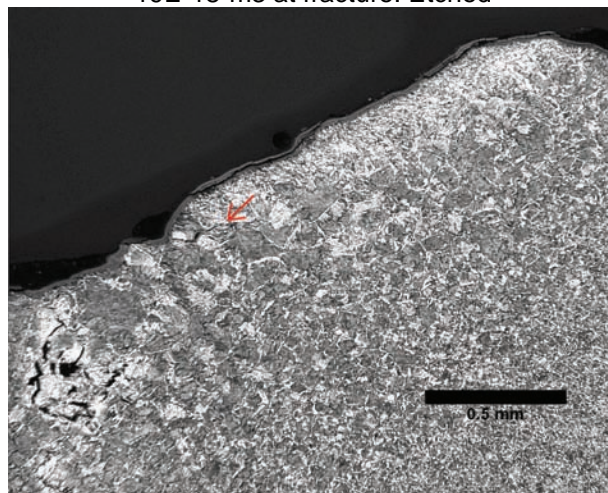
**CS4 WELD, SAMPLE 19E-18-M3/18-M3**

19E-18-m3 at fracture. Un-etched

19E-18-m3 at fracture. Etched

18-m3 at fracture, at OD. Un-etched

18-m3 at fracture, at OD. Etched

Damage Depth	
Left of Weld	Right of Weld
0 (Clad)	21.8

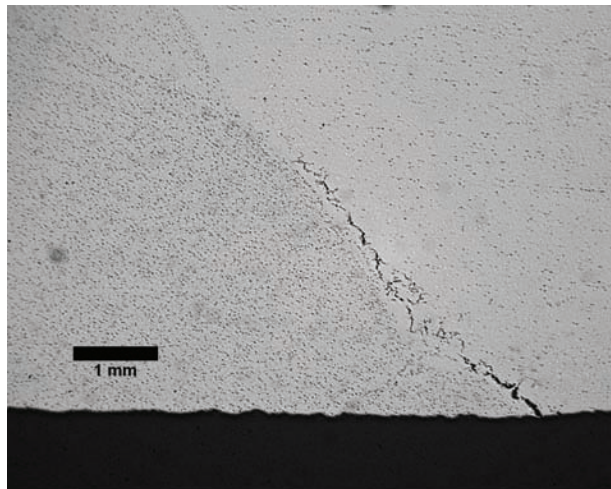
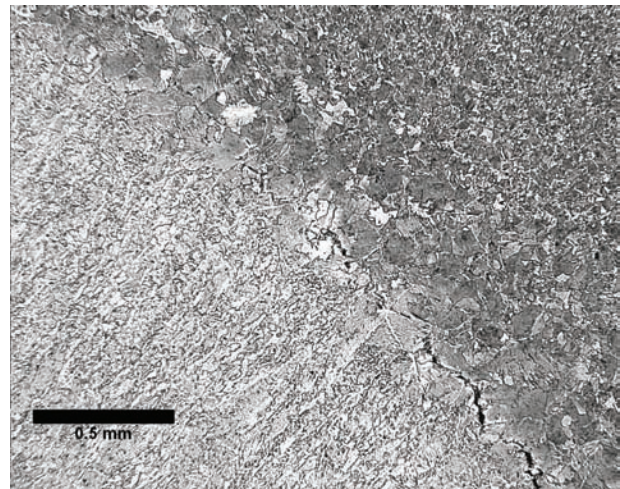
**LABORATORY REPORT  
CS3 WELD, SAMPLE 14-M1**

Detail of above-Un-etched

Detail of above-Etched

Damage Depth, mm
Right of Weld
3.19

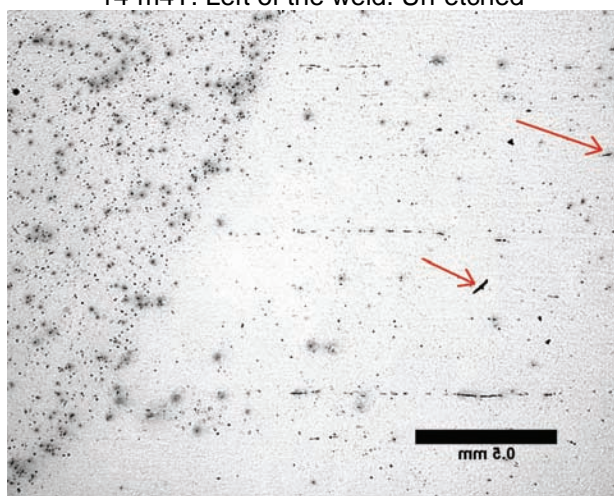
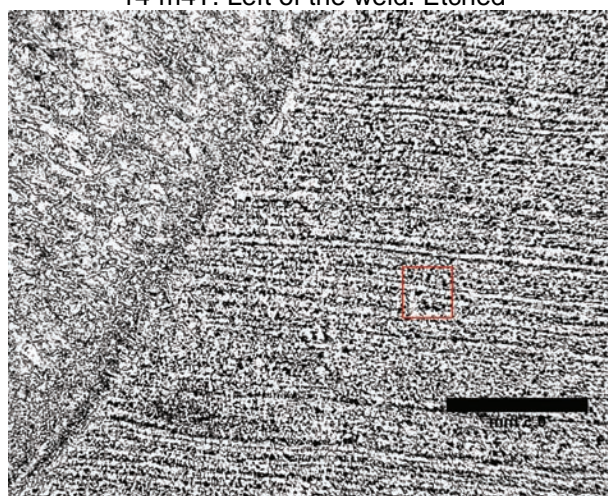
14-m4T. Left of the weld. Etched

15-m4T. Right of the weld. Un-etched

15-m4T. Right of the weld. Etched

Damage Depth, mm	
Left of Weld	Right of Weld
21.8	14.28

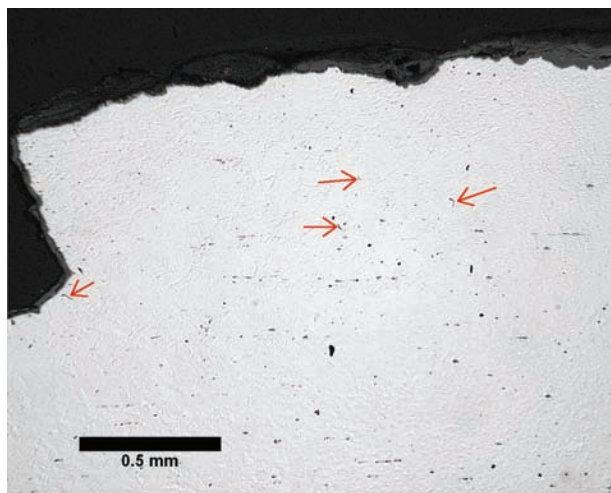
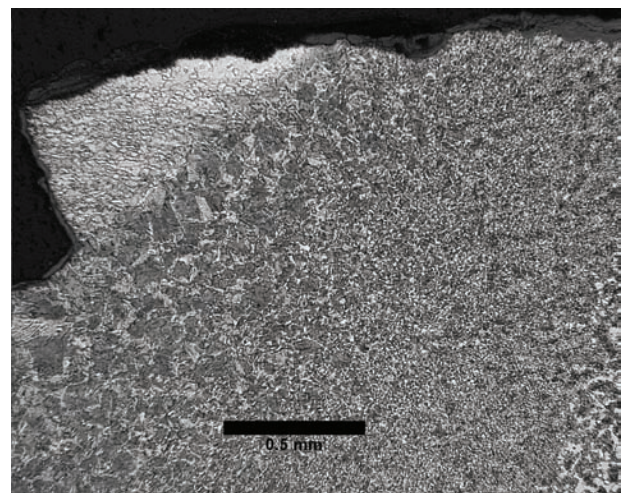
**LABORATORY REPORT  
LS3 WELD, SAMPLES 14-T0/15-T0**

15-T0. Un-etched

15-T0. Etched

Damage Depth, mm	
Left of Weld	Right of Weld
NA	21.8

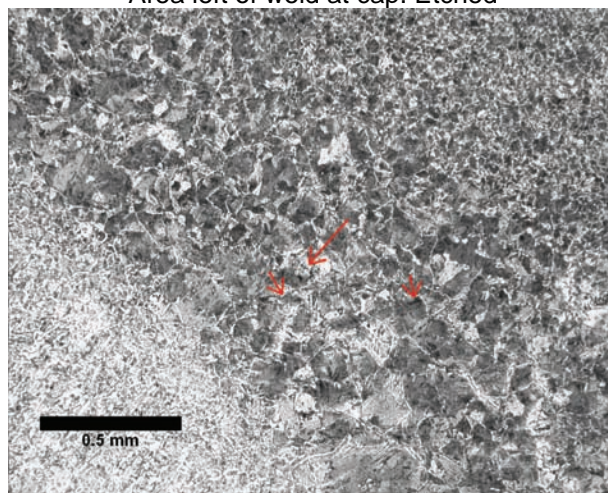
**LABORATORY REPORT  
PART 16-1. CS3 WELD, SAMPLE T-2C**

Area left of weld at cap. Un-etched

Area right of weld. Un-etched

Area right of weld. Etched

Damage Depth	
Left of Weld	Right of Weld
19.9	0.344

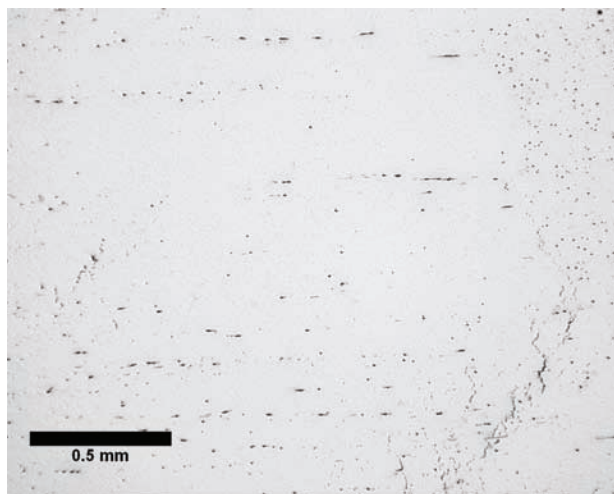
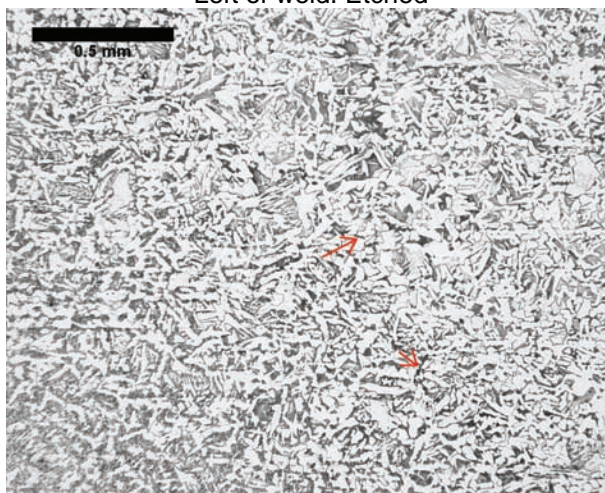
**LABORATORY REPORT**  
**PART 16-1. LS2 WELD, SAMPLE T-2L**

Left of weld. Un-etched

Right of weld. Un-etched

Right of weld. Etched

Damage Depth	
Left of Weld	Right of Weld
5.85	7.45

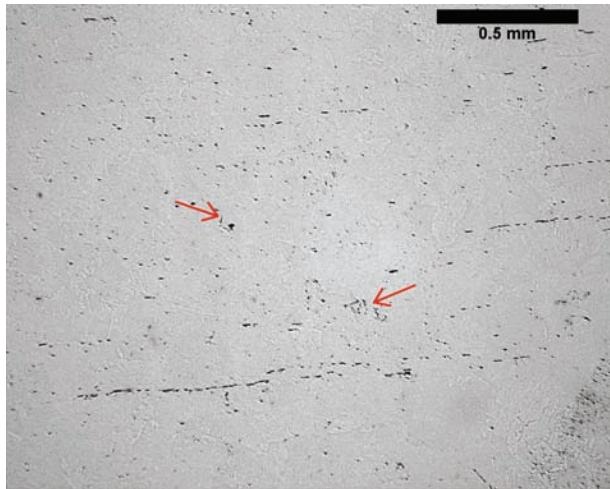
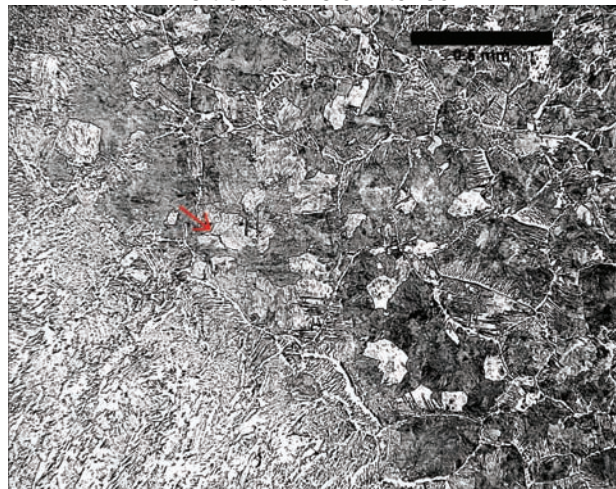
**LABORATORY REPORT  
PART 16-2. LS2 WELD, SAMPLE 22" FROM CS3**

Left of the weld. Un-etched

Right of the weld. Un-etched

Right of the weld. Etched

Damage Depth, mm	
Left of Weld	Right of Weld
3.04	5.37

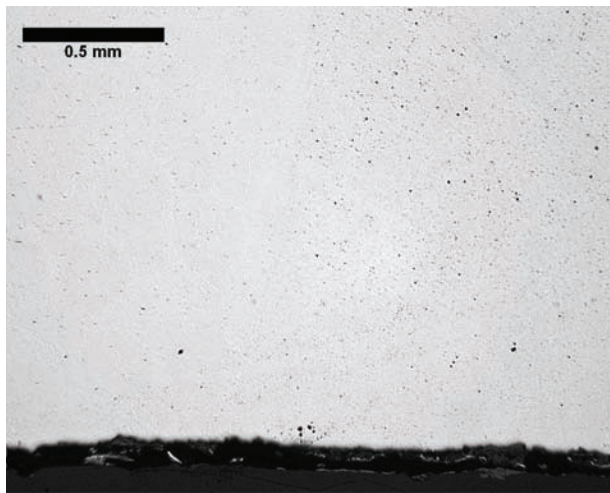
**LABORATORY REPORT  
PART 22, LS2-CS2-T, SAMPLE CS2-A**

Left of the weld. Un-etched

Left of the weld. Etched

Right of the weld. Un-etched

Right of the weld. Etched

Damage Depth	
Left of Weld	Right of Weld
0	4.05
