# Investigation Report

Published: December 2022

## SAFETY ISSUES:

On November 27, 2019, a series of explosions occurred at the TPC Group (TPC) Port Neches Operations (PNO) facility, located in Port Neches, Texas, after highly flammable butadiene released from the process unit. The explosions caused a process tower to propel through the air and land within the facility, other process towers to fall within the unit, extensive facility damage, and fires that burned for more than a month within the facility. The butadiene unit was destroyed, forcing the facility to cease butadiene production operations indefinitely. As of the date of this report, the butadiene production operations remain shut down. Two TPC PNO employees and a contractor reported minor injuries, and according to media reports, at least five local residents reported injuries. Officials in Jefferson County, Texas declared the county to be in a state of disaster and issued a mandatory four-mile radius evacuation order that affected people in the cities of Port Neches, Groves, Nederland, and a portion of Port Arthur. The explosion also led to reduced usage of the Sabine-Neches Waterway, the nation's third largest waterw

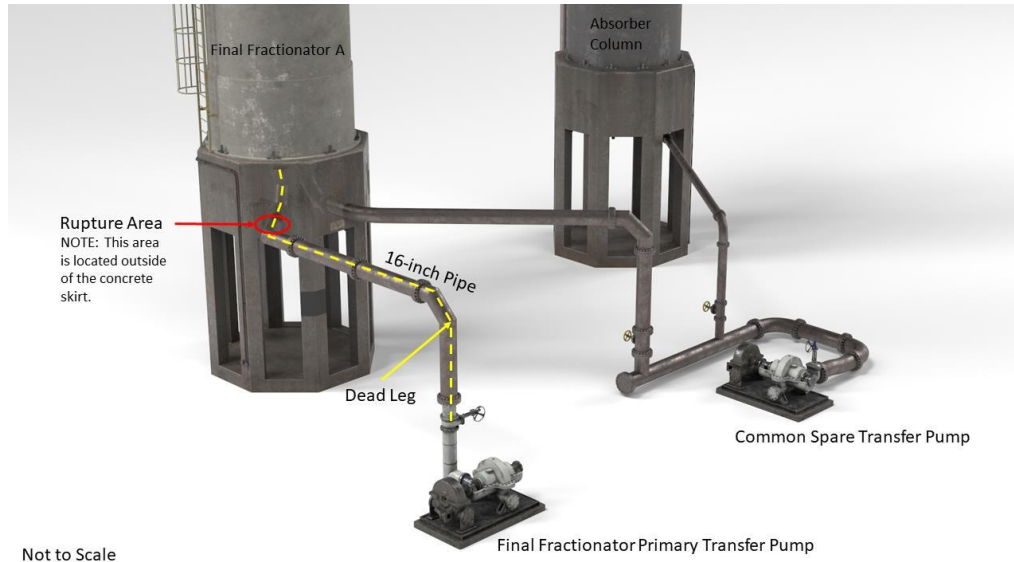
**Figure 9.** Schematic showing dead leg location when Primary Pump was nonoperational. (Credit: CSB)

During this 114-day period, the process piping between Final Fractionator A and the manual isolation valve upstream of the Primary Pump was a dead leg, as the pump could not initiate flow through the line. The portion of dead leg piping was 16 inches in diameter and approximately 35 feet long (**Figure 9**). During this 114-day period, TPC PNO continued to experience popcorn polymer formation and plugging in the unit (see Section 4.3). The U.S. Chemical Safety and Hazard Investigation Board (CSB) did not find that anyone at the TPC PNO facility realized the potential popcorn polymer and rupture hazard in the dead leg that was created when the Primary Pump became nonoperational.

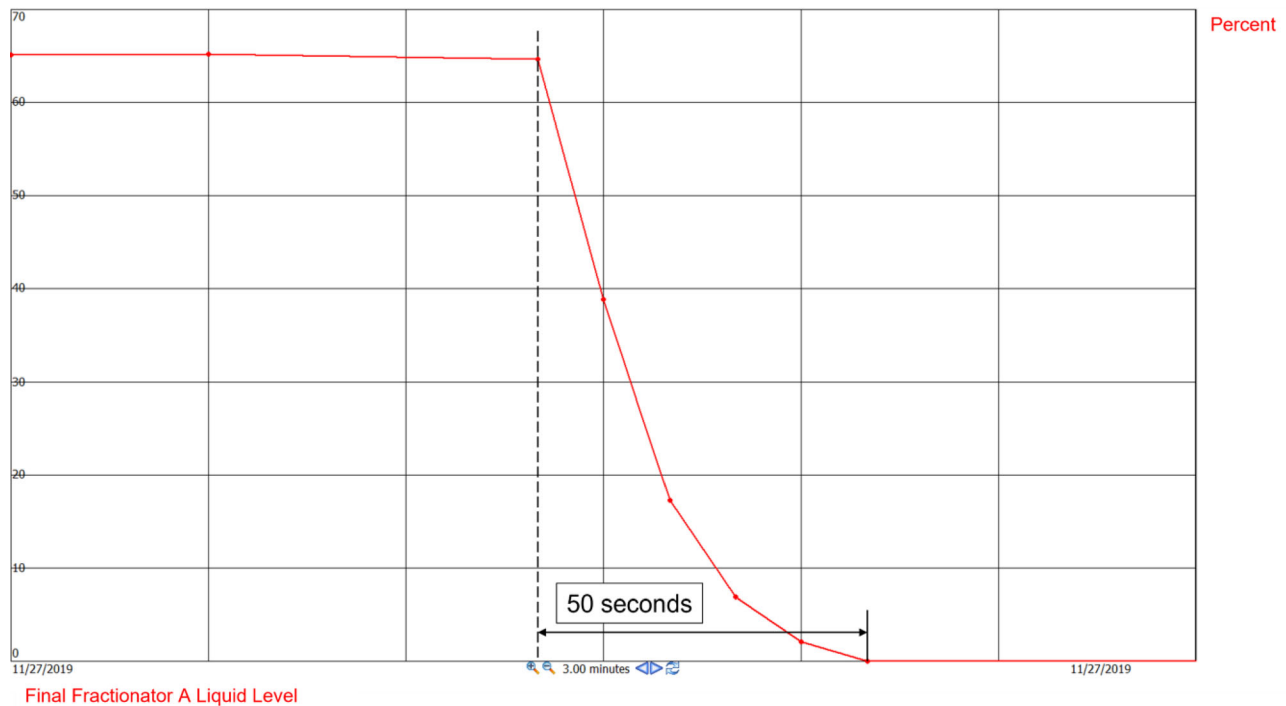
**Figure 10.** Process data trend showing the liquid level (in percent) in the Final Fractionator A at the time of the incident. (Credit: CSB)

A loss of containment event then occurred as a result of the rupture, causing the liquid level in the Final Fractionator A to drop rapidly from its operating level. The CSB calculated the Final Fractionator A liquid volume at the time of the initial level drop to be approximately 6,000 gallons.<sup>d</sup> Process data indicate that the liquid, which was primarily butadiene, fully emptied from the Final Fractionator A in less than a minute (**Figure 10**). The liquid butadiene vaporized upon release<sup>e</sup> and formed a flammable vapor cloud.

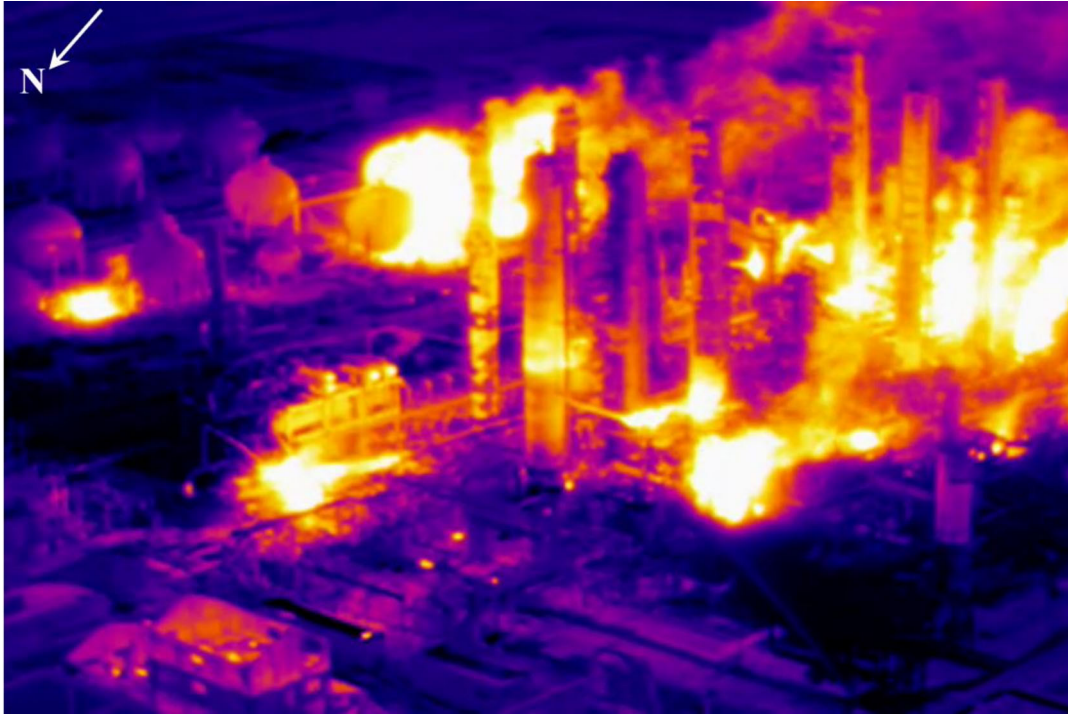
**Figure 12.** Thermal drone imagery of the TPC PNO facility South Unit taken the morning after the initial explosion. (Credit: TPC)

At 12:56 a.m., the butadiene vapor cloud ignited,<sup>a</sup> causing an explosion that heavily damaged the site. Thermal imagery (**Figure 12**)<sup>b</sup> provided by TPC shows multiple fires within the TPC PNO facility that ignited following the explosion.

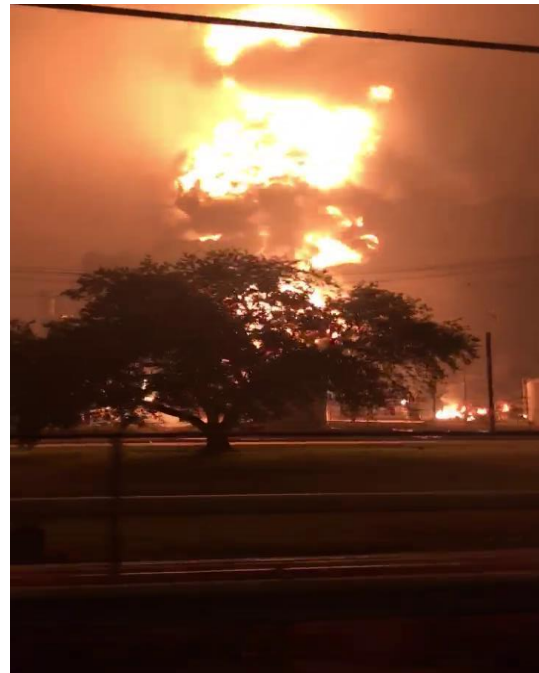
**Figure 13.** Explosion at 2:40 a.m. on November 27, 2019 captured by cell phone video. (Credit: TPC)

At least two additional explosions occurred following the initial blast. At 2:40 a.m., a cell phone recording captured one of the explosions (**Figure 13**). That afternoon, at 1:48 p.m., another explosion occurred, which caused one of the facility's towers to propel into the air (**Figure 14**). The tower landed within the confines of the TPC PNO facility.

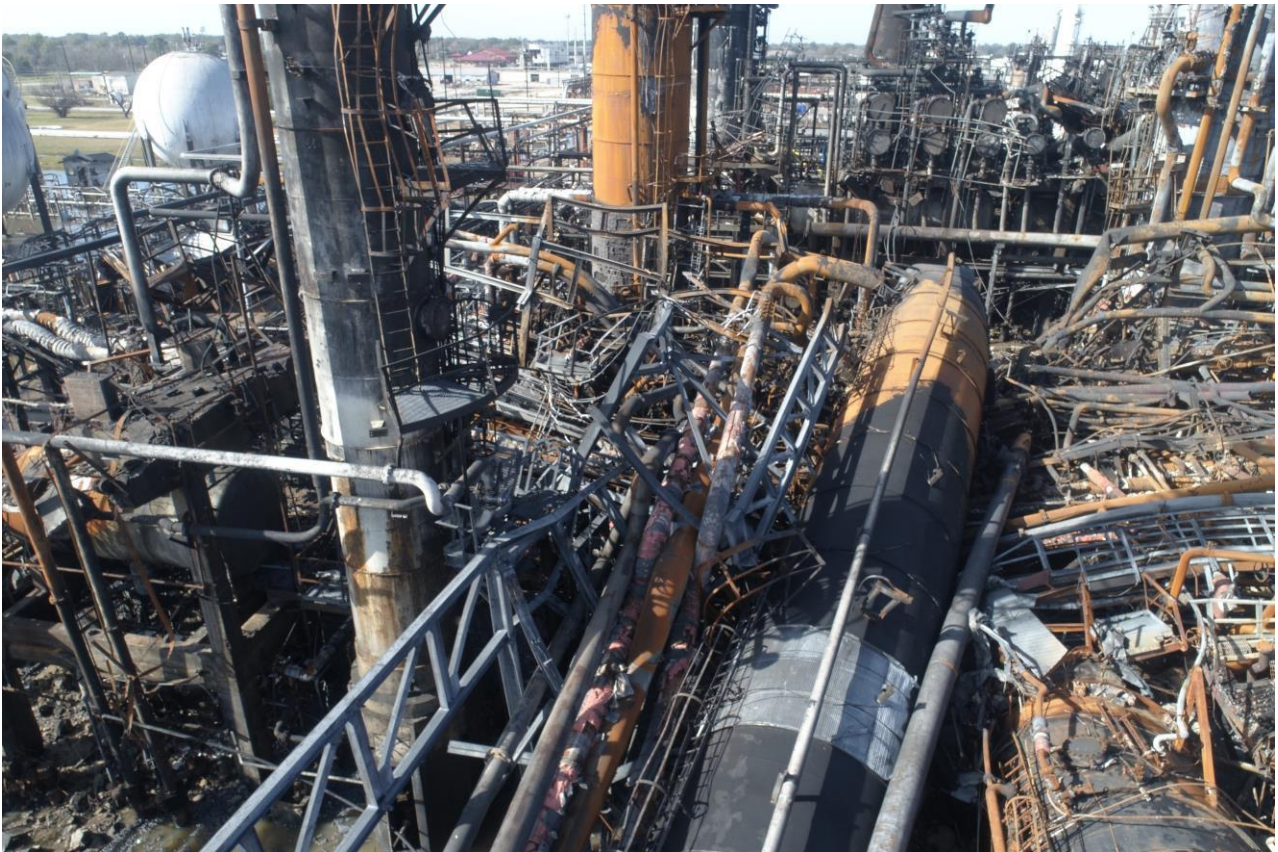
Figure 15. Damaged piping and equipment in the South Unit. (Credit: TPC)

The incident caused significant damage to piping and equipment (**Figure 15**). At least four columns fell as a result of the explosions and fires: the Final Fractionator A, an extractive distillation absorber, an out-of-service water wash tower, and the depentanizer (**Figure 16**).

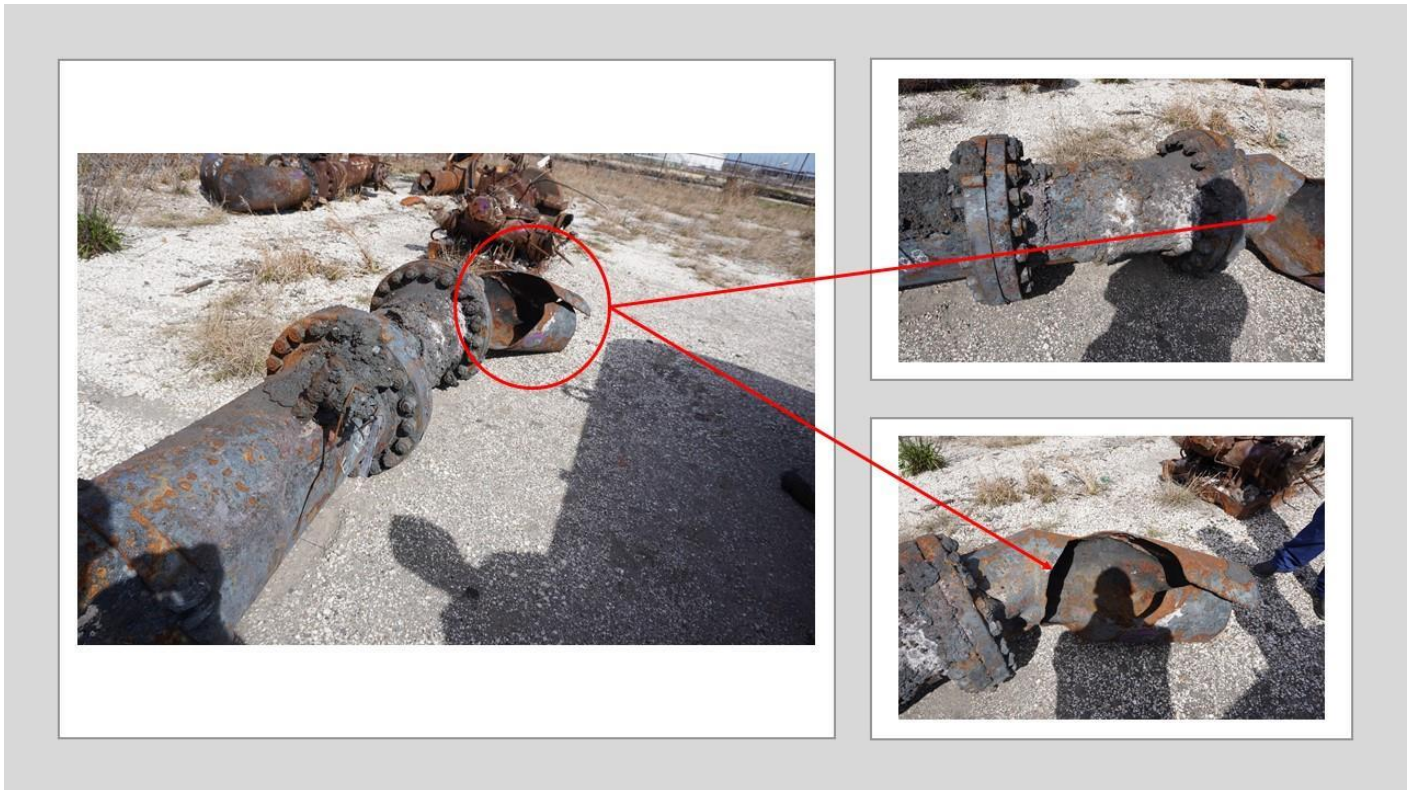
**Figure 18.** Photos of the recovered Final Fractionator A/B Primary Pump suction piping. (Credit: CSB)

The dead leg piping between Final Fractionator A and the manual isolation valve upstream of the Primary Pump was recovered after the incident. As shown in **Figure 18**, a rupture is visible within the piping segment. A CSB-commissioned metallurgical examination of the rupture concluded that the longitudinal rupture was consistent with internal pressure that exceeded the rupture strength of the pipe.

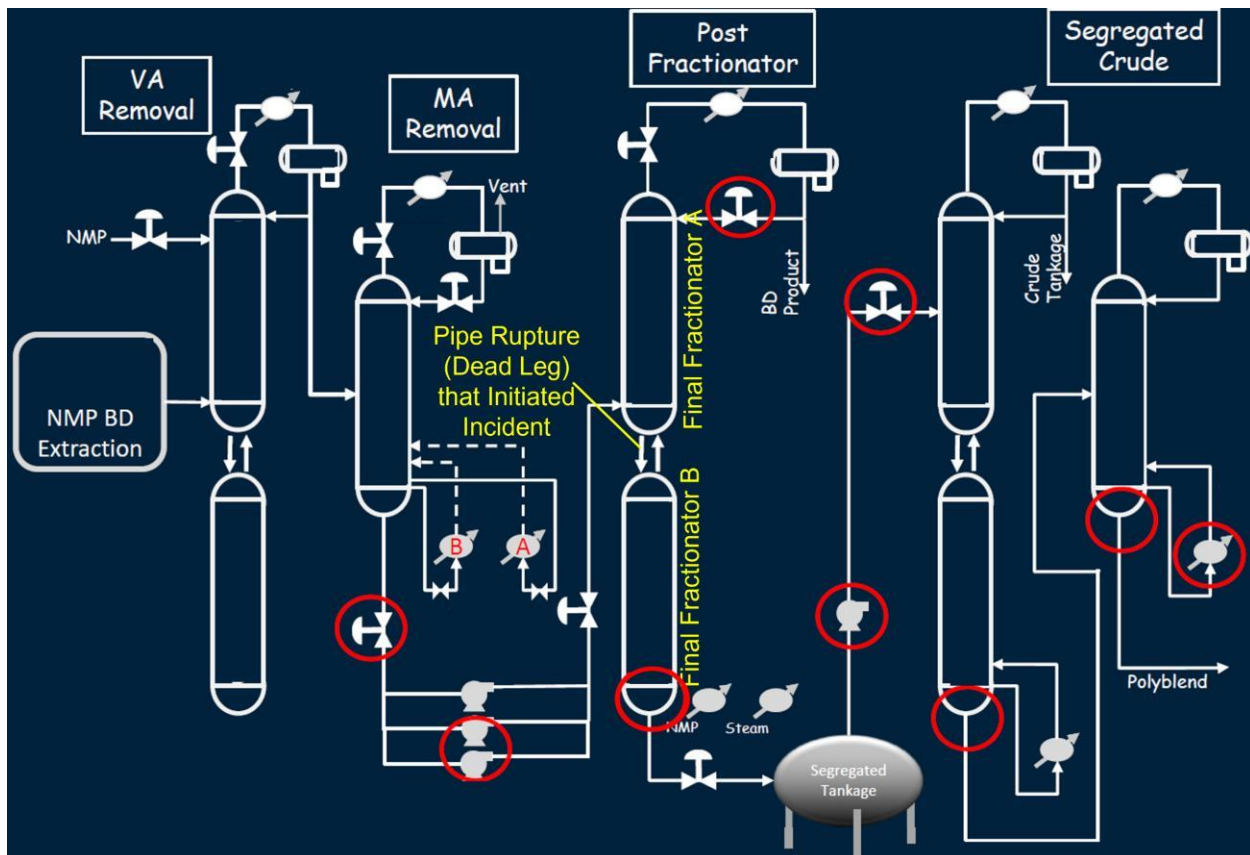
**Figure 34.** Locations of popcorn polymer blockages or fouling between June and October 2019. (Credit: TPC with text added by CSB)

TPC PNO continued to experience popcorn polymer and equipment plugging in the butadiene process throughout the remainder of 2019. Circled in red in **Figure 34** below are locations where the TPC PNO facility had experienced popcorn polymer blockage in equipment between June and October 2019.<sup>a</sup>

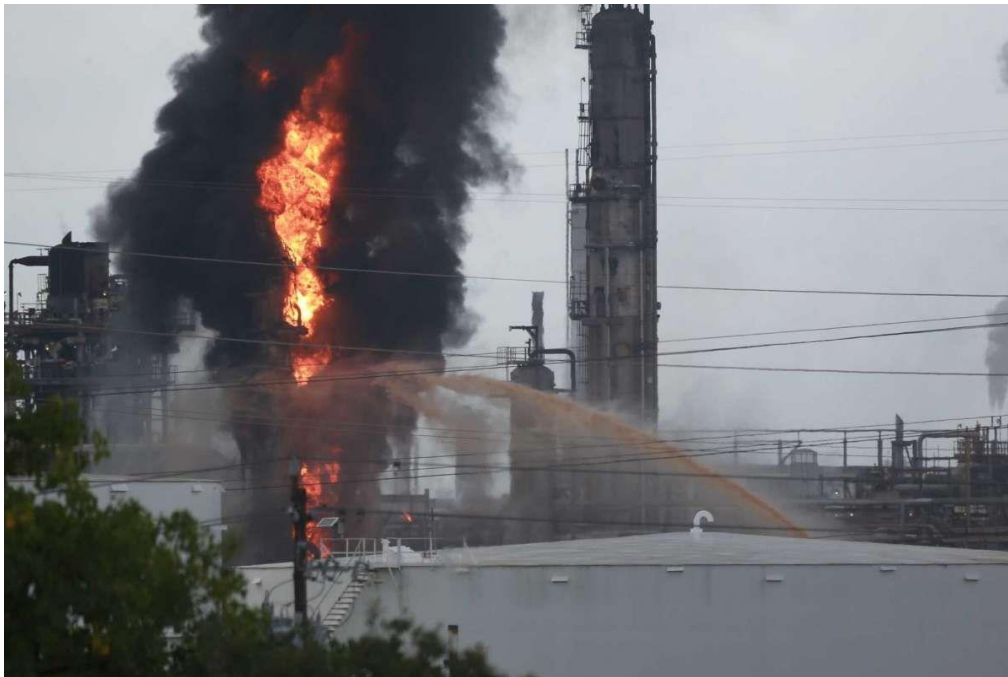
**Figure 38.** July 31, 2019, Baytown Incident. This picture shows the fire following the rupture of a section of 20-inch piping attributed to butadiene popcorn polymer. (Credit: Houston Chronicle [35]).

On July 31, 2019, a hydrocarbon release, explosion, and fire occurred at the ExxonMobil Baytown Olefins plant (“ExxonMobil”) (**Figure 38**). Local media reported that the incident injured 37 people [35].<sup>a</sup> ExxonMobil’s investigation of the incident found that butadiene popcorn polymer ruptured 20-inch (diameter) piping connected to a heat exchanger. The piping was in a part of the system that did not have material flowing through it. ExxonMobil described this dead leg piping as being in a “stagnant zone” of a depropanizer reboiler piping circuit. The report noted that, “Stagnant zones give popcorn polymer time to initiate seeds and grow.”
