Explosion and Fire at KMCO Chemical Facility

Crosby, Texas | Incident Date: April 2, 2019 | No. 2019-02-I-TX

Factual Update

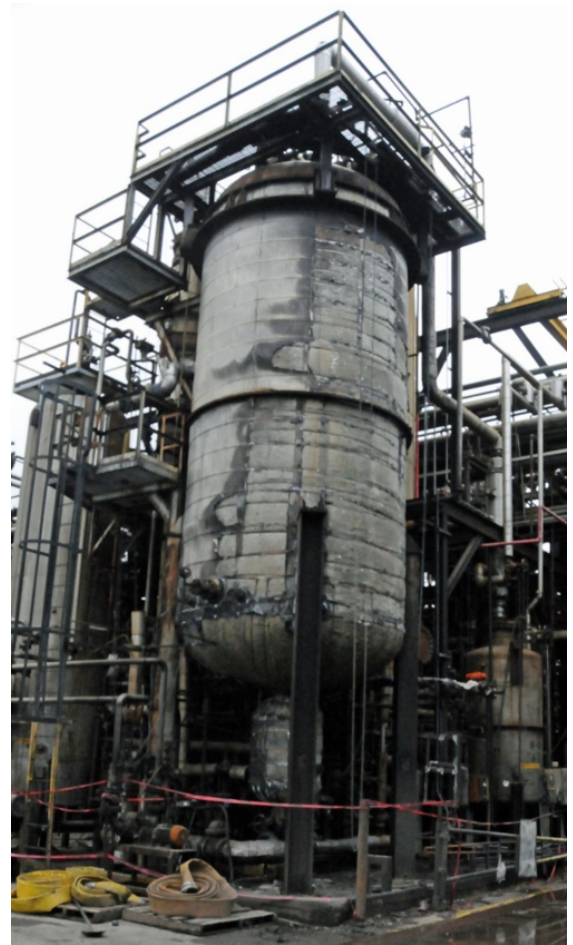
Figure 3. Batch Reactor. This photo shows the post-incident condition of the batch reactor KMCO used to manufacture sulfurized isobutylene products. (Credit: CSB).

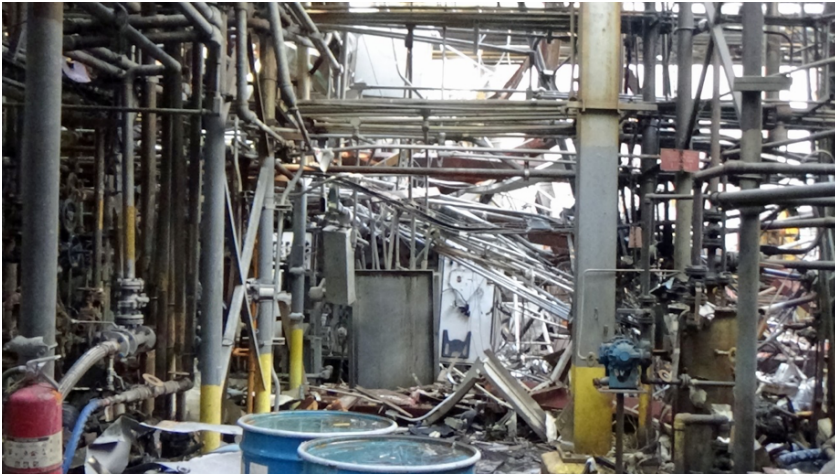
Figure 6. Plant Building (North Side). This post-incident photo shows the path KMCO workers commonly took to enter the plant building. With process units on the left and right, this walkway led to the entrance on the north side of the plant building, where emergency responders recovered the operator. (Credit: CSB).

Shrapnel. ... There was nothing left of it. Wires, there was nothing there. There wasn't a building there anymore
(**Figure 6**, **Figure 7**, and **Figure 8**).

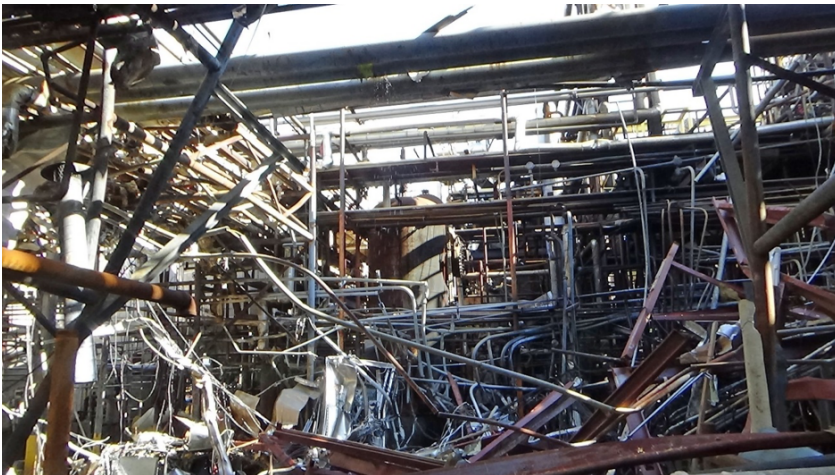
Figure 7. Plant Building (South Side). This post-incident photo shows the south side of the plant building. (Credit: CSB).

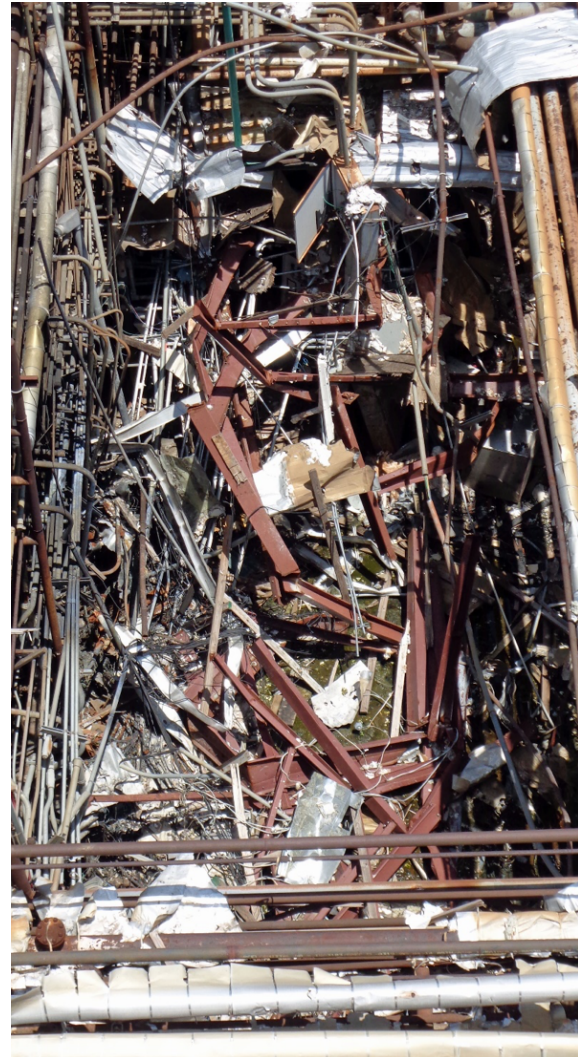
Figure 8. Plant Building (Top View). This photo, taken from the top of adjacent equipment, shows the post-incident condition of the plant building. (Credit: CSB).

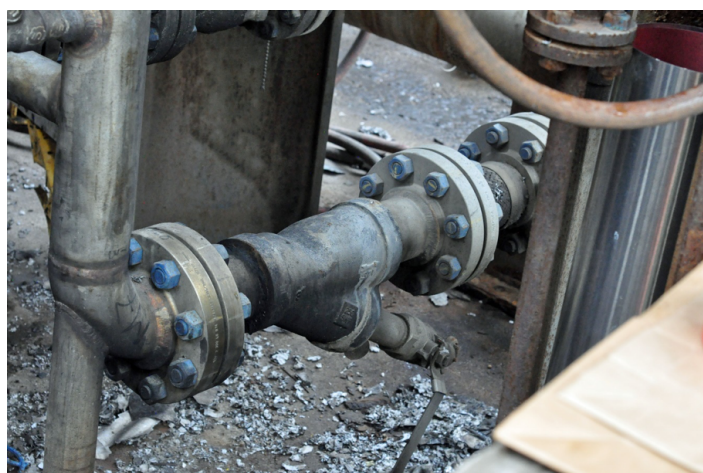
Figure 10. Y-Strainer (East Side). This post-incident photo shows the top and east side of the three-inch y-strainer on the inlet piping to the isobutylene charge pump. The orientation of the y-strainer was such that the straight through flow was headed north. (Credit: CSB).

KMCO installed a filtration strainer (y-strainer) on the inlet (suction) piping to the isobutylene charge pump. A typical application for a y-strainer is to remove solid particles from a liquid stream (**Figure 9**). The three-inch y-strainer had threaded ends, and KMCO added flange-to-threaded connections to allow the y-strainer to connect to the isobutylene piping flanges (**Figure 10**).

Post-incident, the source of the isobutylene release was identified as the three-inch y-strainer on the inlet (suction) piping to the isobutylene charge pump. The y-strainer was found with a hole, which is roughly 3-inches by 5.5-inches, on its west side (**Figure 11**). A KMCO operator (who saw the release) confirmed that the location of the hole was consistent with where he saw the isobutylene escaping.

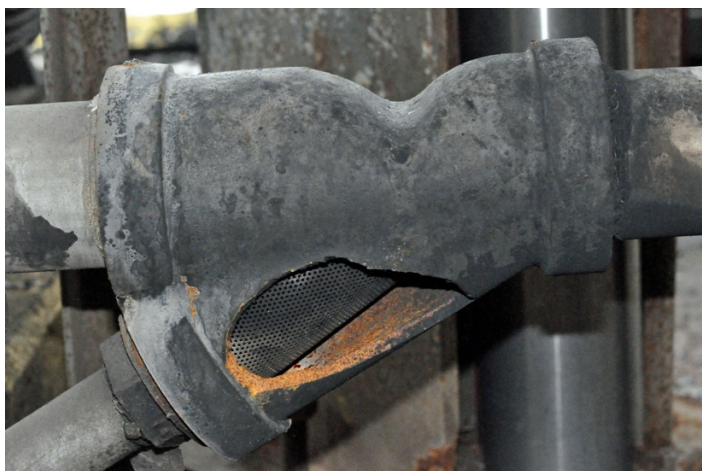
Figure 11. Y-Strainer. This photo shows west side of the failed y-strainer involved with the April 2, 2019 incident. (Credit: CSB).

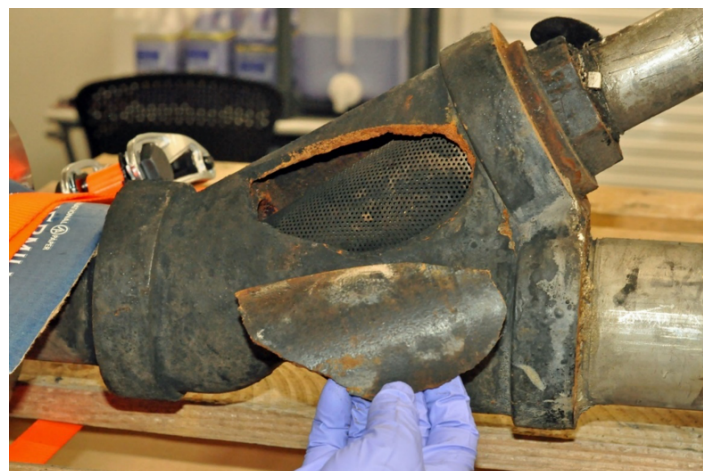
Figure 12. Y-Strainer Piece. This photo shows the single piece that likely separated from the failed y-strainer. (Credit: CSB).

A metal fragment that appears to be consistent with the piece missing from the y-strainer was found on the ground, near the sulfurized isobutylene reactor, and to the west of the y-strainer (**Figure 12**).

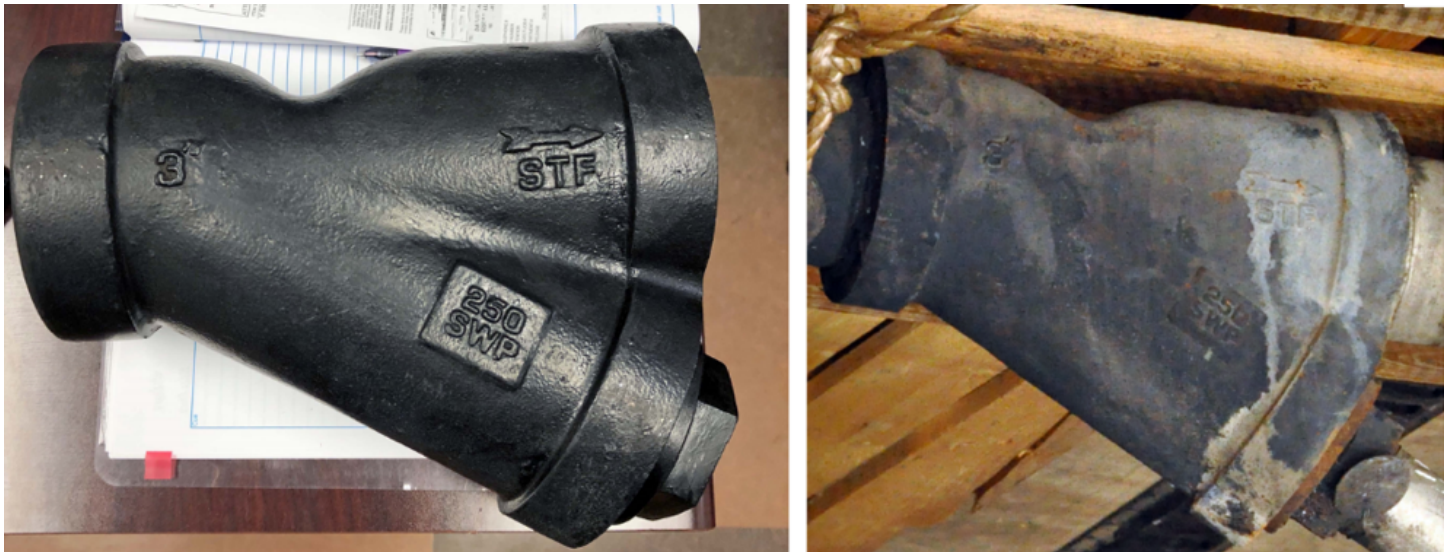
Figure 13. Exemplar Y-Strainer. The CSB purchased an exemplar y-strainer (left image) using the inventory information available in KMCO’s warehouse. The image on the right is the y-strainer involved in the April 2, 2019 KMCO incident. (Credit: CSB).

The y-strainer involved in the incident appears physically consistent with the standard three-inch gray iron y-strainer KMCO stocks in its warehouse. Using the KMCO warehouse inventory information, the CSB purchased an exemplar y-strainer that also appears physically consistent with the y-strainer involved in the incident (**Figure 13**).
