Report No. 5005.7350

May 8, 2020

**METALLURGICAL EVALUATION OF A RUPTURED
DEPROPANIZER ACCUMULATOR DISCHARGE LINE INVOLVED IN THE
JUNE 21, 2019 LOSS OF CONTAINMENT AND FIRE AT
PHILADELPHIA ENERGY SOLUTIONS REFINERY
IN PHILADELPHIA PENNSYLVANIA**

Customer Authorization: CSB-1125-19-0023

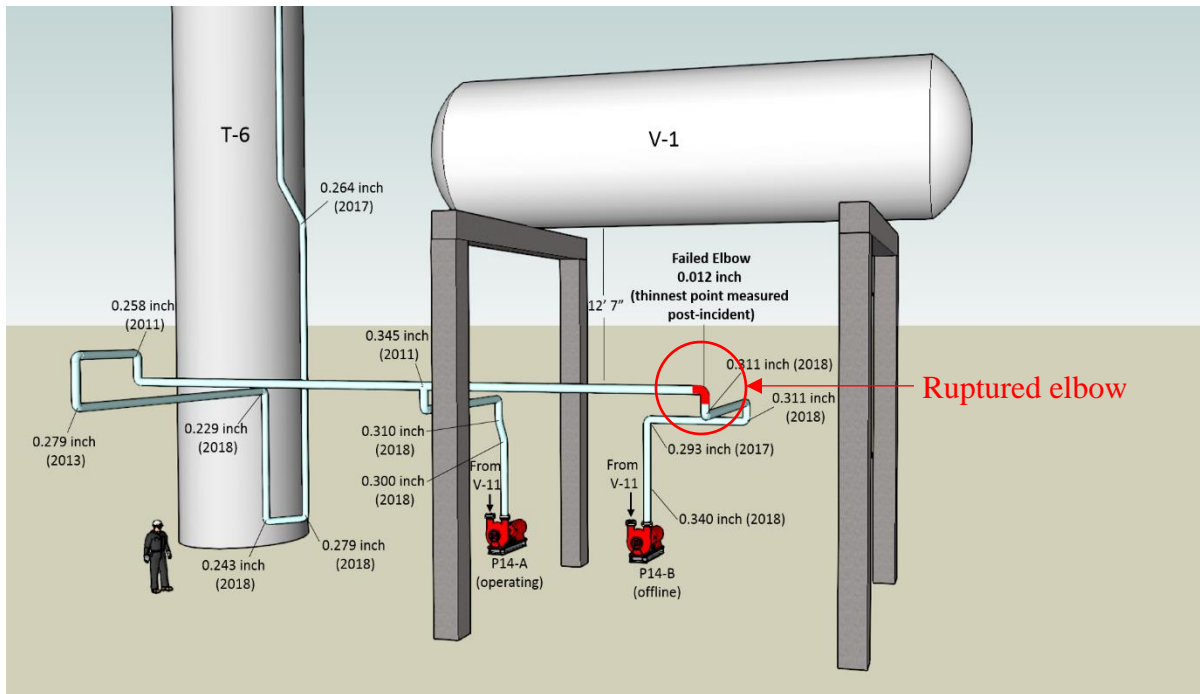
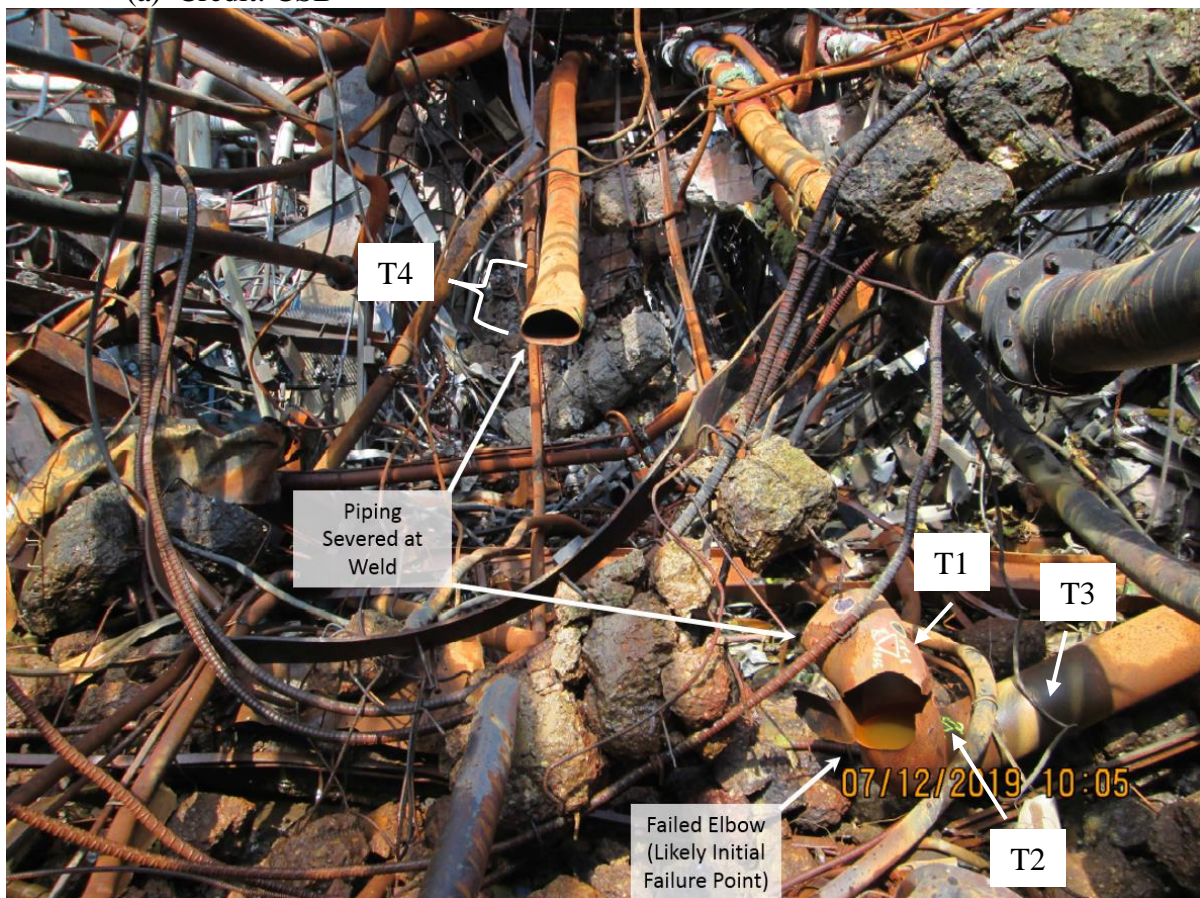
Figure 1 Model of the subject ruptured line in relationship to T-6 and V-1, and a post incident photograph of the ruptured elbow and fractured girth weld.

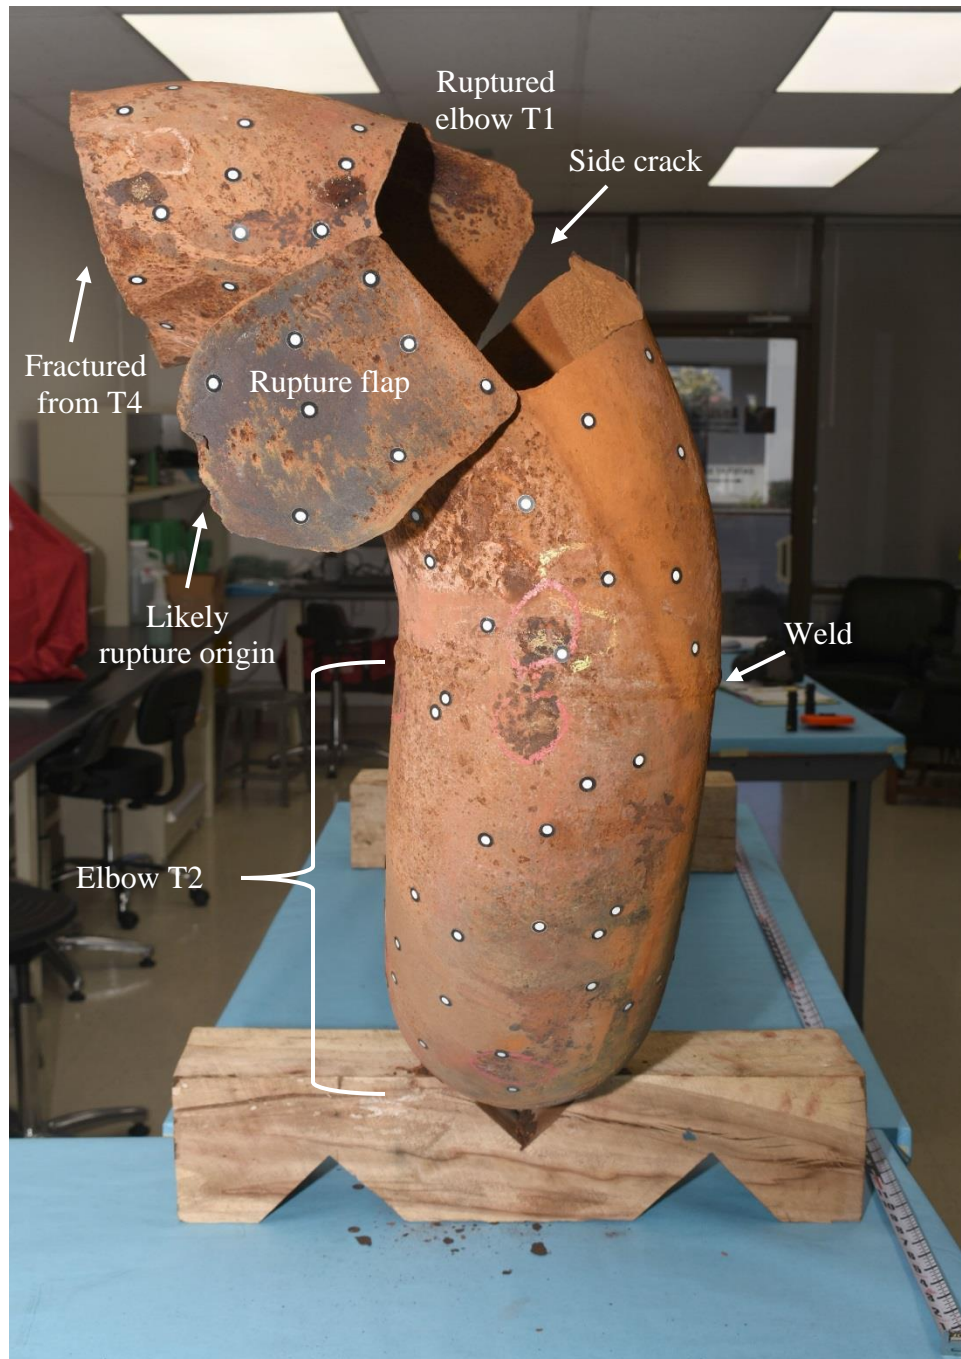
Rupture of elbow T1 occurred on the outside of the bend. Based on the shape of the rupture, failure initiated near the location indicated in Figure 2. The rupture path from the origin was approximately parallel to the longitudinal axis of the elbow, which indicates that failure was driven by hoop stresses developed from internal pressure. A flap formed by the rupture was displaced to the outside of the uninsulated line, also indicative of rupture driven by internal pressure. The remaining wall thickness near the rupture origin was as low as 0.023-inch, measured by point anvil micrometer without cleaning tenacious scale from the region. Thickness measurements along the edges of the rupture and rupture flap averaged 0.056-inch and did not exceed 0.120-inch. The locations of thickness measurements are shown in Figure 6 and the corresponding results are listed in Table 1. Visual examination indicated this range of thickness was consistent across the majority of the outside bend in the elbow. A V-shaped side crack that intersected the rupture origin and propagated transverse to the longitudinal axis was predominantly driven by events secondary to the rupture initiation and release of hydrocarbons.

Figure 2 Photograph of E004, viewed from the ruptured end. Spots are reflectors that were applied to facilitate laser scanning.

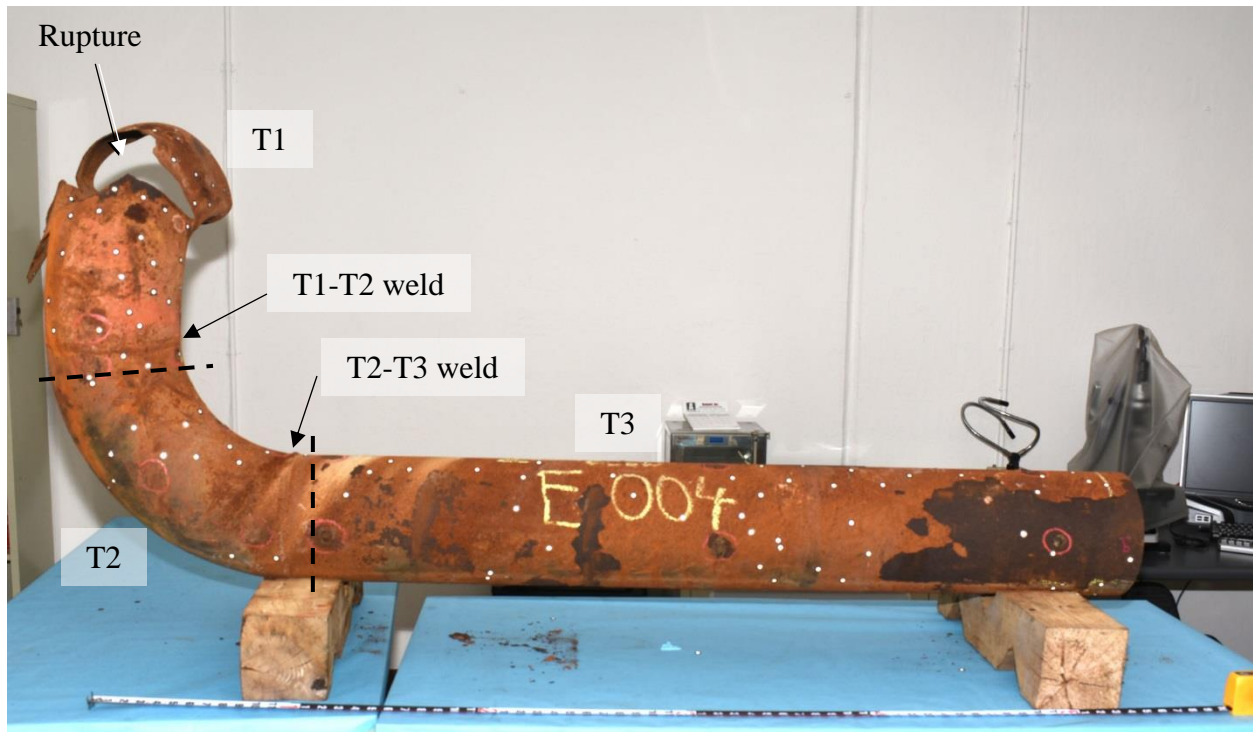
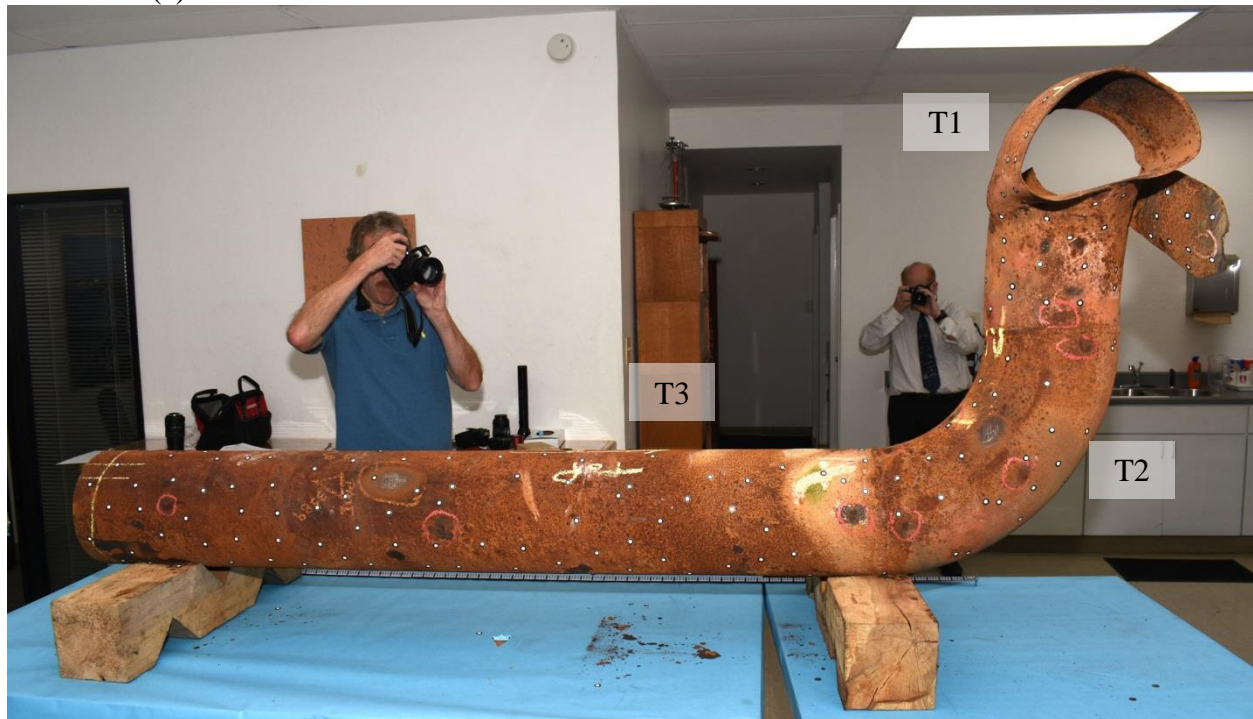
Transverse cuts were made to separate elbow T1 from elbow T2, and elbow T2 from pipe T3, indicated by dashed lines in Figure 3a. The elbows were also cut along their longitudinal plane of symmetry. The longitudinal sections demonstrated a large difference in wall thickness between elbow T1 and elbow T2. Photographs of one half of T1 and one half of T2 are shown in Figure 7 and Figure 8, respectively. Wall thickness measurement results are listed in Table 5 and Table 6.

Figure 3 Photographs of E004. Spots are reflectors that were applied prior to laser scanning. Dashed lines in (a) indicate transverse cut locations.

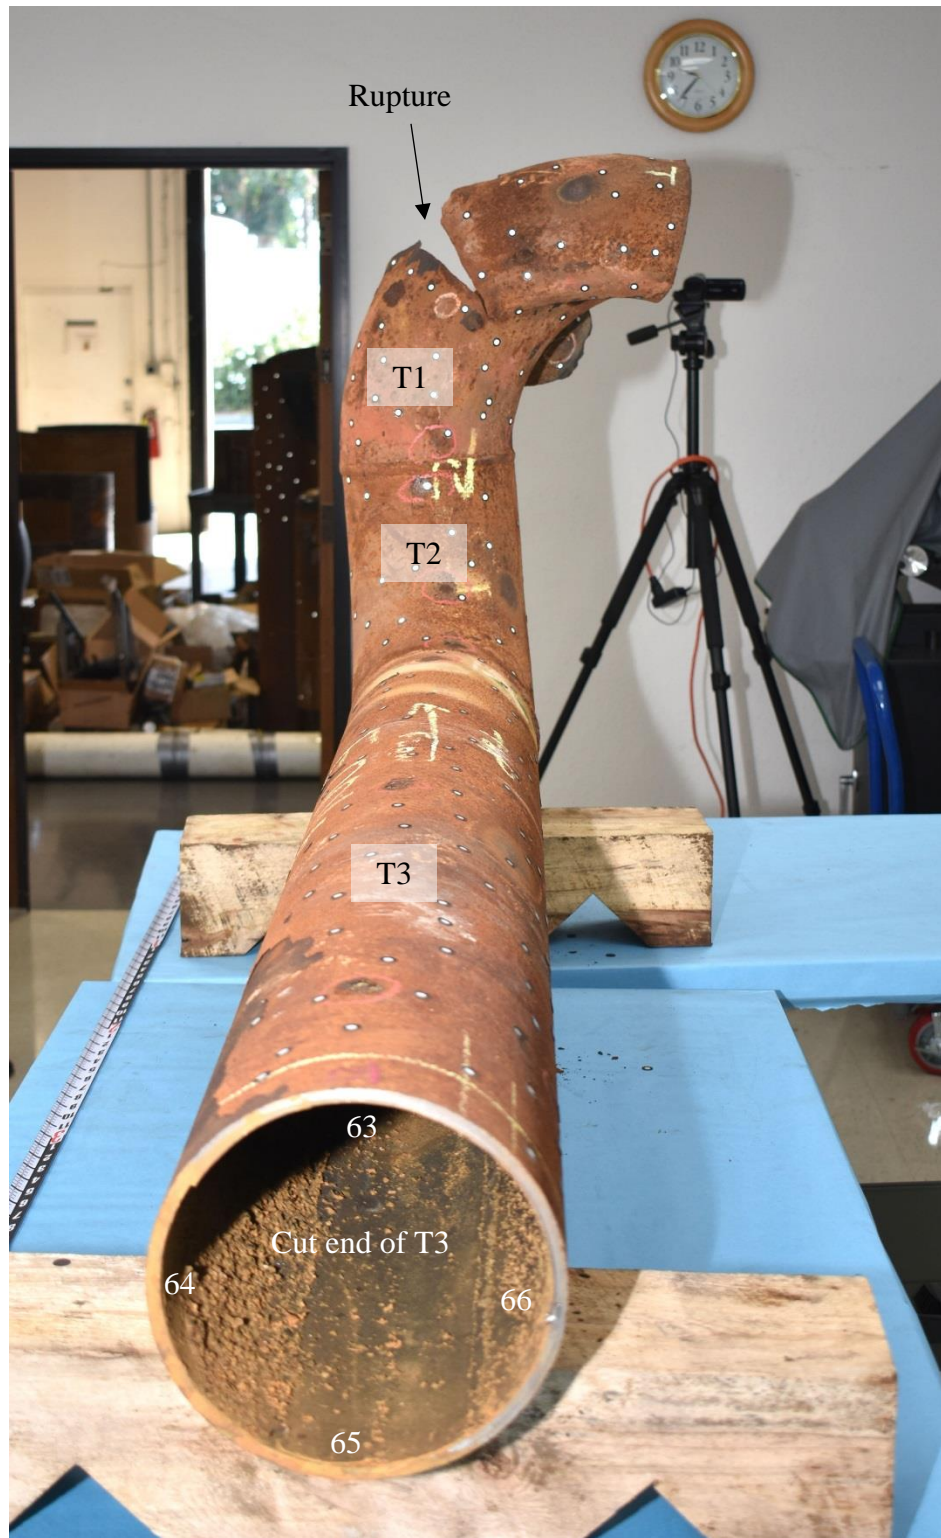
Table 3
Thickness Measurements From the Field Cut End of T3
From Locations Indicated in Figure 4

Figure 4 Photograph of E004, viewed from the cut end of T3. Spots are reflectors that were applied prior to laser scanning. Numbers at the cut end indicate locations of wall thickness measurements listed in Table 3.

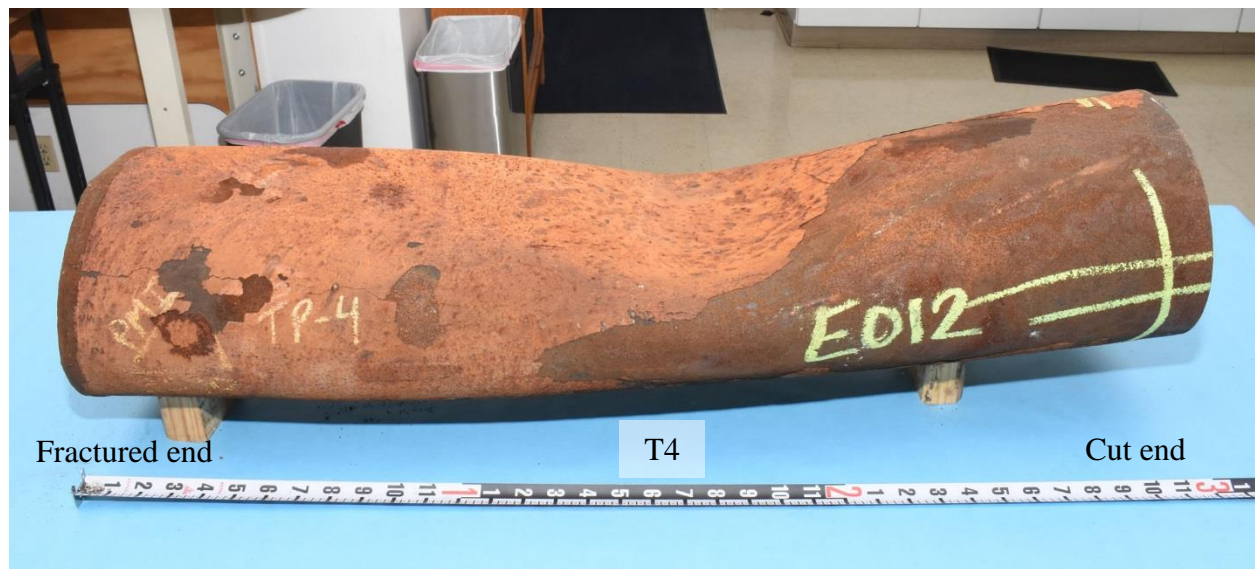
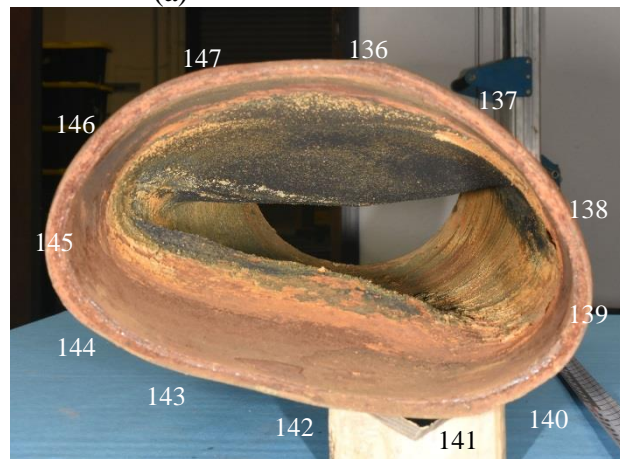
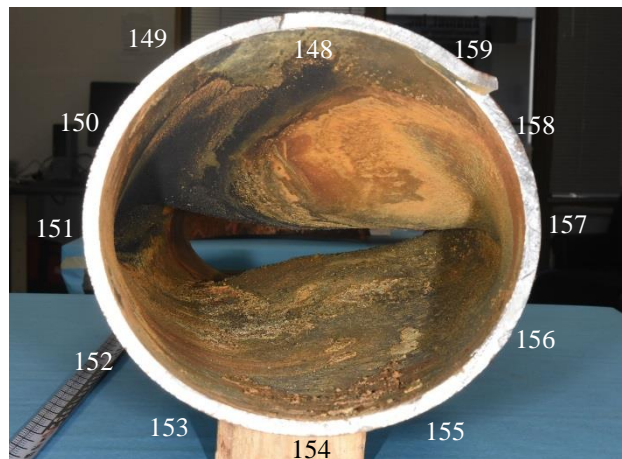
A thick, flakey, rust scale was present on the outside surfaces of the samples, consistent with exposure to fire suppression water. Immediately inside the fractured ends of T1 and T4, the scale was thin and mostly tenacious. Within T1, the inside scale transitioned to friable rust that was thicker below a water level line, indicated in Figure 7. Standing water within T1 is visible in Figure 1b. Accumulation of rust was greatest within elbow T2. At the cut end of pipe T3, some longitudinal bands of the inside surface scale were dark colored and tenacious under a light rust bloom. Other longitudinal bands of the dark scale in T3 were partially lifted from the surface and mixed with rust. Both inside scale morphologies are visible in Figure 4, at the cut end of T3. Similar internal scale morphologies were present in the pipe sample T4, as shown in Figure 5.

Table 4
Thickness Measurement Results from the T4 Side of the T1 to T4 Rupture and the Cut End of T4
From Locations Indicated in Figure 5b and Figure 5c

Figure 5 Photographs of E012, referred to as T4. Numbers in (b) and (c) indicate locations of wall thickness measurements listed in Table 4.

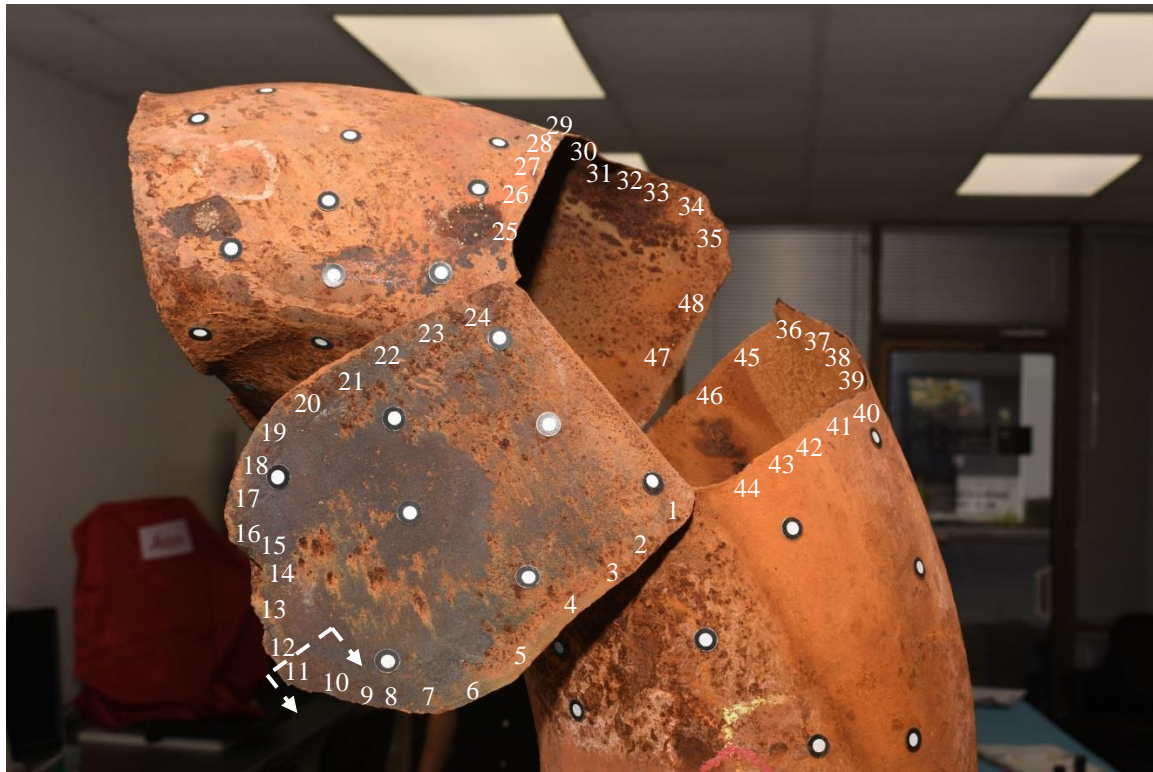
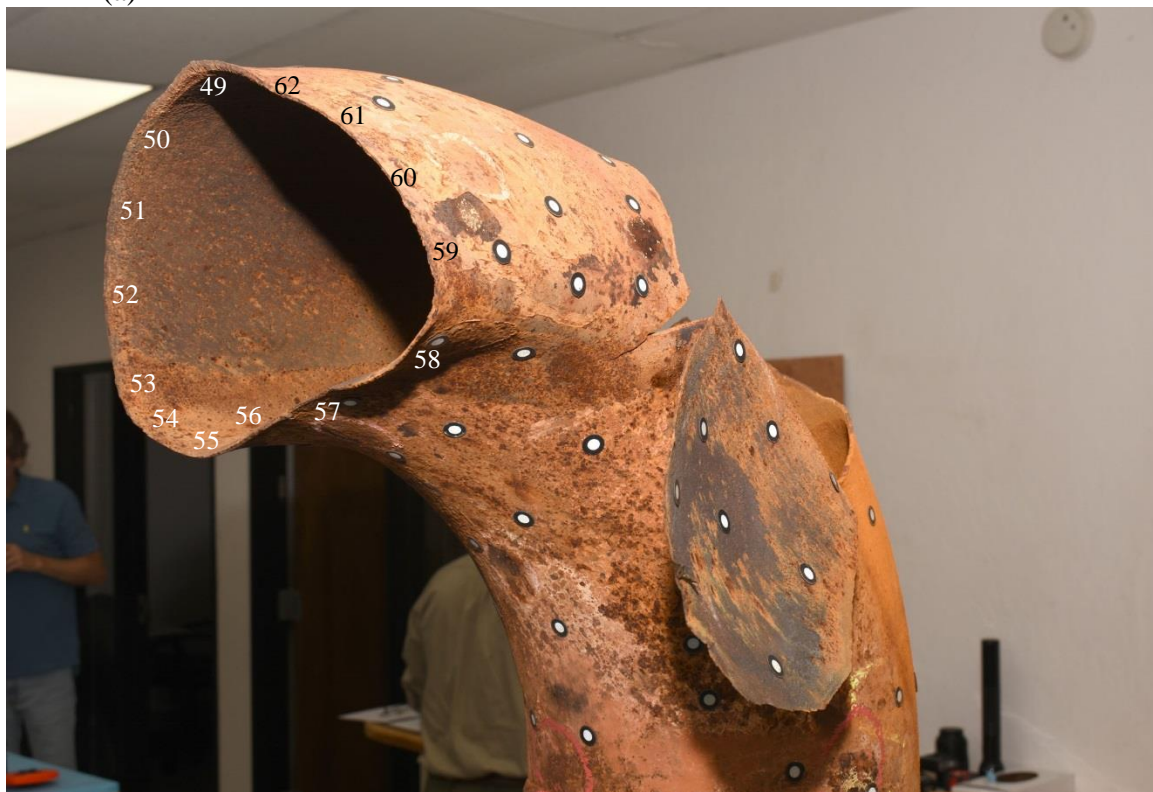
value of 0.287-inch, and the wall thickness at the cut end had an average thickness of 0.302-inch. The locations of thickness measurements around the fractured end of T1, the cut end of T3, and both ends of T4 are shown in Figure 6b, Figure 4, Figure 5b, and Figure 5c, respectively. Corresponding thickness values are listed in Table 2 through Table 4. The macroscopic morphology of the fracture along the top edges of T1 and T4 indicated global shear loading consistent with the post incident position of T1 lower than T4, as shown in Figure 1b. Because the T1 to T4 fracture would have released pressure within T1 and the T1 rupture was driven by internal pressure, the T1 rupture must have preceded the fracture between T1 and T4.

Table 1
Thickness Measurement Results for the Rupture Flap and Rupture Edge
From Locations Indicated in Figure 6a

Table 2
Thickness Measurement Results from the T1 Side of the T1 to T4 Fracture
From Locations Indicated in Figure 6b

Figure 6 Photographs of ruptured elbow T1. Numbers indicate thickness measurement locations indicated in Table 1 and Table 2. Dashed lines in (a) between location 11 and 12 indicate a section prepared for metallography.

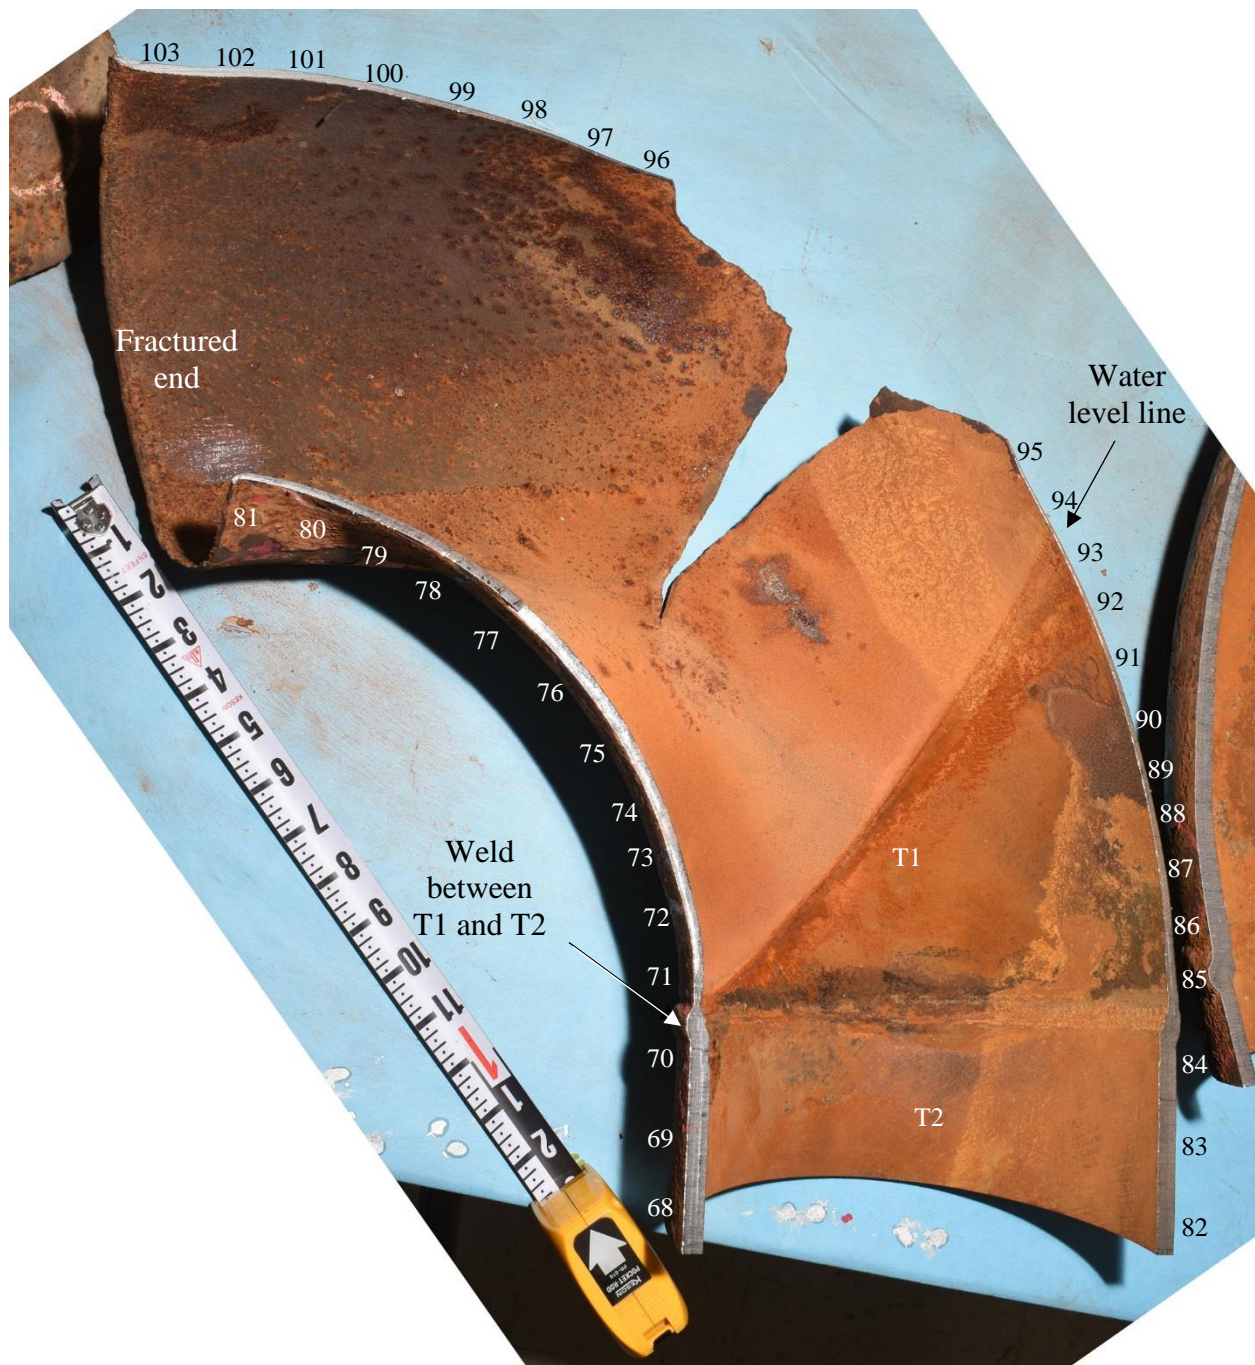
Table 5
Thickness Measurement Results for the Longitudinal Section Through T1
From the Locations Indicated in Figure 7

Figure 7 Longitudinal section of ruptured elbow T1. Numbers indicate thickness measurement locations listed in Table 5.

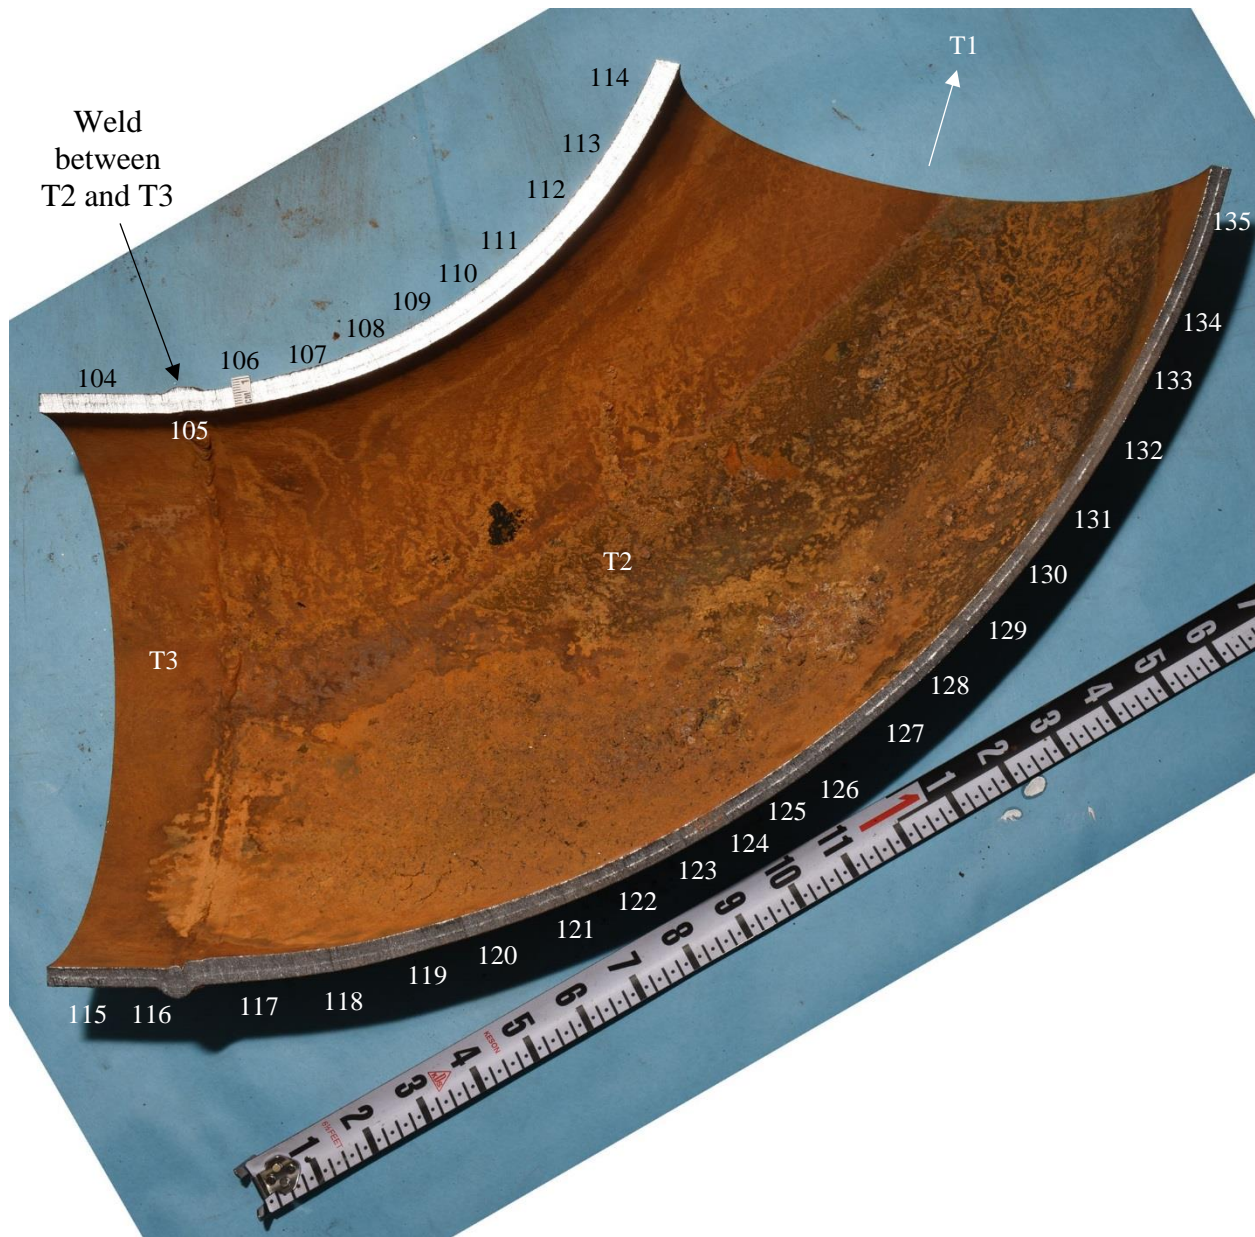
Table 6
Thickness Measurement Results for the Longitudinal Section Through T2
From the Locations Indicated in Figure 8

Figure 8 Longitudinal section through elbow T2.. Numbers indicate thickness measurement locations listed in Table 6.

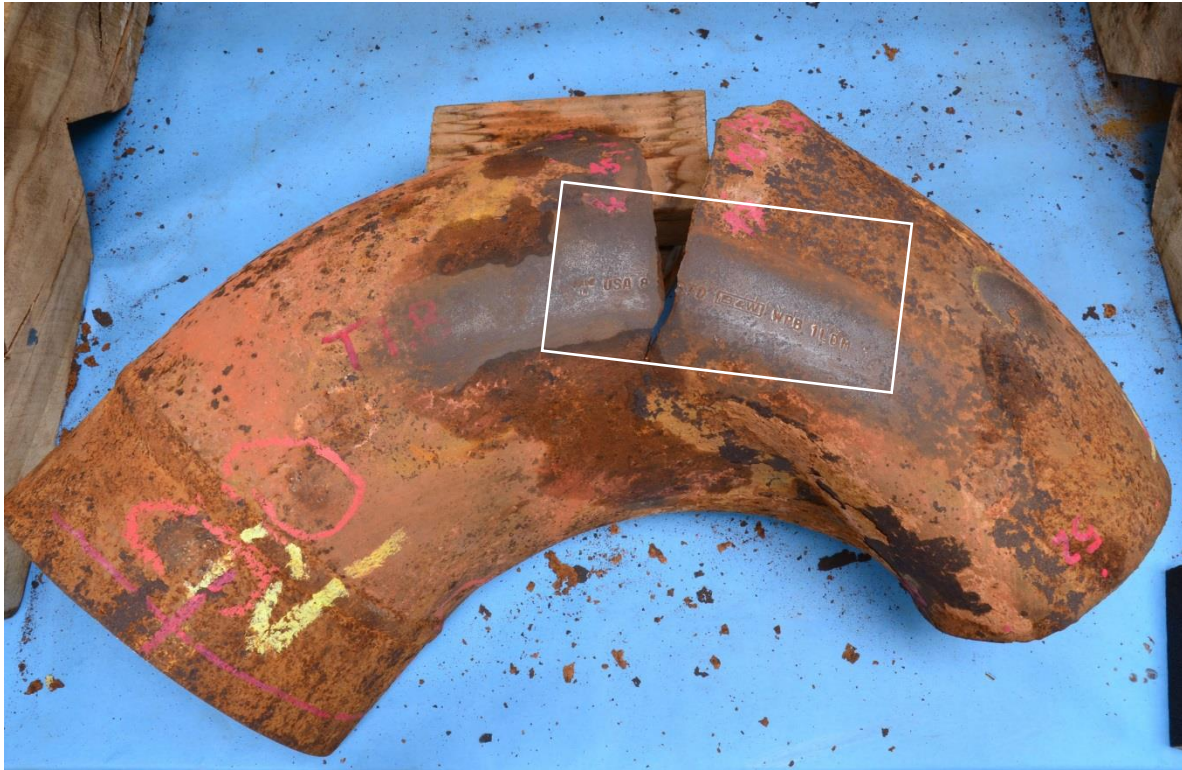
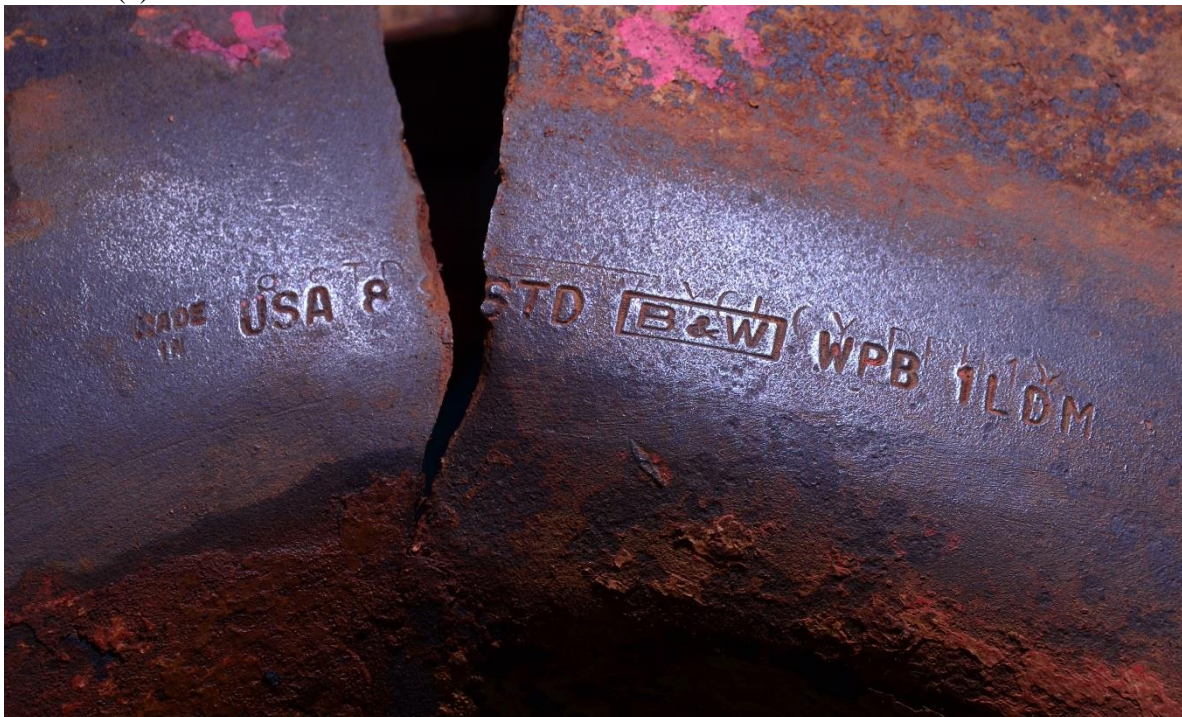
Identification stamps were present on the outside surface of elbows T1 and T2, but were difficult to read through the scale. Scale on the stamped regions was removed by scrubbing with a silicon carbide abrasive pad and water. Photographs of the stamps after scrubbing are shown in Figure 9 and Figure 10. Elbow T1 was stamped: MADE IN USA 8 STD B&W WPB 1LDM, where 8 STD indicates 8-inch nominal pipe size standard Schedule; B&W is the manufacturer's identification; WPB indicates the seamless fitting steel Grade, and 1LDM should be a heat or lot code. These stamps partially overlapped a lighter set of stamps that followed the same general sequence of: 8 STD followed by a mostly illegible manufacturer's identification, partially legible grade designation, and heat or lot code DFH1Y. The CSB suggested that the partially legible grade designation was YOLOY, an older trade name for 2-wt% nickel, 1-wt% copper, 0.25-wt% carbon steel marketed for atmospheric corrosion resistance.¹ Chemical analysis, described in Section 2.2, found that the composition of the T1 elbow was consistent with Yolo steel. In contrast, only one set of stamps was present on elbow T2, which read MADE IN USA 8 STD B&W WPB 1LDM.

Two sets of identification stamps had been made on the ruptured elbow T1. The first, lighter stamp indicated the elbow was Yoloy steel. The second, heavier stamp indicated the elbow was WPB steel. Yoloy was a trade name for a high-strength low-alloy steel to which copper and nickel were intentionally added to increase the atmospheric corrosion resistance and tensile yield strength.¹¹ In 1961, the Metals Handbook indicated:

4. Stamps on the ruptured elbow T1 accurately identified the subject as Yolo, a high-strength low-alloy steel to which nickel and copper were intentionally added to provide increased yield strength and atmospheric corrosion resistance compared to carbon steel.

5. A second set of stamps on the ruptured elbow T1 incorrectly identified the subject as WPB, a grade of carbon steel.
6. The chemical composition of the ruptured elbow T1 met the chemical composition requirements of ASTM A 234, Grade WPB in 1965 because WPB requirements applied to carbon steel and, therefore, did not place limits on residual elements such as copper and nickel.

Figure 9 Photographs of the stamped surface of the ruptured elbow T1 after removing corrosion scale with a grinding pad.

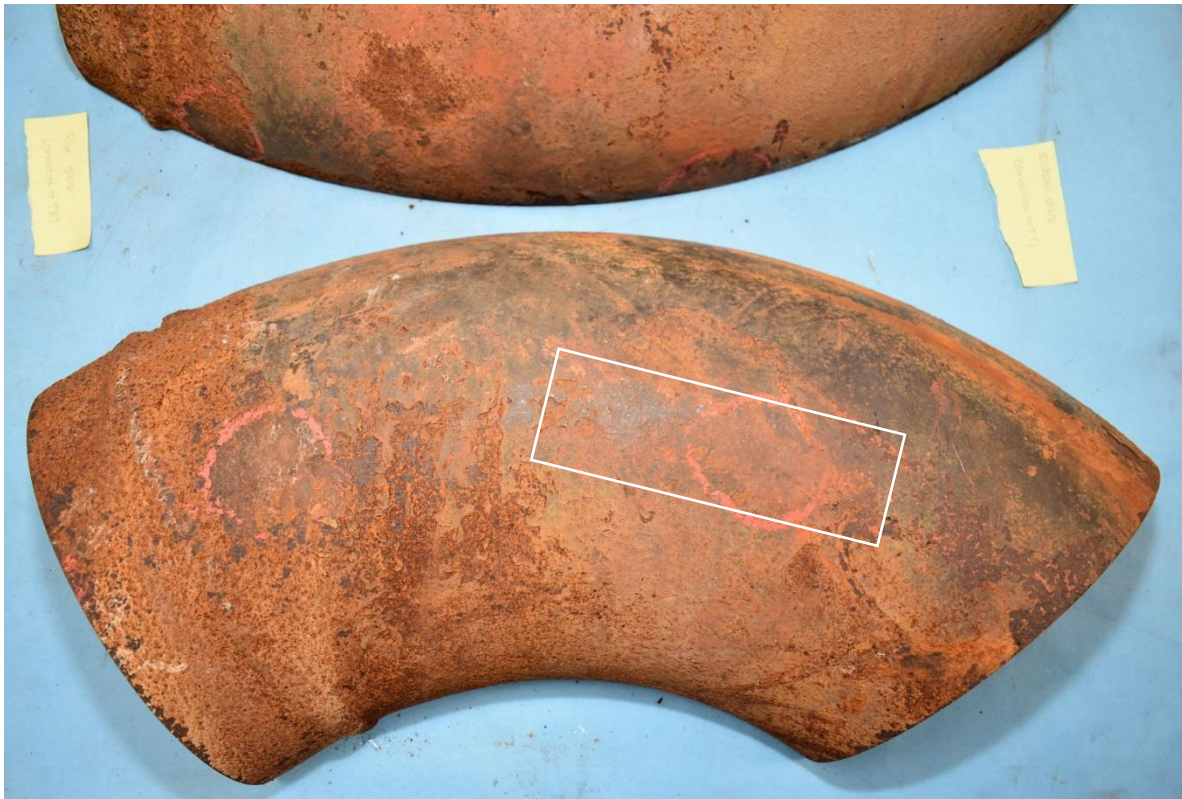
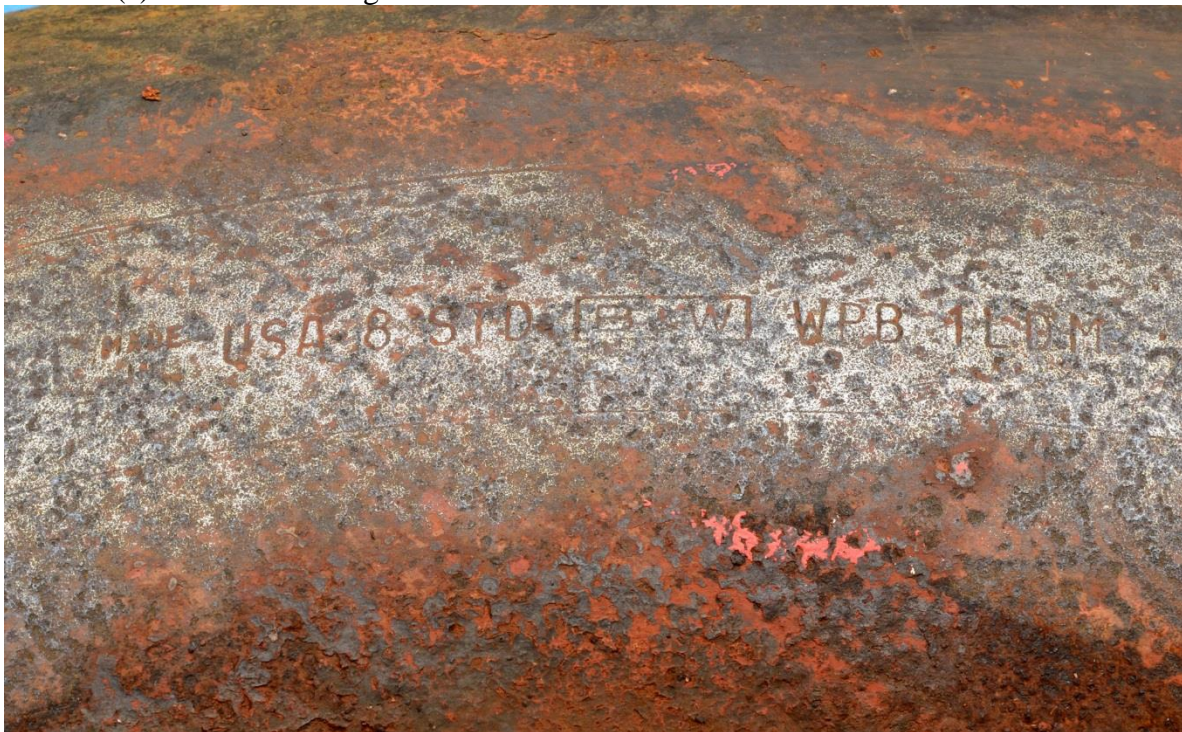
Figure 10 Photographs of elbow T2. In (a), stamps are shown after removing corrosion scale with a grinding pad.

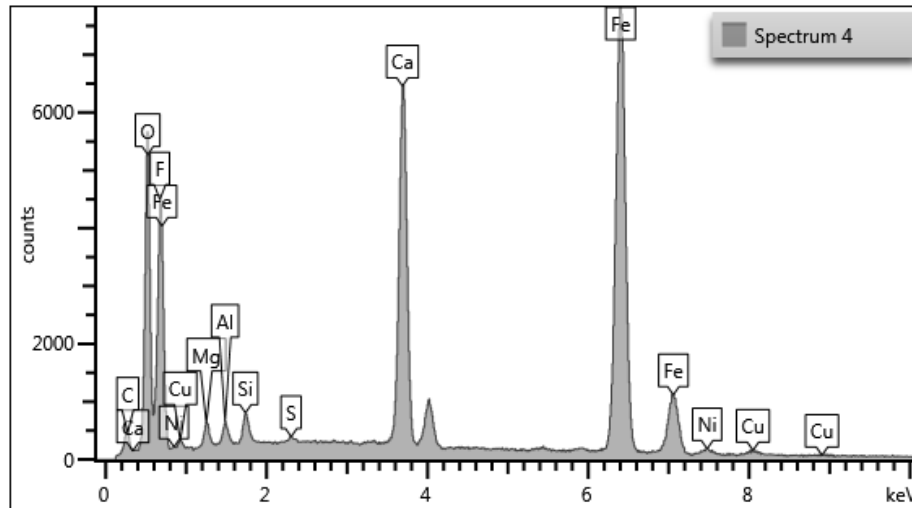
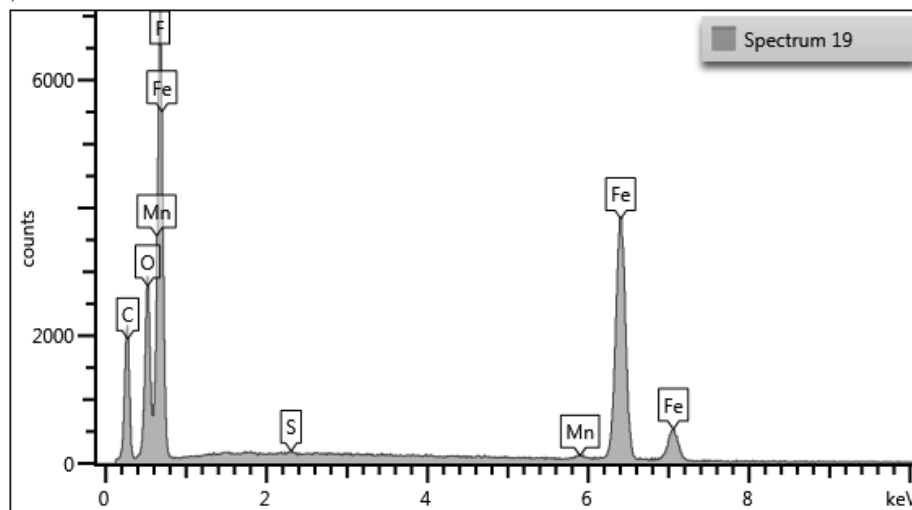
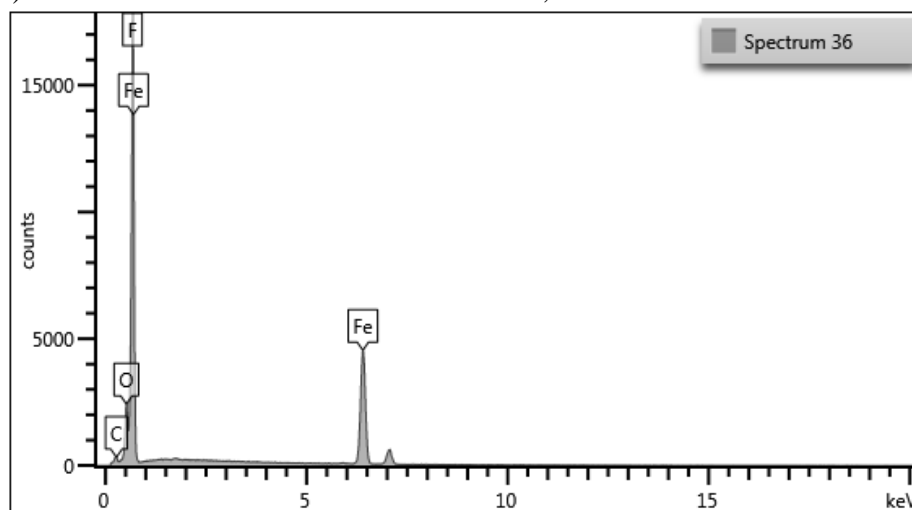
from iron overlap, comparison of the ratios of iron peak amplitudes and modeled spectra provided confidence that fluorine (F) was detected by EDS in all of the specimens. Intense peaks from iron (Fe), and lower amplitude peaks from elements such as chromium (Cr), nickel (Ni), copper (Cu), and silicon (Si) commonly found in carbon steel corrosion product were detected. Calcium (Ca) and magnesium (Mg) were also detected. The presence of fluorine in the scale is consistent with HF corrosion of carbon steel. Representative EDS spectra are shown in Figure 11.

Figure 11 Representative EDS spectra.

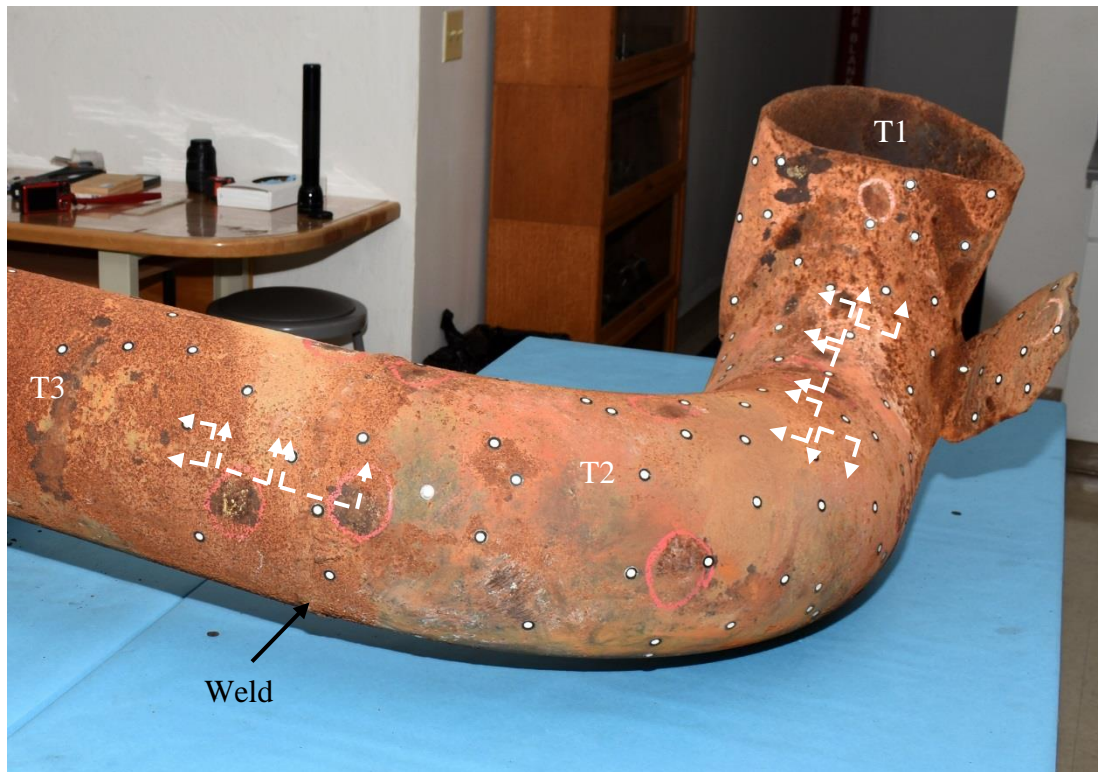
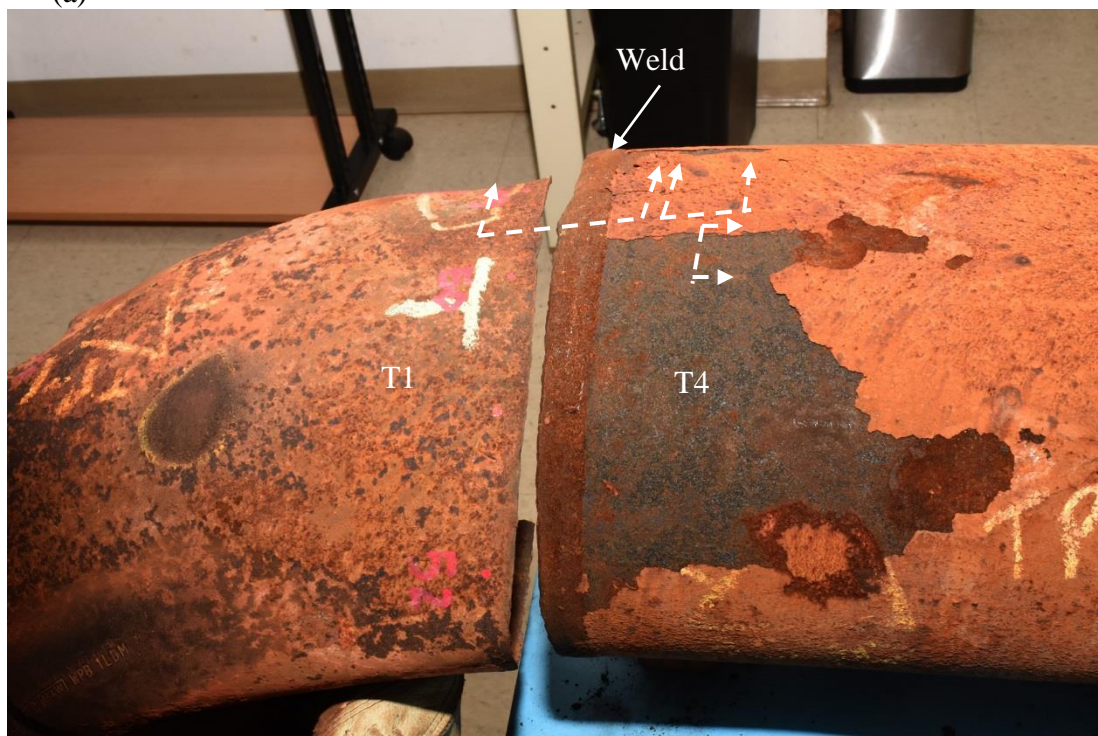
Longitudinal sections were prepared through each of the three welds, through the rupture origin on the flap, and through base metal of T1, T2, T3, and T4 unaffected by the welds, as indicated by dashed lines in Figure 6a and Figure 12. All sections, T1 was much thinner than the other samples, and the weld heat affected zone (HAZ) of T1 and T2 were thinner than the unaffected base metals. Photographs of the weld and flap sections along with representative micrographs are shown in Figure 13 through Figure 25. The microstructure of elbows T1 and T2 consisted of bands of spheroidized carbide in ferrite. In the flap section, the grain size was less than that in T1 base metal sections, indicative of recrystallization from the heat of the fire. The microstructure of pipe T3 and T4 consisted of fine pearlite and ferrite. No unusual microstructures for carbon or high-strength low-alloy steels were revealed by metallography.

Figure 12 Photographs of the locations from which sections were cut for metallography.
