Report No. 5005.7350

May 8, 2020

**METALLURGICAL EVALUATION OF A RUPTURED
DEPROPANIZER ACCUMULATOR DISCHARGE LINE INVOLVED IN THE
JUNE 21, 2019 LOSS OF CONTAINMENT AND FIRE AT
PHILADELPHIA ENERGY SOLUTIONS REFINERY
IN PHILADELPHIA PENNSYLVANIA**

Customer Authorization: CSB-1125-19-0023

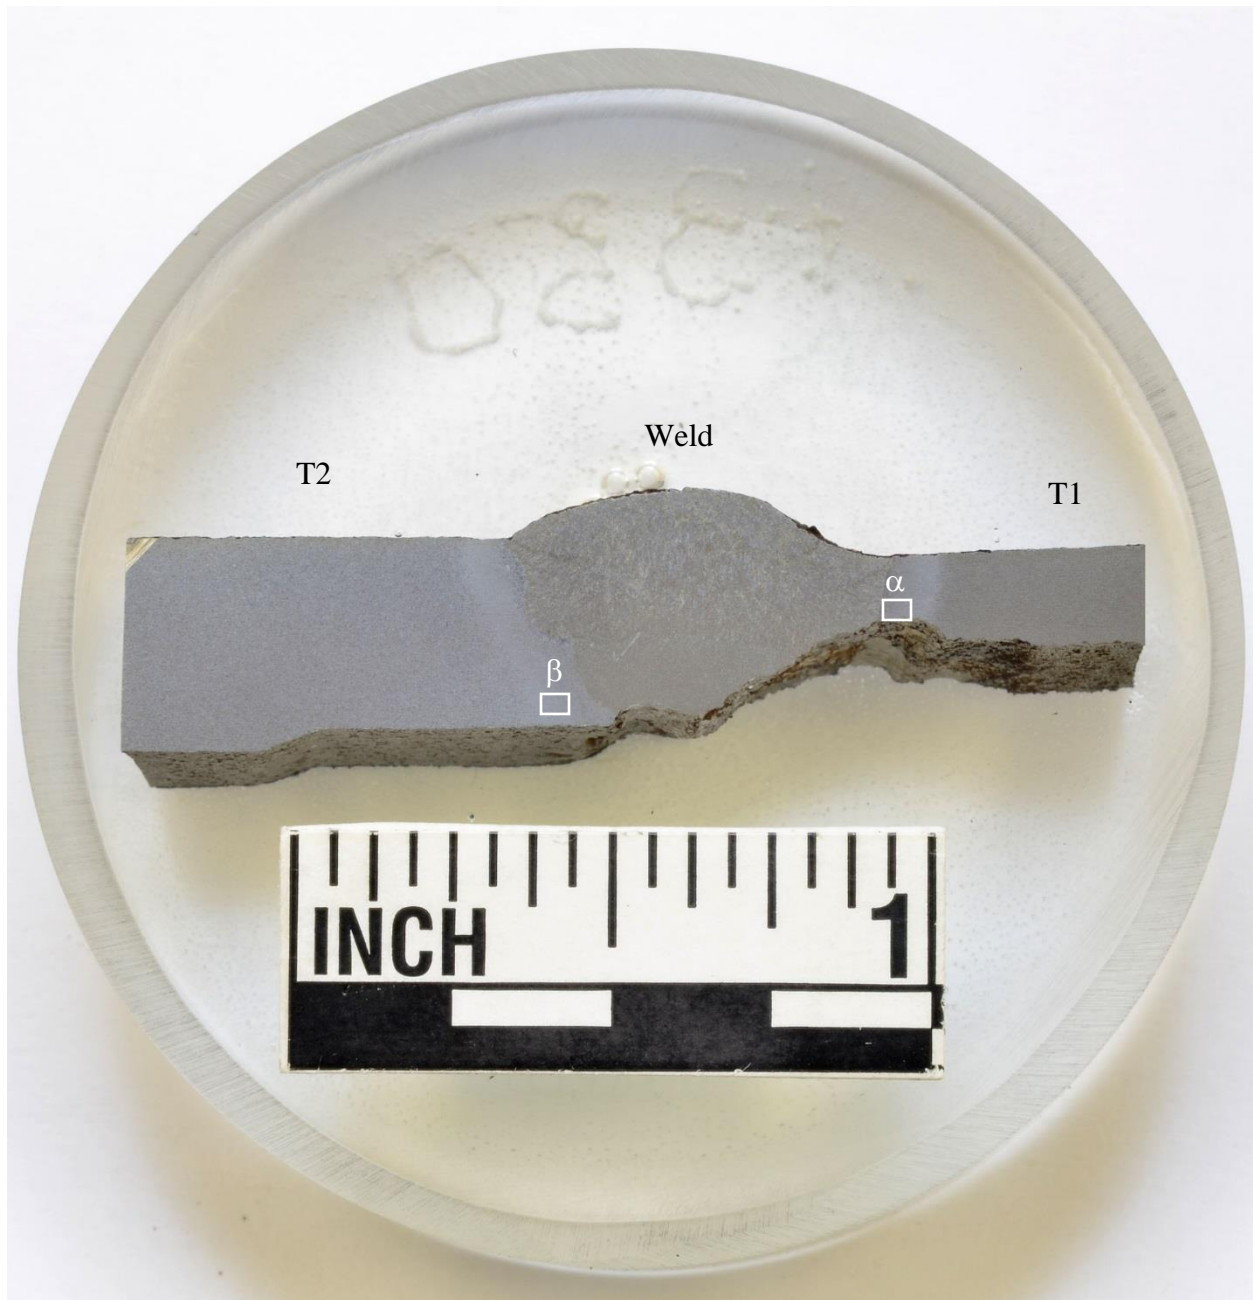
Figure 13 Photograph of the longitudinal section through the T1 to T2 weld prepared for metallography.

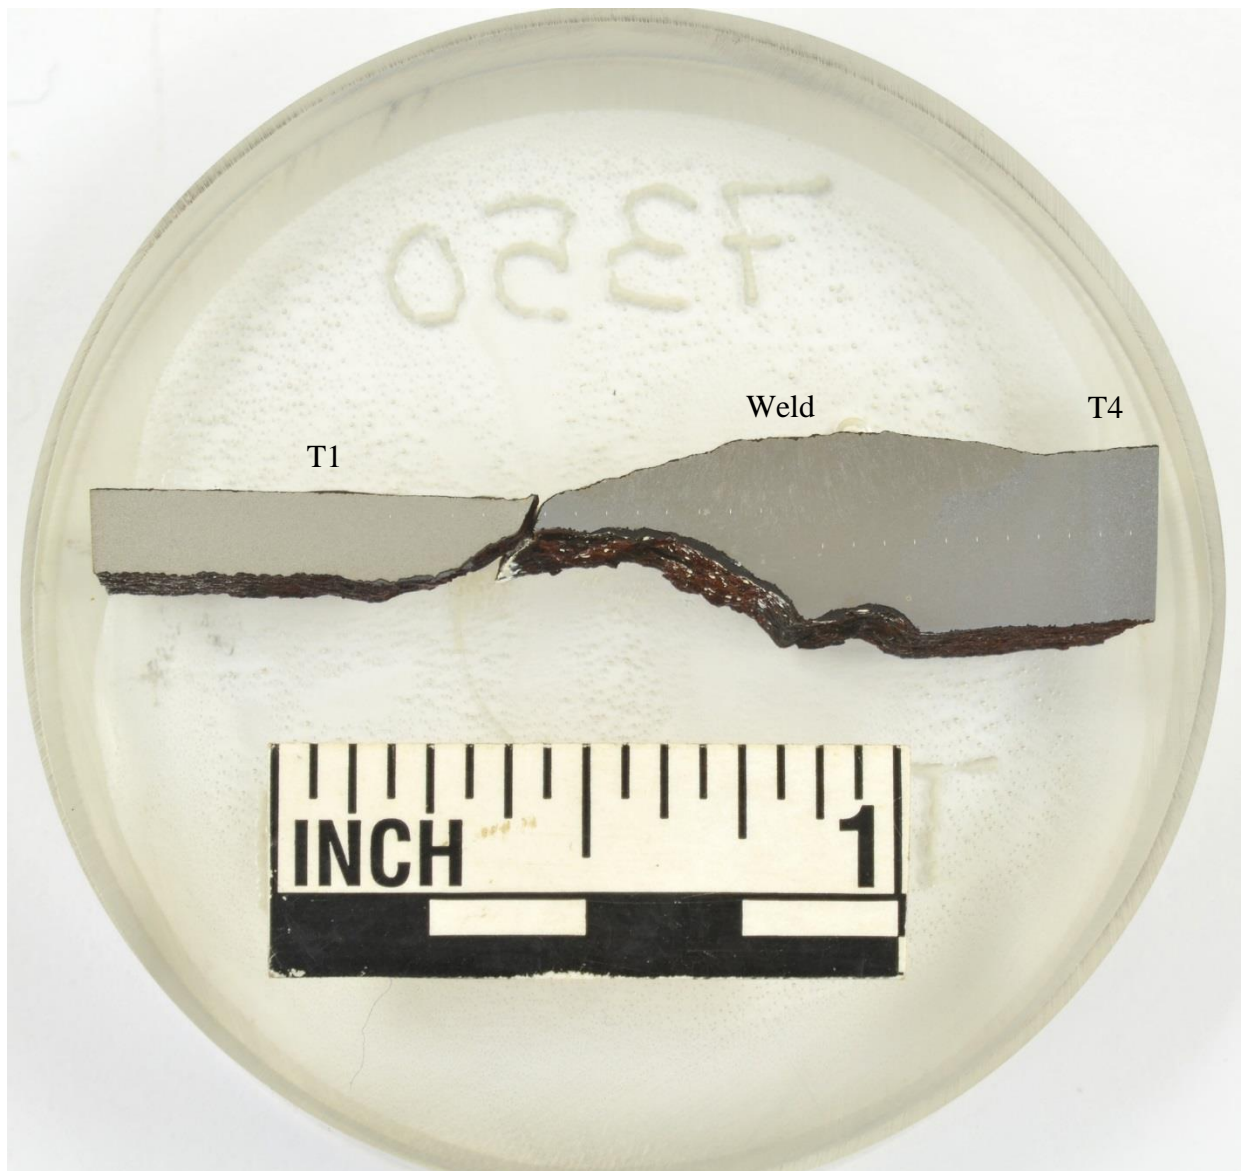
Figure 16 Photograph of the longitudinal section through the T1 to T4 weld prepared for metallography.

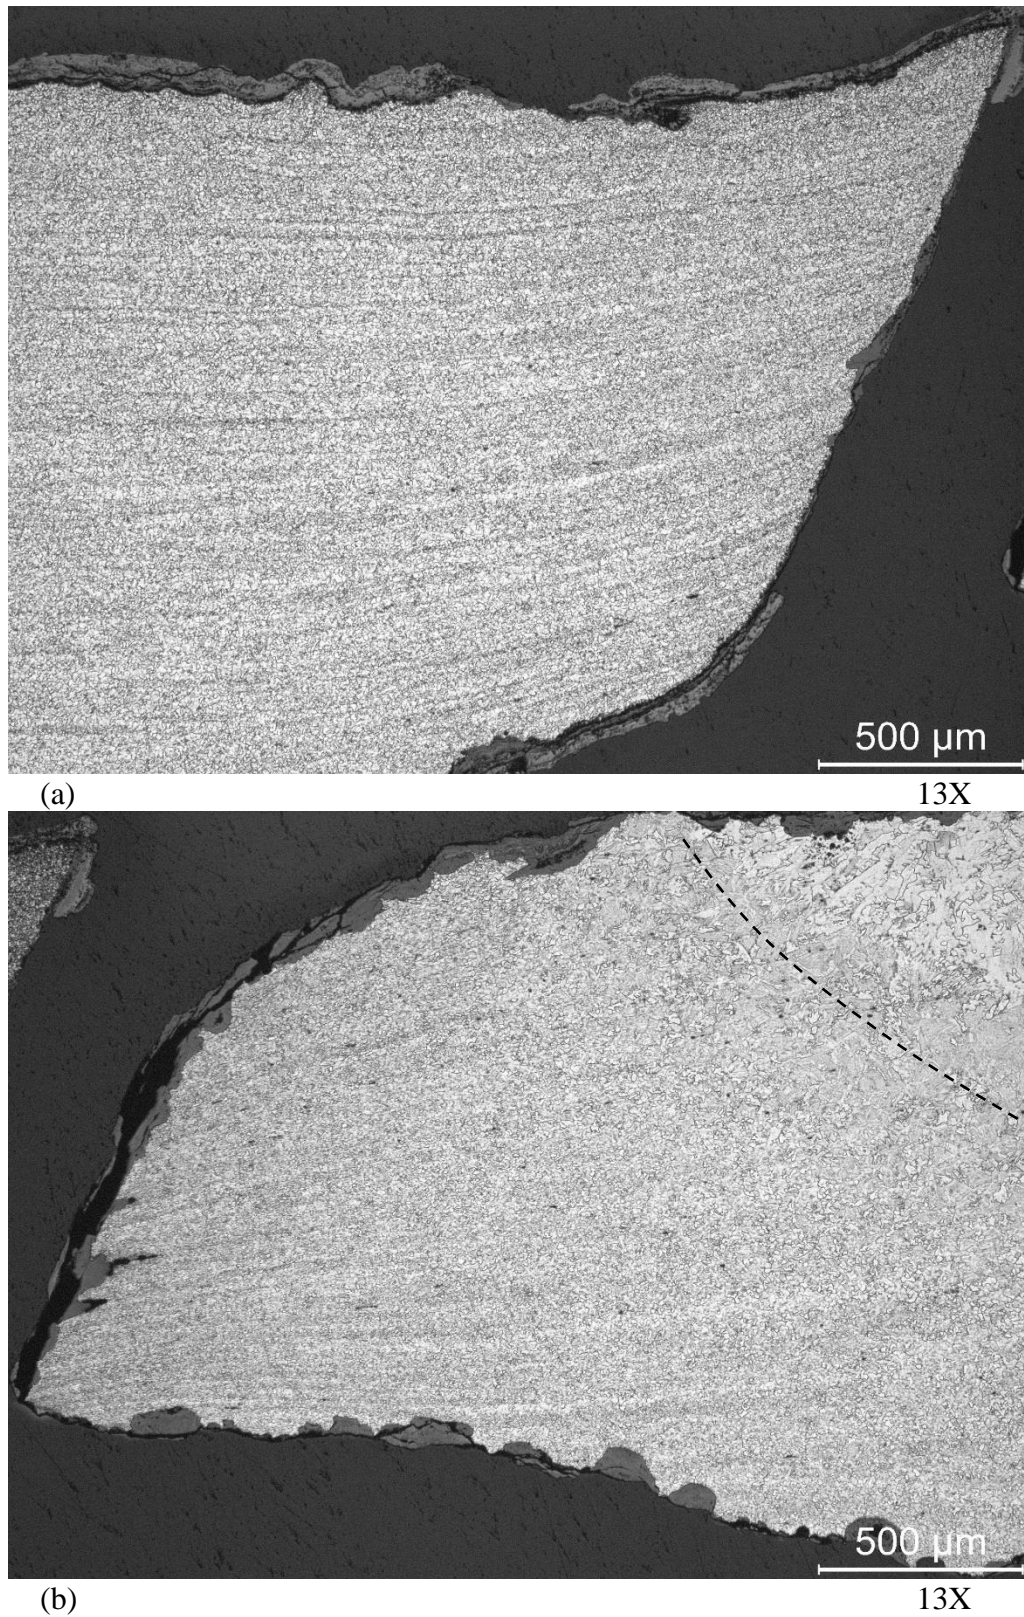
Figure 17 Micrographs of the section through T1 to T4 weld. The dashed line in (b) indicates the weld fusion zone on the T1 side of the joint.

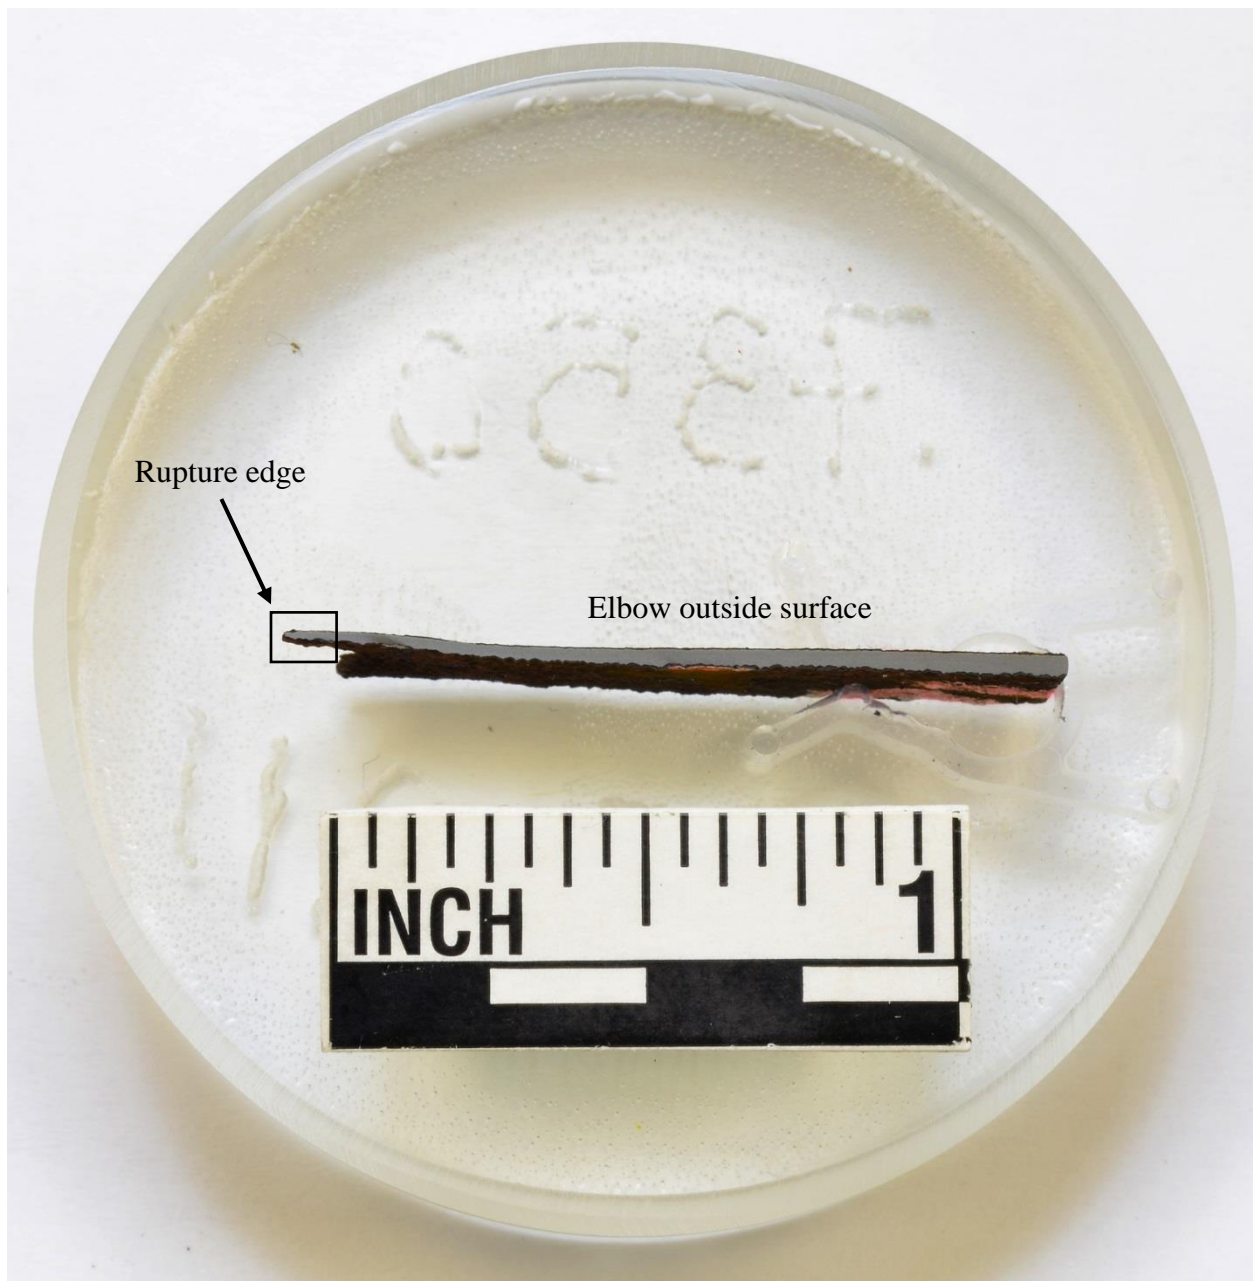
Figure 18 Photograph of the rupture flap section prepared for metallography.

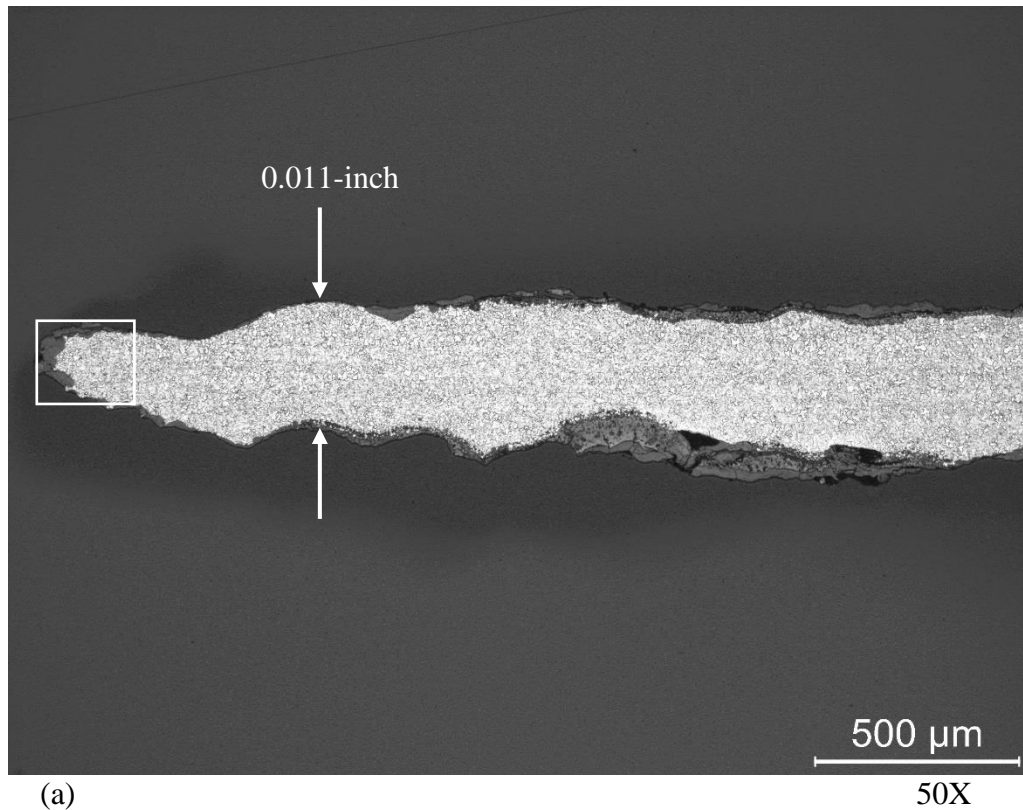
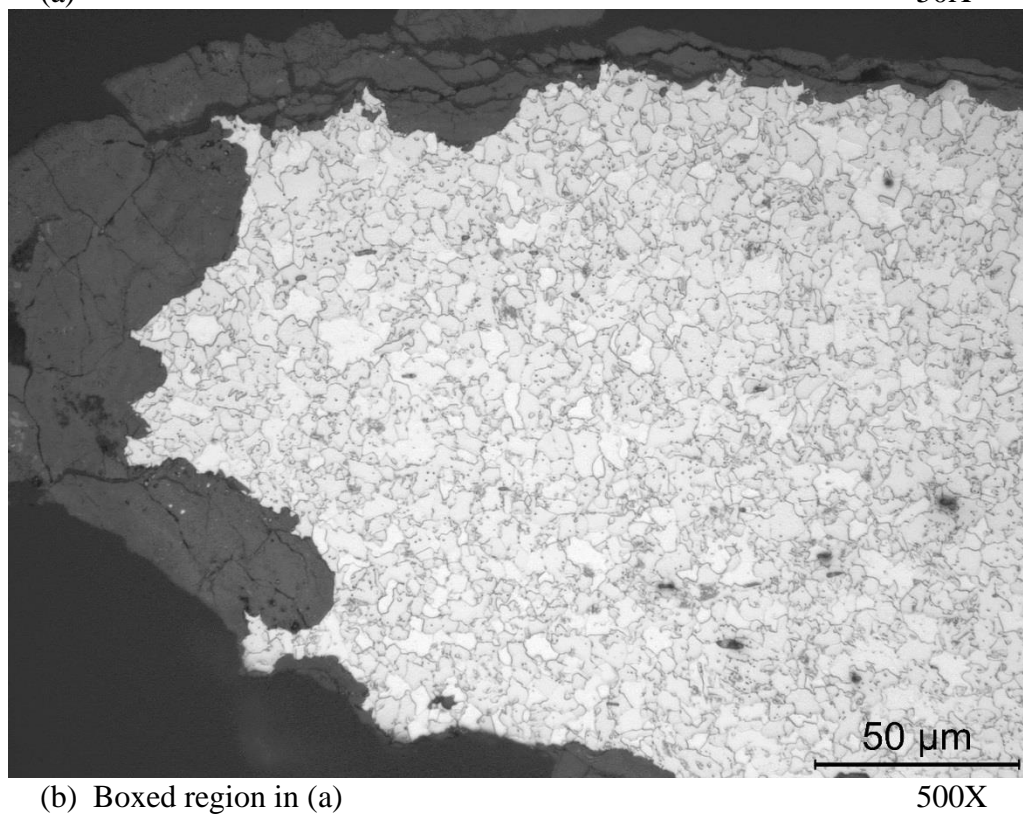
Figure 19 Micrographs of the rupture flap section prepared for metallography, from the boxed region in Figure 18.

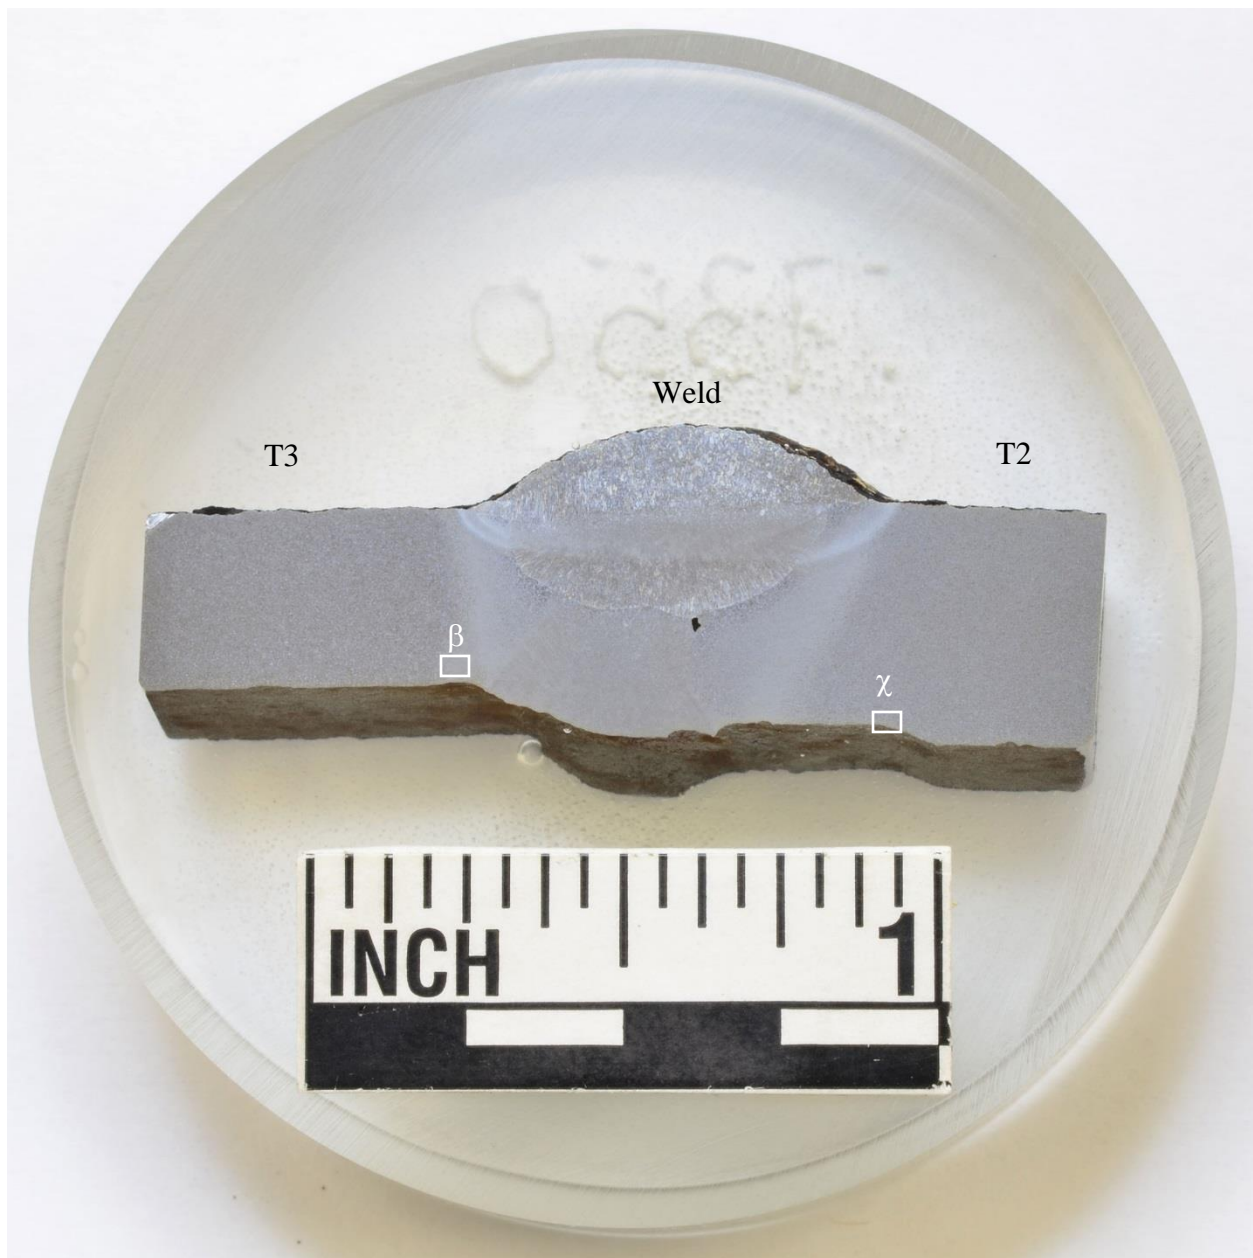
Figure 20 Photograph of the longitudinal section through the T2 to T3 weld prepared for metallography.
