U.S. Chemical Safety and
Hazard Investigation Board

Chemical Reaction, Decomposition, and Toxic Gas Release at Bio-Lab, Inc.

Westlake, LA | Incident Date: August 27, 2020 | No. 2020-05-I-LA

Investigation Report

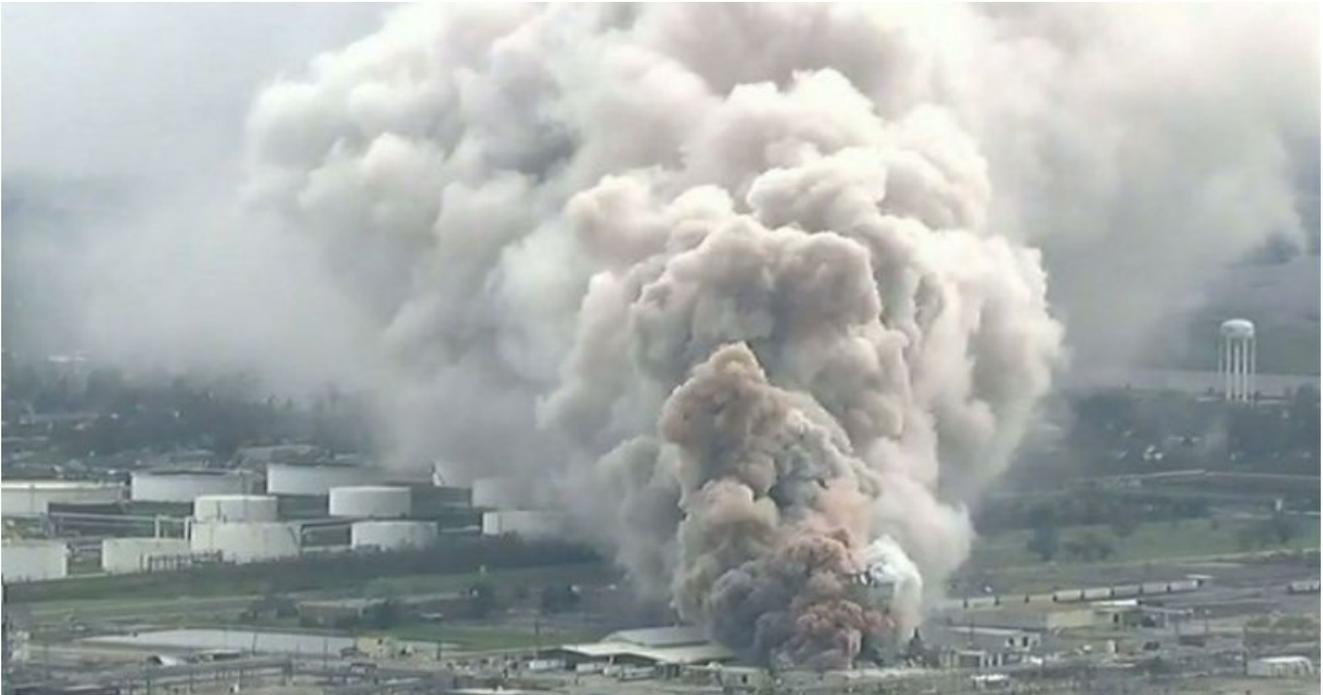
Figure 7. Photo of decomposition gases, including toxic chlorine, released from Bio-Lab Plant 4 after the building was severely damaged during Hurricane Laura and rainwater contacted the stored chemicals. (Credit: The Associated Press [22])

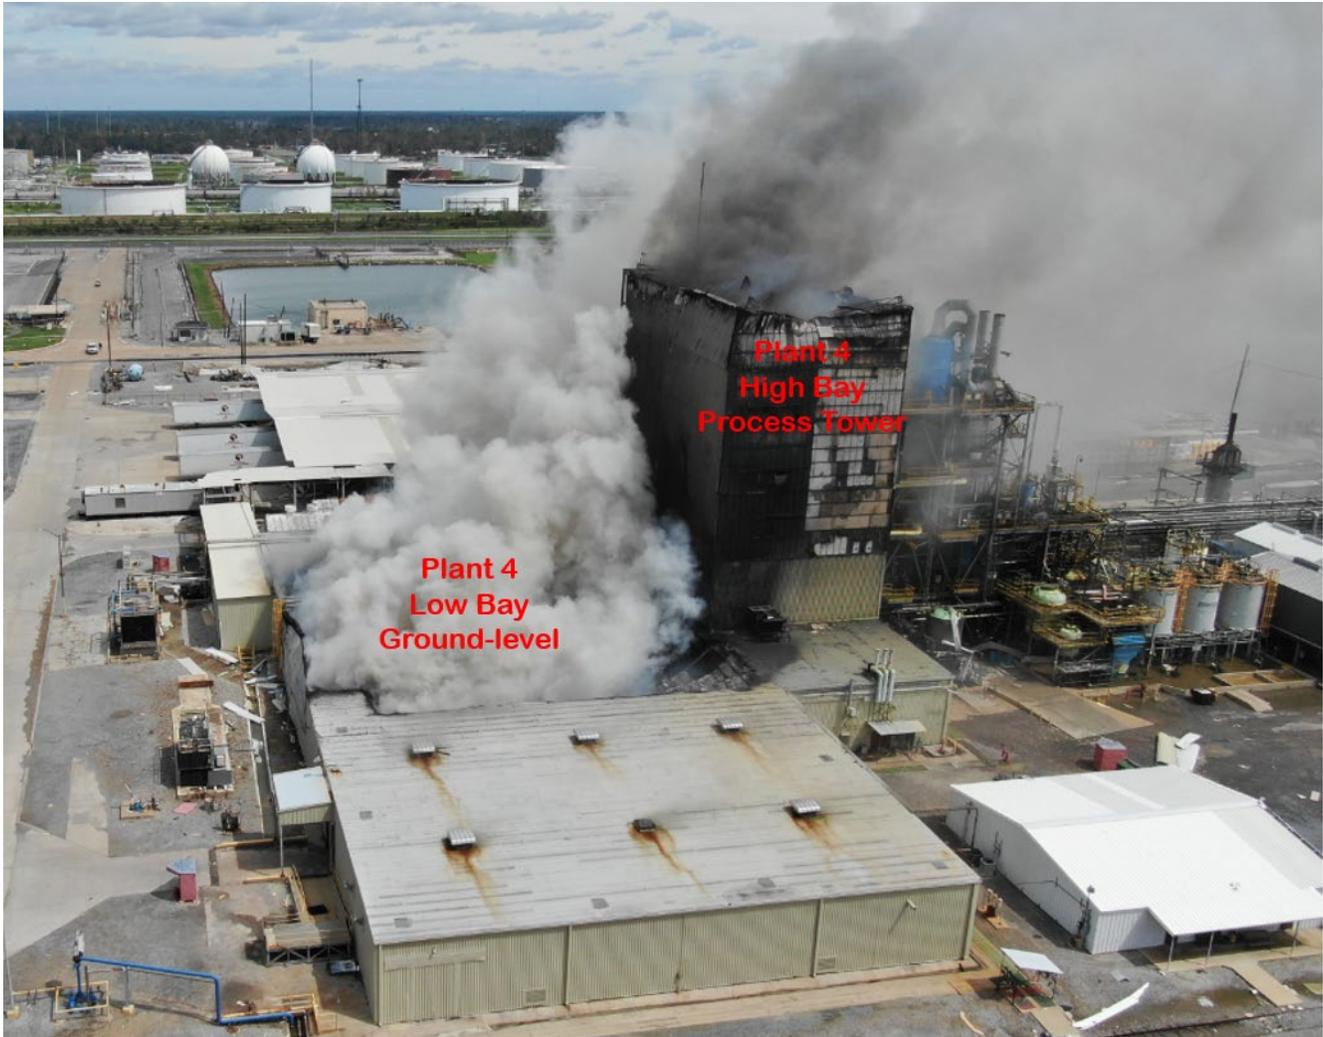
Figure 9. Decomposing chemicals in Plant 4 on August 27, 2020. (Credit: Louisiana State Police, annotations by CSB)

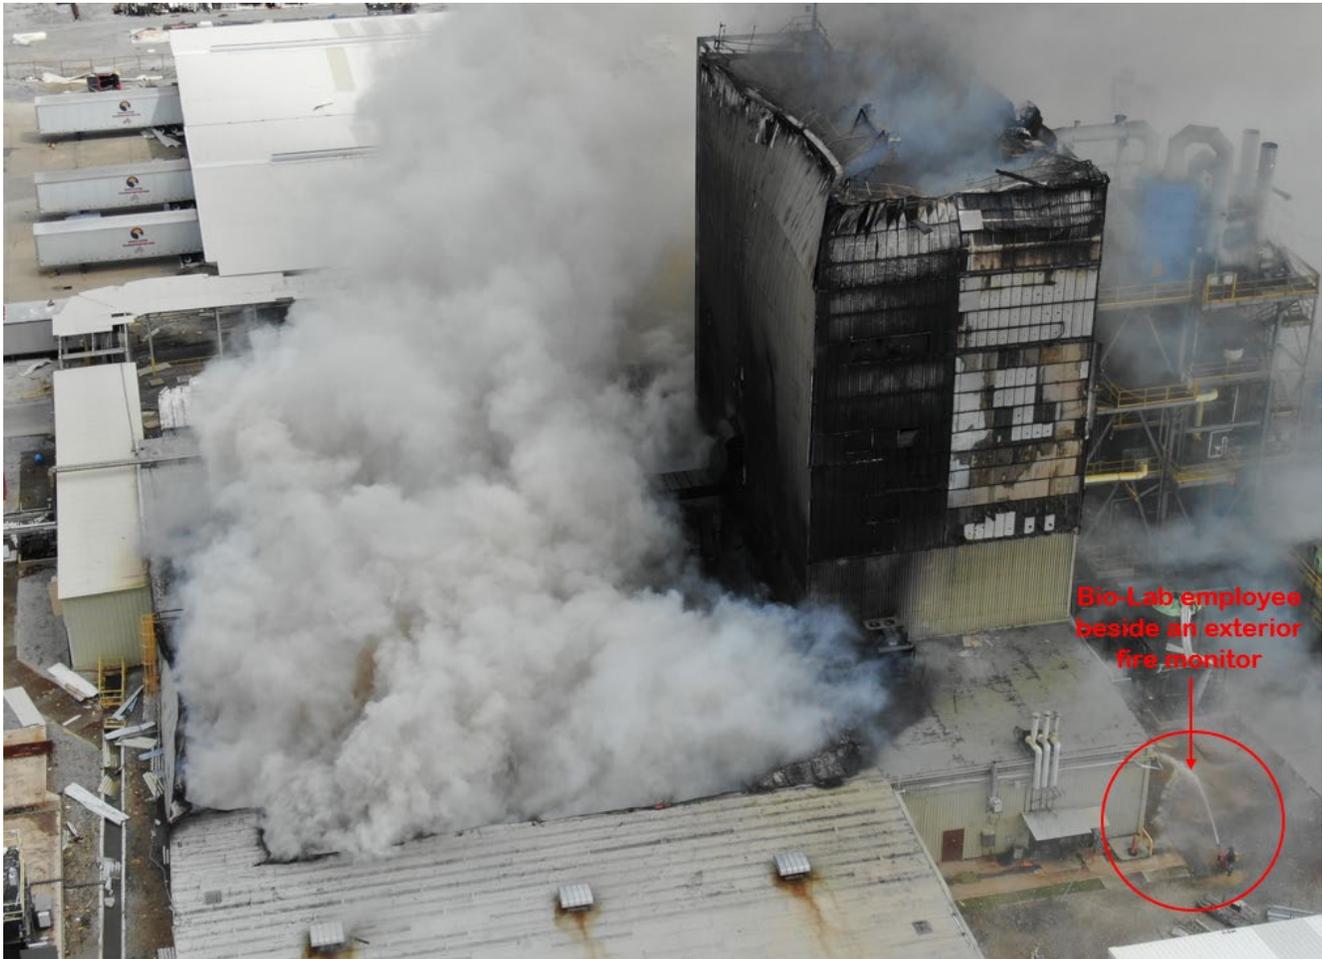
Figure 11. Available water pressure at an exterior fire monitor near Plant 4. (Credit: Louisiana State Police, annotations by CSB)

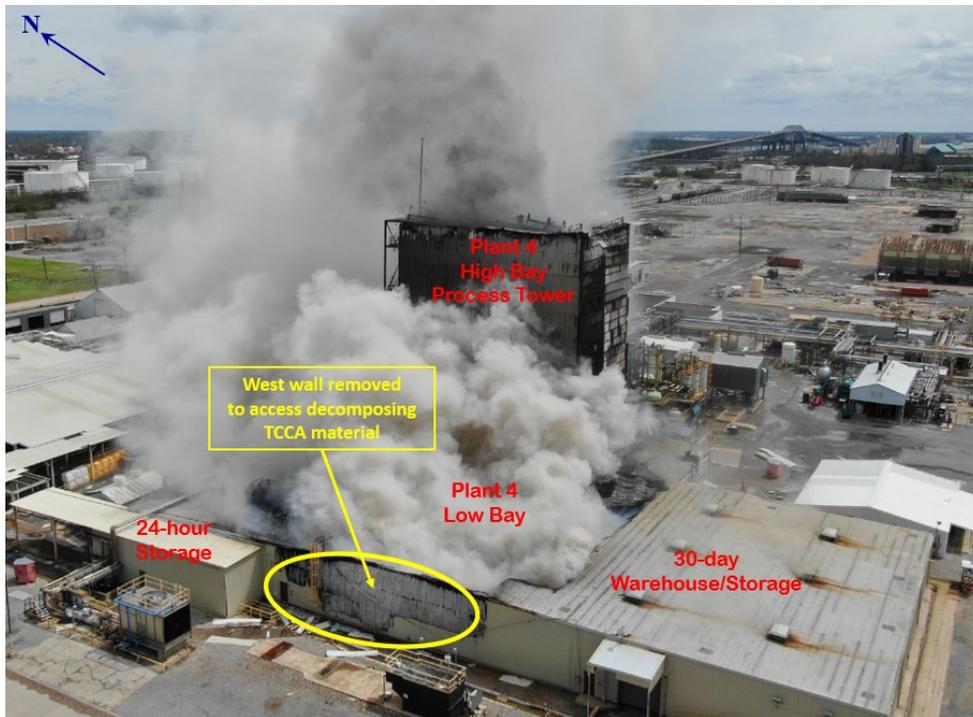
Figure 12. Decomposing chemicals stored in Plant 4. (Credit: Louisiana State Police, annotations by CSB)

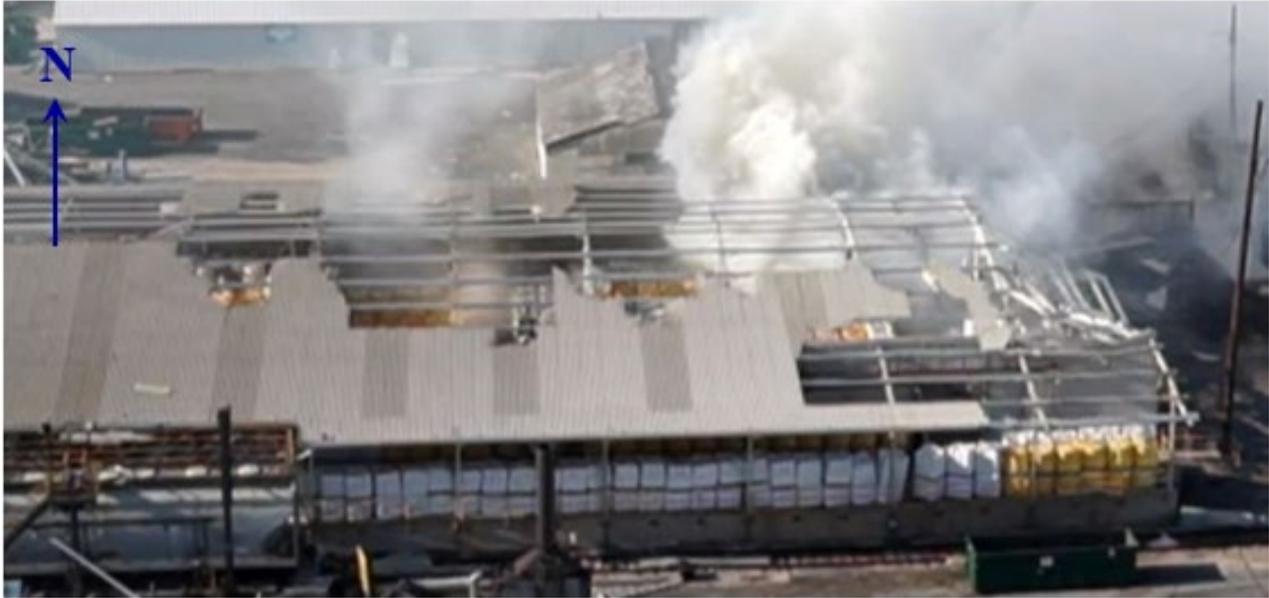
Figure 13. Damaged Finished Goods Warehouse roof emitting white fumes. (Credit: Bio-Lab)

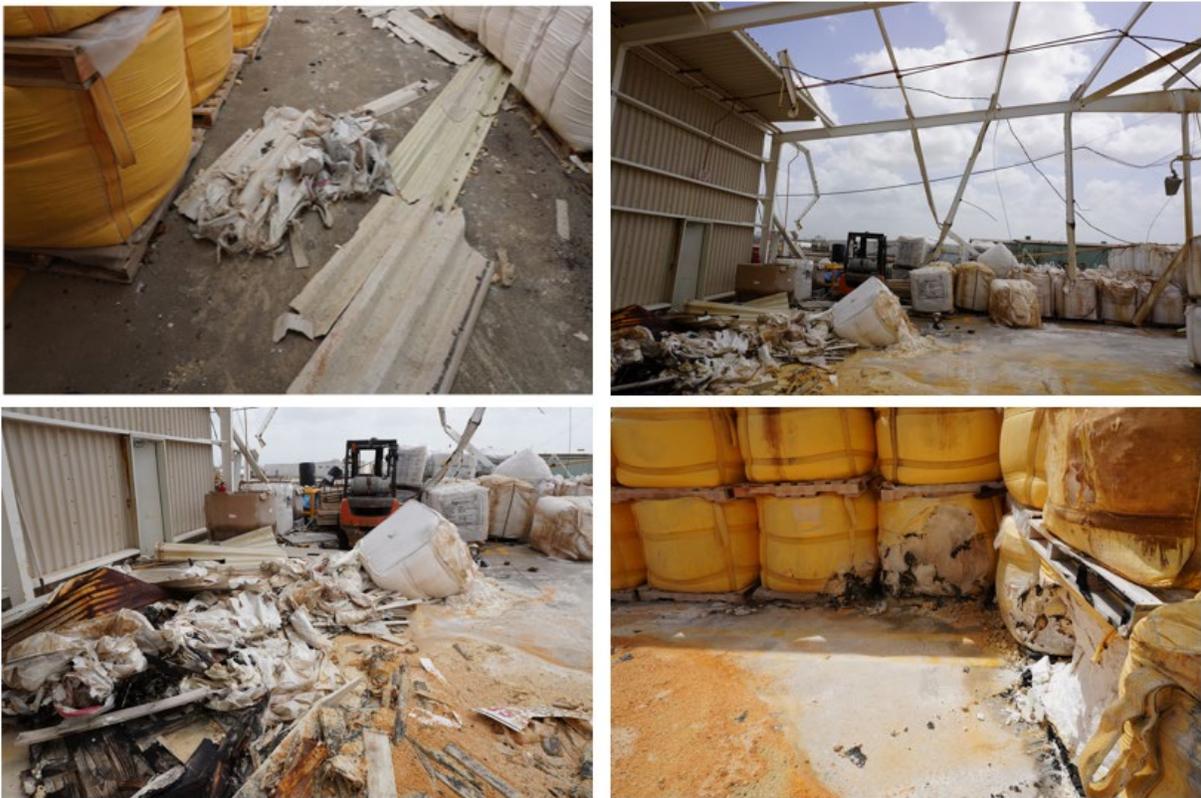
Figure 14. Inventory and storage areas inside the Finished Goods Warehouse following the second event. (Credit: CSB)

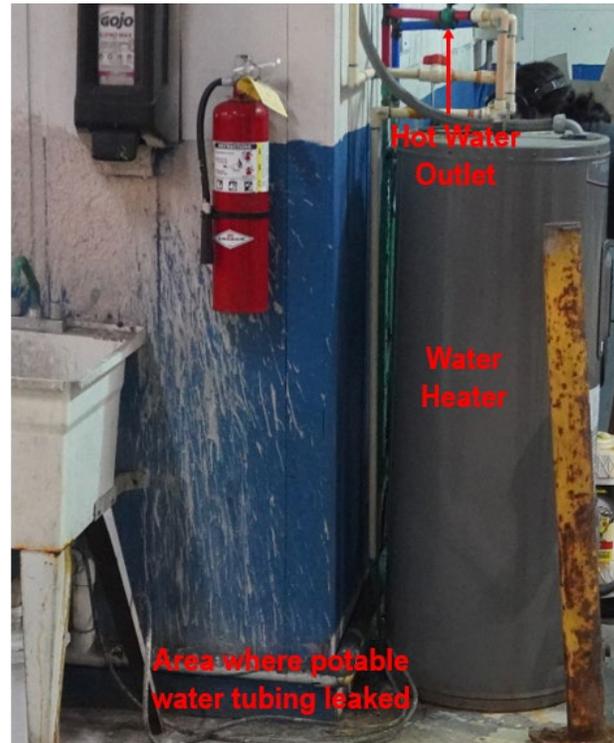
Between the close of business on Saturday, September 12, 2020, and the normal arrival of employees on Monday, September 14, 2020, a 3/8-inch polyethylene water line leaked in the Bio-Lab Conyers Plant 6, flooding a portion of the building. At approximately 4:50 a.m. on Monday, September 14, 2020, while Worker #1, a production lead, was in the building office preparing for the shift, Worker #2, a blending operator, entered the office and reported seeing water on the building floor. Worker #1 proceeded to the area to assess the situation and saw that water covered approximately 75% of the floor. Worker #1 estimated that the floodwater was about two or three inches deep in some areas but lower than the top of the wood pallets used to store TCCA-based formulation near the building's north wall (**Figure 23**).^a He then walked near the employee restrooms (**Figure 23**) and saw water releasing from a polyethylene line connected to the water heater (**Figure 24**). Worker #1 immediately closed the water heater's hot water outlet valve, which stopped the water leak. After stopping the water leak, Worker #1 contacted the Maintenance Department to report the damaged line and notified management of the flooded warehouse.

Figure 24. Location of polyethylene line that leaked, causing an area in the Bio-Lab Conyers Plant 6 to flood. (Credit: CSB)

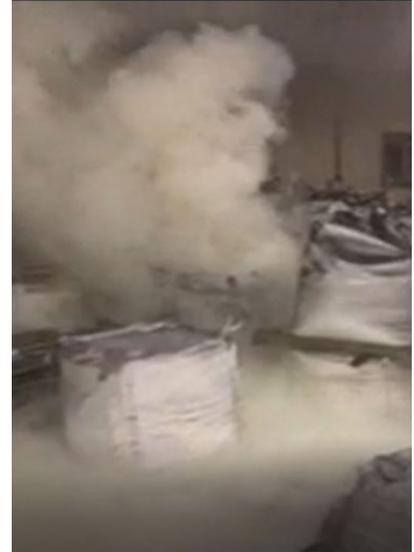
Figure 25. Decomposition on September 14. (Credit: Bio-Lab Conyers)

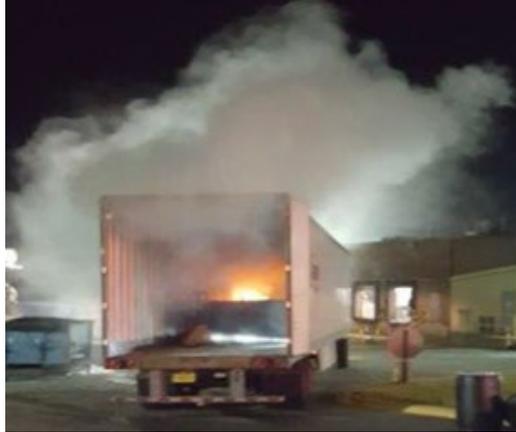
Figure 28. Decomposition on a rental trailer at Bio-Lab Conyers. (Credit: Bio-Lab Conyers)

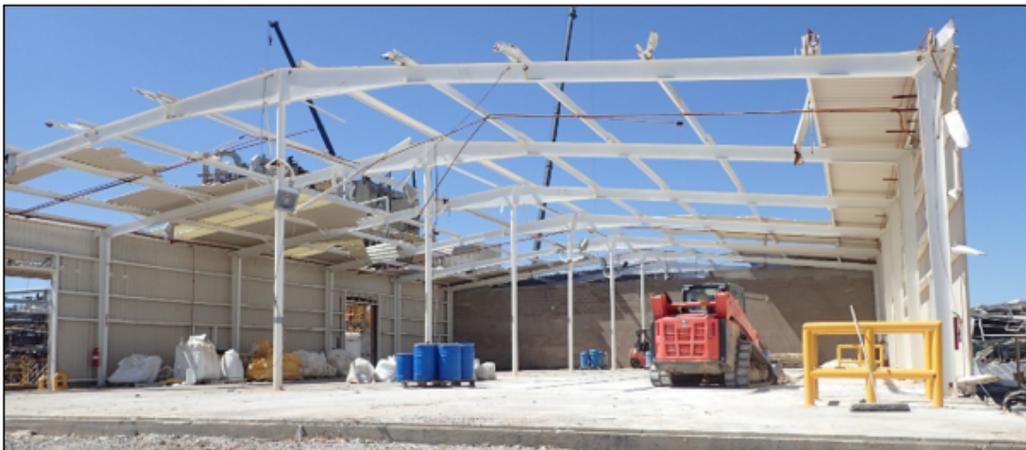
Eastern bay of south FGW, looking SW. Wrecked framing has been removed (Atlas, 9/29/2020)

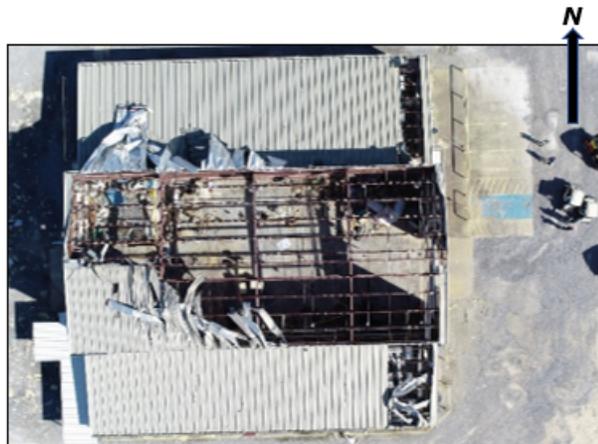
We observed debris from the roof and found that the metal roof panels tore free around the screw heads. At the roof areas that had been stripped, the purlins and structural frames appeared undamaged.

A-Z Building (Atlas UAV, 9/30/2020)

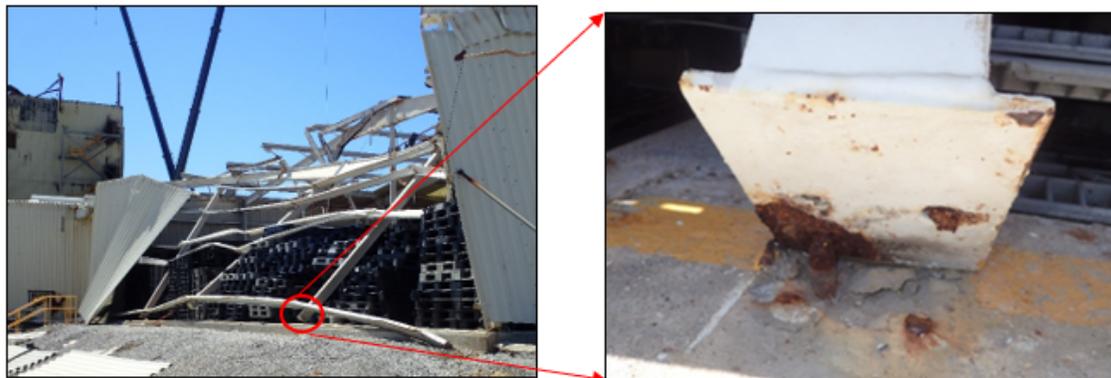
Eastern bay of north FGW, looking SW, & close-up of column base and anchor bolts (Atlas 9/29/2020)

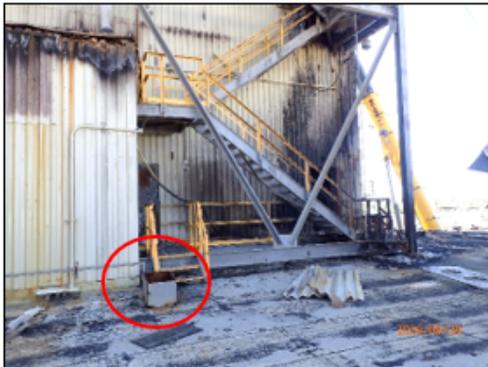
Roof-top ductwork torn away, at two roof areas adjacent to Low Bay

Roof opening at broken duct, Low Bay roof north of High Bay tower (Atlas 9/29/2020)

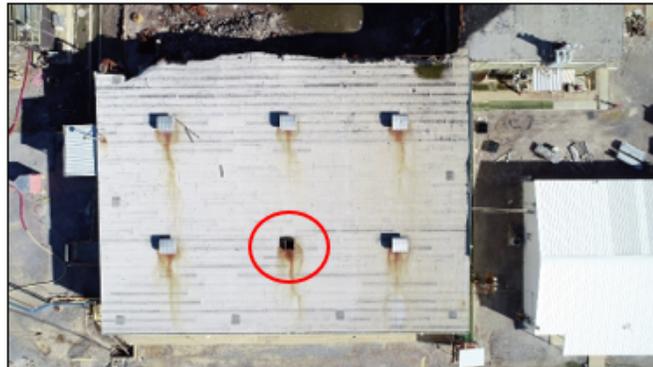
Open roof duct at 30-day Warehouse, just south of Low Bay (Atlas UAV 9/30/2020)

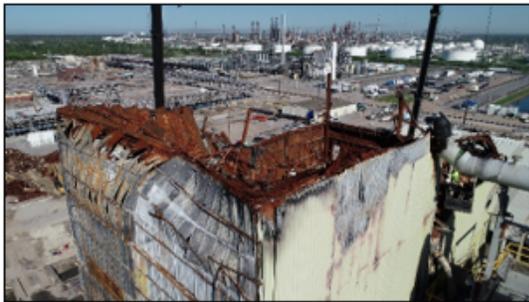
Upper 35’ of tower looking NW, after fire & demo work (Atlas UAV, 9/30/2020)

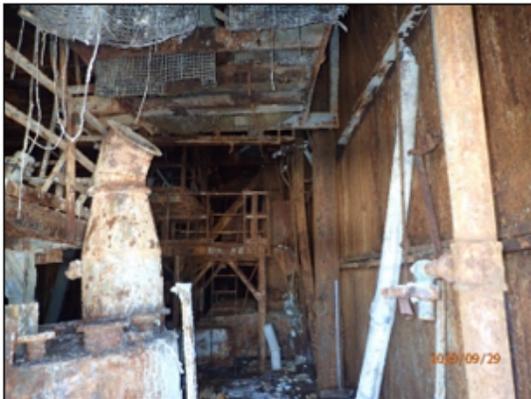
3rd floor level from north stair, showing heat-deformed columns & bracing (Atlas, 9/29/2020)

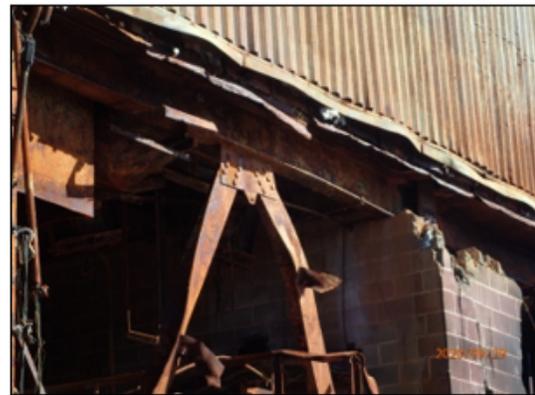
Ground floor level looking east, showing heat-deformed brace & spandrel (Atlas, 9/29/2020)
