Factual Update

Published: October 30, 2019

U.S. Chemical Safety and Hazard Investigation Board

On Sunday, March 17, 2019, at approximately 10:00 am, a large fire erupted at the Intercontinental Terminals Company, LLC (ITC) bulk liquid storage terminal located in Deer Park, Texas (**Figure 1**). The fire originated in the vicinity of Tank 80-8, an 80,000-barrel aboveground atmospheric storage tank that held naphtha, a flammable liquid, typically used as a feedstock or blend stock for production of gasoline. ITC was unable to isolate or stop the release of naphtha product from the tank, and the fire continued to burn, intensify, and progressively involved additional tanks in the tank farm. The fire was extinguished on the morning of March 20, 2019.

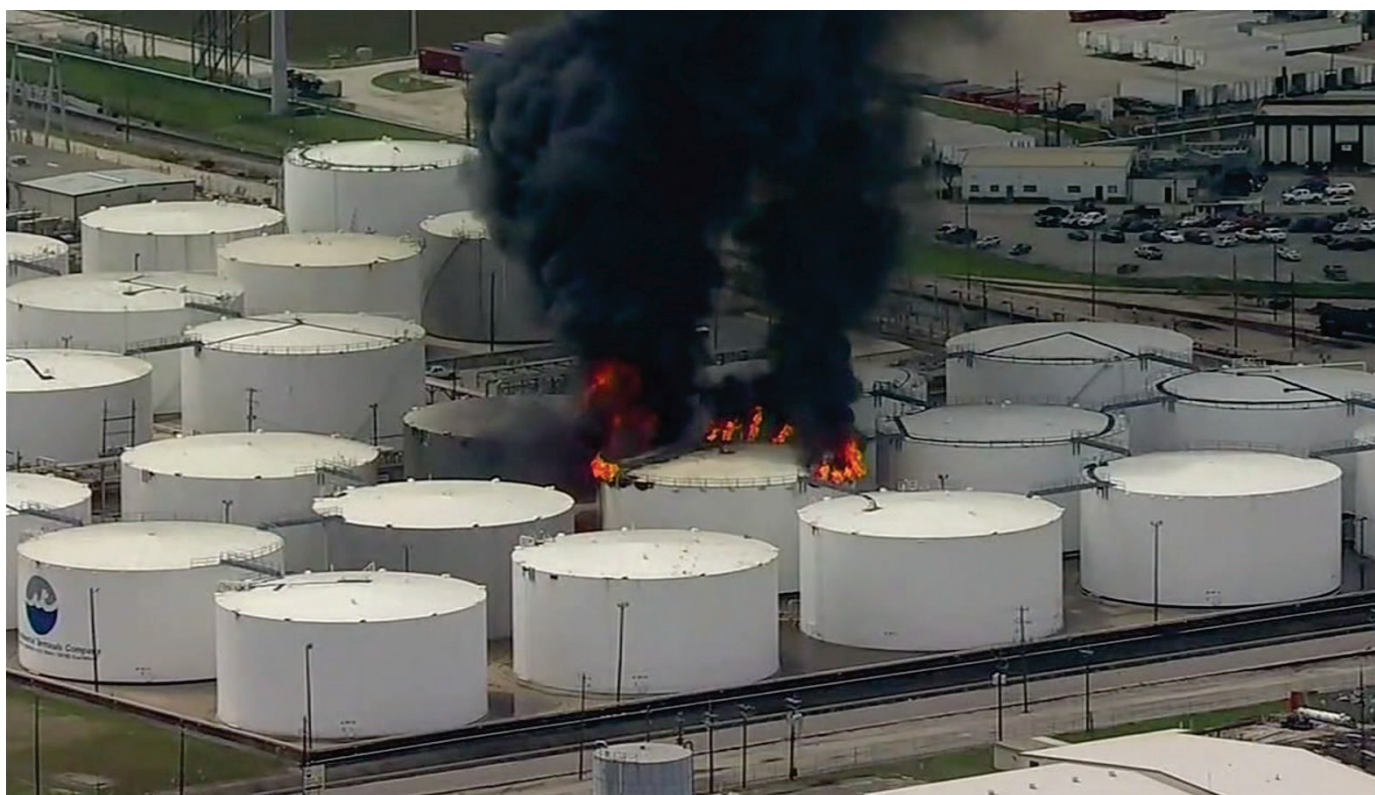
Figure 1. ITC Fire. This photo shows the ITC fire involving tank 80-8 on March 17, 2019. (Source: ABC13 Houston).

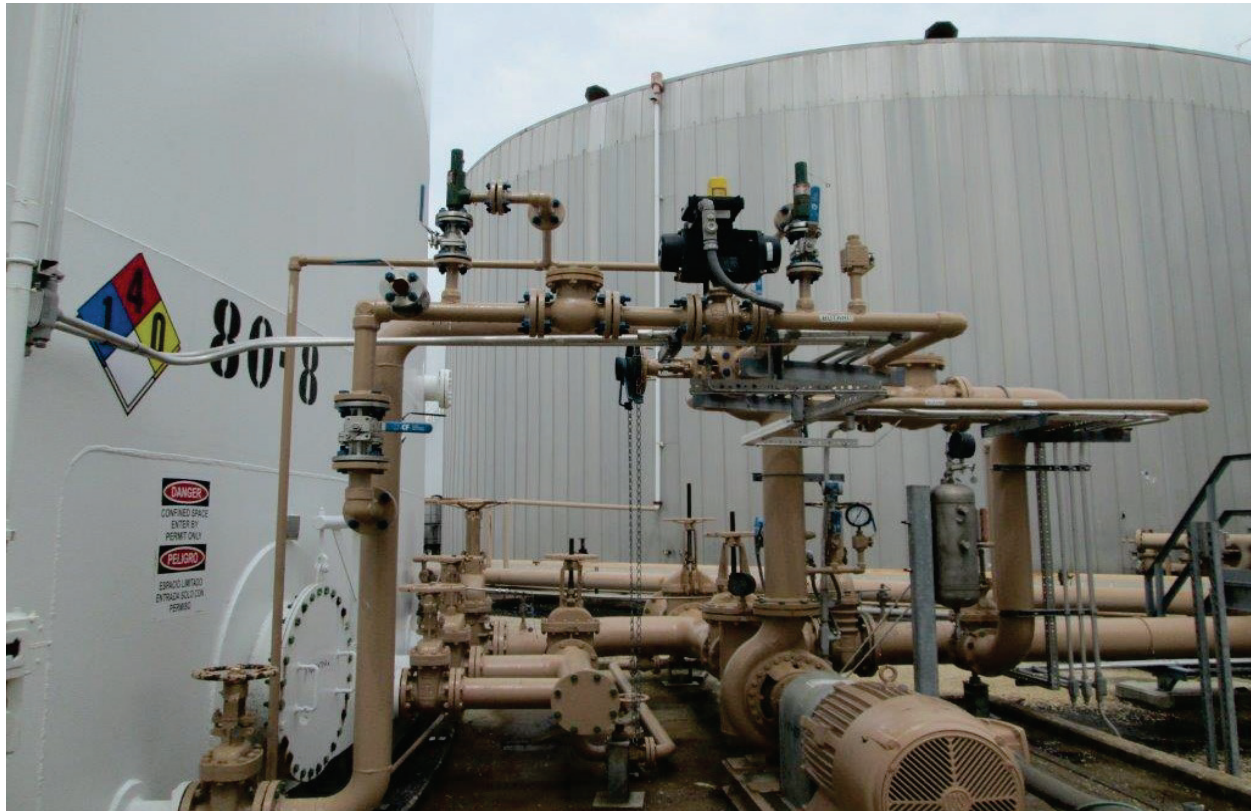
Tank 80-8 was an 80,000-barrel aboveground atmospheric storage tank. The tank went into service in 1972 and was original to the ITC Deer Park Terminal. Tank 80-8 was leased to another company for naphtha storage and for naphtha-butane blending operations. ITC injects butane into the naphtha product using external piping and equipment (piping manifold) (**Figure 3**) to increase the octane level of the fuel product.

Figure 3. Tank 80-8 Piping Manifold. This image taken before 2016 shows Tank 80-8 and its piping manifold. (Source: ITC).

^b Both Figure 3 and Figure 4 show the Tank 80-8 piping manifold before the January 2016 revision, when ITC replaced some of the 2-inch piping with 4-inch piping.

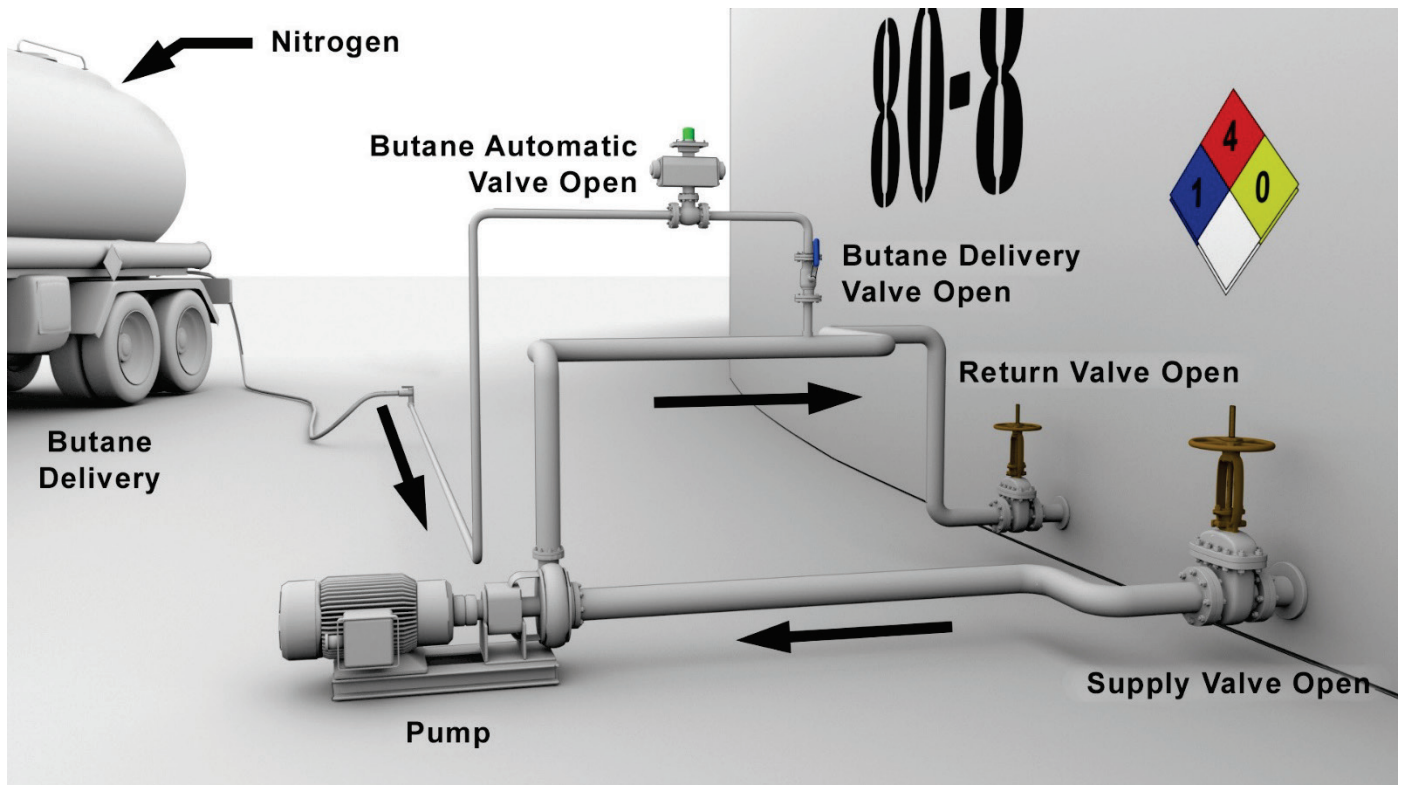
Butane is incorporated into Tank 80-8 via truck deliveries by way of a fixed butane injection system. The butane injection system originates at the truck loading rack, located south-west of the tank farm, and terminates at an injection point in the circulation line (piping manifold) at Tank 80-8. The control system is designed so that the butane injection operation cannot be started unless the Tank 80-8 pump is turned on to ensure that product is circulating. When this condition is met, an ITC operator can open an actuator valve by pressing the ON button at the truck loading rack to allow the butane unloading to begin. The butane is unloaded from the cargo tank truck, travels through 4-inch piping, which reduces to 2-inch piping, to the product circulation line where it combines with the existing naphtha product. The pump stays on throughout the unloading activity and for several hours afterward in order facilitate the mixing of naphtha and butane (**Figure 4**). ITC did not equip the Tank 80-8 piping manifold with

emergency or remotely operated isolation valves.^a Such isolation valves could stop an uncontrolled release if for example, the pump or piping manifold were damaged. Instead, to isolate equipment such as the pump, ITC operators must manually close both the Tank 80-8 supply valve to the pump and the return valve from the pump back to the tank. Under a major fire scenario resulting from a leak near this equipment, neither ITC operators nor emergency responders could access the area to close these manually operated valves.

Figure 4. Simplified schematic showing ITC’s butane blending system. The arrows in the figure show the butane flow direction and the naphtha product circulation path through the piping. (Source: CSB).

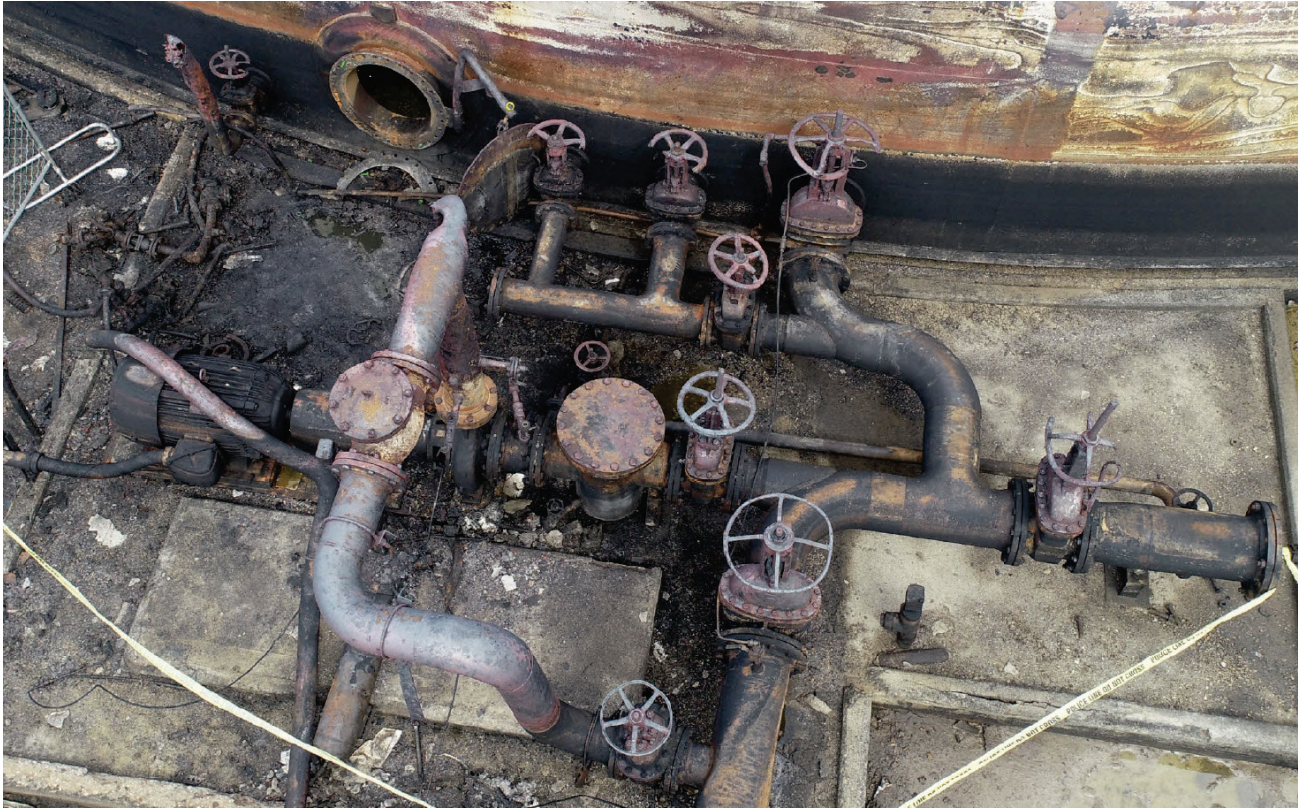
On the morning of March 17, 2019, ITC distributed control system (DCS) data indicates a series of unanticipated changes to the monitored pump operating pressures and tank volume. These fluctuations suggest a mechanical problem developed in the pump circulation system. DCS data indicates that at approximately 7:25 am, the pump discharge pressure readings began to rise slowly; by around 8:45 am the pump discharge pressure reading had increased from 80 to 84 pounds per square inch (psi). Consistent with a naphtha product release, beginning at roughly 9:34 am, the recorded tank volume began to decrease steadily. At about the same time, the pump discharge pressure reading suddenly dropped back down to 80 psi. At about 9:45 am DCS data indicates a second sudden decrease in discharge pressure from 80 to 75 psi, and the recorded tank volume continued to decrease during this time. Between 9:34 and 10:01 am, the DCS data shows that the tank volume decreased by approximately 221 barrels. The tank farm was not equipped with a fixed gas detection system, so no alarms were activated to warn ITC personnel of a release. The reduction in tank level and volume that occurred as naphtha product released from Tank 80-8 did not trigger any alarms in the ITC control room. As a result, ITC personnel were unaware of the naphtha product release before the fire erupted.

At approximately 10:00 am, a large fire erupted in the vicinity of the Tank 80-8 piping manifold (**Figure 5**). Shortly thereafter, at 10:01 am, control system event logs indicate that the pump shut down, and then the Tank 80-8 equipment lost communication with the DCS. No further control system data for Tank 80-8 or the pump were available after this time.

Figure 5. Tank 80-8 Piping Manifold. This photo shows the post-incident condition of the Tank 80-8 piping manifold. (Source: ITC).

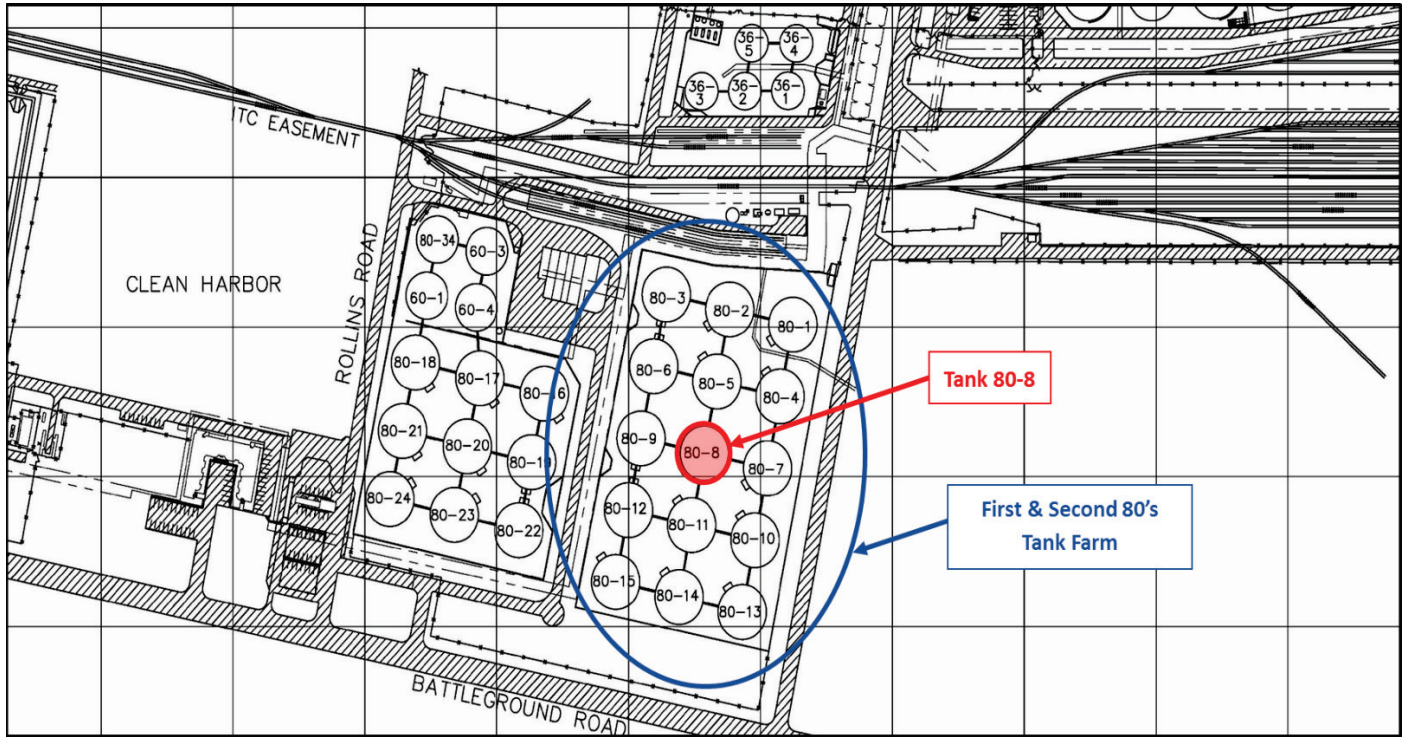
Tank 80-8 was situated in the center of the facility's "First & Second 80's" tank farm (**Figure 6**), surrounded by other 80,000-barrel storage tanks. ITC was unable to stop or isolate the naphtha being released from Tank 80-8, so the fire continued to rage and intensify. On the evening of March 17, 2019, an adjacent tank west of Tank 80-8, became fully

Figure 6. Plot Plan of Tank Farm. This image shows an excerpt from the overall plot plan for the ITC Deer Park, Texas terminal showing the location of the First and Second 80's Tank Farm. (Source: ITC).

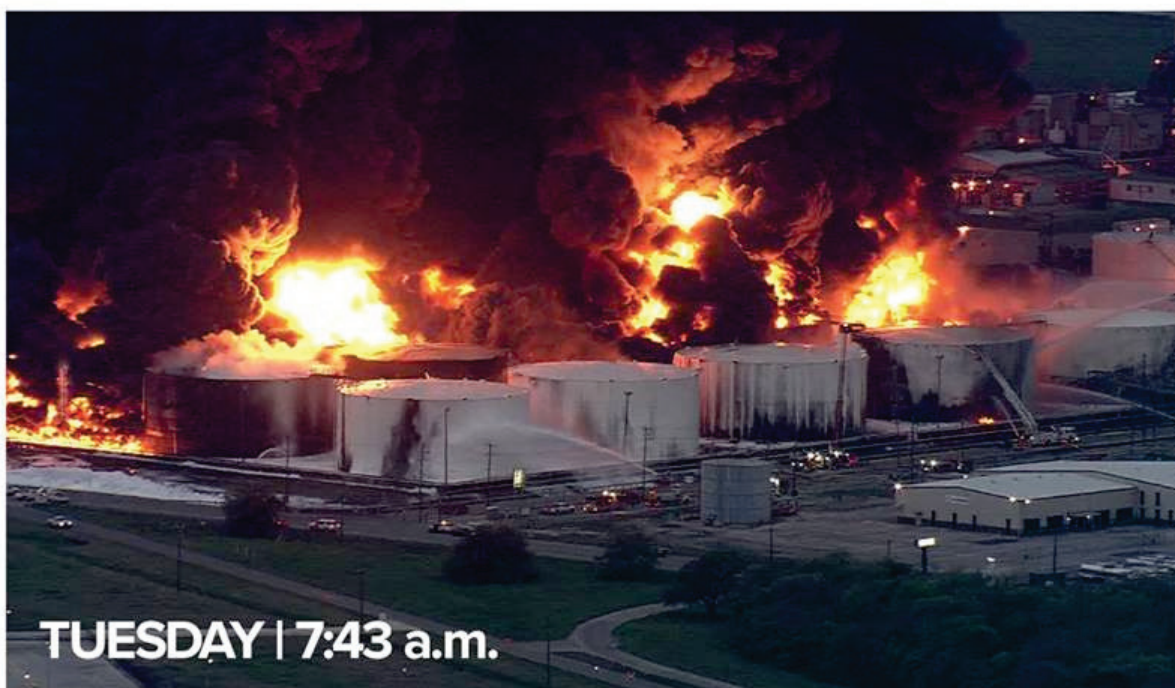
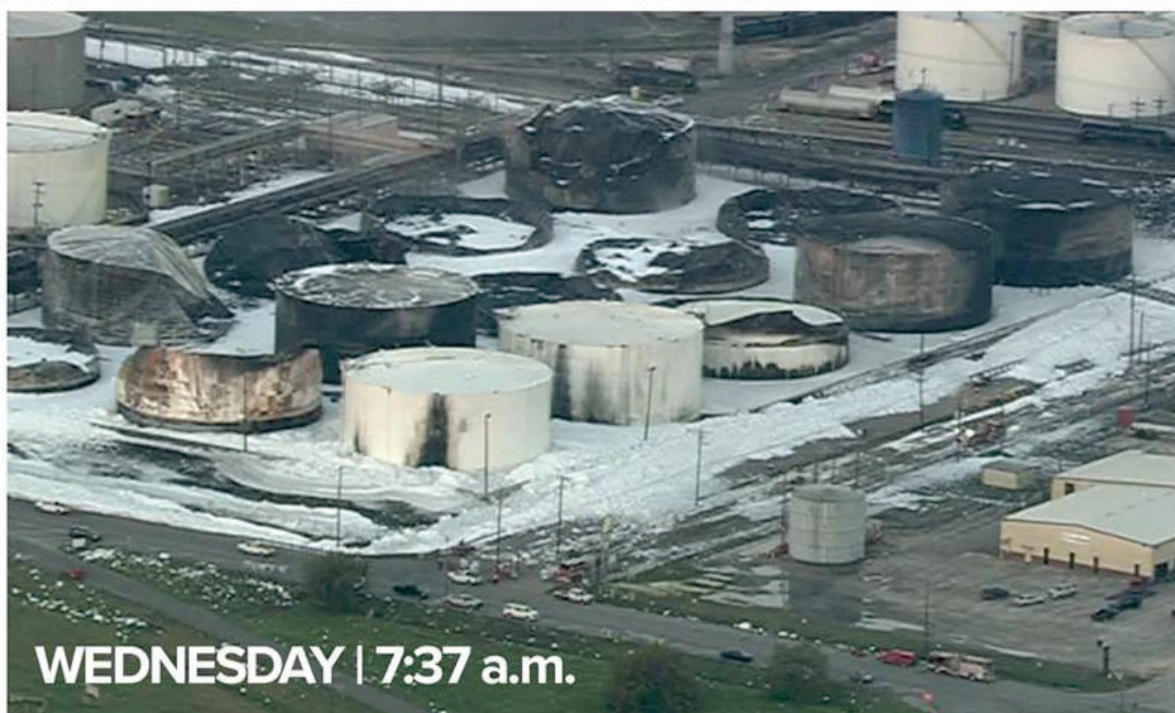
By approximately 3:03 am on Wednesday, March 20, 2019, ITC, with assistance from CIMA and US Fire Pump, had successfully extinguished the tank farm fire at the ITC Deer Park terminal (**Figure 7**). The fire did not spread outside the perimeter of the First & Second 80's tank farm.

Figure 7. First & Second 80's Tank Farm. This photo shows the fire raging on Tuesday, March 19, 2019, and fully extinguished on Wednesday, March 20, 2019. (Source: KHOU 11 News).
