U.S. CHEMICAL SAFETY AND HAZARD INVESTIGATION BOARD

# INVESTIGATION REPORT

## T2 LABORATORIES, INC.

## RUNAWAY REACTION

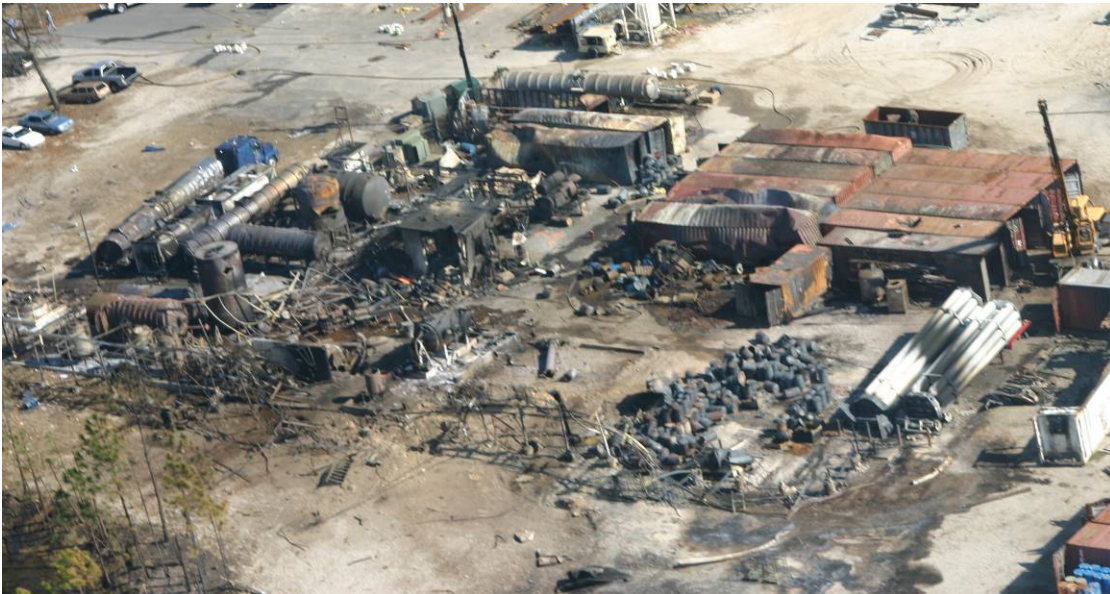
Figure 1. Aerial photograph of T2 taken December 20, 2007.

Debris from the explosion was found up to one mile away, and the blast damaged buildings within one quarter mile of the facility. The City of Jacksonville subsequently condemned buildings used by four of the businesses surrounding T2. Three of these businesses relocated operations while their buildings were repaired; the remaining business, a trucking company adjacent to T2, permanently closed due to lost business.

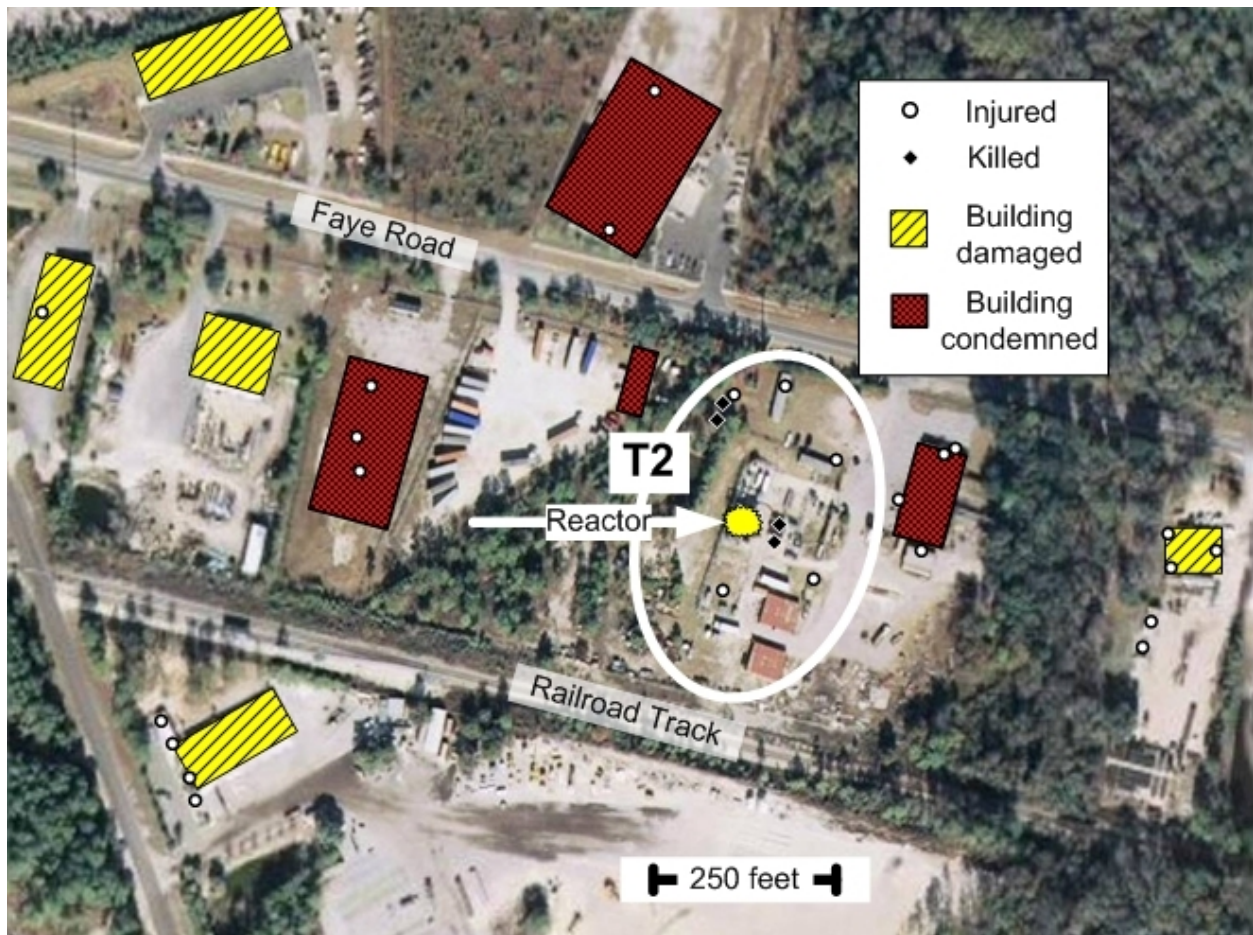
The CSB conducted a community survey of the surrounding businesses to characterize injuries and structure damage (Figure 4). At the nine businesses within 1,900 feet of the reactor, the explosion injured 27 workers. Of those, 11 suffered lacerations and contusions, seven reported hearing loss, and five fell or were thrown by the force of the blast. The CSB survey team photographed and catalogued 32 damaged structures, some as far as 1,700 feet from T2.

Figure 4. Injury and business locations.

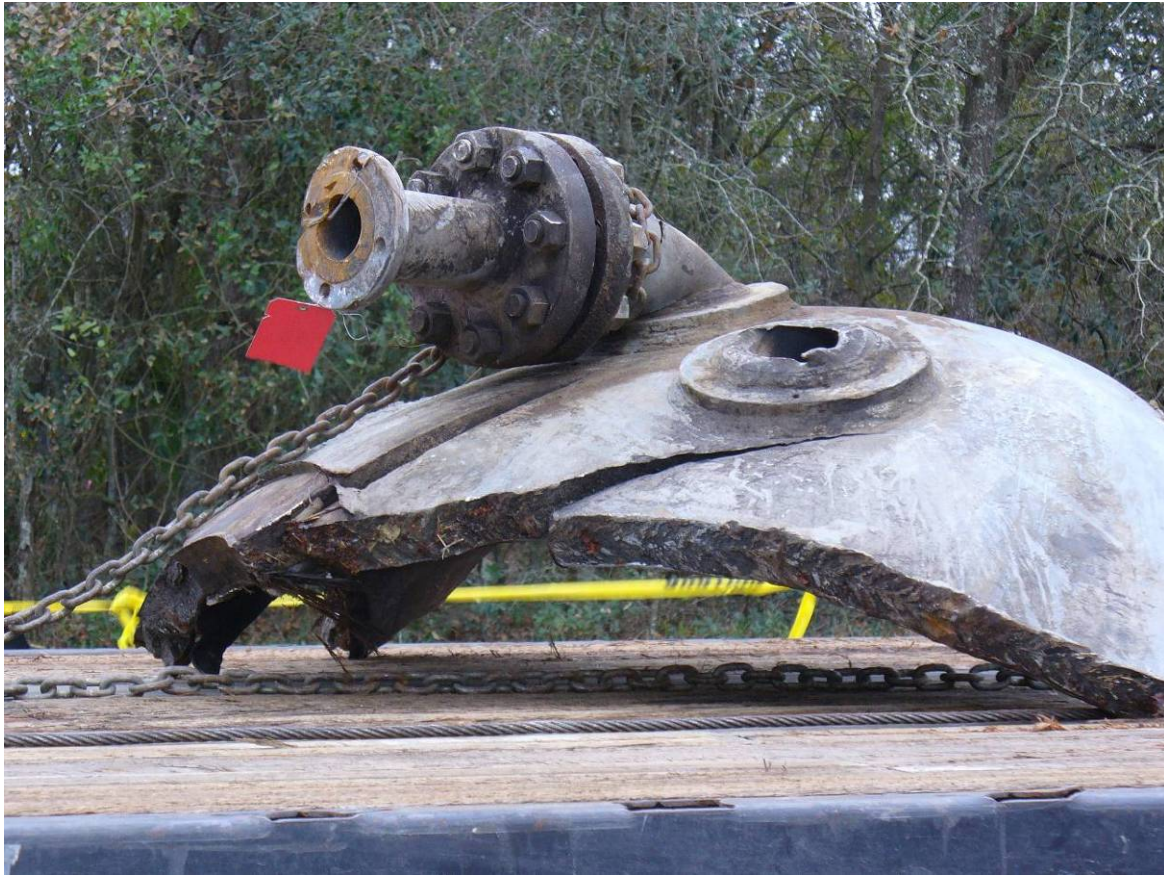
The explosion leveled the plant, propelling debris in all directions. Two large steel support columns from the reactor structure traveled about 1,000 feet along Faye Road in both directions. A 2,000-pound section of the 3-inch-thick reactor head (Figure 5) impacted railroad tracks adjacent to T2, pushing a rail out of place, before impacting and damaging a building about 400 feet from the reactor. The explosion threw piping from inside the reactor hundreds of feet onto the other businesses and wooded areas surrounding T2. The 4-inch diameter agitator shaft from the reactor was thrown about 350 feet across Faye Road in two large pieces that imbedded in a sidewalk and the ground (Figure 6).

Figure 5. Portion of the 3-inch-thick reactor.

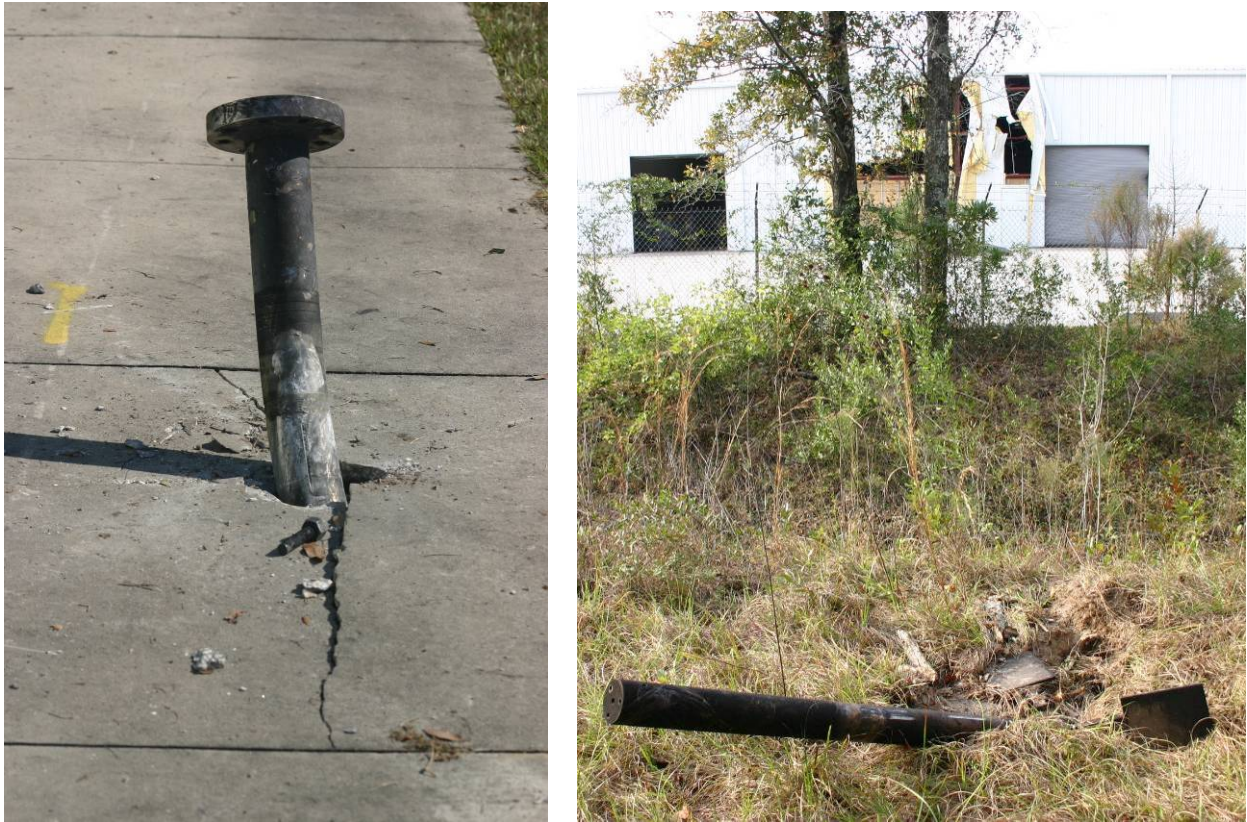
Figure 6. Agitator shaft pieces.

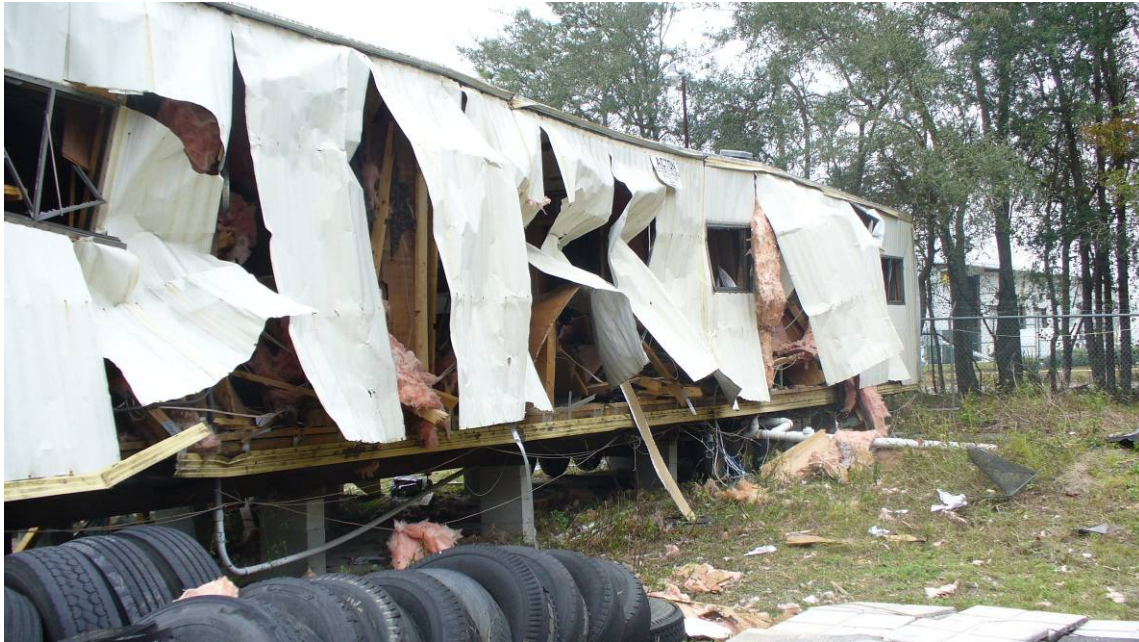
Businesses near T2 sustained heavy damage. Structures sustained window damage from the overpressure up to 1,700 feet away from T2. The explosion destroyed a trucking company office trailer located 250 feet from the reactor (Figure 7). If trucking company employees had been in the trailer at the time of the incident, it is likely that they would have been seriously injured or killed.<sup>11</sup> Two warehouses located about 400 to 500 feet from the reactor both sustained heavy damage; nine of the 25 employees at these two businesses were injured.

Figure 7. Trucking company trailer adjacent to T2.

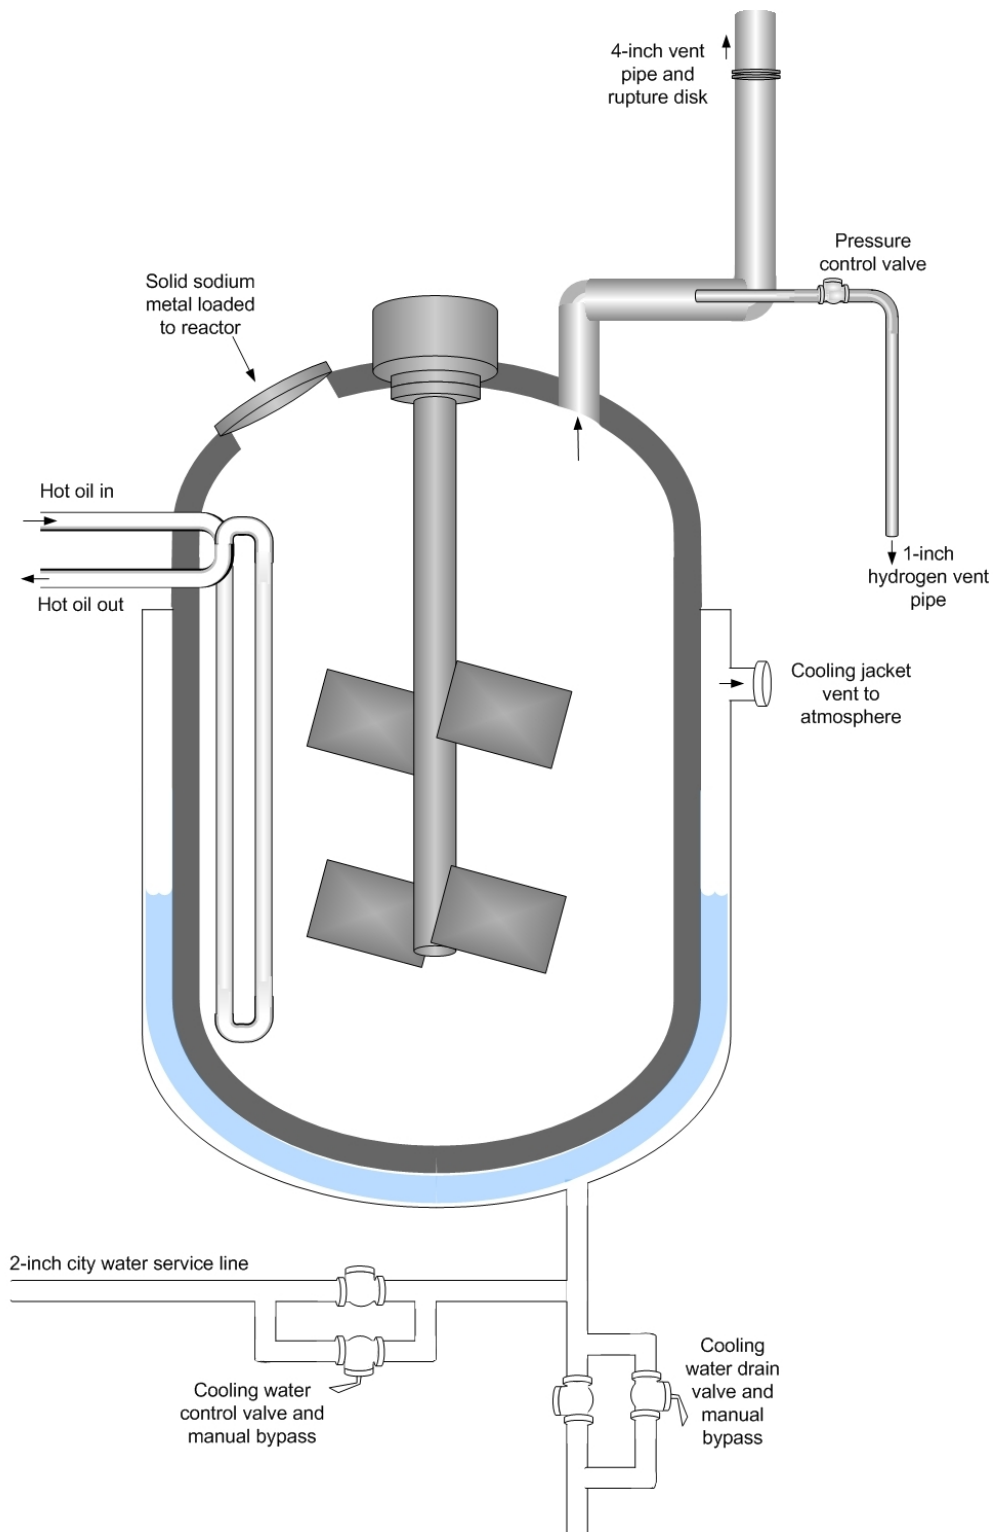
A 4-inch<sup>19</sup> vent pipe that made two 90-degree pipe bends before connecting to a 4-inch rupture disk provided overpressure protection for the reactor. Employees stated that the rupture disk was set at 400 psig. A pressure control valve installed in a 1-inch vent pipe, which branched off of the 4-inch vent pipe below the rupture disk, controlled reactor pressure.

Figure 8. Reactor cross-section.

Similarly, T2 sized the reactor relief devices based on anticipated normal operations, without considering potential emergency conditions. T2 employees stated that the owner/chemical engineer sized the rupture disk based on the maximum expected hydrogen gas generation during normal operation. T2 could not provide any documents related to the sizing and set point of the rupture disk. However, there was no evidence that T2 evaluated a runaway reaction as a possible overpressure source.

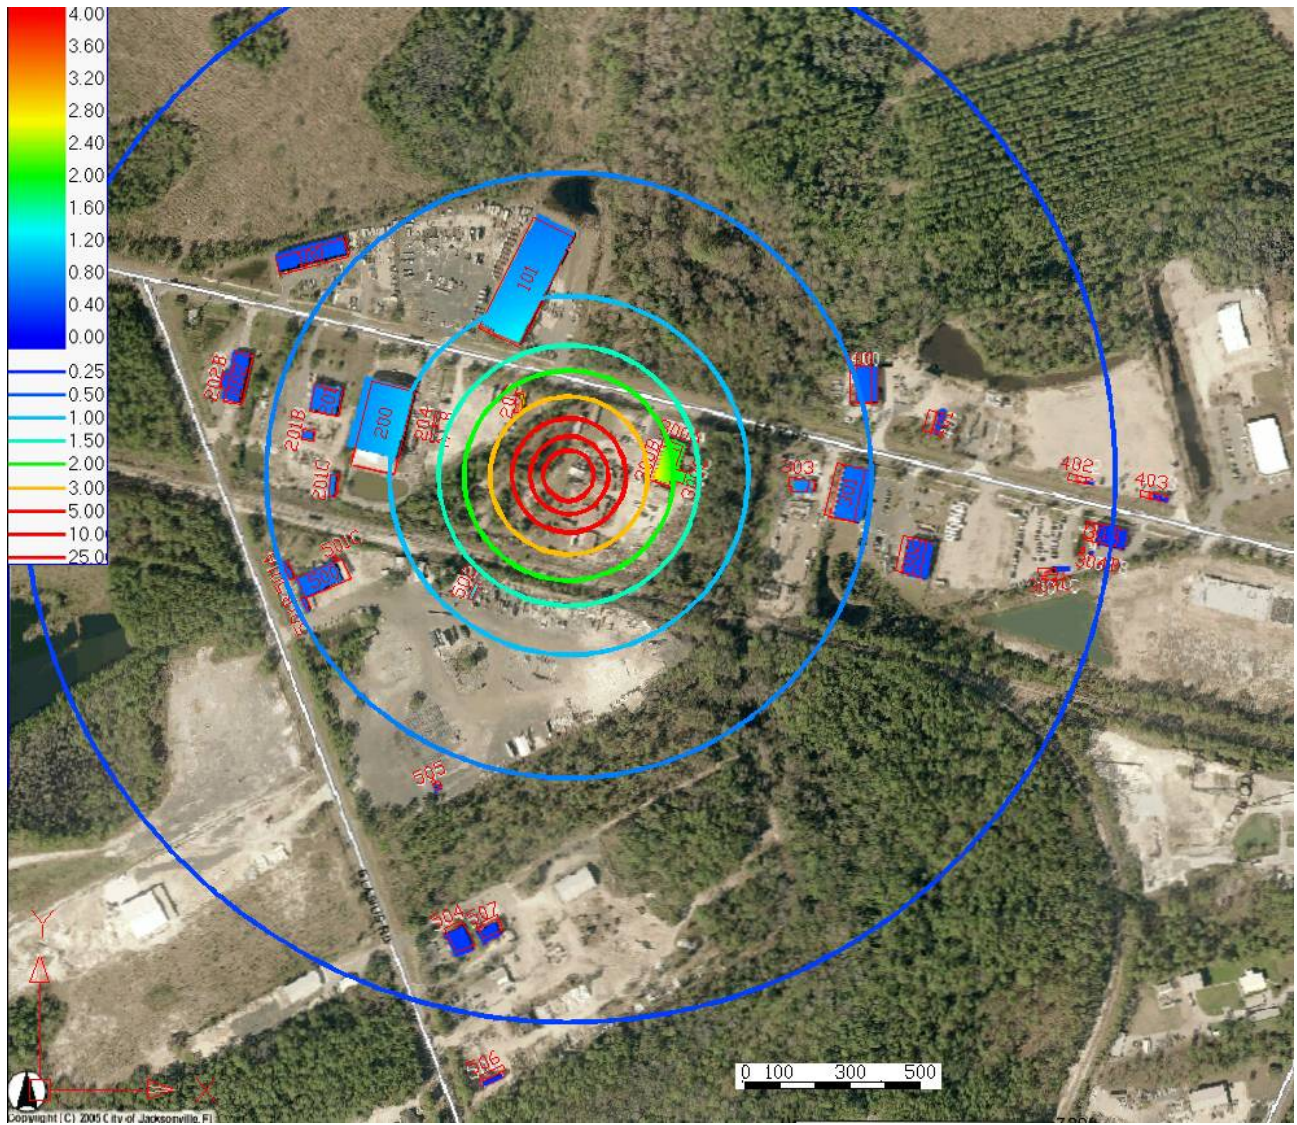
Figure 13. Free-Field Pressure Contours for Estimated TNT Yield of Explosion.

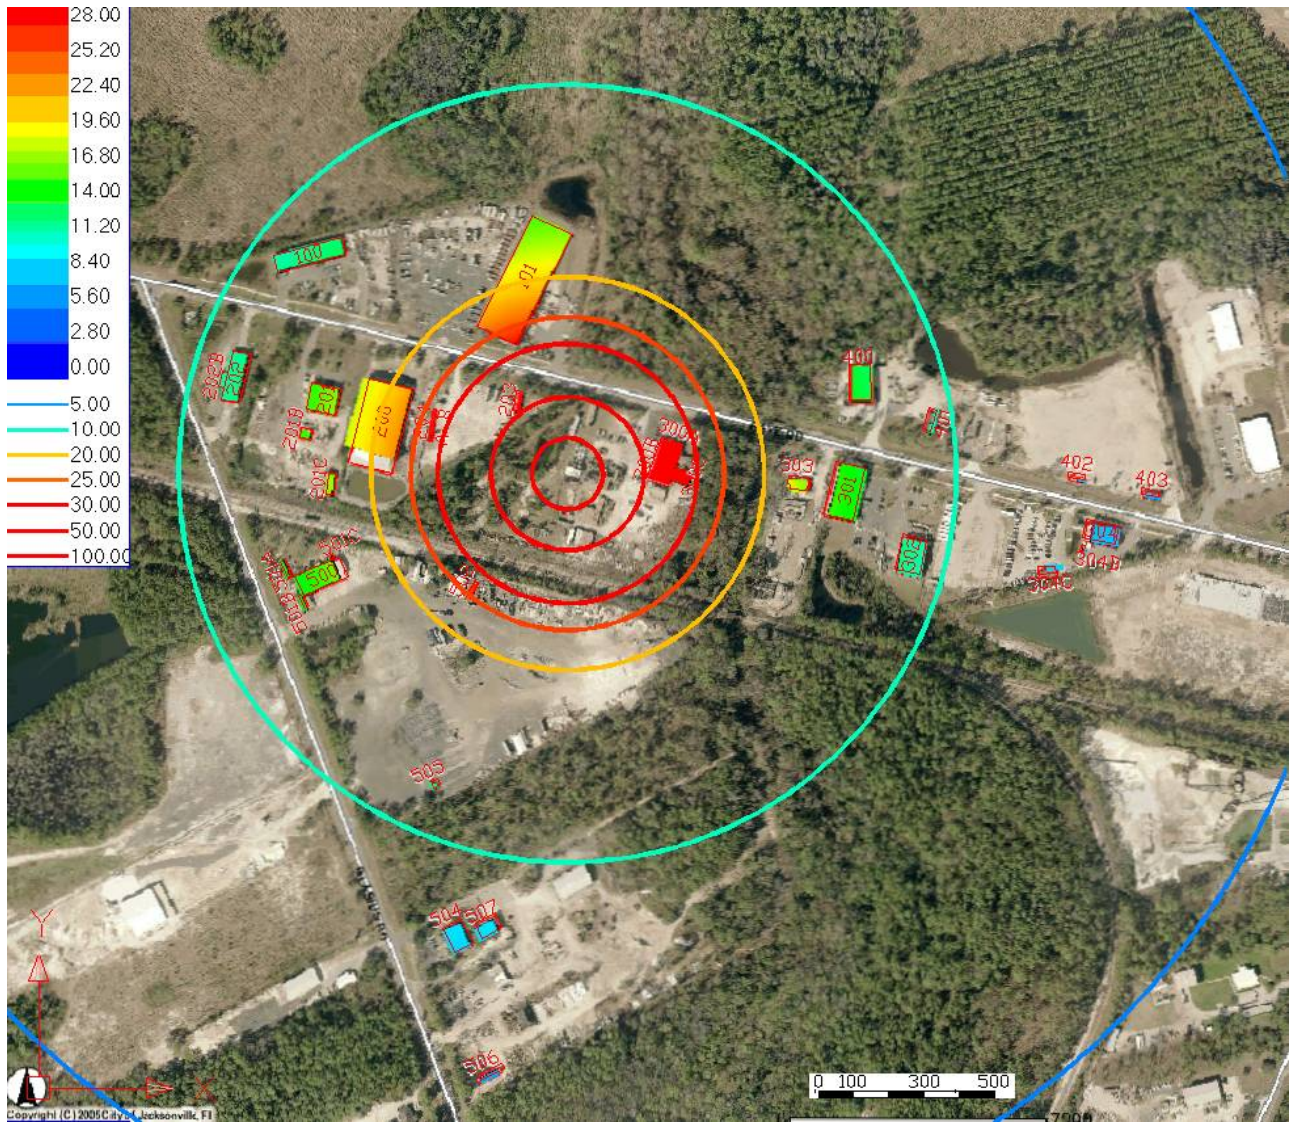
Figure 14. Free-Field Impulse Contours for Estimated TNT Yield of Explosion.

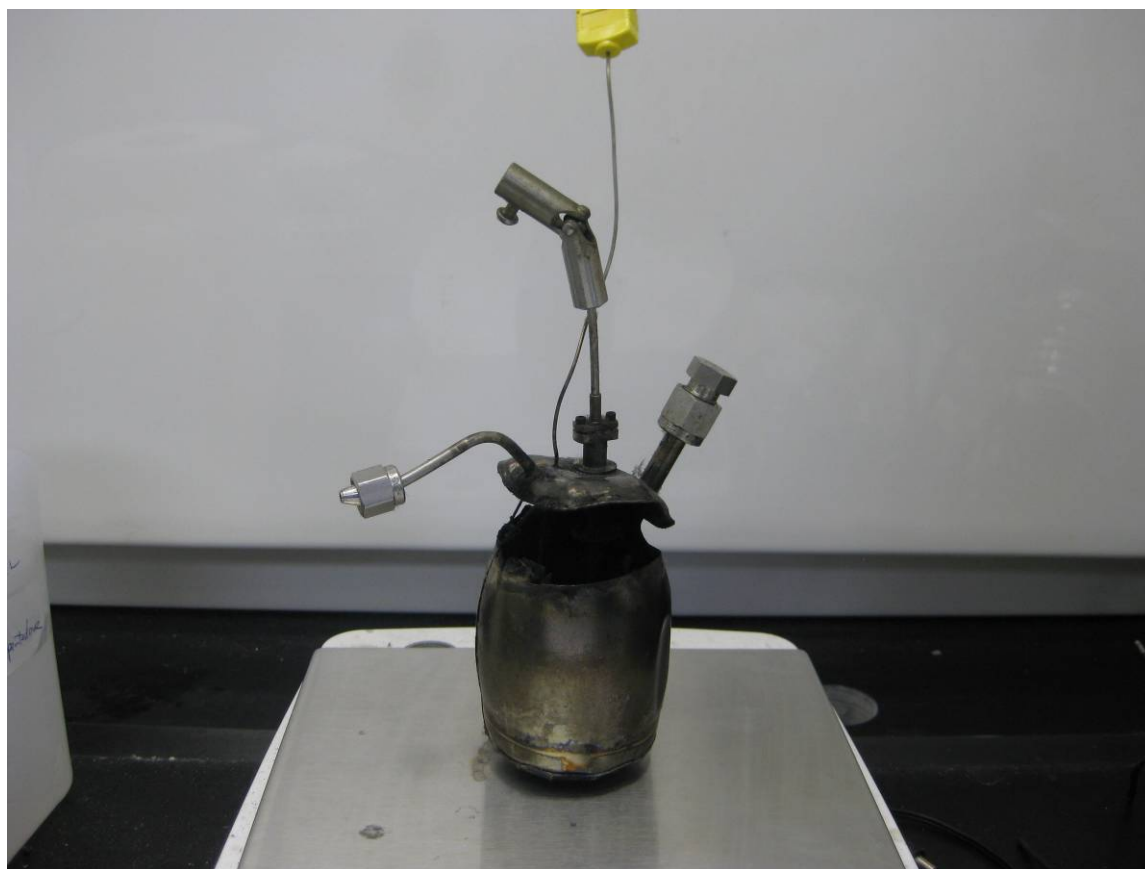
For the first two VSP2 tests, the test cell was open to the containment vessel and results similar to the ARRST tests were obtained. The CSB conducted the remaining four VSP2 tests in a closed (sealed) test cell. A second and more energetic exothermic reaction was observed when the temperature exceeded 390°F (198.9°C) in two test that used the T2 recipe. The pressure and temperature rise during the second exothermic reaction was about 32,000 psig per minute (2,206 bar per minute) and 2340°F per minute (1300°C per minute) respectively and burst the test cells (Figure 16). The other two tests performed using only sodium and diglyme solvent, suggest that this second more energetic exothermic reaction is a reaction between the sodium and diglyme solvent.

Figure 16. Burst VSP2 Test Cell.

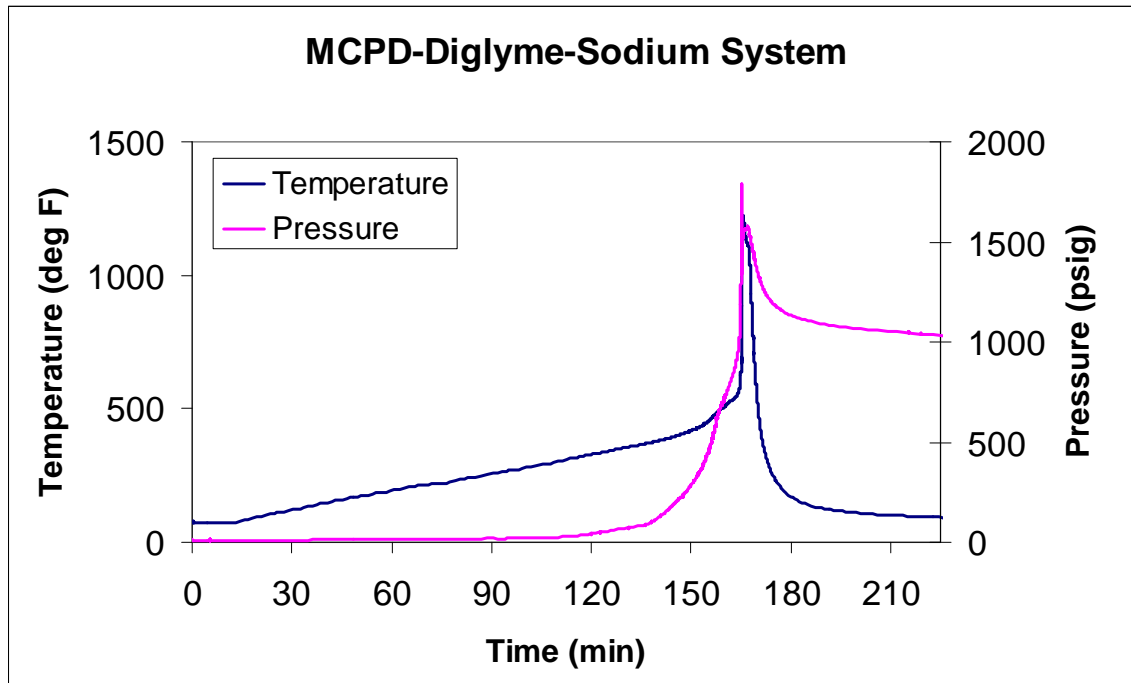
Figure 18. MCPD Diglyme Sodium Test Results.

The peak rate of temperature rise for the final test is 2340°F/minute (1300°C/minute) and the peak rate of pressure rise is 32,000 psi/minute (2206 bar/minute). In the closed system, a strong exothermic reaction occurs using the normal T2 chemical recipe.
