FINAL INVESTIGATION REPORT

CARIBBEAN PETROLEUM TANK TERMINAL EXPLOSION AND MULTIPLE TANK FIRES

CARIBBEAN PETROLEUM CORPORATION (CAPECO)

OCTOBER 23, 2009

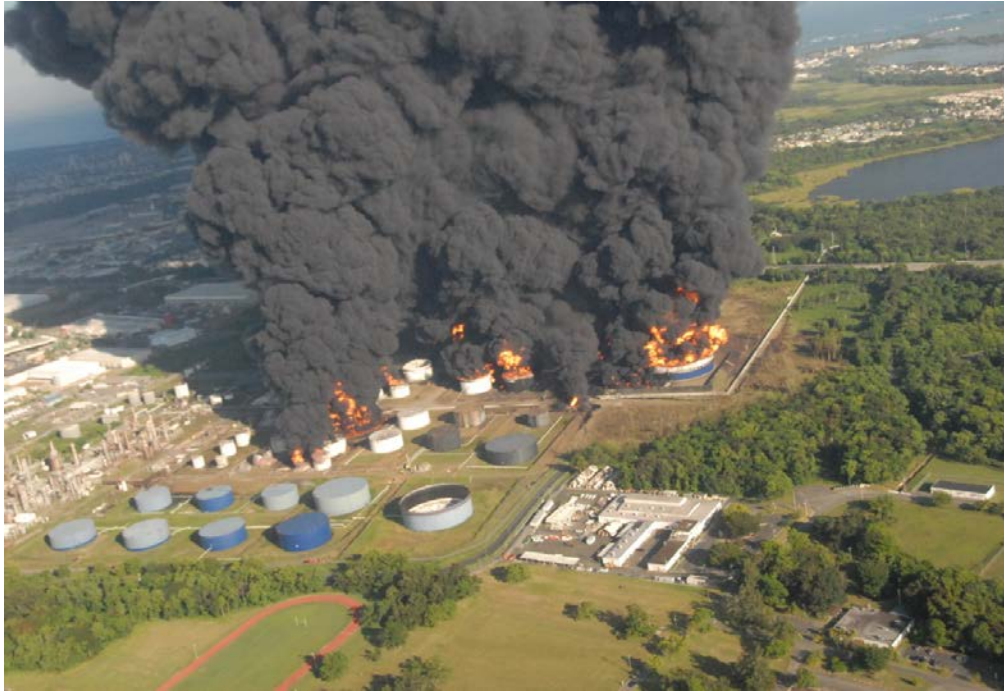
After the explosion, fuel in the damaged tanks burned for over two days while emergency responders fought to control the fire and prevent other tanks from igniting. The large fire demanded emergency personnel and resources from across the Commonwealth of Puerto Rico and the US mainland. Local fire departments with assistance from an industrial firefighting company took 66 hours to extinguish the fire after the explosion. As a result, 17 of the 48 tanks burned. (See Figures 5 and 6.)

Figure 5: CAPECO multiple tank farm fire, October 23, 2009.

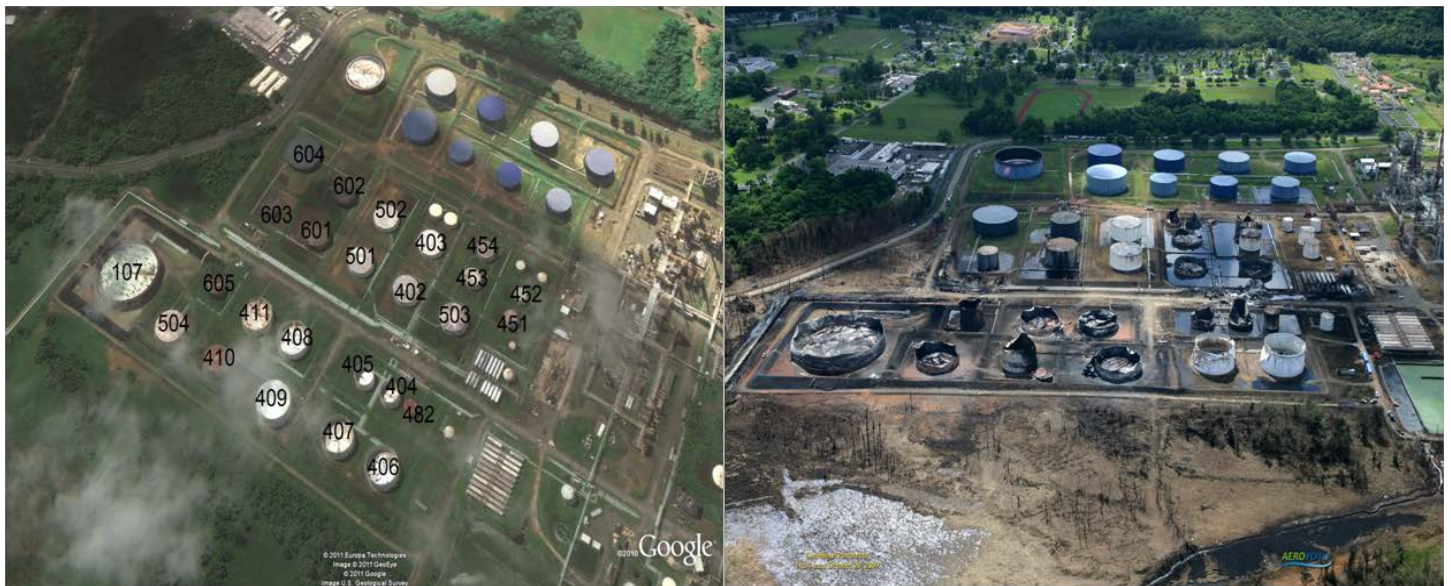
Figure 6: Impact of the explosion and multiple tank fires after the October 23, 2009 incident

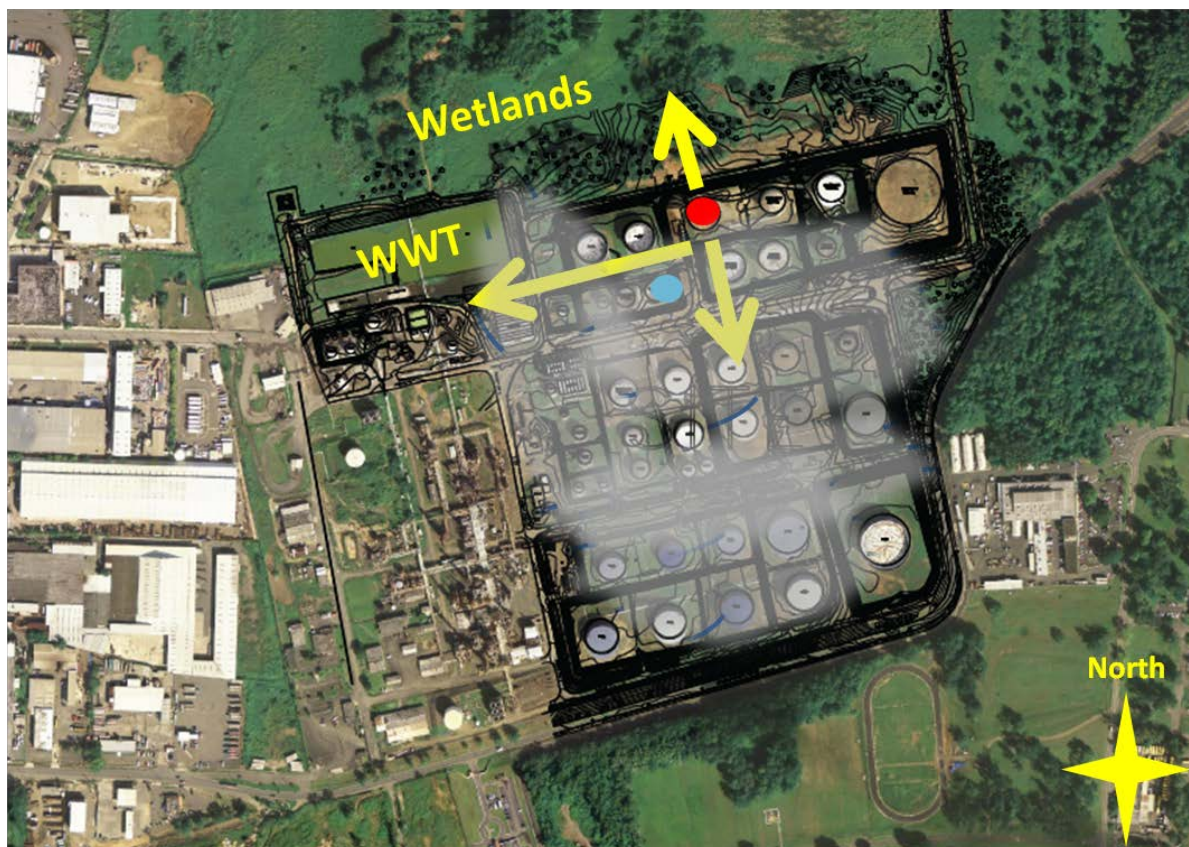
Figure 7. Topographic Survey of CAPECO Tank Farm showing the gasoline vapor cloud migration from higher elevation (Tank 409-Red and Tank 411-Blue) toward low-lying areas by the WWT plant, the south eastern end of the refinery and wetlands to the north. The cloud indicates the approximate area where the vapor cloud migrated based on surveillance footage.

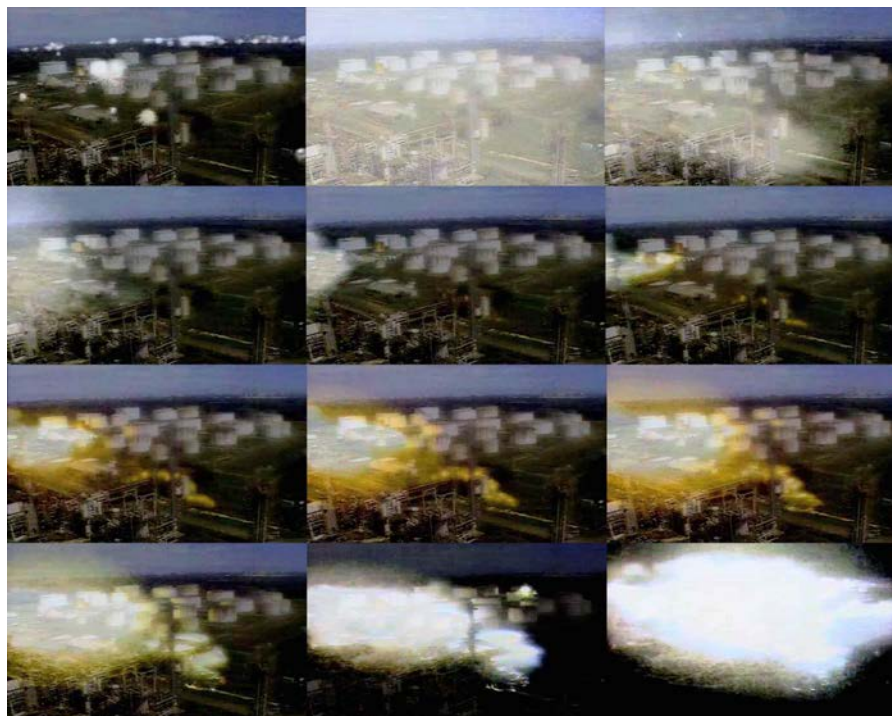
At 12:23 a.m., on October 23, 2009, security cameras at CAPECO and neighboring facilities recorded the ignition of the vapor cloud in the WWT area. About seven seconds after ignition, the vapor cloud exploded, creating a pressure wave that damaged hundreds of homes and businesses up to 1.25 miles from the site. The fire propagated through the vapor cloud and ignited multiple subsequent tank explosions registering 2.9 on the Richter scale.¹⁹

Figure 8: CAPECO surveillance footage of flame propagation during October 23, 2009 CAPECO explosion

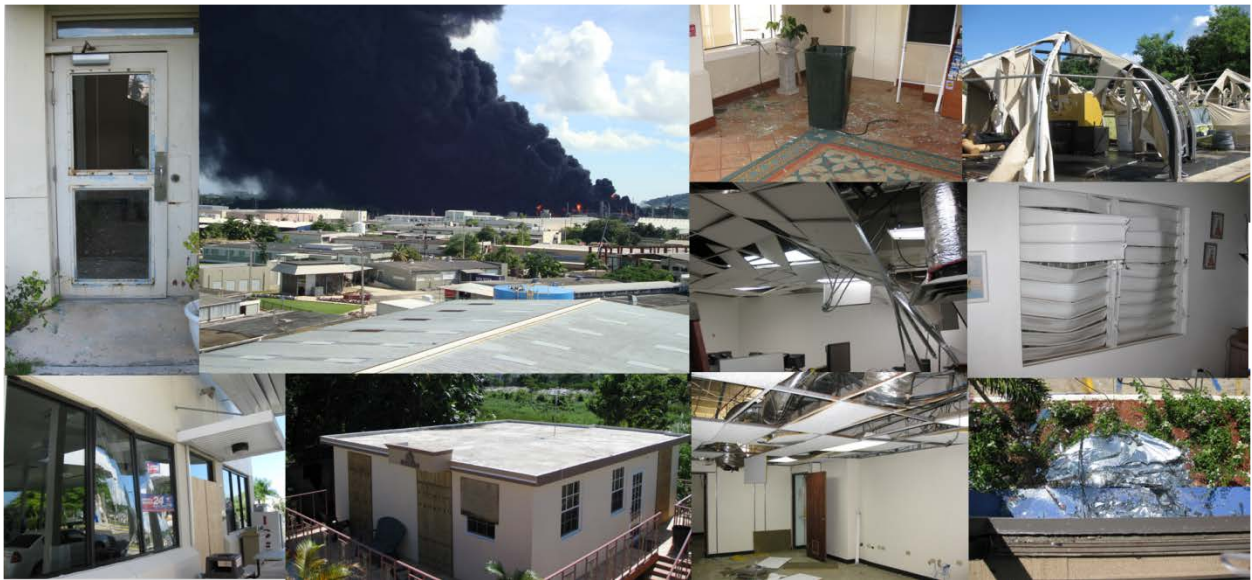
Fort Buchanan experienced the most severe damage—suffering an estimated \$5 million in repair costs. Community impact assessments³⁷ found most of the structural damage occurred in the Puente Blanco neighborhood where PREMA and the Department of Housing (DOH) found damage to 232 of the 266 homes assessed; 139 were repaired and 6 were demolished by November 2009.³⁸ The Puente Blanco community also experienced environmental contamination to several surface water bodies, including federally protected wetlands and streams surrounding the CAPECO site. After assessing 289 homes damaged by the explosion in the Cataño community, the Small Business Administration (SBA)³⁹ designated 25 single-family homes as destroyed or severely damaged at or beyond 40% of their fair market value. (See Figure 10.)

Figure 10: Community damage surrounding the CAPECO facility

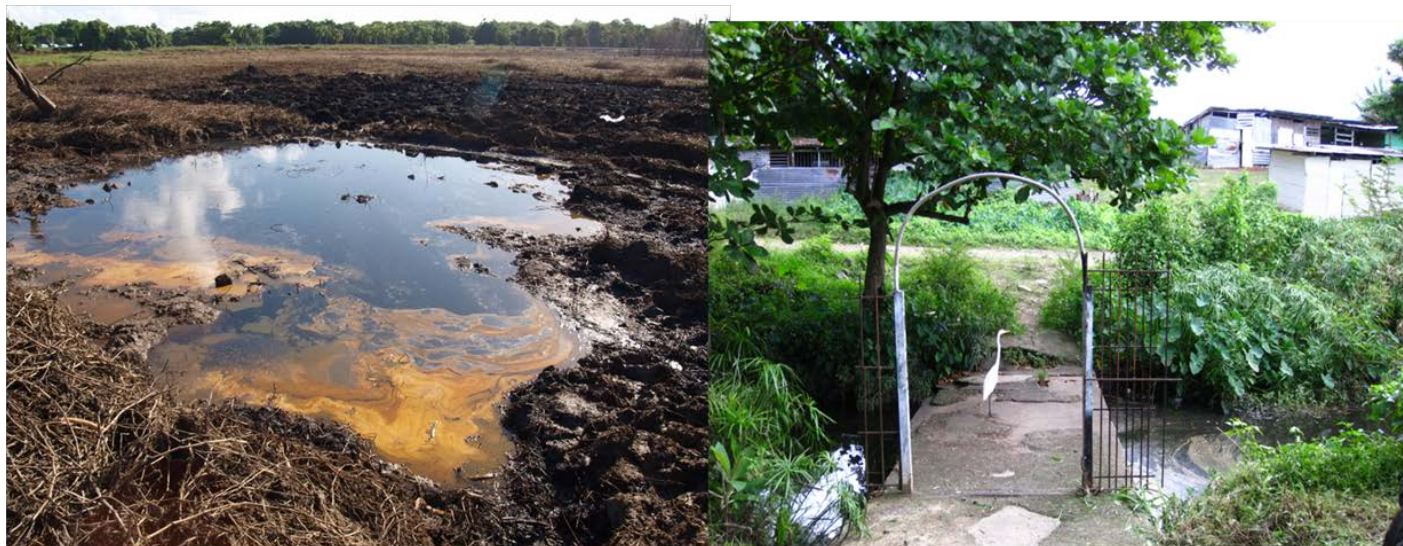
Figure 11: Oil Spill into nearby wetlands (photo from NOAA.gov) and in a local community drain after CAPECO explosion and tank fires

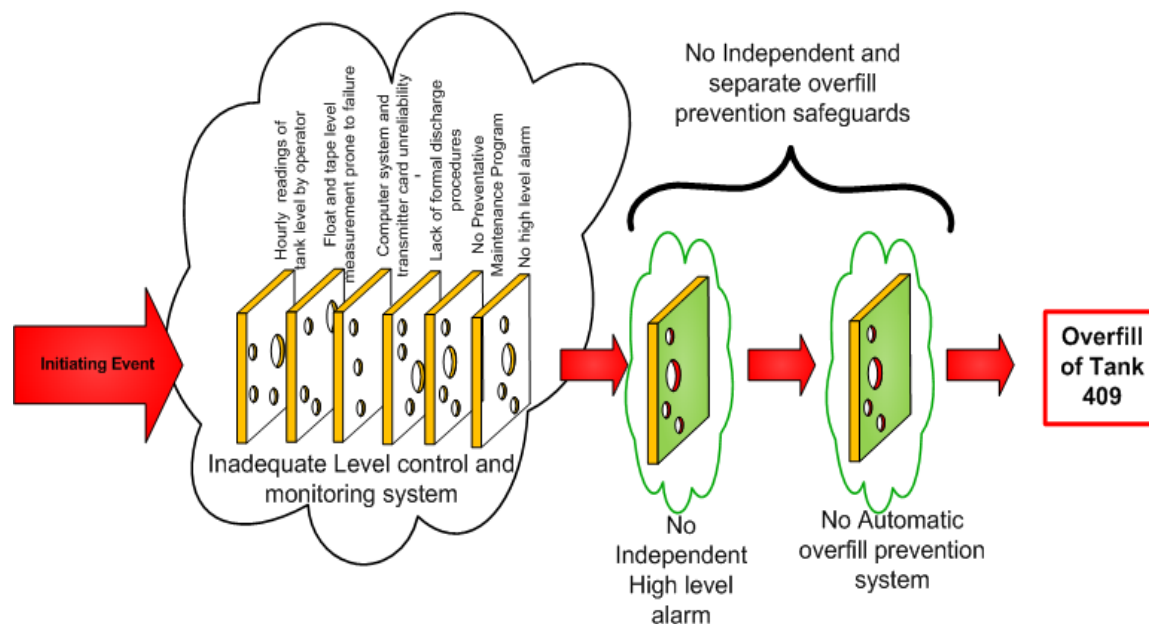
The CSB determined that numerous technical and systemic failures contributed to the explosion and multiple tank fires at the CAPECO tank terminal. The CSB found that multiple layers of protection failed within the level control and monitoring system at the same time in addition to a lack of independent safeguards. James Reason's Swiss Cheese Model best demonstrates these systemic failures that led to the accident.⁴⁸ Reason postulates that an accident results from the breakdown of the "interaction between latent failures⁴⁹ and a variety of local triggering events (active failures)"⁵⁰ and although rare, the "adverse conjunction of several causal factors" from various layers.⁵¹ The deficiencies or holes at each layer of protection are constantly increasing or decreasing based on management decisions and operational deviations.⁵²

Figure 12: Contributing to the October 2009 overfill incident at CAPECO were multiple failures of the level control and monitoring system in addition to a lack of safeguards like a high level alarm, an independent level alarm and an automatic overfill prevention system that allows for automatic shutdown or diversion.

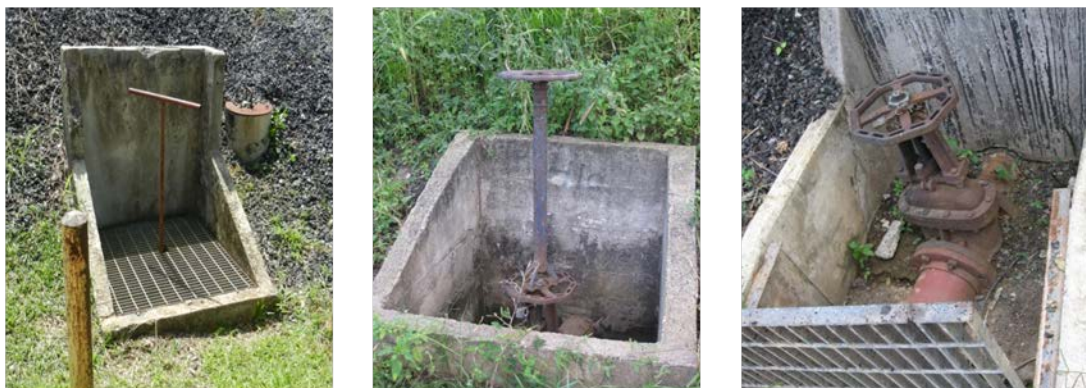
fixed stem valve on the dike drain for Tank 409 made it difficult for tank farm operators to observe its position without physically turning it. (See Figure 15.) In some cases, the valve position could not be determined with a visual inspection because the rising stem valve position was hidden in the sump. (See Figure 15, center photo.) Furthermore, none of the dike valves shown in Figure 15 were consistent with RAGAGEP. Regulatory coverage under the EPA Risk Management Plan (RMP) or OSHA's Process Safety Management (PSM) Standard requires that CAPECO use the best available engineering practices to assess valve open/close status.

Figure 15: Various dike drain valves at CAPECO. Tank 409 dike drain valve (left): position of the valve is undeterminable without physically turning the valve. Rising stem valves (center, right). In some cases, the valve position is hidden in the sump (center).
