BETA LAB NO. M10198- LS3 BOTTOM - FRACTOGRAPHY AND 19 M-5 MOUNT PART: 6600-E HEAT EXCHANGER, FRACTOGRAPHY OF SEM2 SAMPLE, LS3 BOTTOM PART 14, AND M-5 MOUNT FROM CS4, PART 19	TESORO REFINING AND MARKETING COMPANY ANACORTES REFINERY 10200 W. MARCH POINT ROAD T91WA4428 ANACORTES, WA 98221	CUSTOMER P.O. No.: 4501667904
		DATE: SEPTEMBER 23, 2010
PAGE 1 OF 32

LABORATORY REPORT-LS3 BOTTOM

This report is the ninth of a series of the reports on the failed parts of the 6600E heat exchanger. The LS# and CS# refer to longitudinal and circumferential weld seams respectively, while the part number refers to the chain of custody number.

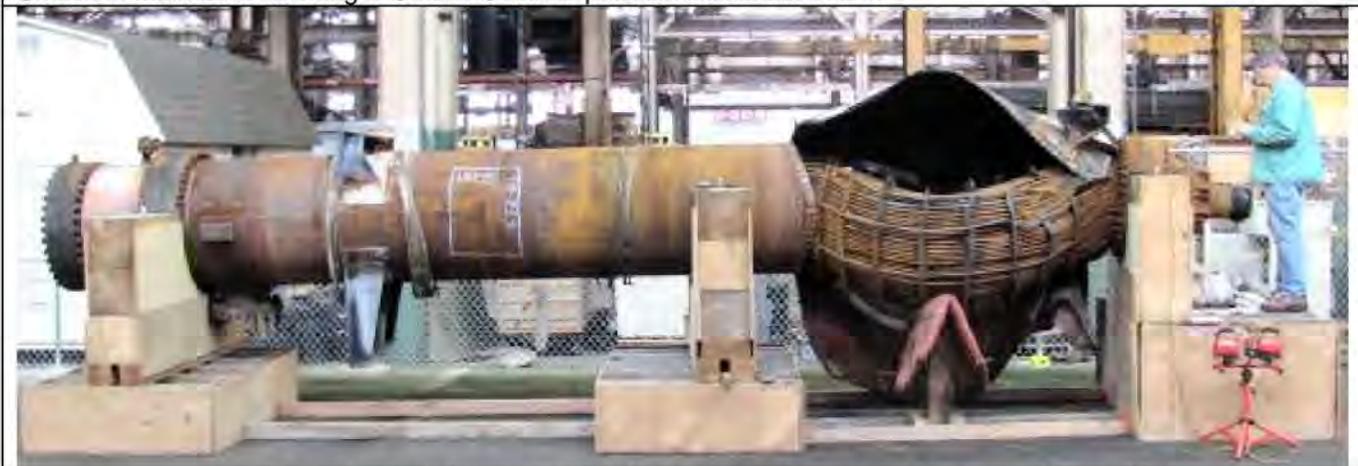
Figure 1 Un-packed main heat exchanger

Overall main heat exchanger with "fish mouth " rupture primarily along LS3 and CS4

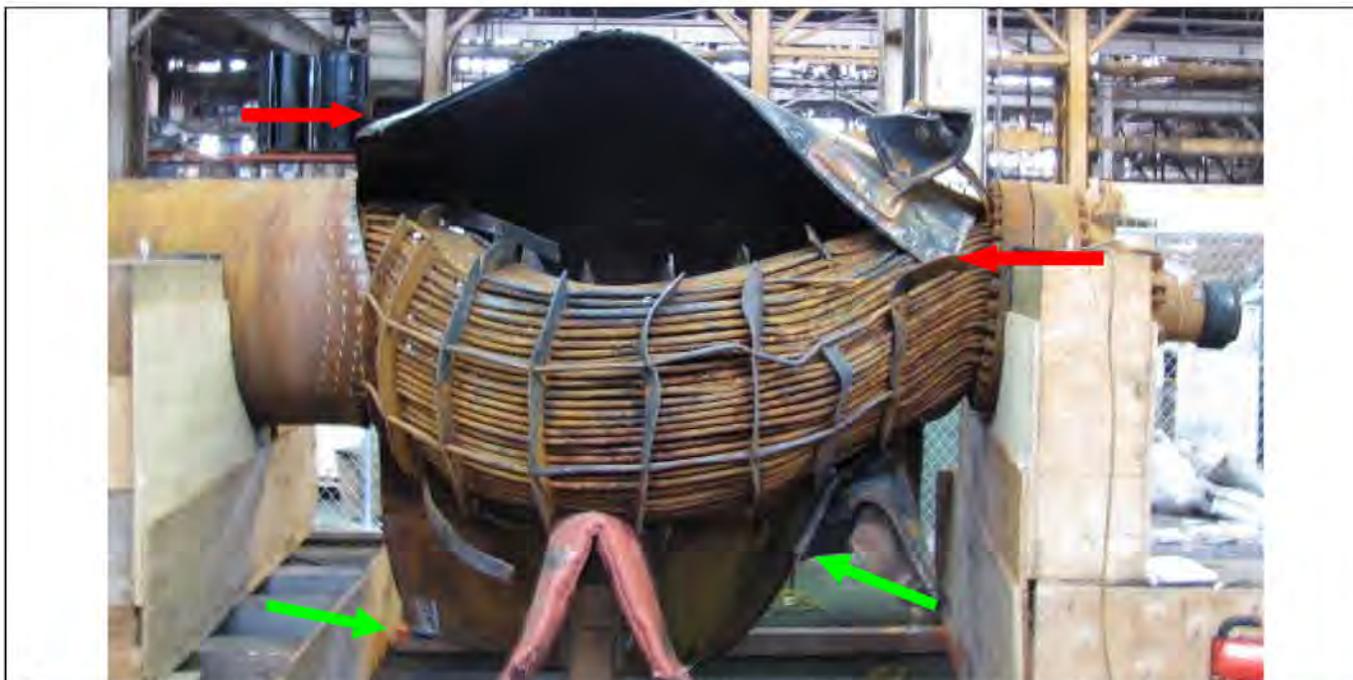
Figure 2 Photo showing the fracture along LS3 where an approximate 6 inch wide portion was removed on each side of the fracture

Fracture along LS3 seam between the green arrows for the bottom part of the fracture, and for the LS3 top – between the red arrows

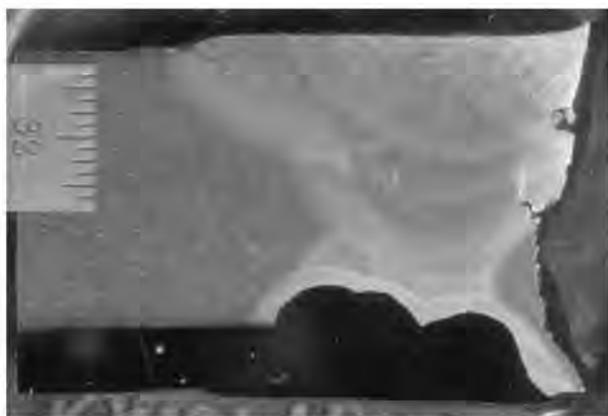
Part 19, Mount M-5

Two mounts shown are matching samples from two different cans – Can 4 on the left, and Can 3 on the right. Part 14, mount M-5 (right picture) was analyzed and reported in **M10198-LS3 Bottom Findings, July 30, 2010.**

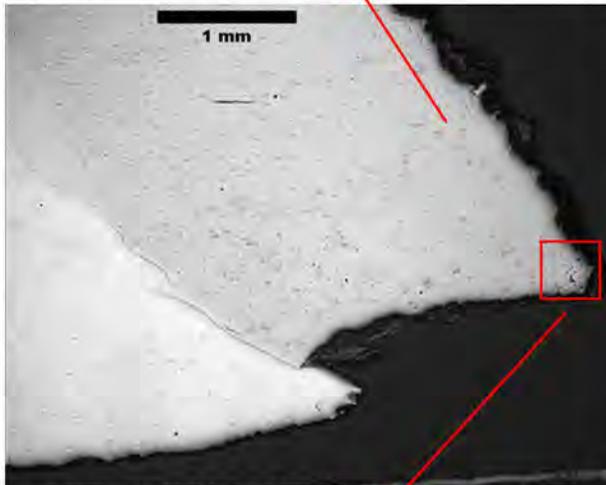
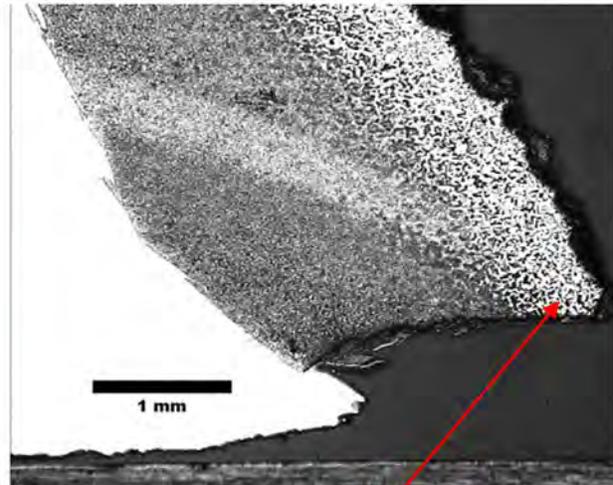
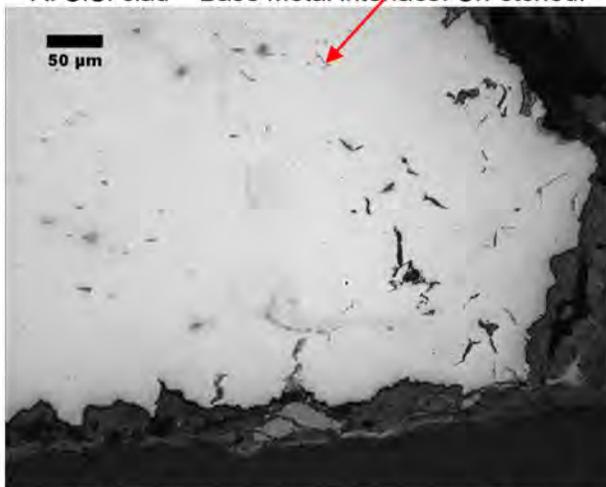
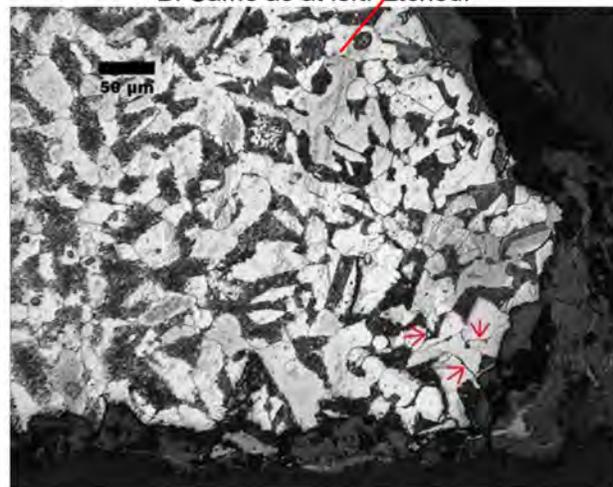
Figure 4

A. S.S. clad – Base Metal interface. Un-etched.

B. Same as at left. Etched.

C. Base Metal at an area shown at higher magnification. Un-etched

D. Same as at left. Etched.

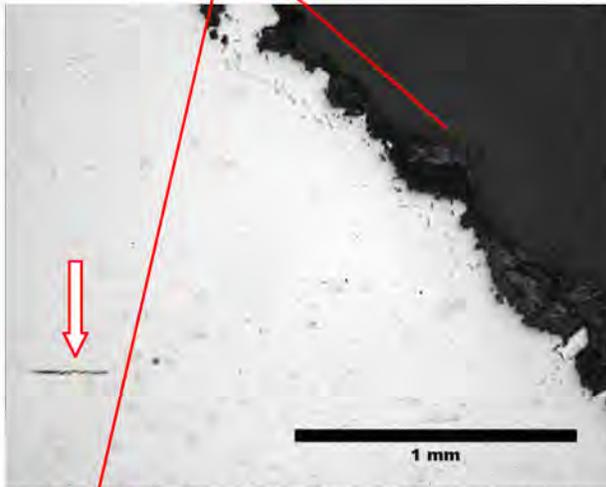
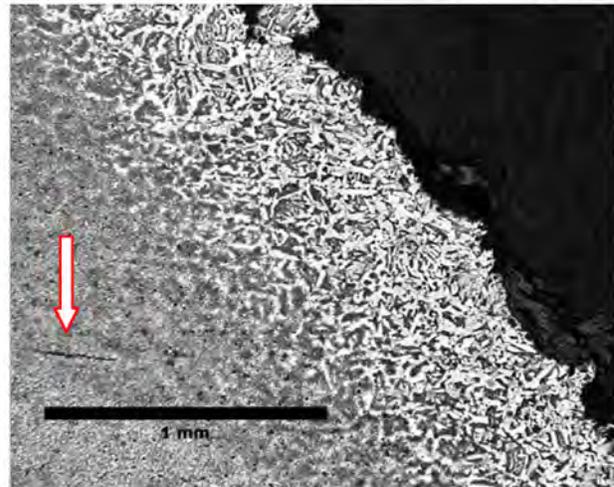
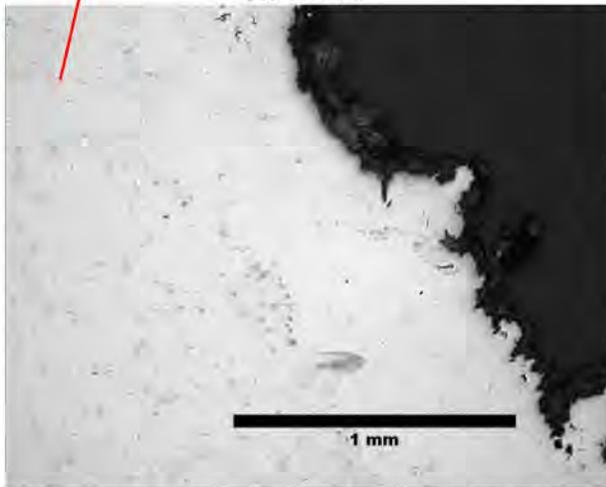
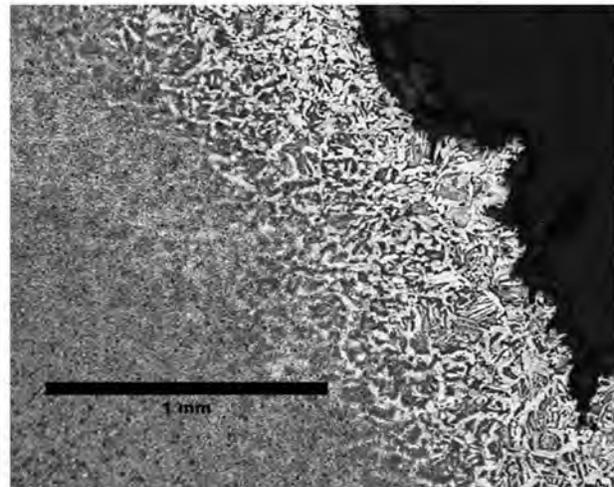
Figure 6. The arrows indicate approximate locations.

A. Fracture edge at approximate location shown.
Arrow indicates an area shown in previous Figure 5.
Un-etched

B. Same as at left. Etched.

C Fracture edge at approximate location shown.
Un-etched

D. Same as at left. Etched

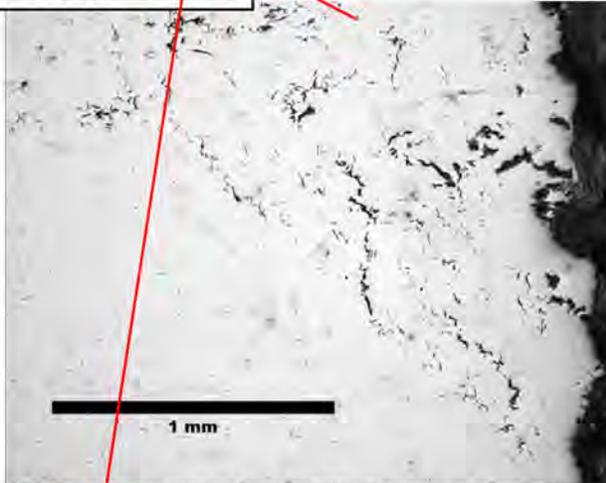
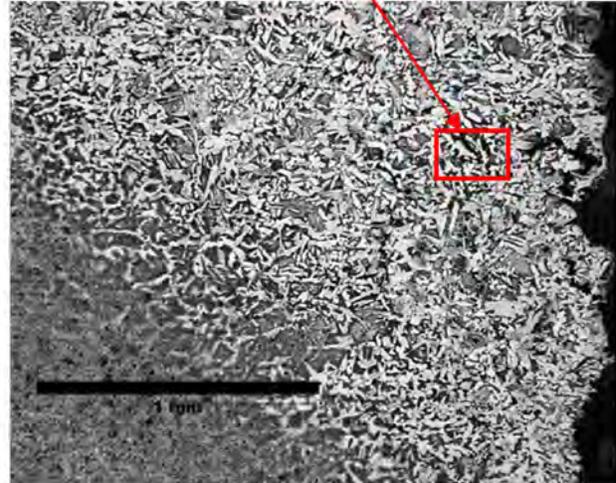
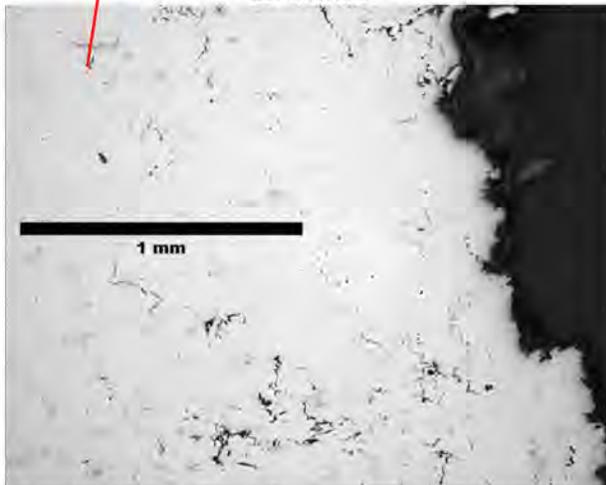
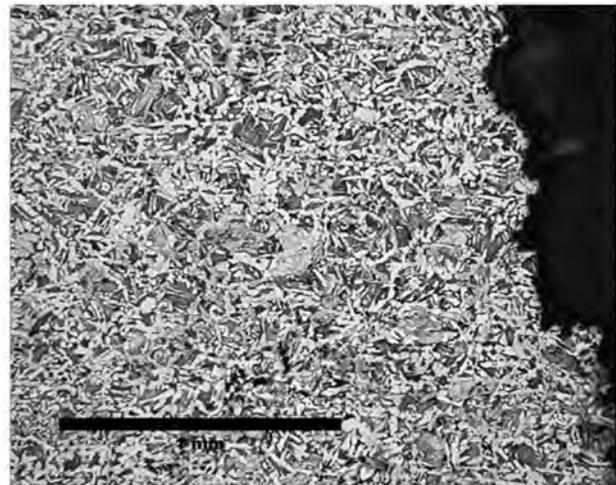
Figure 7. The arrows indicate approximate locations.

A Fracture edge at approximate location shown.
Un-etched

B. Same as at left. Etched.

C. Fracture edge at approximate location shown.
Un-etched

D. Same as at left. Etched.

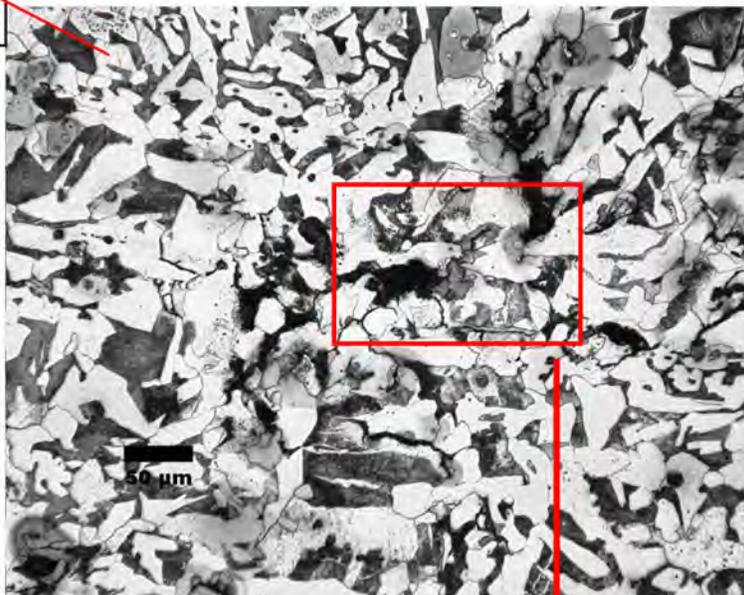
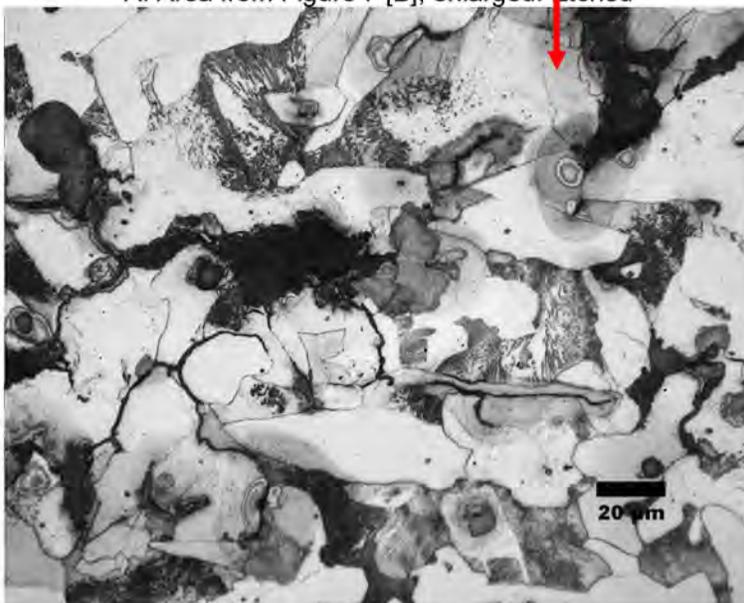
Figure 8.

A. Area from Figure 7 [B], enlarged. Etched

B. Enlarged area marked above.

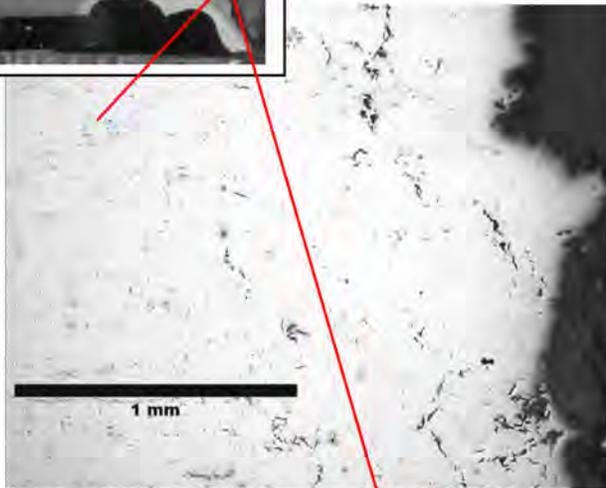
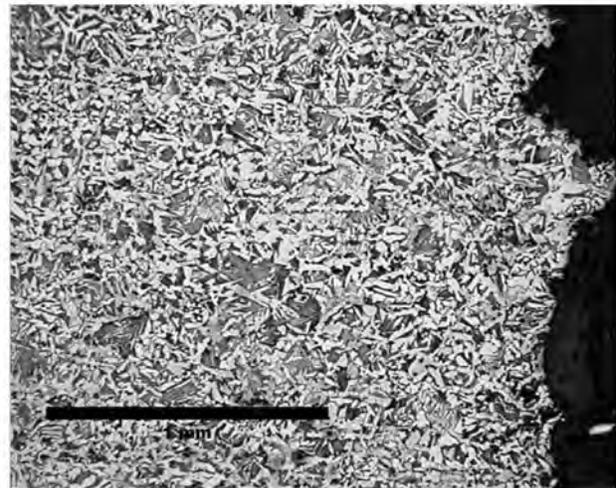
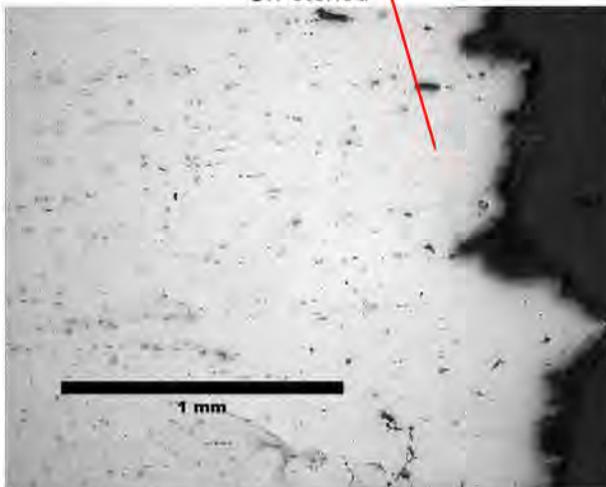
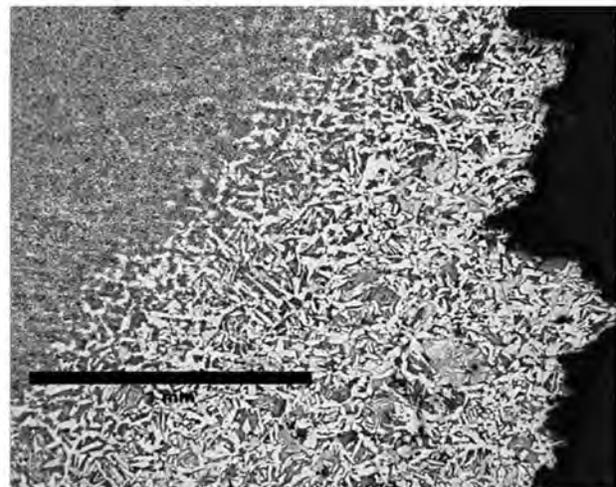
Figure 9

A. Fracture edge at approximate location shown.
 Un-etched

B. Same as at left. Etched

C. Fracture edge at approximate location shown.
 Un-etched

D. Same as at left. Etched

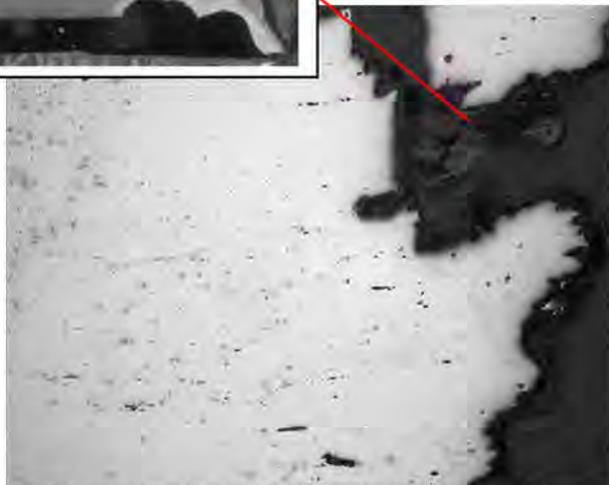
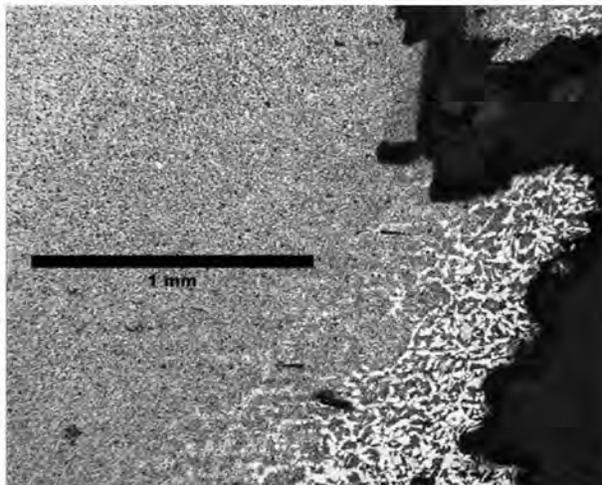
Figure 10.

A. Fracture edge at approximate location shown.
Un-etched

B. Same as at left. Etched.

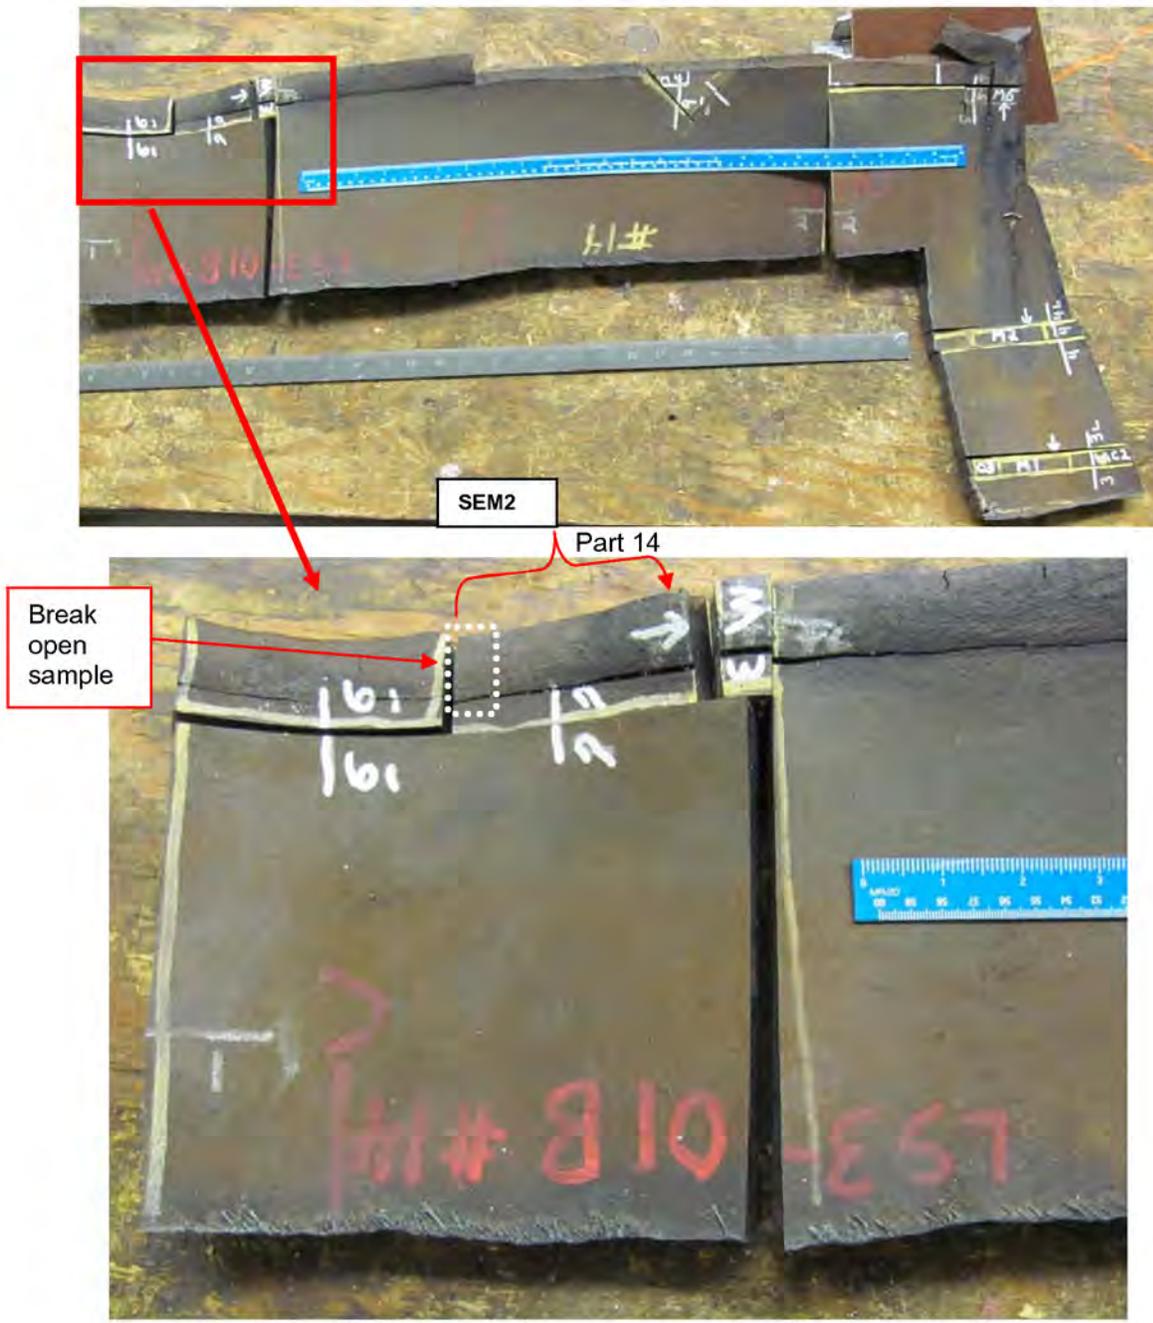
Figure 11

Approximate location of break open sample in SEM2 is marked

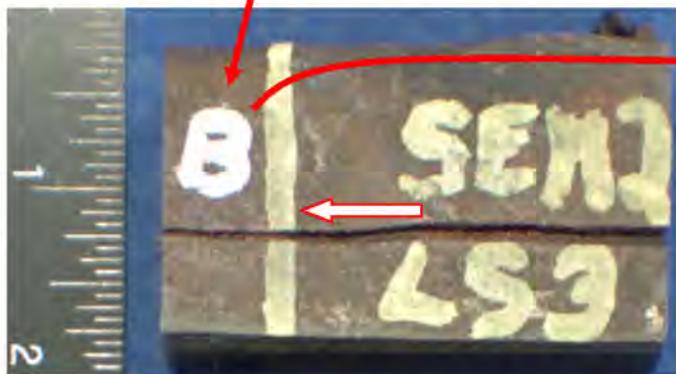
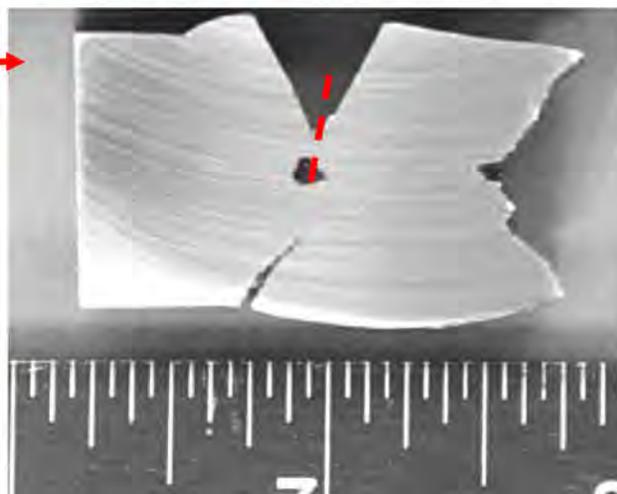
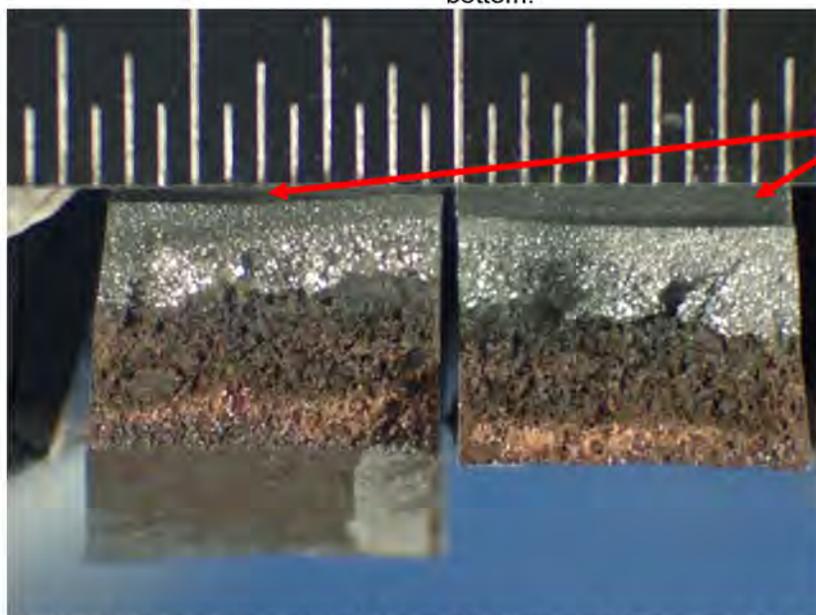
A. Piece of Part 14 with SEM 2 sample before its extraction, looking at ID.

B. Break open sample before opening the crack. The red dotted line shows approximate location of the saw cut. The black spot is the marker dot indicating approximate location of the crack tip. ID is on the bottom.

C. Break open portion of SEM 2 sample looking at the opened in the Laboratory crack sides. ID is at the bottom. Sample evaluated in SEM is on right.

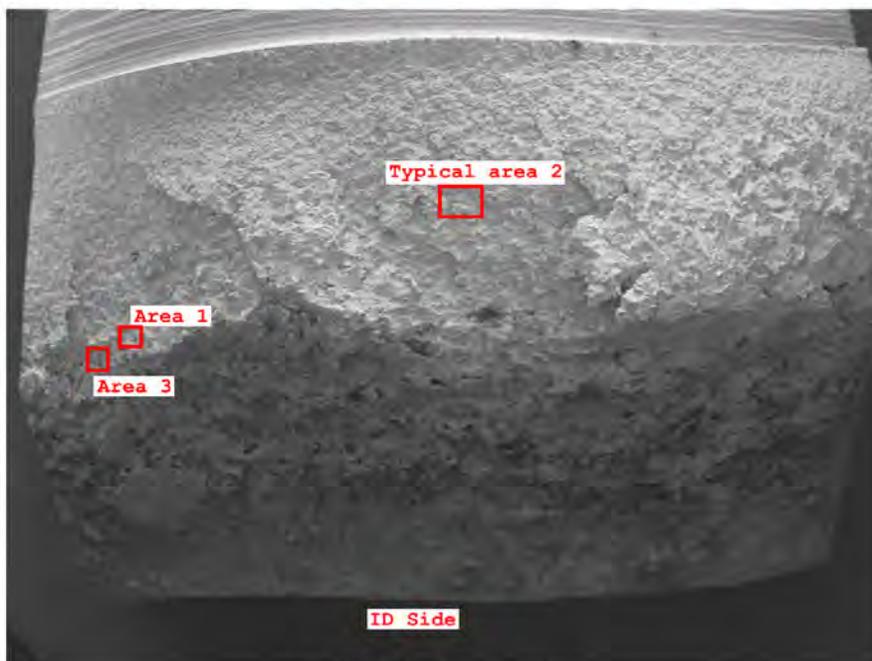
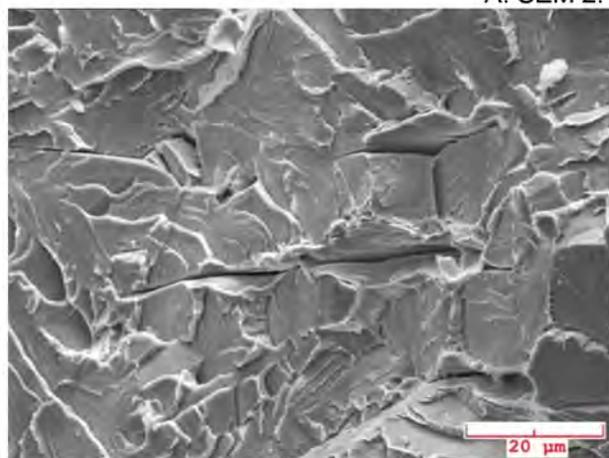
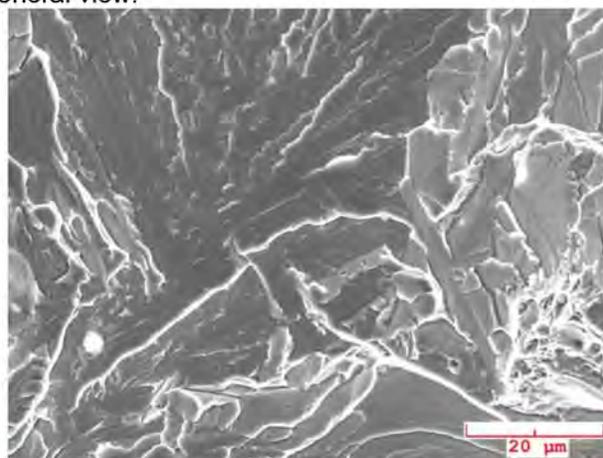
Figure 13

A. SEM 2. General view.

B. Area 1

C. Area 2
