U.S. CHEMICAL SAFETY AND HAZARD INVESTIGATION BOARD

## CHLORINE RELEASE

**DPC ENTERPRISES, L.P.**

REPORT NO. 2004-02-I-AZ

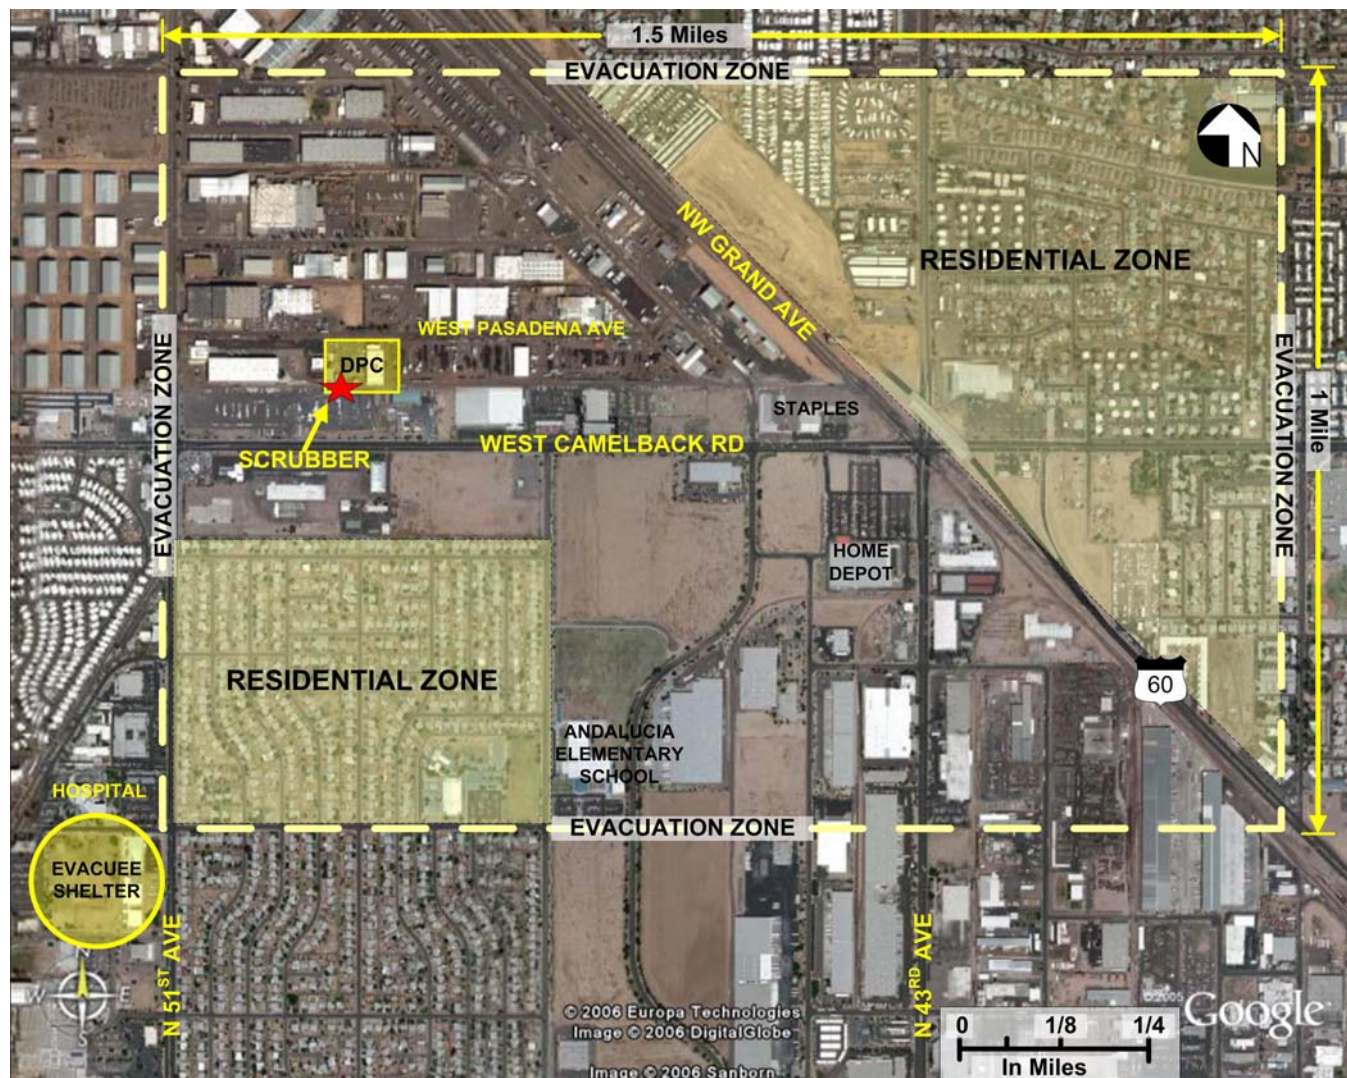
Figure 1. Surrounding community (Glendale and Phoenix, Arizona)

The incident commander established an initial isolation zone covering roughly two city blocks, based on the *DOT Emergency Response Guidebook's* recommendations for chlorine releases, and excluded traffic from a segment of Camelback Road (a major east-west roadway). Based on dispersion modeling by the Tempe Fire Department,<sup>30</sup> the incident commander expanded the isolation zone to a 1 by 1.5 mile rectangle extending downwind from the DPC site (Figure 1).

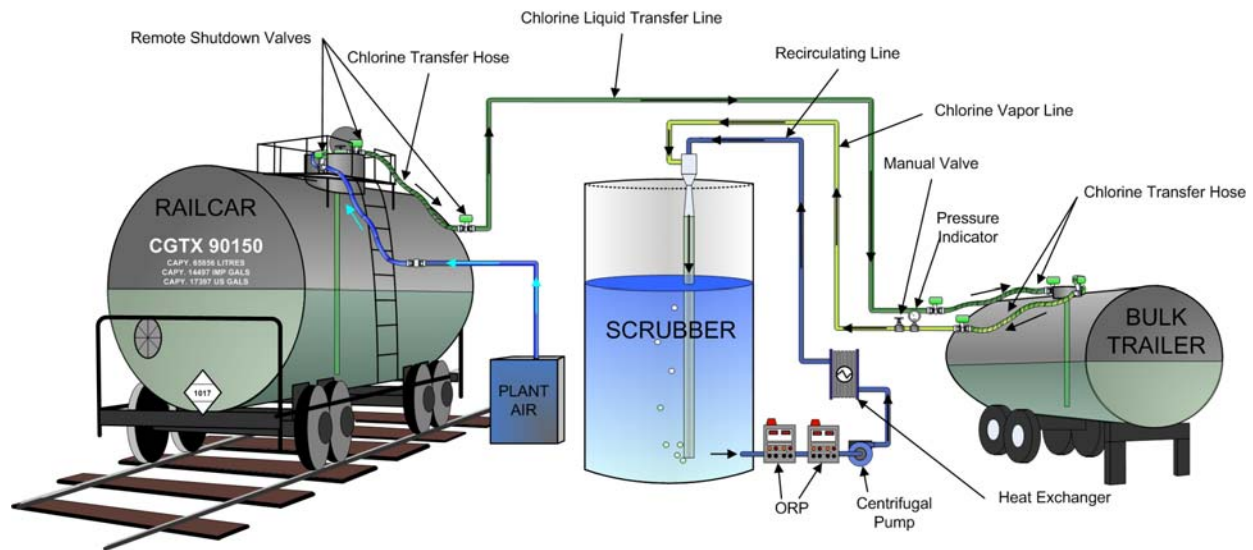
Figure 3. Chlorine bulk road trailer loading and caustic scrubber systems

As Figure 3 shows, a centrifugal pump circulates the scrubber solution through monitoring equipment and a heat exchanger (cooler) to the top of the scrubber where it mixes with chlorine vapors.<sup>11</sup> The cleaned air vents through the top of the scrubber. Scrubber efficiency is normally close to 100 percent.

Two oxidation reduction potential (ORP)<sup>12</sup> meters located in the suction line to the pump (Figure 3) track the concentration of caustic in the scrubber liquid. The meter readings are displayed in millivolts (mV)

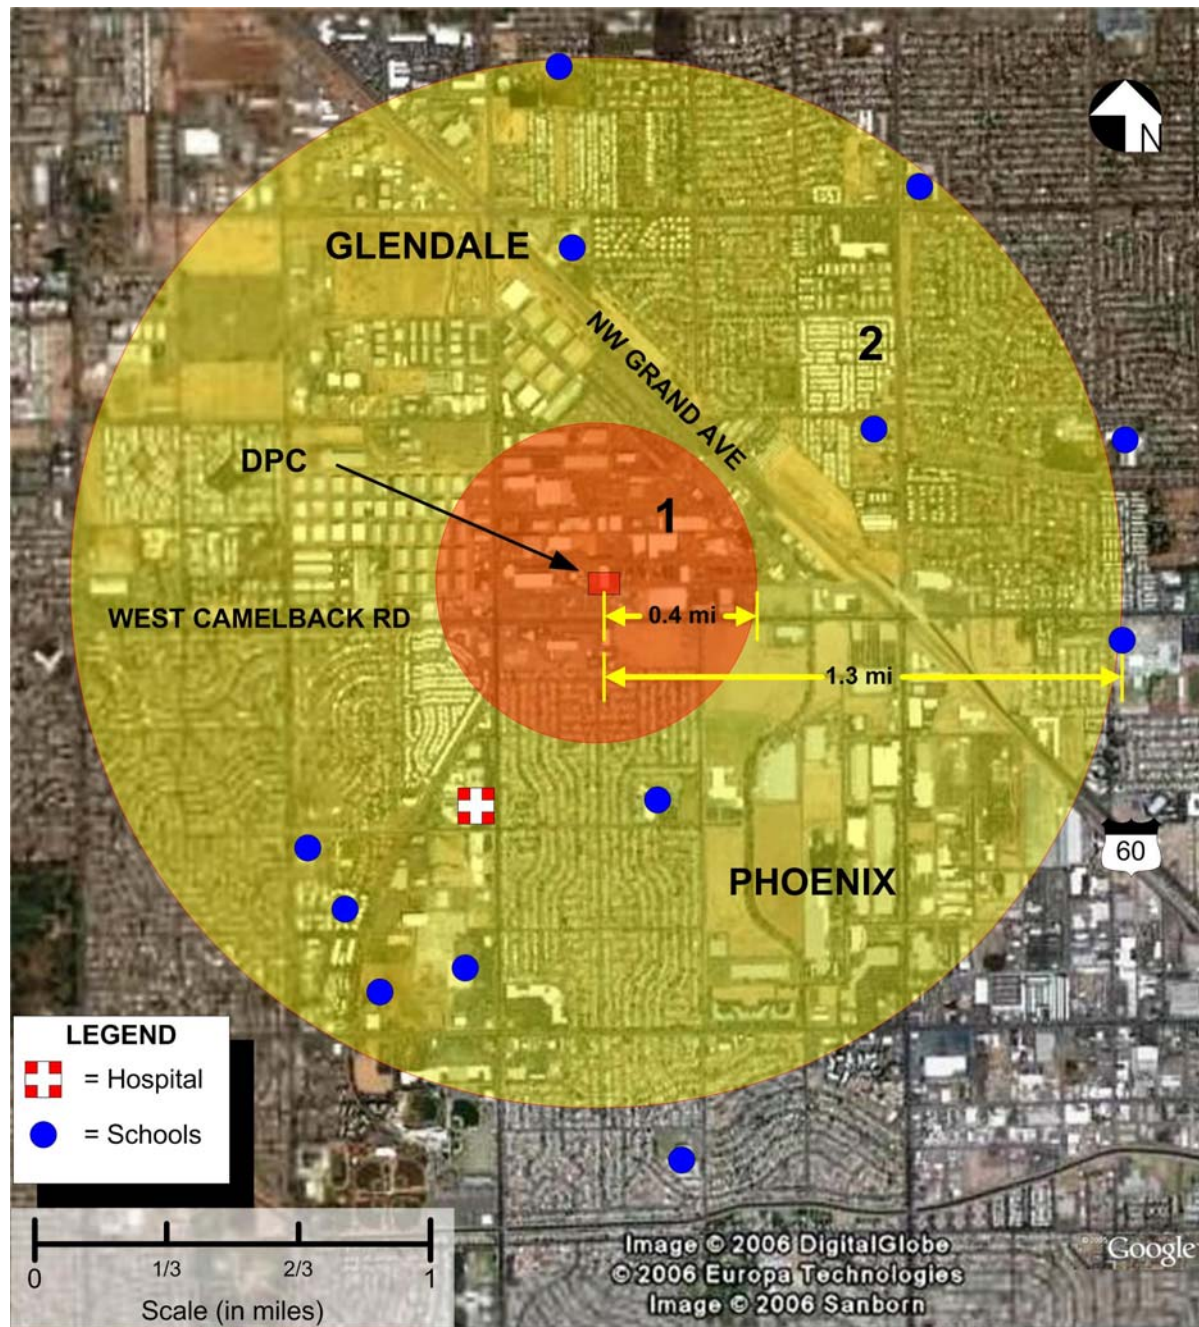
Figure 6. Hazardous chlorine concentration distances

The November 17 chlorine release was serious, and had the potential to significantly harm workers and the community. The CSB investigators estimate that the scrubber could have released up to 1,920 pounds of chlorine (Appendix B). Fortunately, the weather conditions during the incident were favorable for dissipation of the release. Under these conditions, the CSB estimates that hazardous concentrations<sup>20</sup> of chlorine likely extended out as far as 0.4 miles from the site.<sup>21</sup> A similar release under highly stable atmospheric conditions could produce toxic concentrations of chlorine up to 1.3 miles from the DPC site.

The areas of Glendale and Phoenix within these distances of DPC are shown in Figure 6. Approximately 750 people live inside the smaller (0.4 mile radius) circle (Region 1), while nearly 30,000 live inside the larger (1.3 mile radius) area (Region 2). Depending on the wind direction and atmospheric conditions, a 1,920 pound release in this densely populated area could place many people at risk.

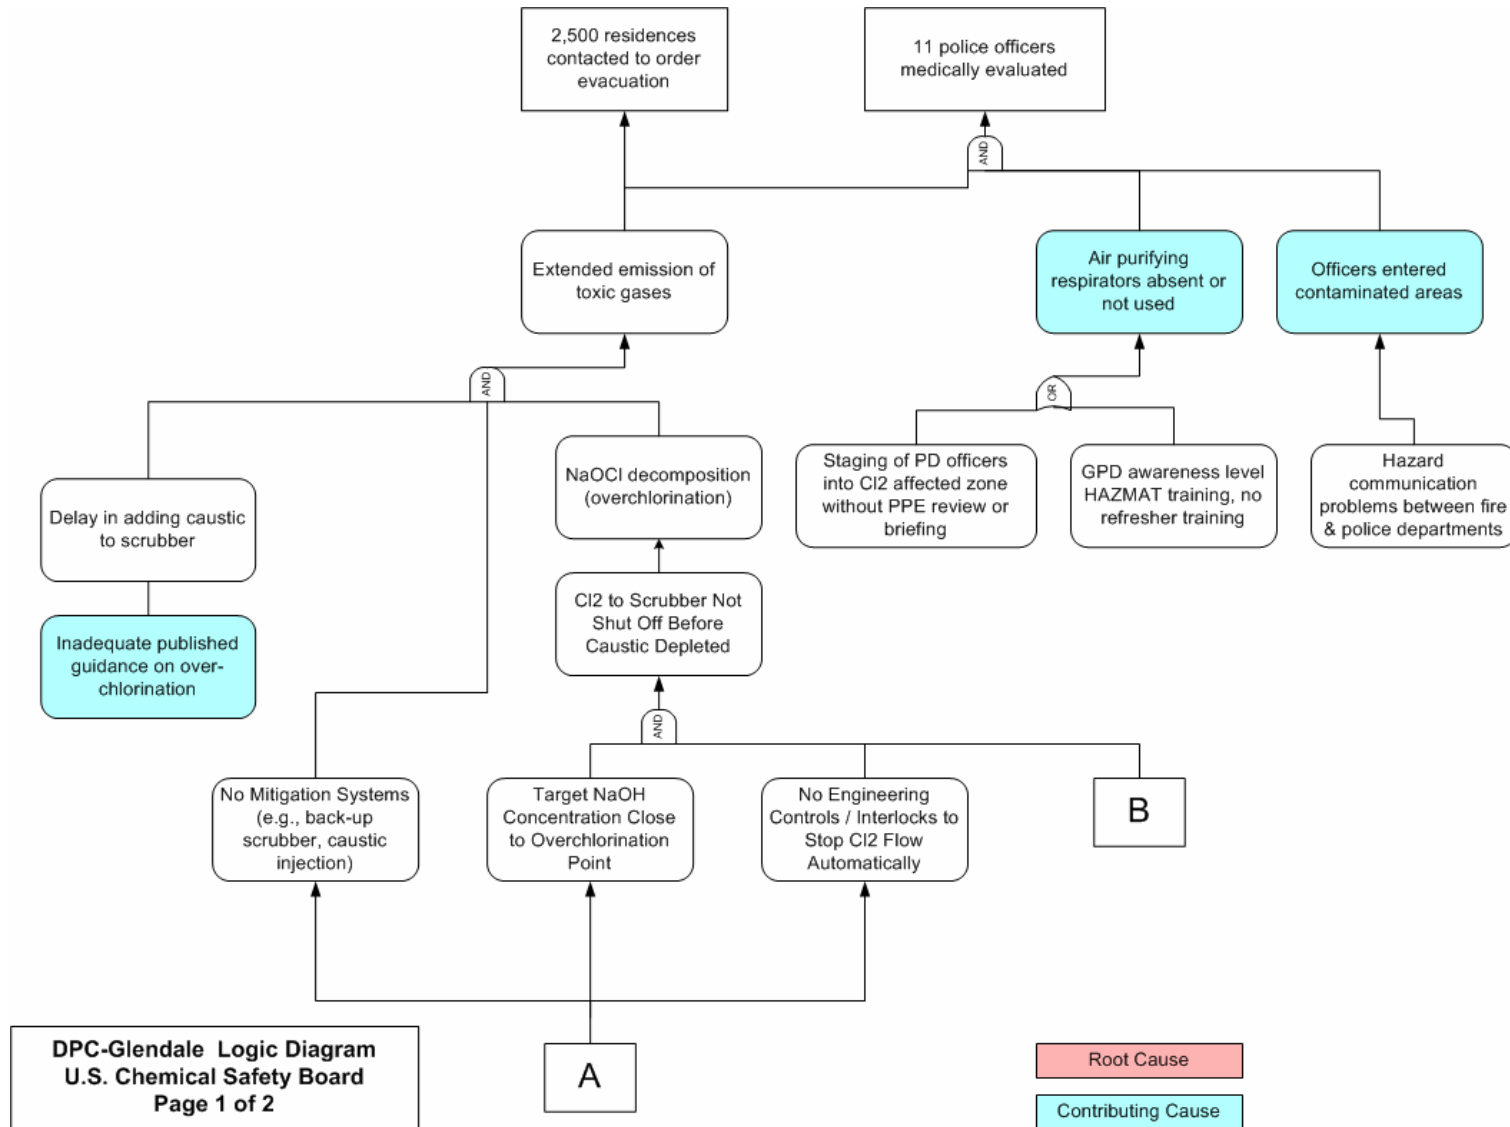
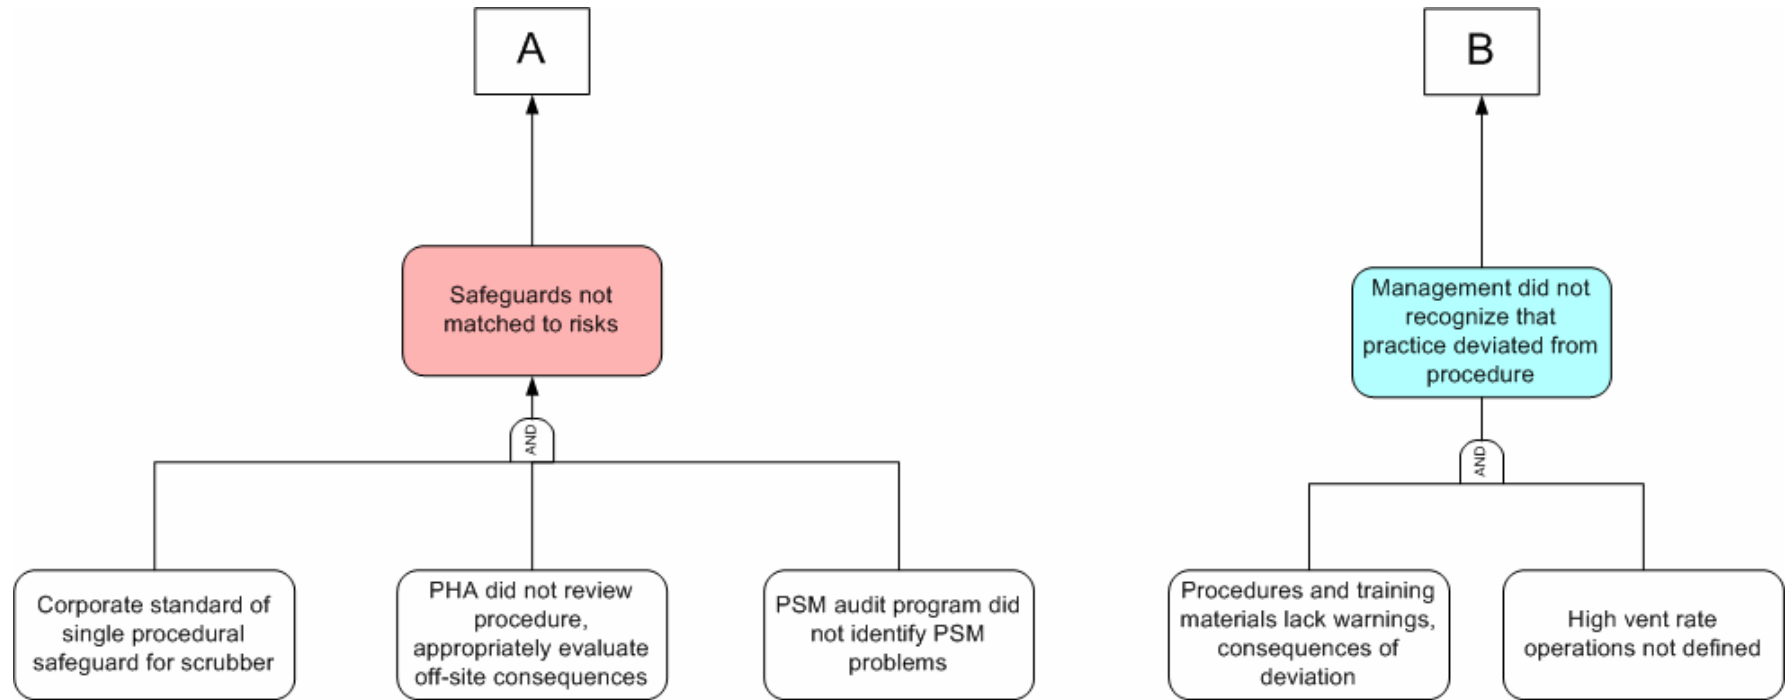
### Appendix D DPC – Glendale Incident Event Tree

- DPC's corporate standards relied solely on procedural safeguards against scrubber over-chlorination.
- DPC's corporate hazard assessment process did not identify or address the consequences of failure to follow the bleach manufacturing SOP, including potential off-site consequences.
- DPC's internal PSM/RMP audit program did not detect deficiencies in operating procedures, training, operating practice, process safety information, and hazard assessment.

1. Practice at DPC's Glendale site deviated from the scrubber SOP when chlorine was venting at a high rate, increasing the risk of scrubber over-chlorination.
  - DPC's corporate scrubber SOP and training materials did not address the consequences of deviating from the scrubber SOP.
  - Compliance with the scrubber procedure was not enforced, further weakening an already inadequate safeguard.
  - Operators were inadequately trained on the consequences of over-chlorination and on the sensitivity of the process to over-chlorination.
