Final Public Meeting – July 16, 2014

**AL Solutions, Inc.
Metal Dust Explosion**

New Cumberland, West Virginia

December 9, 2010

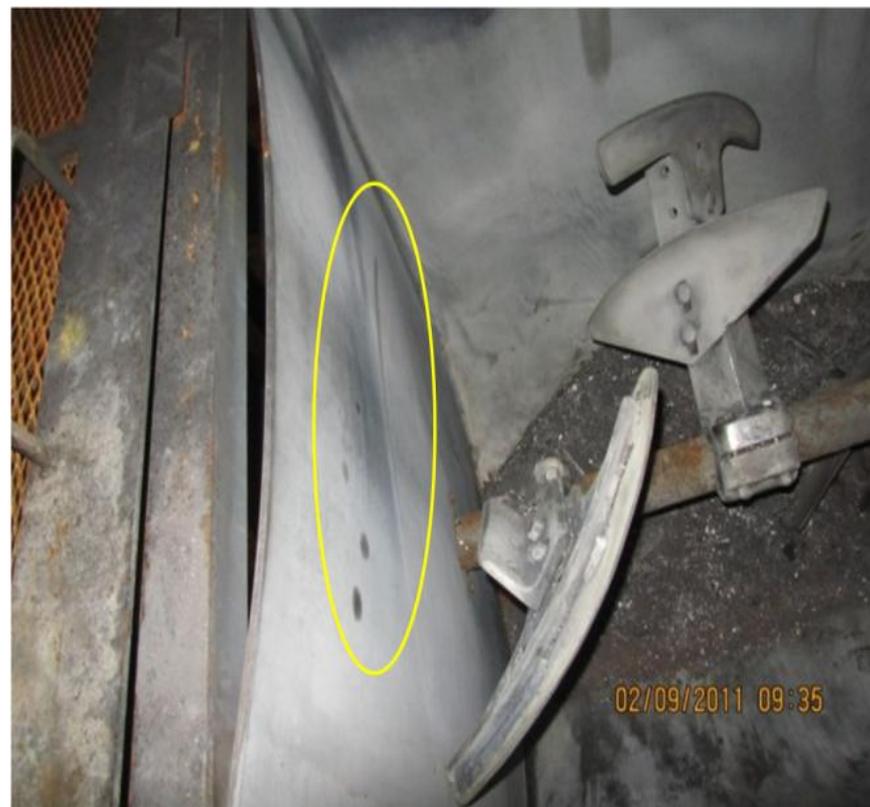
Likely Ignition Point

- Metal blender blades impacted metal blender walls for weeks prior to incident
- Friction likely ignited zirconium in blender

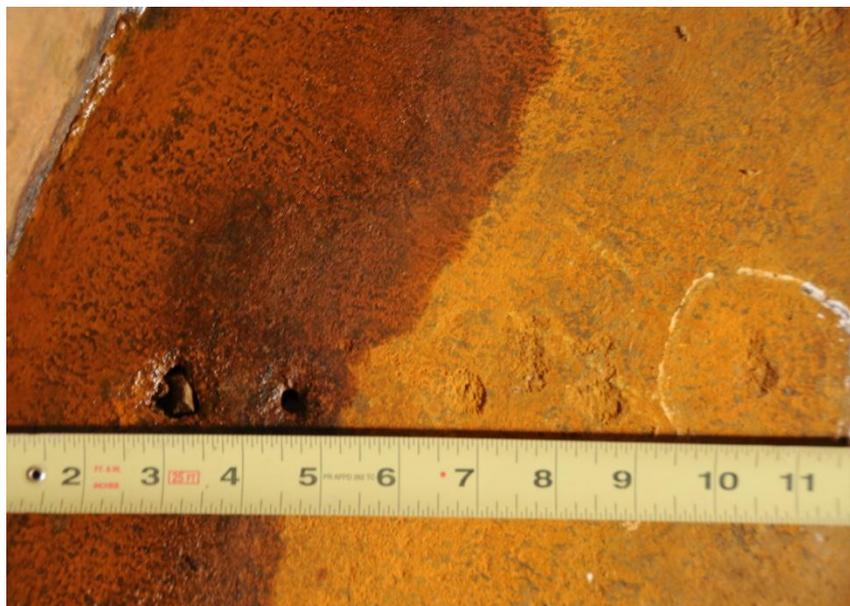
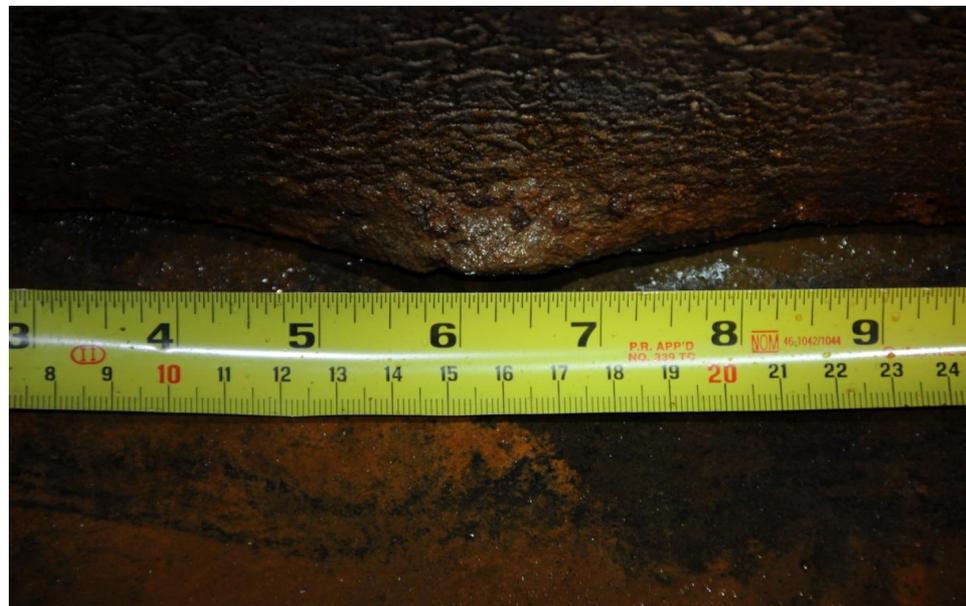
- The CSB observed visible metallurgical failures on the bottom interior surface of the tank that leaked into the Elk River.
- Holes and pits on the tank floor are a likely source of the MCHM leak.

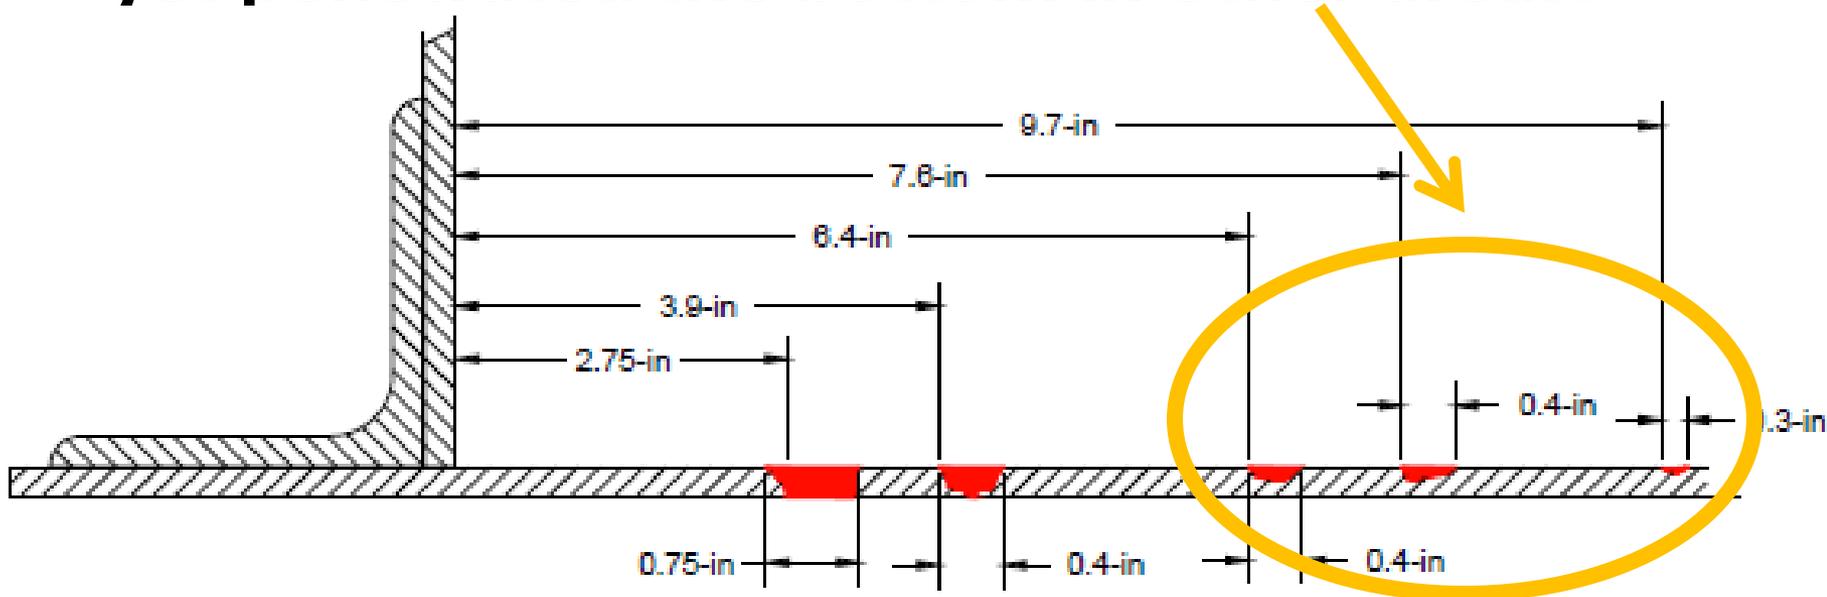
- The holes likely initiated from the interior of the tank due to corrosion associated with water pooling.
- Pitting observed from tank interior had not yet penetrated the bottom in other areas.

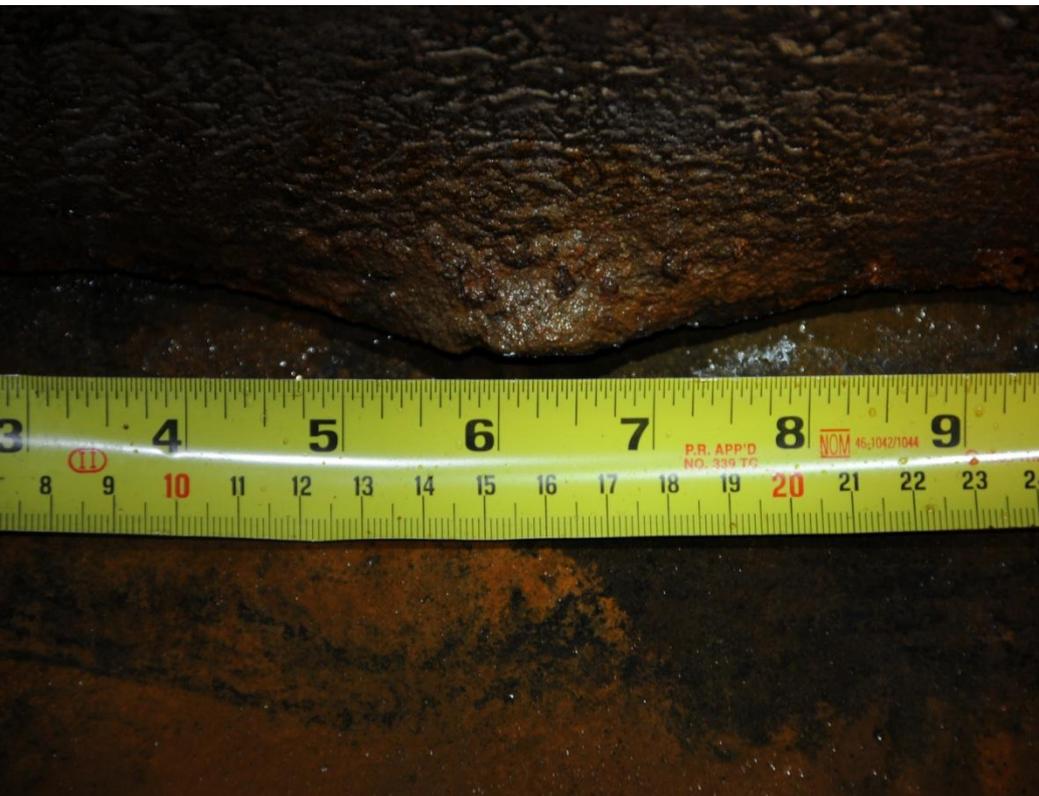
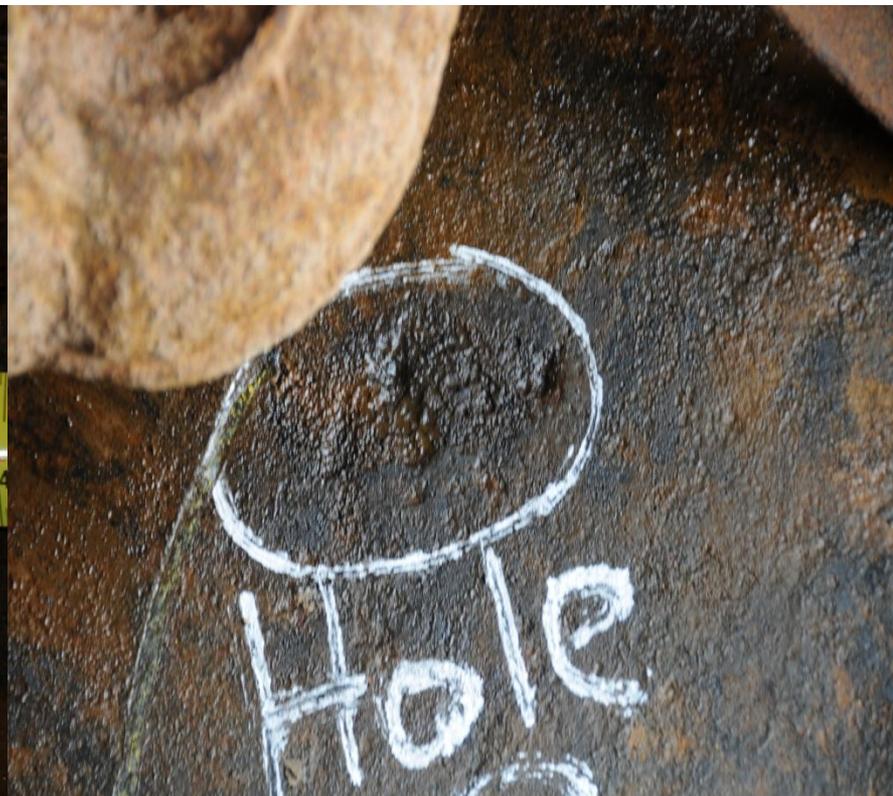
- Multiple pitting and metallurgical damage in T-396 and other tanks containing MCHM.

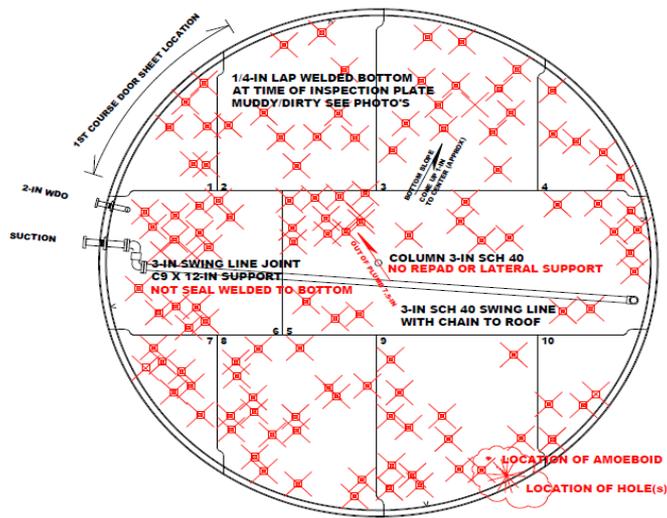
T-396

- Tank 397, another tank also containing the MCHM and PPH mixture, had a hole penetrating the bottom of the tank similar to the holes identified in Tank 396, the tank involved in the release.
- Due to extensive corrosion the CSB suspects that the leaks existed prior to January 9th
