BETA LAB NO.M10198, REV. 1 - Tesoro E6600 HEAT EXCHANGER "E". SUMMARY OF THE RESULTS  PART: 6600-E HEAT EXCHANGER "E", ALL PARTS DAMAGE DEPTH, AND PART 17 MOUNTS	TESORO REFINING AND MARKETING COMPANY ANACORTES REFINERY 10200 W. MARCH POINT ROAD T91WA4428 ANACORTES, WA 98221	CUSTOMER P.O. No.: 4501667904
		DATE: 3/7/2011
		PAGE 1 OF 70

**LABORATORY REPORT**

This report contains the summary of the results obtained in ten previous reports, measurements of the damage penetration on all mounts, as well as evaluation of the Part 17, mounts from weld LS1 labeled LS-1 and 17-LS1 (see layout of the mounts on Figure 1).

This report is the eleventh in a series of the reports on the failed parts ("E") of the 6600E heat exchanger "E". The LS# and CS# refer to longitudinal and circumferential weld seams respectively, while the part number refers to the chain of custody number.

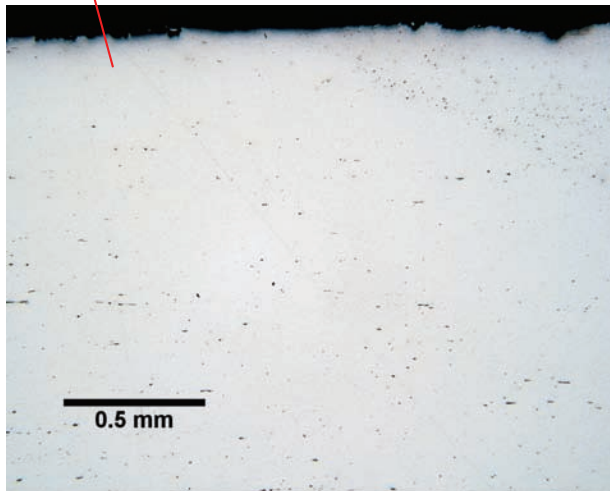
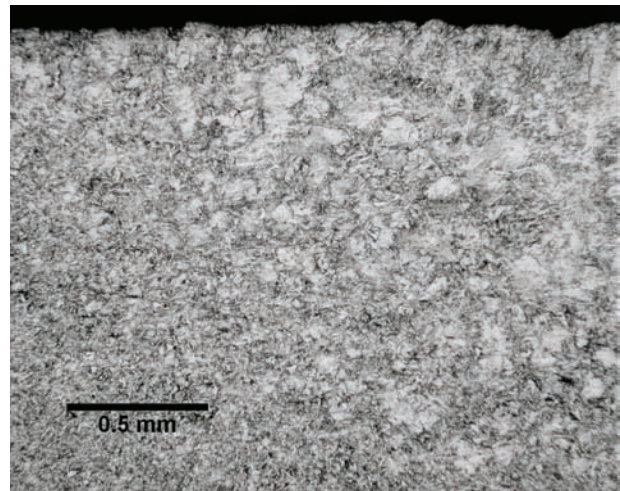
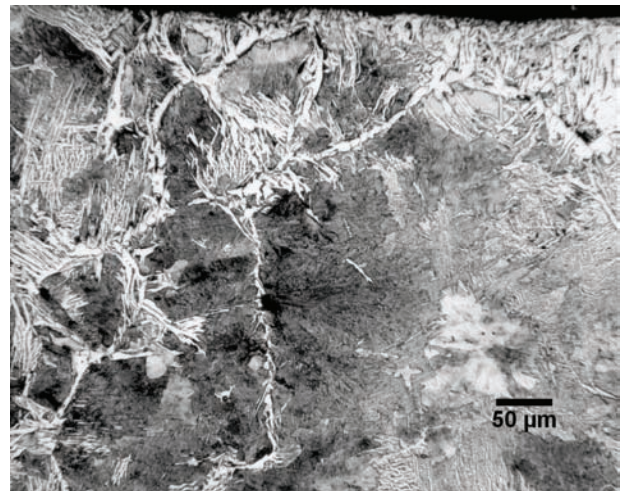
Microstructure at the toe at the left of the weld. Un-etched

Same as at left. Etched

Figure 4. ID is on the top.

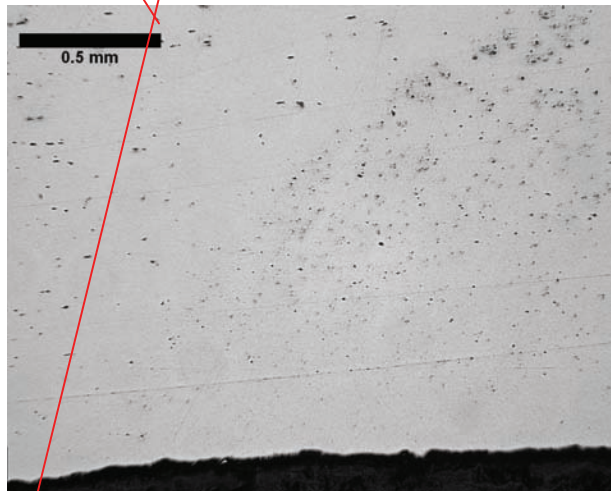
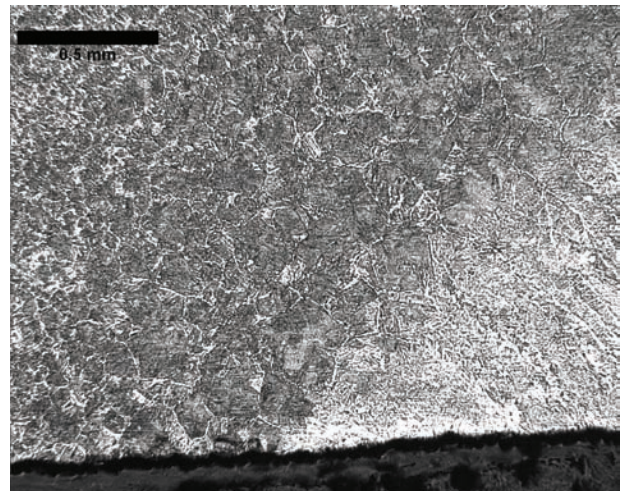
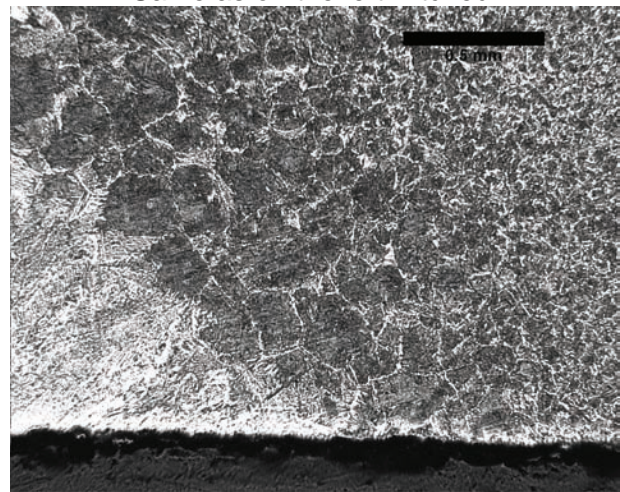
Left toe at the ID. Un-etched

Same as on the left. Etched.

Right toe at the ID. Un-etched

Figure 6. The ID is on the bottom.

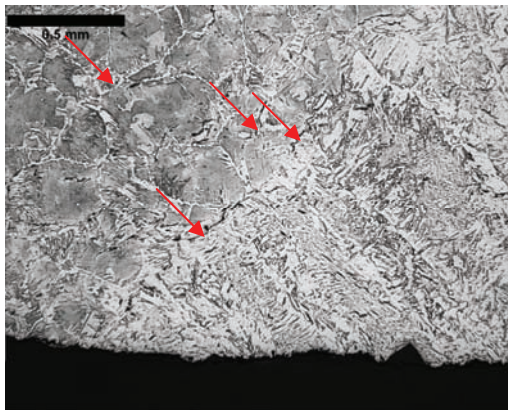
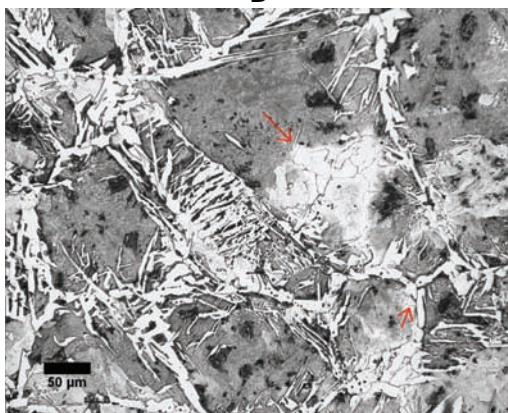
When the observed damage is located at the fusion line (FL) or at the 1<sup>st</sup> or 2<sup>nd</sup> grain of the CG HAZ (Coarse Grain of the Heat Affected Zone, CG everywhere in this report), it is marked as **"FL"**

It is typical to find damage beyond the FL and the 2<sup>nd</sup> grain of the CG, as it shown on the micrographs at left. The arrows at the microphotograph [B] show a spot indicative of the damage well deep in the CG, away from the FL. On microphotograph [C] the damage is in the 21<sup>st</sup> – 22<sup>nd</sup> grain inside the CG.

If this is observed, the location of the damage is defined as **"CG"**.

Figure 9. Definitions of the damage locations (devised by others) used in Table 11 and in the text. The locations in the base metal (BM) or in the weld metal (WM) are self-explanatory.

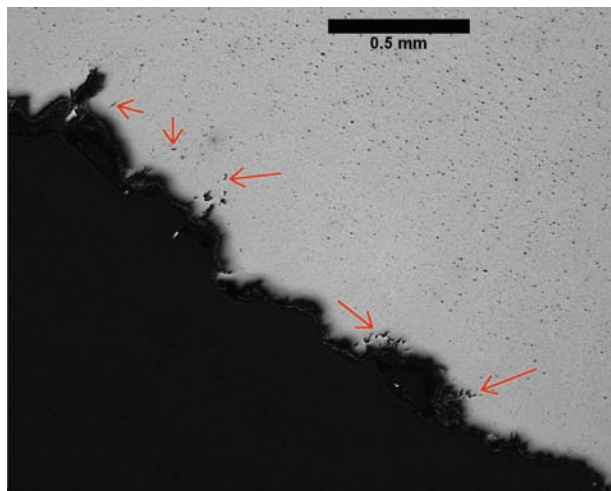
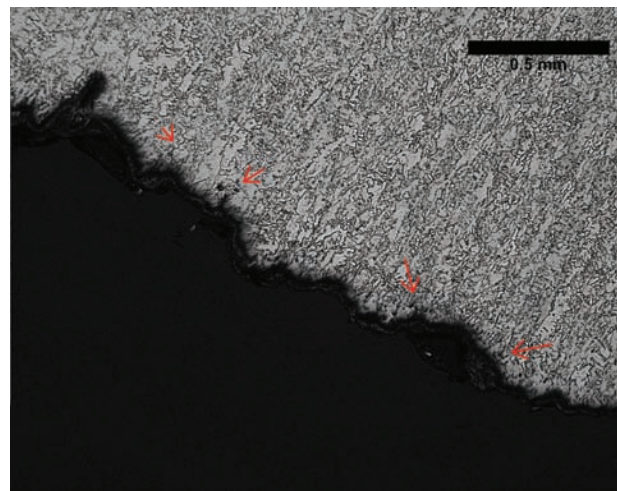
Un-etched left of weld

Etched left of weld

Damage Depth, mm	
Left of the Weld	Right of the Weld
18.51	0 (Clad)

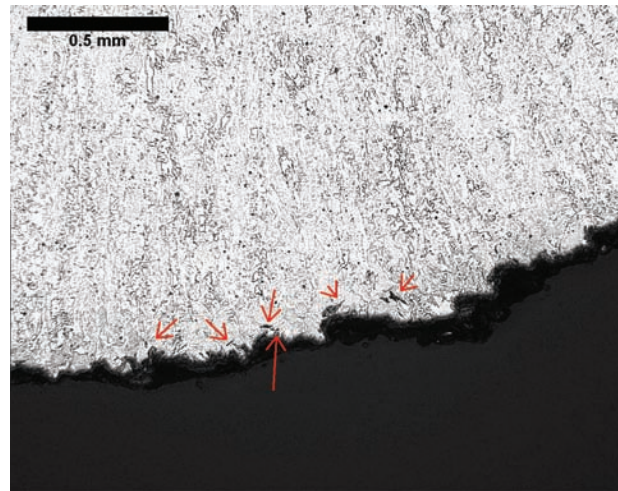
Un-etched- right side of weld

Etched- right side of weld

Damage Depth, mm	
Left of Weld	Right of Weld
0 (Clad)	17.73

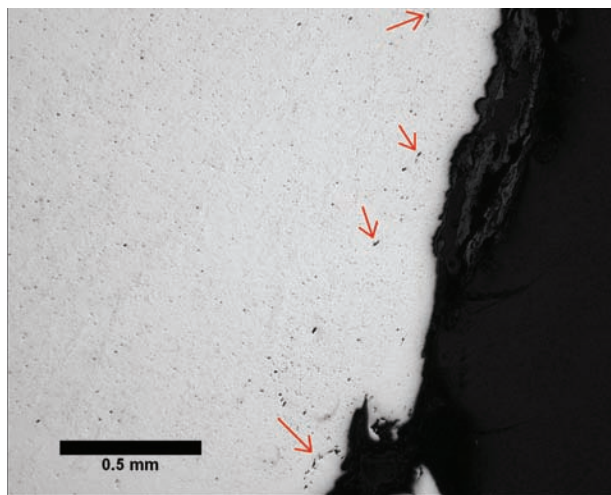
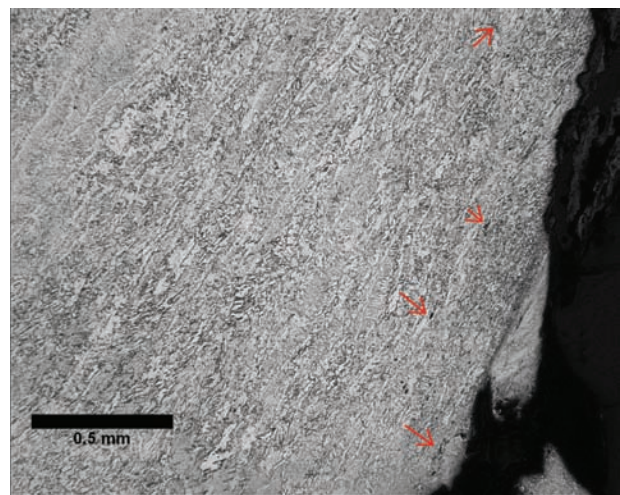
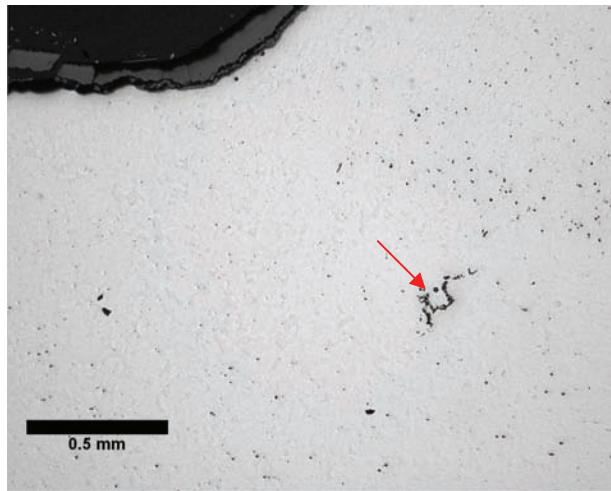
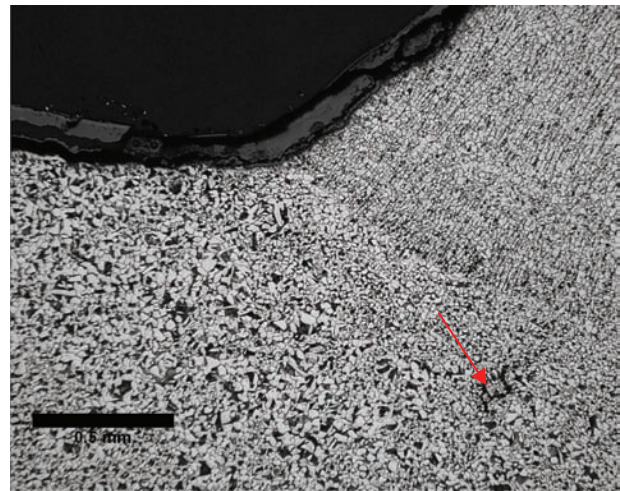
**LABORATORY REPORT**  
**CS4 WELD, SAMPLE 19E-M5/14-M5**

19E-m5 at fracture. Un-etched

19E-m5 at fracture. Etched

14-m5 at O.D. Un-etched.

14-m5 at O.D. Etched

Damage Depth, mm	
Left of Weld	Right of Weld
0 (Clad)	21.8

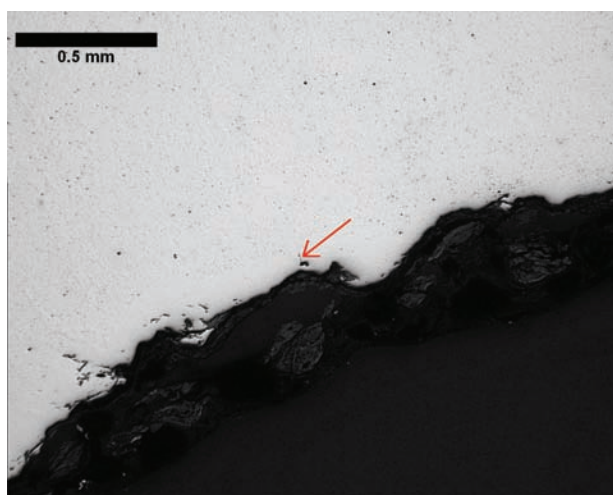
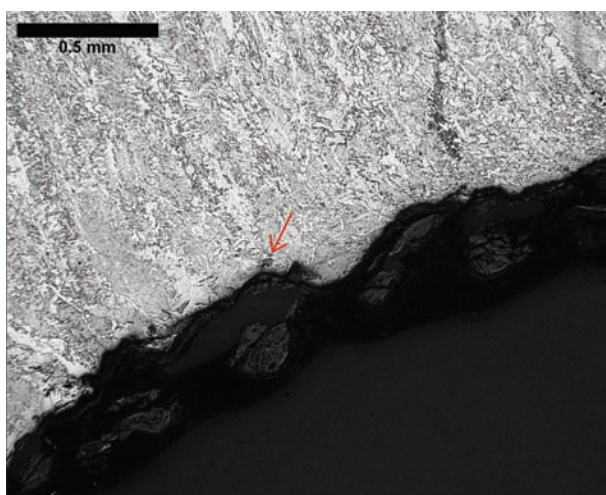
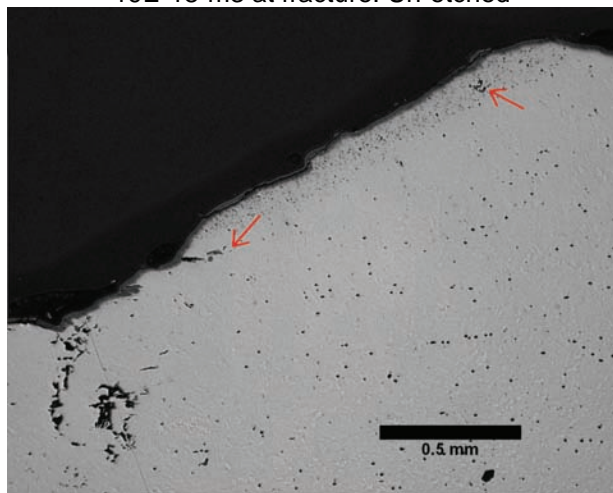
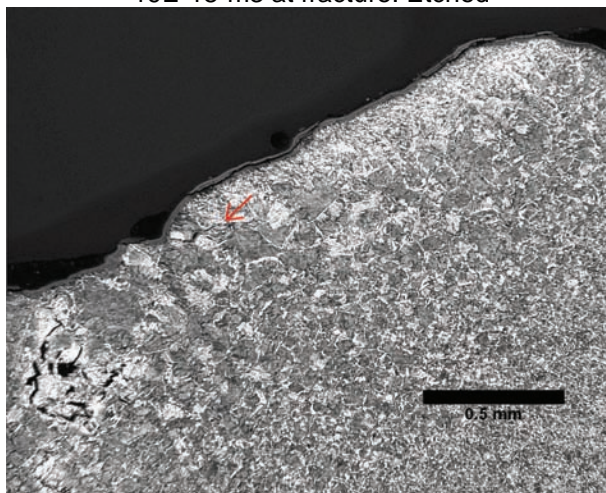
19E-18-m3 at fracture. Un-etched

19E-18-m3 at fracture. Etched

18-m3 at fracture, at OD. Un-etched

18-m3 at fracture, at OD. Etched

Damage Depth	
Left of Weld	Right of Weld
0 (Clad)	21.8

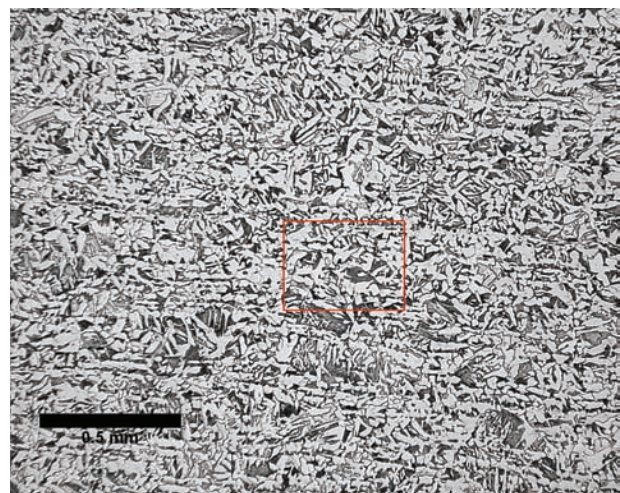
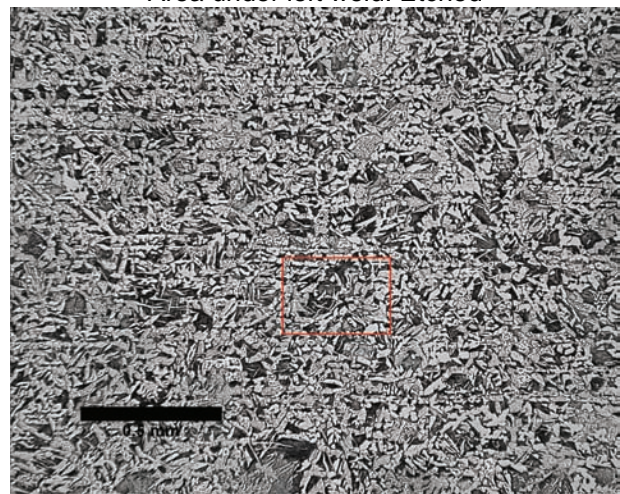
Area under left weld. Un-etched

Area under left weld. Etched

Area under right weld. Un-etched

Area under right weld. Etched

Damage Depth, mm	
Left of Weld	Right of Weld
4.98	5.53

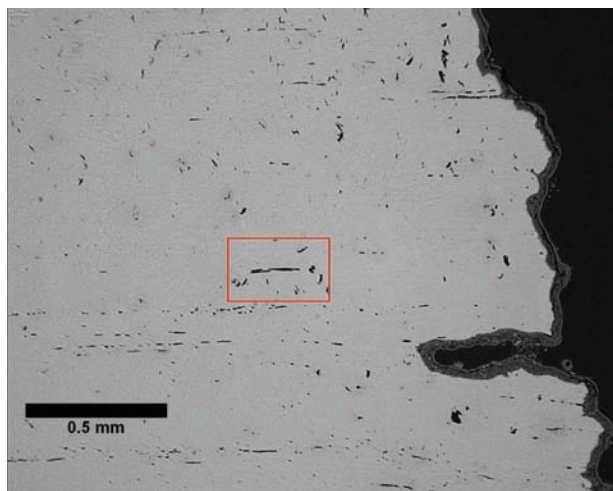
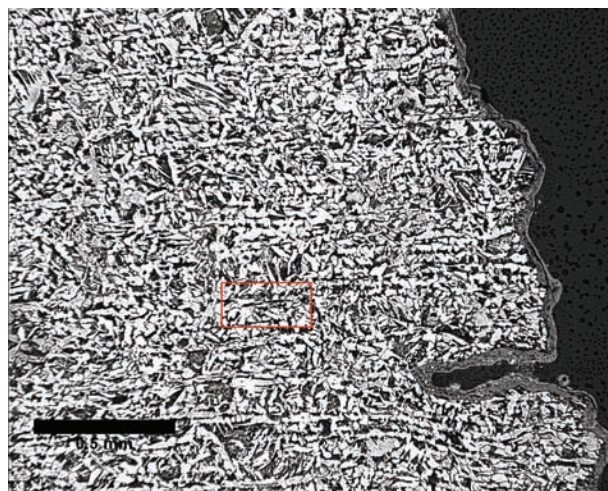
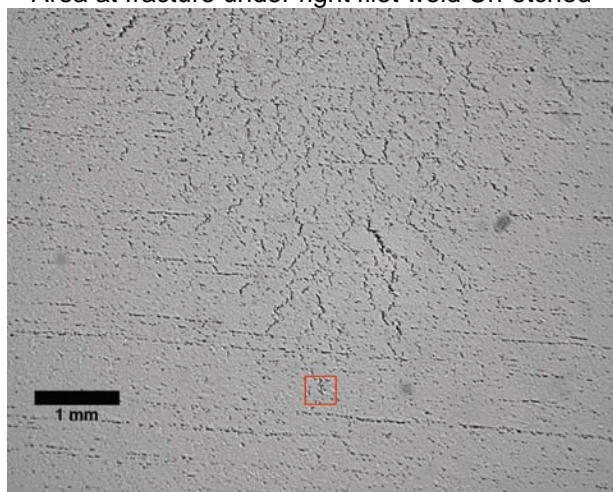
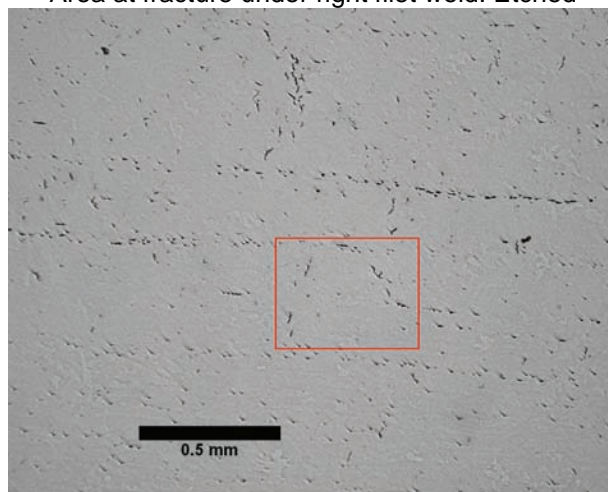
**CS4 WELD, SAMPLE 18-M2**

Area at fracture under right fillet weld Un-etched

Area at fracture under right fillet weld. Etched

Area under left weld. Un-etched

Area under left weld enlarged. Un-etched

Damage Depth, mm	
Left of Weld	Right of Weld
9.32	9.86

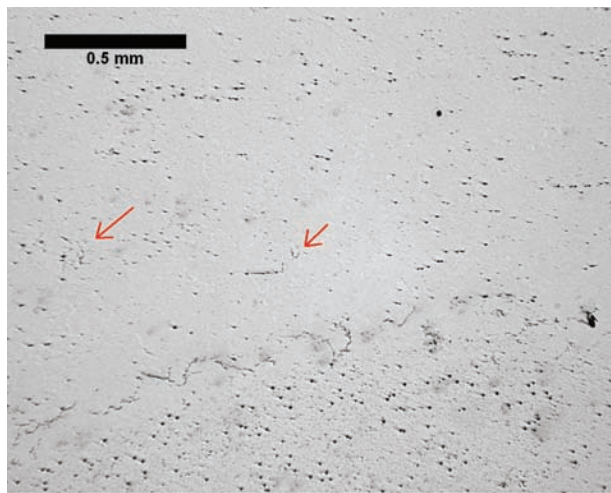
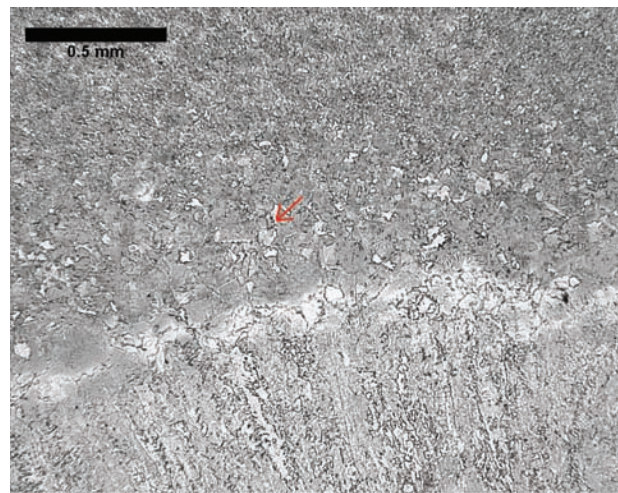
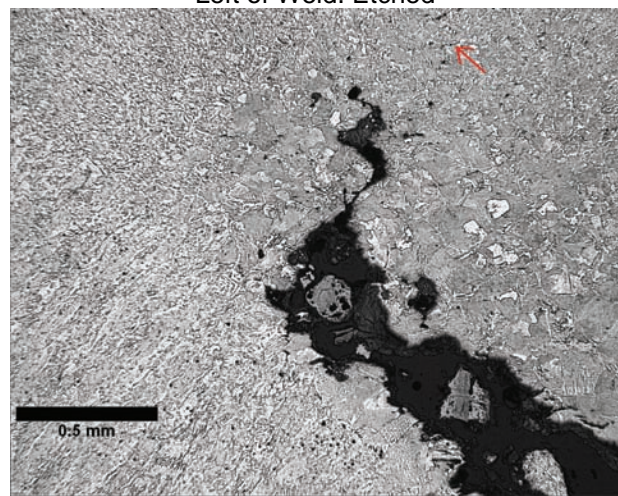
**LABORATORY REPORT  
CS3 WELD, SAMPLE 14-M2**

Left of Weld. Un-etched

Left of Weld. Etched

Right of Weld

Right of Weld. Etched

Damage Depth	
Left of Weld	Right of Weld
2.54	1.23

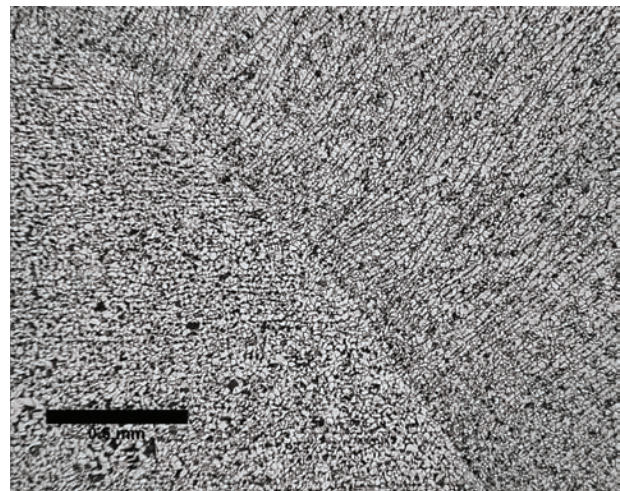
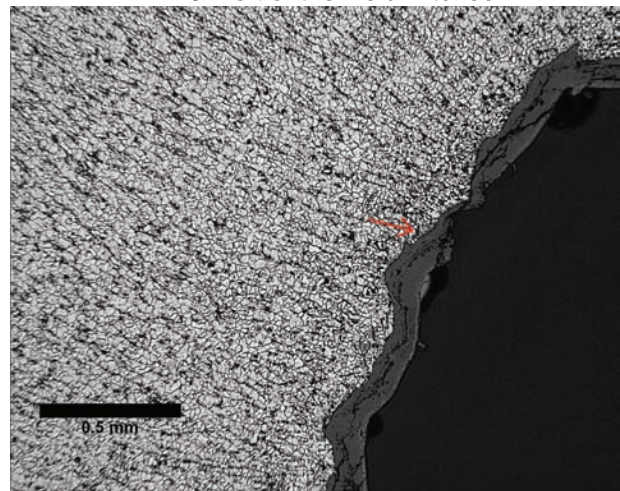
14-T0. Left of the weld. Un-etched

14-T0. Left of the weld. Etched

14-T0. Right of the weld. Un-etched

14-T0. Right of the weld. Etched

Damage Depth, mm	
Left of Weld	Right of Weld
20.91	21.8 (14-T0)

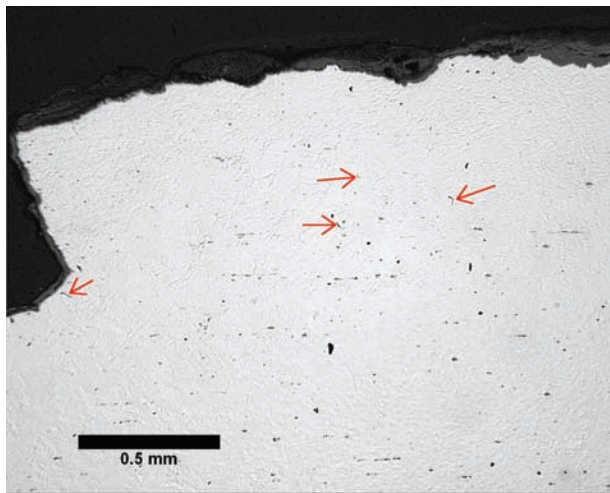
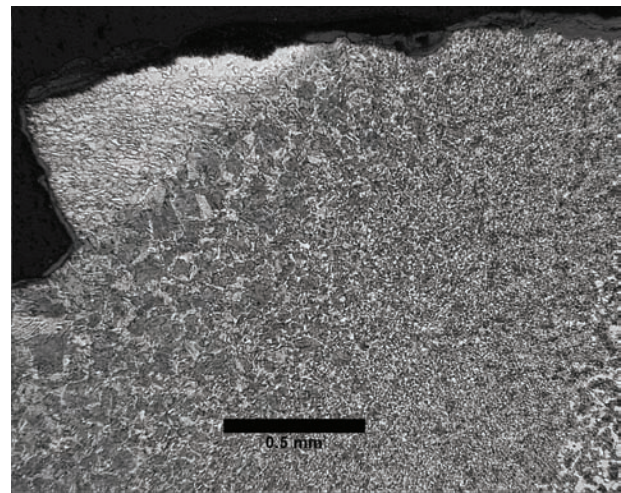
**LABORATORY REPORT  
LS3 WELD, SAMPLES 14-T0/15-T0**

15-T0. Un-etched

15-T0. Etched

Damage Depth, mm	
Left of Weld	Right of Weld
NA	21.8

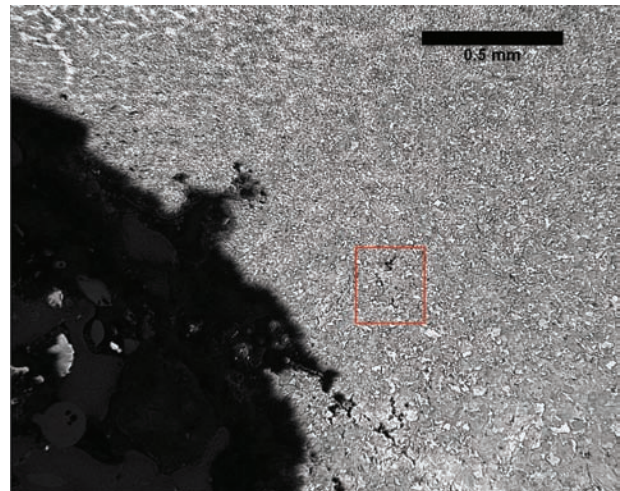
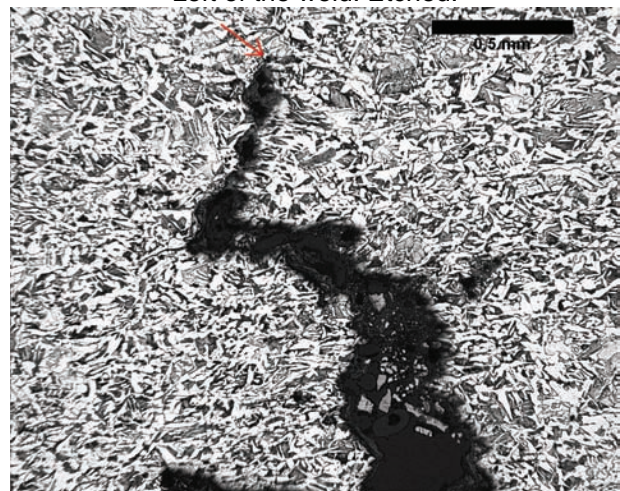
Left of the weld. Un-etched

Left of the weld. Etched.

Right of the weld. Un-etched.

Right of the weld. Etched.

Damage Depth	
Left of Weld	Right of Weld
3.37	7.29

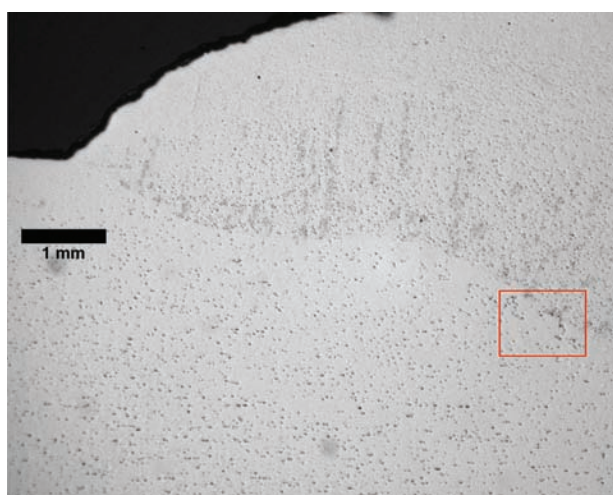
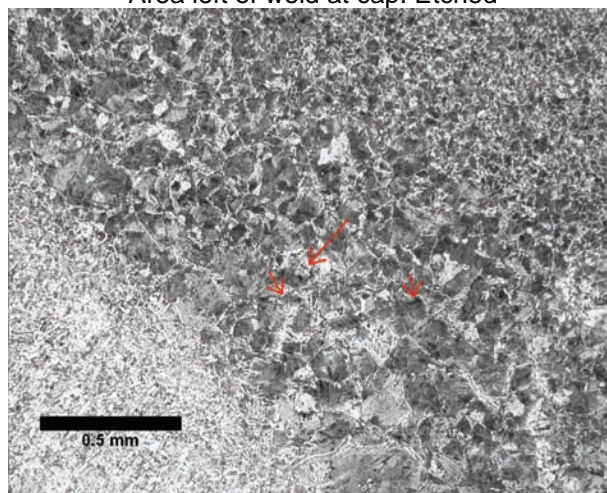
**LABORATORY REPORT  
PART 16-1. CS3 WELD, SAMPLE T-2C**

Area left of weld at cap. Un-etched

Area right of weld. Un-etched

Area right of weld. Etched

Damage Depth	
Left of Weld	Right of Weld
19.9	0.344

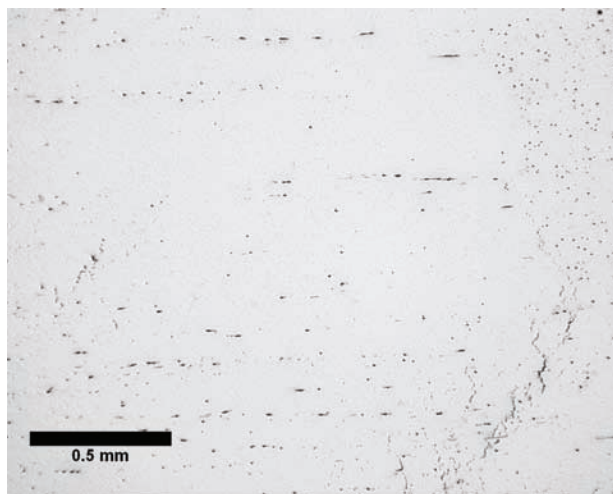
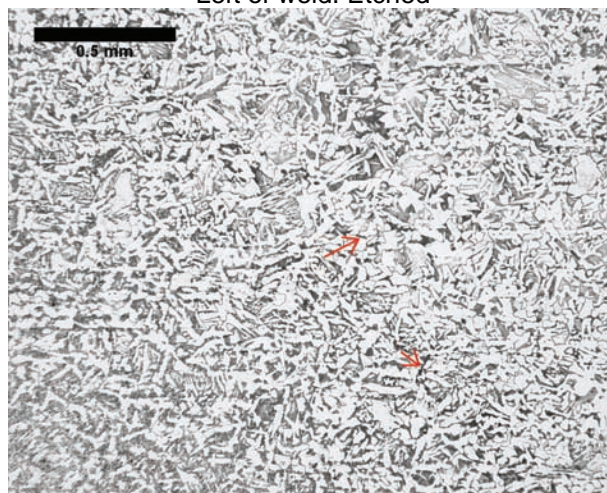
**LABORATORY REPORT  
PART 16-1. LS2 WELD, SAMPLE T-2L**

Left of weld. Un-etched

Right of weld. Un-etched

Right of weld. Etched

Damage Depth	
Left of Weld	Right of Weld
5.85	7.45

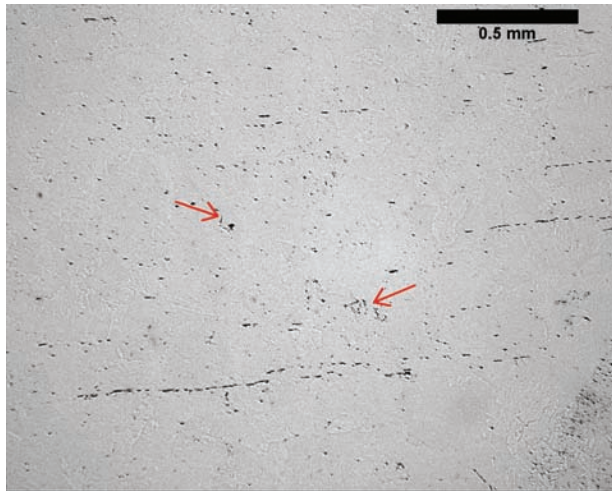
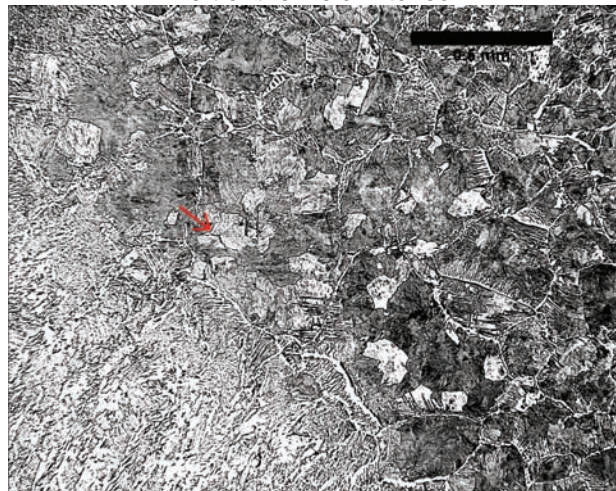
**LABORATORY REPORT  
PART 16-2. LS2 WELD, SAMPLE 22" FROM CS3**

Left of the weld. Un-etched

Right of the weld. Un-etched

Right of the weld. Etched

Damage Depth, mm	
Left of Weld	Right of Weld
3.04	5.37

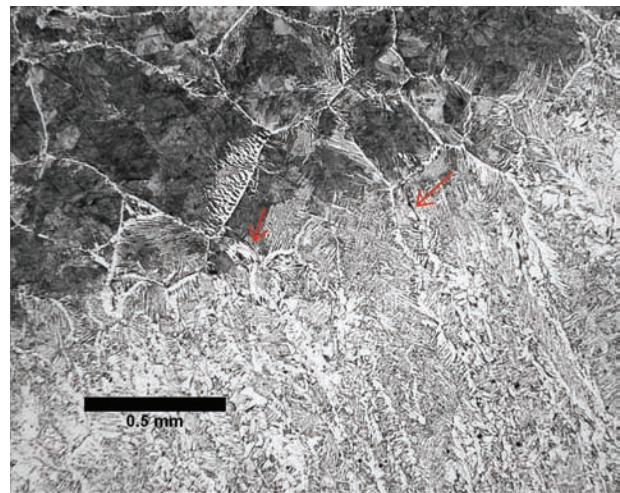
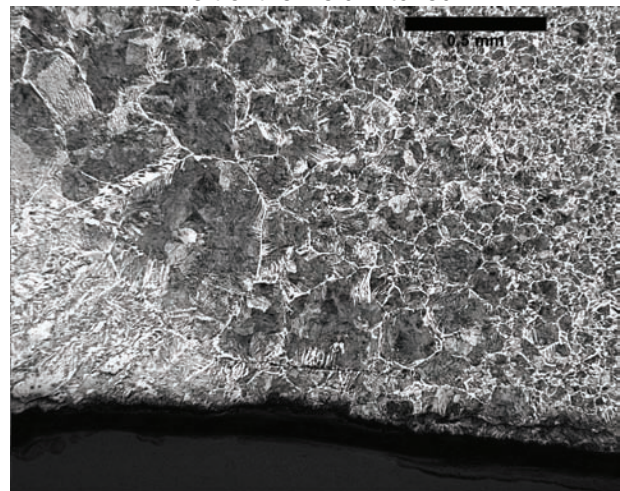
Left of the weld. Un-etched

Left of the weld. Etched

Right of the weld. Un-etched

Right of the weld. Etched

Damage Depth, mm	
Left of Weld	Right of Weld
3.18	0

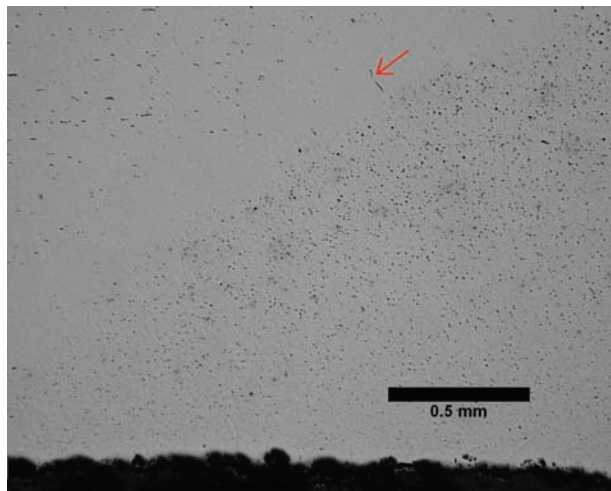
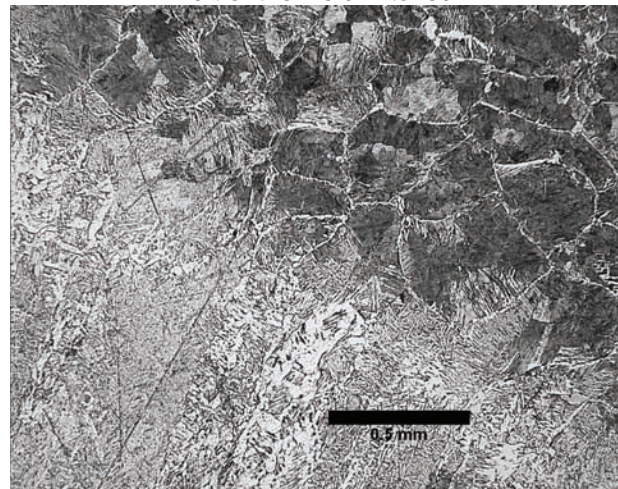
**LABORATORY REPORT  
PART 22, LS2-CS2-T, SAMPLE LS2-A**

Left of the weld. Un-etched

Right of the weld. Un-etched

Right of the weld. Etched

Damage Depth, mm	
Left of Weld	Right of Weld
1.38	2.11

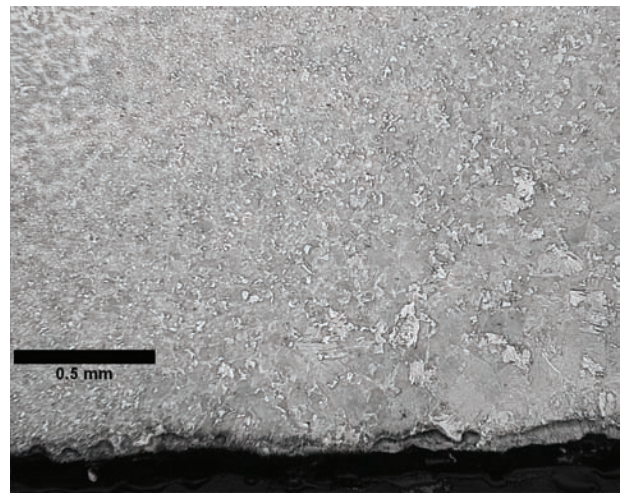
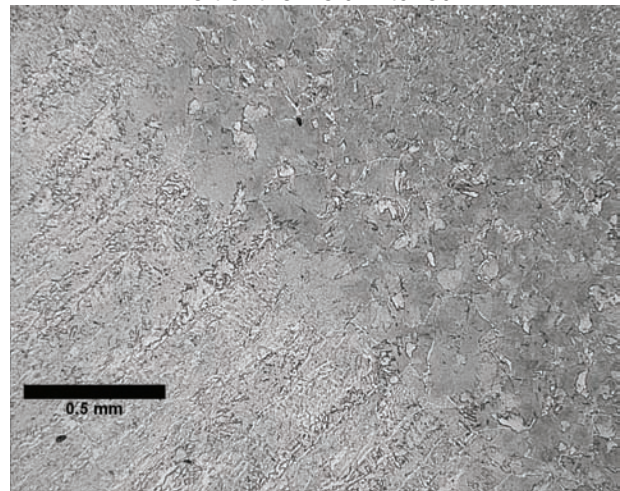
Left of the weld. Un-etched

Left of the weld. Etched

Right of the weld. Un-etched

Right of the weld. Etched

Damage Depth	
Left of Weld	Right of Weld
0	4.05
