| BETA LAB No.M10198, TESORO LS2 AND LS2/CS2 TEE FINDINGS | TESORO REFINING AND MARKETING COMPANY ANACORTES REFINERY 10200 W. MARCH POINT ROAD T91WA4428 ANACORTES, WA 98221 | CUSTOMER P.O. No.: 4501667904 |
| PART: 6600-E HEAT EXCHANGER, LS2 22 IN, 36.5 IN MOUNTS, LS2 T2L SEM FRACTOGRAPHY AND PART 22 LS2-CS2 TEE FINDINGS PARTS 16-1 AND 22 | | DATE: OCTOBER 13, 2010 |

LABORATORY REPORT

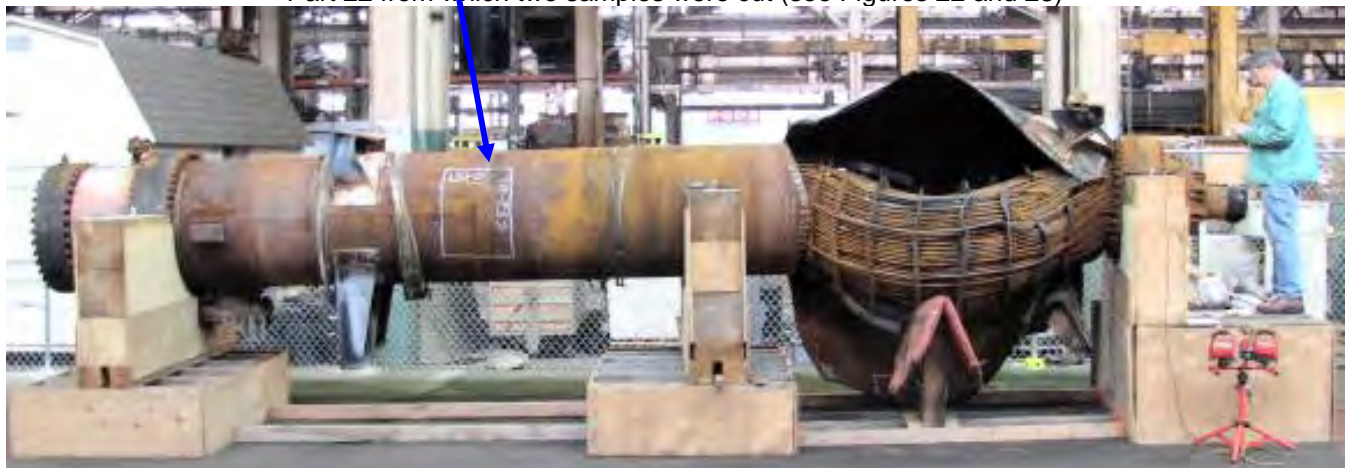
Figure 1 Un-packed main heat exchanger

Overall main heat exchanger with "fish mouth " rupture primarily along LS3 and CS4

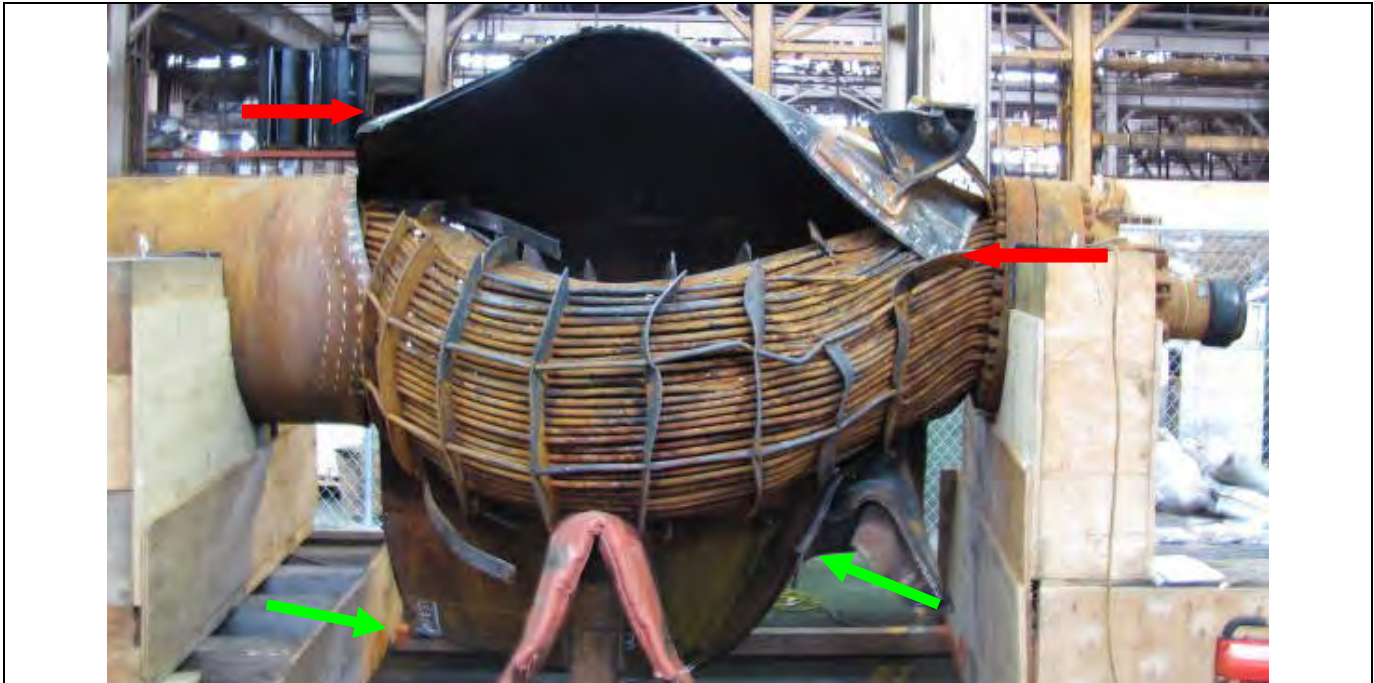
Figure 2 Photo showing the fracture along LS3 where an approximate 6 inch wide portion was removed

Fracture along LS3 seam between the green arrows for the bottom part of the fracture, and for the LS3 top – between the red arrows

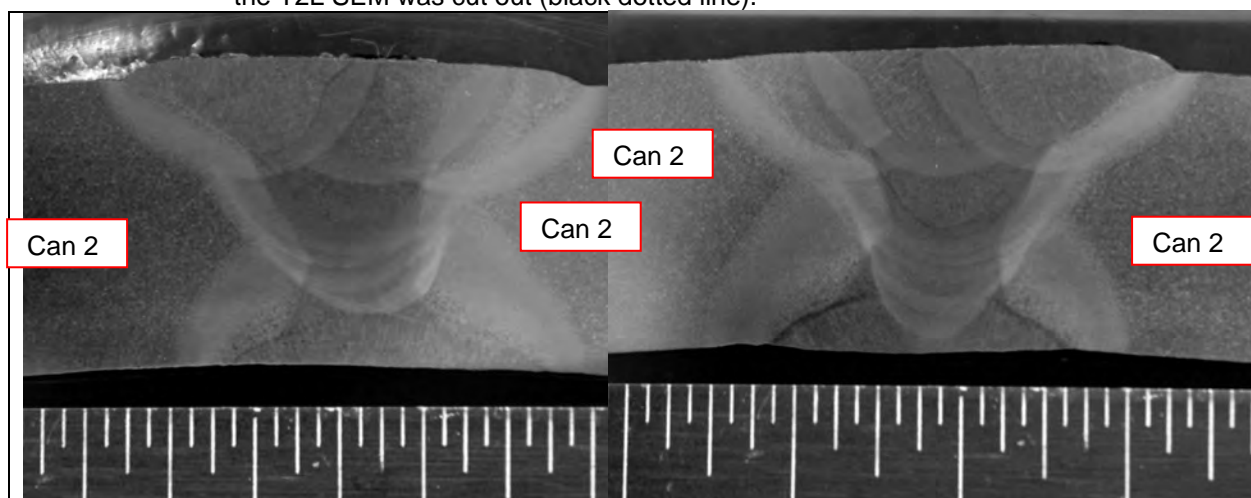
Photomicrograph of 22 inch sample-ID on
bottom, scale mark is 1/16 inch

Photomicrograph of 36.5 inch sample-ID on bottom, scale mark is 1/16
inch

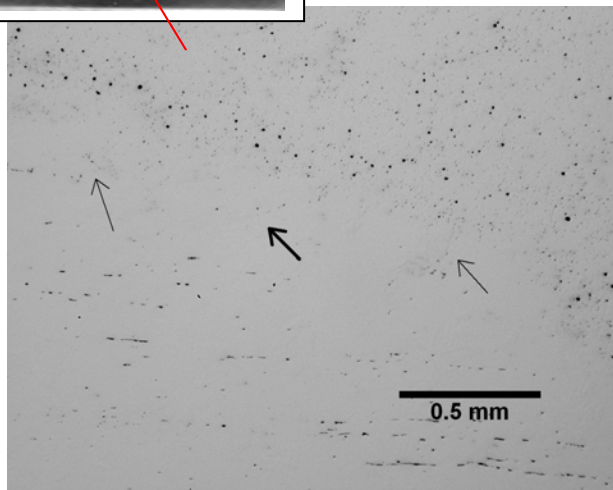
Figure 14

A. HAZ-Weld metal interface 3.28 mm down from ID. Un-etched

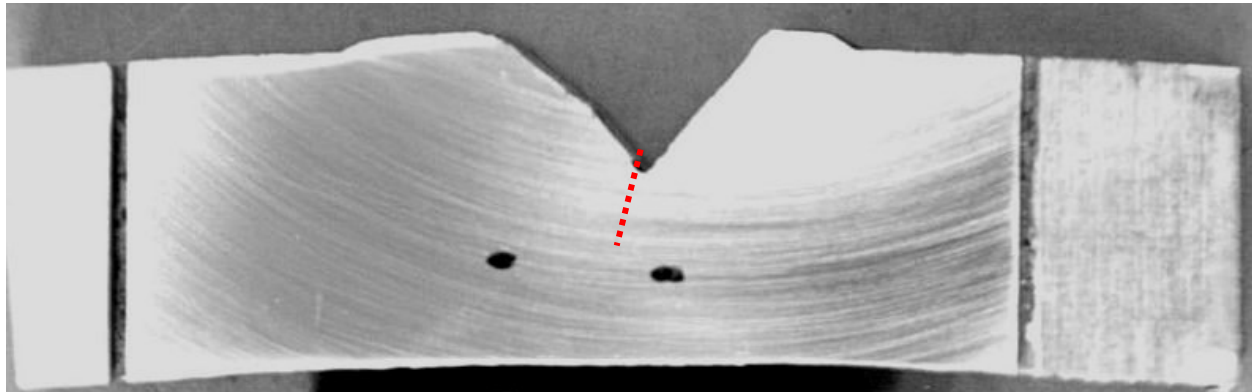
Figure 18

T2L SEM sample before break. The dotted line shows approximate location of the saw cut to facilitate the break. Two black dots are markers of approximate location of the crack tips.

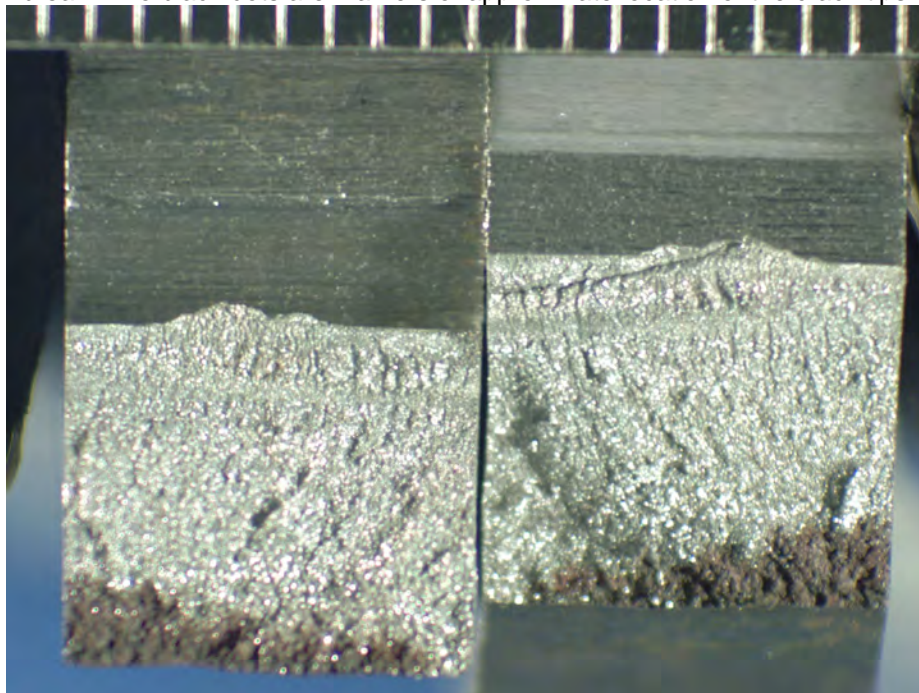
Fracture surfaces of the T2L sample after break. The sample on the right was evaluated in the SEM.

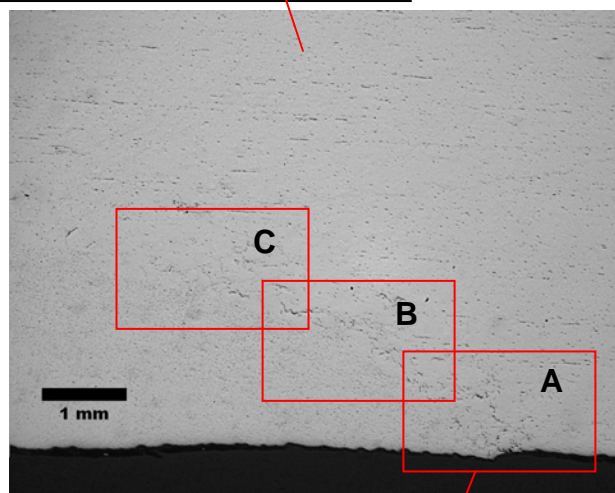
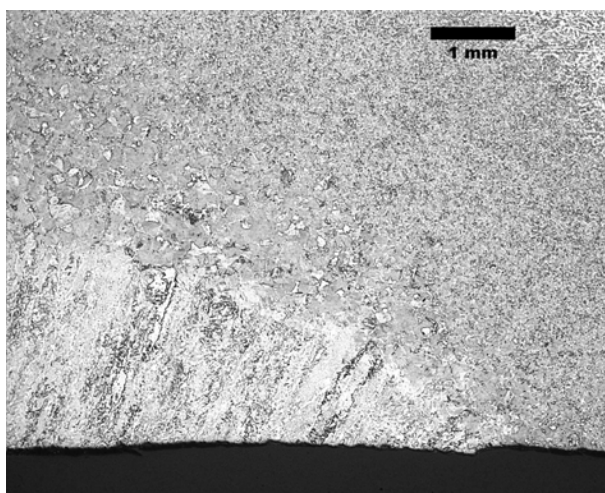
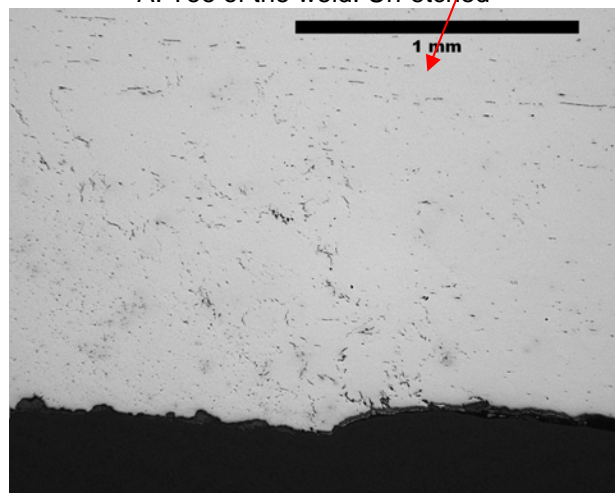
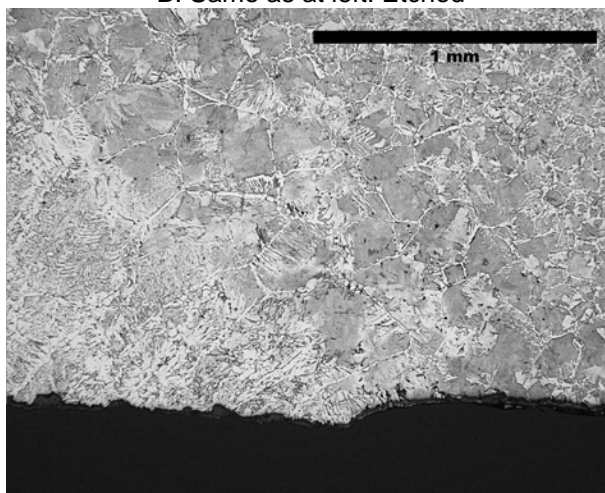
Figure 25. Enlarged areas in the rectangles are shown on Figure 26 A&B, and 26 C&D. Locations are approximate.

A. Toe of the weld. Un-etched

C. Toe of the weld in the marked area A above. Un-etched

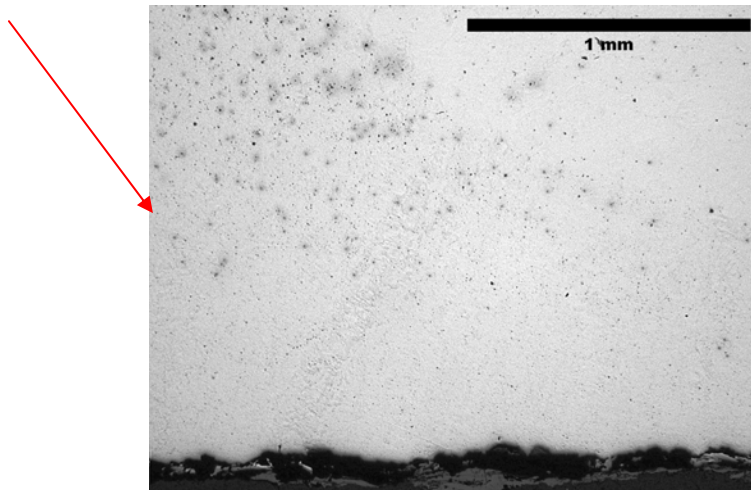
Figure 30

Toe of the weld. No damage found on CS2-A
mount. Typical. Un-etched

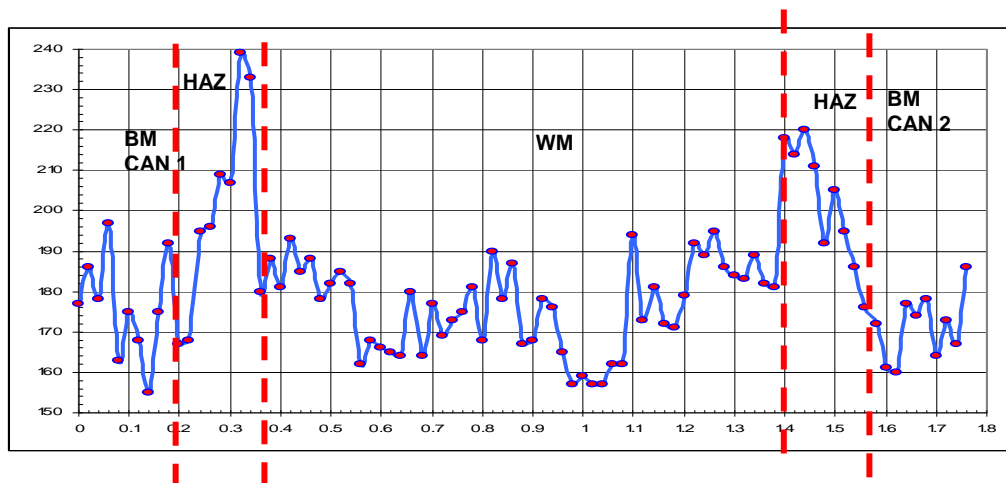
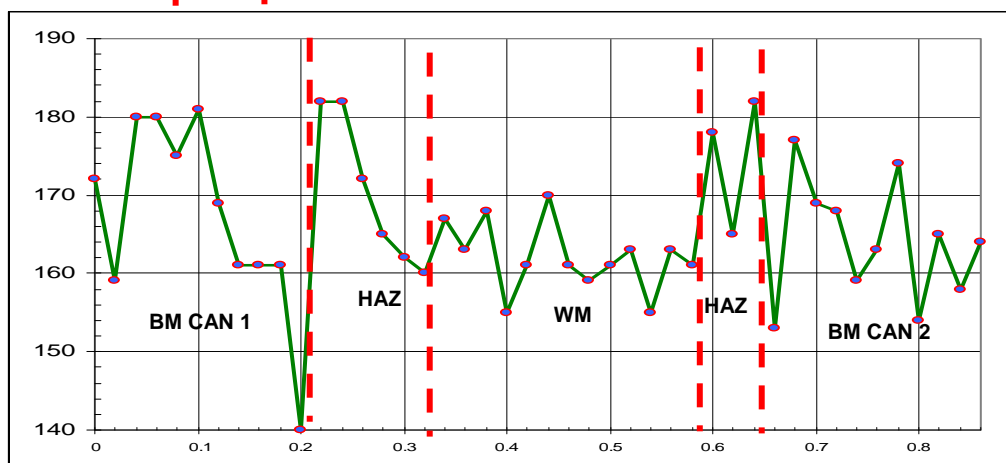
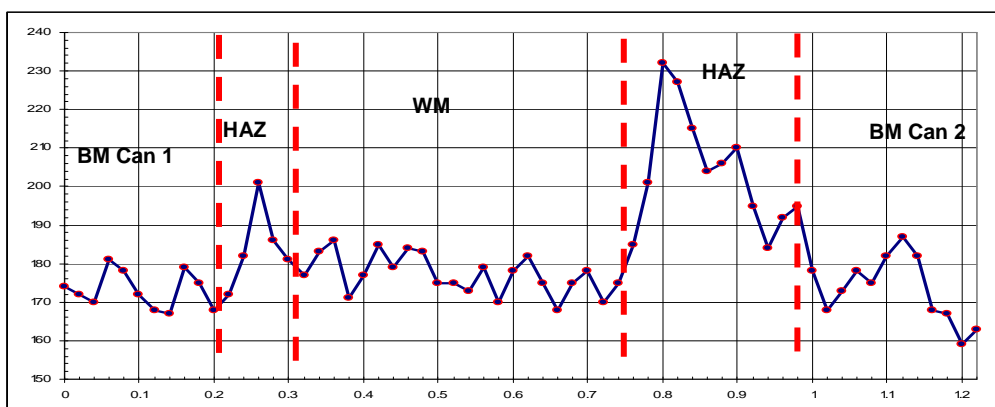
BM – Base Metal, HAZ – Heat Affected Zone, WM – Weld Metal
Figure 31. CS2-A hardness measurements results.

HARDNESS
HV⁵⁰⁰
TRAVERSE
O.D. LINE

HARDNESS
HV⁵⁰⁰
TRAVERSE
CUSP LINE

HARDNESS
HV⁵⁰⁰
TRAVERSE
I.D. LINE
