BETA LAB NO. M10198- CS4-01/ LS3 BOTTOM	TESORO REFINING AND MARKETING COMPANY ANACORTES REFINERY 10200 W. MARCH POINT ROAD T91WA4428 ANACORTES, WA 98221	CUSTOMER P.O. NO.: 4501667904
PART: 6600-E HEAT EXCHANGER CS4 01/BOTTOM PART 18/14		DATE: AUGUST 25, 2010
PAGE 11 OF 51

LABORATORY REPORT-CS4-01/ LS3 Bottom

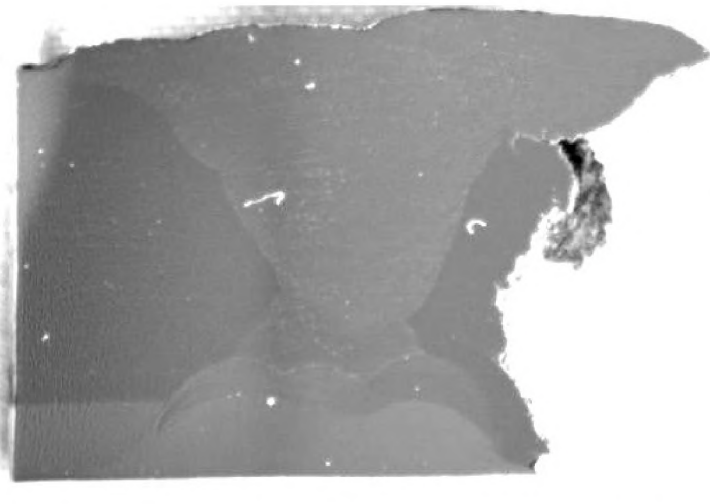
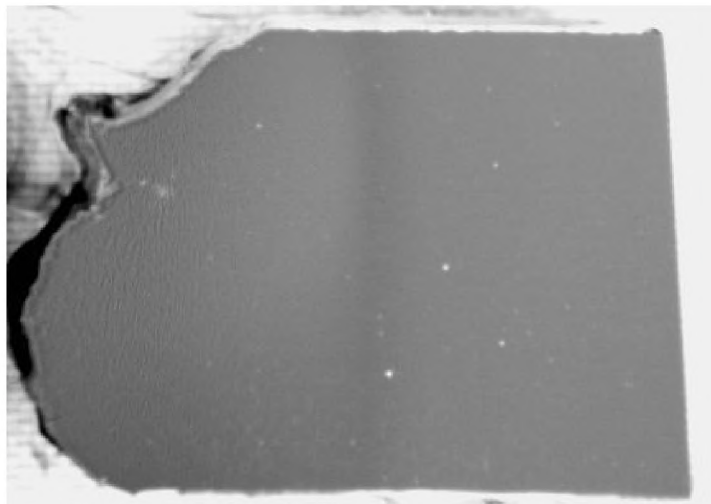
Mounts of matching samples 19E-18-M3 (Can 4, left), and 18-M3 (Can 3, right), un-etched

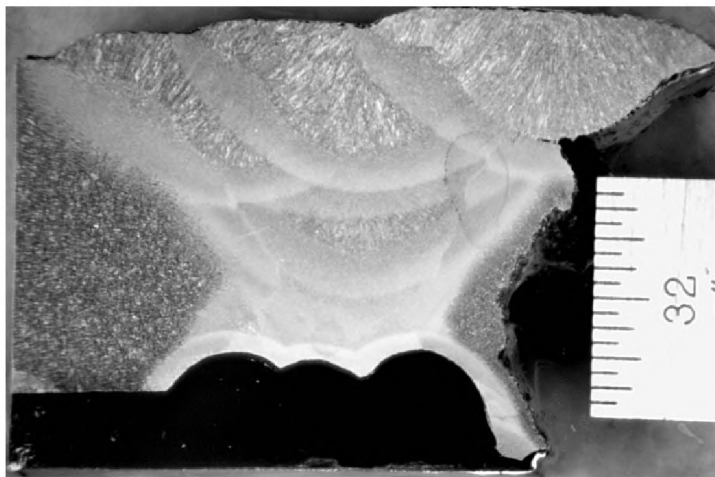
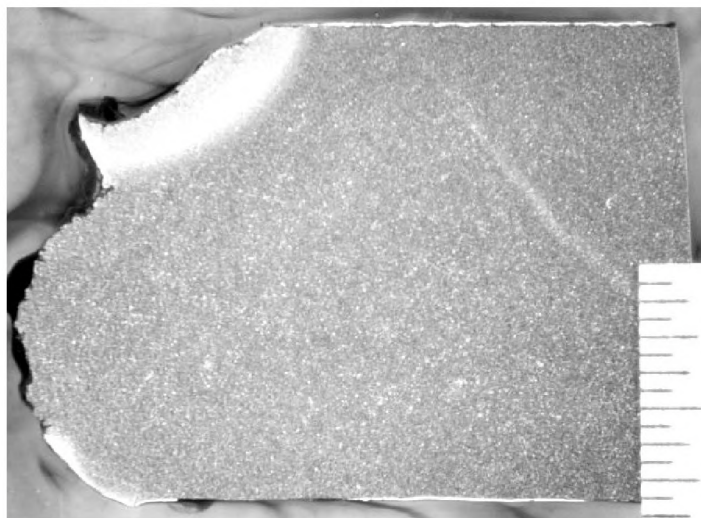
FIGURE 6- OD on top

Mounts of matching samples 19E-18-M3 (Can 4, left), and 18-M3 (Can 3, right), etched

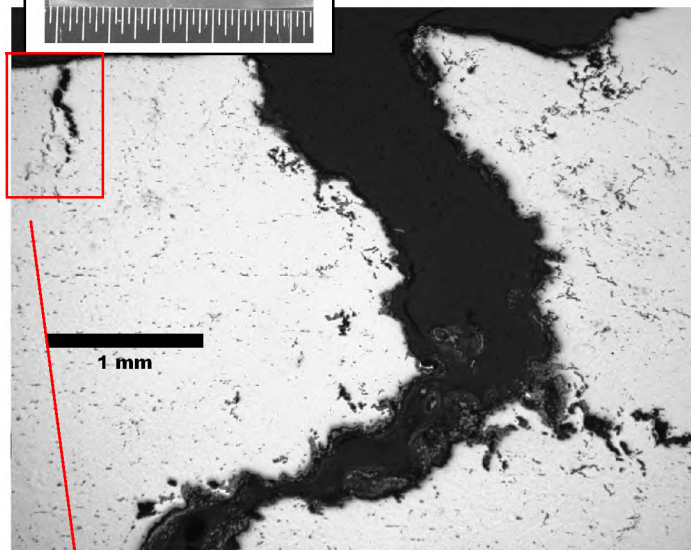
A. Mount 18-M1, un-etched

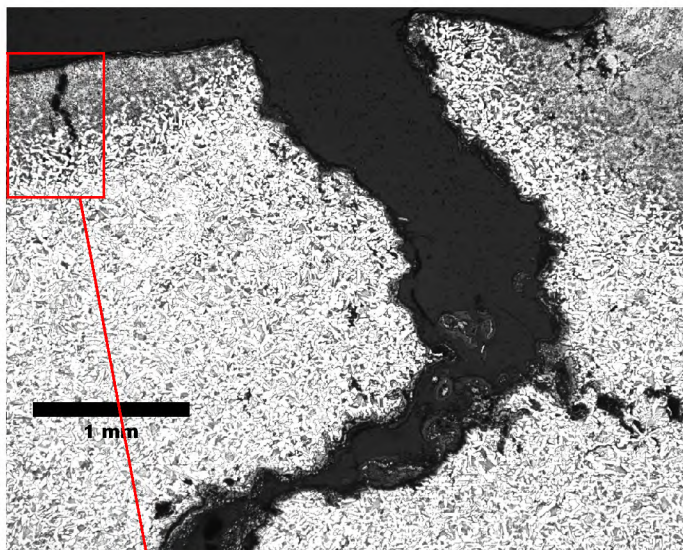
B. Mount 18-M1, etched

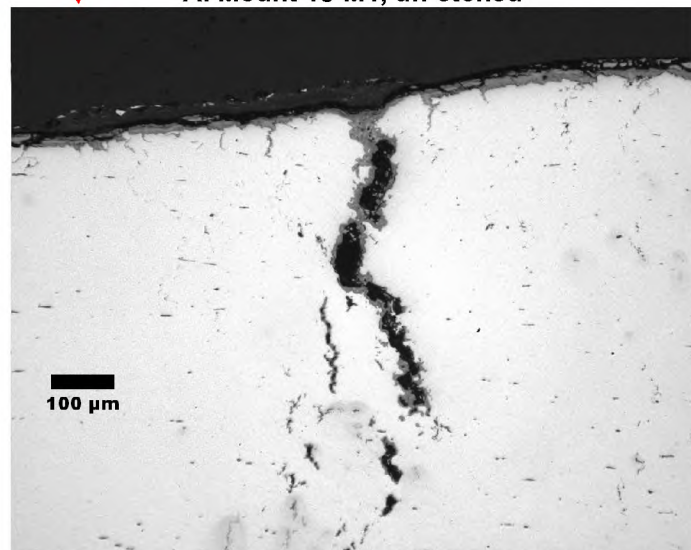
C. Indicated area at higher magnification. Un-etched

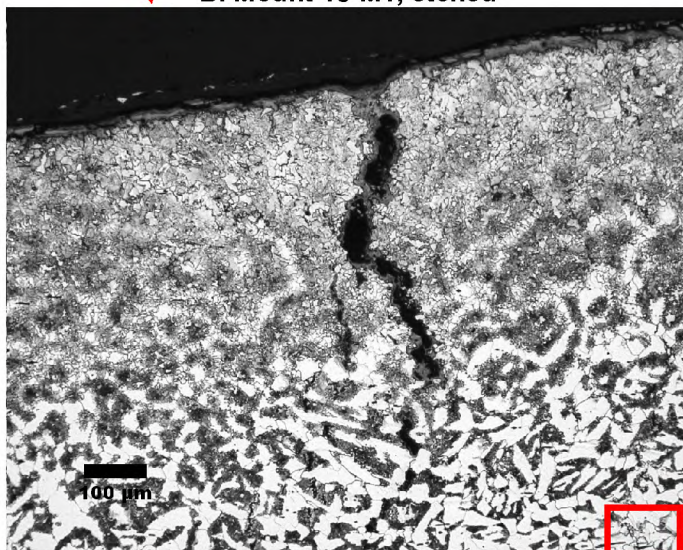
D. Indicated area at higher magnification. Etched.

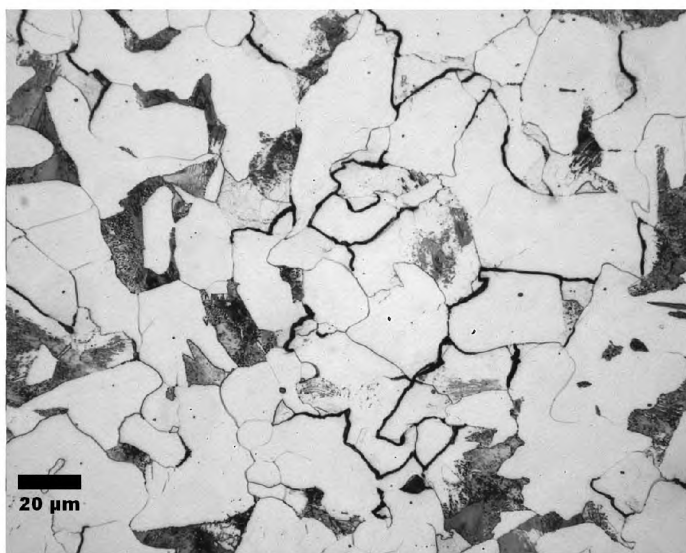
A. Marked area in Fig. 7C at higher magnification.

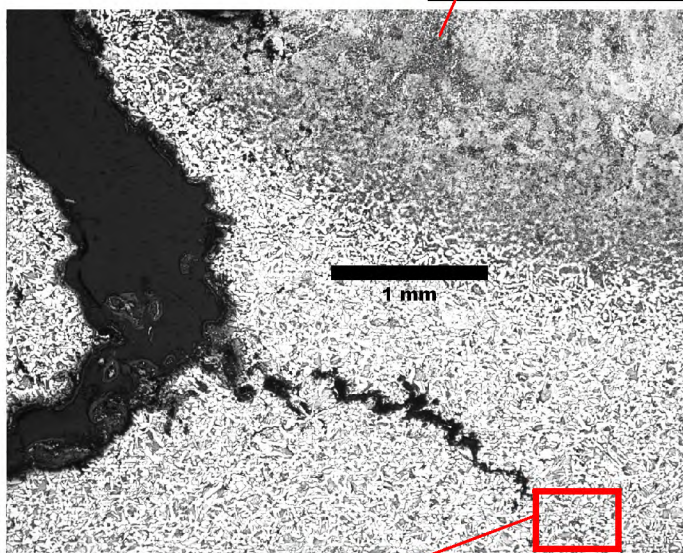
B. Area near the crack in Fig. 7B above

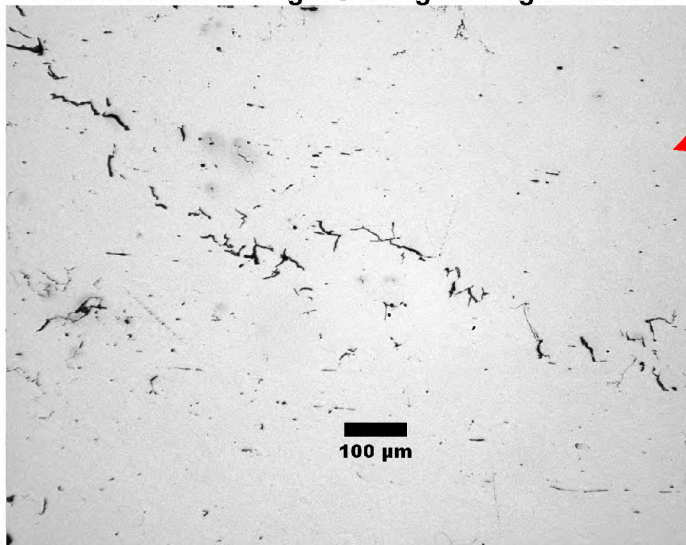
C. Enlarged area in the box. Un-etched

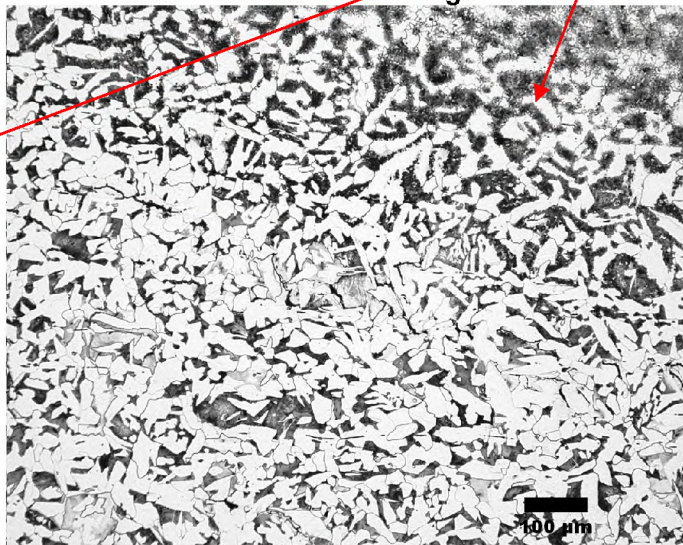
D. Enlarged area in the box. Etched

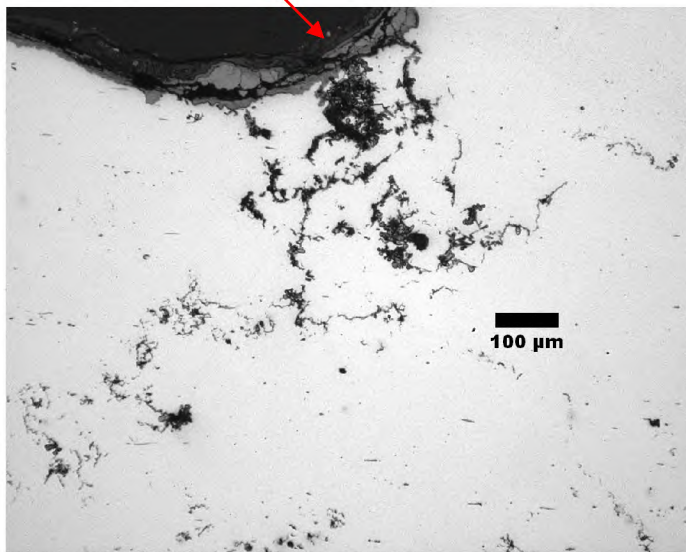
A. Area at the toe of the weld. Un-etched

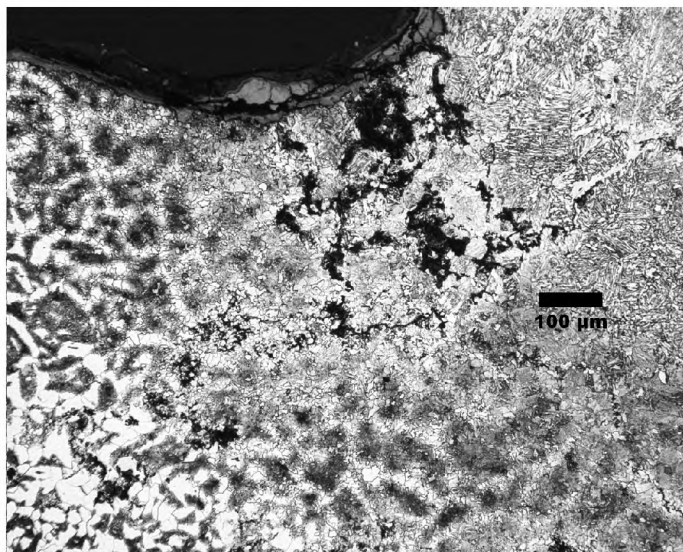
B. Same as A at the left. Etched

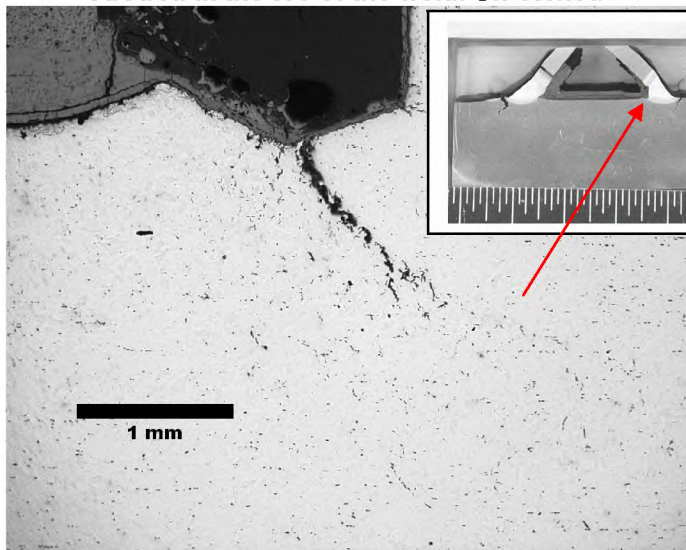
C. Weld root inside the angle. Un-etched

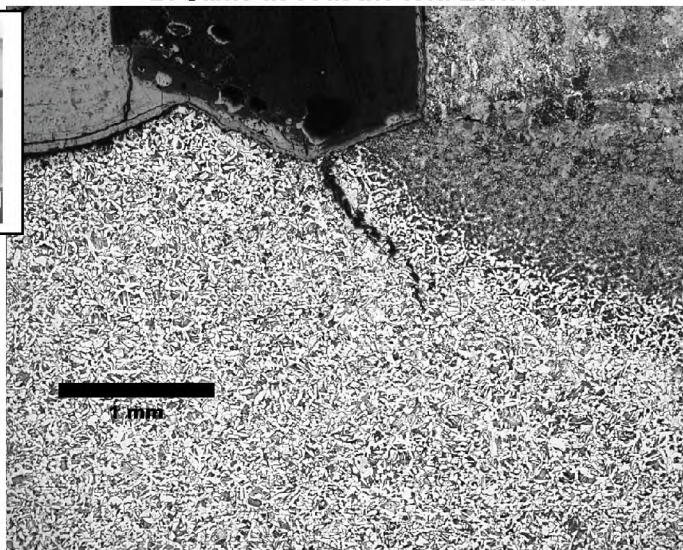
D. Same as C at left. Etched

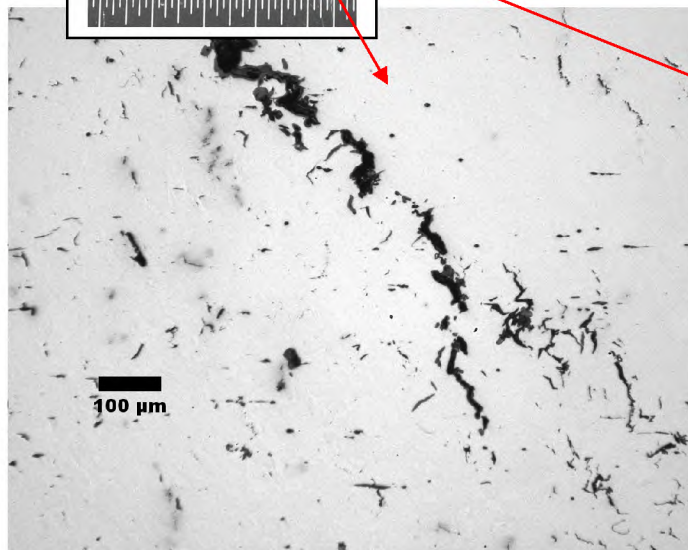
A. Area below the crack in Figure 9C. Un-etched

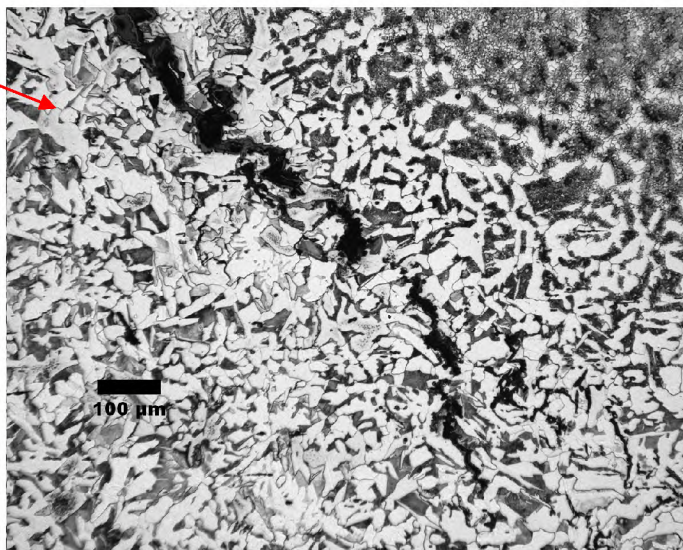
B. Same as A at left. Etched

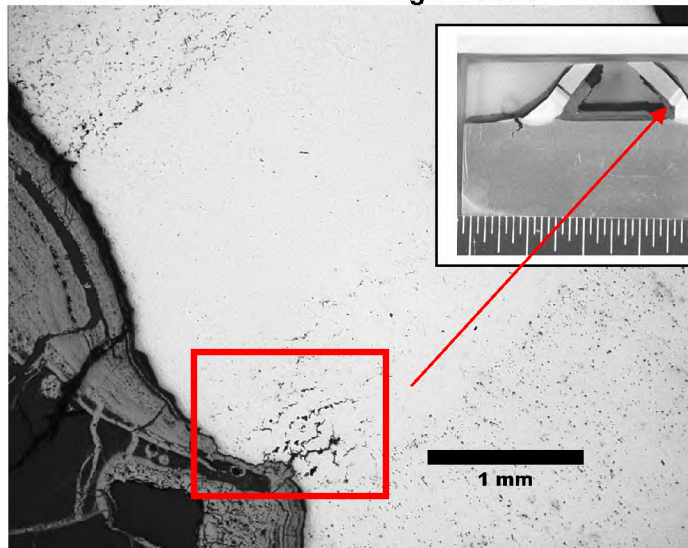
C. Root of the weld, angle side. Un-etched.

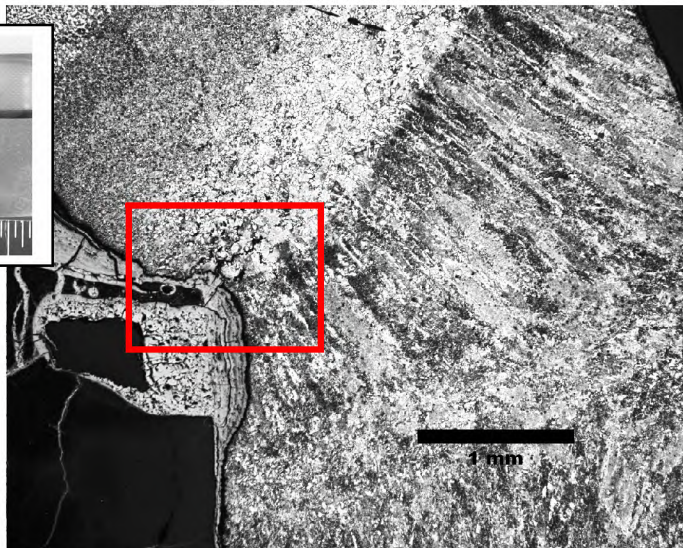
D. Same as C at left. See Fig. 11A for the details of marked area Etched.

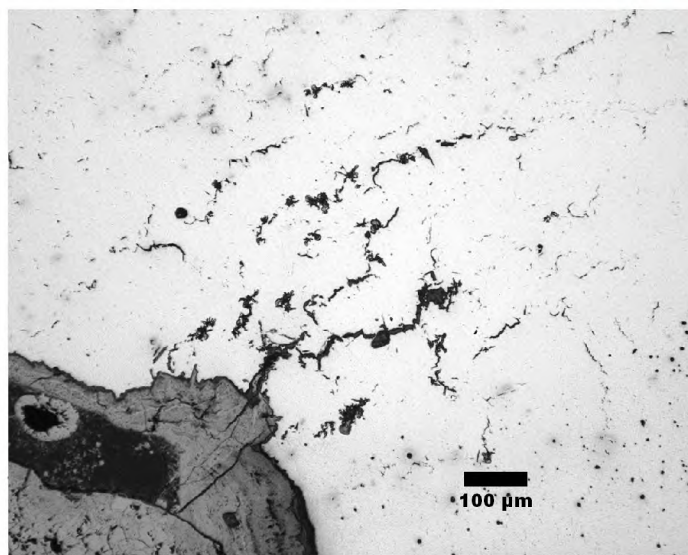
A. Area in Fig. 10C at higher magnification. Un-etched

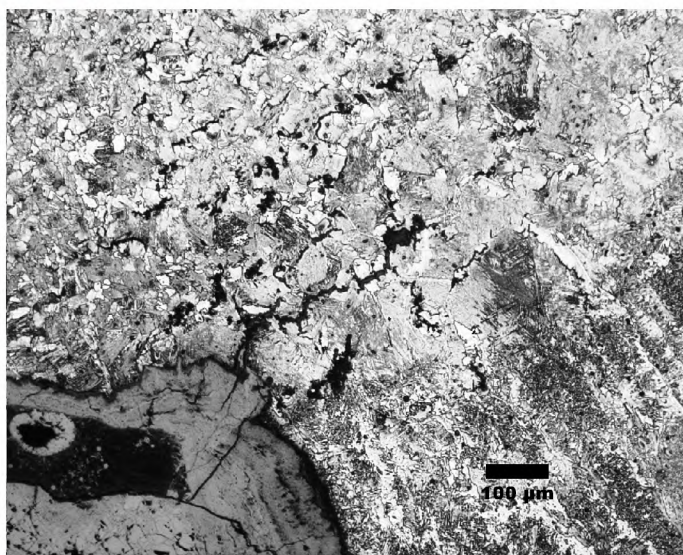
B. Area in Fig. 10D at higher magnification. Etched

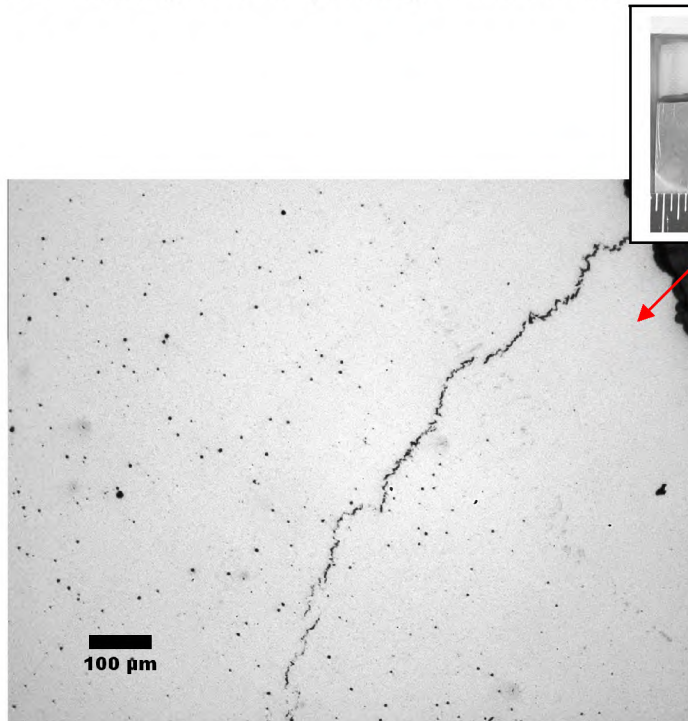
C. Crack in the cap of the weld. Un-etched

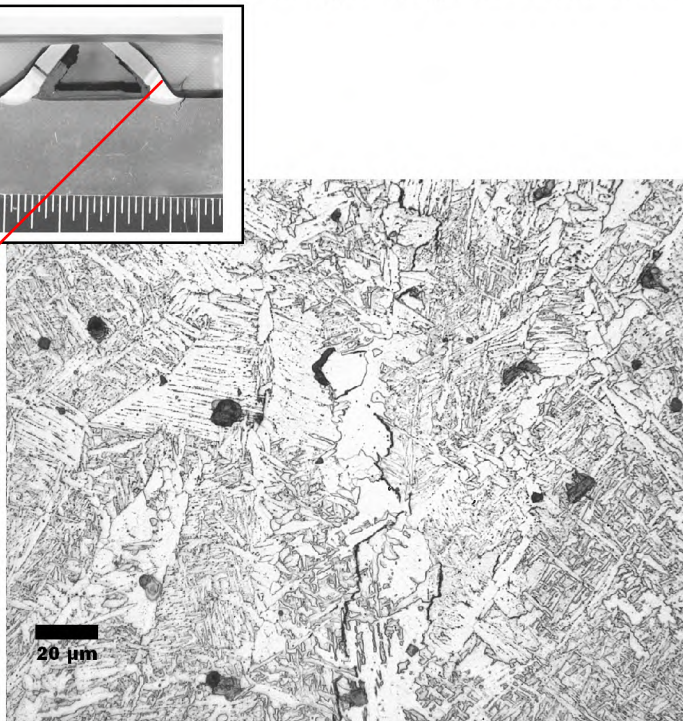
D. Area near the tip of the crack in C at left. Etched

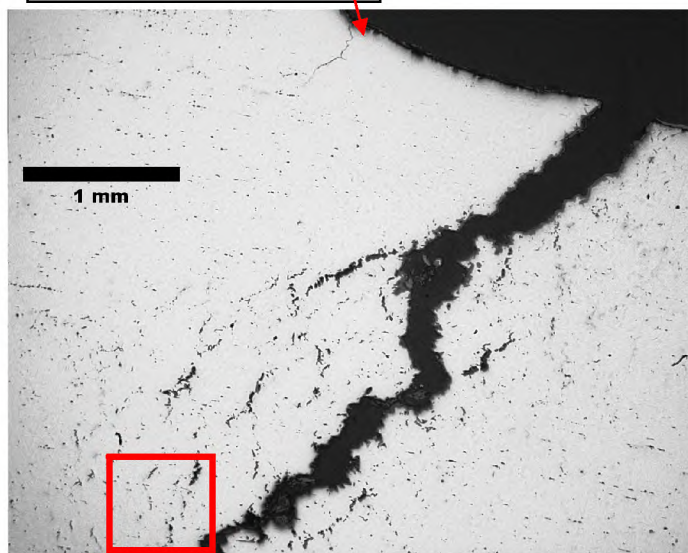
A. Crack at the toe of the weld. Un-etched

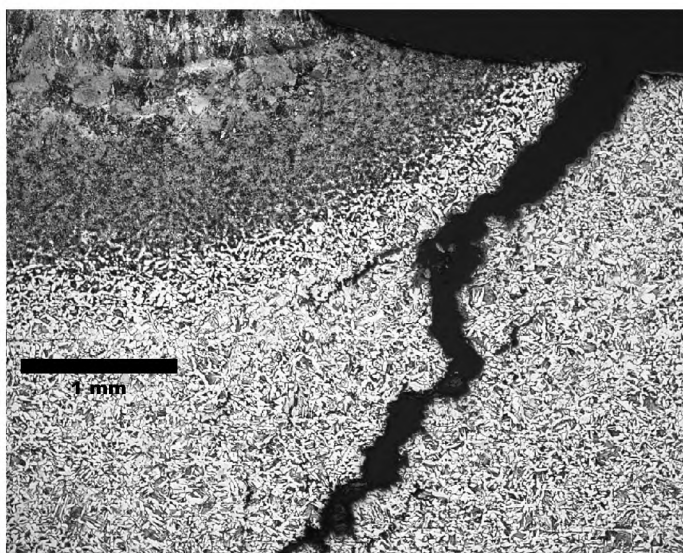
B. Crack at the toe of the weld. Etched

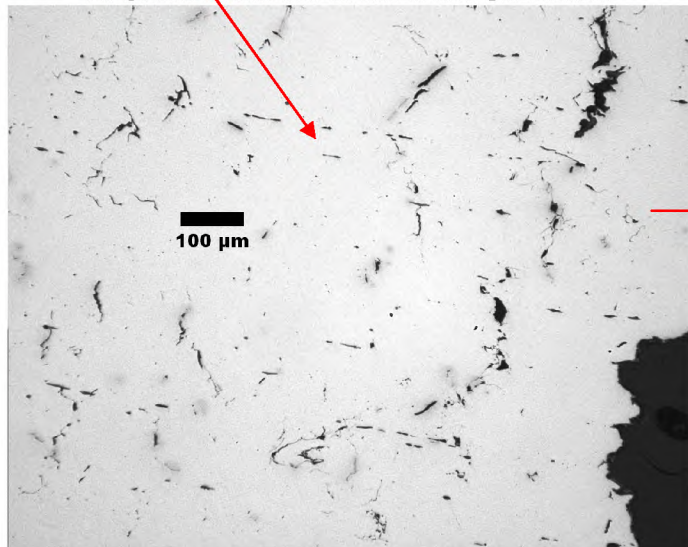
C. Area near the crack in the base metal. Un-etched

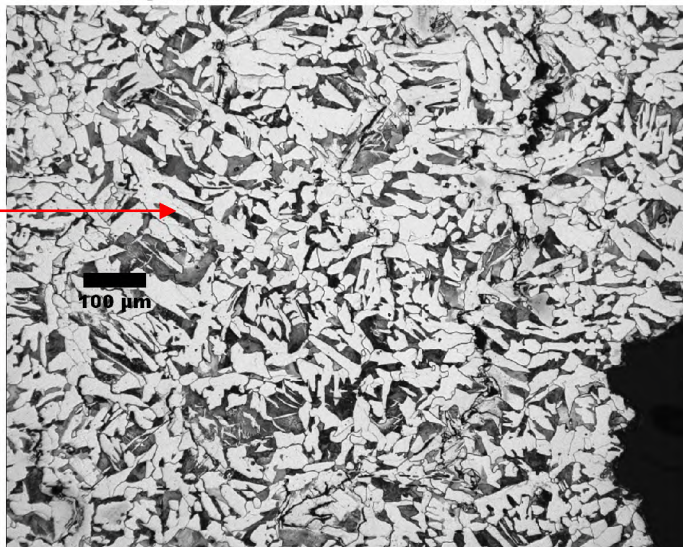
B. Same as in C at left. Etched

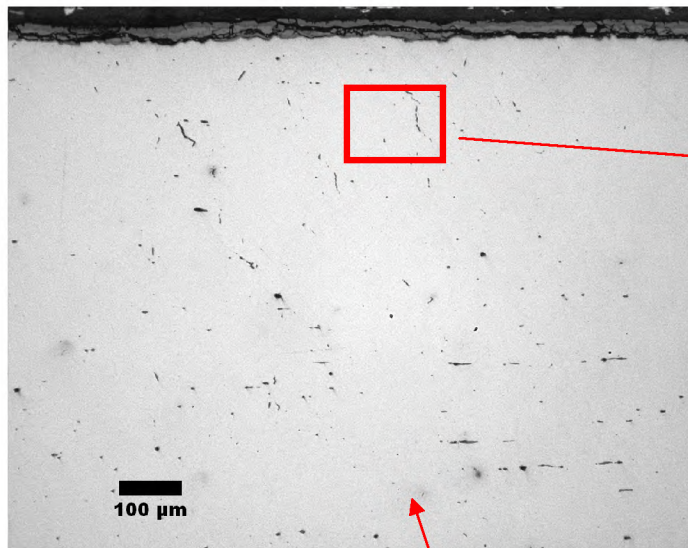
A. Base metal away from the weld and HAZ.

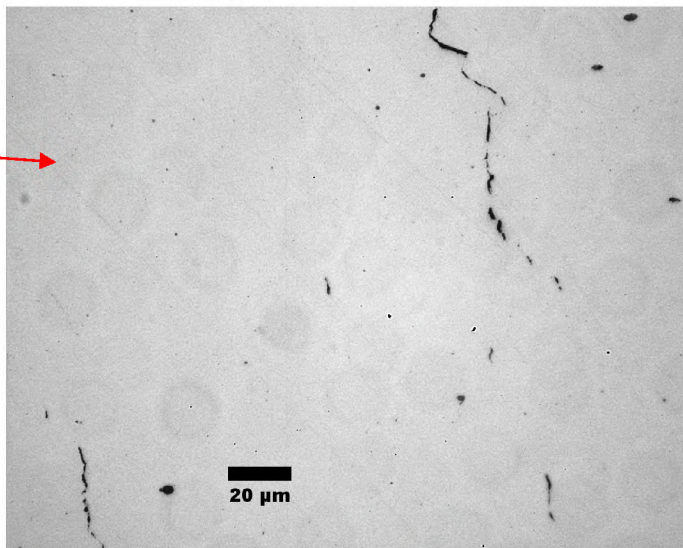
B. Enlarged area marked in A.

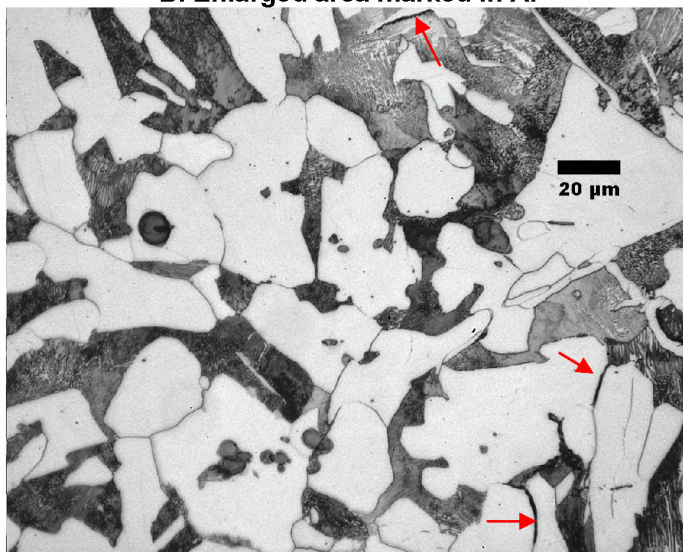
C. Base metal near the area in B above.

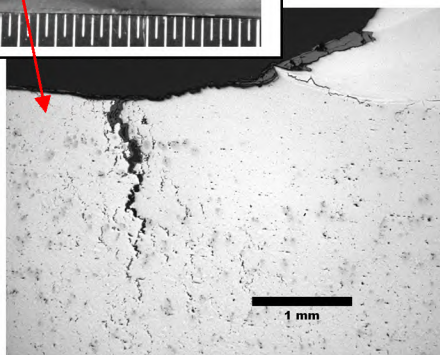
A. Left weld toe. Un-etched

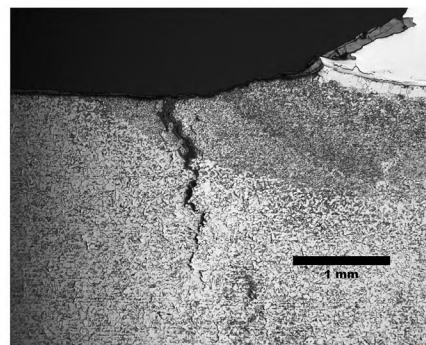
B. Left weld toe. Etched

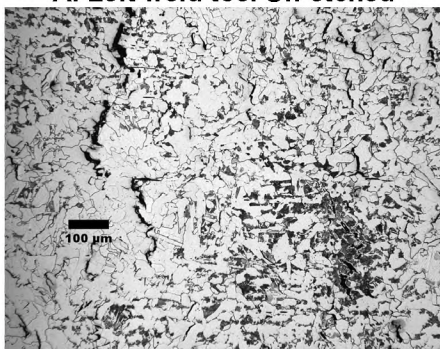
C. Area near the tip of the crack in B

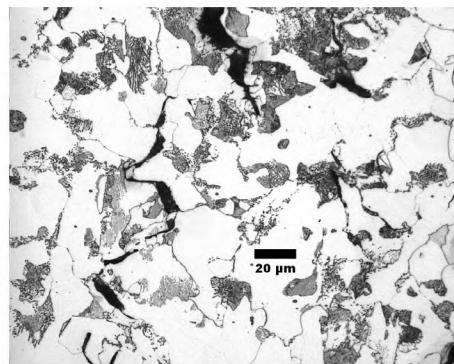
D. Area near the tip of the crack in B at higher magnification

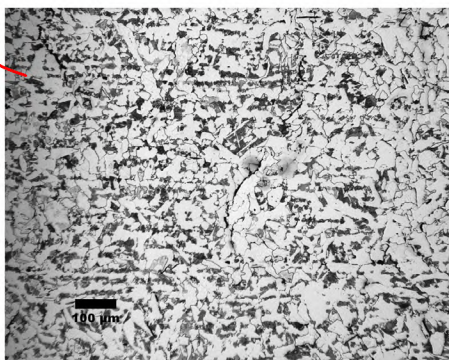
E. Area of the base metal three fields down under the weld toe. Etched

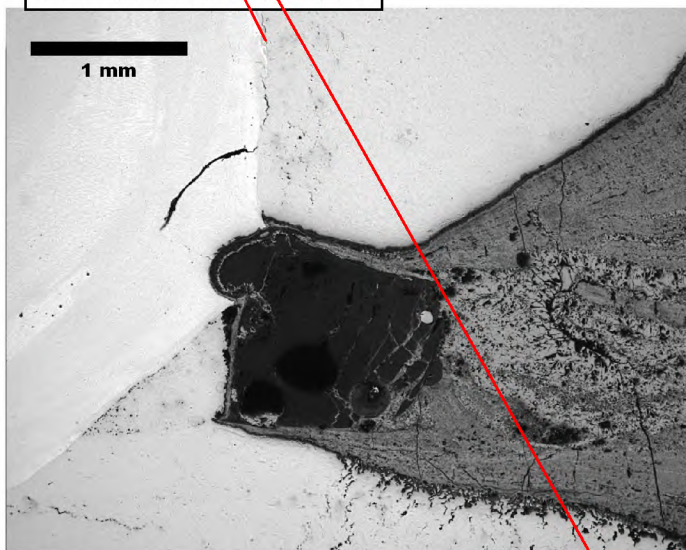
A. Root of the weld (left side of the mount). Un-etched

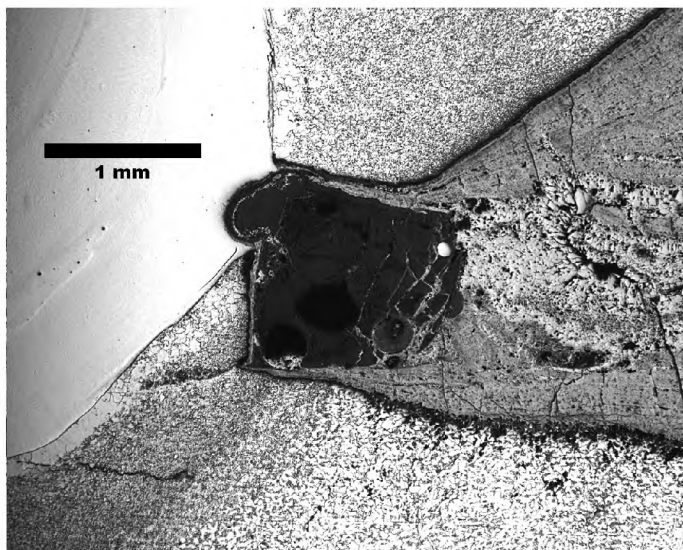
B. Same as in A at right. Etched

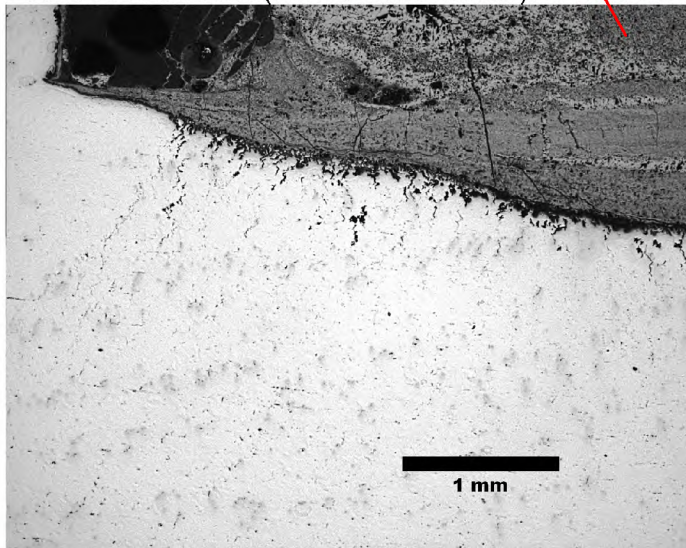
C. Base metal inside the angle, left side. Un-etched

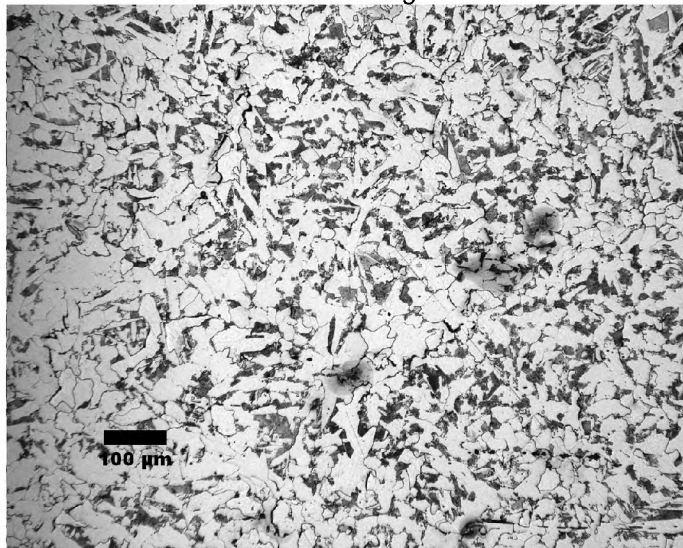
D. Same as in C at left at higher magnification, etched
