BETA LAB NO. M10198- CS4-01/ LS3
 BOTTOM

PART: 6600-E HEAT EXCHANGER CS4
 01/BOTTOM PART 18/14

TESORO REFINING AND MARKETING COMPANY
 ANACORTES REFINERY
 10200 W. MARCH POINT ROAD T91WA4428
 ANACORTES, WA 98221

LABORATORY REPORT-CS4-01/ LS3 Bottom

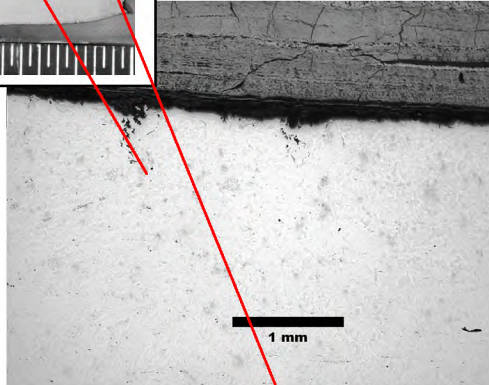
A. Base metal inside the angle, center of the sample. Un-etched

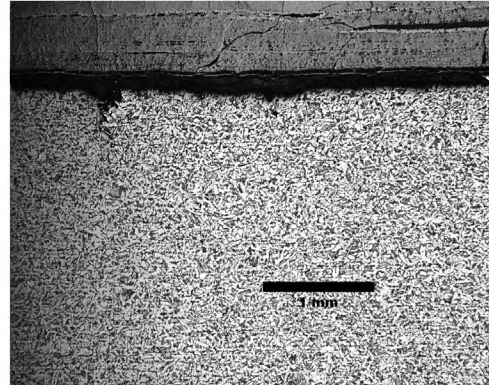
B. Base metal inside the angle, center of the sample. Etched

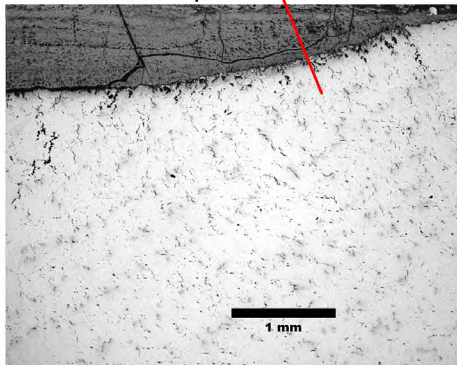
C. Base metal inside the angle, right area of the sample. Un-etched

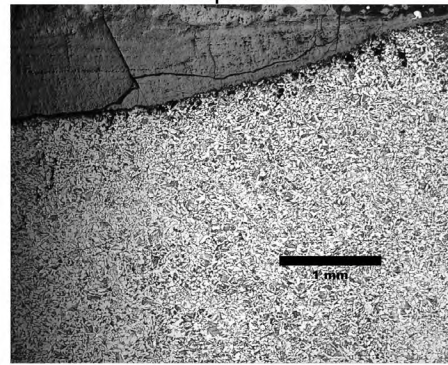
D. Base metal inside the angle, right area of the sample. Etched

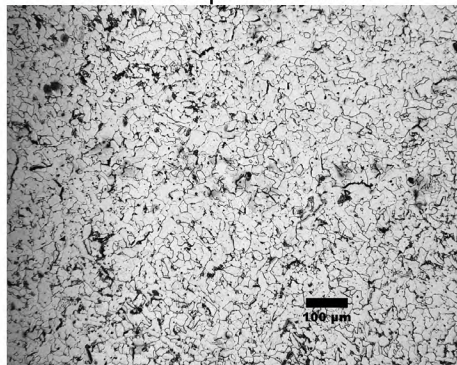
E. Base metal inside the angle, right area of the sample at higher magnification. Un-etched

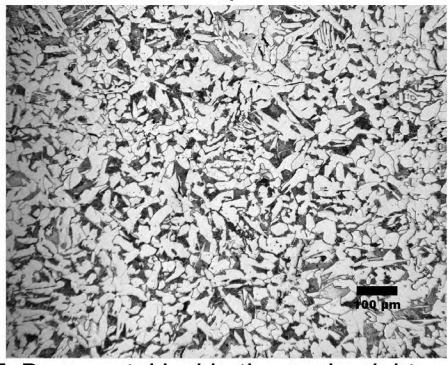
F. Base metal inside the angle, right area of the sample at higher magnification. Etched

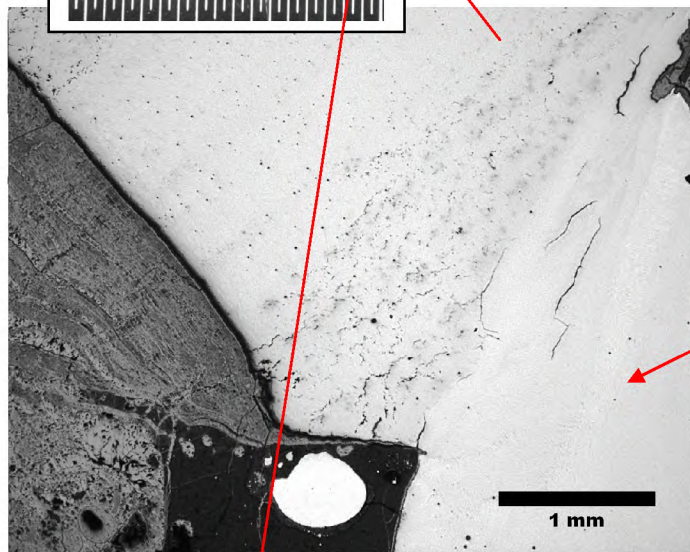
A. HAZ of the angle at the root of the weld. Un-etched

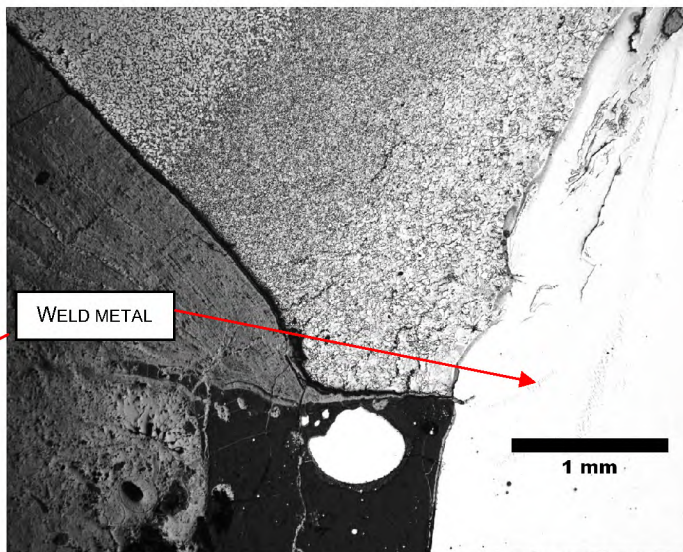
B. HAZ of the angle at the root of the weld. Etched

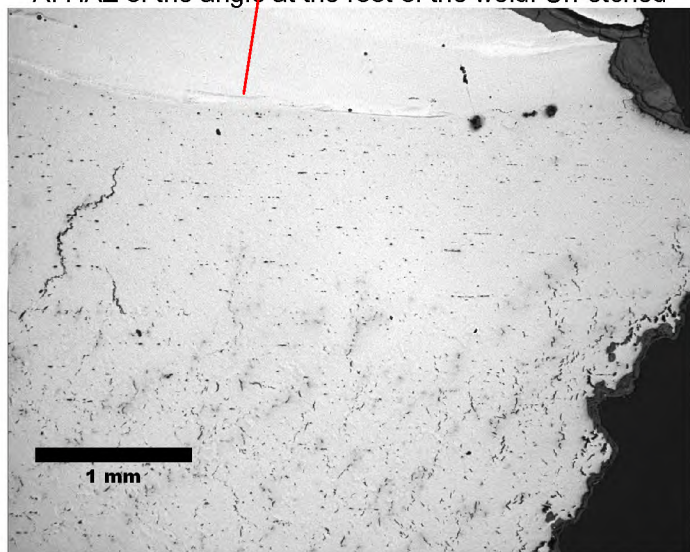
C. HAZ under the toe of the weld. Un-etched.

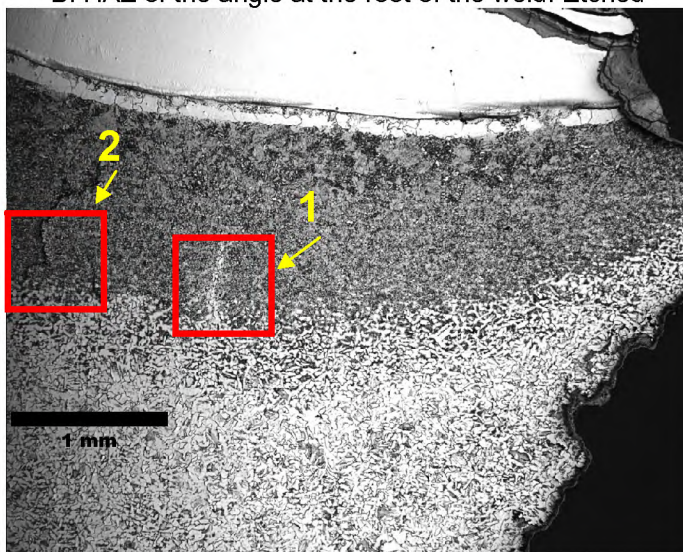
D. HAZ under the toe of the weld. Etched

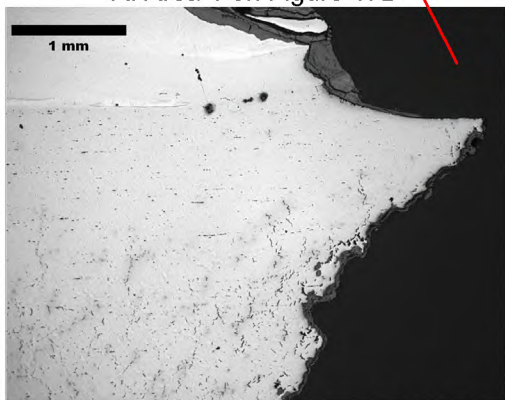
C. Fracture edge at the weld toe. Un-etched

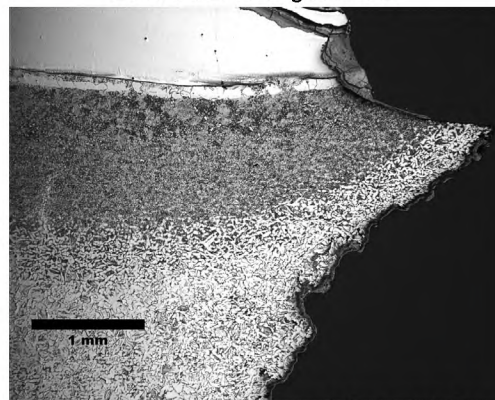
D. Fracture edge at the weld toe. Etched

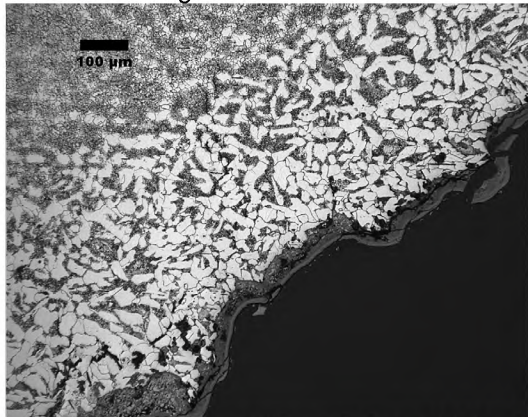
E. Fracture edge at the weld toe at higher magnification. Etched

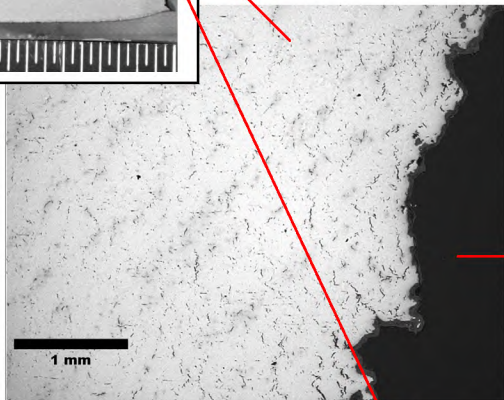
A. Fracture edge. Un-etched

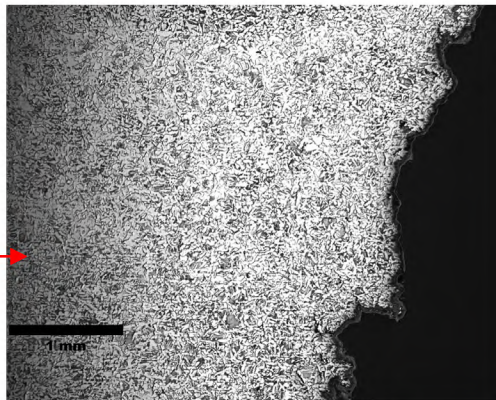
B. Fracture edge. Etched

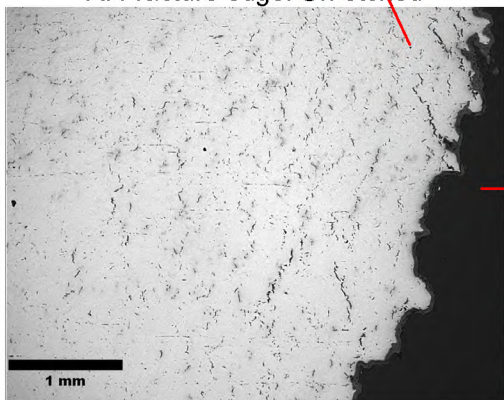
C. Fracture edge. Un-etched

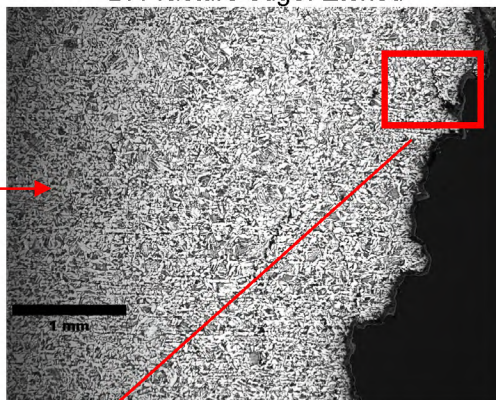
D. Fracture edge. Etched

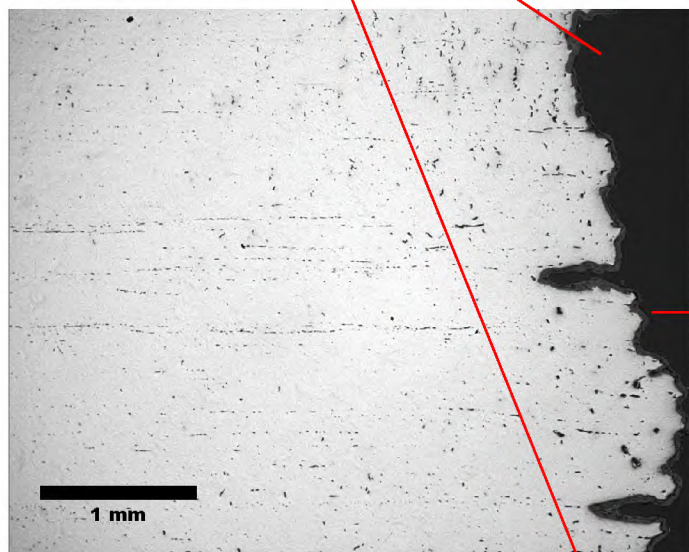
A. Fracture edge. Un-etched

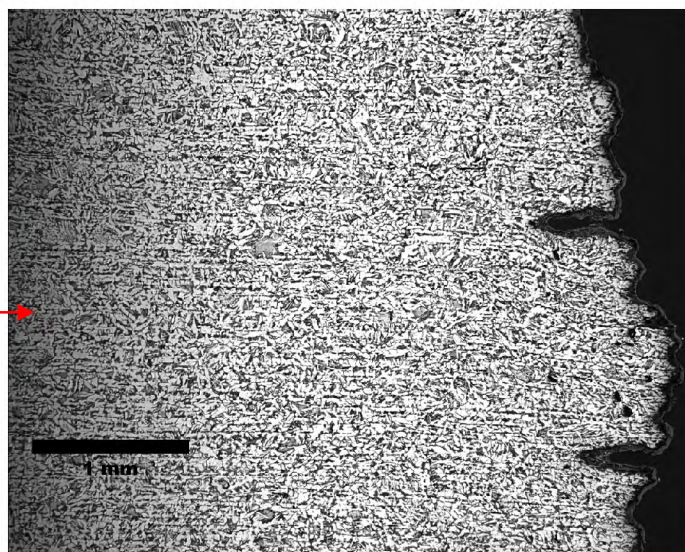
B. Fracture edge. Etched

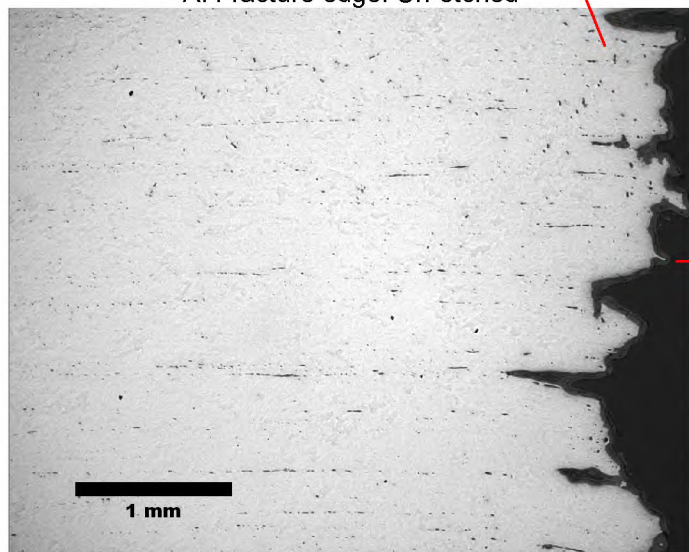
C. Fracture edge. Un-etched

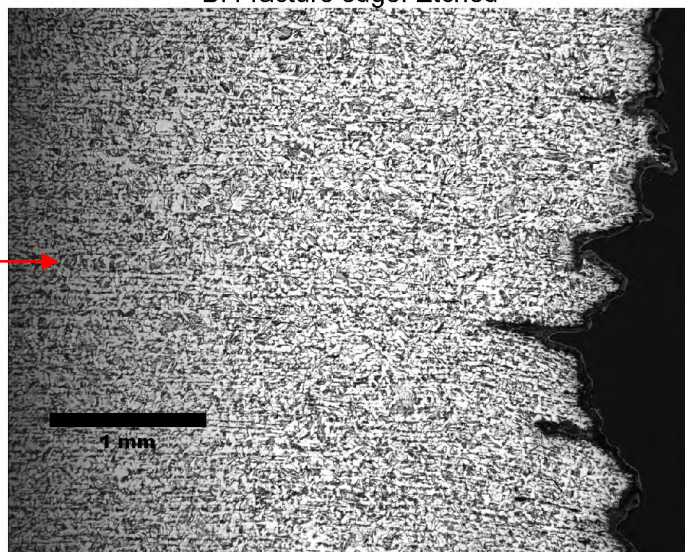
D. Fracture edge. Etched

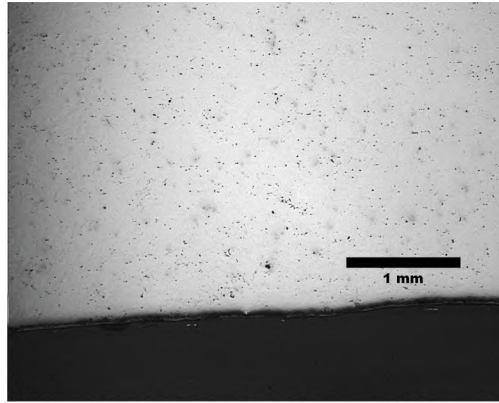
A. Base metal. Un-etched

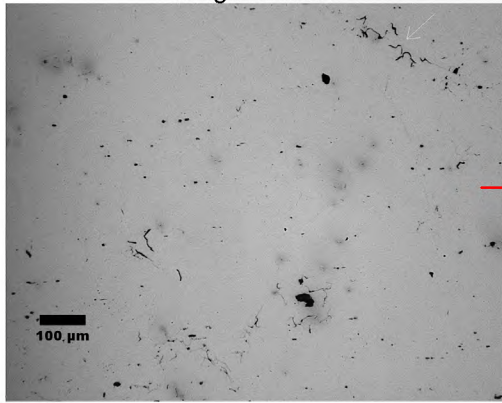
D. Base metal one field deeper than in B.
 Un-etched

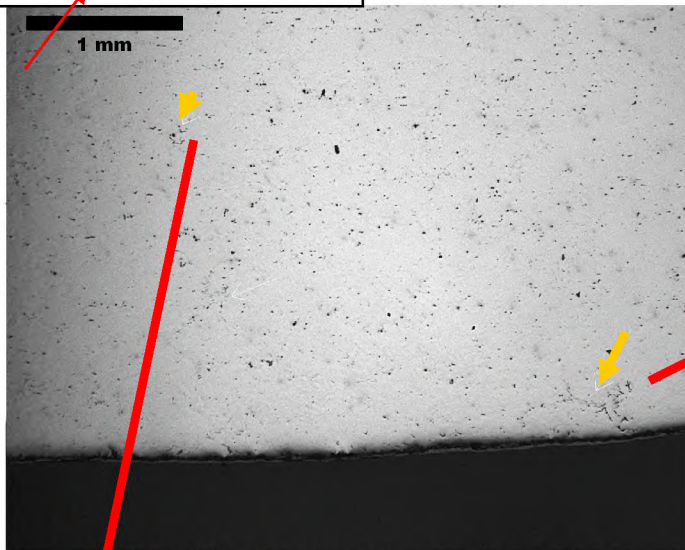
A. Field at ID close to the fracture. Un-etched

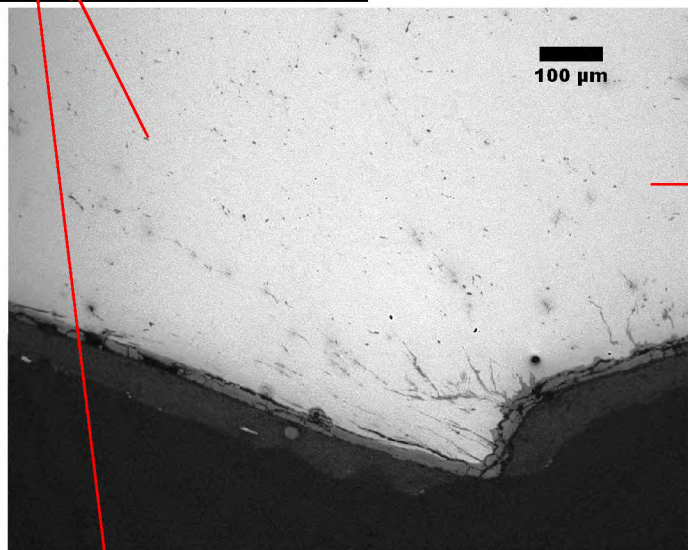
A. The fracture edge at ID. Un-etched

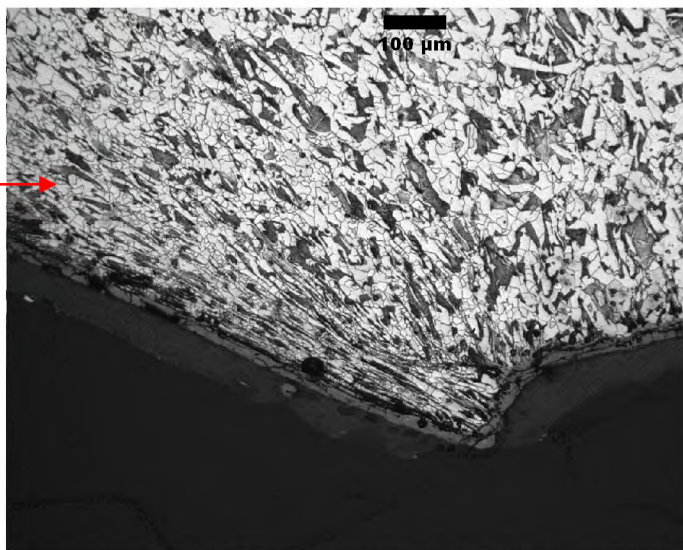
B. The fracture edge at ID. Etched

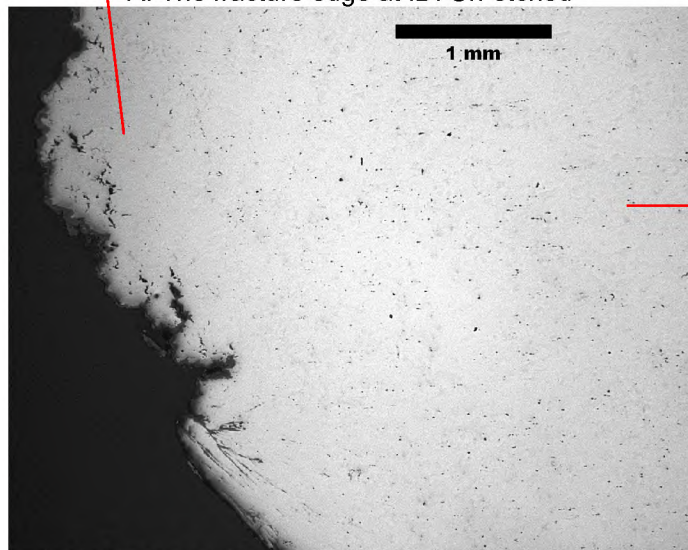
C. The fracture edge farther up at ID. Un-etched

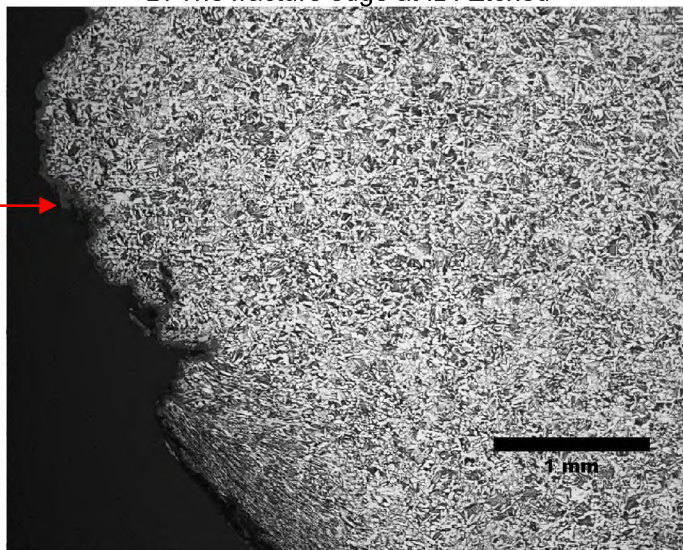
D. The fracture edge farther up at ID. Etched

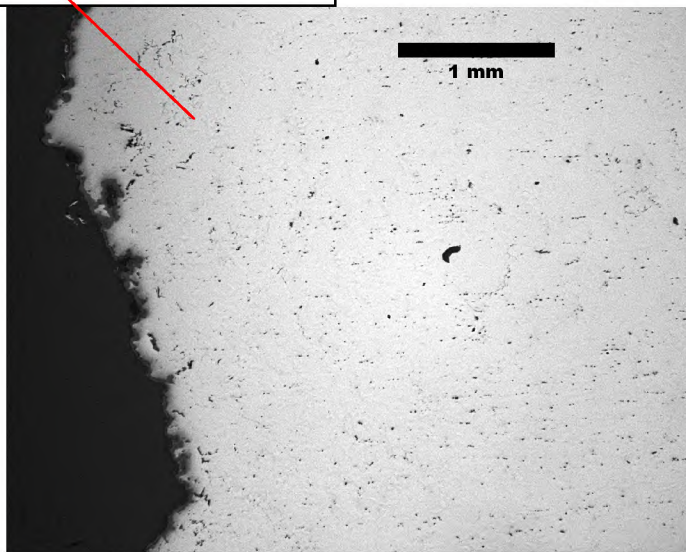
A. Fracture edge, one field up. Un-etched

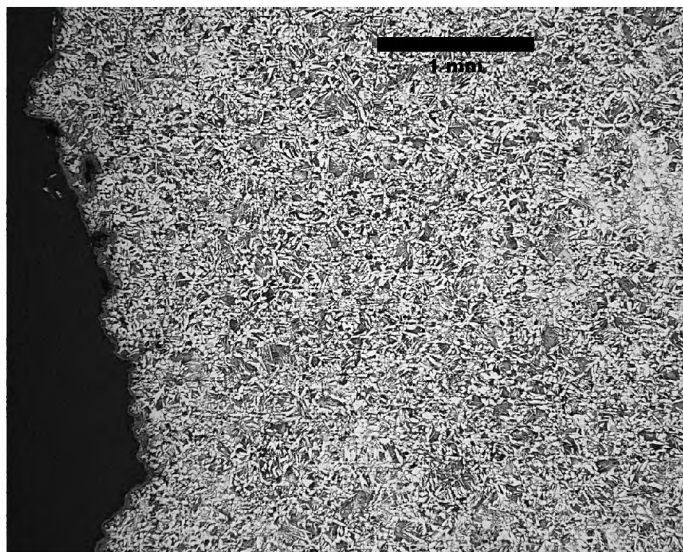
B. Fracture edge, one field up. Etched

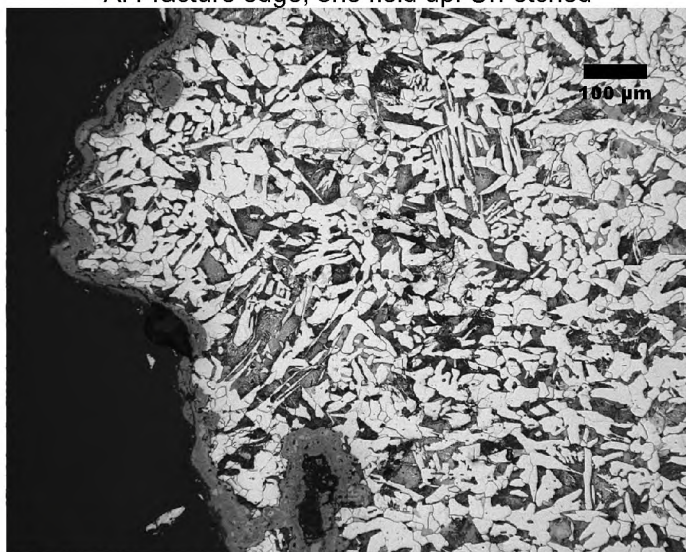
C. Fracture edge, one field up at higher magnification.
Etched

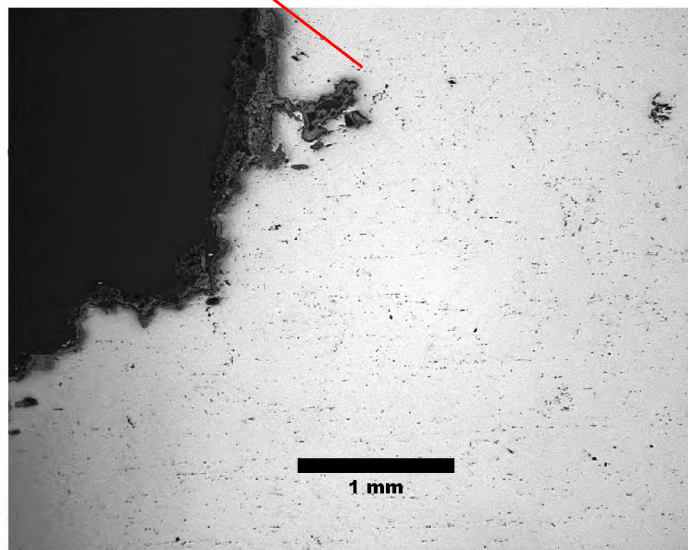
A. Fracture edge near HAZ. Un-etched

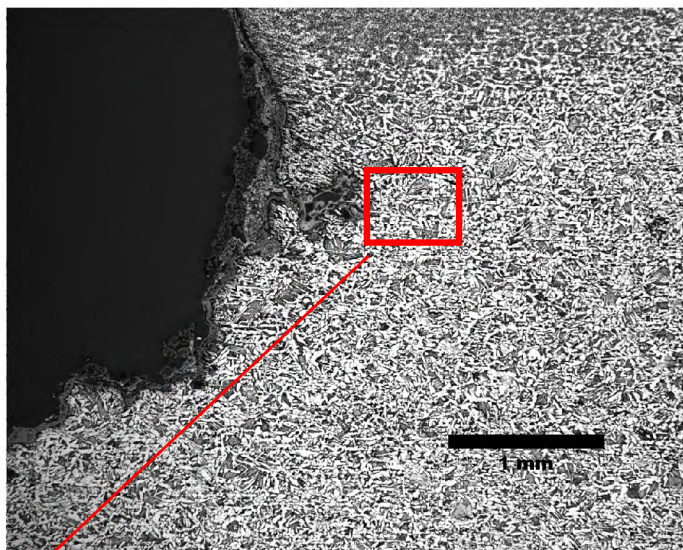
B. Fracture edge near HAZ. Etched

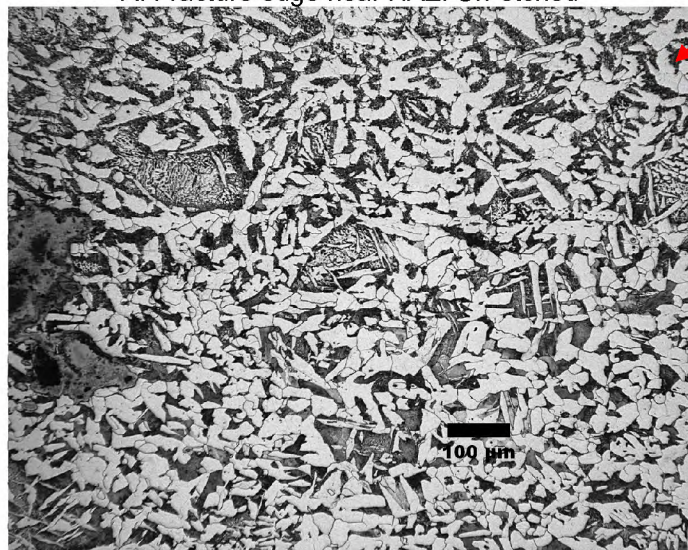
C. . Fracture edge near HAZ at higher magnification.
 Etched
