CASE STUDY

Heat exchanger rupture and ammonia release in Houston, Texas (One Killed, Six Injured)

2008-06-I-TX January 2011

The Goodyear Tire and Rubber Company

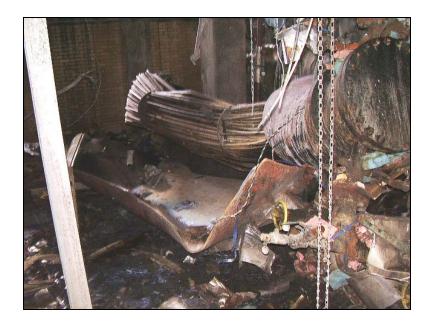
This case study examines a heat exchanger rupture and ammonia release at The Goodyear Tire and Rubber Company plant in Houston, Texas. The rupture and release injured six employees. Hours after plant responders declared the emergency over; the body of an employee was discovered in the debris next to the heat exchanger.

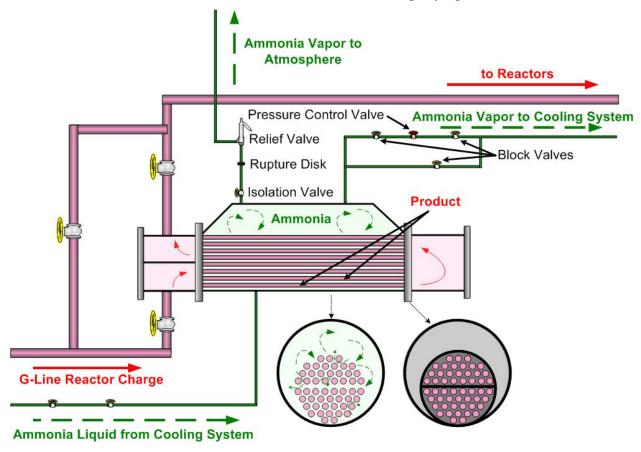
Figure 2. Ammonia heat exchanger

The process chemicals exiting the heat exchanger flow to the process reactors. Each heat exchanger is equipped with a rupture disk in series with a pressure relief valve (both set at 300 psig) to protect the heat exchanger from excessive pressure. The relief system vented ammonia vapor through the roof to the atmosphere.

As Figure 2 shows, a rupture disk and a pressure relief valve in series protected the ammonia heat exchanger from overpressure. An isolation valve installed between the rupture disk and the heat exchanger isolated the rupture disk and relief valve for maintenance. However, when the valve was in the closed position, the heat exchanger was still protected from an over-pressure condition by the automatic pressure control valve.

the heat exchanger and the automatic pressure control valve. This isolated the ammonia side of the heat exchanger from all means of over-pressure protection. Steam flowing through the heat exchanger increased the ammonia temperature and the pressure in the isolated heat exchanger. Because the over-pressure protection remained isolated, the internal pressure increased until the heat exchanger suddenly and catastrophically ruptured.

In accordance with the ASME Boiler and Pressure Vessel Code, over-pressure protection shall be continuously provided on pressure vessels installed in process systems whenever there is a possibility that the vessel can be over-pressurized by any pressure source, including external mechanical pressurization, external heating, chemical reaction, and liquid-to-vapor expansion. Workers should continuously monitor an isolated pressure relief system throughout the course of a repair and reopen blocked valves immediately after the work is completed.

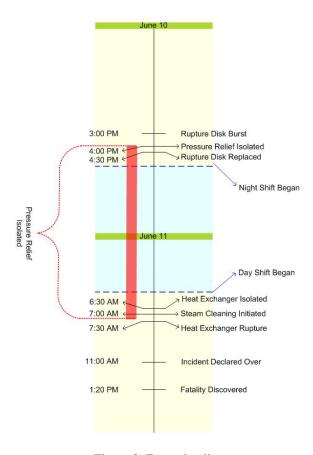
Figure 3. Event timeline

Although maintenance workers had replaced the rupture disk by about 4:30 p.m. on June 10, the valve isolating the rupture disk was not reopened. No further activities involving the rupture disk or relief line occurred on the nightshift or the dayshift on June 11 and the valve remained closed. Figure 3 shows the timeline of these events.

Goodyear's work order system for maintenance requires the process operator to sign off when the repairs are completed. However, whether this occurred during the June 10 dayshift is unclear, and Goodyear was unable to produce a signed copy of the work order.

Communicating plant conditions between maintenance and operations personnel is critical to the safe operation of a process plant. Good practice includes formal written turnover documents that inform maintenance personnel when a process is ready for maintenance and operations personnel when maintenance is completed and the process can be safely restored to operation.
