Investigation Report

Published: July 6, 2023

On Sunday, March 17, 2019, a large fire erupted at the Intercontinental Terminals Company, LLC (ITC) bulk liquid storage terminal located in Deer Park, Texas. The fire originated in the vicinity of Tank 80-8, an 80,000-barrel aboveground atmospheric storage tank that held a blend of naphtha and butane product, a flammable liquid. Once the fire erupted, ITC was unable to isolate or stop the release. As a result, the fire burned, intensified, and spread to the other 14 tanks located in the same containment area. The fire burned for three days, until it finally was extinguished on Wednesday, March 20, 2019. The fire caused substantial property damage at the ITC Deer Park terminal, including the destruction of fifteen (15) 80,000-barrel aboveground atmospheric storage tanks and their contents.

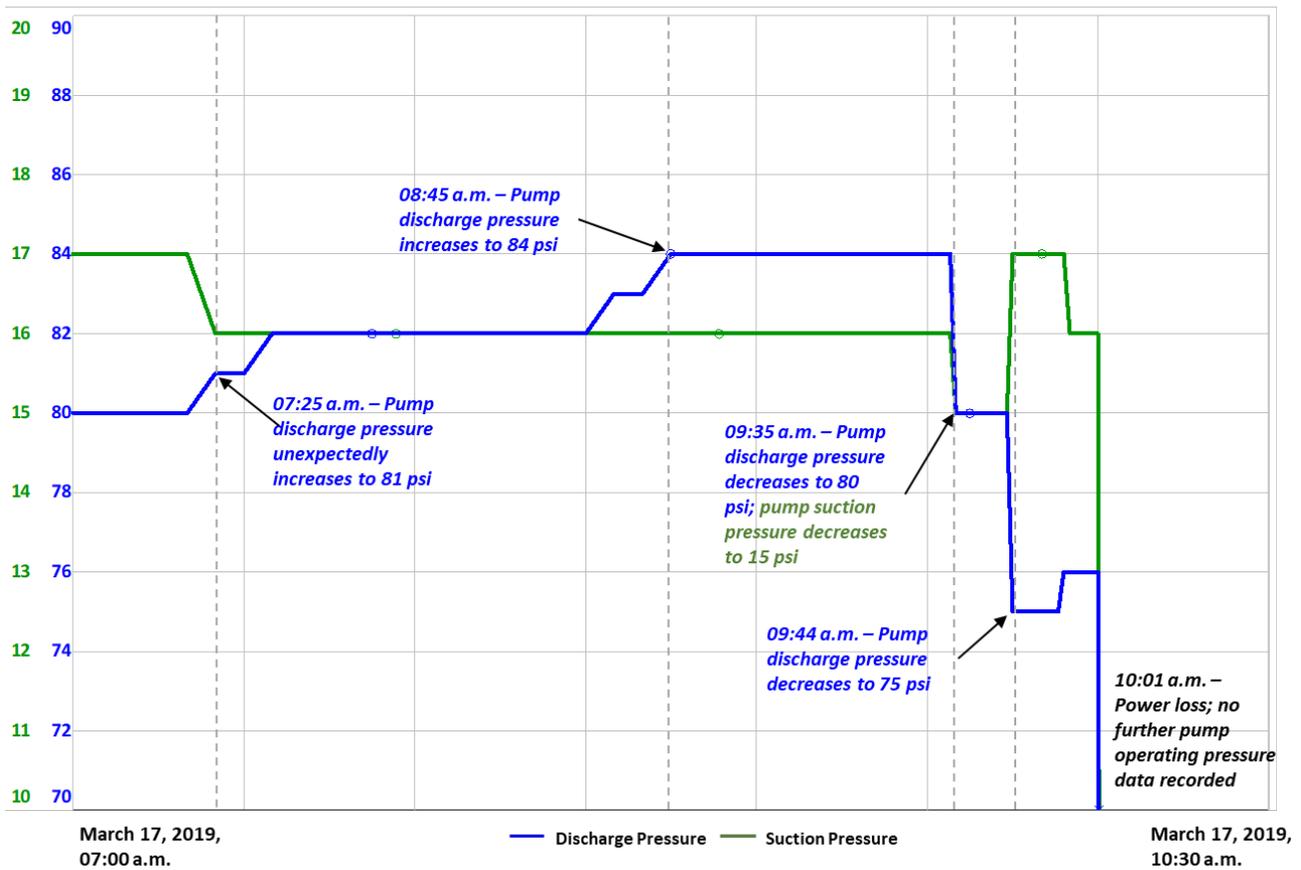
Tank 80-8 Pump Discharge Pressure & Suction Pressure

On the morning of March 17, 2019, as the Tank 80-8 circulation pump continued to operate, distributed control system (DCS) data for the tank indicated a series of unanticipated changes in the monitored operating pressures, flow rate, and tank volume. Beginning at approximately 7:25 a.m., the pump discharge pressure began to increase with no change in operation having occurred (**Figure 7**). By 8:45 a.m., the pump discharge pressure had gradually increased from 80 psi to 84 psi. At approximately 9:30 a.m., when the mechanical seal on the pump failed and butane-enriched naphtha product began to release to the atmosphere, the recorded tank level began to decrease, and recorded average flow rate^a for the tank, automatically calculated from changes in tank level measurements, began to increase (**Figure 8**). At approximately 9:35 a.m., the pump discharge pressure abruptly dropped to 80 psi, and within the next 10 minutes dropped further to 75 psi. At the same time, the recorded average flow rate of material from the tank had increased to about 158 barrels per hour (bph), and by 9:44 a.m. had increased to over 388 bph.

Figure 7. Recorded data historian trends showing recorded pump operating pressure data for Tank 80-8. (Credit: CSB)

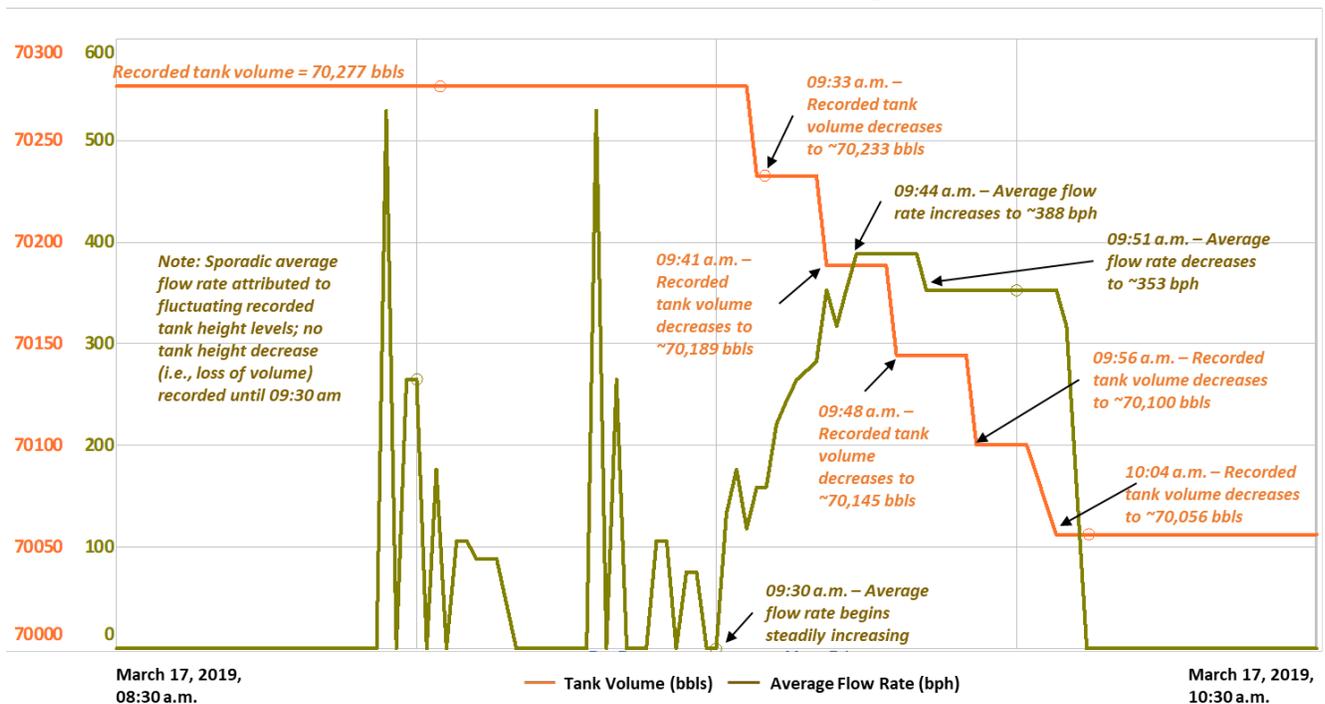
Tank 80-8 Recorded Tank Volume & Average Flow Rate

Figure 8. Recorded data historian trends showing recorded average flow rate and tank volume data for Tank 80-8. (Credit: CSB)

Between 9:30 and 10:00 a.m., the recorded tank volume^a in Tank 80-8 decreased by more than 177 barrels as the naphtha product continued to release from the failed pump.^b At 10:00:46 a.m., approximately 30 minutes after the release began, the butane-enriched naphtha product releasing from the Tank 80-8 piping manifold ignited (**Figure 9**). No operators were working outside in the First & Second 80's tank farm during this time frame. The acting shift manager was working in the adjacent Third 80's tank farm that morning and an operator was working in the nearby 100's tank farm. However, neither of them heard, saw, or smelled anything out of the ordinary during the time of the release. The First & Second 80's tank farm was not equipped with a gas detection system.

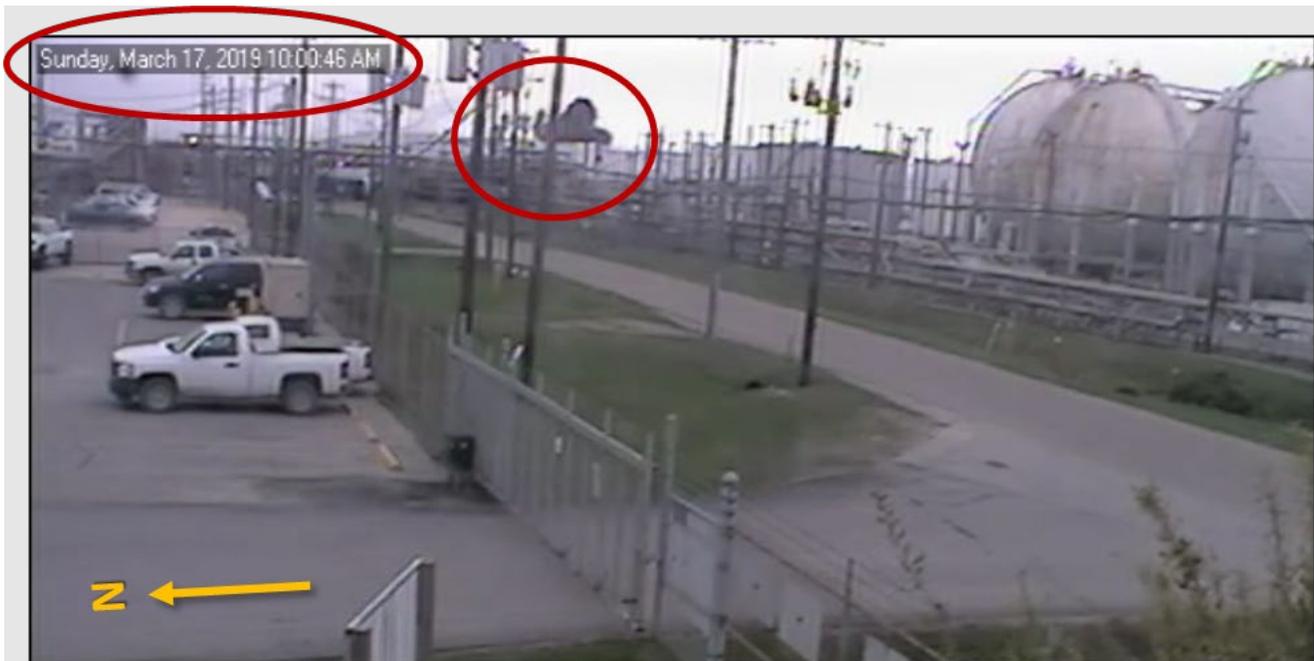
Figure 9. ITC Deer Park terminal security camera footage showing fireball over First & Second 80's Tank Farm at 10:00:46 a.m. on March 17, 2019. (Credit: ITC, annotations by CSB)

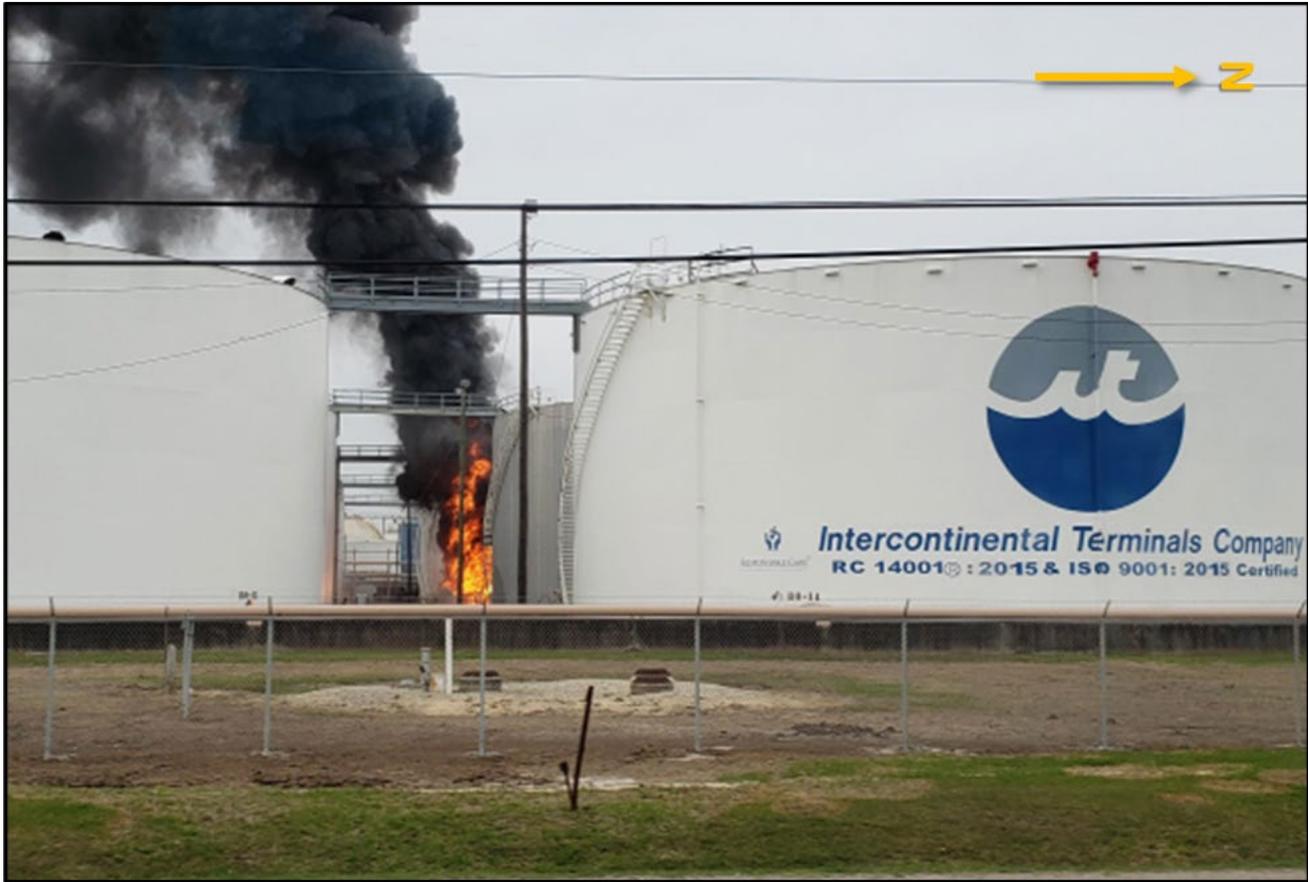
Figure 11. Initial ITC tank fire that ignited at Tank 80-8 on March 17, 2019. (Credit: HCFMO, annotations by CSB)

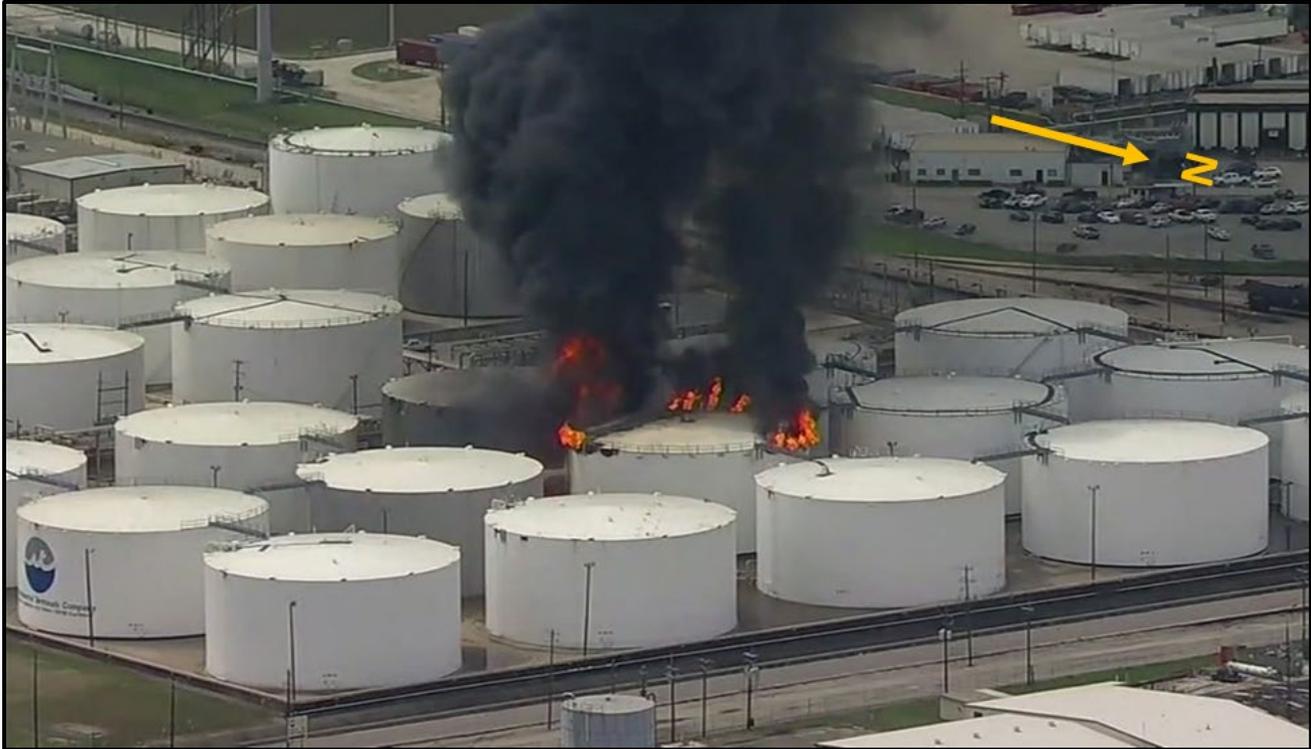
Given that Tank 80-8 was situated in the center of the First & Second 80's tank farm, the initial response efforts focused on using water to cool the tanks, control the fire, and prevent it from spreading. Since Tanks 80-9 and 80-12 were both empty, resources were not focused on cooling these tanks; however, a wind shift caused the fire to inundate the Second 80's tank farm manifold located in this area, which connected to process piping from other locations in the facility.^a As a result, the ERT positioned a portable fire monitor between Tanks 80-11 and 80-12 to assist with cooling efforts and prevent the combustible insulation surrounding Tank 80-11 from reigniting. At this time, fire was visible near the rim of Tank 80-8, with flames being expelled through the roof vents (**Figure 12**).

Figure 12. ITC fire involving Tank 80-8 on the morning of March 17, 2019. (Credit: ABC13 Houston, annotations by CSB)

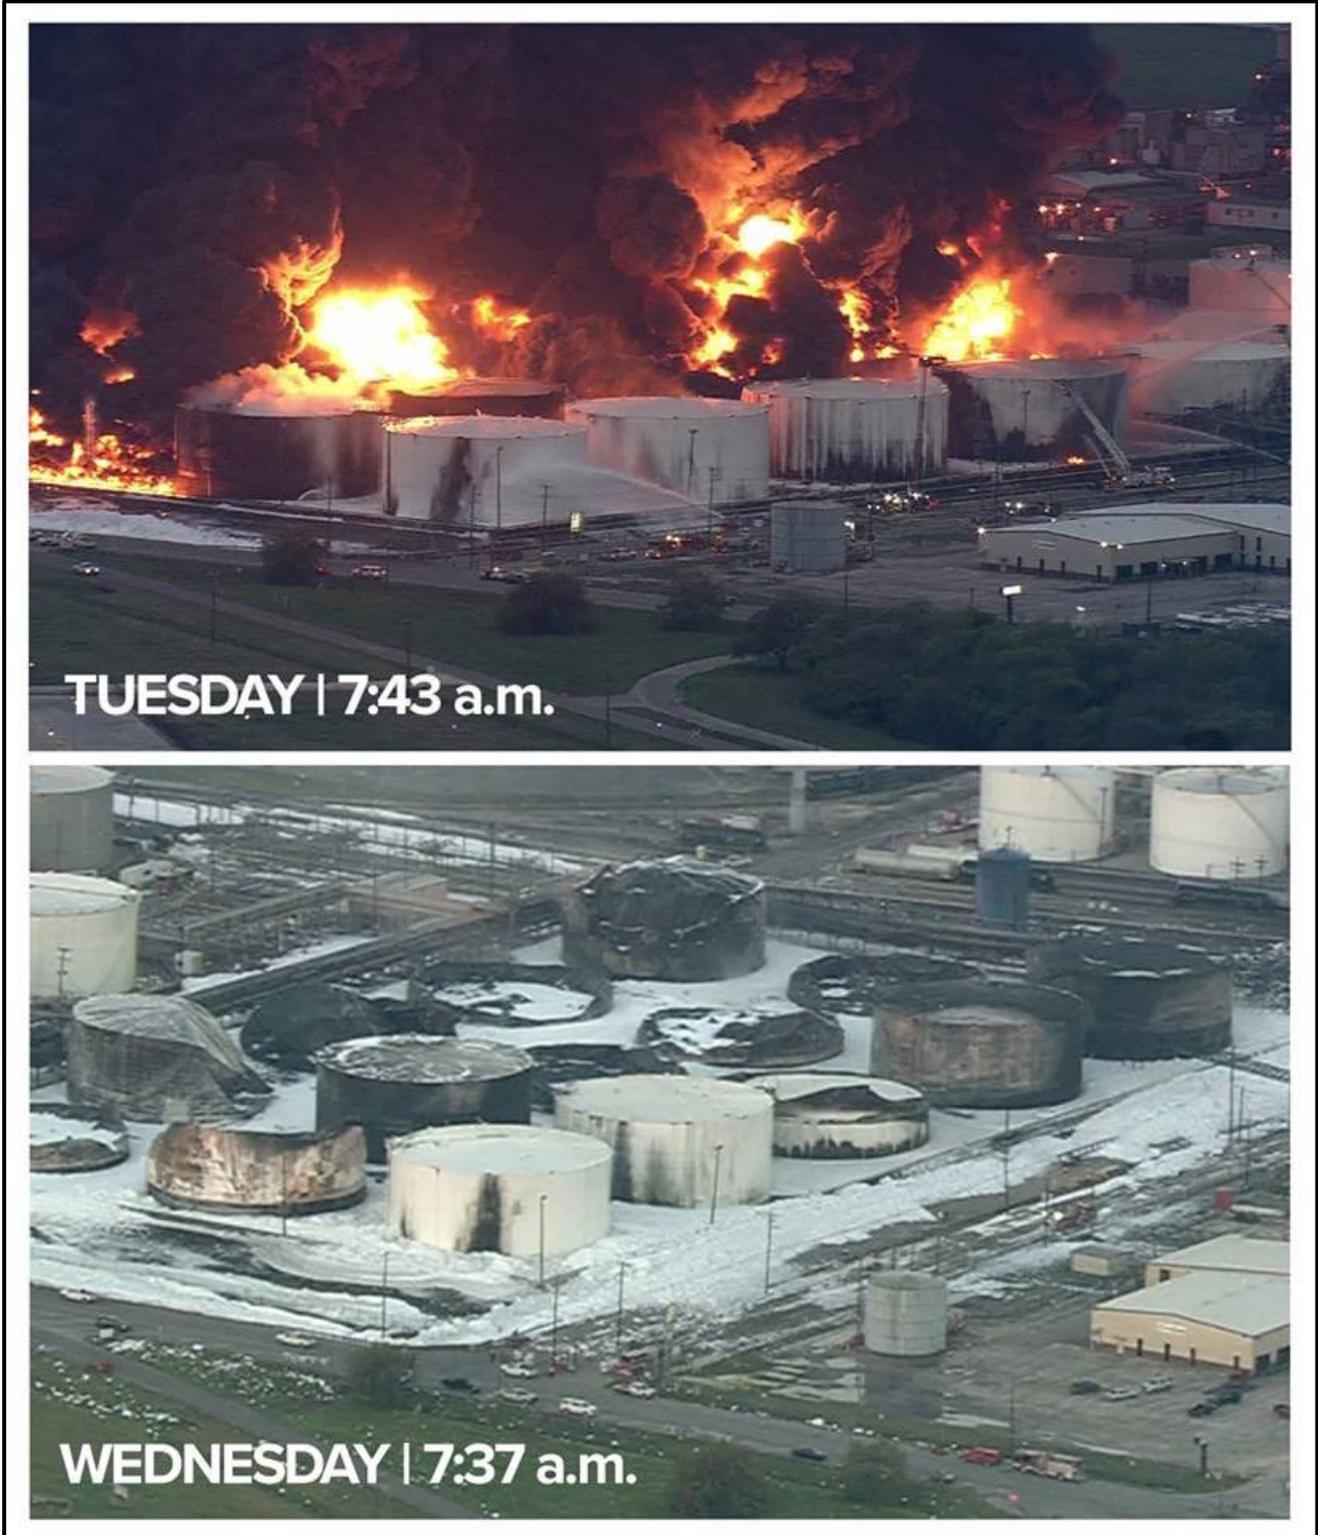
Figure 14. First & Second 80's tank farm on fire on Tuesday, March 19, 2019, and fully extinguished on Wednesday, March 20, 2019. (Credit: KHOU 11 News)

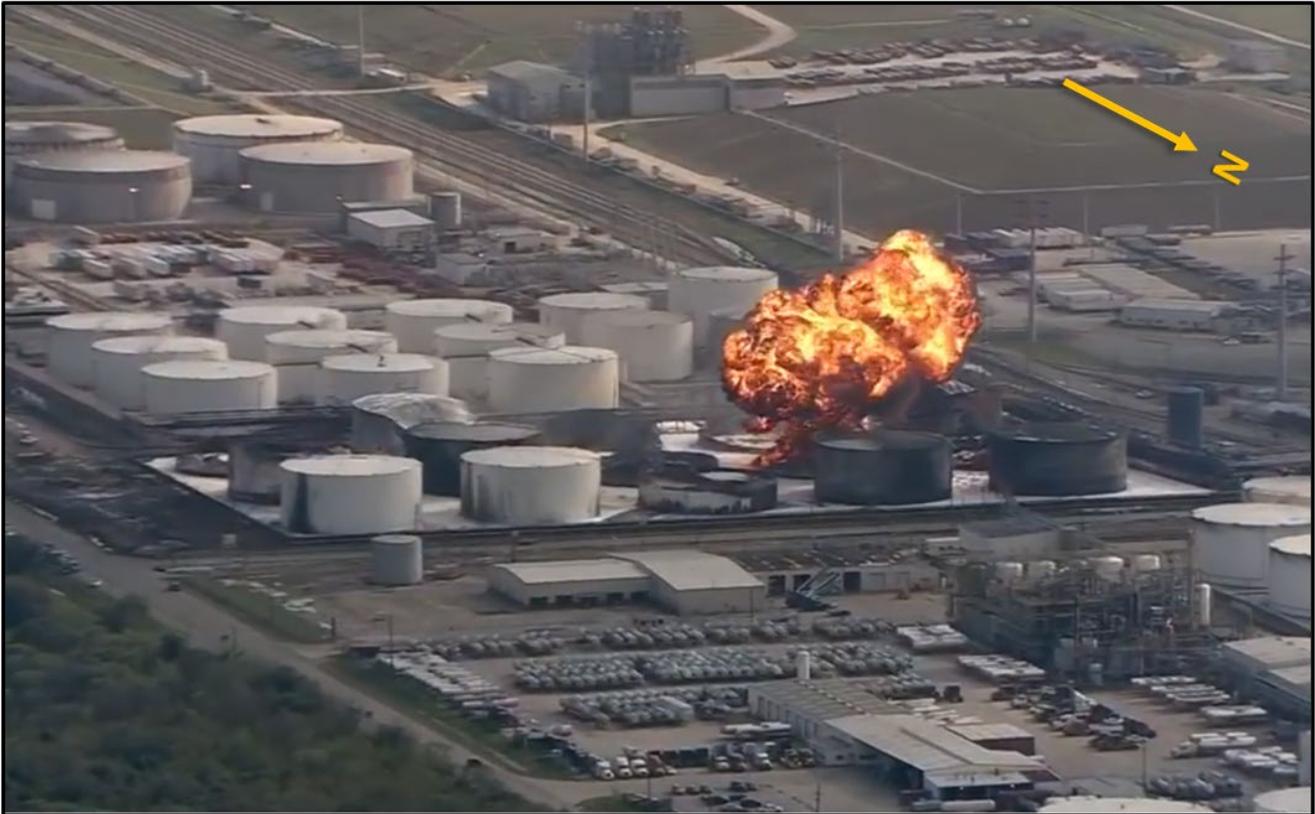
Figure 15. Tank 80-5 flare-up that occurred on March 20, 2019. (Credit: “Raw video ITC fire reignites in Deer Park”, annotations by CSB)

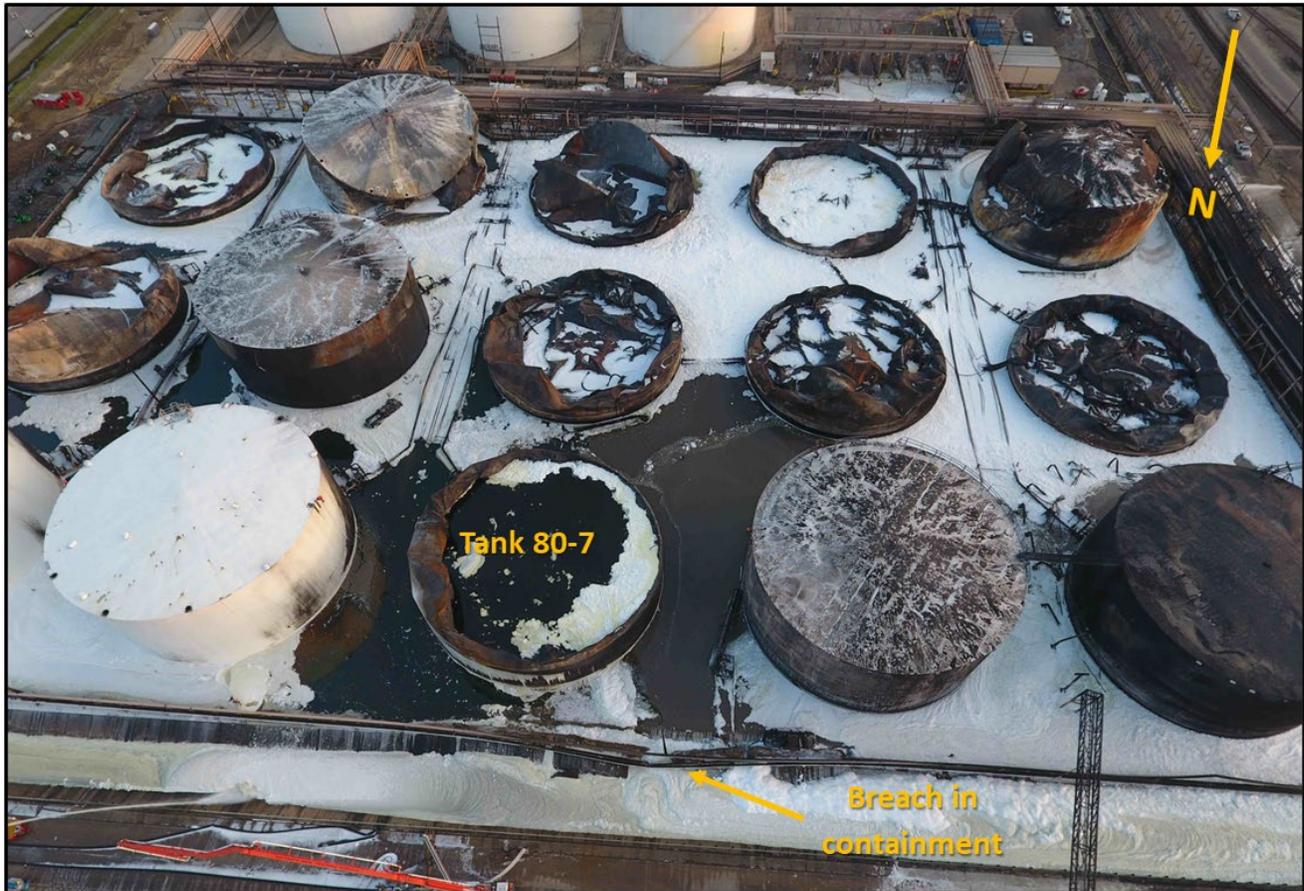
On Friday, March 22, 2019, at around 12:15 p.m., the secondary containment wall surrounding the First & Second 80’s tank farm partially collapsed near Tank 80-7. The containment wall displaced laterally due to excessive lateral soil and hydrostatic pressures.^b The containment wall failure allowed the mixture of released hydrocarbon products, firefighting foam, and contaminated water previously confined to the tank farm to exit the containment area and enter the ditch running adjacent to Tidal Road on the north side of the tank farm

Figure 16. Overhead view of the First & Second 80's tank farm containment wall failure that allowed materials to enter the surrounding waterways on Friday, March 22, 2019. (Credit: ITC, annotations by CSB)

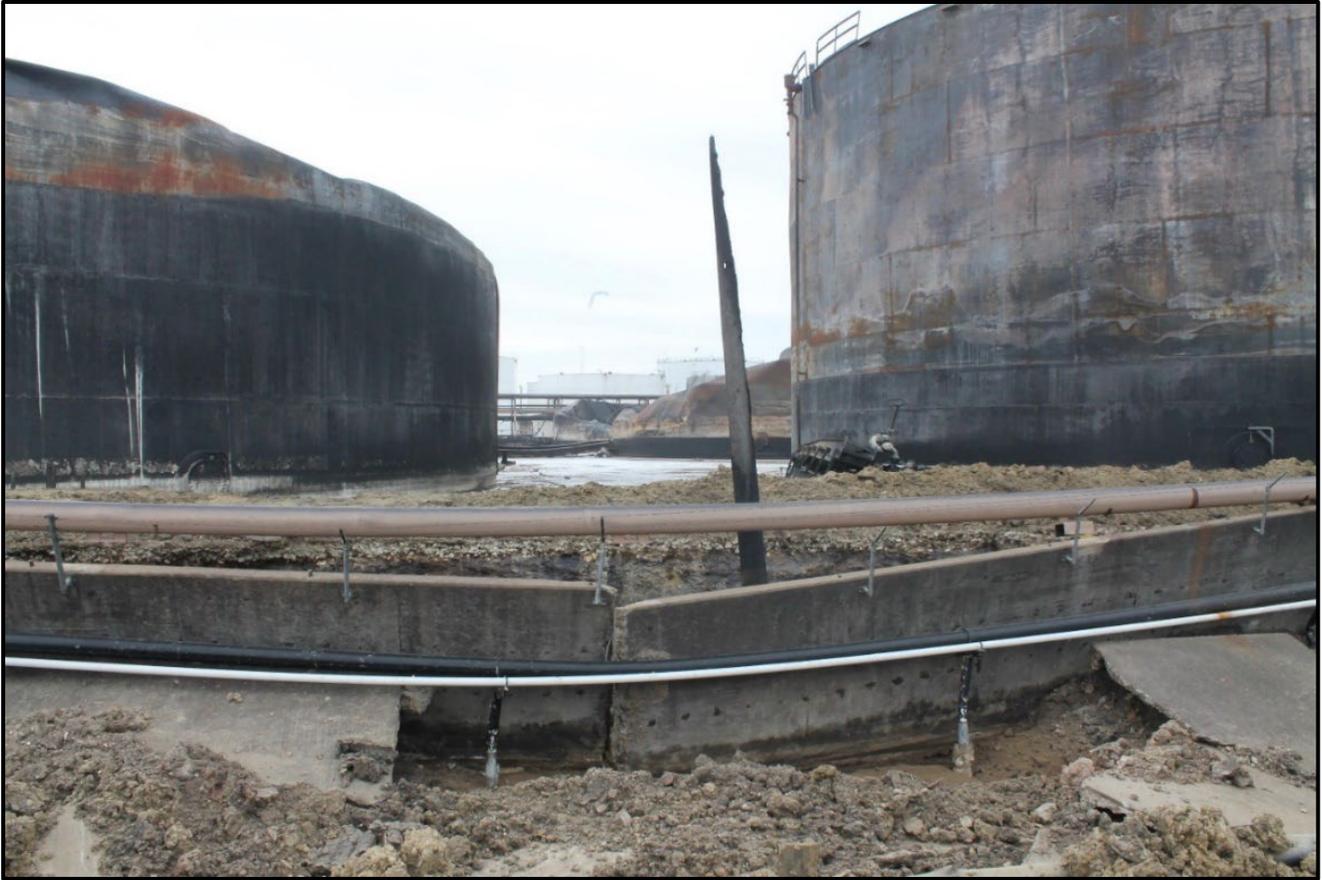
(Figure 16). The release also resulted in the potential for elevated levels of volatile organic compounds (VOCs)^a in the immediate industrial area. As a result, ITC notified its industrial neighbors and local state parks of the potential exposure and recommended that they shelter in place. The breach in the containment wall measured roughly 10 feet in width (Figure 17).

Figure 17. Close-up view of the First & Second 80's tank farm containment wall breach that occurred on Friday, March 22, 2019. (Credit: HCFMO).

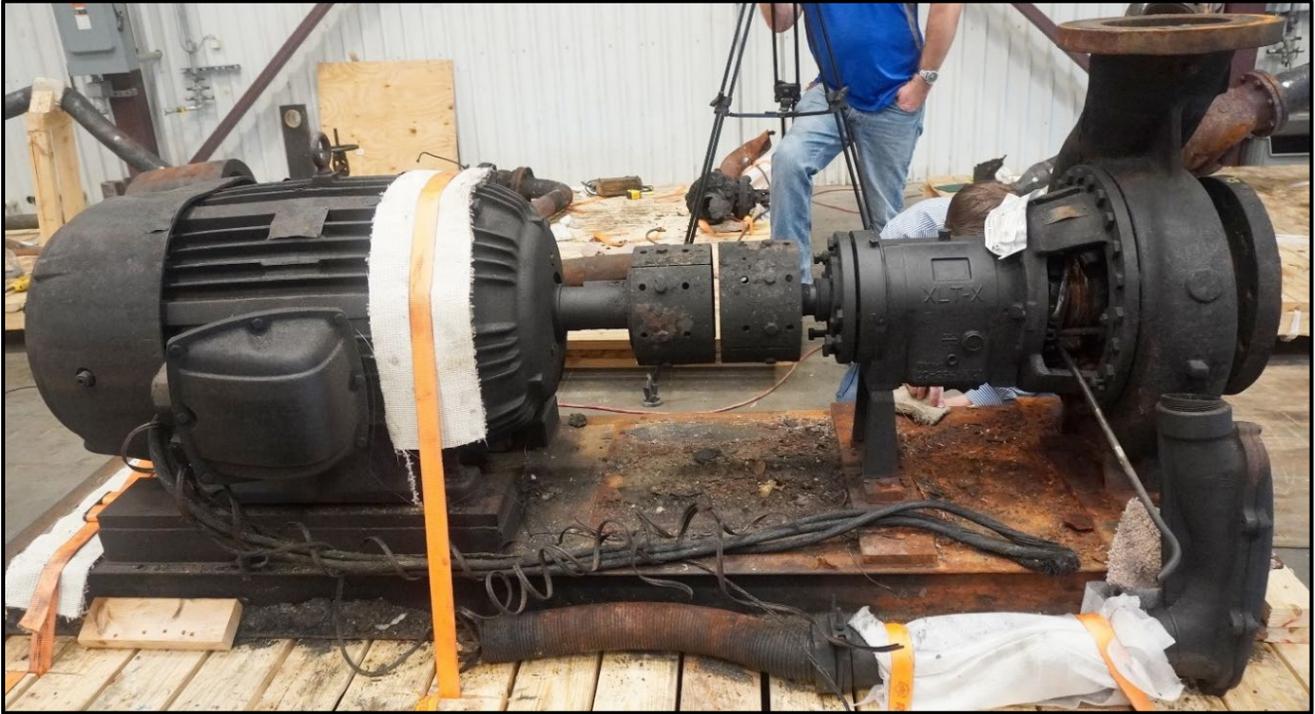
Following the incident, the Tank 80-8 circulation pump skid was transported to a third-party facility for inspection and teardown (**Figure 22**). The pump was fully disassembled to allow for visual examination of its individual components and documentation of their condition. Severe degradation and wear damage were observed on the pump shaft, seal, and outboard bearing. Substantial abrasive wear was visible on the pump shaft adjacent to the seal on the inboard side of the bearing housing (**Figure 23**). Extensive contact wear was also visible on the seal gland (**Figure 24**).

Figure 22. Tank 80-8 pump removed from ITC Deer Park terminal. Pictured is the pump kit on a pallet, as removed from the incident site. (Credit: CSB)

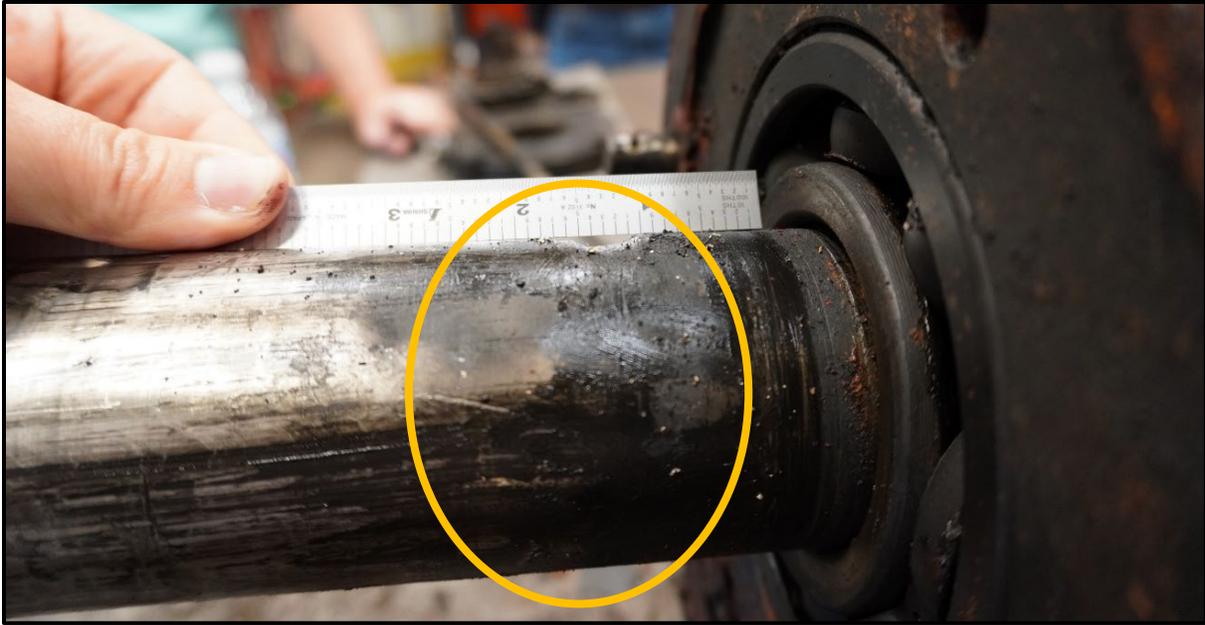
Figure 23. The severe abrasive wear damage observed on the Tank 80-8 pump shaft adjacent to inboard side of bearing housing, on August 30, 2019. (Credit: CSB)

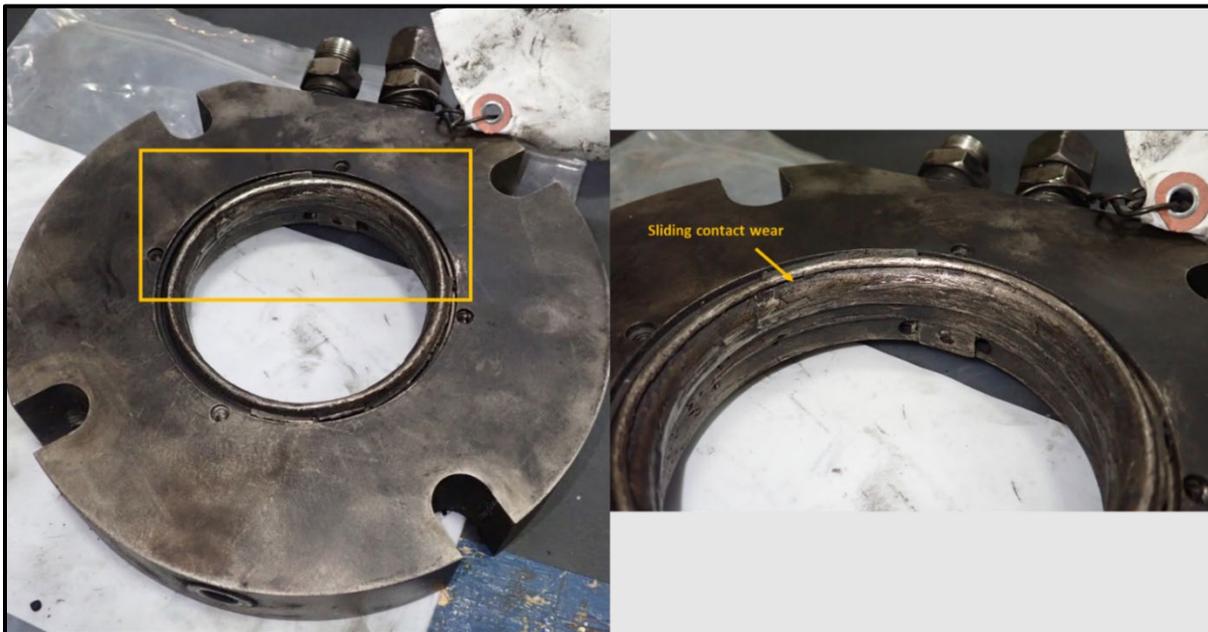
Figure 24. Smear metal on inside surface of seal gland that indicates sliding contact with the pump shaft. (Credit: Stress Engineering)

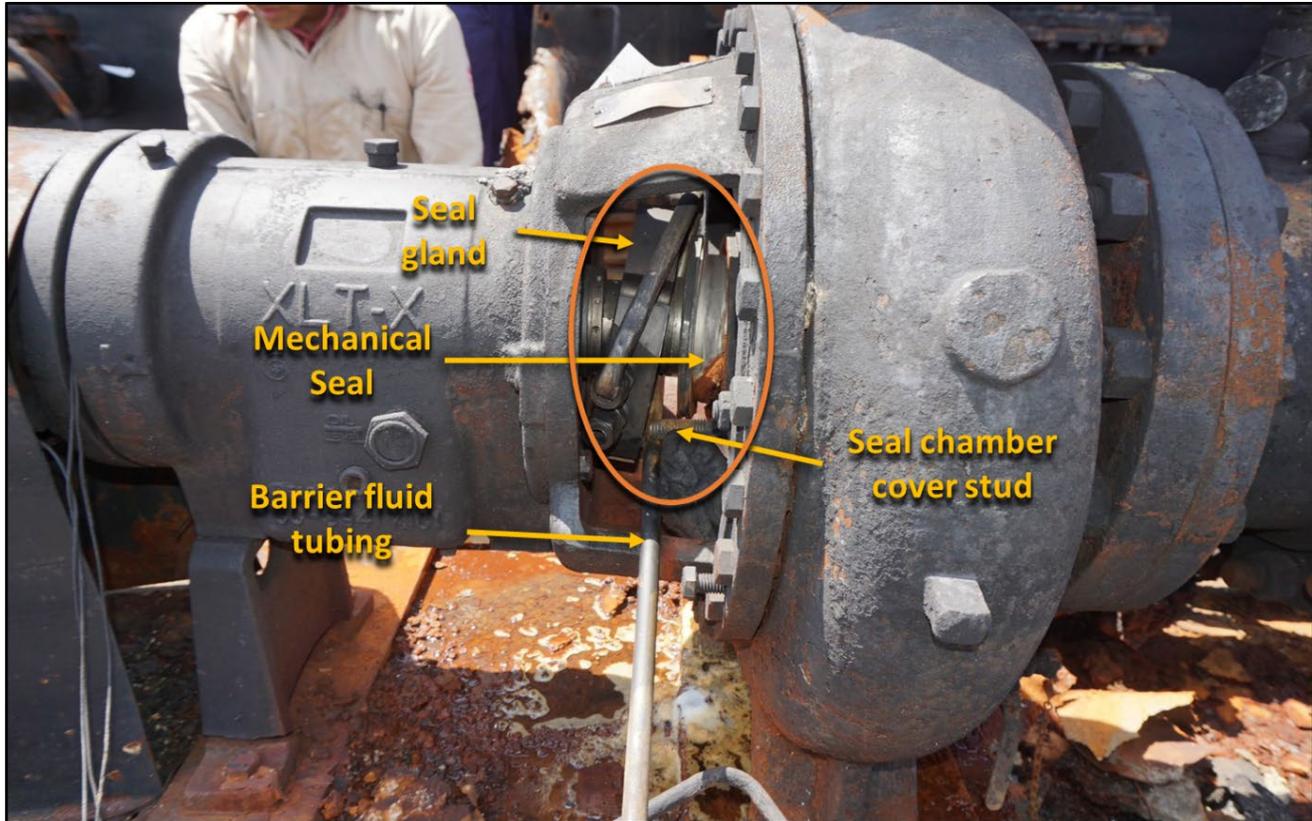
Figure 26. Tank 80-8 circulation pump. This photo shows the point of separation observed between the mechanical seal gland and seal chamber cover where the butane-enriched naphtha product released. (Credit: CSB).

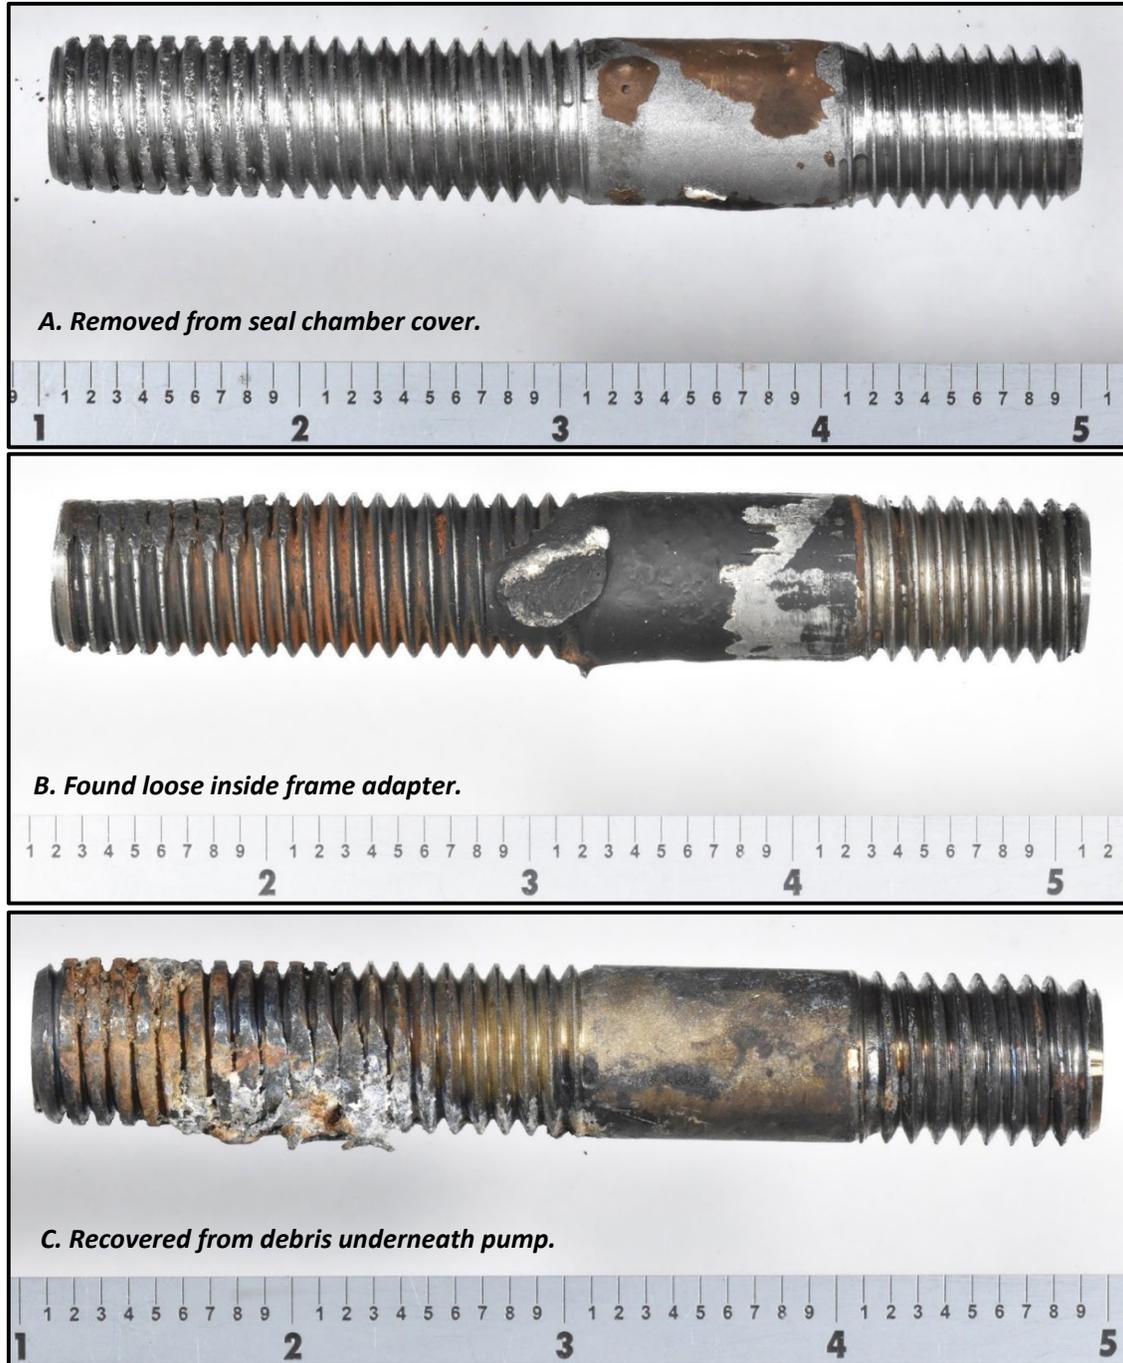
^a The internal threads of the blind holes in which the studs were located, as well as the threads on the studs where they engaged the blind holes, were in good condition.

Figure 27. Three seal chamber cover studs recovered from Tank 80-8 circulation pump, post-cleaning. The longer threaded ends passed through the slots in the seal gland, while the shorter threaded ends were engaged in the seal chamber cover. (Credit: Stress Engineering)

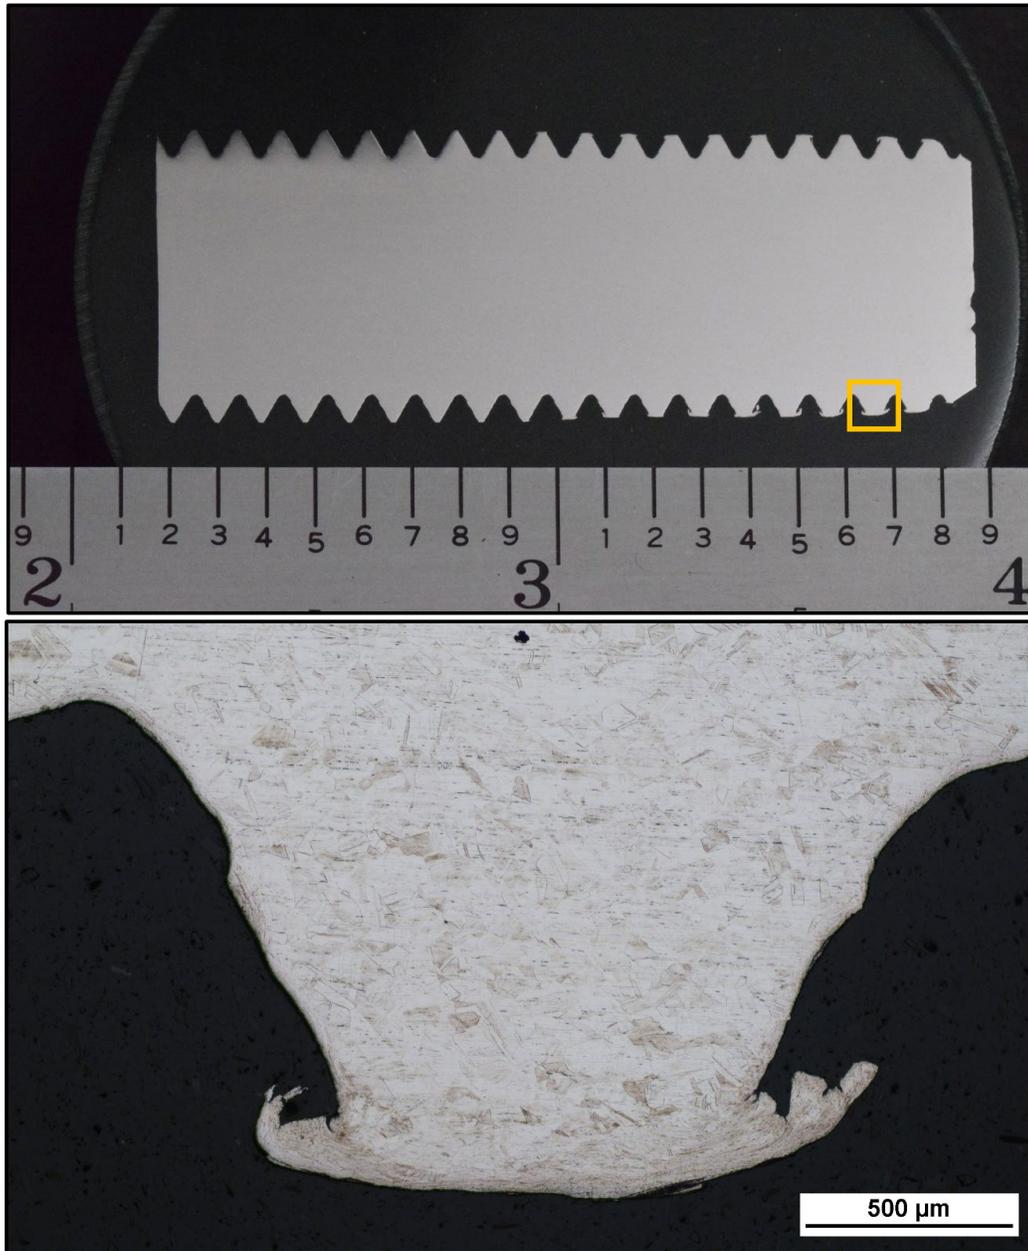
Figure 28. Section of threads from seal chamber stud that projected through slots in seal gland, where flattening of the thread crowns was observed (Credit: Stress Engineering)

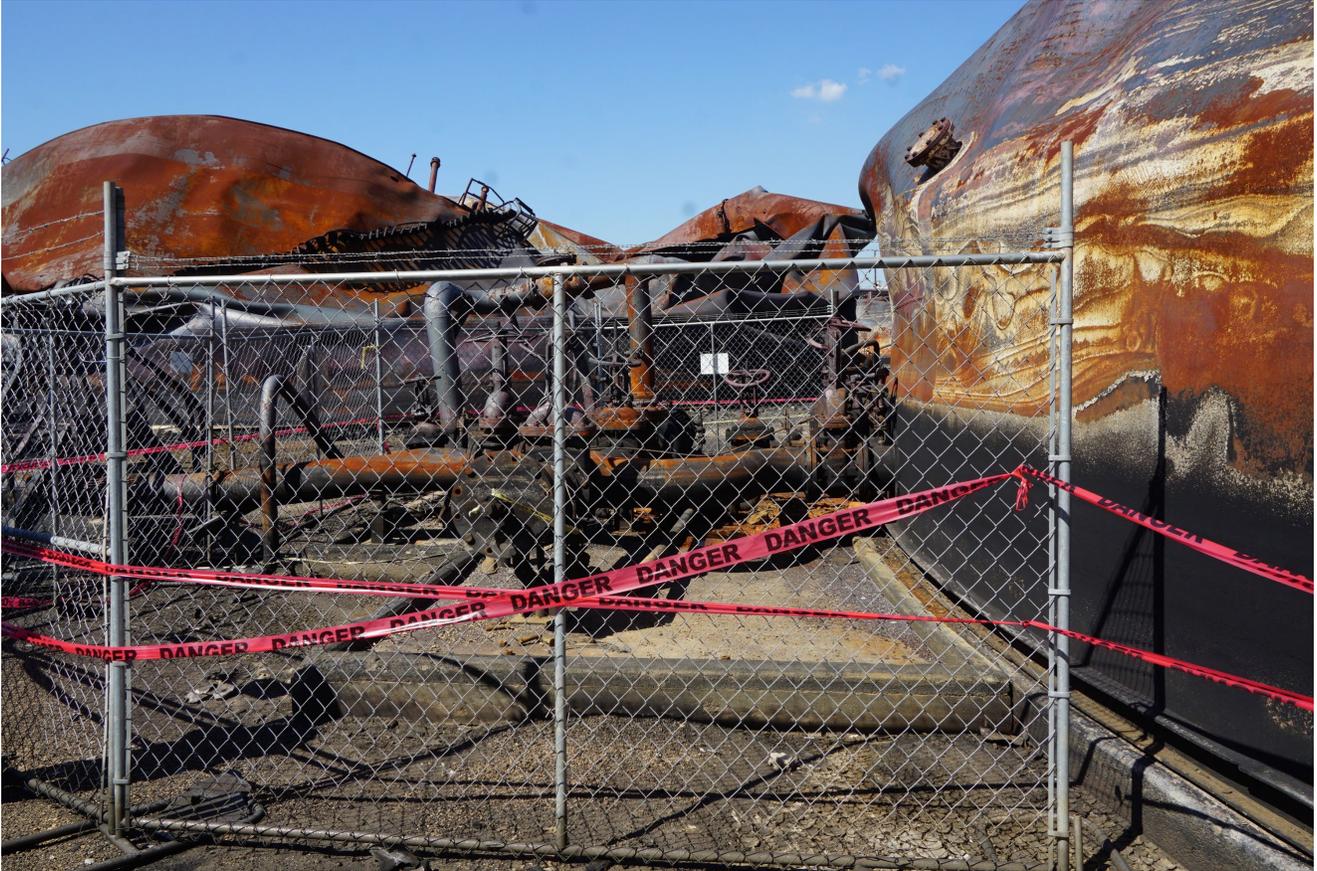
Figure 30. Small concrete containment area around the Tank 80-8 circulation pump. (Credit: CSB)
