## **Kuraray Investigation – Factual Update**

Kuraray America EVAL Facility, Pasadena TX Fire, May 19, 2018

Steve Cutchen October 24, 2018

#### U.S. Chemical Safety and Hazard Investigation Board Kuraray America EVAL Facility, Pasadena TX

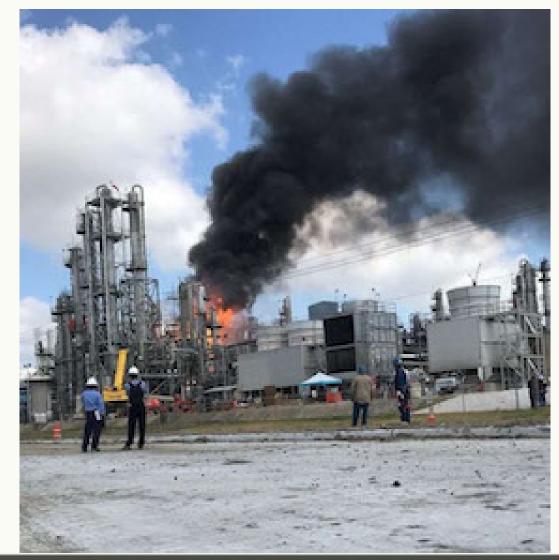
Saturday, May 19 10:28 Reactor overpressures. Reactor vapor ejected horizontally from relief valve. Vapor ignited by welding machine – Fire Marshal.
