# Fatal Propylene Release and Explosion at Watson Grinding

Houston, Texas | Incident Date: January 24, 2020 | No. 2020-03-I-TX

## Investigation Report

Published: June 29, 2023

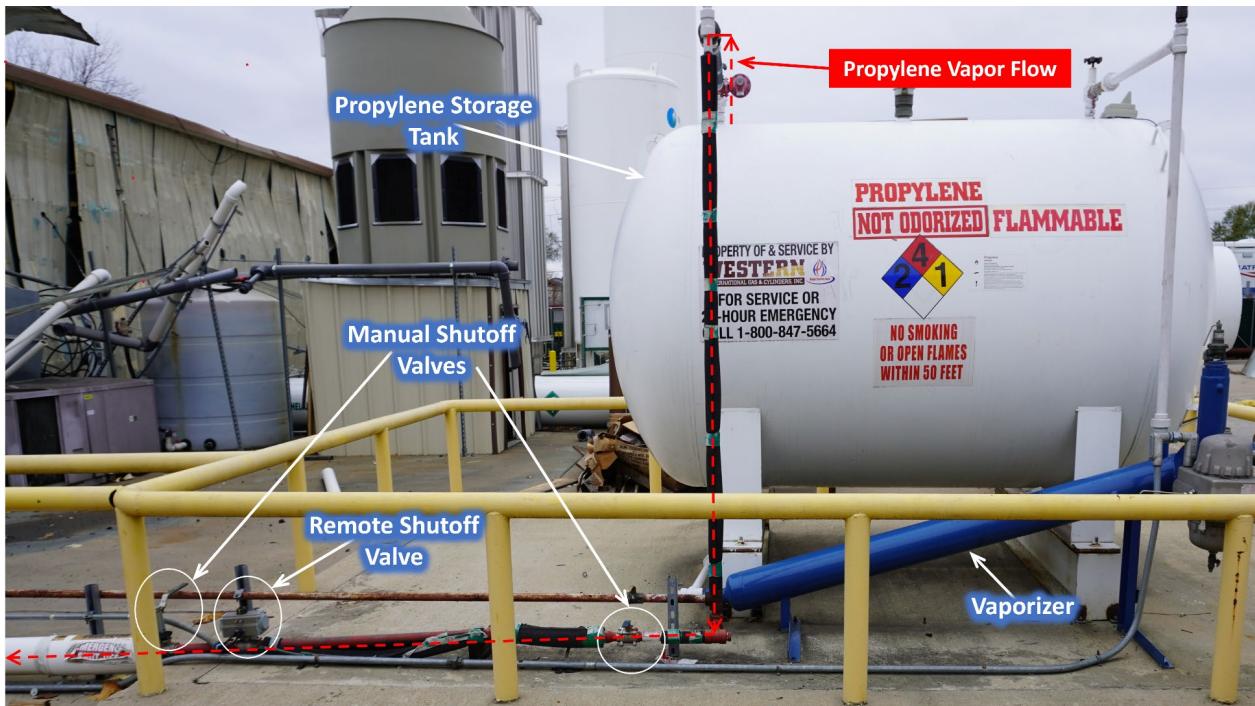
**Figure 7.** Post-Incident Photo of Propylene Storage Tank. (Source: CSB)

At the end of the workday on the evening before the incident, neither of the manual shutoff valves nor the remote shutoff valve located at the propylene storage tank were closed.<sup>a</sup> The CSB found that there was no established policy or procedure for isolating the propylene storage tank at the end of the workday.

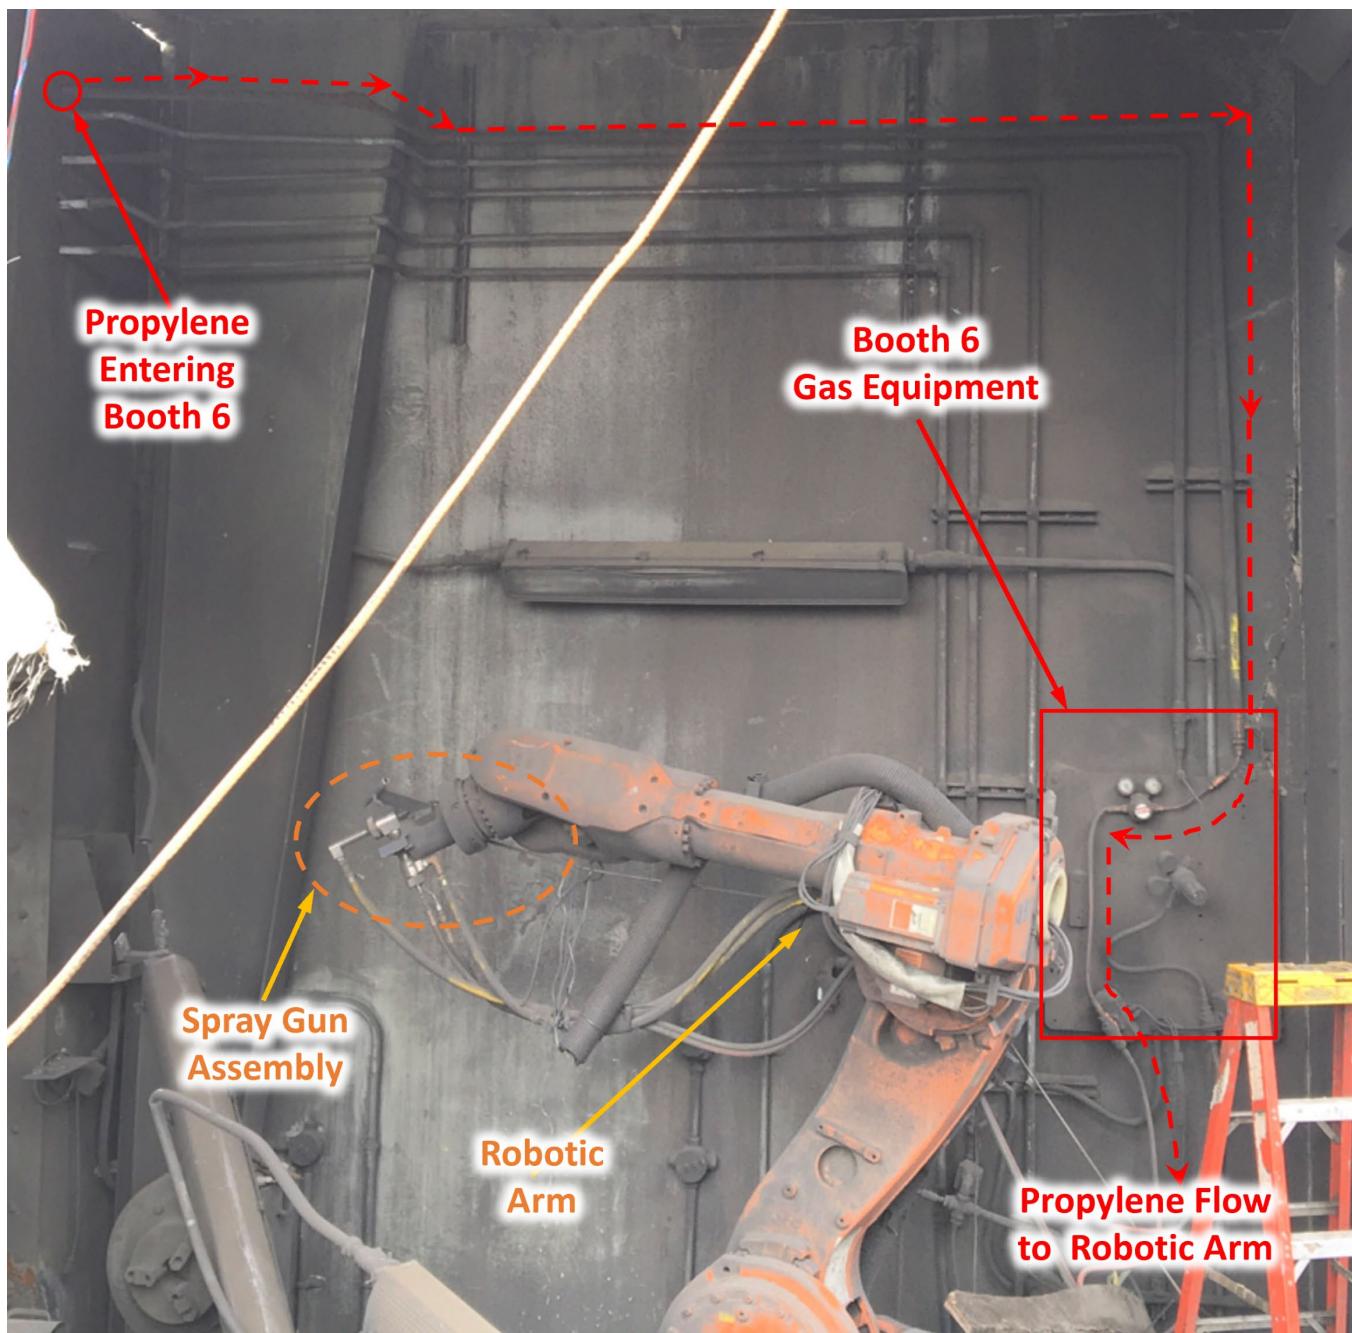
**Figure 9**, a photo of Booth 6 taken after the incident, shows the propylene piping (see red dashed line) after it entered the inside of each HVOF coating booth (Booths 3 through 10). The propylene pressure was controlled inside each booth by a pressure regulator. **Figure 10** shows the Booth 6 gas equipment. The propylene flowed from the pressure regulator and other equipment to the robotic arm (which directed the coating spray gun) and into the spray gun, where it fueled the HVOF spray coating. The propylene equipment in the six HVOF coating booths (Booths 3 through 8) in the coating building was observed to be similarly arranged but was not equipped identical to one another.

Figure 9. Interior of Coating Booth 6. (Source: Watson Grinding, annotations by CSB)

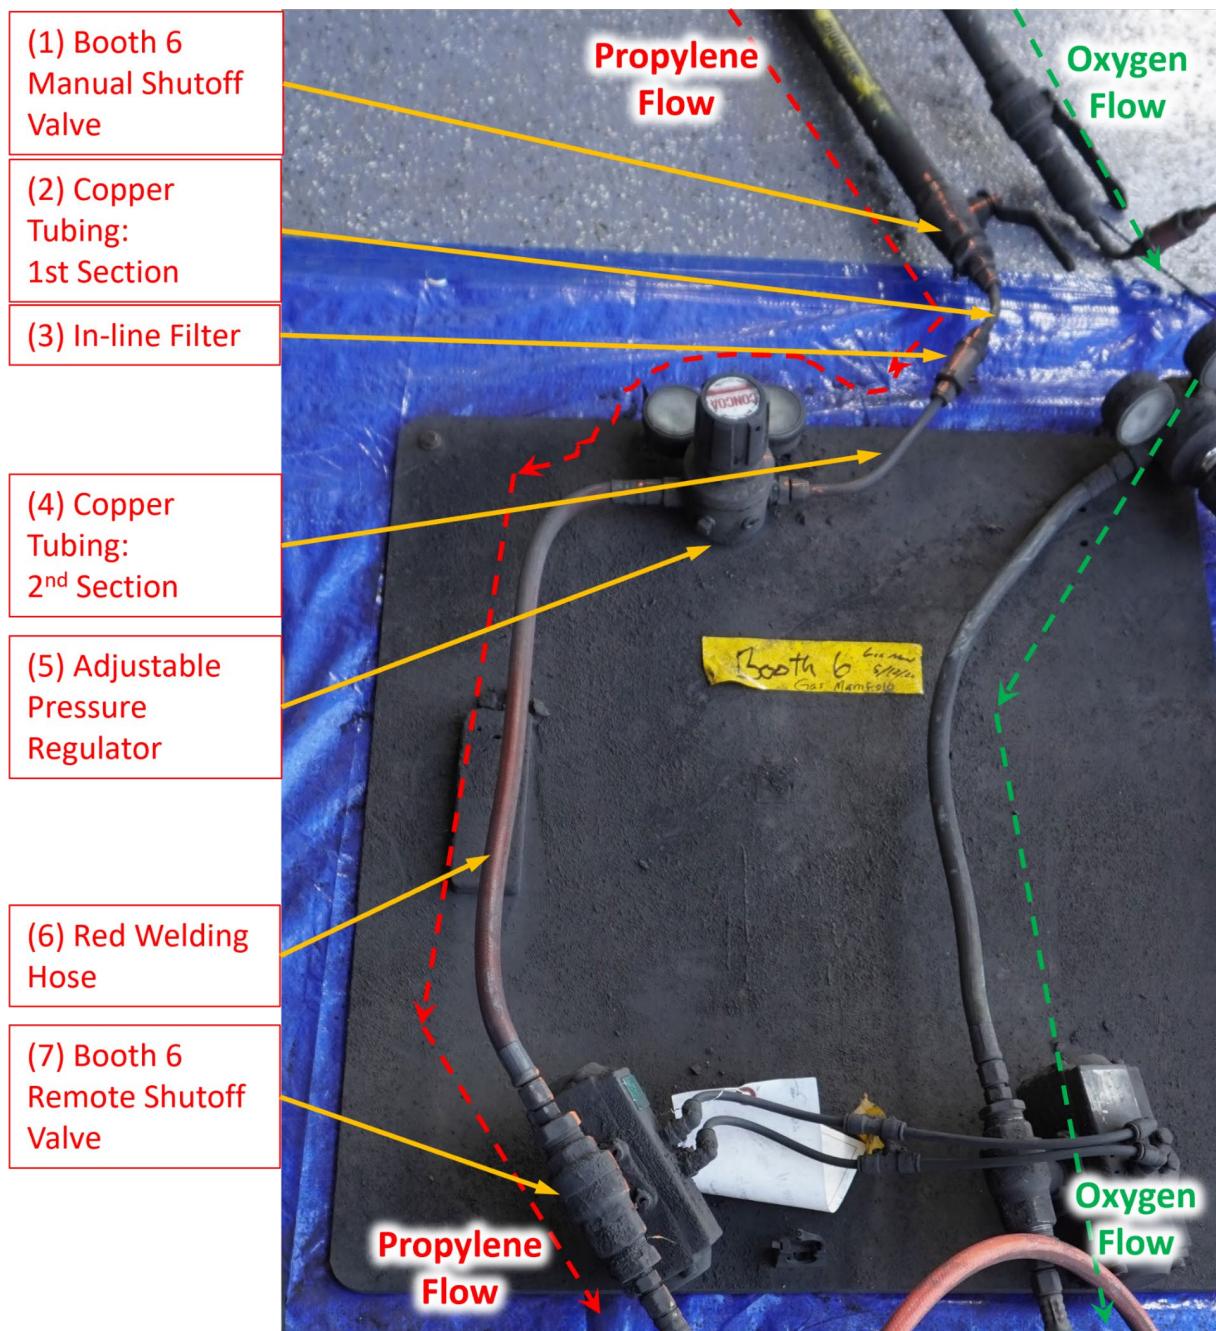
Figure 10. Booth 6 Gas Equipment. (Source: CSB)

Booth 4, the likely location of the propylene leak, differed from Booth 6 in that rather than using the rigid copper tubing located at numbers (2), (3), and (4), as shown in **Figure 10**, these items were substituted with a single section of Grade R flexible red rubber welding hose. This change is further discussed in Sections 3 and 4.1.5. When shutting down at the end of the workday, each booth's remote shutoff valve would automatically close to isolate each booth's robot and spray gun.

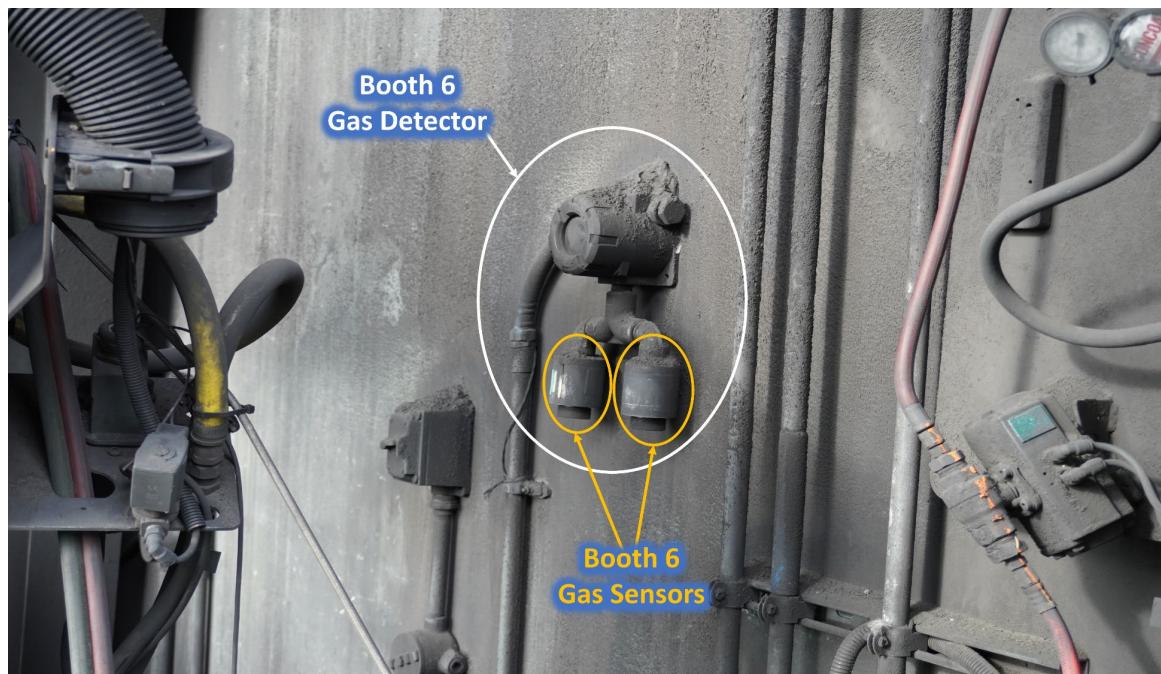
The alarms were both audible and visual (see **Figure 13**). The audible alert consisted of a verbal message alerting employees of the hazard and directing employees to evacuate, alternating with a siren. Meanwhile, the visual alarm consisted of a flashing red beacon located outside of alternating coating booths. At the time of the incident, the automated gas detection alarm, exhaust fan startup, and gas shutoff system was not functional.

**Figure 12.** Booth 6 Gas Detector, Including Flammable Gas and Oxygen Sensors. (Source: CSB)

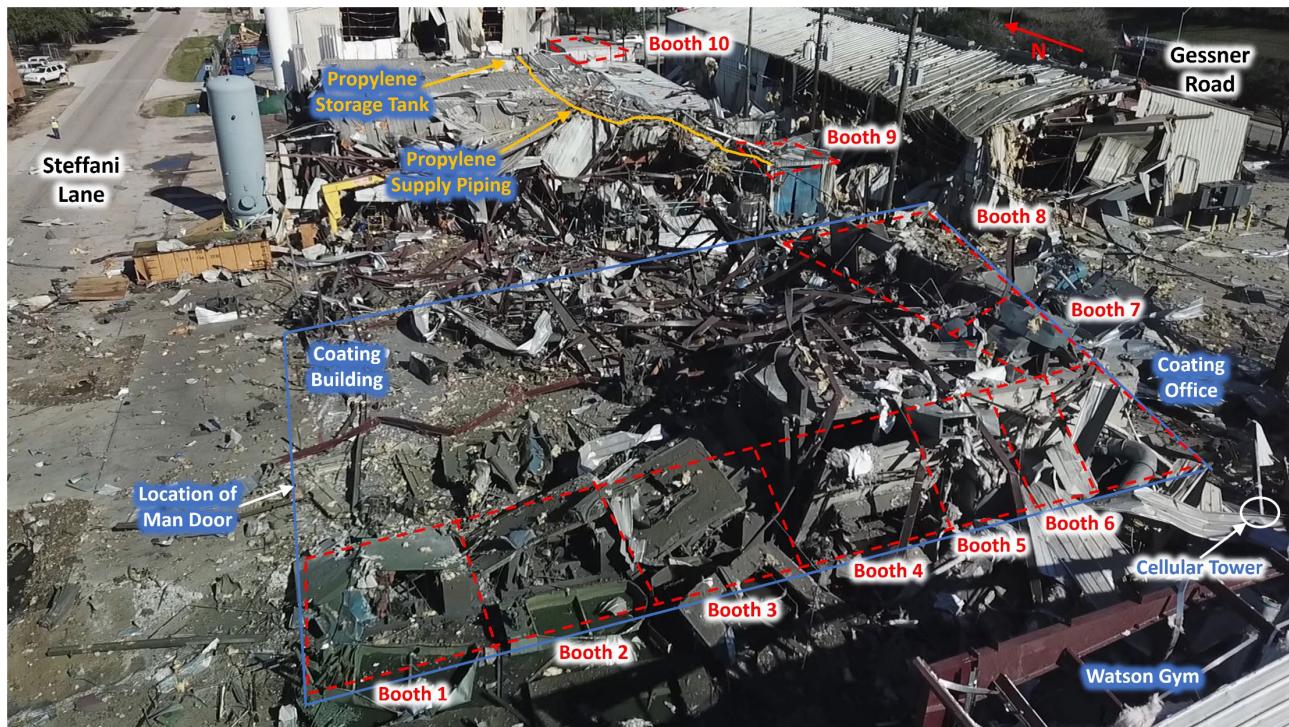
**Figure 17** shows a drone image of the devastation from the explosion.

**Figure 17.** Post-Expllosion Image of Coating Building and Adjacent Area. (Source: HFD, annotations by CSB)

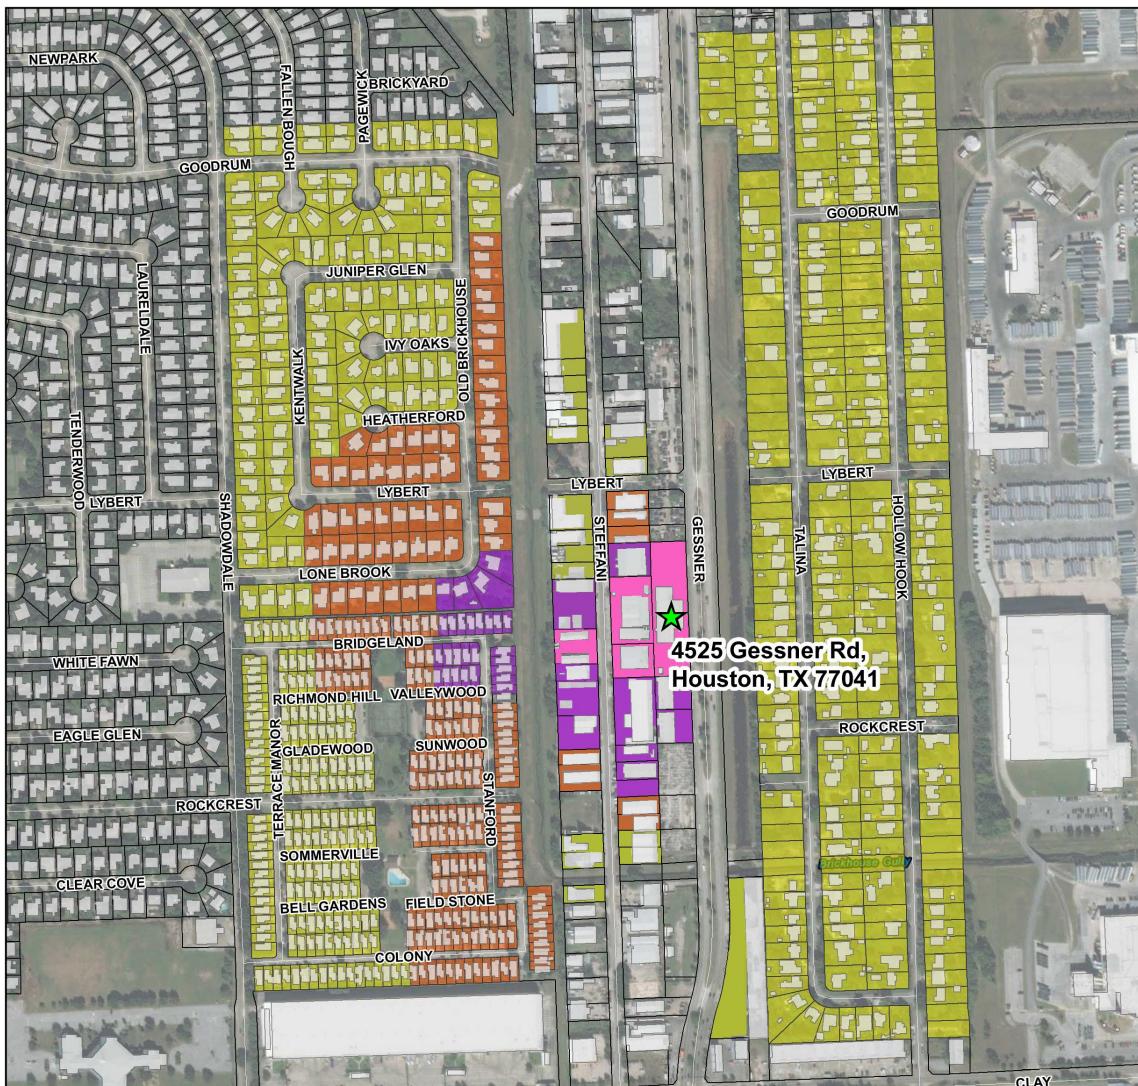
The City of Houston's Office of Emergency Management subsequently reported that the incident damaged numerous nearby structures (see **Figure 18**). Some homes, located to the west of the Watson Grinding facility, experienced major damage.

**Figure 18.** Damage Assessment. (Source: City of Houston Office of Emergency Management)

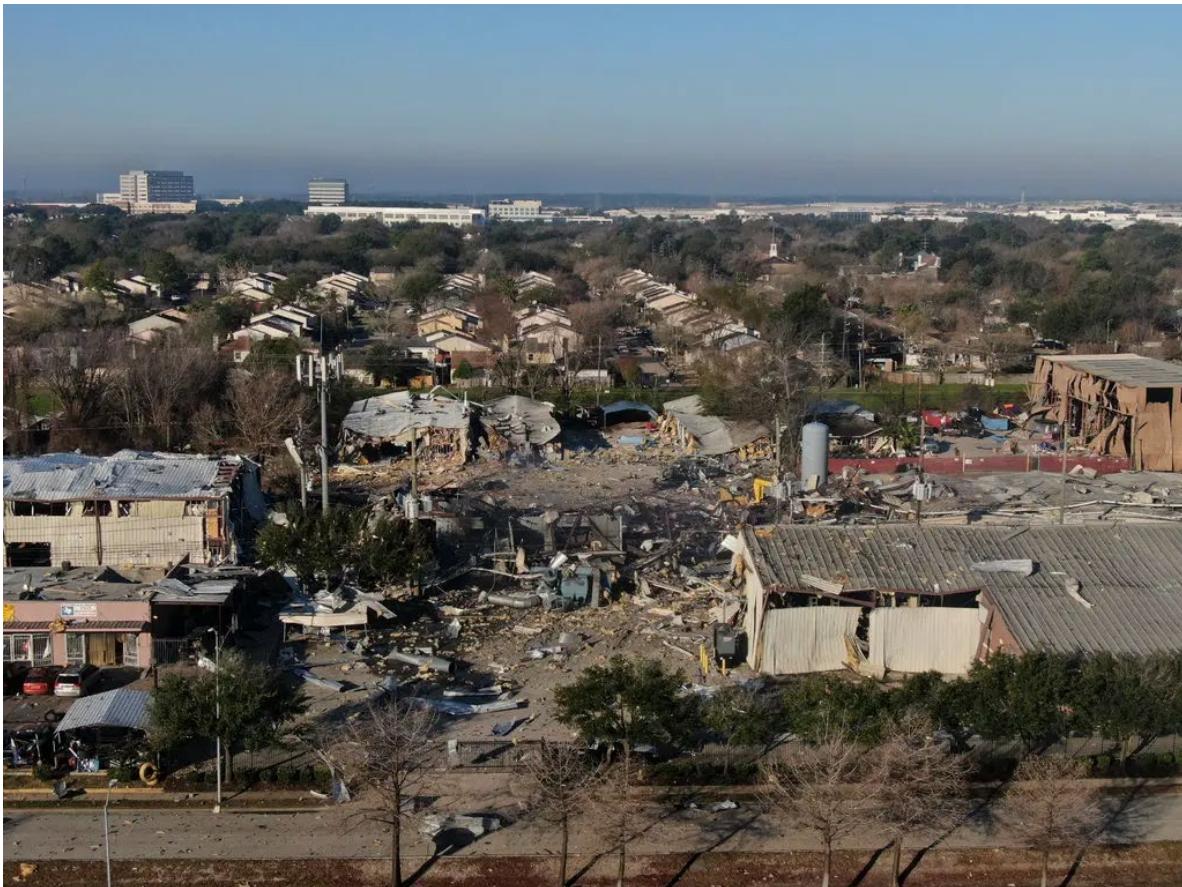
Some homes were located within a few hundred feet of the Watson Grinding facility. Due to the close proximity of the Watson Grinding facility to so many homes and facilities, over 450 structures were affected by the explosion, with some sustaining major damage. A resident died due to injuries sustained in his house caused by the explosion. An aerial view of the damage is shown in **Figure 19**.

**Figure 19.** West-facing aerial view of Watson Grinding. (Source: The New York Times [13])

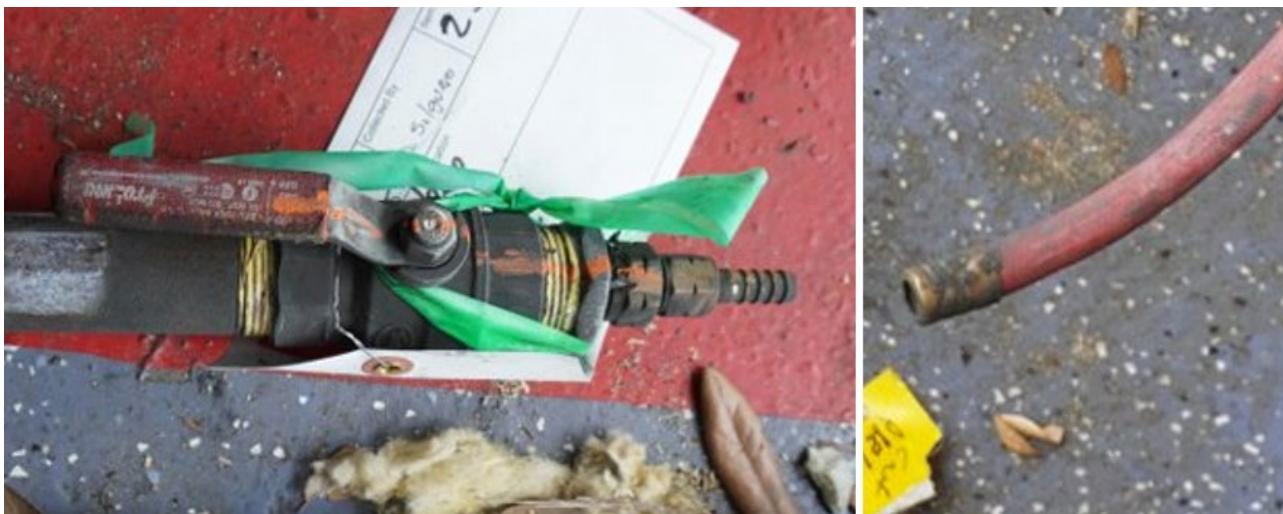
<sup>b</sup> The rubber welding hose was located between the manual shutoff valve and the pressure regulator within Booth 4. The point where the hose disconnected was on the outlet of the Booth 4 manual shutoff valve.

Figure 20. Disconnected Welding Hose from Booth 4. (Source: CSB)

The CSB concludes that the propylene leak began when a rubber welding hose, which was degraded and poorly crimped, disconnected from its fitting overnight in Booth 4. Propylene gas continued to flow into Booth 4 and accumulated inside the coating building.

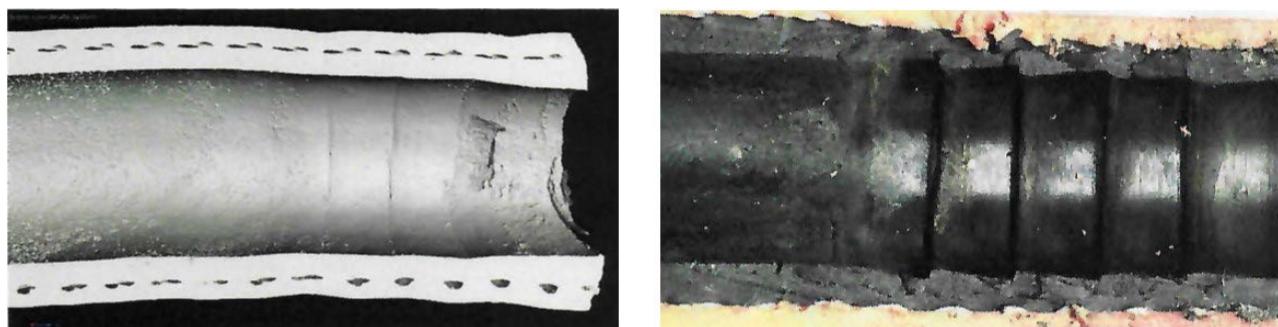
<sup>c</sup> The rubber welding hose was crimped to secure the hose to its fitting. Crimping involves bending metal parts to lock them into place [36, p. 327].

Figure 21. Booth 4 Crimping Comparison: The image on the right shows a different welding hose in Booth 4 with distinct lines that highlight where it was properly crimped; the image on the left shows a computerized tomography scan of the hose that disconnected in Booth 4, leading to the incident. The minimal crimp lines are evidence that the incident hose was not effectively crimped [16].

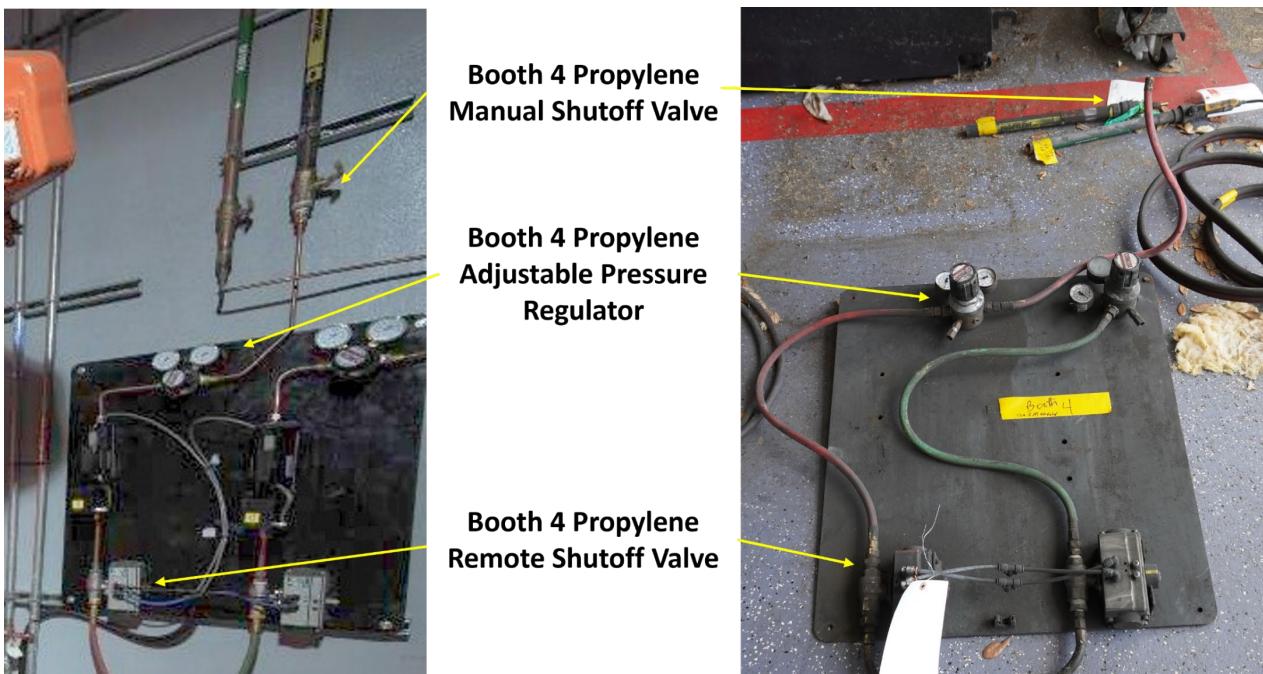
**Figure 22.** Booth 4 Gas Equipment. At left from 2010; at right from post-incident. (Source: Automation Plus (left), CSB (right), annotations by CSB)

The Grade R rubber welding hose that Watson Grinding used is a less expensive type of hose that is designed for acetylene and oxygen service only and is not recommended by the hose manufacturer for use with any other gases, such as propylene. The hose manufacturer recommends a Grade T hose for propylene service because the oils found in fuel gases such as propylene can dry rot a Grade R hose<sup>a</sup> in a reasonably short amount of time, causing the hose to form cracks and lose pliability. In addition, the Association for Rubber Products Manufacturers<sup>b</sup> (ARPM) states that the use of a Grade R rubber welding hose in propylene service may reduce its life and present a safety hazard [18, p. 3].<sup>c</sup> The hose that failed was found to have lost its flexibility and elasticity. This likely contributed to its detachment, leading to the incident.

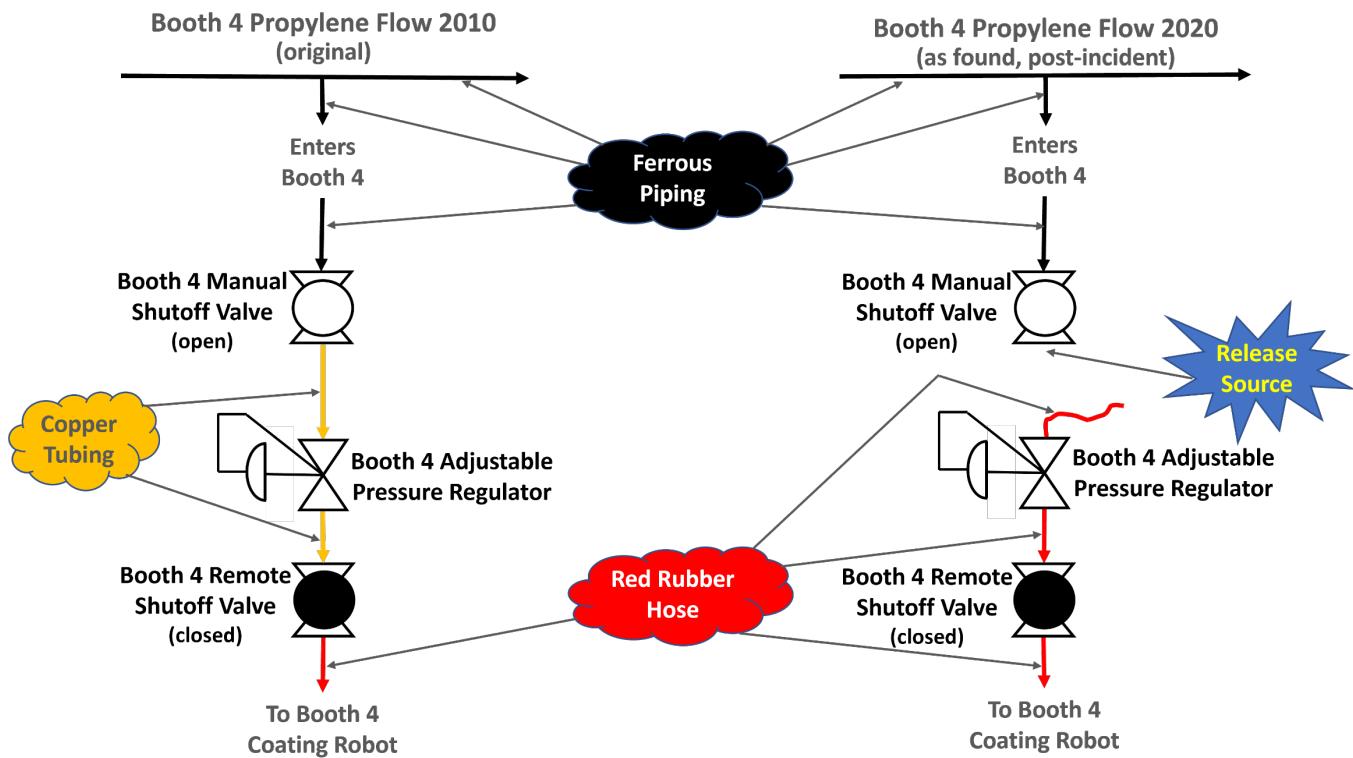
**Figure 23.** Simplified Propylene Flow Diagram of the Booth 4 Gas Equipment. (Source: CSB)
