U.S. Chemical Safety and
Hazard Investigation Board

Trichloroisocyanuric Acid Reaction, Decomposition, and Toxic Gas Release at Bio-Lab, Inc.

Westlake, LA | Incident Date: August 27, 2020 | No. 2020-05-I-LA

Investigation Report

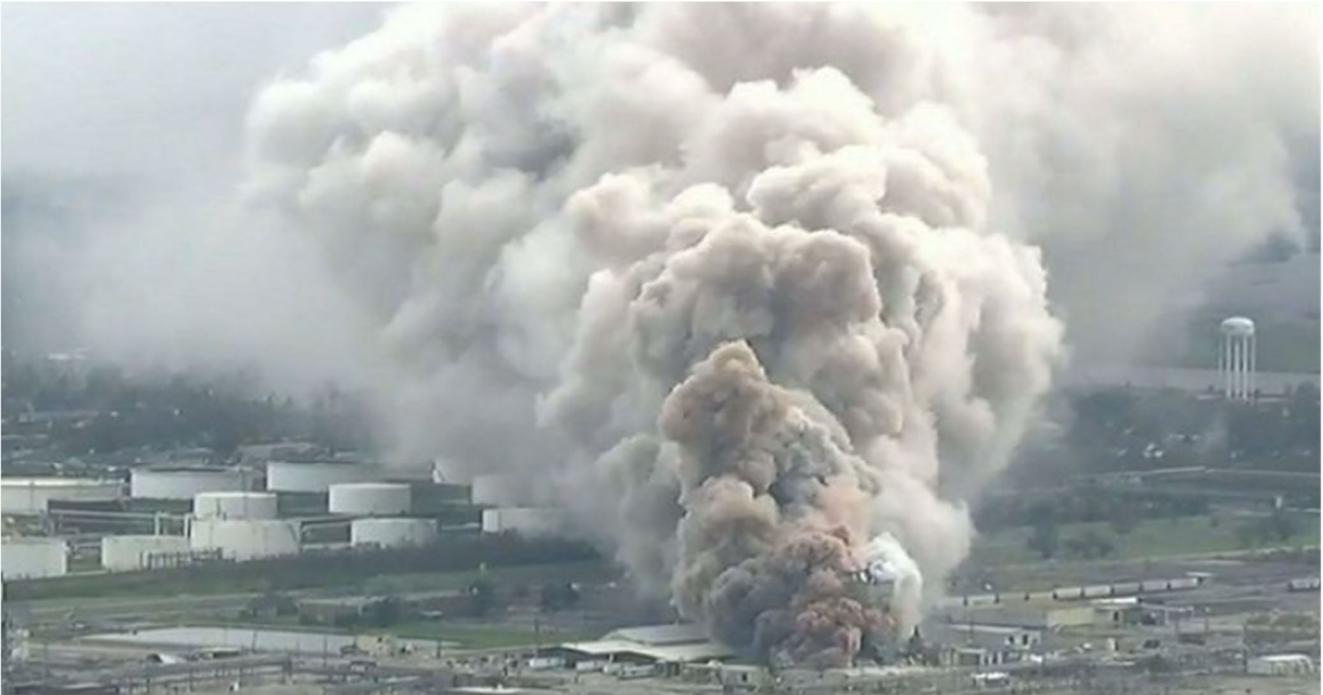
Figure 7. Photo of TCCA decomposition gases, including toxic chlorine, released from Bio-Lab Plant 4 after the building was severely damaged during Hurricane Laura and rainwater contacted the stored TCCA. (Credit: The Associated Press [21])

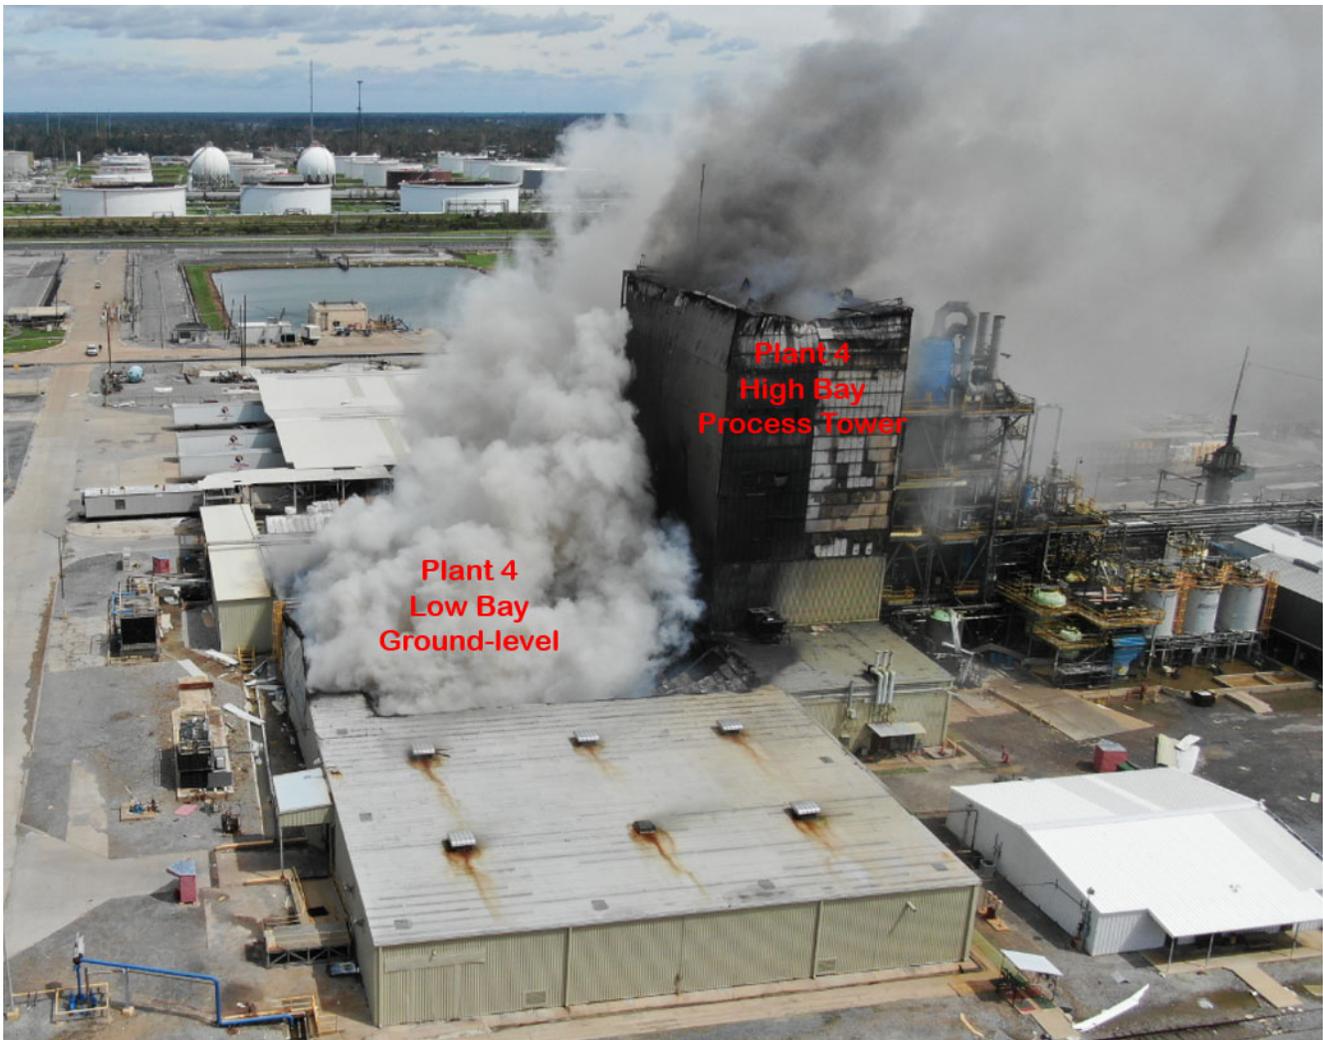
Figure 9. Decomposing TCCA in Plant 4 on August 27, 2020. (Credit: Louisiana State Police, annotations by CSB)

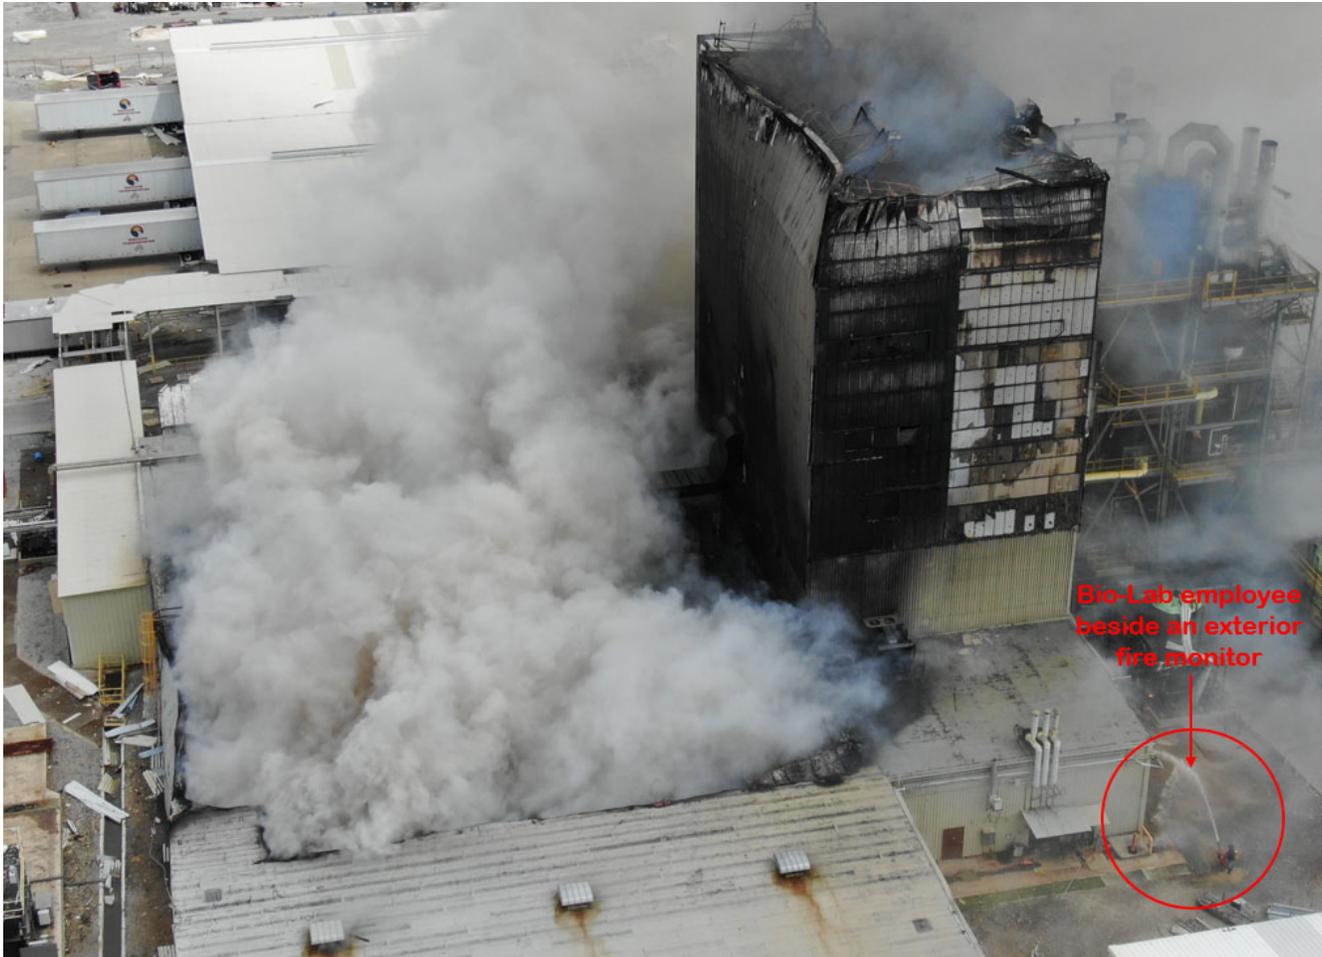
Figure 11. Available water pressure at an exterior fire monitor near Plant 4. (Credit: Louisiana State Police, annotations by CSB)

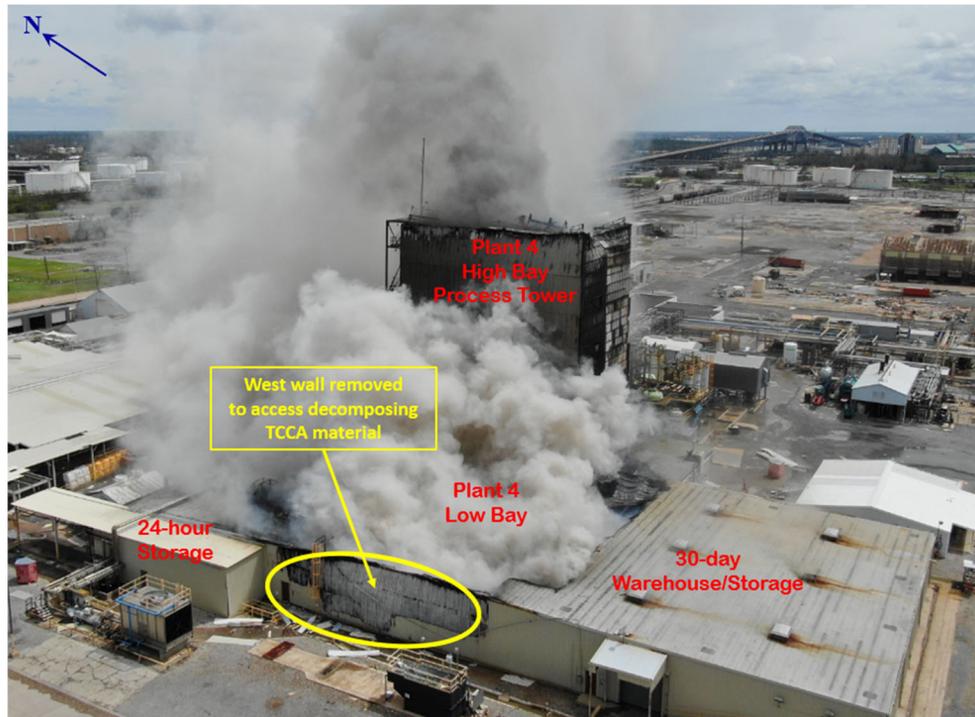
Figure 12. Decomposing TCCA stored in Plant 4. (Credit: Louisiana State Police, annotations by CSB)

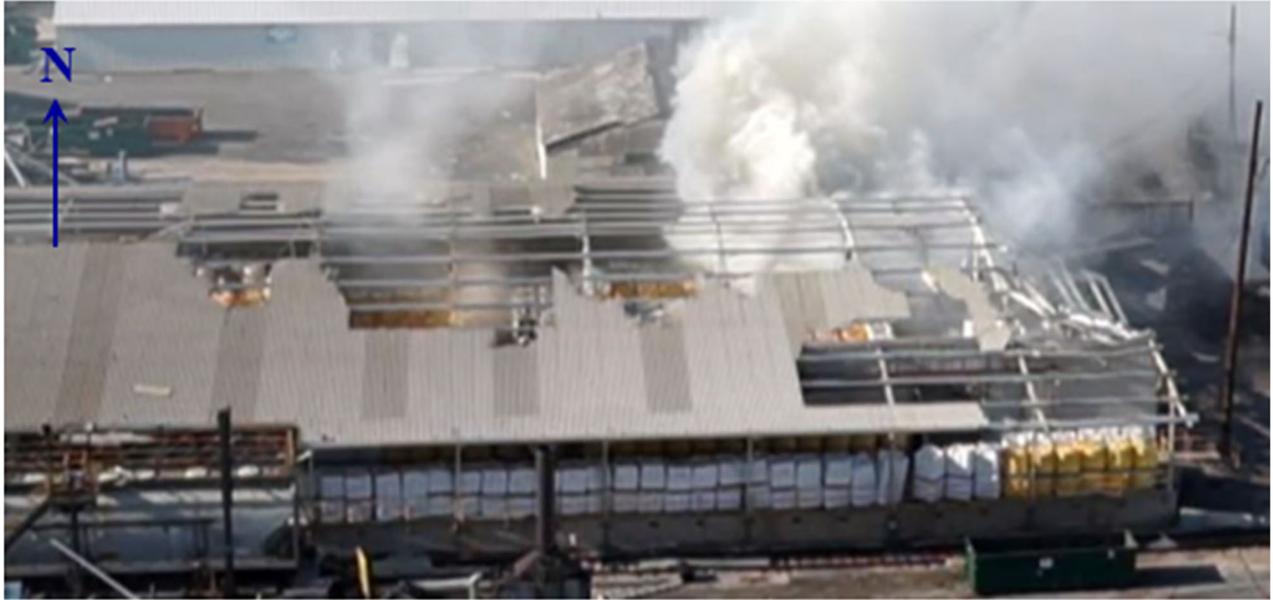
Figure 13. Damaged Finished Goods Warehouse roof emitting white fumes. (Credit: Bio-Lab)

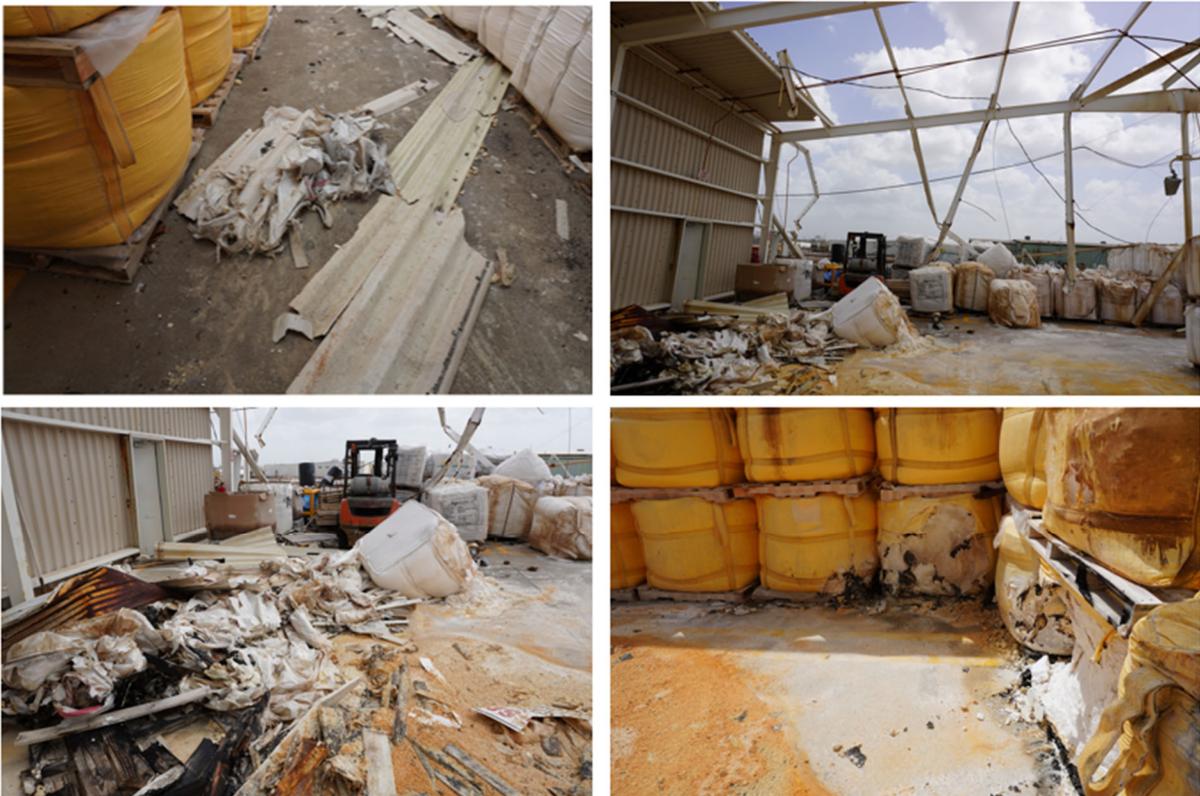
Figure 14. Inventory and storage areas inside the Finished Goods Warehouse following the second event. (Credit: CSB)

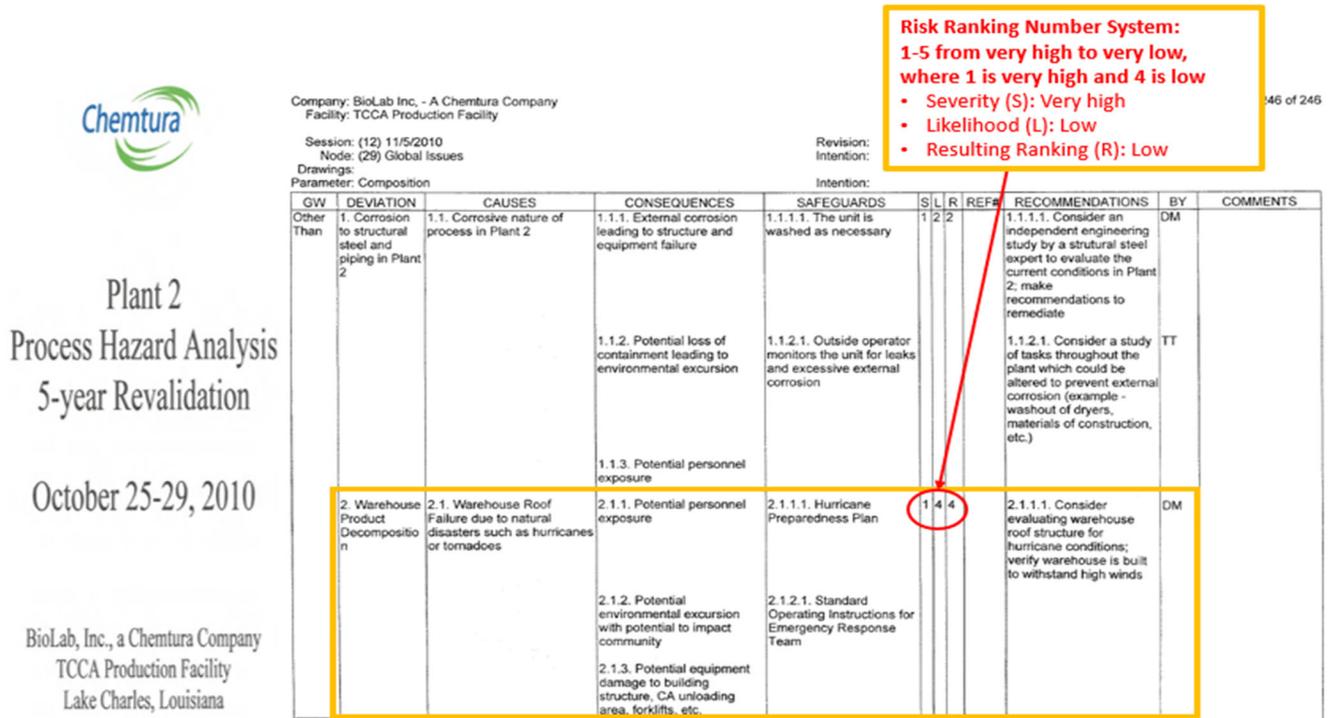
documentation, for deviations such as this one classified as having a low overall risk, “mitigation is optional depending on cost-benefit.”

Figure 17. Excerpt from 2010 Plant 2 PHA. (Credit: Bio-Lab, annotations by CSB)

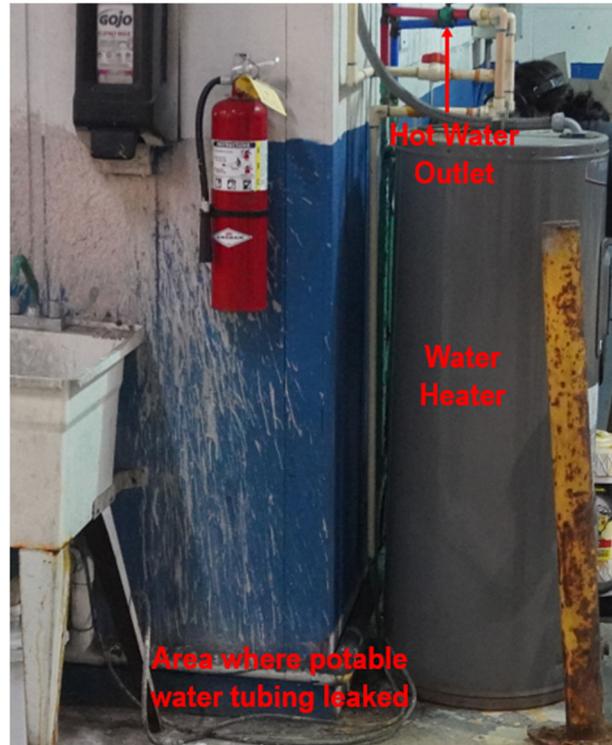
Between the close of business on Saturday, September 12, 2020, and the normal arrival of employees on Monday, September 14, 2020, a 3/8-inch polyethylene water line leaked in the Bio-Lab Conyers Plant 6, flooding a portion of the building. At approximately 4:50 a.m. on Monday, September 14, 2020, while Worker #1, a production lead, was in the building office preparing for the shift, Worker #2, a blending operator, entered the office and reported seeing water on the building floor. Worker #1 proceeded to the area to assess the situation and saw that water covered approximately 75% of the floor. Worker #1 estimated that the floodwater was about two or three inches deep in some areas but lower than the top of the wood pallets used to store TCCA near the building's north wall (**Figure 23**).^a He then walked near the employee restrooms (**Figure 23**) and saw water releasing from a polyethylene line connected to the water heater (**Figure 24**). Worker #1 immediately closed the water heater's hot water outlet valve, which stopped the water leak. After stopping the water leak, Worker #1 contacted the Maintenance Department to report the damaged line and notified management of the flooded warehouse.

Figure 24. Location of polyethylene line that leaked, causing an area in the Bio-Lab Conyers Plant 6 to flood. (Credit: CSB)

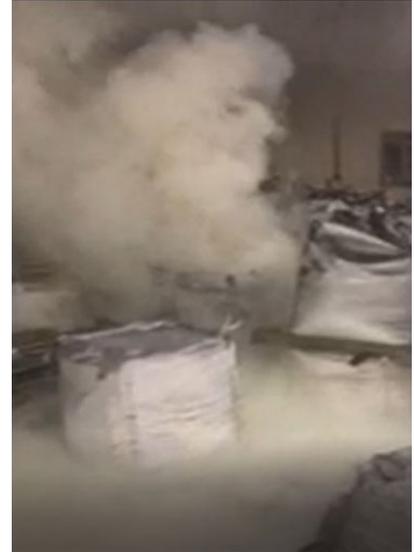
Figure 25. September 14 TCCA decomposition. (Credit: Bio-Lab Conyers)

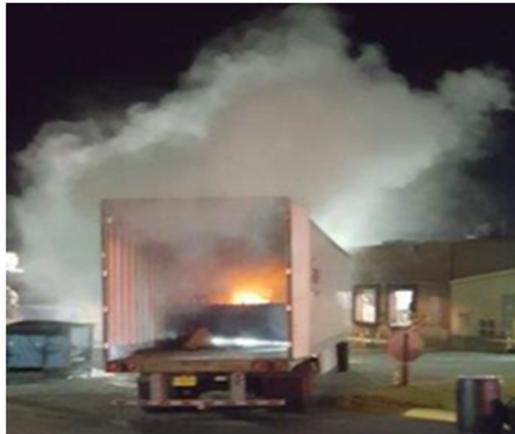
Figure 28. TCCA decomposition on a rental trailer at Bio-Lab Conyers. (Credit: Bio-Lab Conyers)

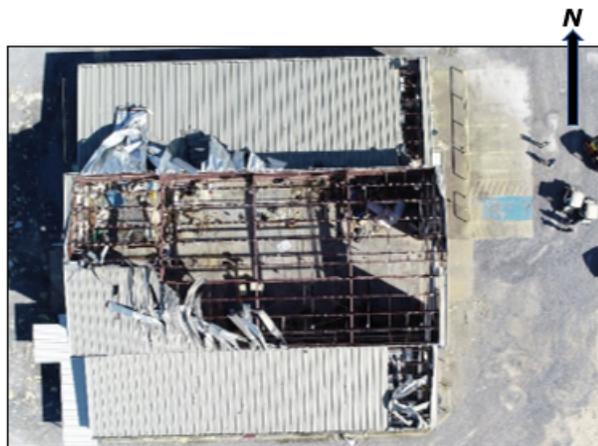
A-Z Building (Atlas UAV, 9/30/2020)

We observed debris from the roof and found that the metal roof panels tore free around the screw heads. At the roof areas that had been stripped, the purlins and structural frames appeared undamaged.

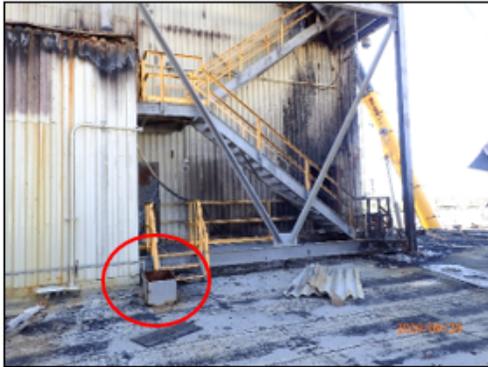
Roof opening at broken duct, Low Bay roof north of High Bay tower (Atlas 9/29/2020)

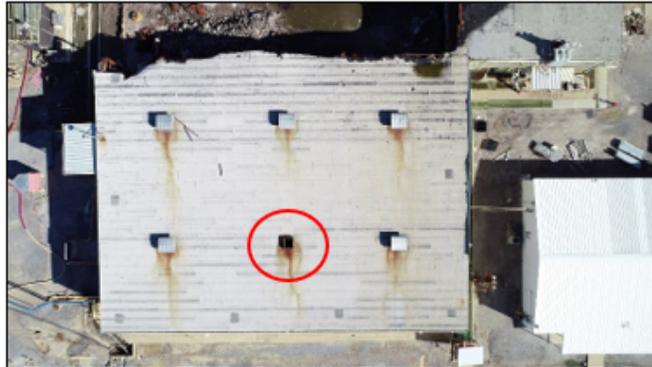
Open roof duct at 30-day Warehouse, just south of Low Bay (Atlas UAV 9/30/2020)

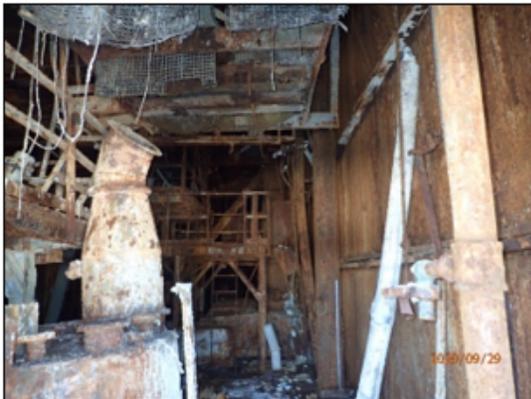
3rd floor level from north stair, showing heat-deformed columns & bracing (Atlas, 9/29/2020)

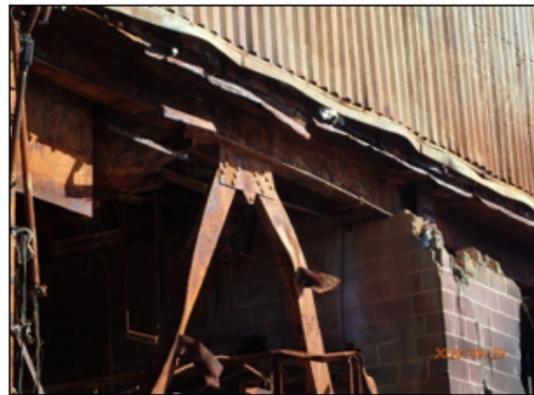
Ground floor level looking east, showing heat-deformed brace & spandrel (Atlas, 9/29/2020)
