Ultrasonic Inspection Report HTHA Inspection of Exchangers E 6600 E and E 6600 B

Introduction: Inspection for detection of High Temperature Hydrogen Attack (HTHA) was performed at selected locations of Exchangers E 6600 E and E 6600 B

Inspection Dates: August 31, 2012
Client: US Chemical and Safety Board
Location: Cleveland, OH
Contact: Roger Evans
Inspectors: Anmol Birring, ASNT Level III

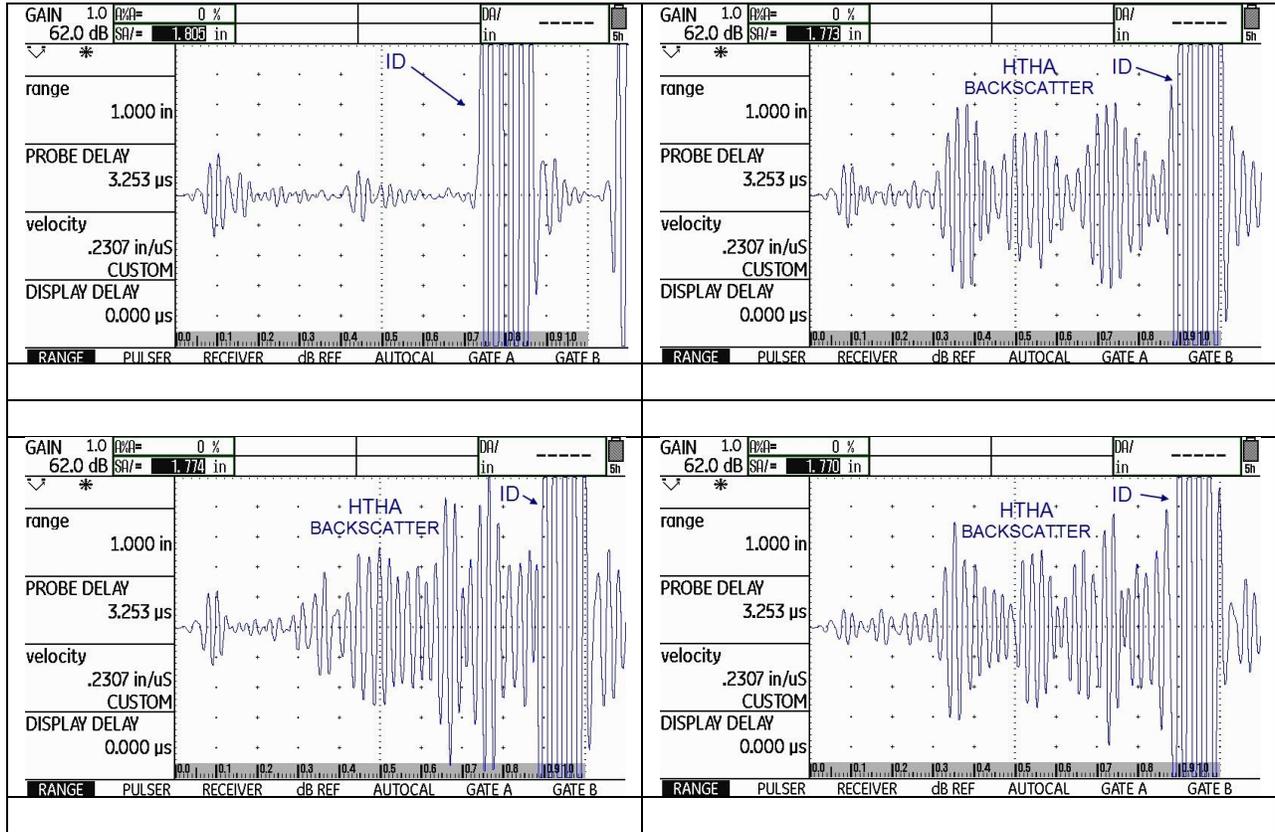
Calibration: Base metal calibration performed on step block and HTHA sample. The HTHA signal was set to 80 % FSH at 62 dB as shown in Figure 2. Testing was performed at a gain of 62 dB
Velocity ratio calibration was performed on a step block with no HTHA and a sample with HTHA. The readings are given in Table 1.

Figure 2. HTHA Backscatter Calibration at 62 dB. Top-left – Step block with no HTHA. Top-right and bottom - Representative HTHA backscatter signals from HTHA 1 SK sample
