### Introduction

**A**t approximately 11:00 PM on May 31, 2017, explosion(s)<sup>1</sup> at the Didion Milling (Didion) facility in Cambria, Wisconsin, resulted in 5 worker deaths and an additional 14 workers injured. Because the event occurred at night, only 19 employees were working within the facility at the time of the incident.<sup>2</sup>

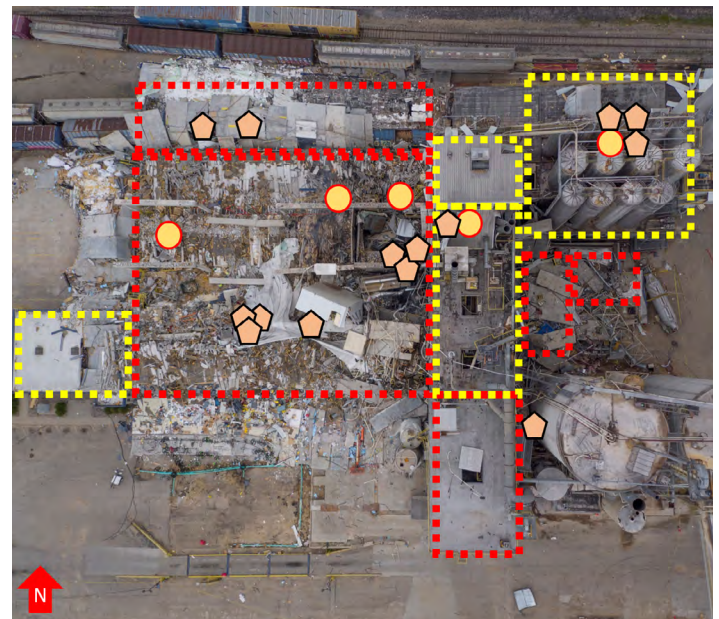
4 Of the 9 buildings (Figure 1 and Figure 2) that made up the Didion facility, 4 had completely collapsed and 5 sustained severe structural damage (Figure 3). The CSB and its contractors entered 4 of the standing buildings, but deemed the fifth building too unsafe to enter.

The explosion(s) caused the complete collapse of the multi-purpose building, the Warehouse Railcar Loading Bay F Mill, and the boiler room, and severely damaged the remaining three mill buildings (A Mill, B Mill and D Mill), bulk loadout, and the front office. Figure 3 depicts the severity of the post-incident damage that various buildings sustained and the approximate locations of workers inside the Didion facility at the time of the incident. Figures 4 and 5 provide pre- and post-incident comparisons of the Didion facility from different locations.

**Figure 3.** This visual depicts the approximate locations of workers inside the Didion facility at the time of the incident. Circles represent workers who sustained fatal injuries, and the pentagons represent injured workers. Red dotted outlines indicate buildings that had completely collapsed or were severely damaged by the explosions on May 31, 2017. Yellow outlines indicate buildings that were accessible to investigators, but sustained severe damage. B Mill was partially accessible.

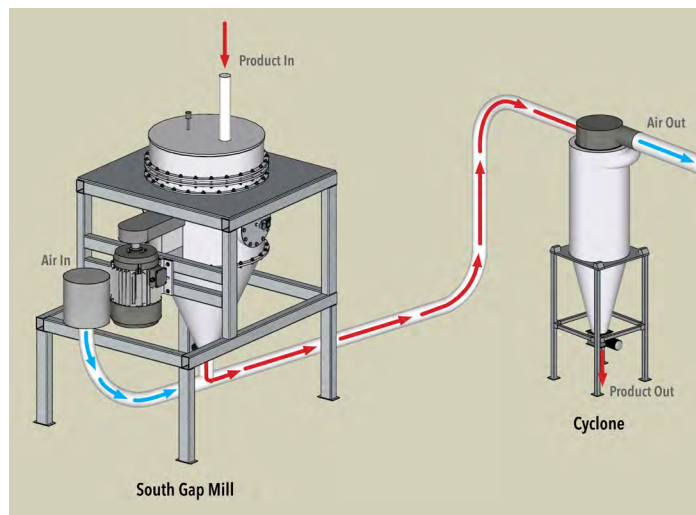
However, Miller B then saw a mixture that looked like dust or smoke being thrown out of the area near the gap mill's product inlet (Figure 10). The gap mill was designed to have product fall through the mill and exit through the bottom,<sup>30</sup> so when it happened, Miller B could not understand why product was flowing in the wrong direction (Figure 10). Miller B called over the radio to request that Miller C shut down the south gap mill through the computer system in the control room,<sup>31</sup> but within seconds of the conversation, there was a loud noise and more smoke and dust came out near the area of the gap mill. At this point, the Superintendent told him it could explode and that they should run. Miller B then quickly left 1B to head toward the control room on the second floor, but while he was on the stairs between the first and second floor, there was an explosion and a large quantity of dust filled the air around him.

**Figure 10.** Diagram of the south gap mill. Miller B witnessed a mixture that looked like dust or smoke coming out near the top of the mill (red box). The design of this mill uses an exhaust fan to draw air through the inlet filter (blue arrows, left), product from the bottom of the mill (red arrows) through a cyclone where the product falls to the bottom of the cyclone, and the air containing fine corn dust (blue arrow, right) continues out of the top to a dust collection system.

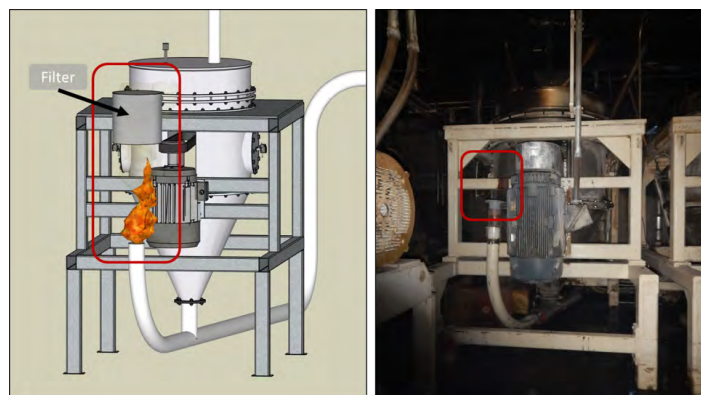
**Figure 12.** The Superintendent saw the filter from the south gap mill air intake line flying in the air and a three- to four-foot flame shooting out from the same line (red box, left image). The post-incident photograph (right) shows the filter missing (red box).

<sup>34</sup> Post-incident, the CSB observed that the filter from the south gap mill was missing from the intake suction line.

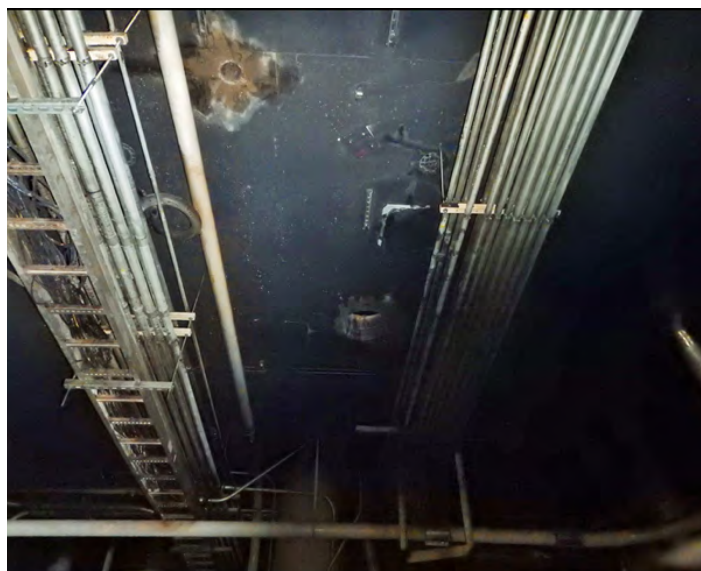
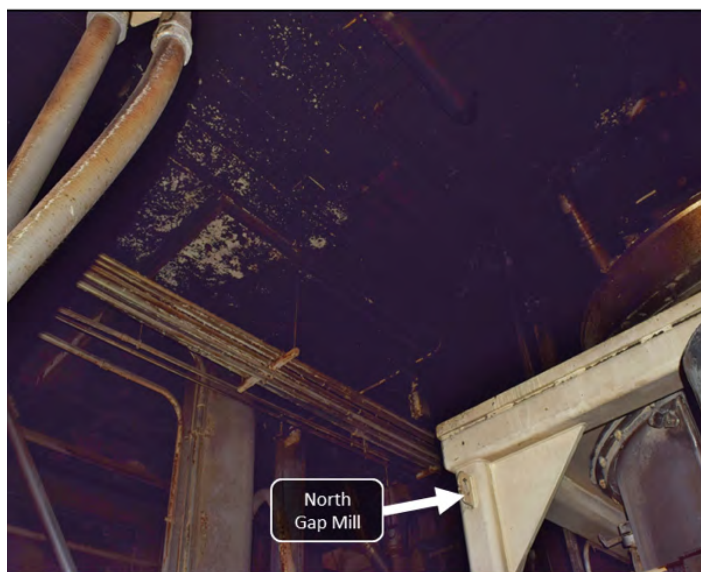
**Figure 13.** Example of overhead horizontal pipes in 1B near the gap mill.

- Dust and product thrown into the air from equipment damaged by an overpressure event, like the one that caused the air intake line of the gap mill to blow off, or some other failure, and
- the lofting or knocking of fugitive dust into the air that had accumulated on floors, overhead piping, and other horizontal surfaces inside the mill.

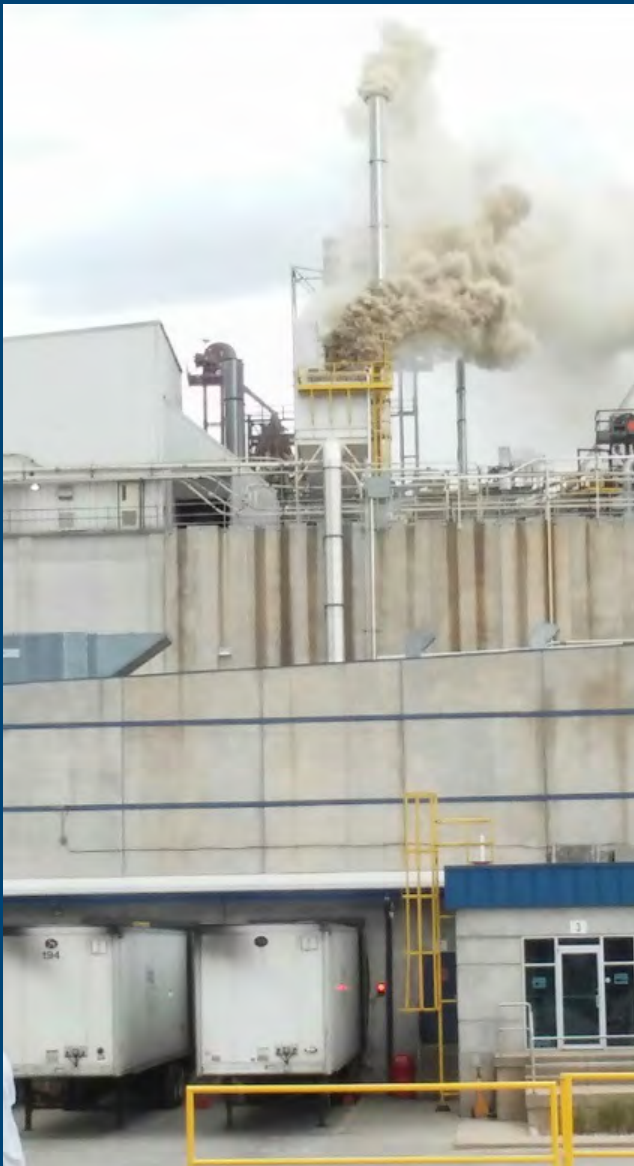
**Figure 14.** Image taken by a Didion worker of the May 29, 2017 fire. The structure on the roof of the building emitting smoke is a dust collector.

Two days before the incident, Didion experienced a fire in a dryer, which is part of its “Expander 5” system inside C Mill. Equipment was damaged as a result of the fire, but no one was injured. The fire department was called, and the plant evacuated after workers believed they would not be able to extinguish the fire on their own. The fire progressed to a dust collector on the roof of B Mill (Figure 14), which the fire department eventually put out with the aid of a ladder truck. The Expander 5 line remained shut down afterwards; Didion was actively investigating the cause of the fire when the May 31, 2017 incident occurred.

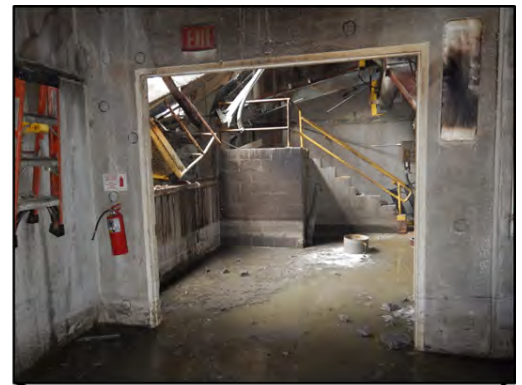
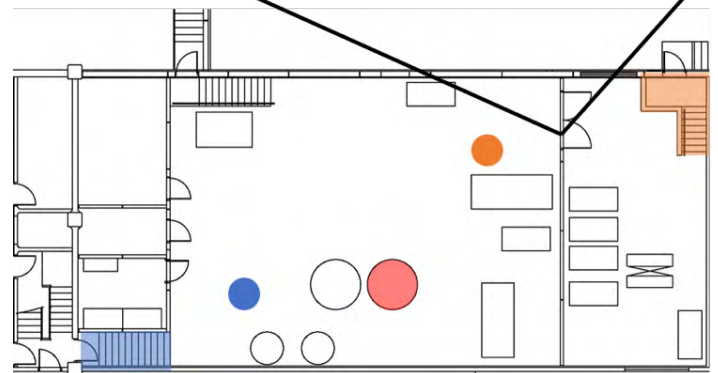
**Figure 15.** After flames shot out of the air intake line to the south gap mill (red circle), the Superintendent (orange circle) left the room using the staircase in the southeast corner of the building (orange) which led outside. Miller B (blue circle) evacuated the room using the staircase leading to the control room (blue). The photograph shows a collapsed structure covering the staircase that the Superintendent used to leave 1B.

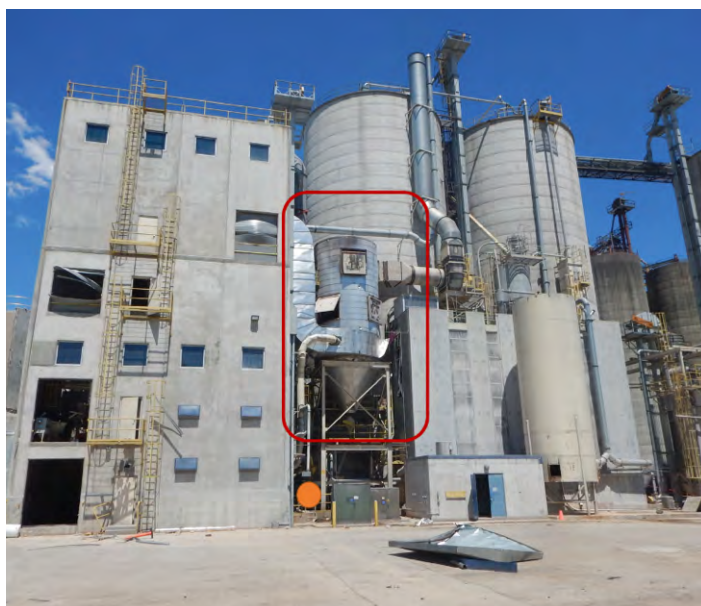
**Figure 16.** South side of D Mill. As the Superintendent (orange dot) was evacuating the Mill he ran under the dry grit filter (red box) as an explosion knocked him down.
