Odessa, Texas | Incident Date: October 26, 2019 | No. 2020-01-I-TX

# **Factual Update**

July 27, 2020

#### **Incident Summary**

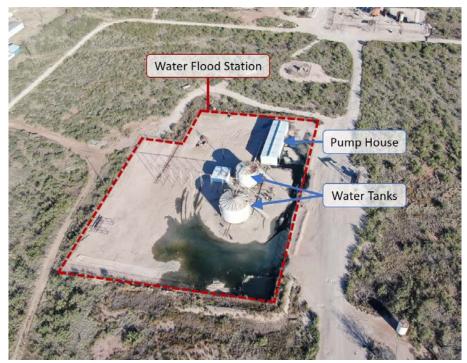
Figure 2. Overhead view of the Aghorn Operating waterflood station in Odessa, Texas, on the morning after the incident. (Photo Credit: Ector County Sheriff's Office, highlighting by U.S. Chemical Safety Board)

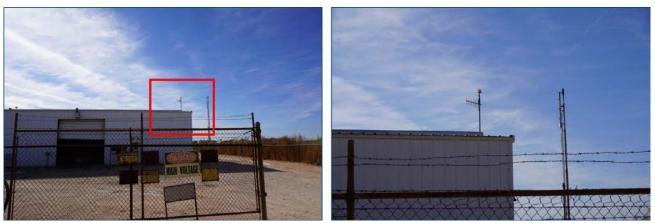
Figure 3. Light designed to illuminate when hydrogen sulfide is detected at the facility.

• Testing after the incident revealed the hydrogen sulfide gas detection system may not have been performing as expected. Emergency responders and the Aghorn employees who responded to the incident did not see the hydrogen sulfide alarm light on the top of the building illuminated.

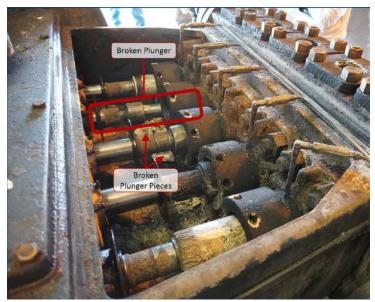
• Examination of the pump revealed that one of the pump's "plungers" was broken (Figure 4).<sup>b</sup> This is the likely release point of the produced water.

Figure 4. The plunger, second from the back, appears to have shattered. This was the likely release point of the produced water.
