U.S. Chemical Safety and
Hazard Investigation Board

Fatal Combustible Dust Explosions at Didion Milling Inc.

Cambria, Wisconsin | Incident Date: May 31, 2017 | No. 2017-07-I-WI

Investigation Report

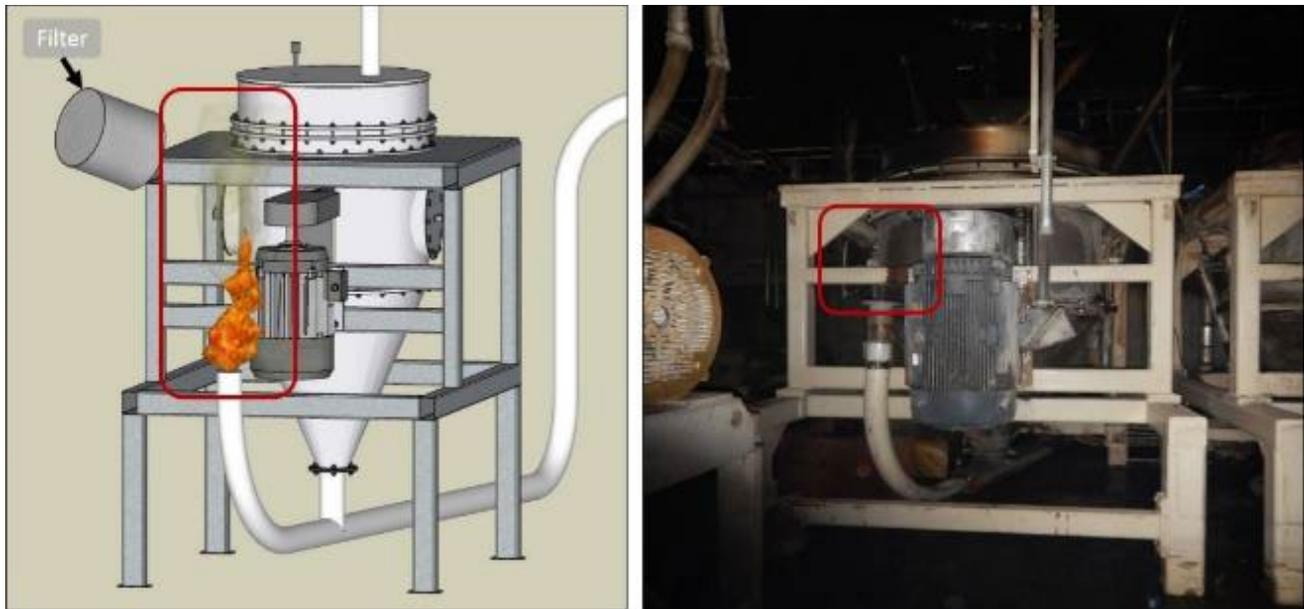
Figure 17: Re-creation of fire observed at Bauermeister air intake filter blowing off (left) and filter missing post-incident (right). (Credit: CSB)

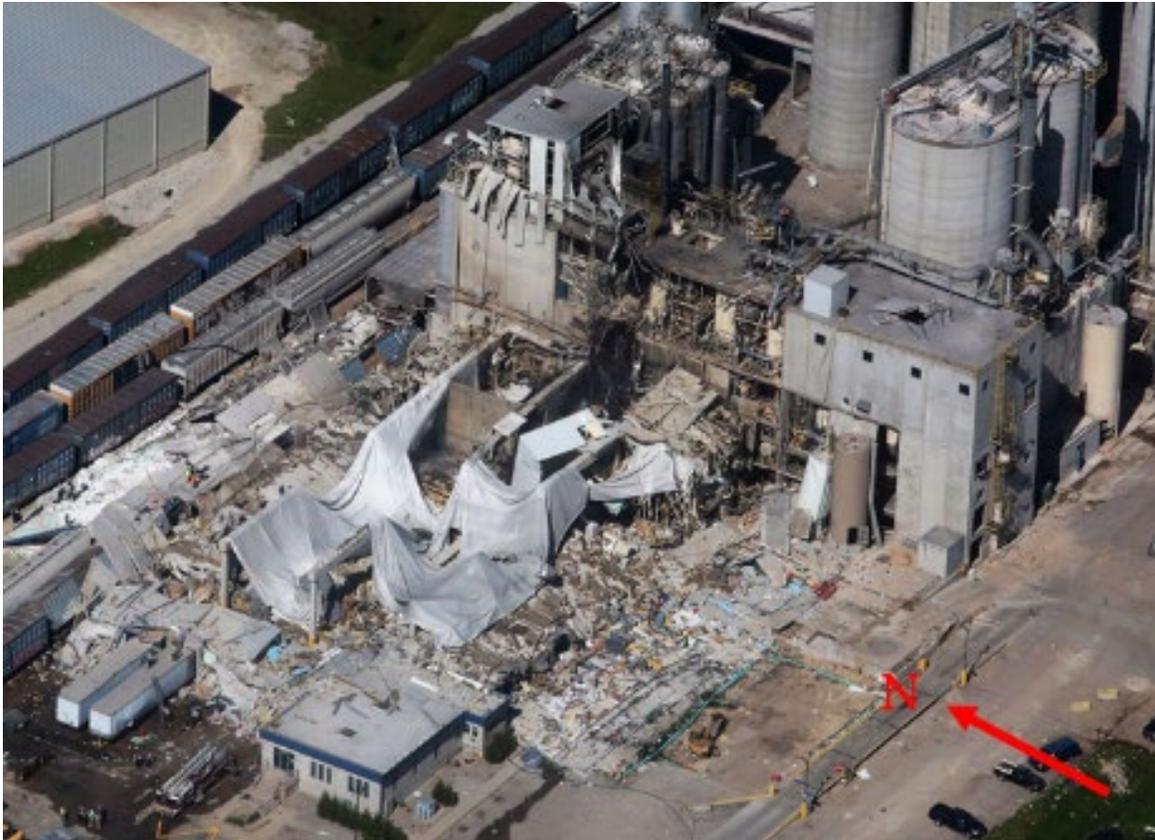
Figure 20: Didion Mill following incident. (Credit: Didion)

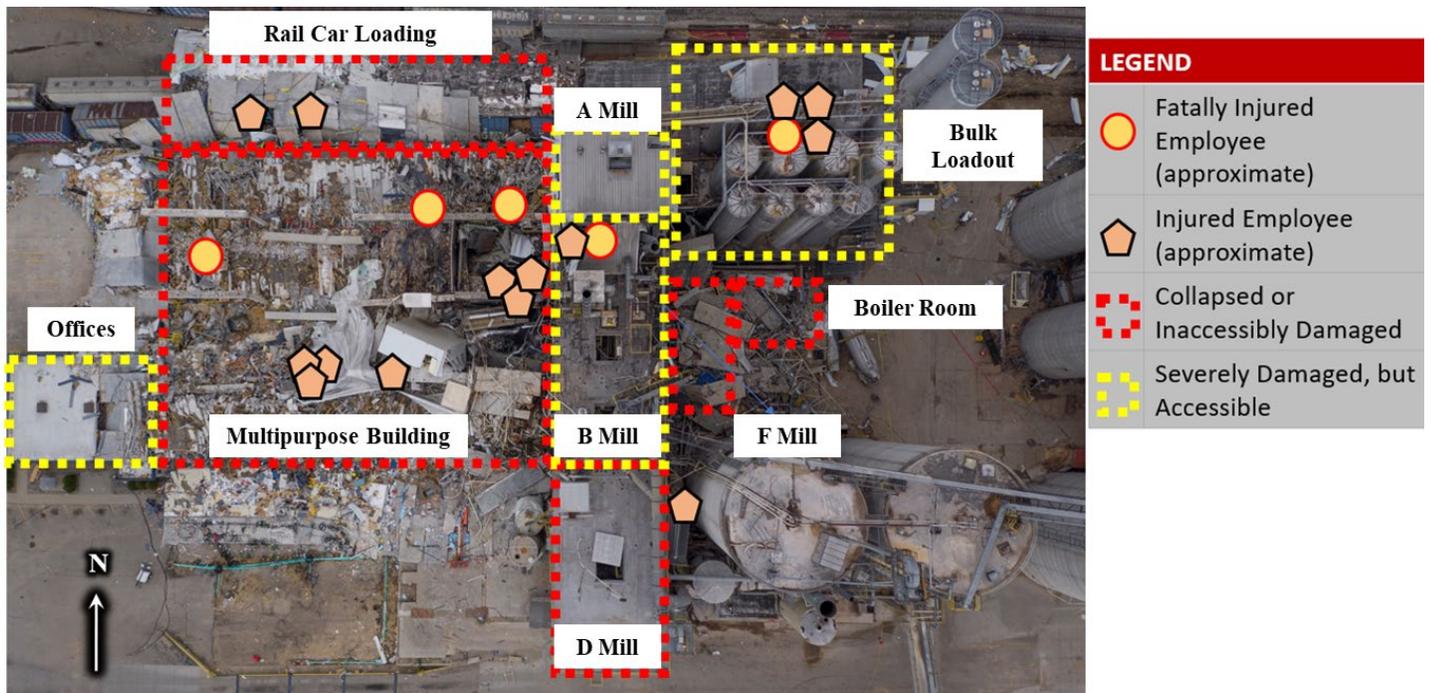
Figure 21: Overhead view of Didion Mill following incident. (Credit: CSB)

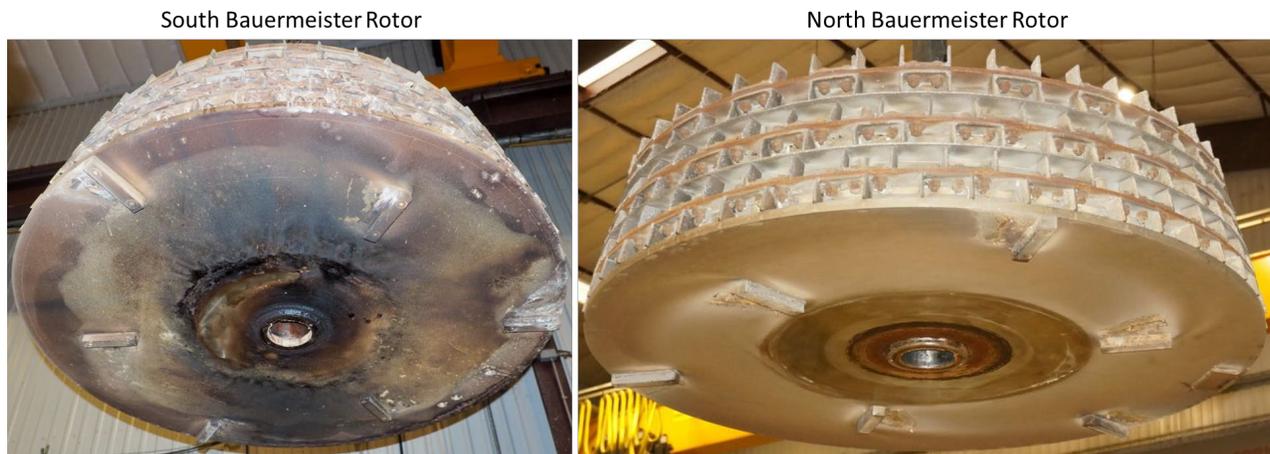
Figure 22: Bottom of gap mill rotors: (left) South BM and (right) North BM. Note greater extent of discoloration on South BM. (Credit: CSB)

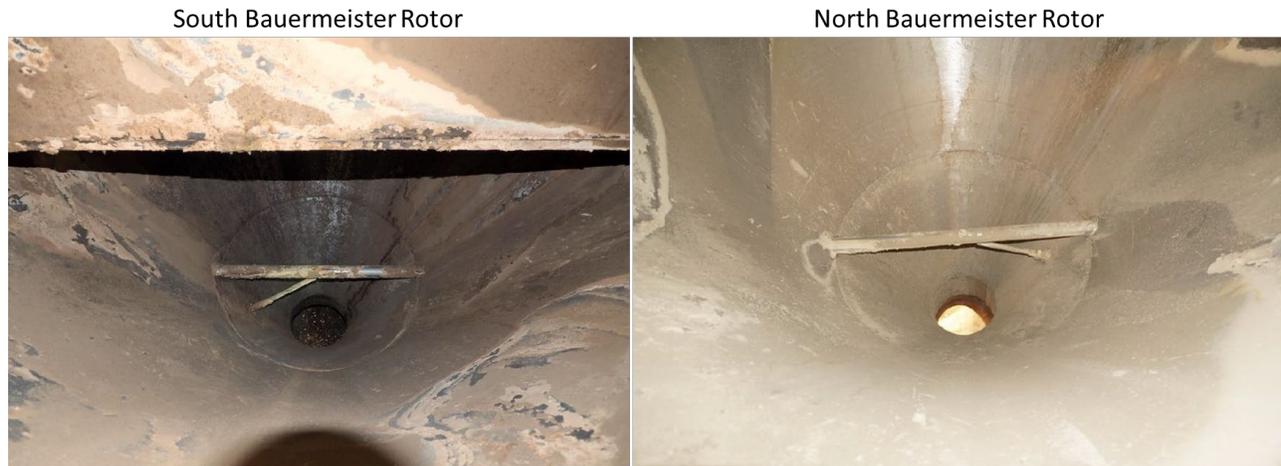
Figure 23: Bottom interior of gap mills: (left) South BM and (right) North BM. Note greater extent of discoloration on South BM. (Credit: CSB)

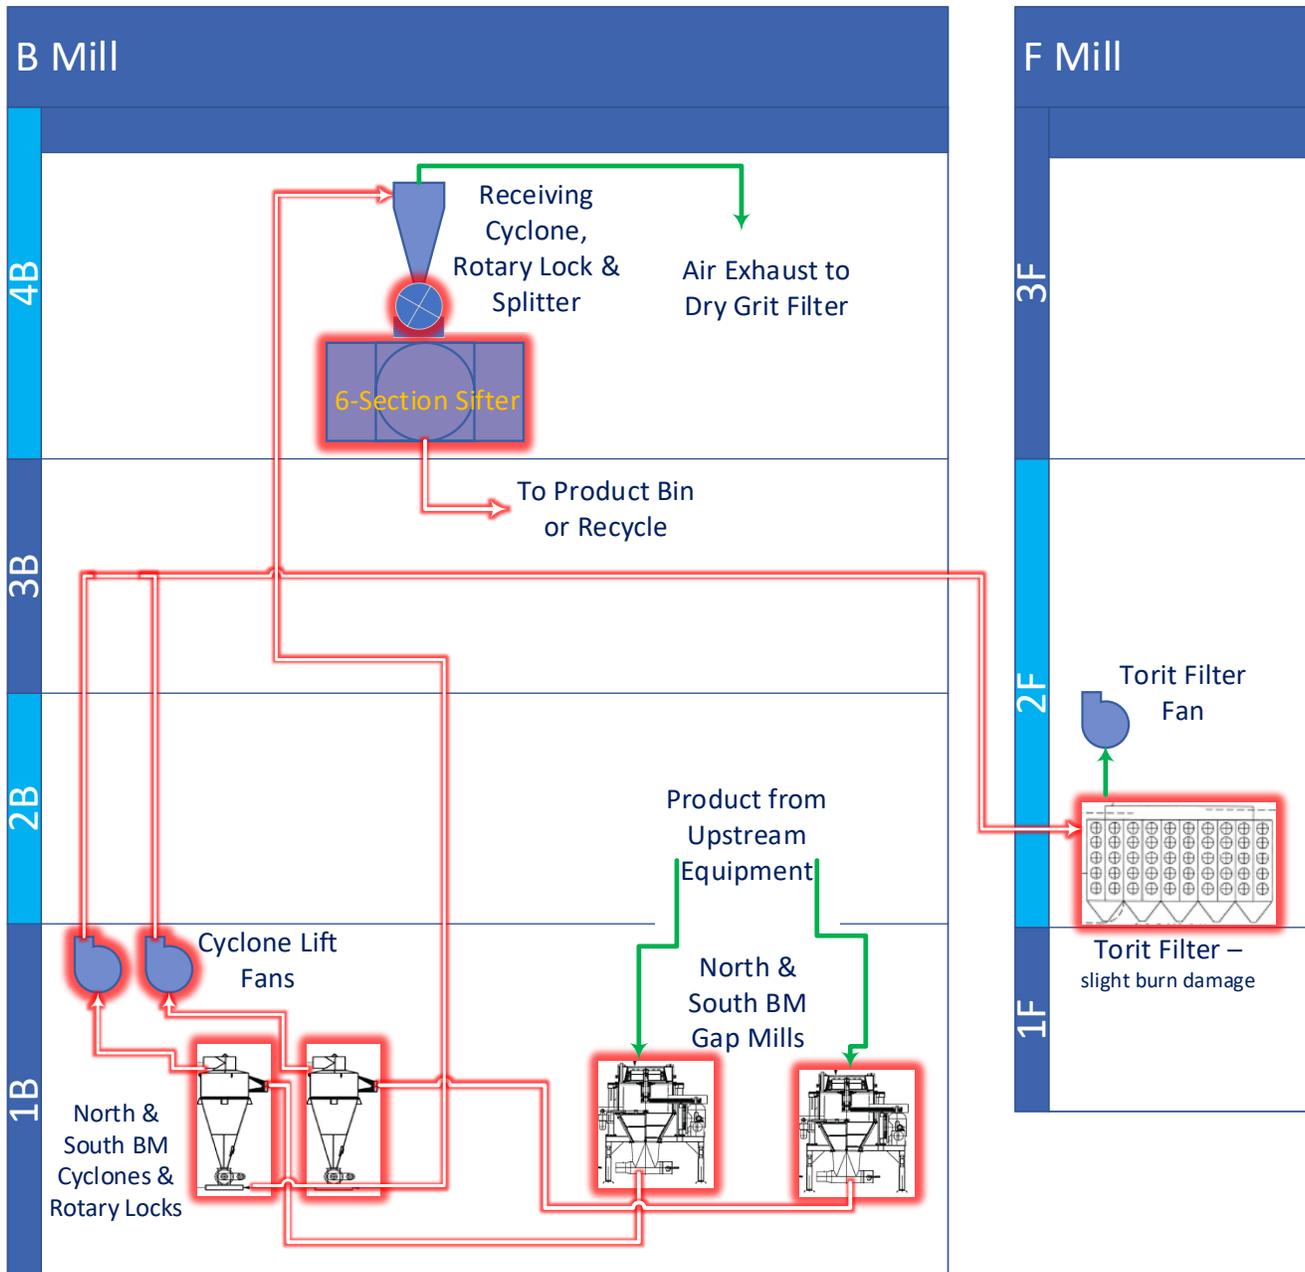
Figure 26: B Mill Bran process equipment with evidence of internal fire damage (highlighted red). Note that not all equipment was internally inspected due to accessibility. (Credit: CSB)

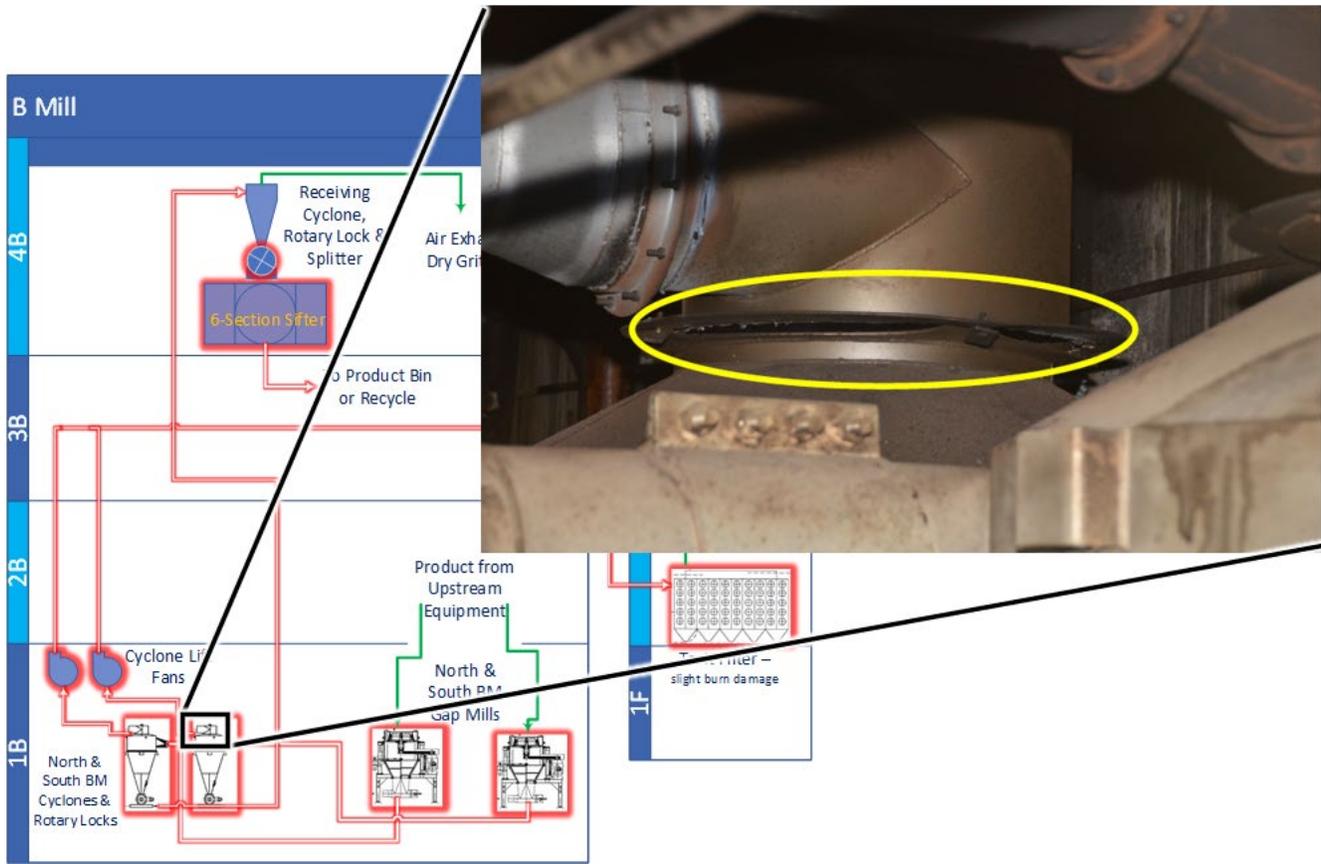
Figure 27: Top (discharge) section of South BM receiving cyclone, separated from body at flange (circled) from an overpressure inside the equipment. (Credit: Didion inset; CSB background)

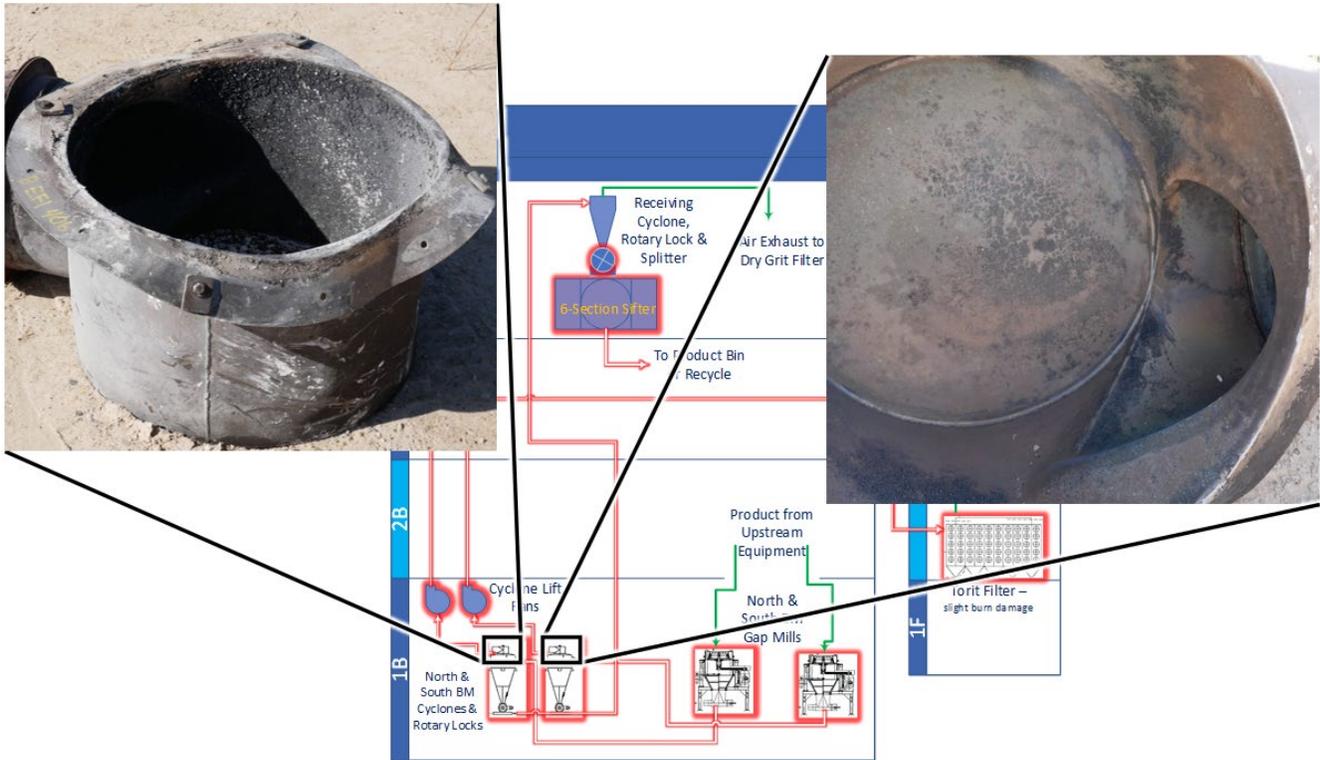
Figure 28: Burn damage inside top of North (left) and South (right) BM Cyclones. (Credit: CSB)

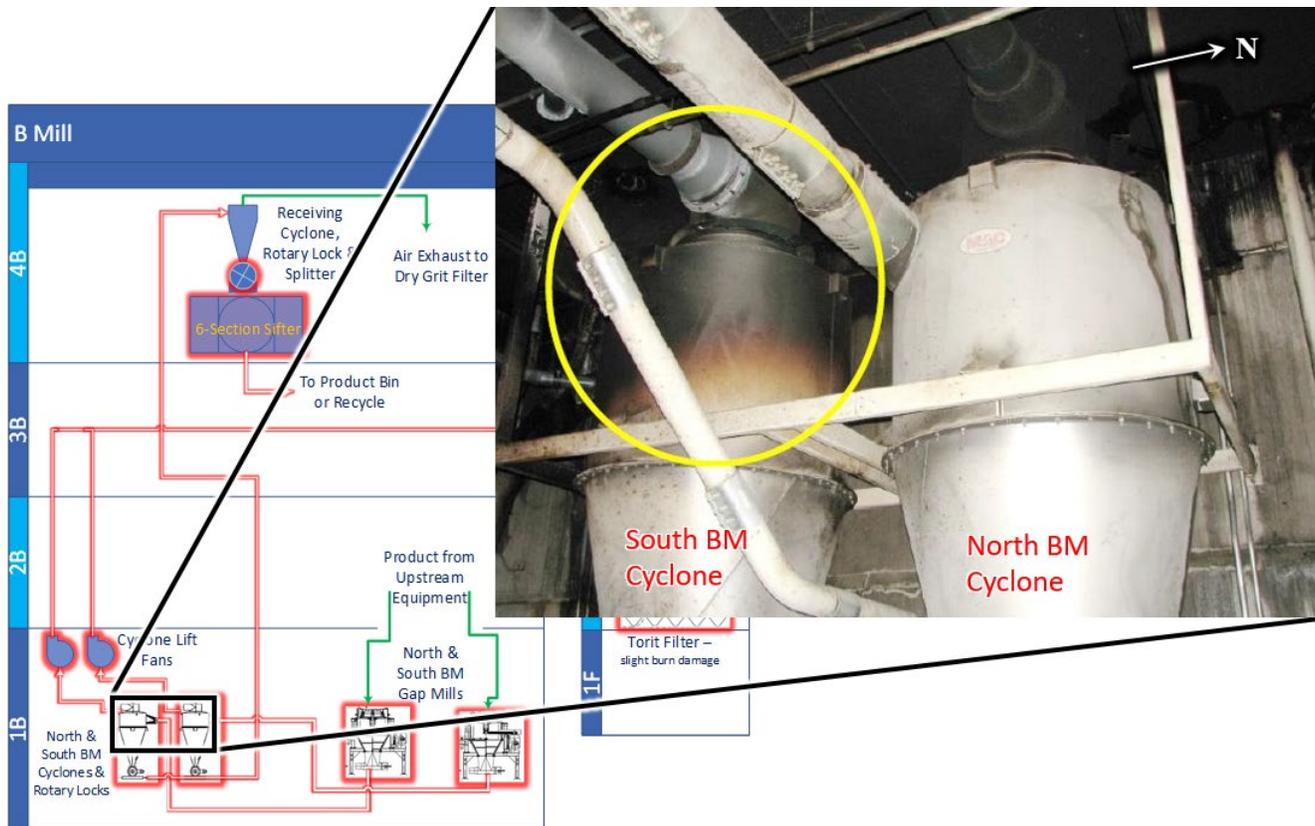
Figure 29: Some of North (right) and South (left) BM Cyclones' burn damage in 1B, circled. (Credit: Didion inset; CSB background and annotations)

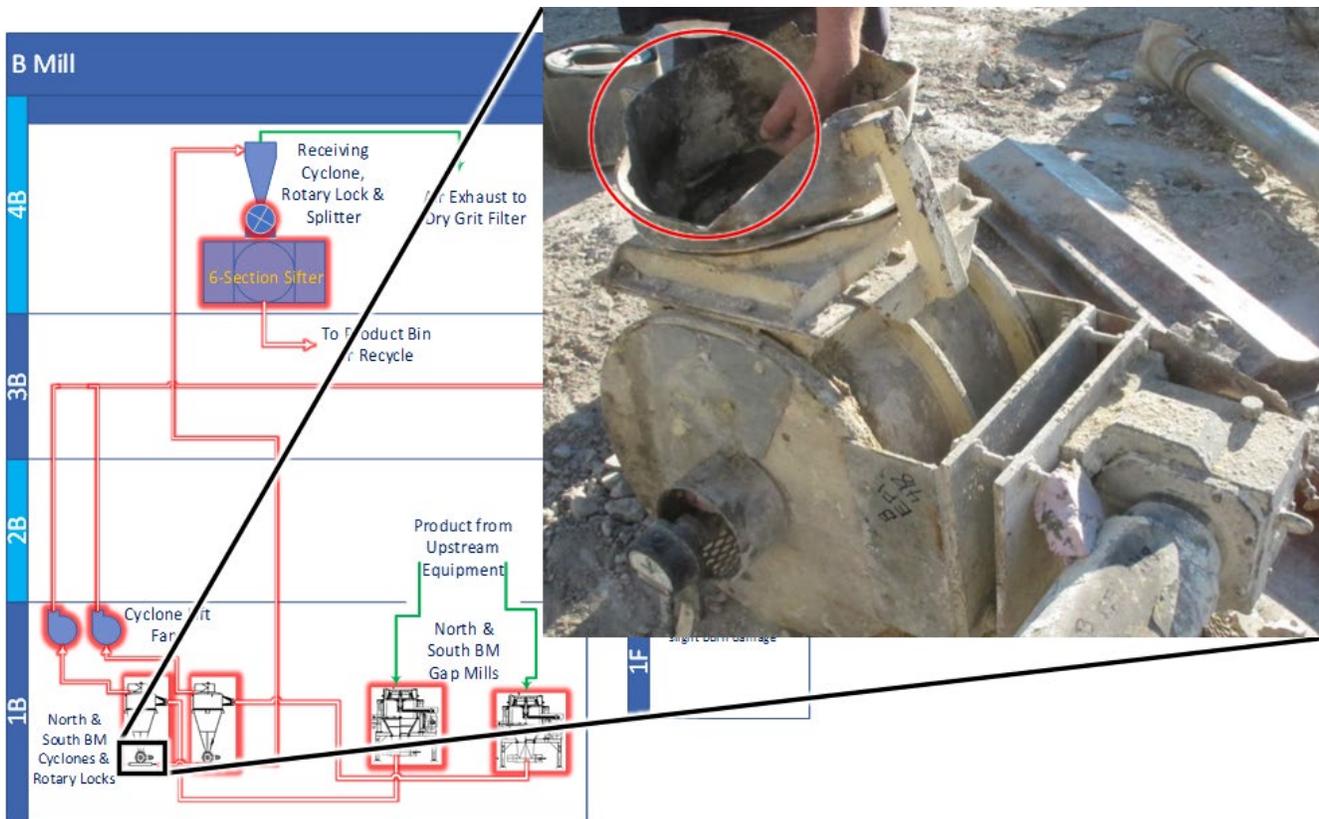
Figure 30: Bottom of North BM receiving cyclone and airlock below, during demolition. The burn mark (circled) is consistent with propagation through airlock. (Credit: Didion inset; CSB background and annotations)

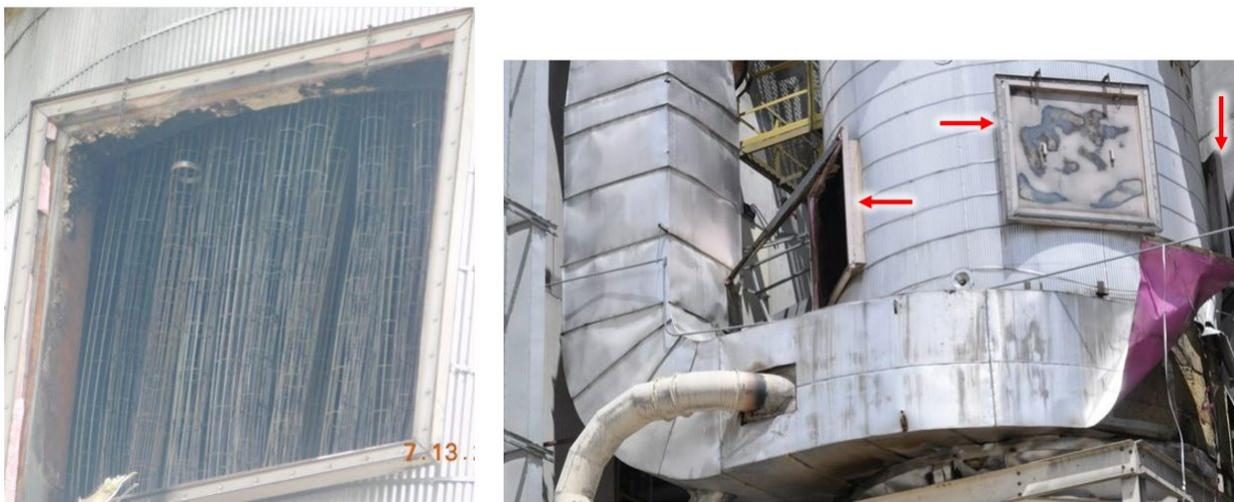
Figure 31: Dry Grit Filter damage. Internal damage (left). The filter socks were burned away, leaving only the metal cages. Deflagration vents (right, red arrows) stuck open and with burn damage. (Credit: Didion, annotations by CSB)

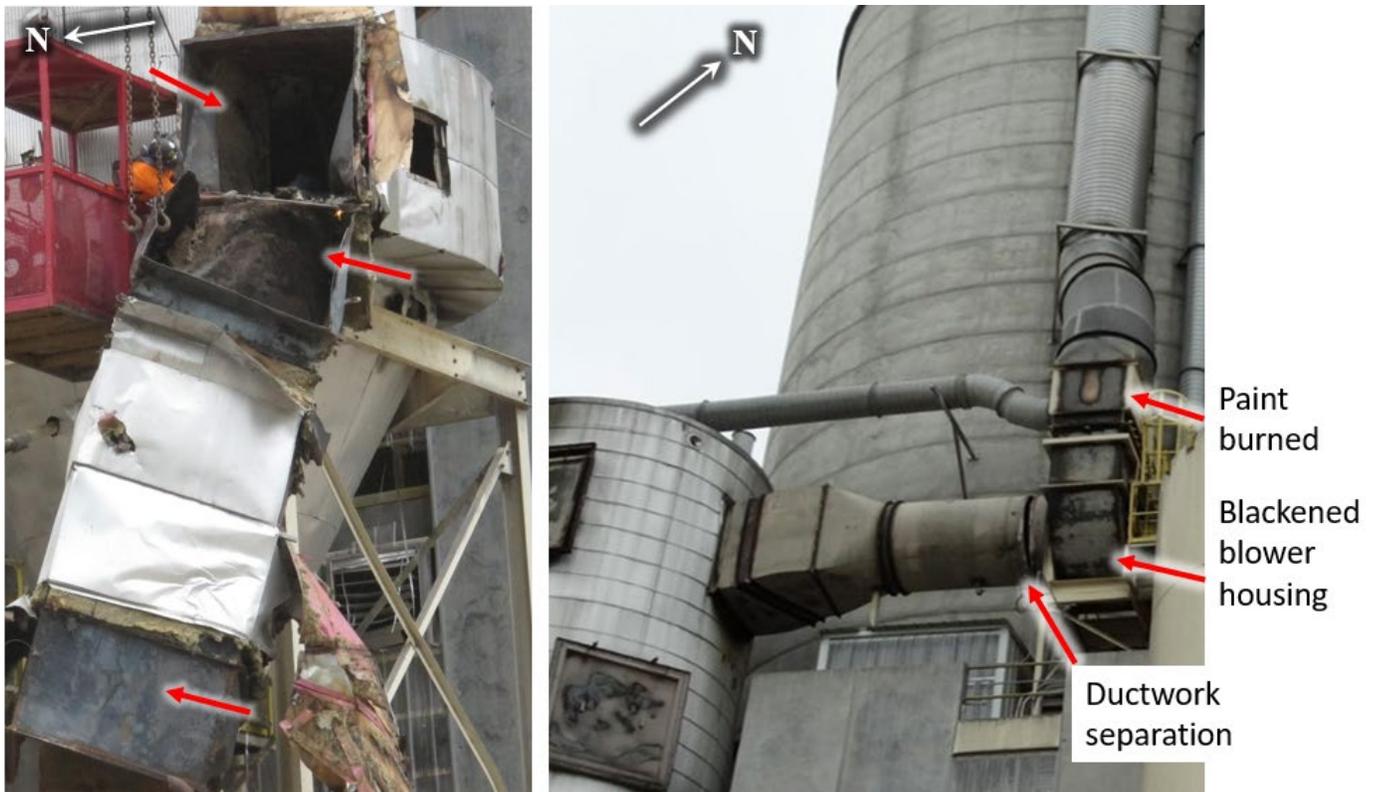
Figure 32: Examples of Dry Grit Filter ductwork and blower damage (red arrows). Inlet duct blackened (shown during demolition, left) and exhaust to atmosphere, including blower (right). (Credit: left, Didion with annotations by CSB; right, CSB)

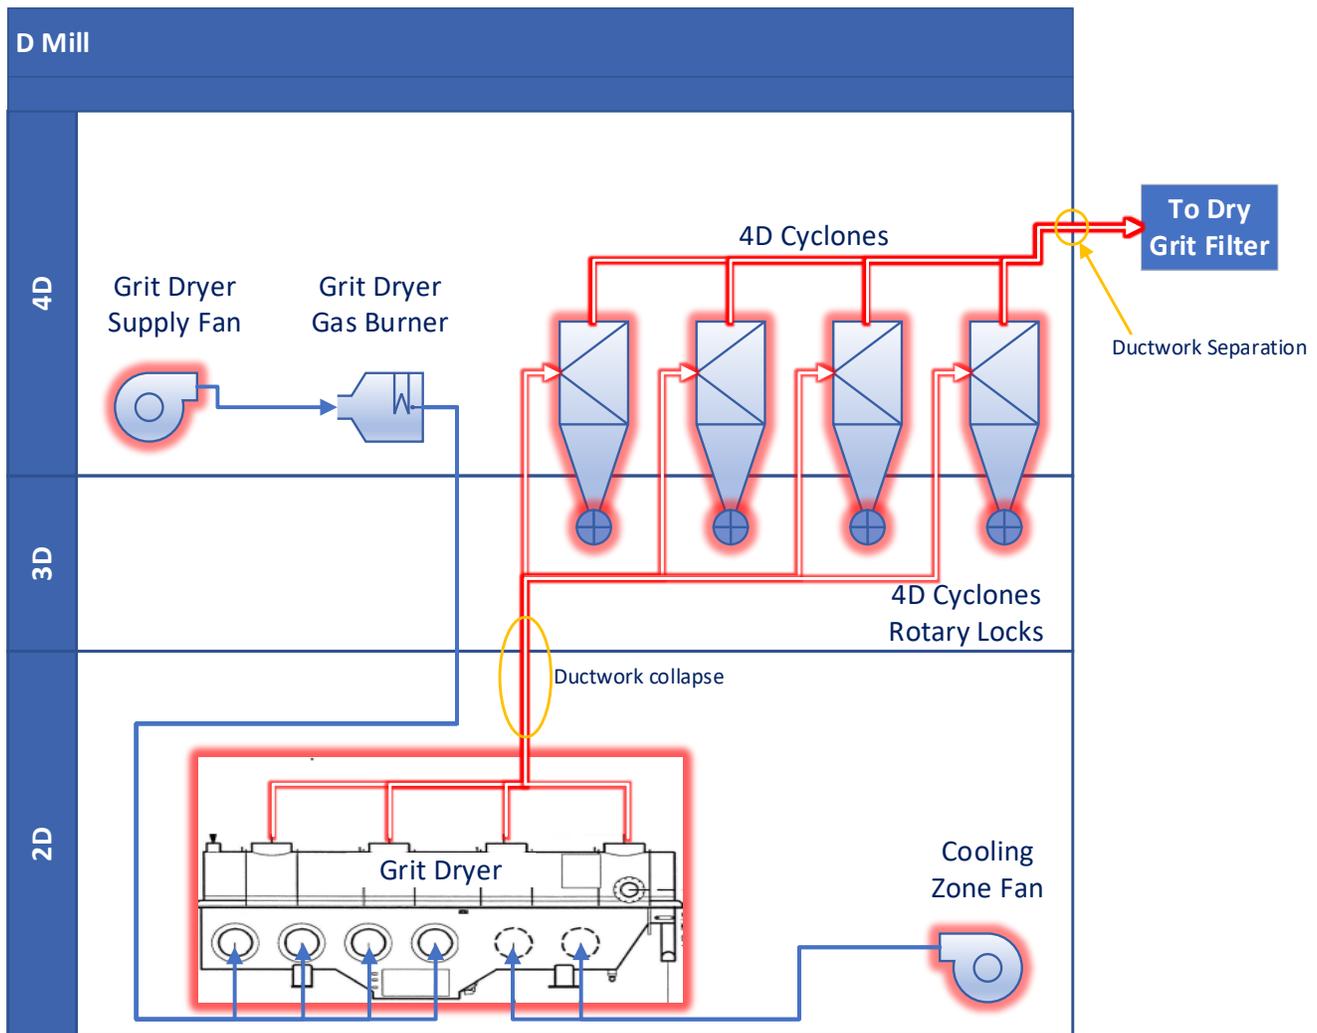
Figure 33: Summary of burn damage found inside the Grit Dryer system, highlighted red, and connection to Dry Grit Filter. Note that some equipment was inaccessible and not inspected internally. (Credit: CSB)

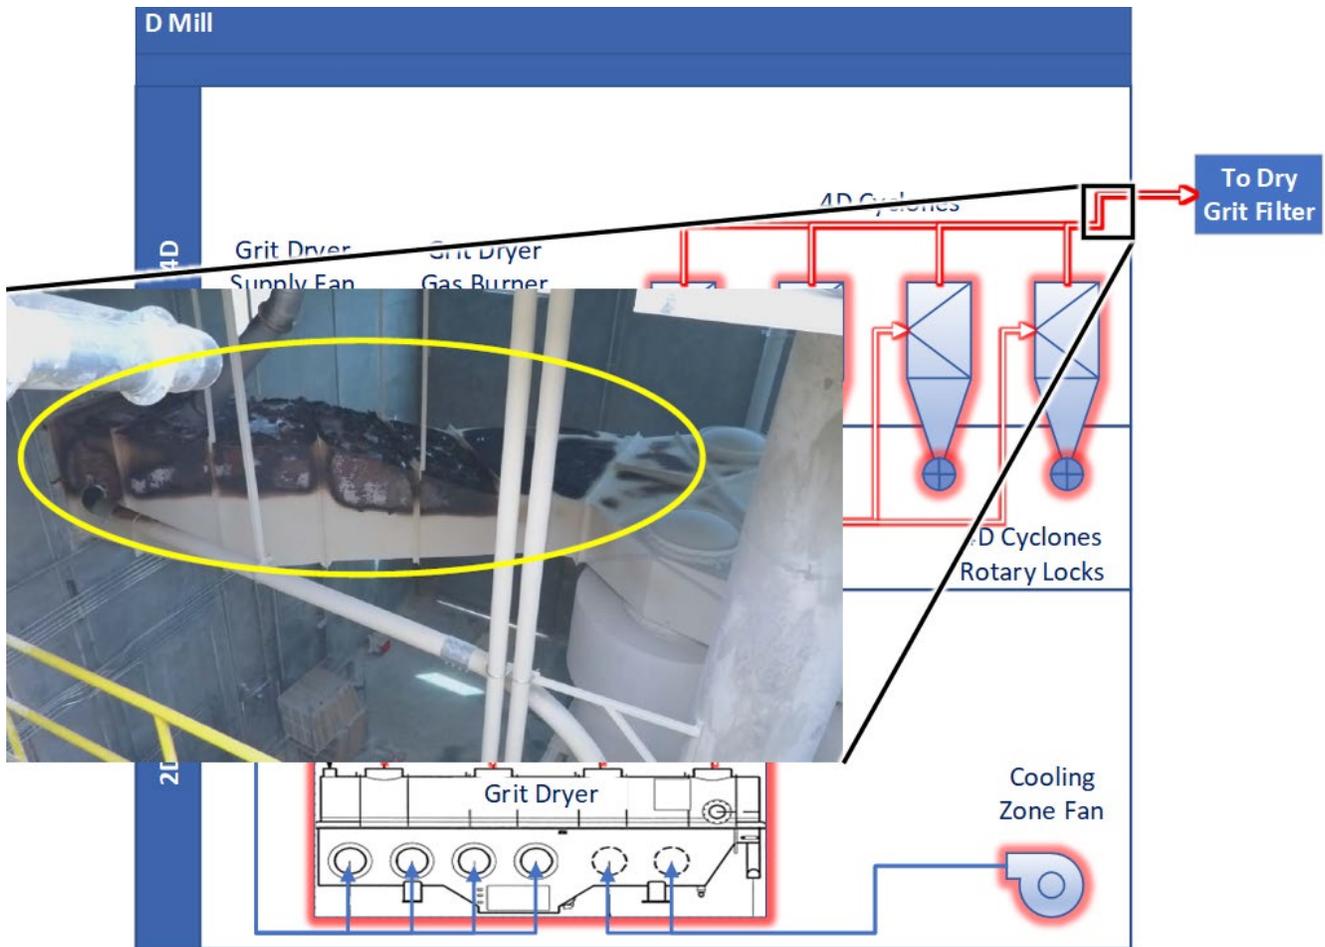
Figure 35: Grit Dryer exhaust ductwork damage, circled. The Dry Grit Filter is just outside the wall. (Credit: inset, Didion; background, CSB)

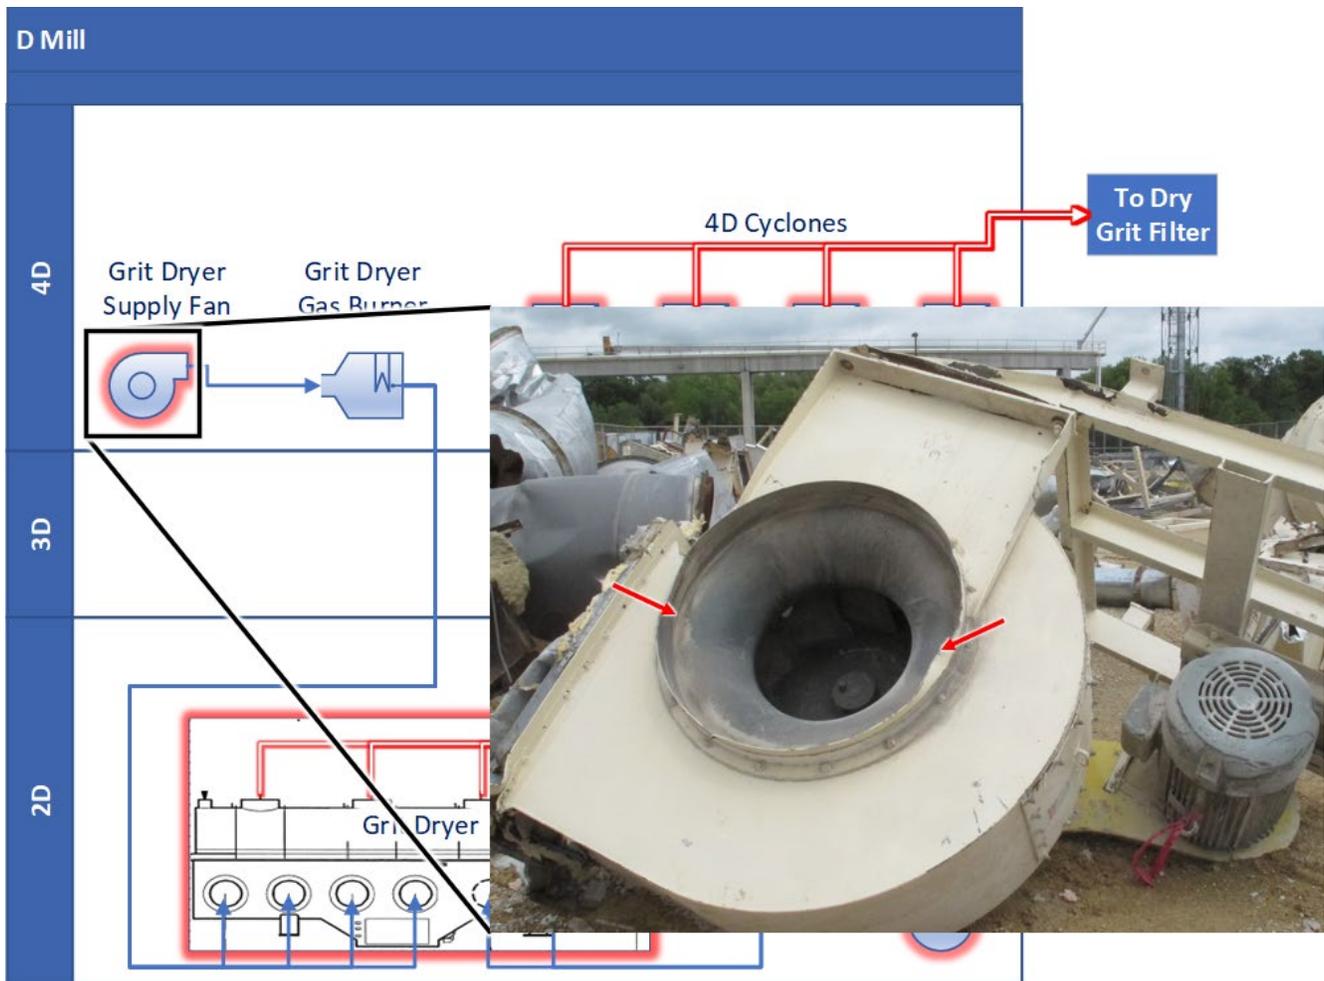
Figure 36: Grit Dryer burner supply fan, post-demolition. Note burn marks on fan suction and inside (arrows). (Credit: inset, Didion with annotations by CSB; background, CSB)

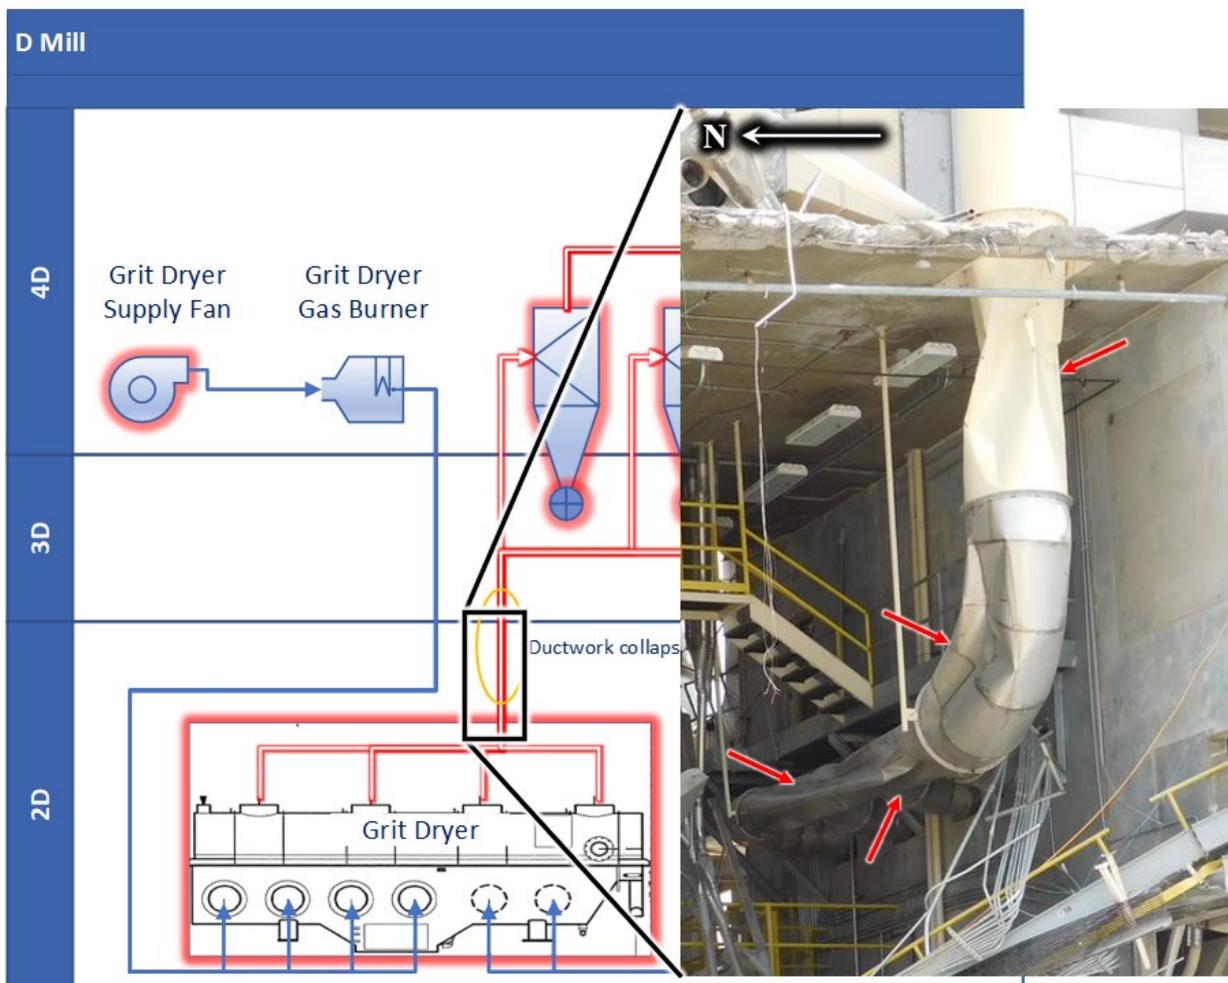
Figure 38: Grit Dryer exhaust ductwork in D Mill, between Grit Dryer and 4D cyclones, found collapsed post-incident (red arrows). (Credit: Didion, annotations by CSB)

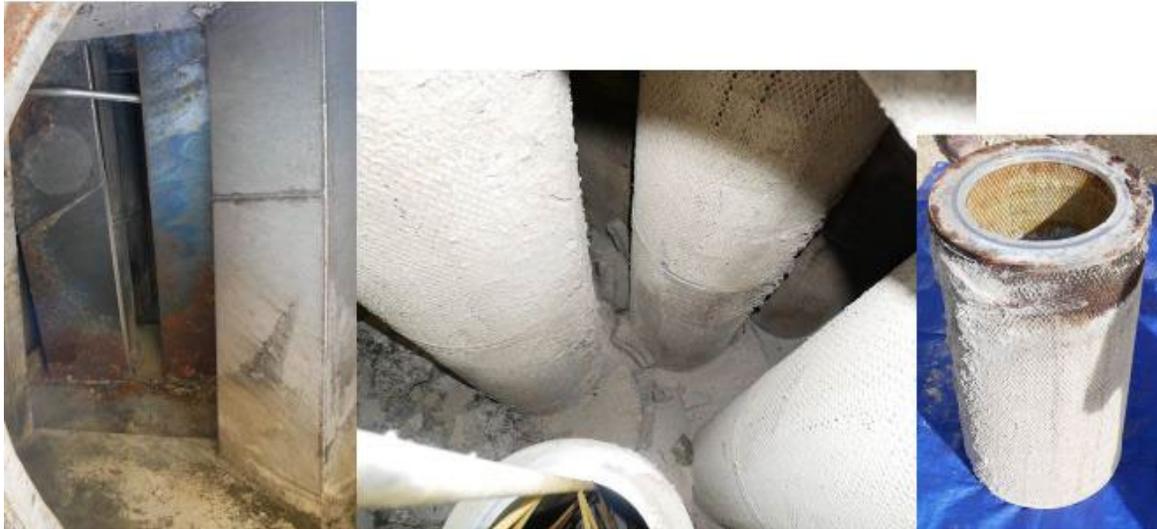
Figure 39: Torit Filter damage: inlet baffle heat damage (left), dark residue inside (center), and a filter element removed (right). (Credit: Didion)

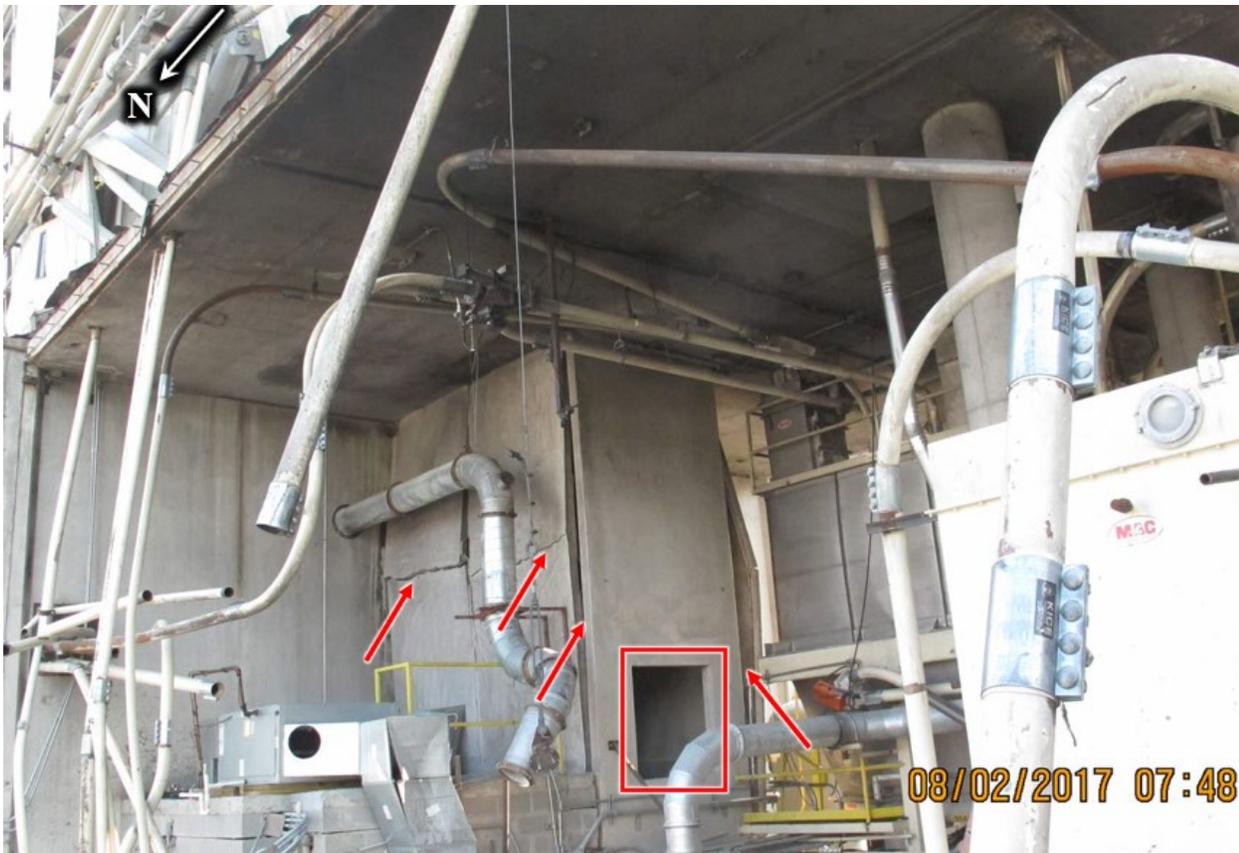
Figure 40: 4B air shaft damage (red arrows) and shaft opening into 4B (red box) in B Mill interior, pre-demolition. The 4B wall panels detached from the B Mill structure during the incident. (Credit: Didion, annotations by CSB)

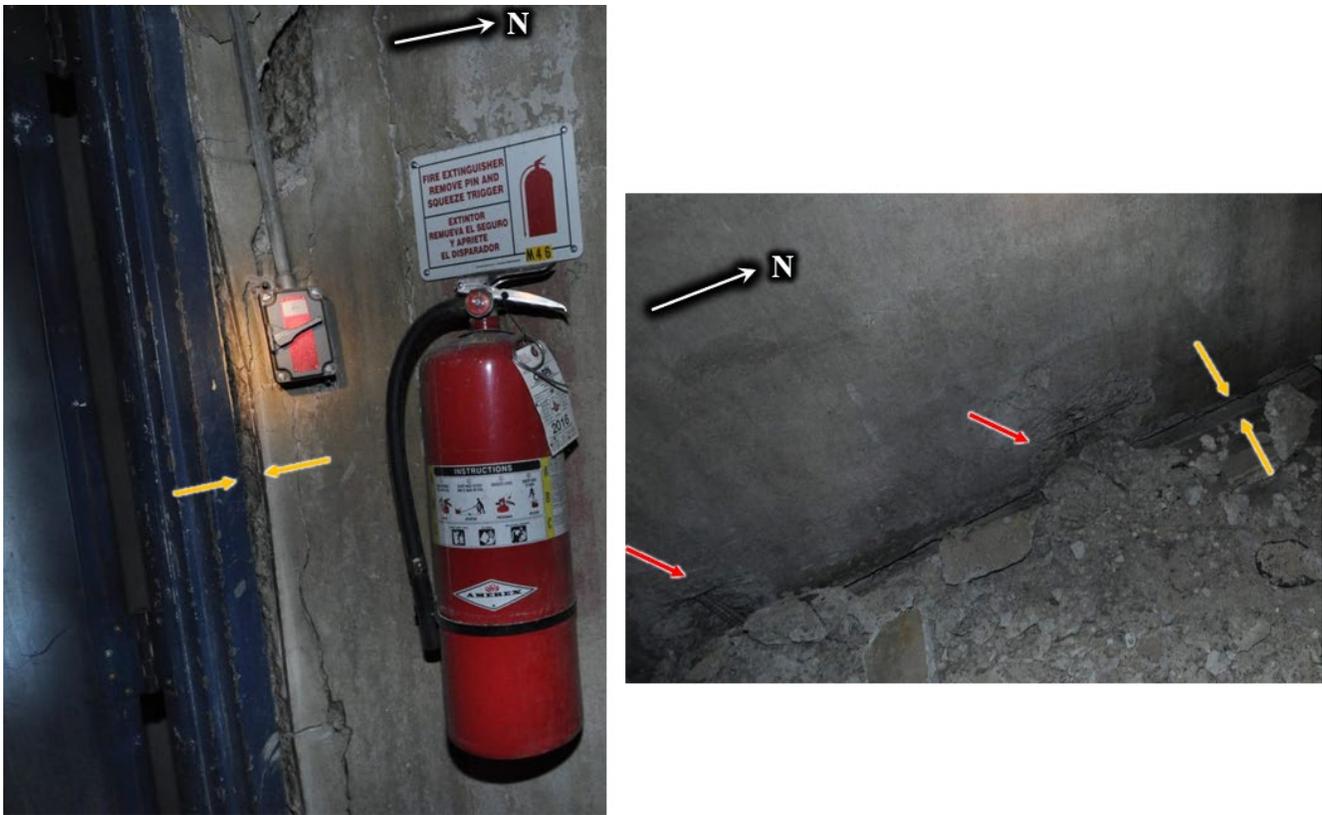
Figure 41: 4A structural damage. Wall bowed and separated from door frame (left, at arrows) and wall separated from floor (right, at orange arrows). Note that wall displacement caused concrete damage, exposing rebar (red arrows). (Credit: CSB)

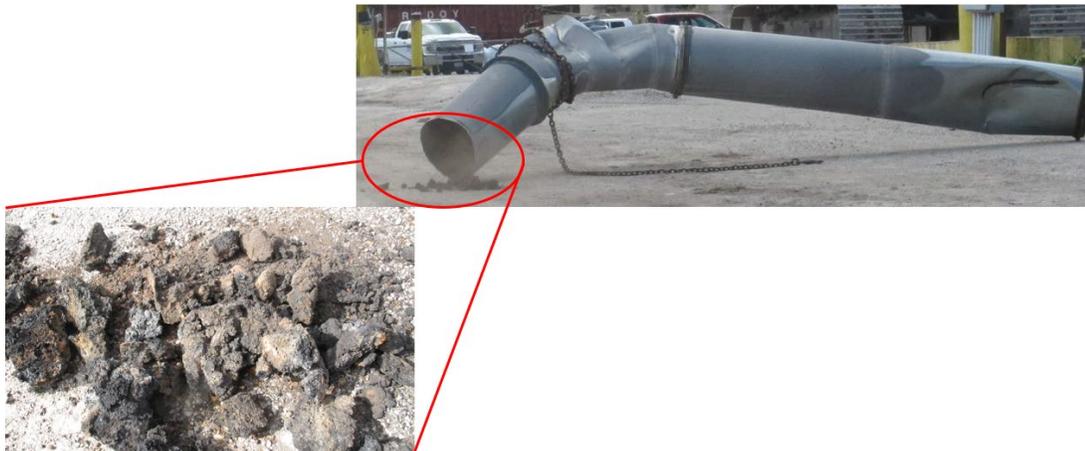
Figure 48: Dry Grit Filter supply ducting post-incident (right) with corn product accumulation (inset). Material fell out of ductwork during demolition. (Credit: CSB, adapted from EFI)

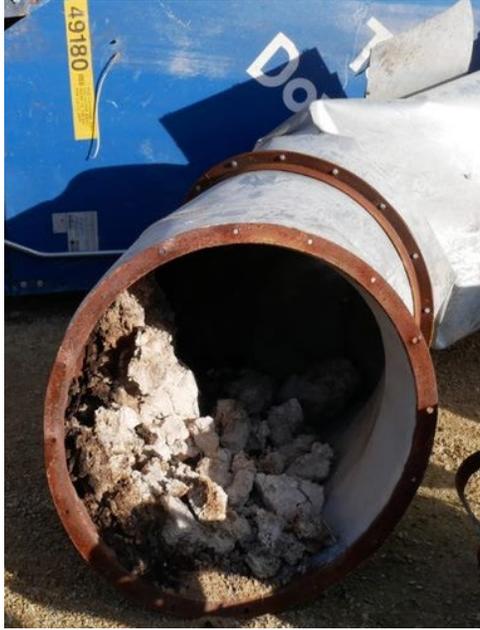
Figure 49: Torit Filter supply ducting with material deposits inside. (Credit: CSB)

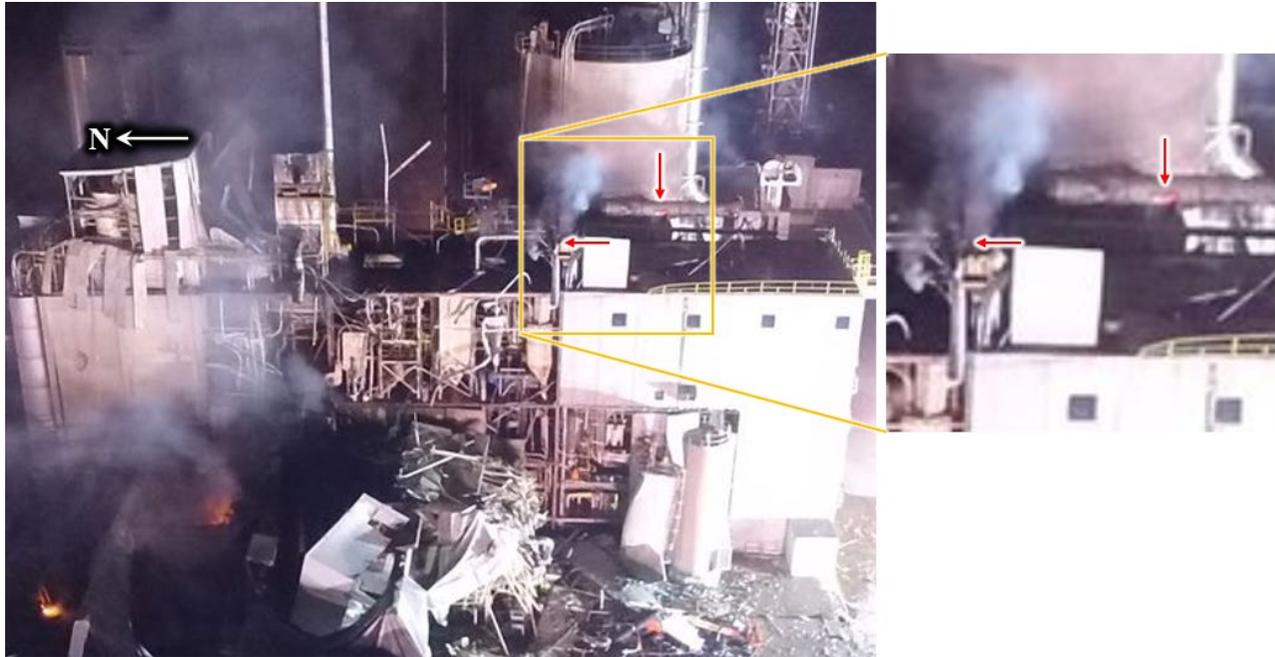
Figure 51: Dry Grit Filter ductwork on fire (red arrows) hours after the explosions. Inset: close-up of ductwork. (Credit: Columbia County Sherriff's Department, annotations by CSB)

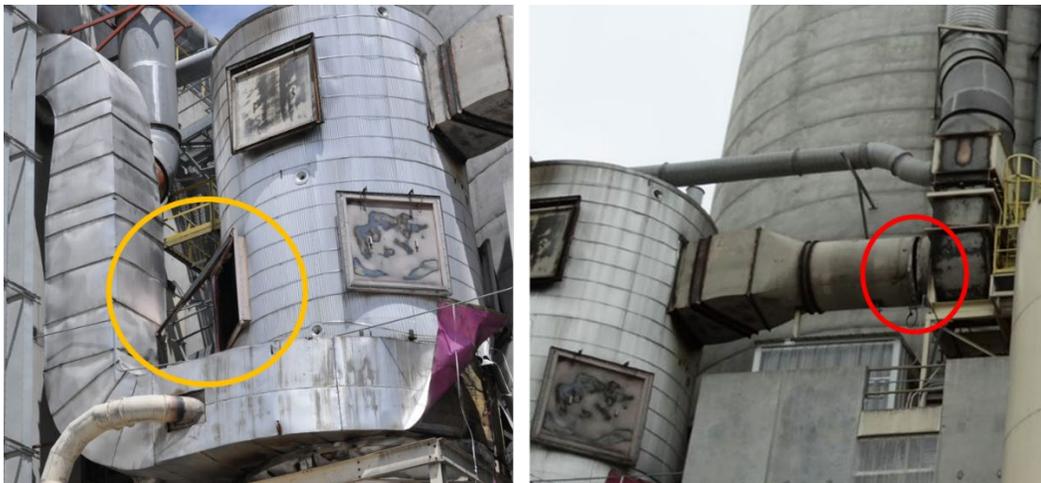
Figure 53: Dry Grit Filter installation. Open vent panel is denoted by the orange circle, and the exhaust ducting damage is highlighted by the red circle. (Credit: CSB)

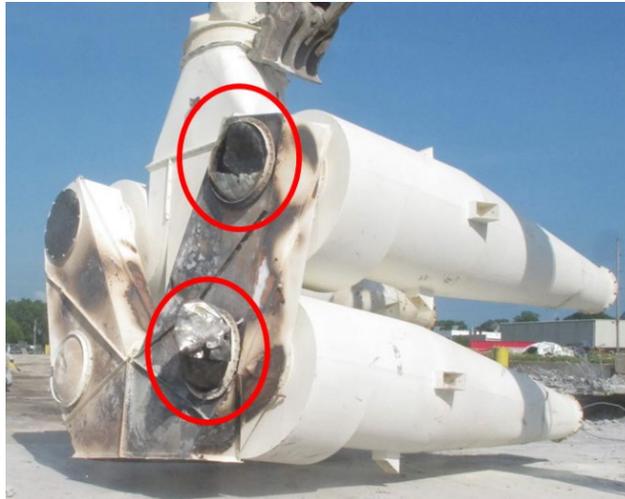
Figure 55: 4D Cyclones with rupture disks, with red circles indicating damaged rupture disks. (Credit: Didion, annotations by CSB)
