U.S. Chemical Safety and
Hazard Investigation Board

Fatal Combustible Dust Explosions at Didion Milling Inc.

Cambria, Wisconsin | Incident Date: May 31, 2017 | No. 2017-07-I-WI

Investigation Report

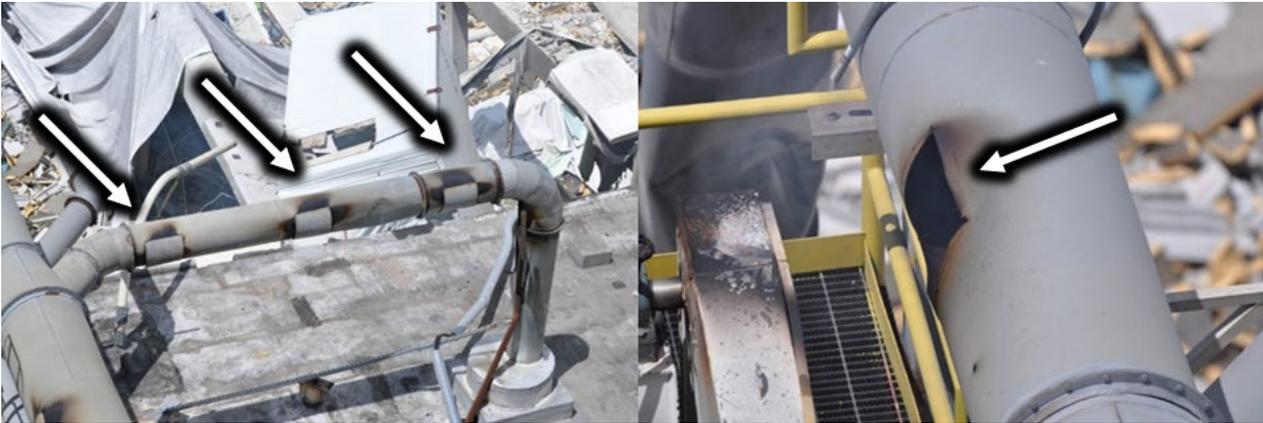
Figure 56: Dry Grit Filter ducting with overpressure indications. (Credit: CSB)

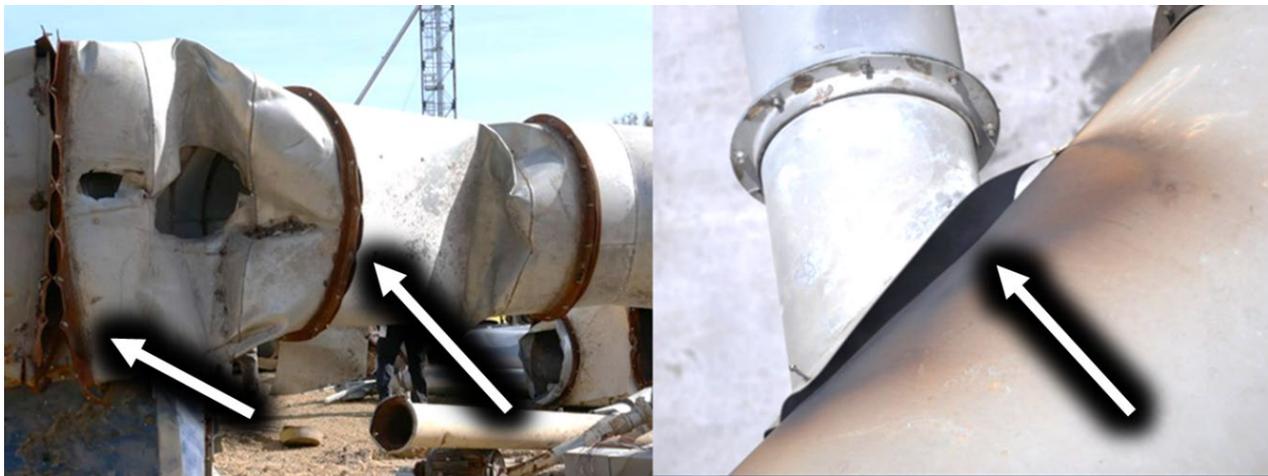
Figure 57: Left: Torit Filter supply duct; right: Dry Grit Filter supply duct on roof of B Mill. (Credit: CSB)

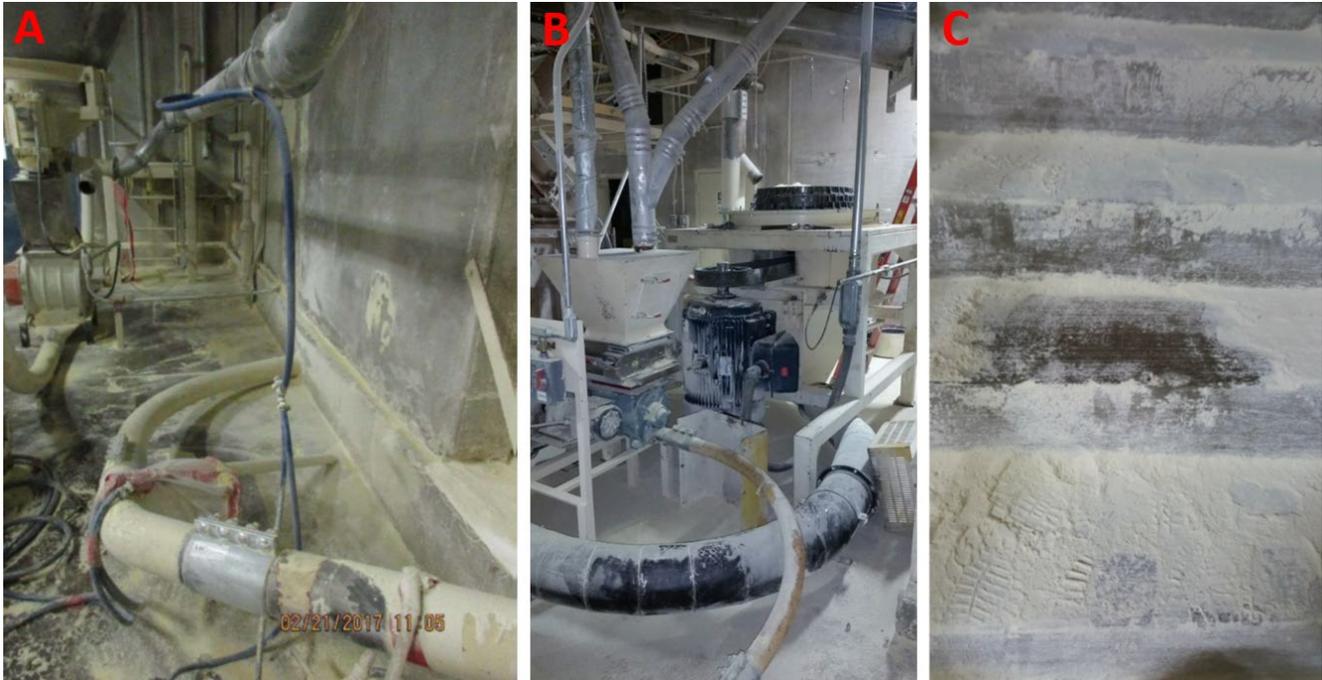
Figure 58: Examples of fugitive dust accumulations, (A) approximately three months before the incident, (B) approximately two weeks before the incident, and (C) less than 24 hours before the incident. (Credit: Didion)

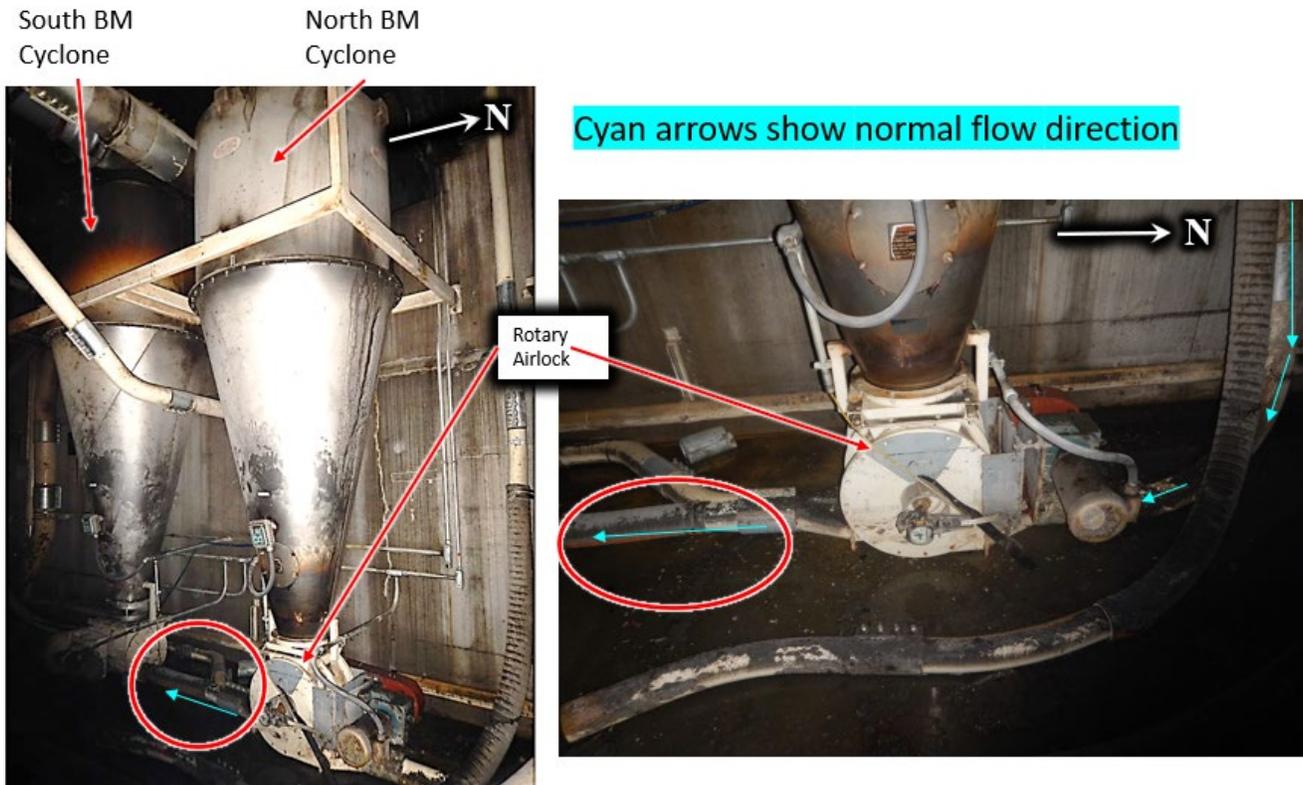
Figure 59: North and South BM receiving cyclones connected by rubber hose (circled). Cyan arrows show process/air flow. (Credit: CSB)

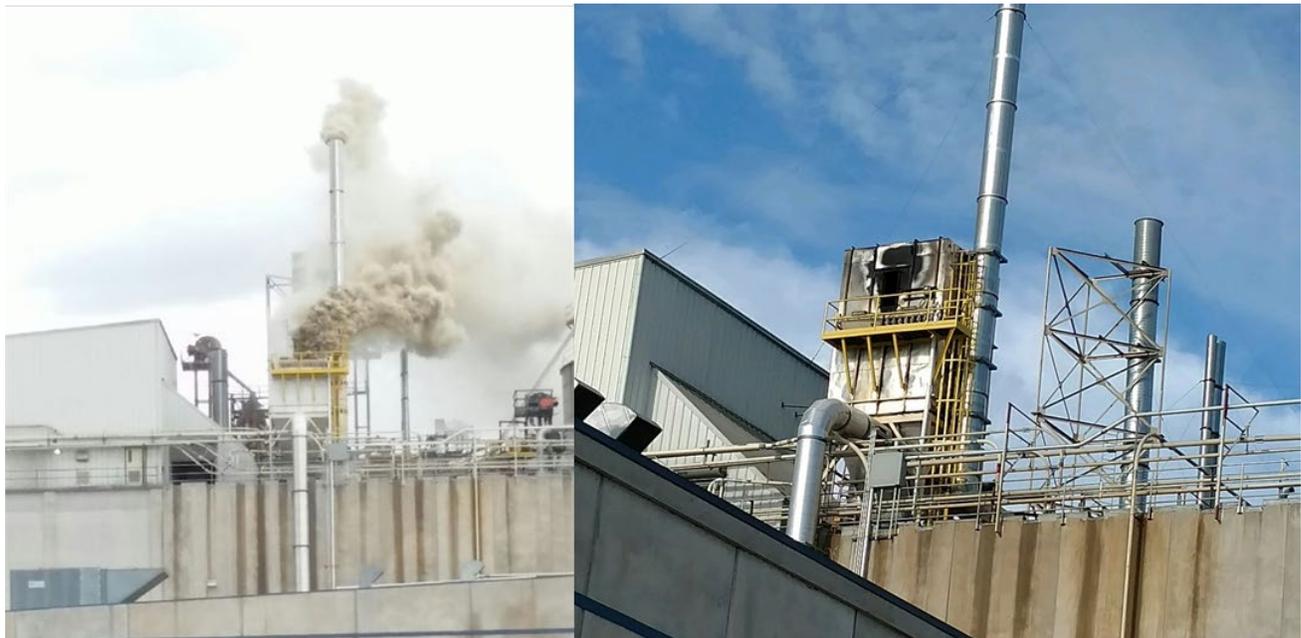
Figure 62: May 29, 2017, process fire during event (left) and following event (right) on B Mill roof. (Credit: Didion)
