Deepwater Horizon RBS 8D BOP MUX Control System Report
To the U. S. Chemical Safety and Hazard Investigation Board
CSB-FINAL REPORT-MUX(06-02-2014)

MUX Control System Investigation Index

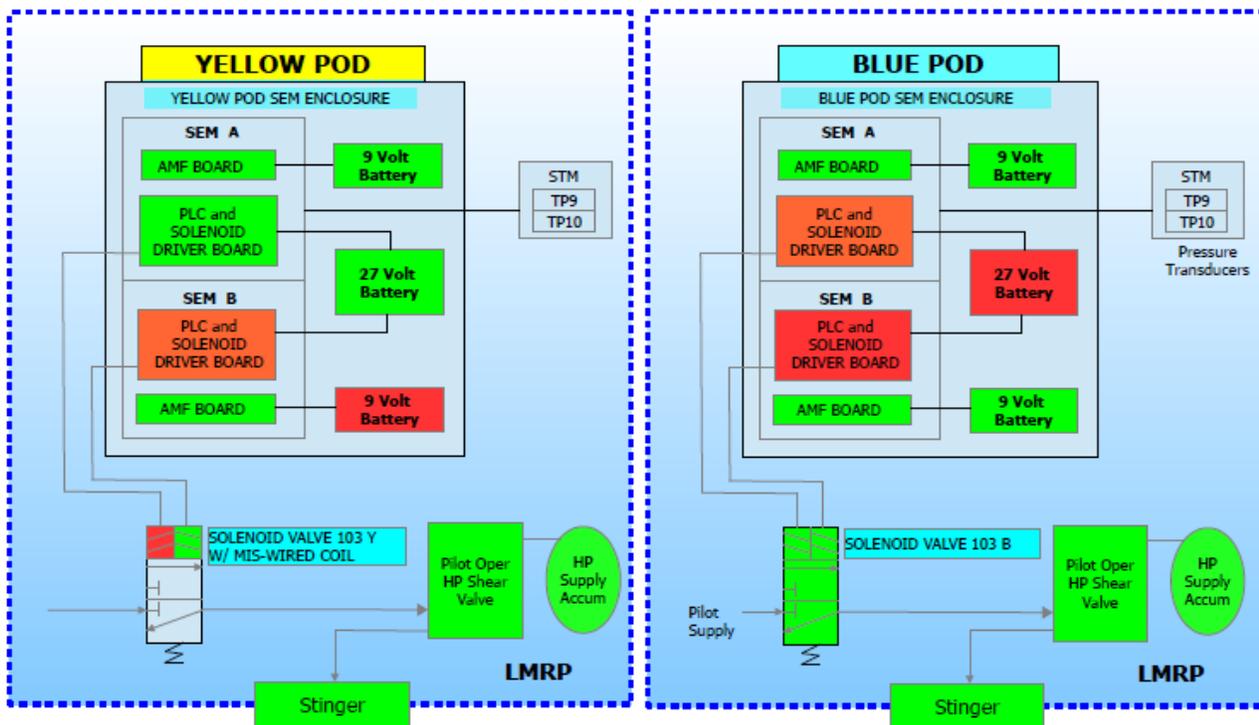
As described in detail is in this section, and summarized in Figure 6, the two SEMs in the blue pod were miswired, which caused the emergency 27 volt battery to prematurely connect the two AMF/deadman pressure transducers. The premature connection drained the 27 volt battery, preventing the AMF/deadman sequence from activating from the blue pod. The yellow pod contained two miswired solenoid valves such that a reverse polarity existed between the dual coils. One of these solenoids (103 Y) was for the yellow pod AMF/deadman system to actuate the BSR. However, a premature depletion of the yellow pod SEM B 9 volt battery caused the solenoid valve to be functioned by the SEM A coil alone, thus actuating the BSR closure. Drill pipe buckled off-center in the BOP prohibited the BSR from fully closing and sealing the well.³⁵

Figure 6. Summary of battery conditions and solenoid 103 wiring within the yellow (left) and blue (right) pods at the time of the incident.

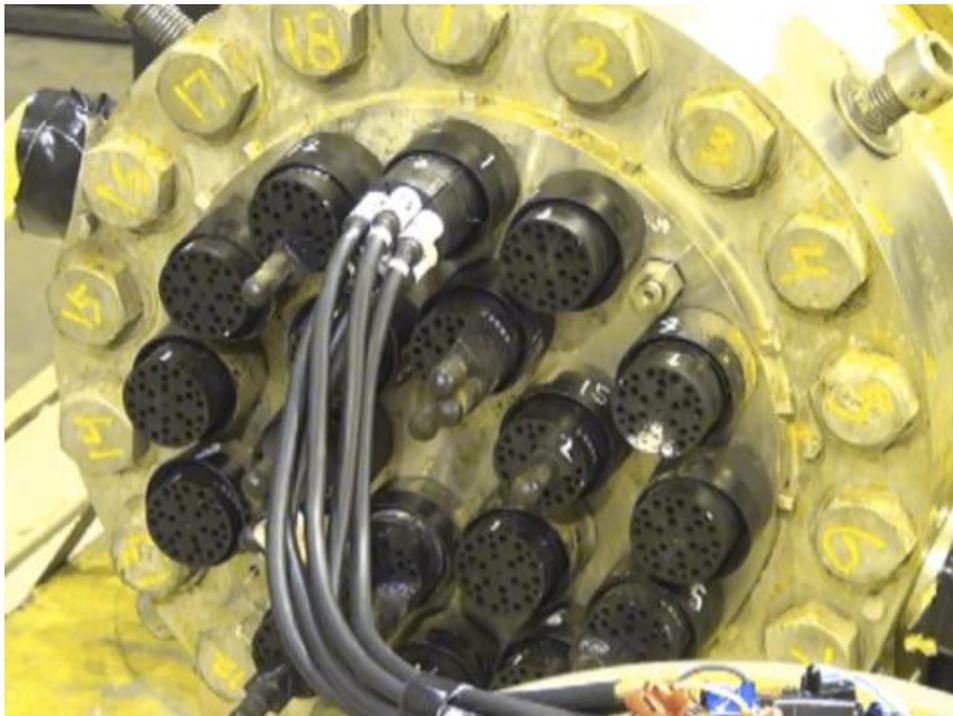
faults were noted on solenoid valves in the AMF/deadman sequence. For additional analysis of the pie connectors and their oxide coating, see Appendix H.

Figure 7. Pie connectors as observed in Phase 2.

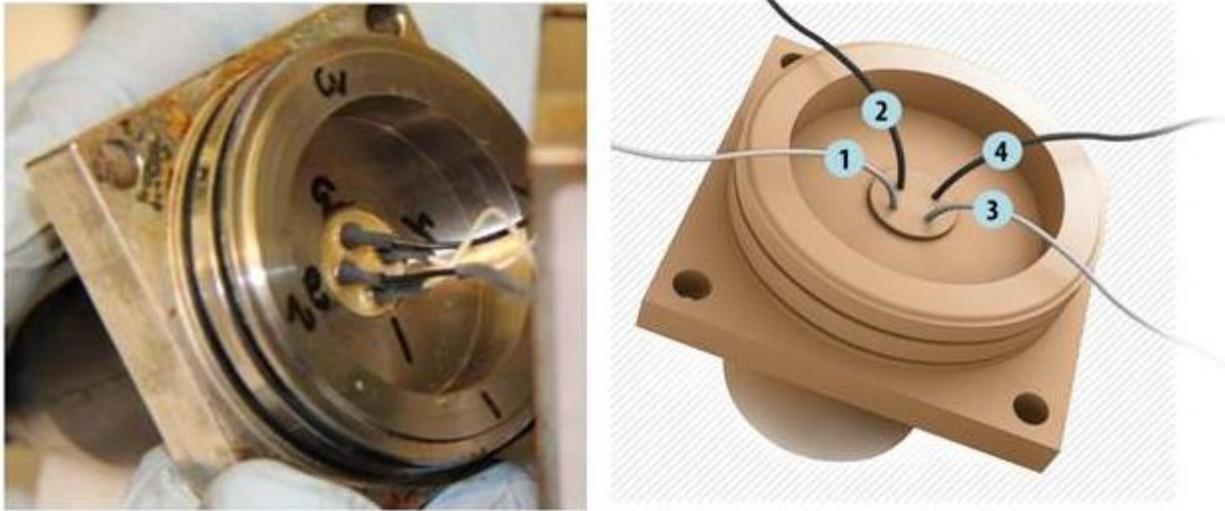
Figure 10. (Left) Photograph of Y103 wire arrangement from Phase 2 testing with pins 1 and 4 connected to white wires and 2 and 3 connected to black wires. (Right) Schematic of correct arrangement of wires, with pins 1 and 3 connected to white wires and 2 and 4 connected to black wires.

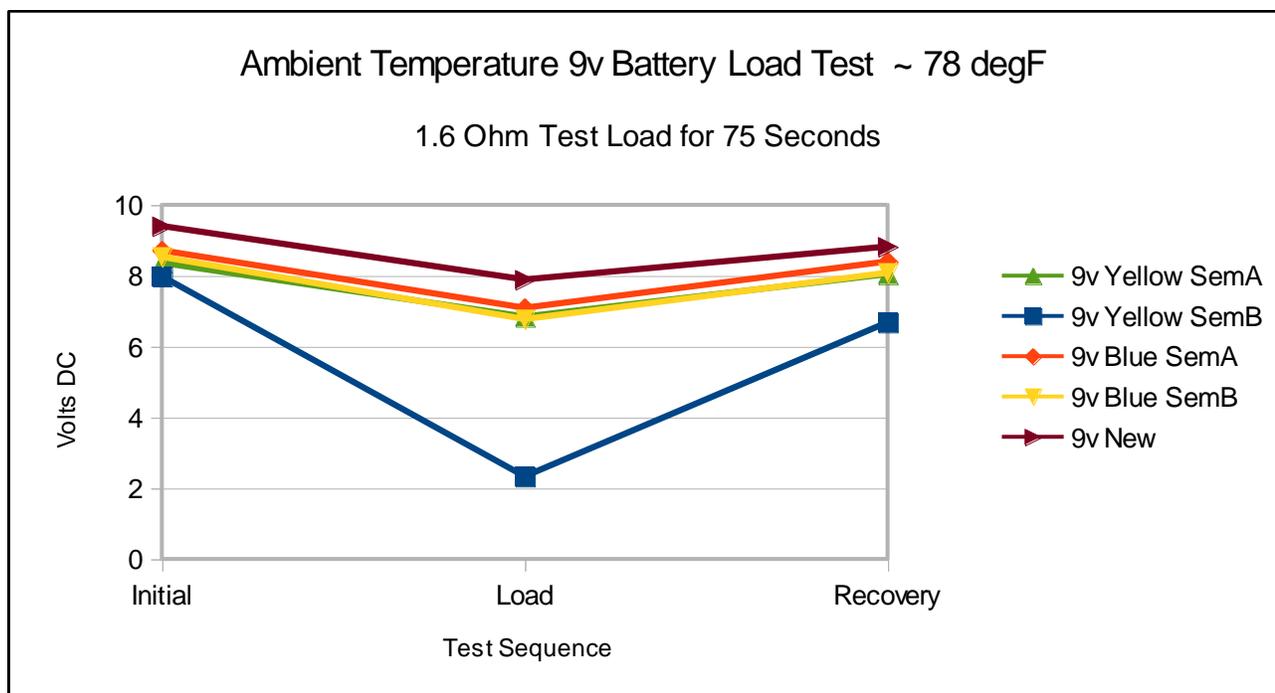
Figure 12 and Figure 13 show that only the SEM B 9 volt battery in the yellow pod failed both ambient and cold load tests during Phase 2 testing.

Figure 12. Ambient load testing of the 9 volt batteries during Phase 2.

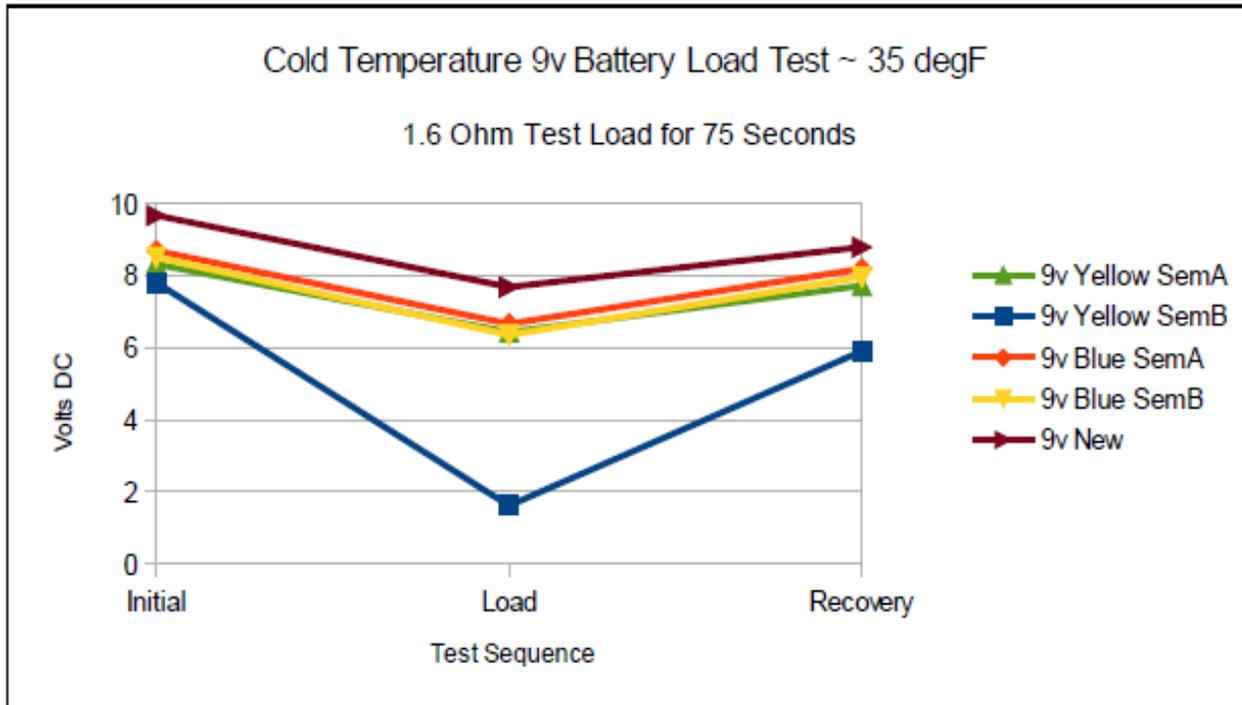
Figure 13. Cold temperature load testing of the 9 volt batteries during Phase 2.

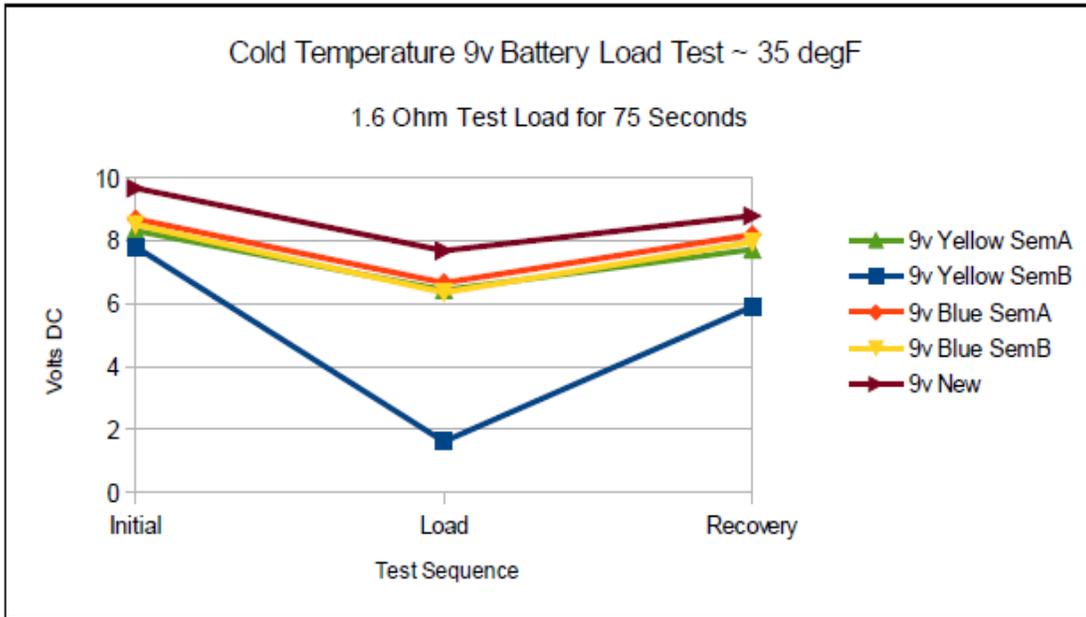
Figure A3-1: 9 volt Battery Cold Test Results
The yellow pod SEM B 9 volt battery failed the load test.

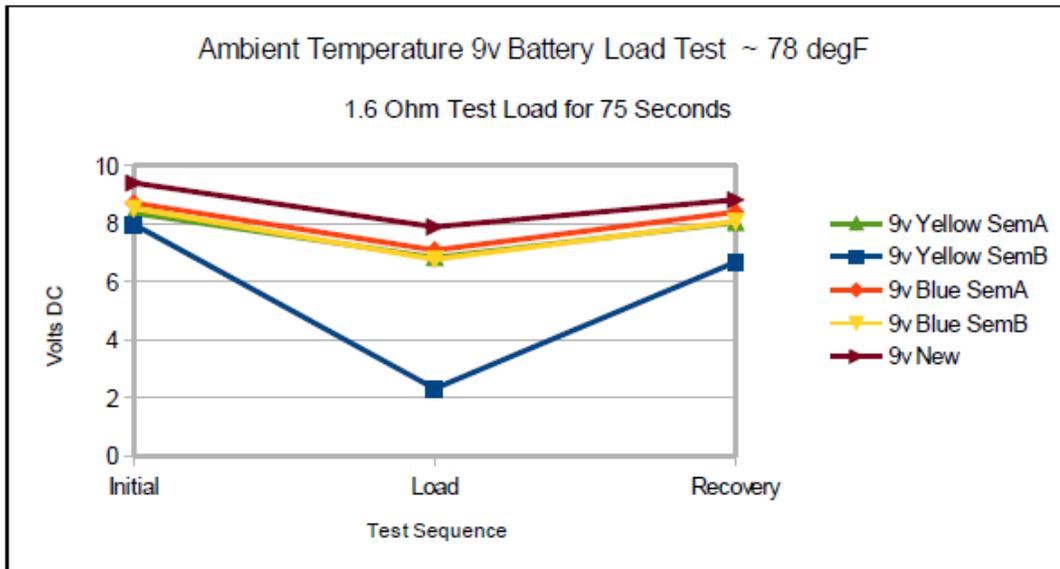
Figure A3-2: 9 volt Battery Ambient Test Results
The yellow pod SEM B 9 volt battery also failed the ambient temperature load test.

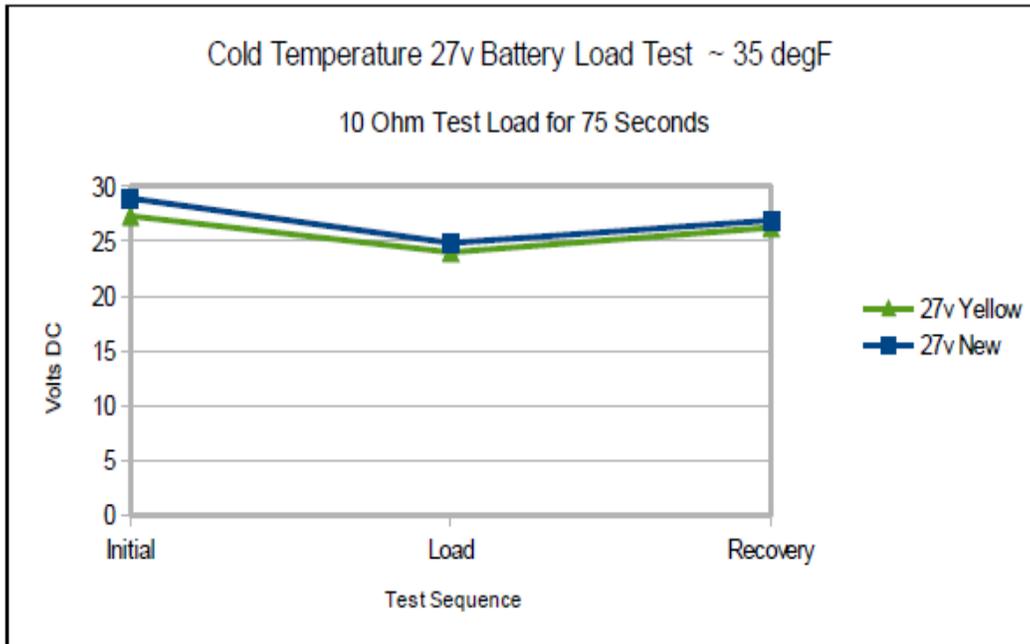
Figure A2-3: 27 volt Cold Battery Load Test Results
 The yellow pod 27 volt battery closely follows the new battery cold load test.
 The blue pod 27 volt battery was drained and could not be tested.

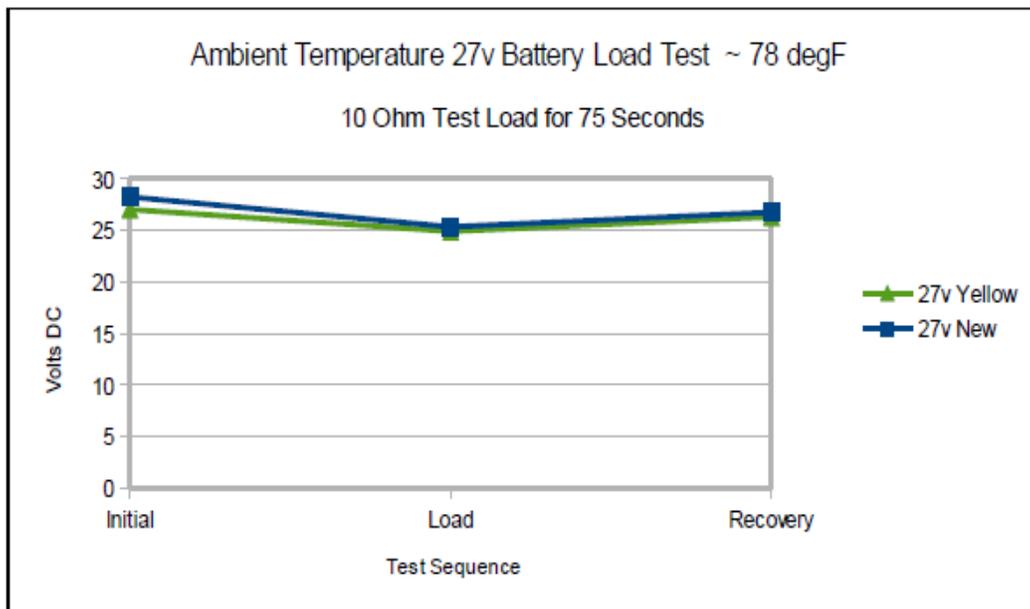
Figure A3-4: 27 volt Ambient Load Test Results
 The yellow pod 27 volt battery closely follows the new battery ambient load test
 The blue pod 27 volt battery was drained and could not be tested

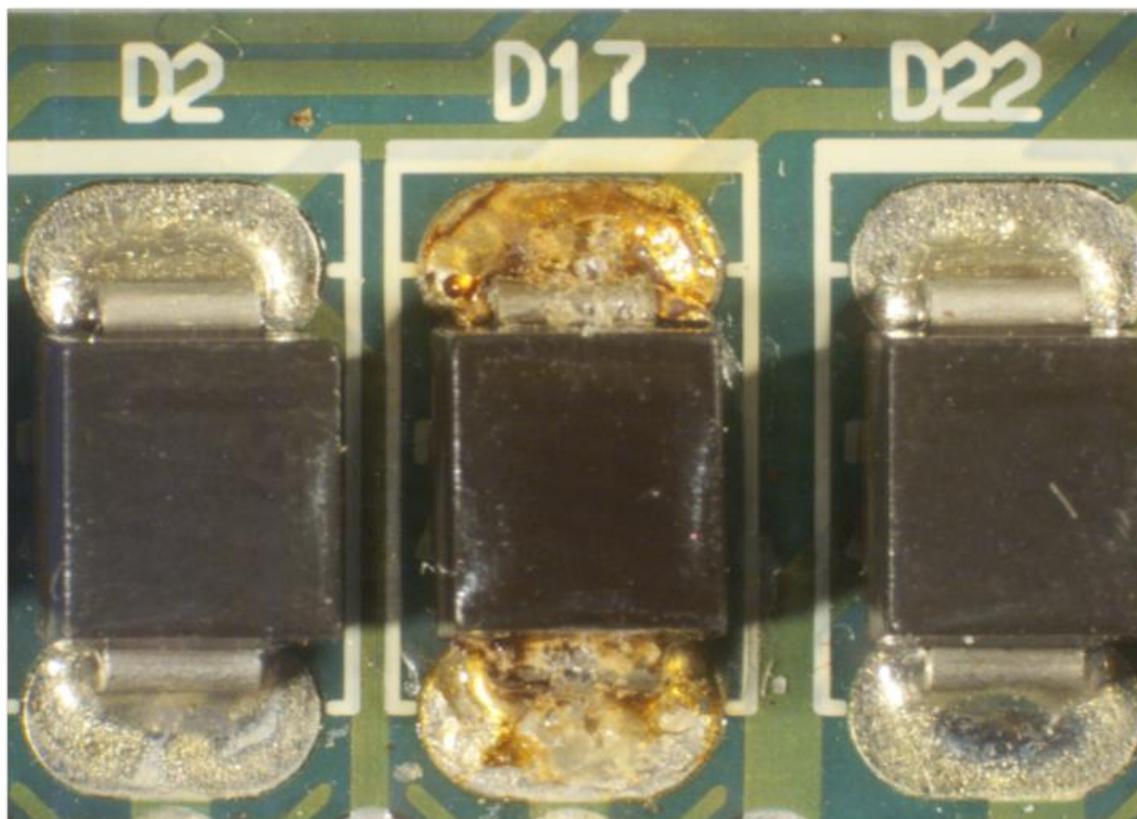
On June 19 and June 20, 2011, as part of Phase 2 testing, technicians removed the AMF/deadman cards from the yellow and blue pod SEMs and traced the circuitry that was attached to the four AMF/deadman cards. The technicians photographed both sides of each card and annotated the photos with notes regarding the quality of the protective conformal coating on the printed circuit boards and other observations of potential quality concerns.¹¹⁴ Most of the notes were relatively innocuous, but a notable exception from June 20 concerned “some discoloration at the solder joints” of diode¹¹⁵ D17 on the blue pod SEM B AMF/deadman card. The discoloration, seen in Figure B-1, on diode D17 suggests heat stress, most likely due to overcurrent.

Figure B-1. Discolored Diode D17 on blue pod SEM B AMF/deadman card as observed during Phase 2 testing.

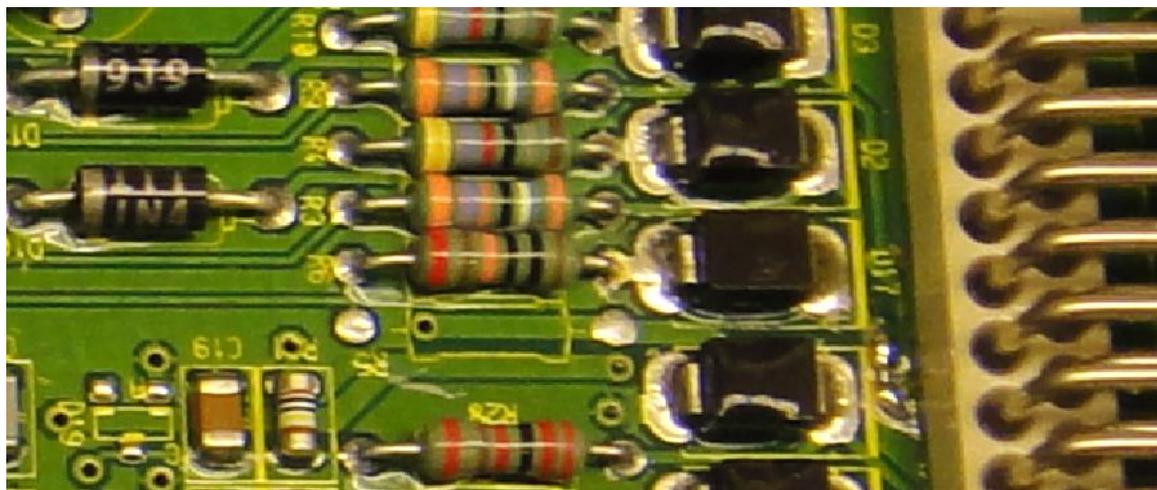
If diode D17 had failed prior to the incident, then the blue pod SEM B AMF card could never have gotten the battery power it needed to operate. In this case, however, MUX diagnostics should have alerted the operator of the

Figure B-2. Photograph of diode D17 connected to resistor R6.

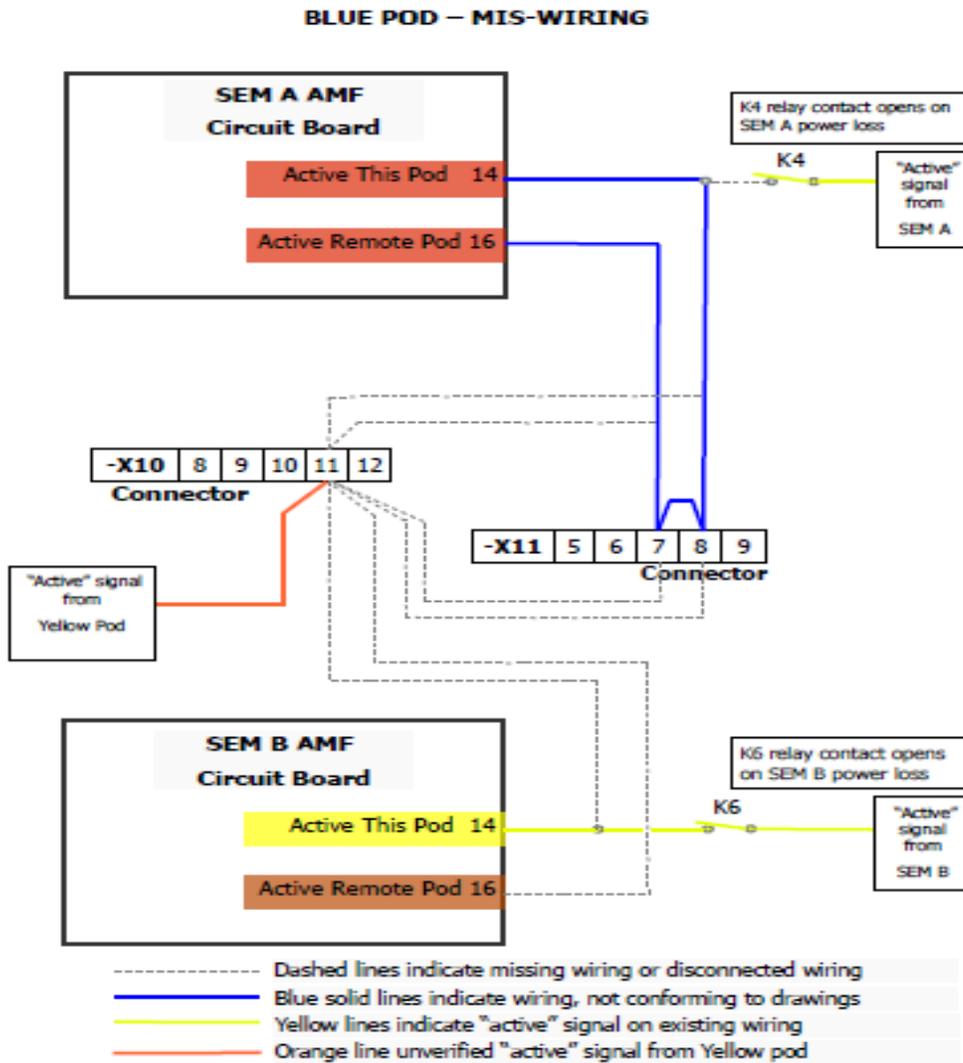
X11. If these SEM B wires were connected to -X11, then, like SEM A, they would not conform to the wiring diagram.

Figure D-1: Blue Pod Miswiring (Source: Engineering Services)

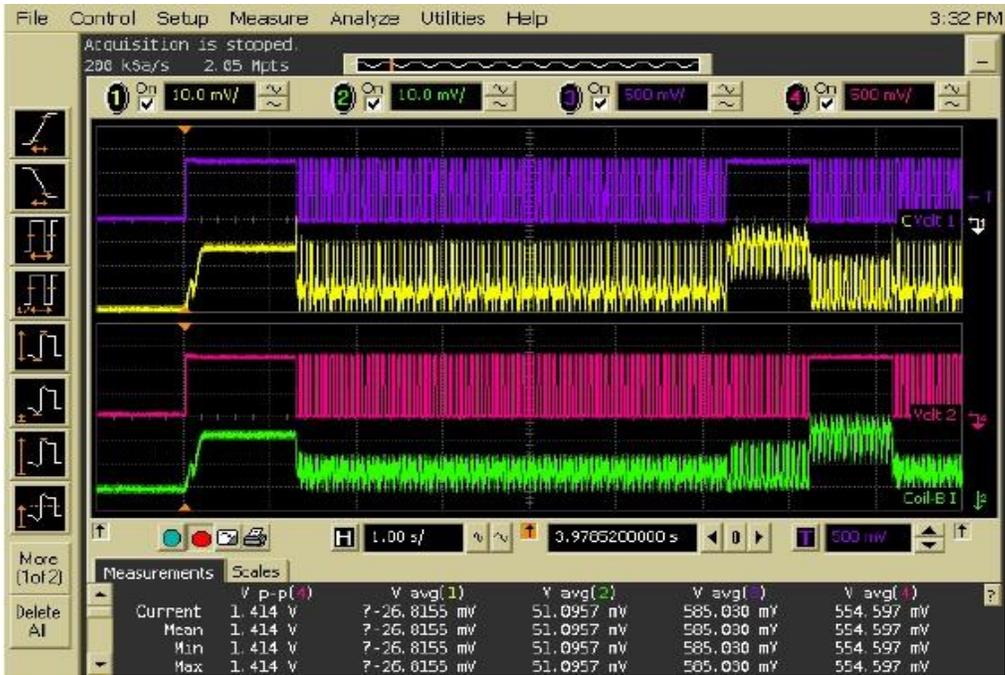
Figure E-11: Short-cycle Seen in PETU Characterization Tests during Phase 2 testing.

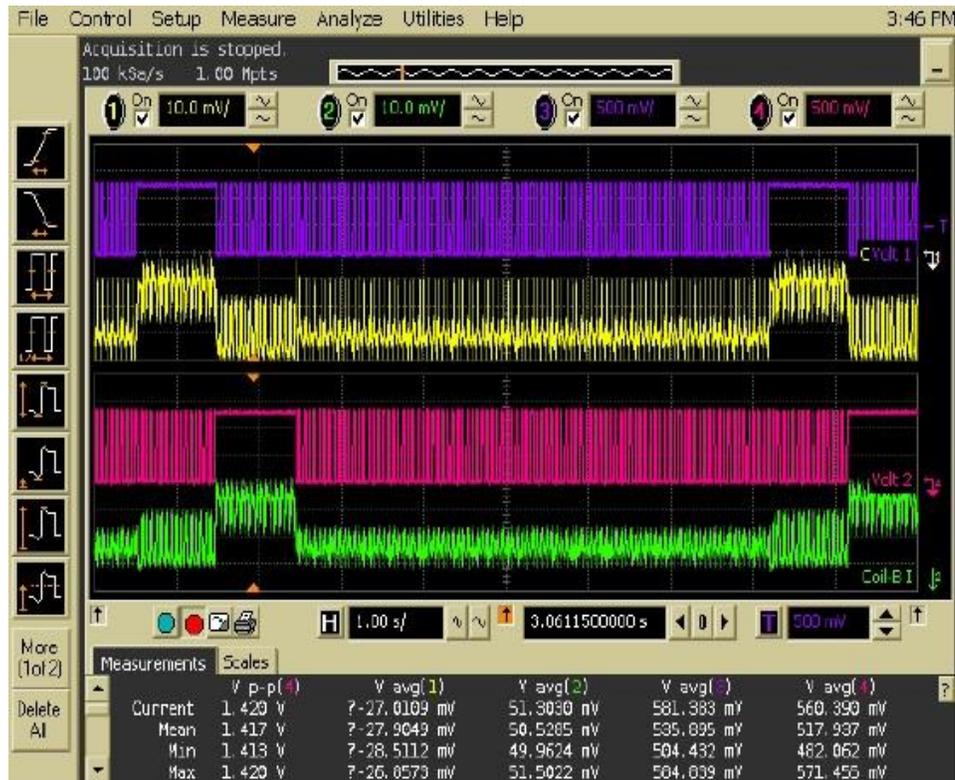
Figure E-12: Out-of-Sync Condition Remains after Short Cycle Ends as observed during Phase 2 testing.

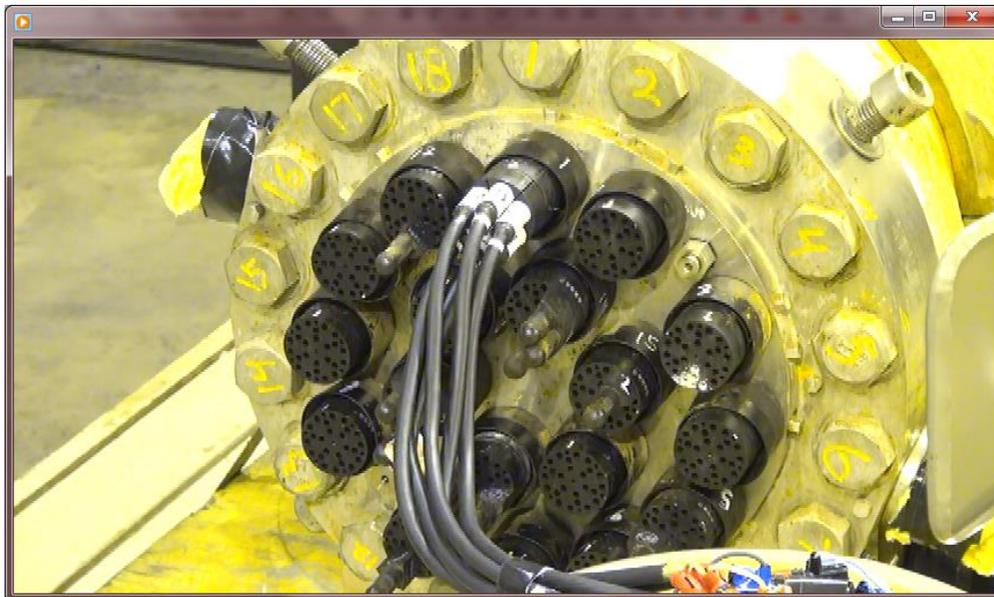
Figure C7-1: Blue Pod SEM

The following snapshots were taken from Phase 2 videos. These views show oxidation created on certain pie connectors.¹⁵⁹

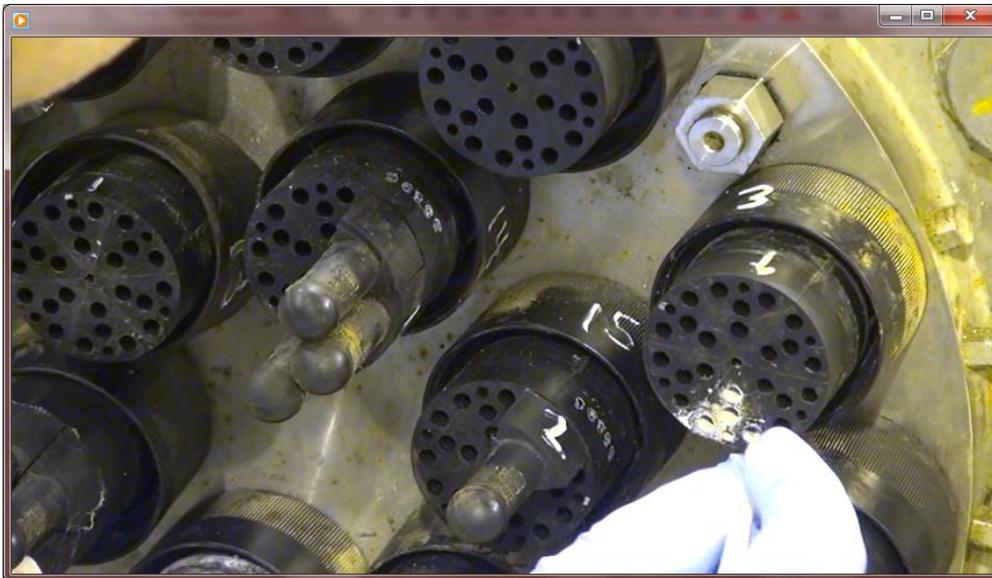
Figure C7-2: Title Pre-test Oxide Cleaning

Close-up of Blue pod SEM connection 3E as technician begins to clean the oxide before testing resistance in connections. Dummy plugs are used to seal unused connections as in connectors #14 and #15.

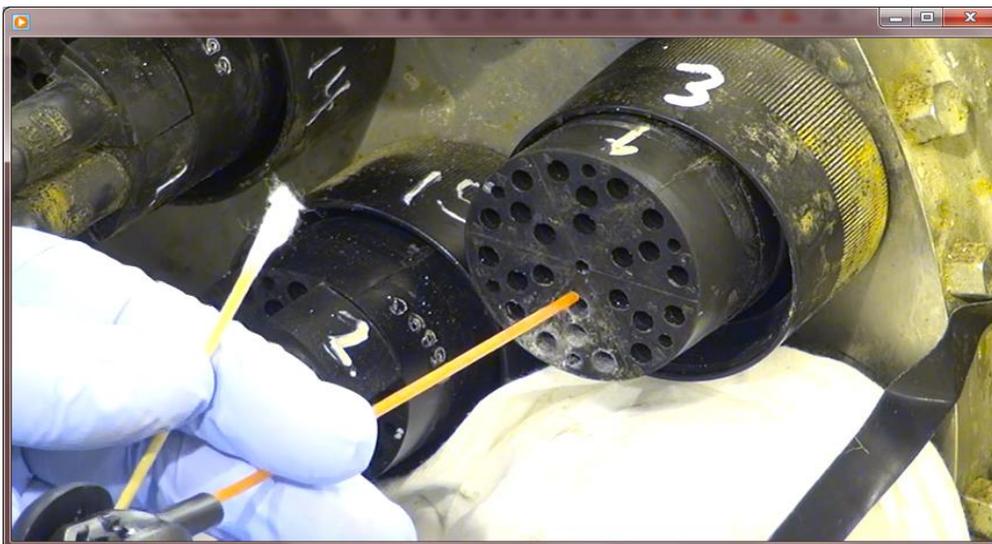
Technician uses swab and compressed air to clean oxide out of connection. After cleaning, 3E pie connection interior contacts are not bright and shiny like other connections.

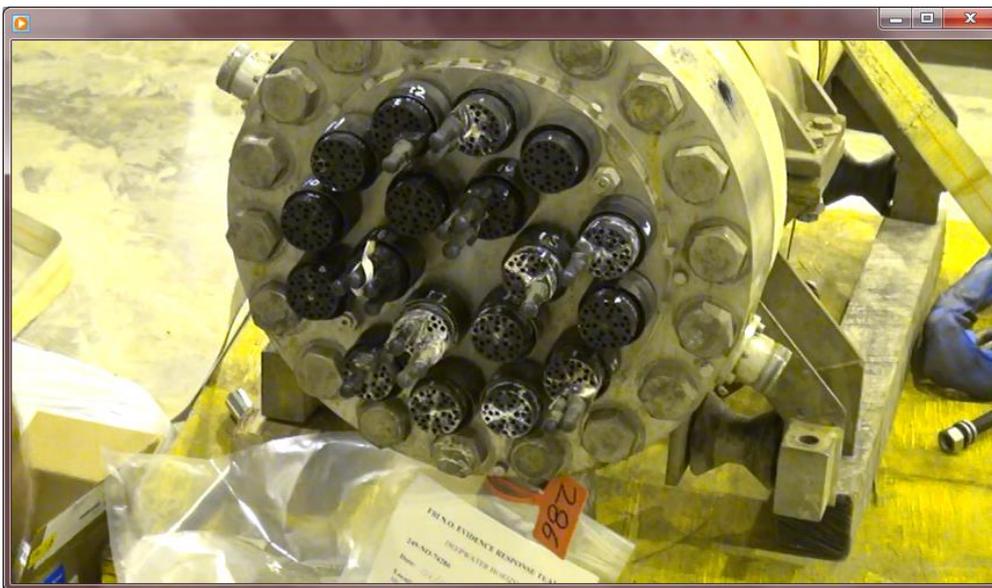
The next photograph shows corrosion on the yellow pod pie connections.

Figure C7-5: Corrosive Oxides on Yellow Pod SEM as seen during Phase 2 testing. The yellow pod SEM has several areas of corrosion from oxides (Video 20110614174414).

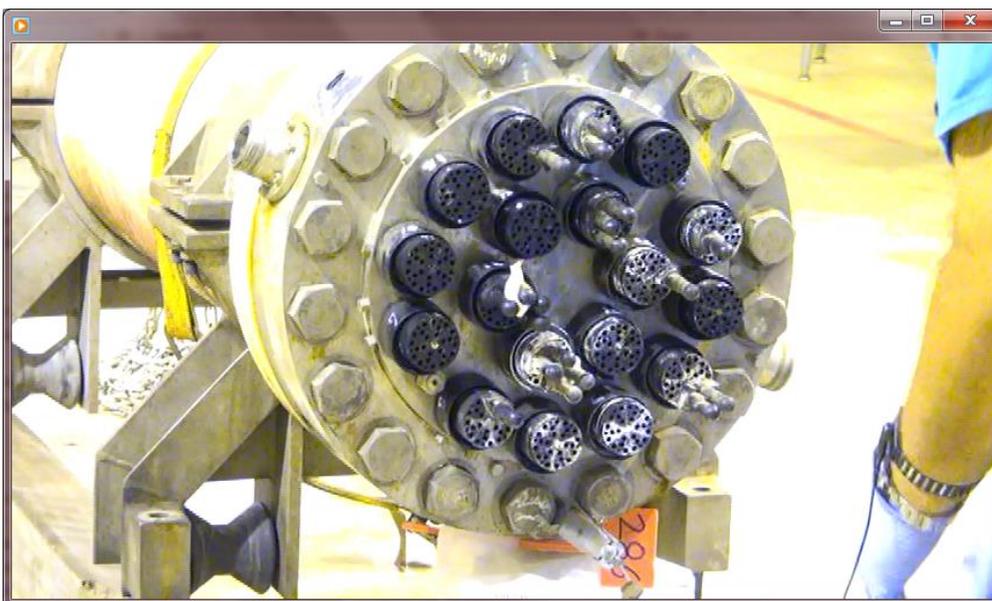
Figure C7-6: Yellow Pod SEM Connections, Alternative View as seen during Phase 2 testing. This view of yellow pod SEM connections is just before cleaning (Video June 15, 2011, BD C14 411 20110615095114).
