U.S. CHEMICAL SAFETY AND HAZARD INVESTIGATION BOARD

ALUMINUM DUST EXPLOSION

HAYES LEMMERZ INTERNATIONAL—HUNTINGTON, INC.

REPORT NO. 2004-01-I-IN

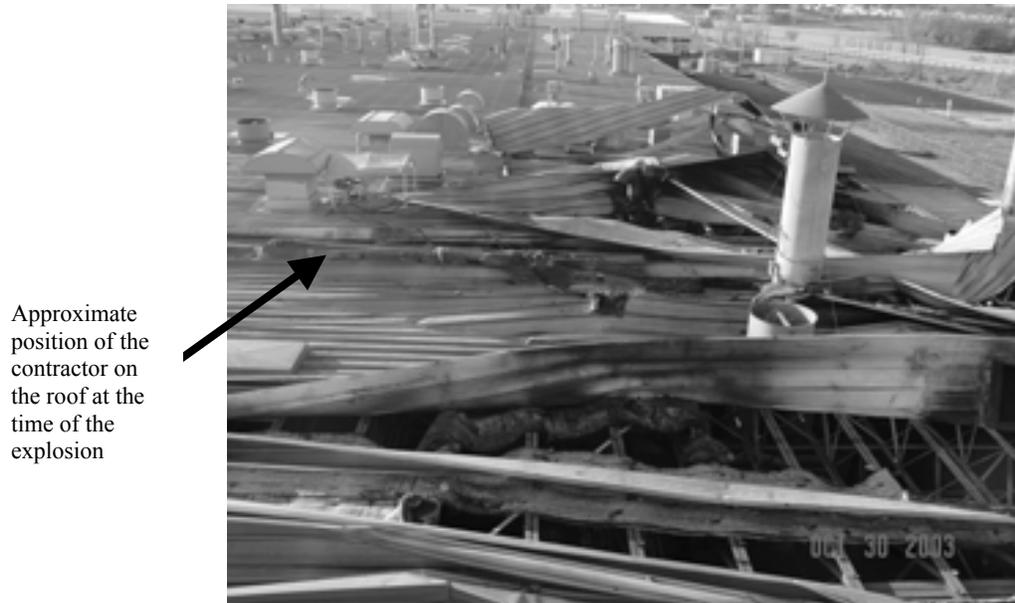
Figure 13. Damaged roof above furnace 5.

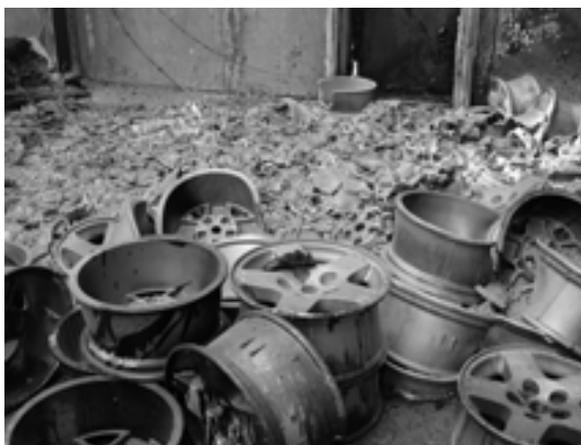
The fireball ignited roofing material and insulation, along with a small accumulation of combustible material stored behind the kiln dryer control panel. Near the furnace sidewall, plastic pallets containing rejected aluminum wheels that would have been remelted were also ignited, and some of those wheels eventually melted (Figure 14).

Figure 14. Melted wheels near furnace 5 after the fire.

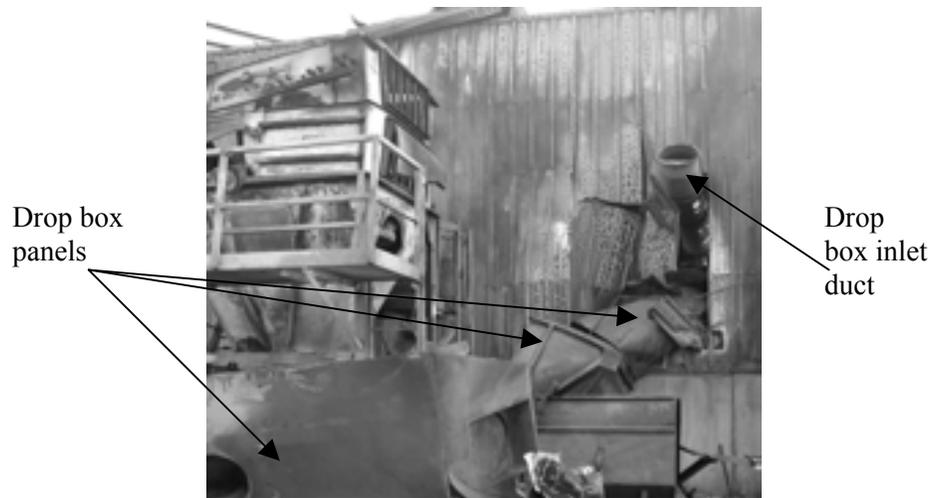
Figure 16. Dust collector (left) and drop box panels destroyed by aluminum dust explosion.

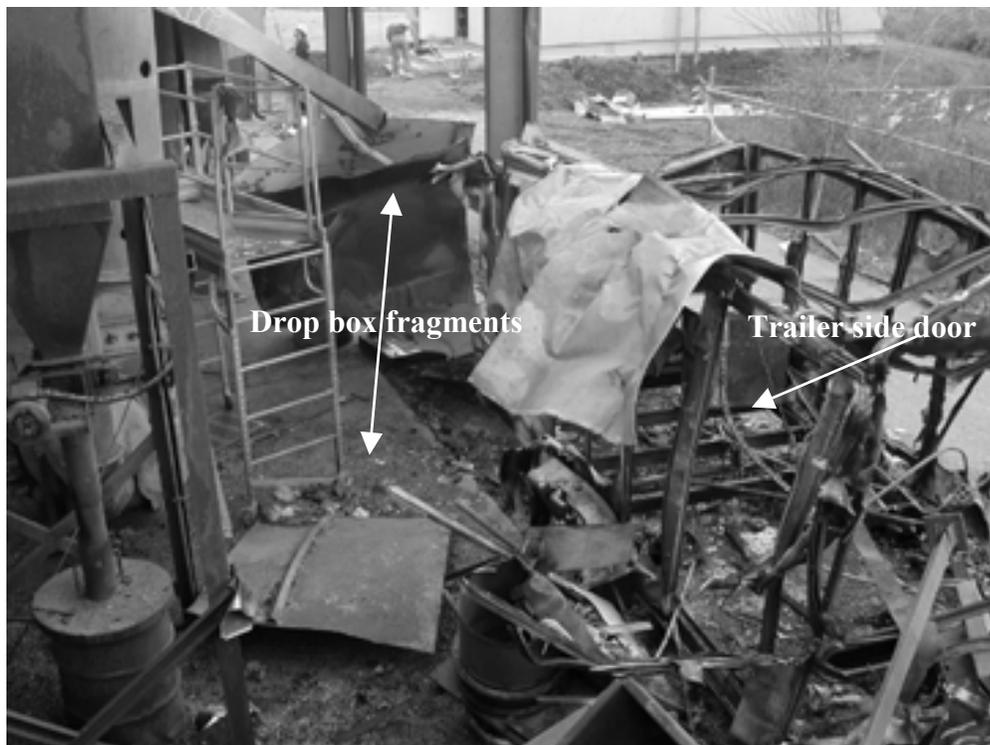
Figure 17. Remains of stack testing contractor's trailer after fire.

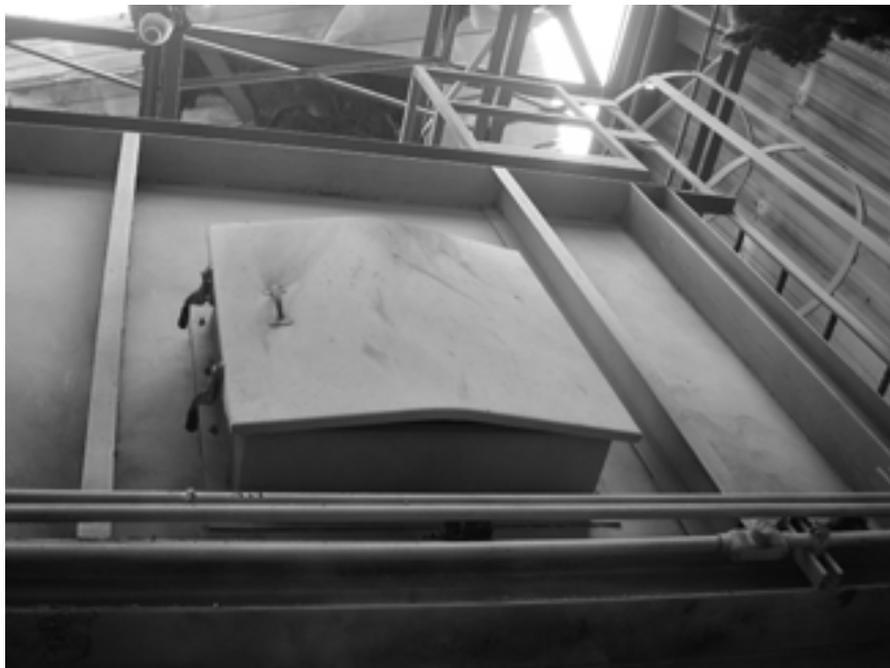
The fire damaged the chip system control console. Internal overpressure bulged the access doors on the side of the dry chip hopper and on the wet chip hopper inlet target box²² (Figure 18 and 19).

Figure 18. Bulged door on dry chip hopper.

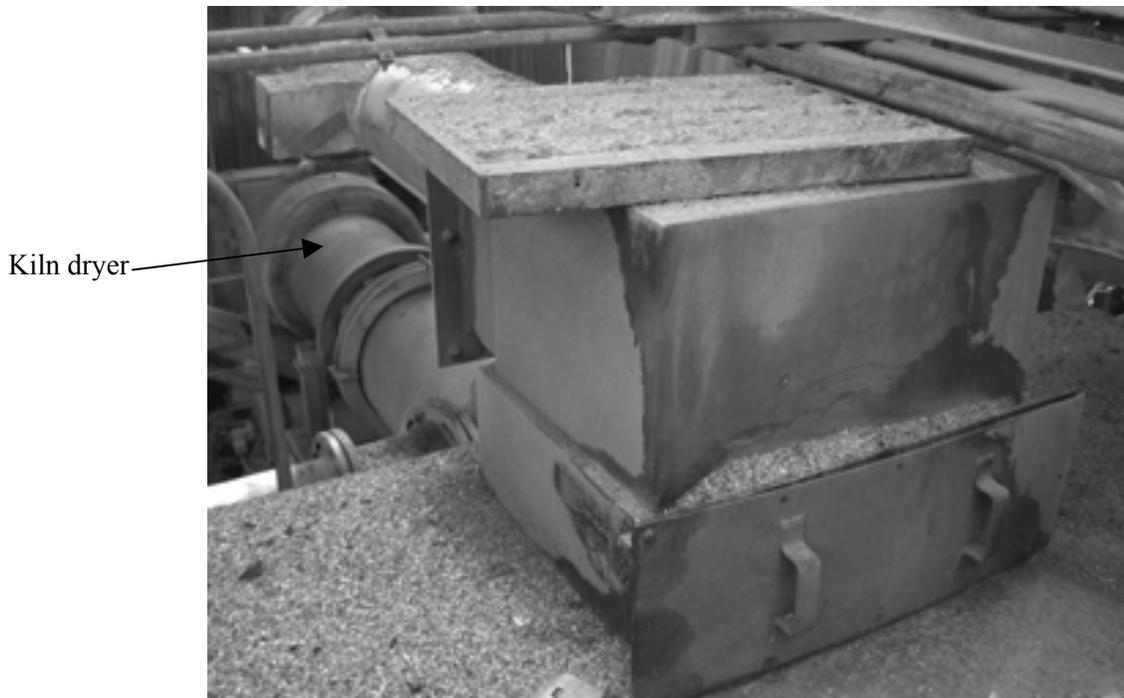
Figure 19. Wet chip hopper target box, with bulged access door.

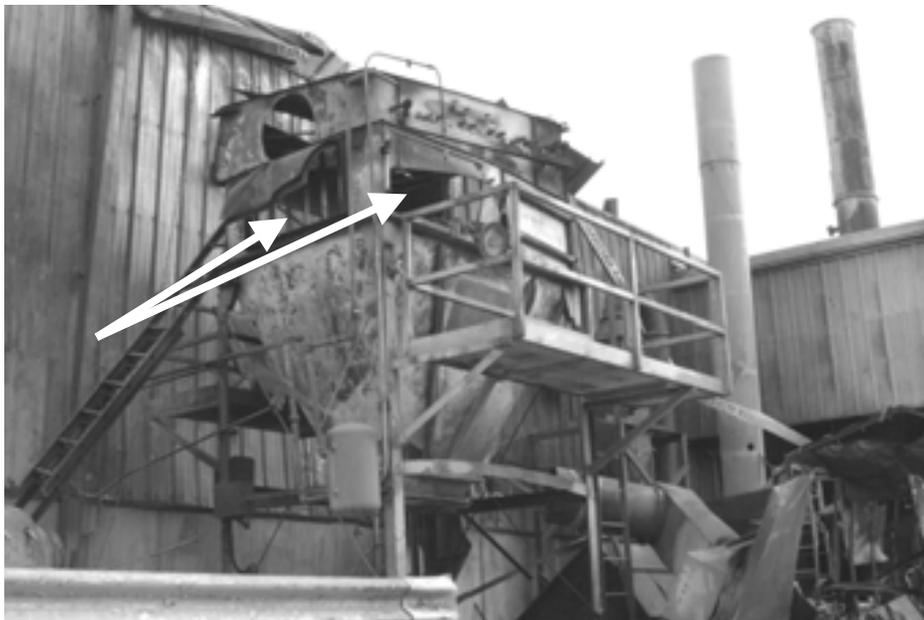
The explosion vent panels and maintenance doors (Figure 21) on the dust collector were blown open by the internal deflagration.

Figure 21. Explosion vent panel and maintenance door blown on dust collector.

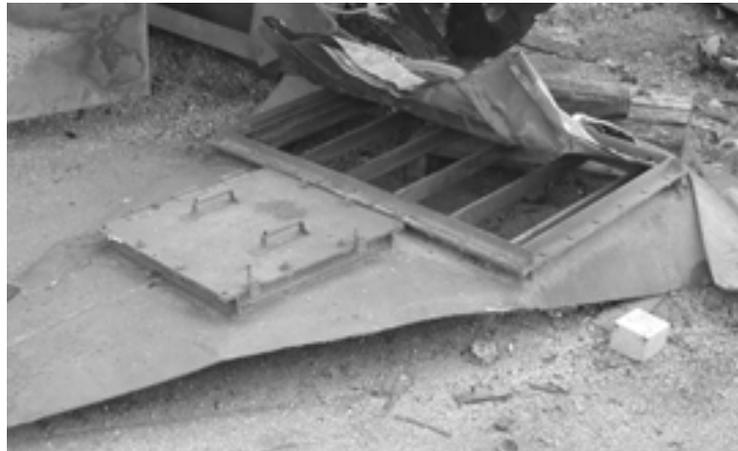
The drop box was pushed away from the dust collector, indicating that the pressure wave traveled into the drop box from the dust collector. The single explosion vent panel was blown and the drop box ruptured (Figure 22). The short duct connecting the drop box to the dust collector was pulled out and away from the dust collector (Figure 23), also indicating that the pressure wave traveled toward the drop box .

Figure 22. Drop box fragment, with blown explosion vent panel.

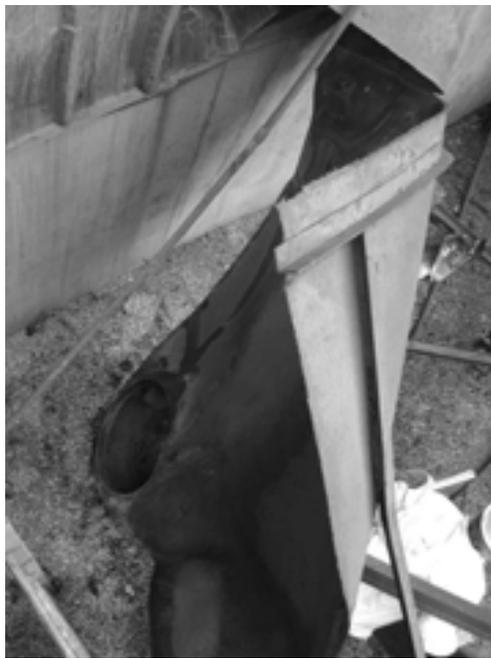
The drop box may have experienced significantly higher pressure than the dust collector, since an explosion propagating between two containers can result in a phenomenon referred to in literature as pressure piling.³³ However, the drop box was a much weaker structure than the dust collector, lacking substantial framing and joined only by small corner welds, and it was relatively unprotected by explosion venting. The drop box failed mainly along the seams and fractured into several large pieces.³⁴ One of the larger fragments impacted the building wall and was found resting below the impact point (Figure 24). The impact slightly bent the vertical steel wall support beam inward (Figure 25).

Figure 24. Drop box fragment after impact with building wall.

³⁴ CSB calculations indicate that the rupture pressure for the drop box was between 2 and 5 pounds per square inch gage.

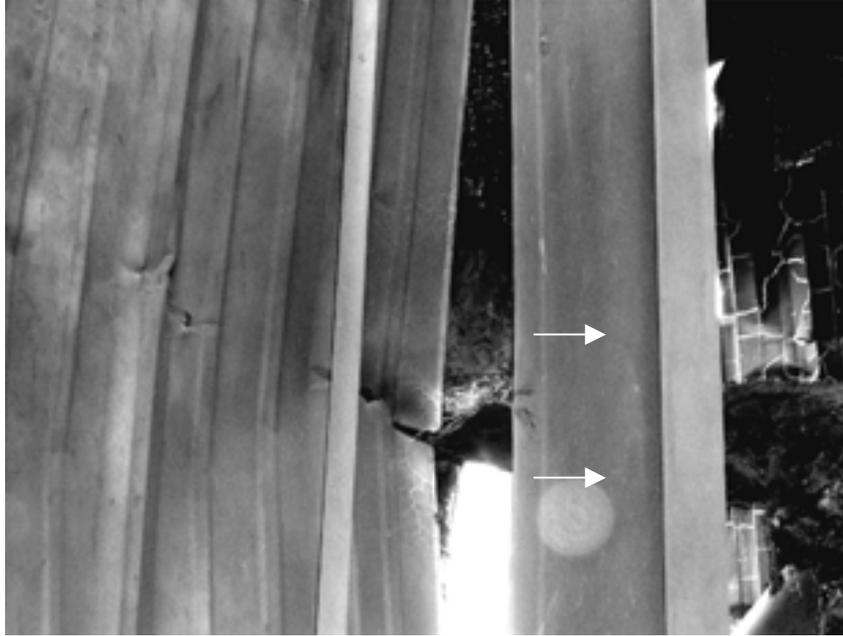
Figure 25. Beam slightly deflected by drop box impact. Arrows on either side of the point of impact show the direction of bending.

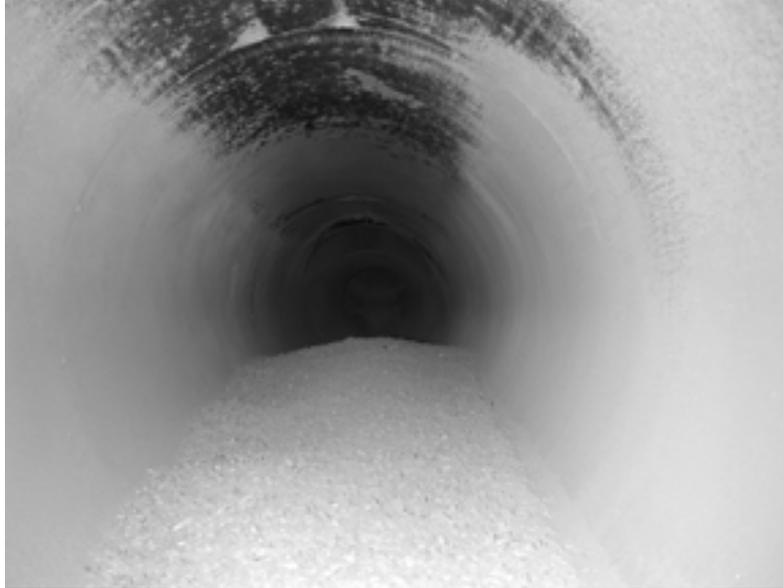
By lofting and igniting dust settled in the ducts (Figure 26), the deflagration also propagated upstream to the furnace 5 chip feed cyclone. CSB concluded that the deflagration traveled down the chip feed pipe and into the vortex box, causing the large fireball to erupt into the room. Witnesses recalled seeing the fireball exit the fume hood and wrap around the furnace. CSB also observed molten aluminum on the front of the victim's safety glasses and splashed onto nearby equipment—further indication that a pressure wave was directed into the vortex box and down into the sidewall.

Figure 26. Interior of main duct between the chip equipment and the drop box with significant dust and chip accumulation.

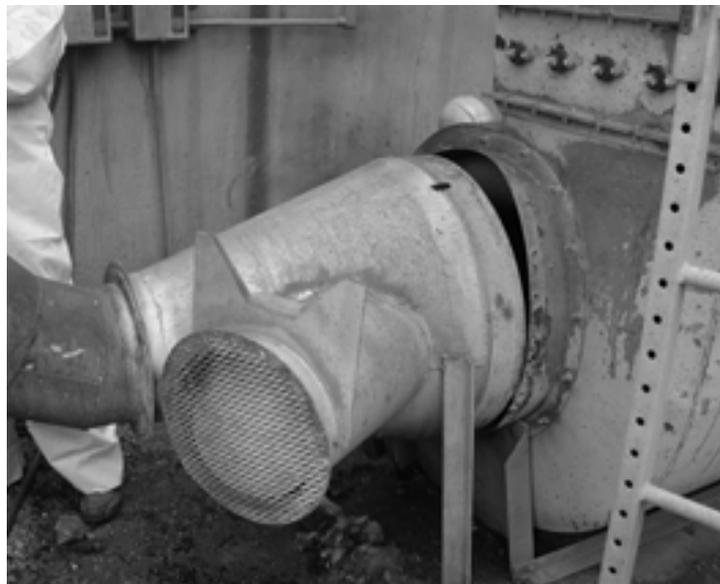
Figure 27. Fume hood exhaust fan cover damaged by overpressure.

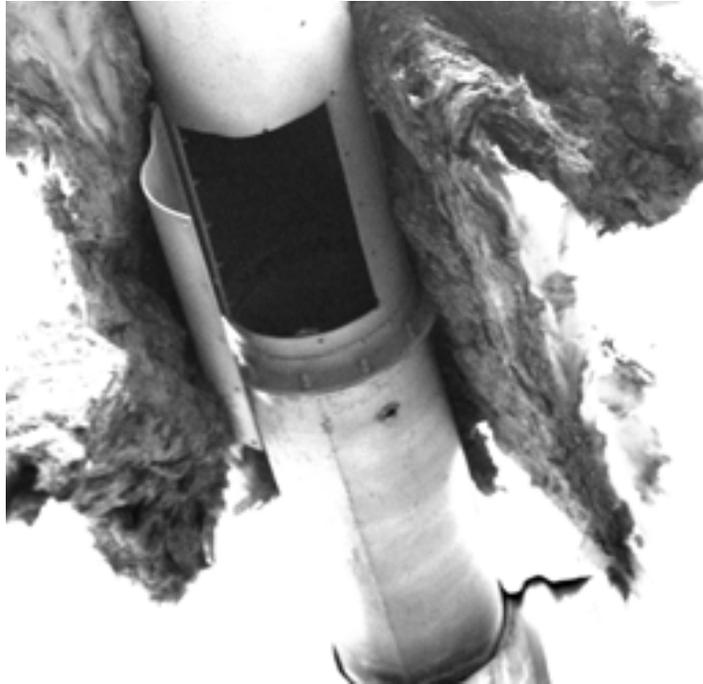
Figure 28. Cleanout door blown open on duct from furnace 5 fume hood to fume separator. Insulation from the roof rests on the duct (Figure 4 shows the location of this duct in the building).

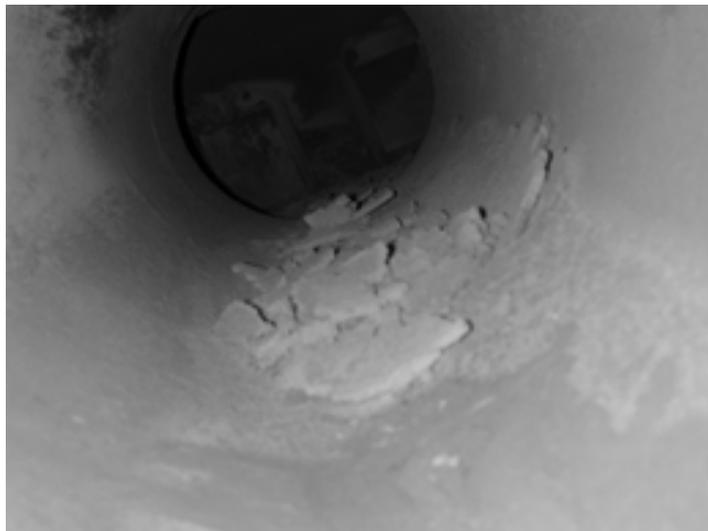
The erupting fireball above the sidewell entered the fume hood, causing burning material to be pulled by the fume separator draft fan along the ducting into the fume separator. This material likely ignited deflagrations inside the ducting and fan housing severe enough to damage the draft fan housing and duct (Figure 27). The cleanout door was blown open on the duct between the fume hood and the fume separator (Figure 28.) CSB found that the duct leading to the fume separator contained hard deposits and dust, which likely were the fuel for the fires in this duct (Figure 29).

Figure 29. Interior of fume duct to fume separator (near the cleanout door.)

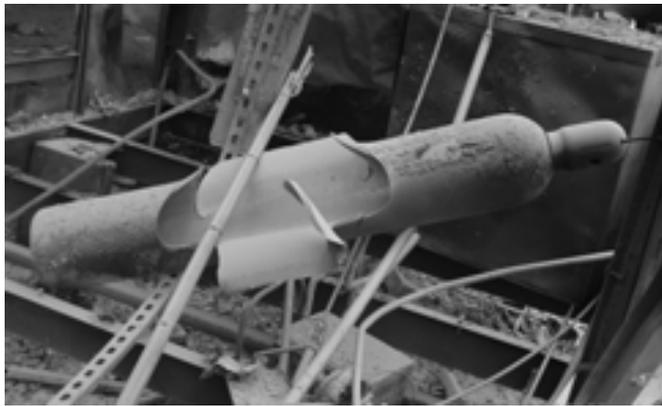
Employees and the Huntington fire chief reported that a series of smaller explosions occurred about 11 minutes after the initial explosion. The fire chief concluded that some of these small explosions could have been the four tires on the contractor trailer failing. After the fire was extinguished, investigators also discovered the remains of high-pressure gas cylinders used for instrument calibration, which had been in the contractor trailer. Figure 30 shows one of the cylinders, lying in the remains of the trailer.

Figure 30. Ruptured gas cylinder in the contractor trailer.

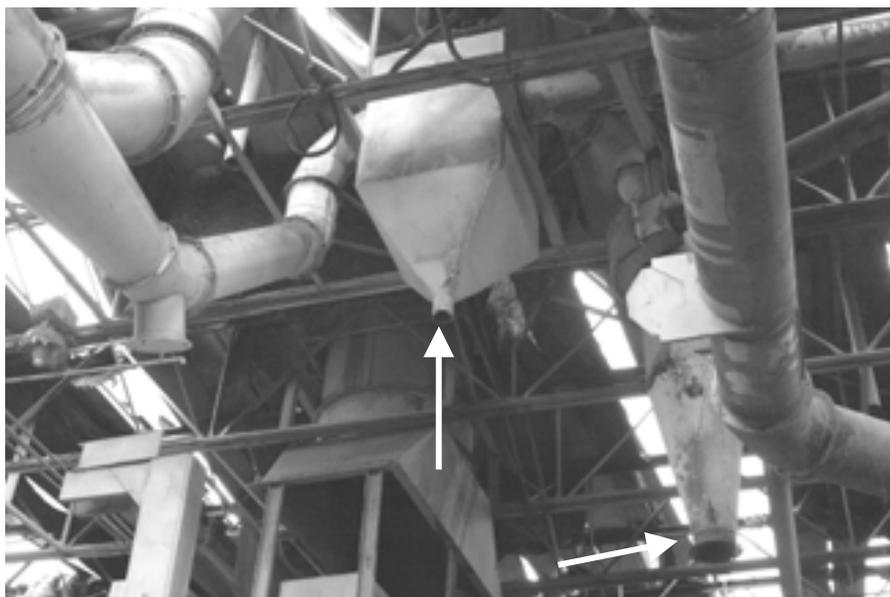
Routine operation of the aluminum melt furnace requires periodic fluxing and drossing to remove impurities from the molten aluminum. Employees recalled that these activities sometimes lofted significant amounts of burning embers.⁴⁰ At least two openings (one at the bottom of the spark box and another on an unused cyclone separator above and close to the sidewell) existed where such embers could be pulled into the dust stream (Figure 31.)

Figure 31. Unused spark box and cyclone, with openings (see arrows) where sparks could be pulled into the dust stream by the airflow.

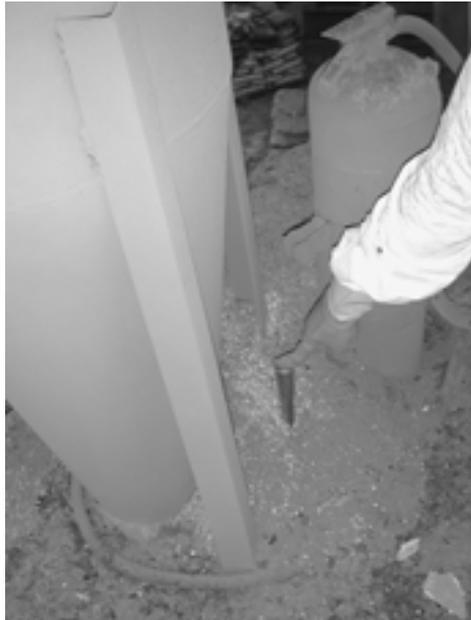
material was up to several inches deep (Figure 33). Employees stated that this was typical of conditions before the incident. Managers and employees CSB interviewed indicated that they were not aware such accumulations presented an explosion hazard.

Figure 33. Typical chip and dust accumulation on floors .
The 4-inch blade of a trowel is buried in the pile.

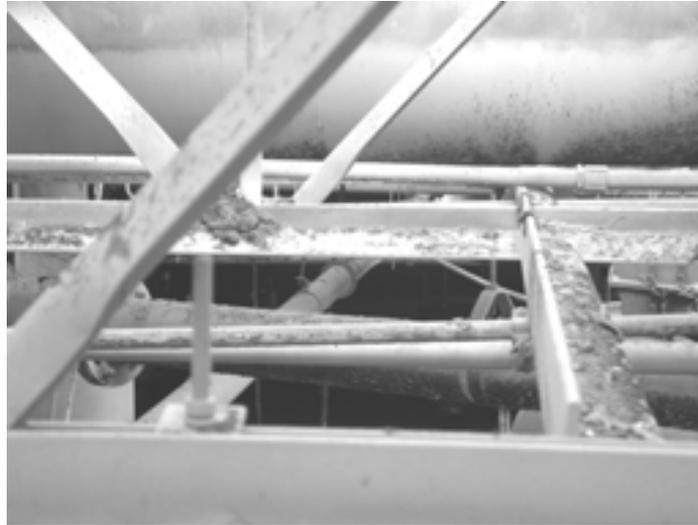
Investigators observed that a layer of dust topped off piles of spilled chips they found throughout the furnace 5 area. Surfaces above the furnace (i.e., ducts, beams, ledges) were covered with even finer dust, which had been carried aloft in air currents. In many areas, dust layers were at least 2 inches thick. (Figure 34). In a dust release of mixed particle sizes, the smaller particles stay aloft longer on air currents and are carried higher. CSB found that dusts on the higher ledges appeared as fine as talcum powder (commercial talc particles are typically in the range of 10 to 20 microns in diameter.)

Figure 34. Dust accumulation on roof trusses.

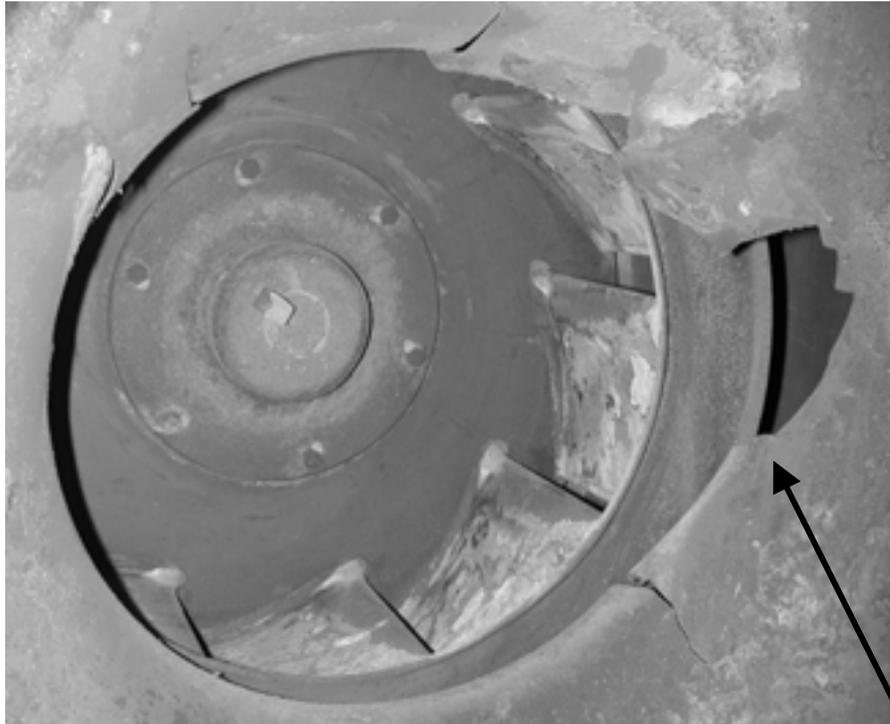
The condition of the dust collector draft fan (Figure 35) was another indication that dust collector maintenance was inadequate. CSB found that the fan housing was eroded, which is typically caused by dust leaking through or past the filters.

Figure 35. Interior of dust collector draft fan housing, showing erosion (arrow)
