INVESTIGATION REPORT

COMBUSTIBLE DUST FIRE AND EXPLOSIONS

CTA ACOUSTICS, INC.

REPORT NO. 2003-09-I-KY

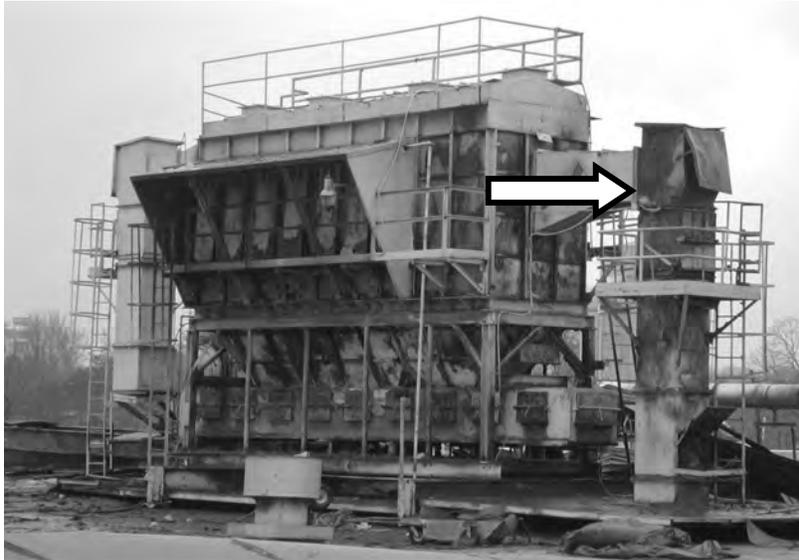
Two operators on the roof stated that moments after the baghouse was turned back on at 7:30 am, flames shot up through the inlet ducts, into and out of the baghouse (Figure 4). Both operators were burned—one received minor facial burns; the other received second-degree burns to his hands and face, which required a lengthy hospital stay. Inside the plant, personnel located about 80 feet northwest of line 405 observed smoke coming from the line prior to the initial explosion. Once the explosion occurred, personnel both heard it, and saw a fireball emerge from the south end of the oven.

Figure 4. Fire damage to inlet duct of line 405 baghouse.

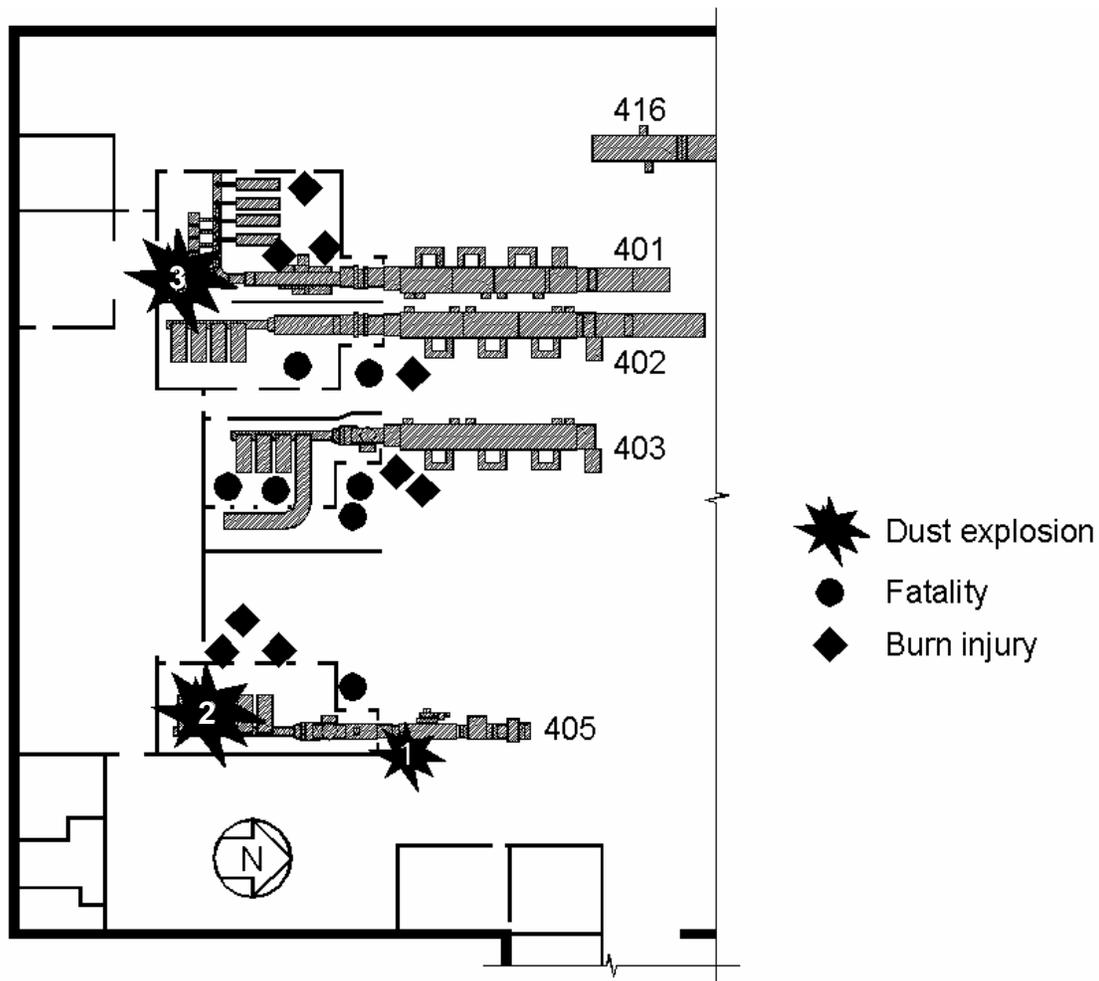
Figure 5 depicts the sequence of explosions and shows the likely locations of those who were burned in the production area. See Section 5.4 for a description of the extent of injuries to employees.

Figure 5. Sequence of dust explosions and likely locations of those killed and burned in the production area (Note: All employee injuries not shown in figure).

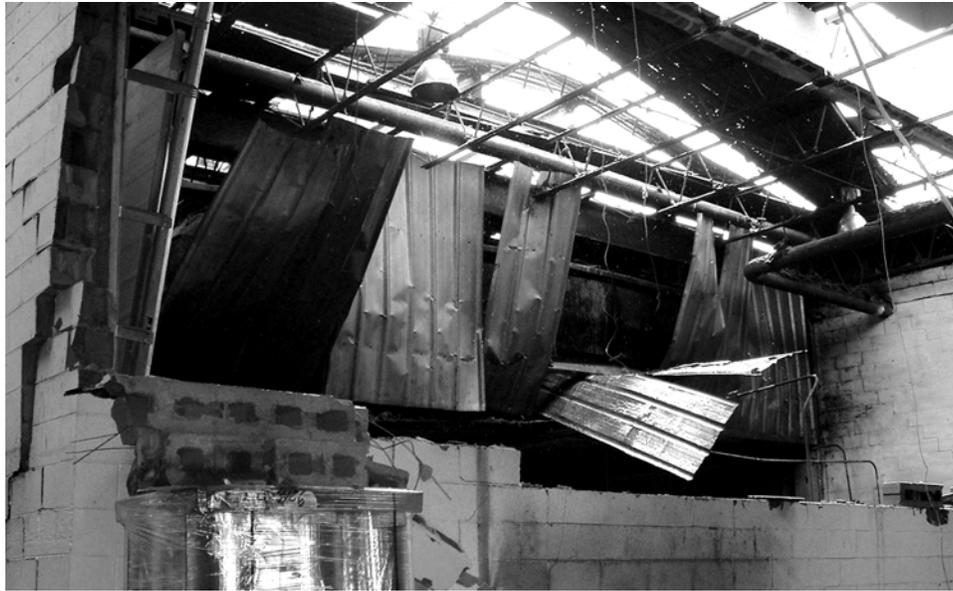
The fireball generated by the initial explosion near the line 405 oven ignited dispersed combustible dust, which caused a secondary explosion in the relatively confined area above the line 405 blend room. The force of this explosion damaged the firewalls to the east and south and pushed metal wall panels above the blend room roof on the south side out to the south (Figure 6). The explosion also pushed ceiling

panels and lights down inside the blend room. The pressure wave vented out of the building, damaging metal wall panels on both the south and east outer walls.

Figure 6. Collapsed firewall and metal panels at south end of line 405 blend room.

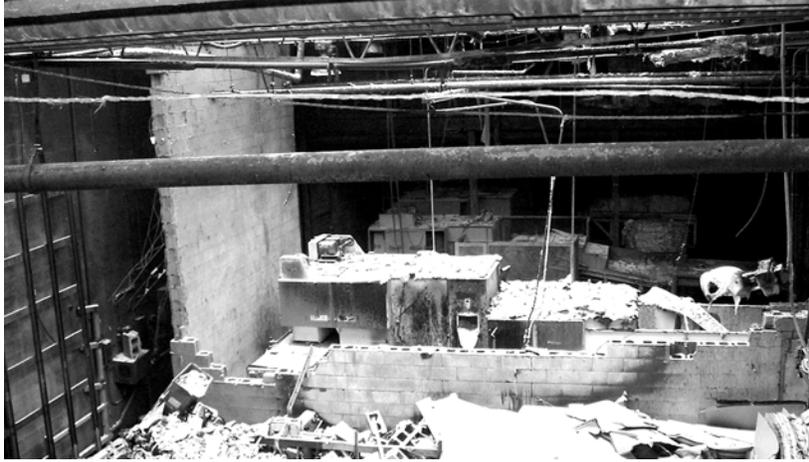
- A collapsed firewall between lines 403 and 405 (Figure 7).
- Metal wall panels above the line 403 blend room on the east side that were blown to the west.
- Burnt residue on the building's roof trusses.

Figure 7. Collapsed firewall between lines 403 and 405.

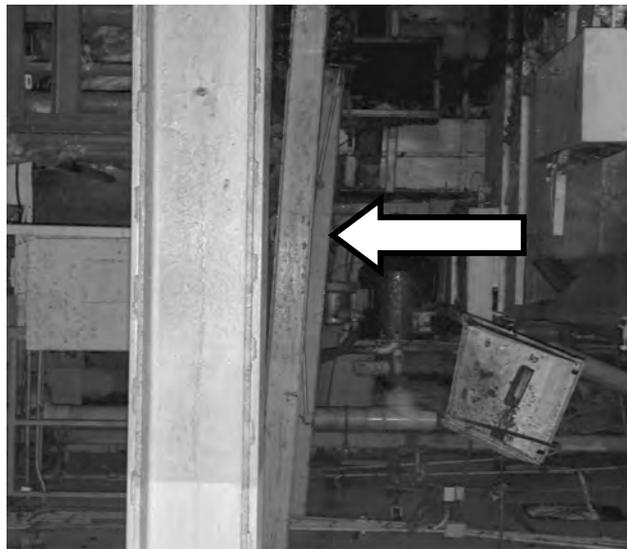
The fireball continued to move west over the top of the line 402 blend room and into line 401. CSB investigators noted extensive explosion damage at line 401, nearly 300 feet from the initial explosion's point of origin at line 405. Physical evidence revealed that an additional secondary dust explosion

occurred in the southeast corner of the line 401 blend room, another confined area. The firewall south of line 401 was partially collapsed, and concrete blocks dislodged from this wall fell to the south. The force of the dust explosion pressure wave likely bent a steel column on the west side of the blend room (Figure 8). Metal panels of the north and west walls were deformed outward. A large hole was blown in the building roof above the southeast corner of the blend room.

Figure 8. Bent support column in line 401 blend room.

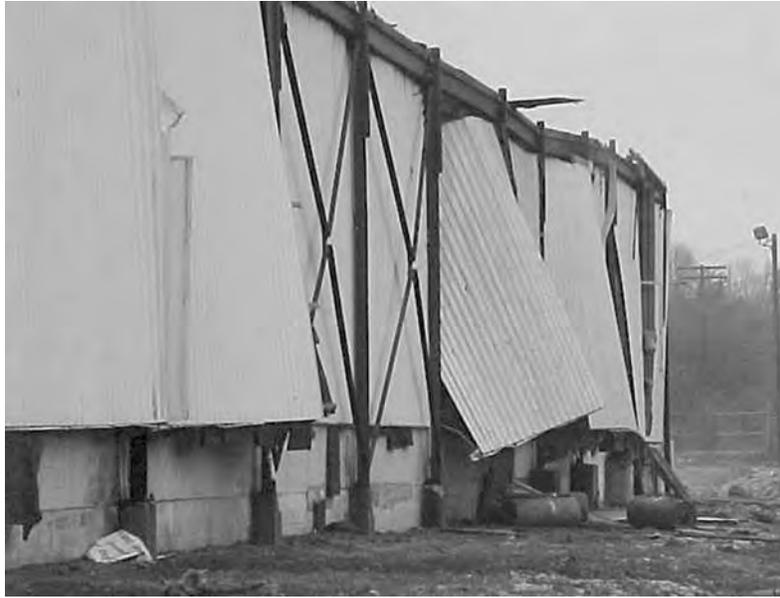
Figure 9. Explosion damage to exterior plant wall at southwest corner of building.

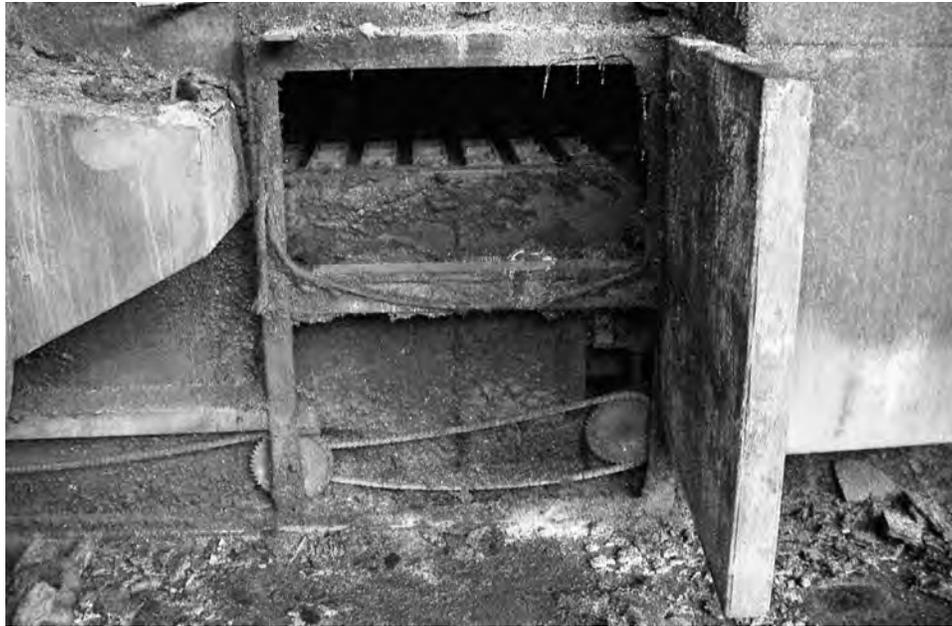
CSB also examined the interior of the oven; virtually all the combustible material that likely had been inside was burned away (Figure 13). In contrast, the interior of the ovens on lines 401, 402, and 403 contained accumulations of resin powder/fiberglass debris. The chain-driven oven flights for 405 were

burned clean but otherwise intact and undamaged. Metal discoloration was noted on the interior of the line 405 oven; however, CSB found no evidence of explosion damage inside the oven.

Figure 13. Interior of line 405 oven.

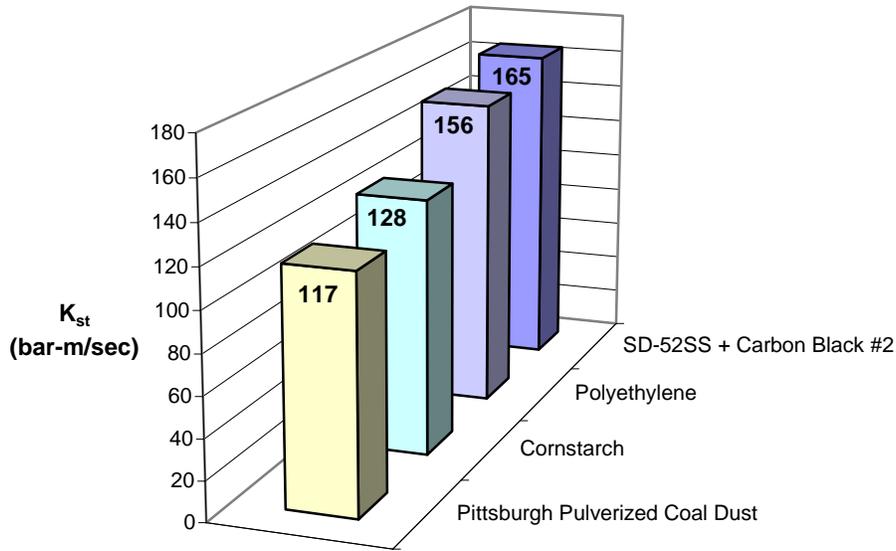
Test data from the resin samples were also compared to the explosion characteristics of other common combustible dusts—namely, Pittsburgh coal dust, polyethylene dust, and cornstarch. Figure 14 shows that the Borden Chemical black phenolic resin used at CTA has a higher K_{st} value than the other dusts.

Figure 14. Explosion severity of Durite SD-52SS compared with other common combustible dusts.

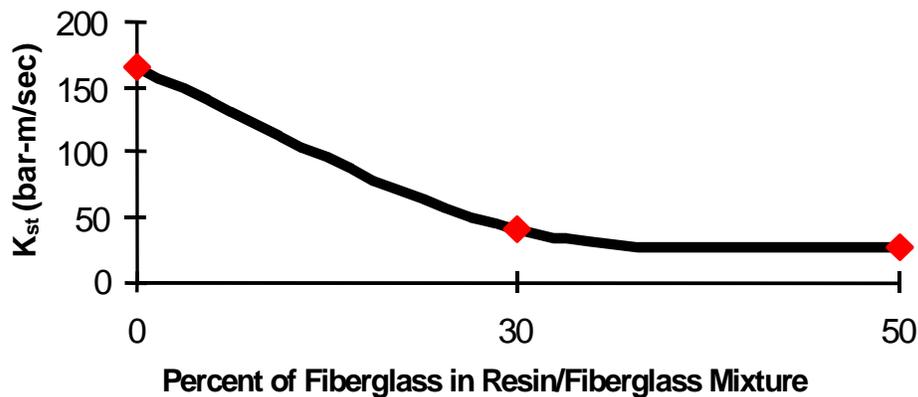
Dust that settled in the CTA production area was typically a mixture of phenolic resin and small fiberglass fibers. Samples of ground fiberglass and phenolic resin were mixed in varying percentages in the CSB contractor’s laboratory and tested. The test results show that as the fiberglass content increased, the mixtures remain explosible, but explosion severity decreased (Figure 15).

Figure 15. Explosivity testing results for resin/fiberglass mixtures.

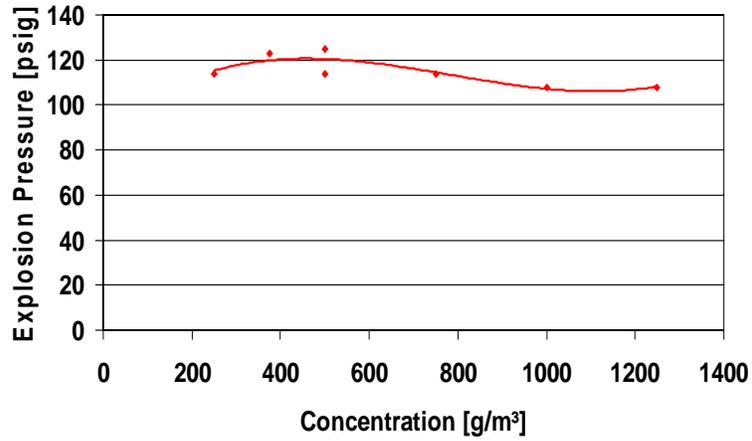
Figures B-1 and B-2 show test overpressures and rates of pressure rise as a function of concentration, respectively. The highest values of each over the entire concentration range determined P_{\max} and $(dP/dt)_{\max}$. For comparison, Figure 14 (Section 7.2) shows explosion severity data for polyethylene, Pittsburgh coal dust, and cornstarch.

Figure B-1. Durite SD-52SS overpressure versus concentration.

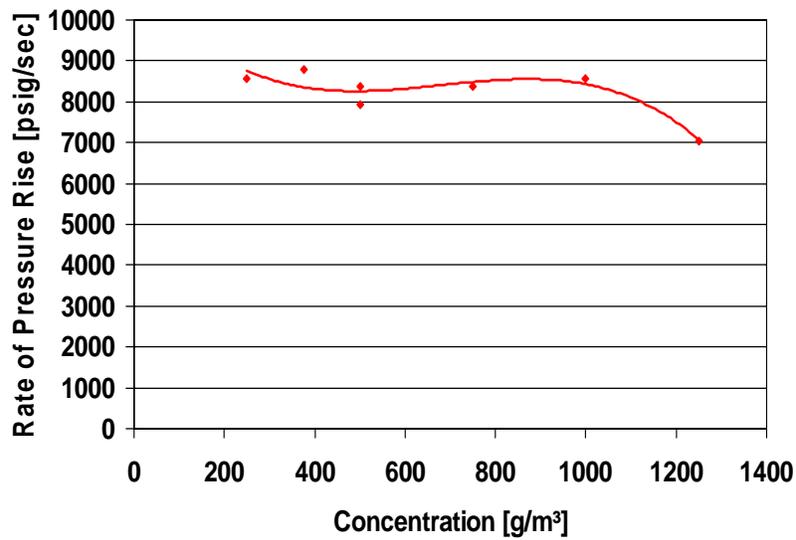
Figure B-2. Durite SD-52SS rate of pressure rise versus concentration.

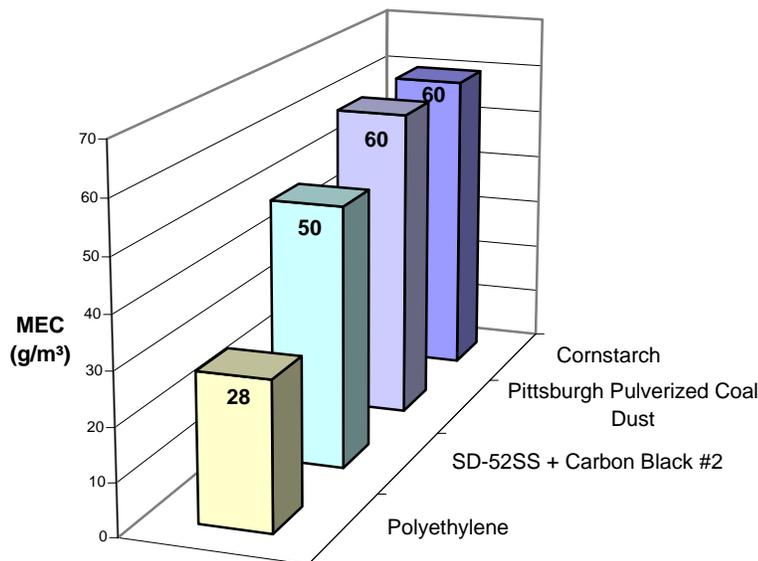
Figure B-3 compares MECs for the Borden Chemical SD-52SS phenolic resin, Pittsburgh coal dust, polyethylene dust, and cornstarch.

Figure B-3. Minimum explosive concentration of Durite SD-52SS compared with other common combustible dusts.

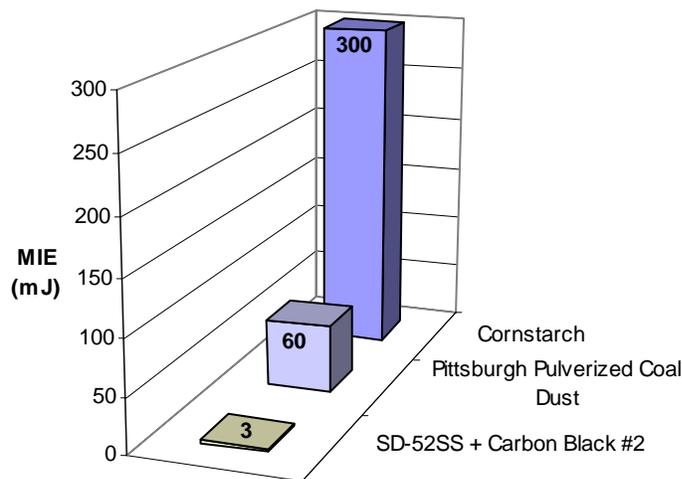
Figure B-4 shows MIE test results for a Durite SD-52SS dust cloud in air. Results indicate that the phenolic resin is very easy to ignite, requiring only 3 millijoules (mJ) of energy to initiate an explosion.

Figure B-4. Minimum ignition energy of Durite SD-52SS compared with other common combustible dusts.

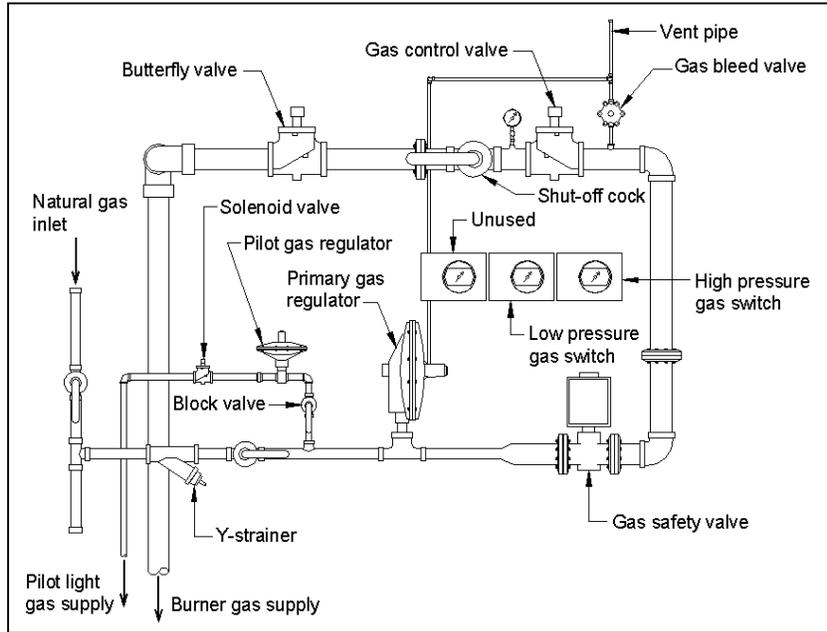
No significant external gas leaks into the building were found. All internal gas leaks (i.e., gas control valve, gas bleed valve) would have been directed to the externally piped gas vent line.

CSB reviewed these findings and conclusions and determined that equipment testing results identified no single component failure as the cause of the incident.

Figure C-1. Oven natural gas piping manifold.
