U.S. CHEMICAL SAFETY AND HAZARD INVESTIGATION BOARD

# INVESTIGATION REPORT

### MOTIVA ENTERPRISES LLC

DELAWARE CITY REFINERY  
DELAWARE CITY, DELAWARE  
JULY 17, 2001

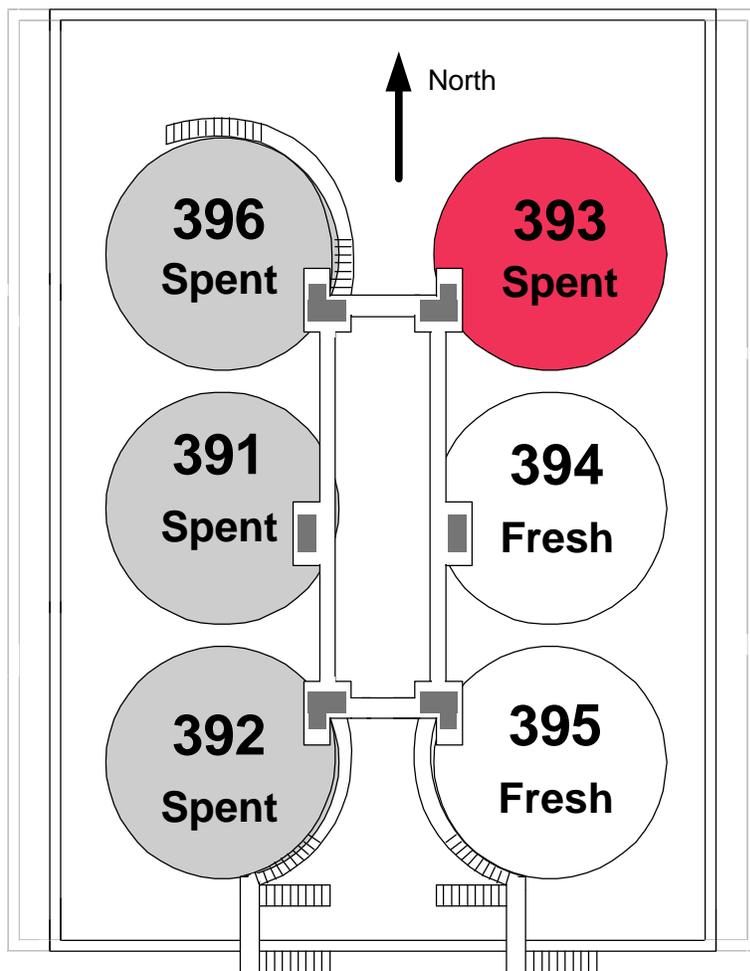
Sulfur dioxide vapors from the storage tanks combined with moisture in the air to form sulfurous acid, which was causing the deterioration of the catwalk.

Figure 1. Layout of acid storage tanks and catwalk.

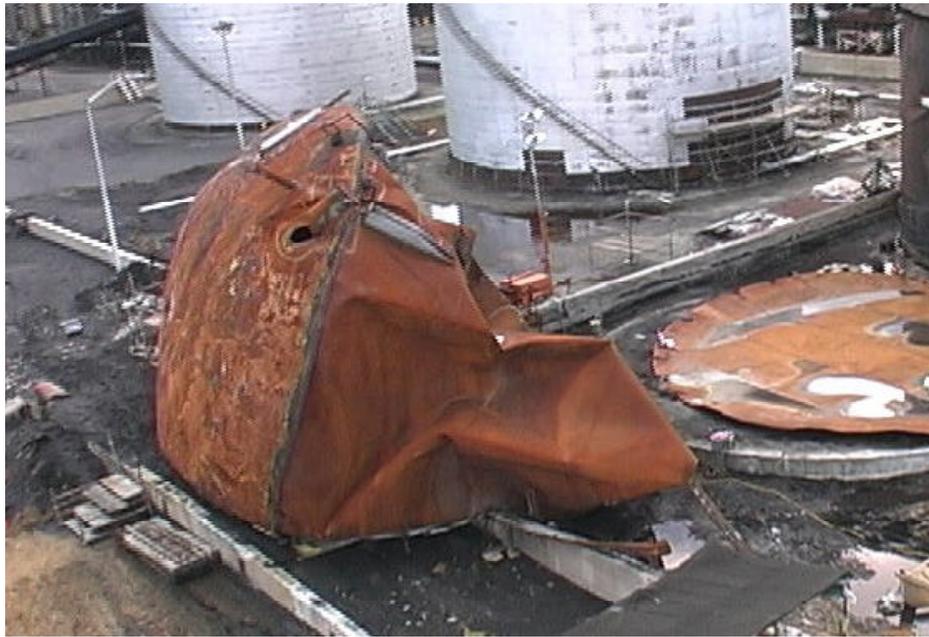
Figure 2. Tank 393, collapsed at northeast corner of storage tank dike.  
(Note floor of tank 393 to the right of tank shell.)

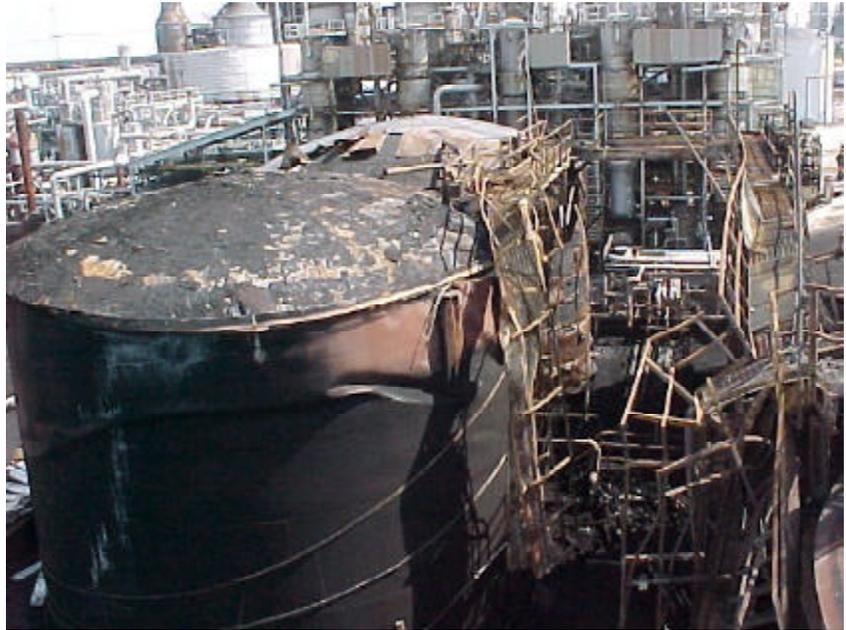
Figure 3. Tank 394 in foreground and remains of catwalk, from the north.

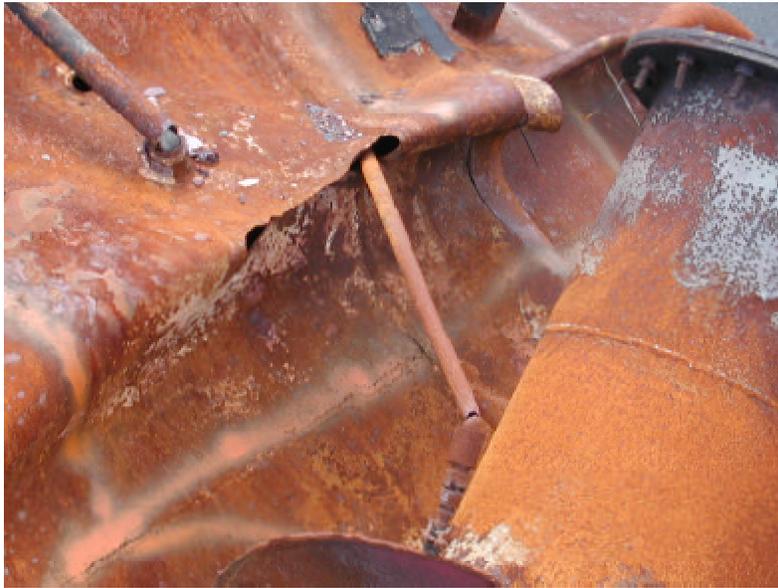
Post-incident analysis revealed three additional openings in the roof and shell of tank 393 that were believed to have been present prior to the incident:

Figure 5. Elongated hole on roof of tank 393 (covered by insulation at time of incident).

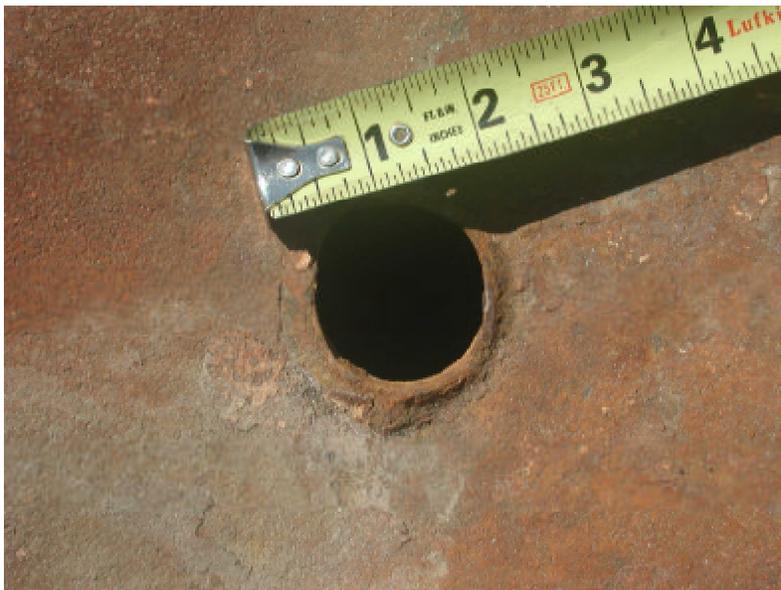
- The hose supplying CO<sub>2</sub> was not attached to tank 393. It was dropped into a hole in the roof, where a nozzle had been located before it corroded. The temporary hose setup was in use for over a year; it was not converted to conventional hard piping, as on the other acid tanks.

Figure 6. Hole in roof of tank 393 through which temporary hose was inserted.

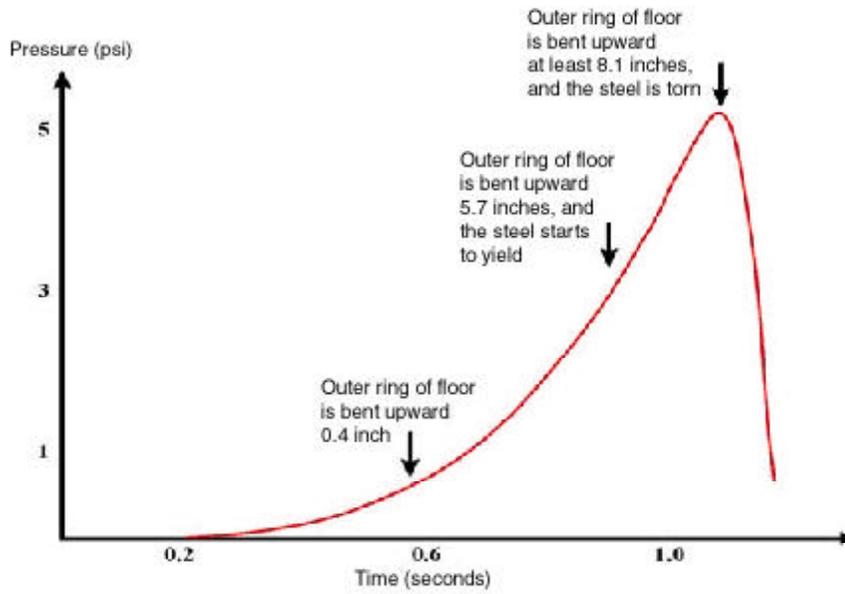
... the peak pressure within the tank—5.0 psig—would have been reached approximately 1 second after ignition of the vapors.

Figure 7. Modeled pressure rise in tank 393 during internal deflagration.

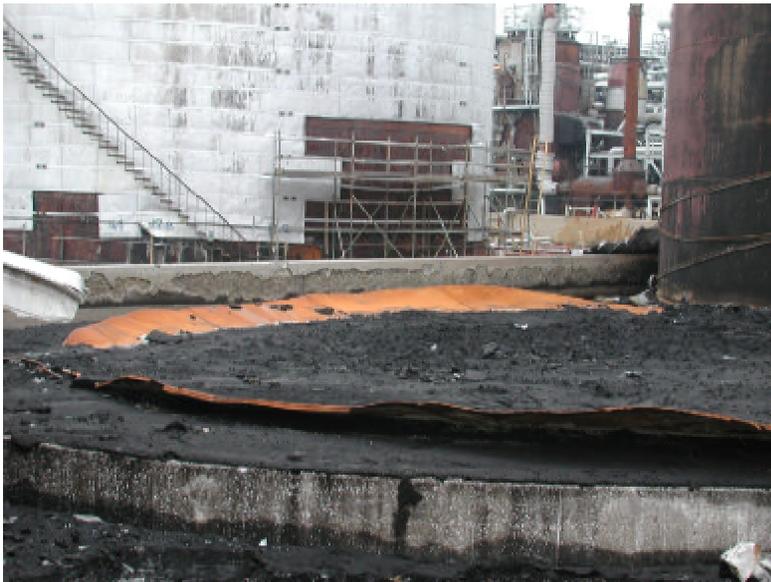
Figure 8. Floor of tank 393 showing uplift due to internal deflagration (before separation of shell).

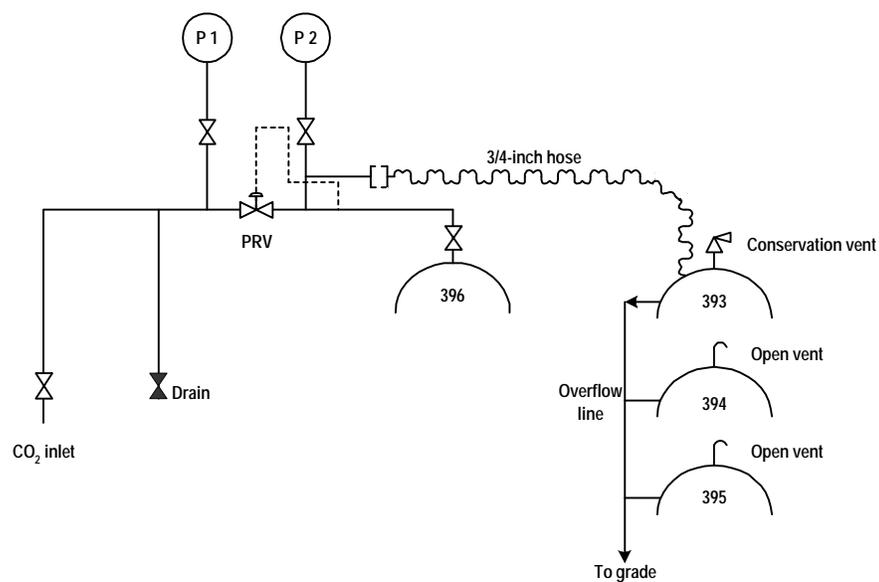
When tanks 391 and 396 were converted to spent acid service in 1997, each tank was equipped with a pressure regulator valve to control CO<sub>2</sub> flow and two local pressure gauges. However, when the inerting system on tank 393 was installed in March 2000, it was set up in a different manner (Figure 9).

Figure 9. Inerting system schematic (CO<sub>2</sub> flow to tank 393 and overflow connection to 394/395).
