## Williams Geismar Olefins Plant

### Reboiler Rupture and Fire

### Geismar, Louisiana

No. 2013-03-I-LA

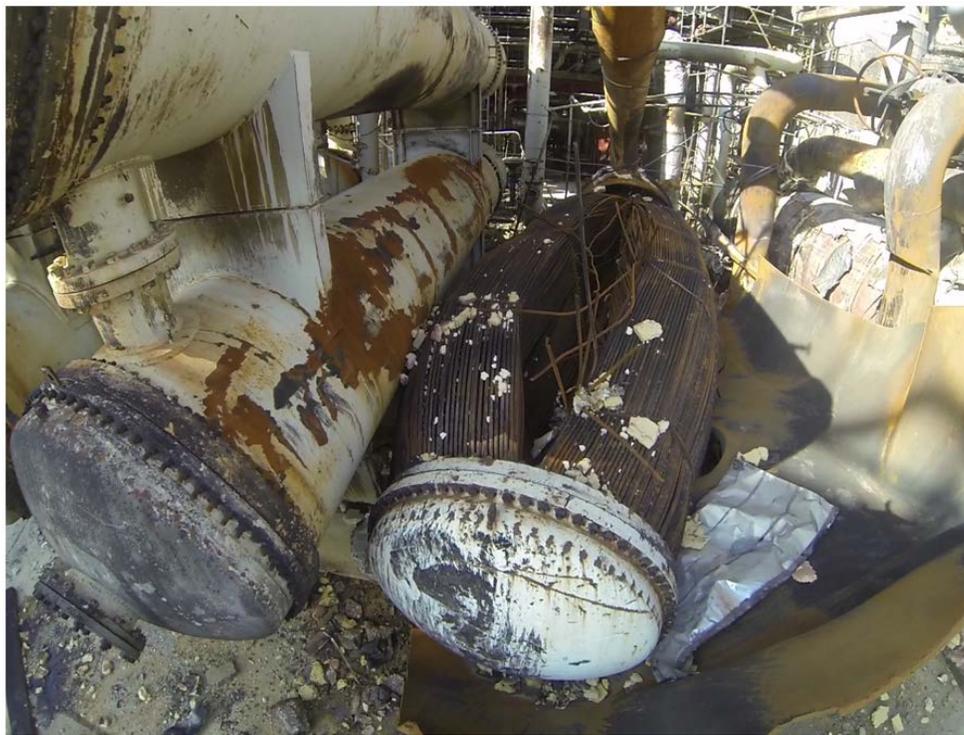
**FIGURE 7**

Post-incident photo of the ruptured Reboiler B.

The high pressure generated from liquid thermal expansion of the propane cracked the reboiler shell. The shell contents began to vaporize near the crack opening, and a jet release of liquid and vapor accelerated out of the crack. The pressure loading on the open edges of the crack caused the crack to continue to grow along the vessel length. As the crack opening increased in size, the liquid and vapor jet release also rapidly grew. The continued internal pressure caused the reboiler shell to fail suddenly and catastrophically, splitting wide open (Figure 7 and Figure 12).

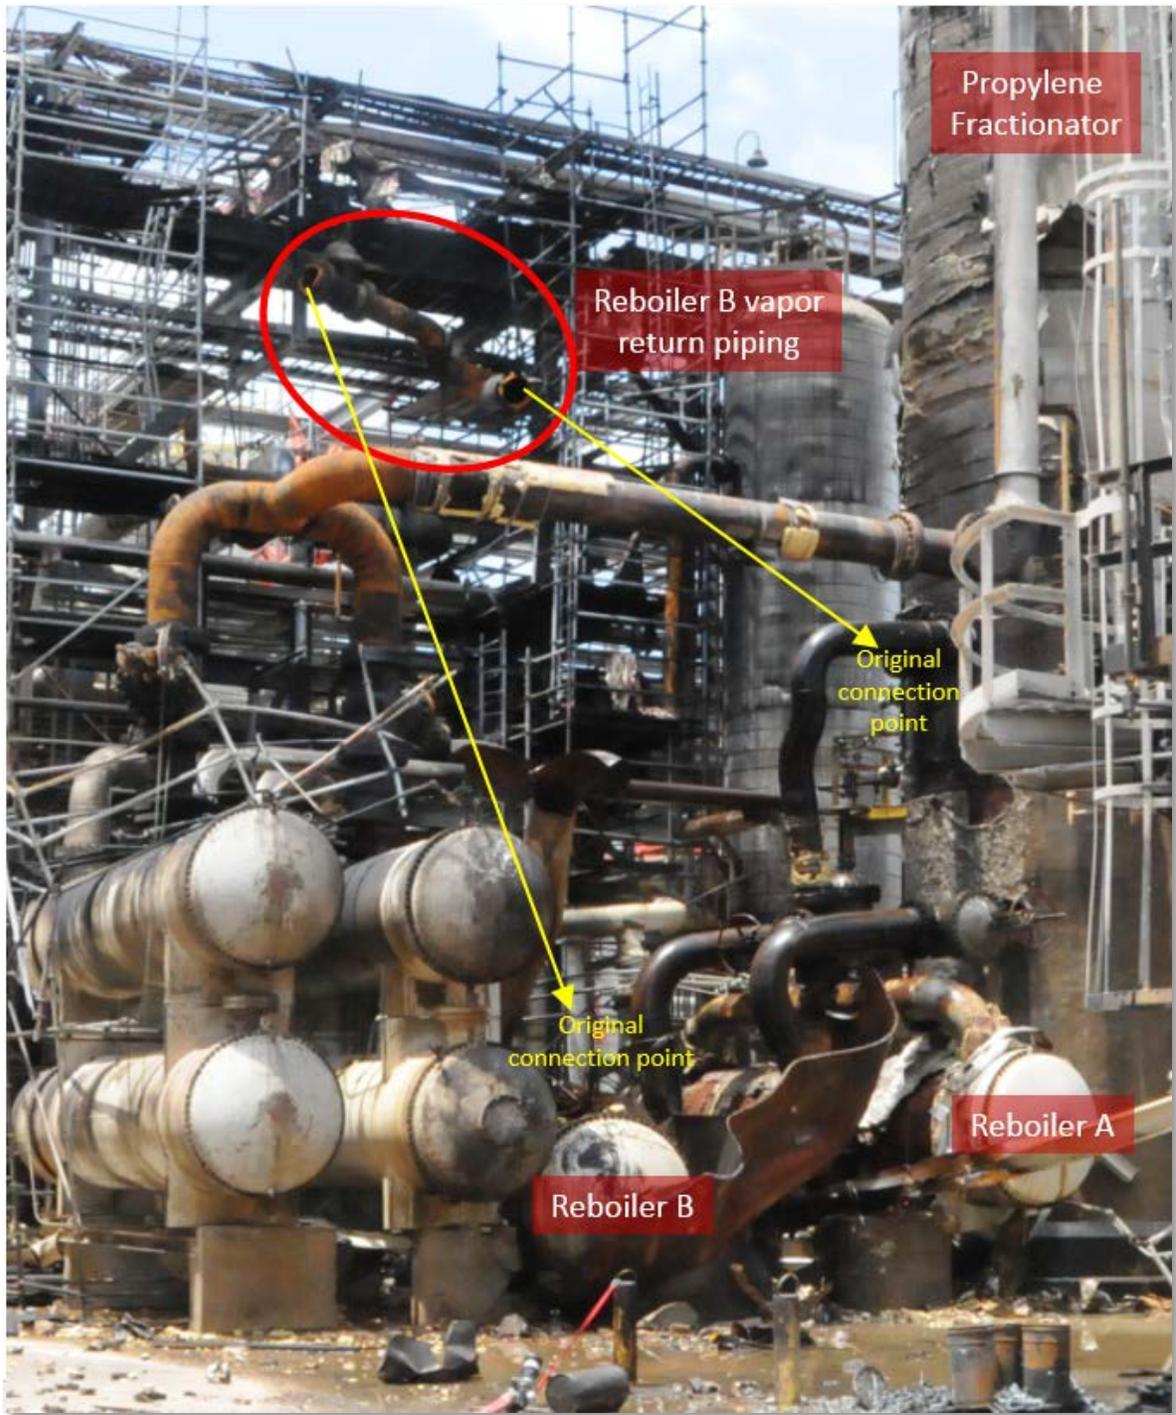
**FIGURE 8**

Post-incident photo of the propylene fractionator reboilers and surrounding area. The Reboiler B vapor return piping can be seen overhead in the pipe rack (red circle). The approximate original configuration of the piping and equipment is shown in Figure 9 and Figure 14.

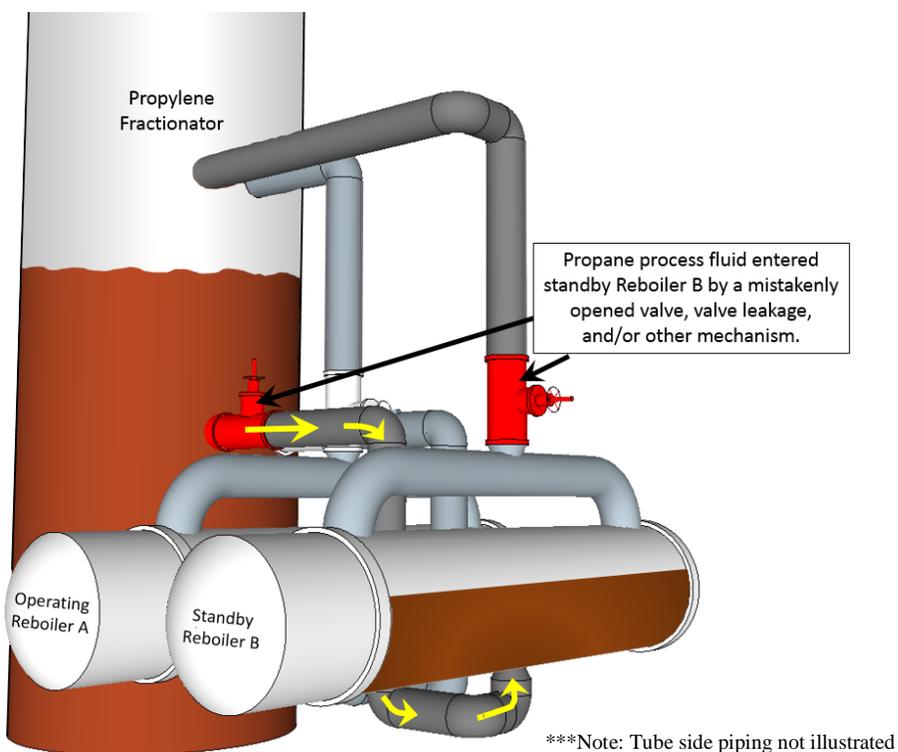
**FIGURE 9**

Closed gate (block) valves leak, and they are susceptible to inadvertent opening. Both scenarios can introduce process fluids to offline equipment. More robust isolation methods, such as inserting a blind, can better protect offline equipment from accumulation of process fluid.

Propane process fluid mixture entered standby Reboiler B by a mistakenly opened valve, valve leakage, and/or another mechanism.

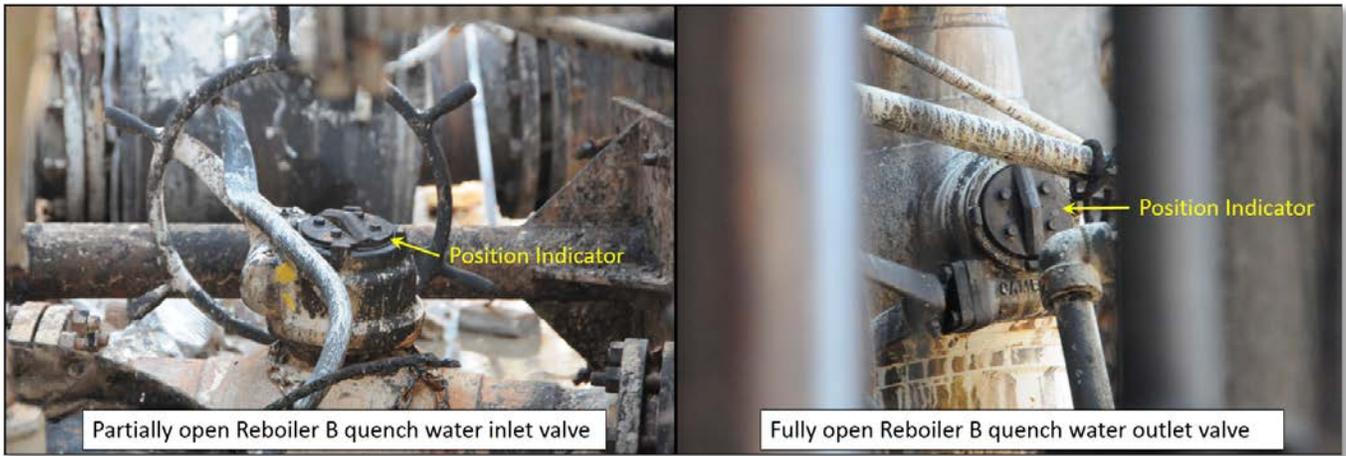
**FIGURE 10**

Post-incident, the Reboiler B quench water inlet ball valve was found partially open (left), and the Reboiler B quench water outlet ball valve was found fully open (right). When the position indicator is parallel to the pipe, the valve is open; when the position indicator is perpendicular to the pipe, the valve is closed.

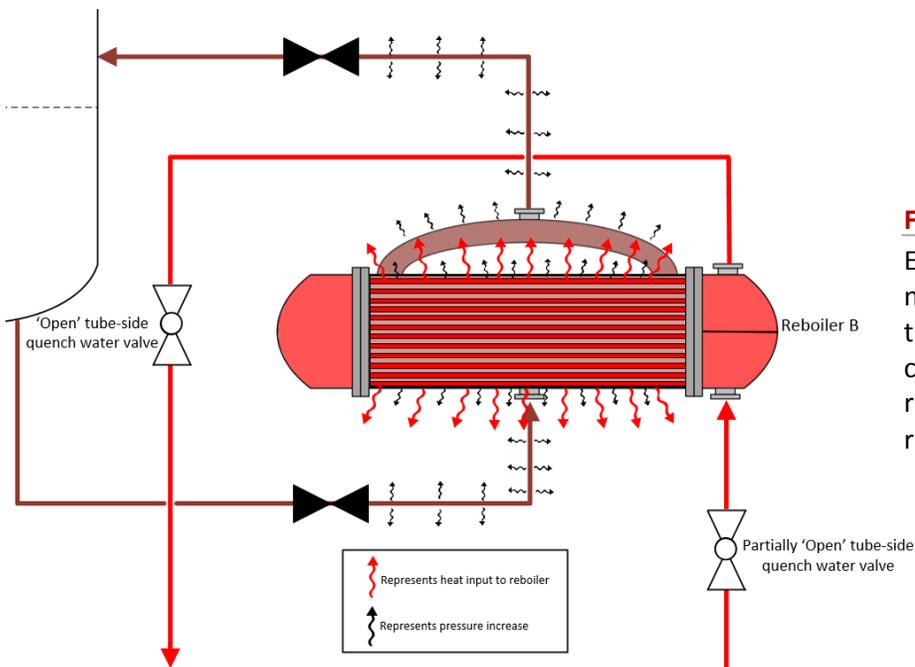
**FIGURE 11**

When the Reboiler B hot quench water valves were opened, the liquid propane within the standby Reboiler B shell began to heat up. This caused the liquid propane to increase in volume due to liquid thermal expansion,<sup>23</sup> filling any remaining occupiable vapor space within the shell. When the liquid could no longer expand due to confinement within the blocked-in Reboiler B shell, the pressure rapidly increased<sup>24</sup> until the internal pressure exceeded the shell's mechanical pressure limit (Figure 11), and the reboiler shell failed.<sup>25</sup>

Expanding shell-side liquid propane could not sufficiently increase in volume due to the lack of overpressure protection and the closed shell-side process valves. As a result, shell-side pressure increased until reboiler shell failed.

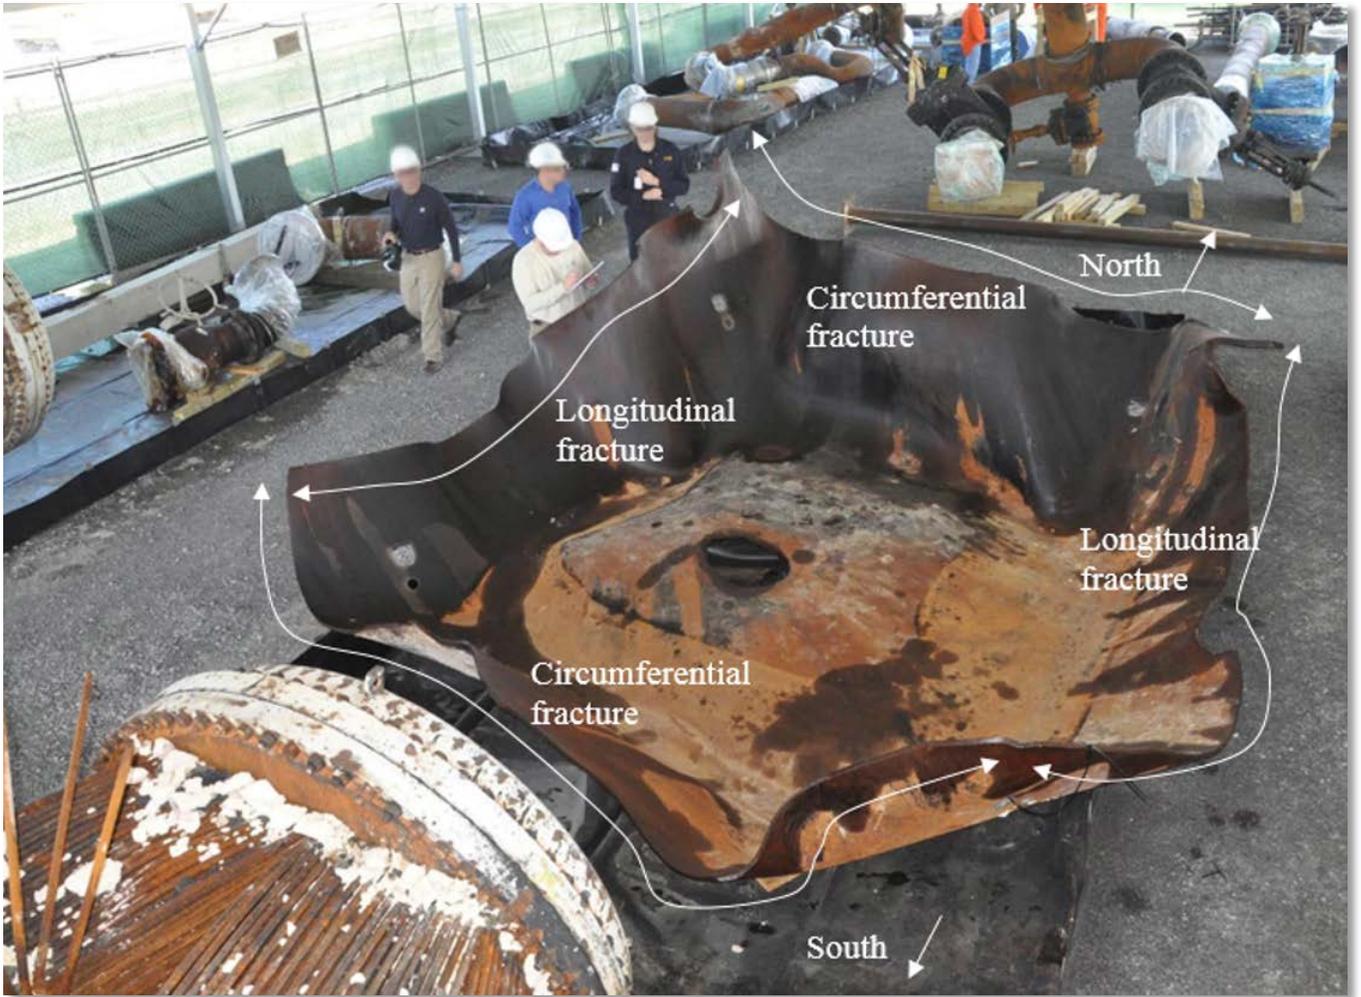
**FIGURE 12**

The propane then found an ignition source and ignited, creating a massive fireball. The blast effects flattened the reboiler shell (Figure 12).

Post-incident photo of Reboiler B shell. The pressure forces during the event flattened the cylindrical steel reboiler shell.

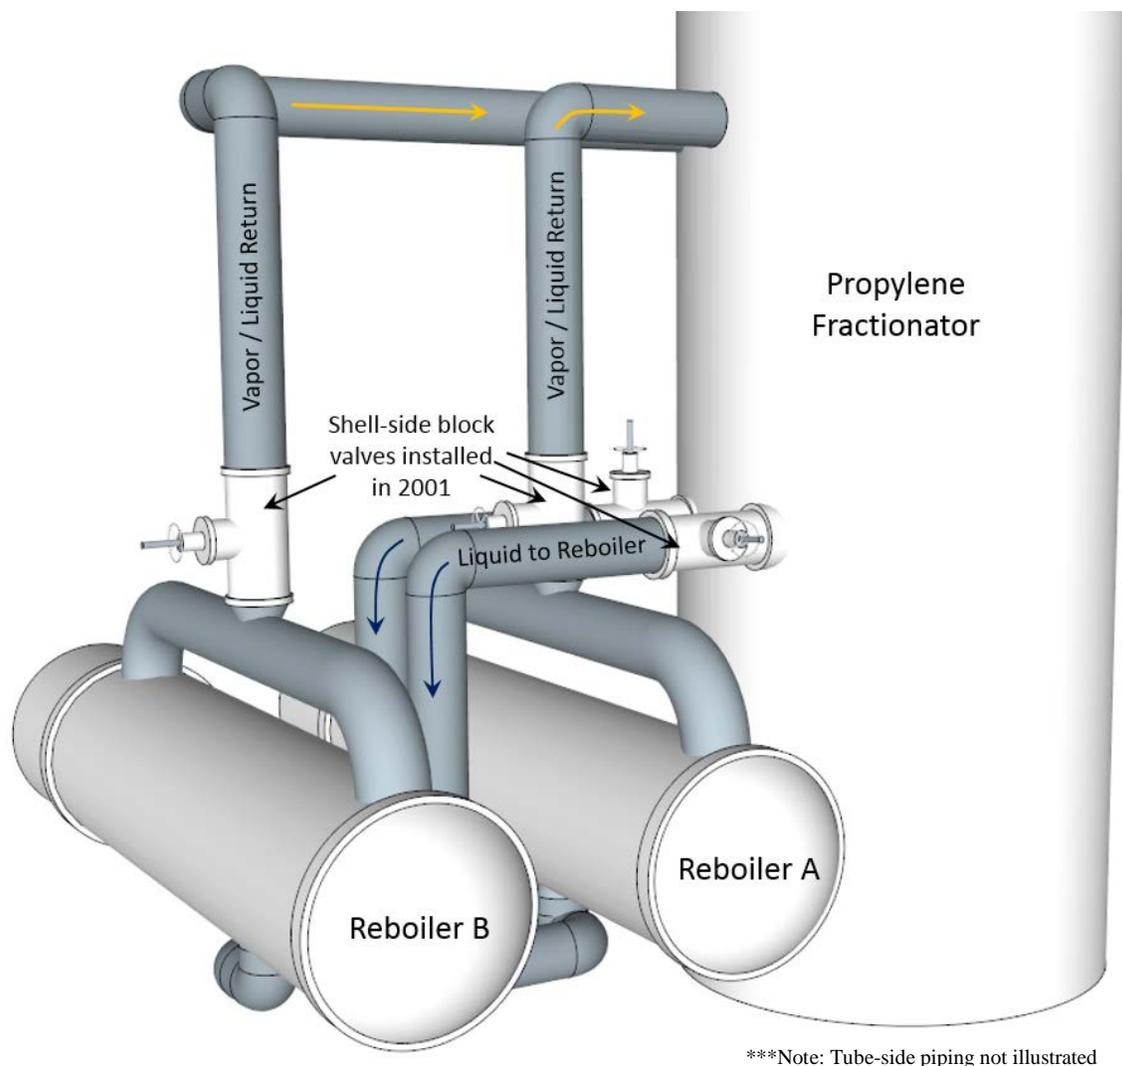
**FIGURE 14**

The original 1967 design of the propylene fractionator required both Reboiler A and Reboiler B in service at the same time. This design had no valves between the reboilers and the propylene fractionator, protecting the two reboilers from overpressure with the relief device located on top of the propylene fractionator. In subsequent years, Williams determined that the propylene fractionator could operate with only one reboiler in service. Operating with a single reboiler allowed continuous propylene fractionator operation and avoided shutdowns when the reboiler tubes fouled and required cleaning. To implement single reboiler operation, in 2000 Williams Geismar management approved a \$270,000 investment to install valves on both the process side and quench water side of six of the quench water heat exchangers, including the propylene fractionator's Reboiler A and Reboiler B. In 2001, Williams installed the valves (Figure 14); however, Williams did not identify the overpressure hazard that resulted from this change.

Illustration of the propylene fractionator reboilers prior to the incident, with shell-side piping shown. The four shell-side process valves were installed in 2001.
