# Investigation Report

Published: July 29, 2022

- Pressure Vessel Corrosion
- Pressure Vessel Inspection and Regulation
- Pressure Vessel Repair
- Process Safety Management Systems

On April 3, 2017, an explosion occurred at the Loy-Lange Box Company (Loy-Lange) in St. Louis, Missouri. The incident occurred when the bottom head of a pressure vessel called a Semi-Closed Receiver, which was used in Loy-Lange's steam system, catastrophically failed. The pressure vessel failure caused a boiling liquid expanding vapor explosion (BLEVE) which fatally injured the Loy-Lange employee working nearby and launched the pressure vessel from the Loy-Lange building into the air. The vessel eventually crashed through the roof of a nearby business, fatally injuring three members of the public.

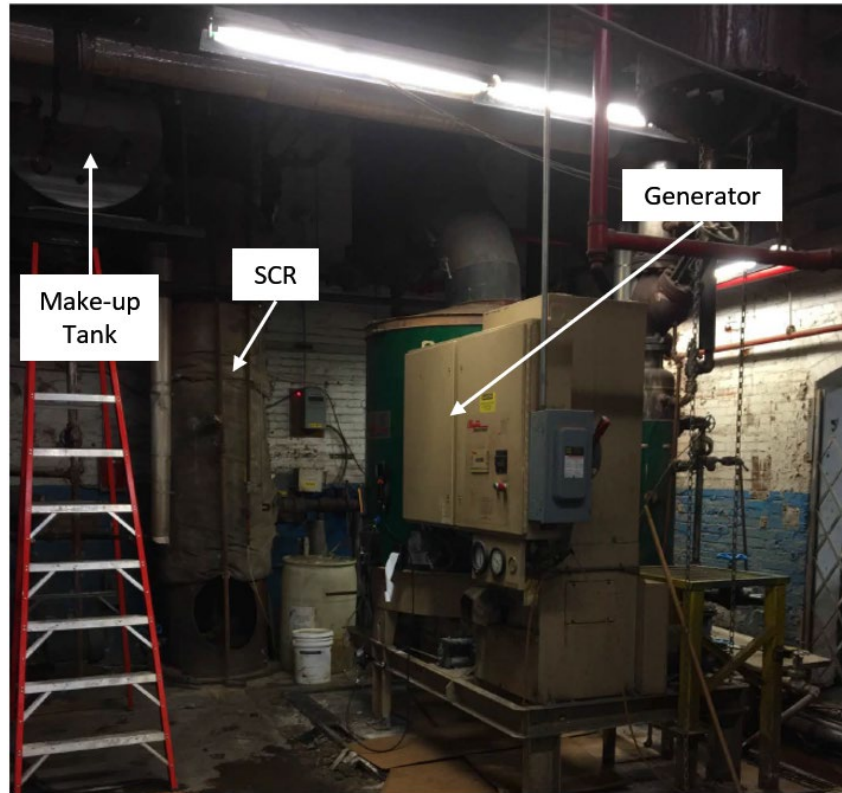
A pre-incident picture of the Loy-Lange steam generation room is shown below in **Figure 3**, which also shows the close proximity of the SCR to one of the steam generators.

**Figure 3.** Pre-incident photo of the Loy-Lange steam generation equipment.  
(Credit: Clayton. Annotated by CSB.)

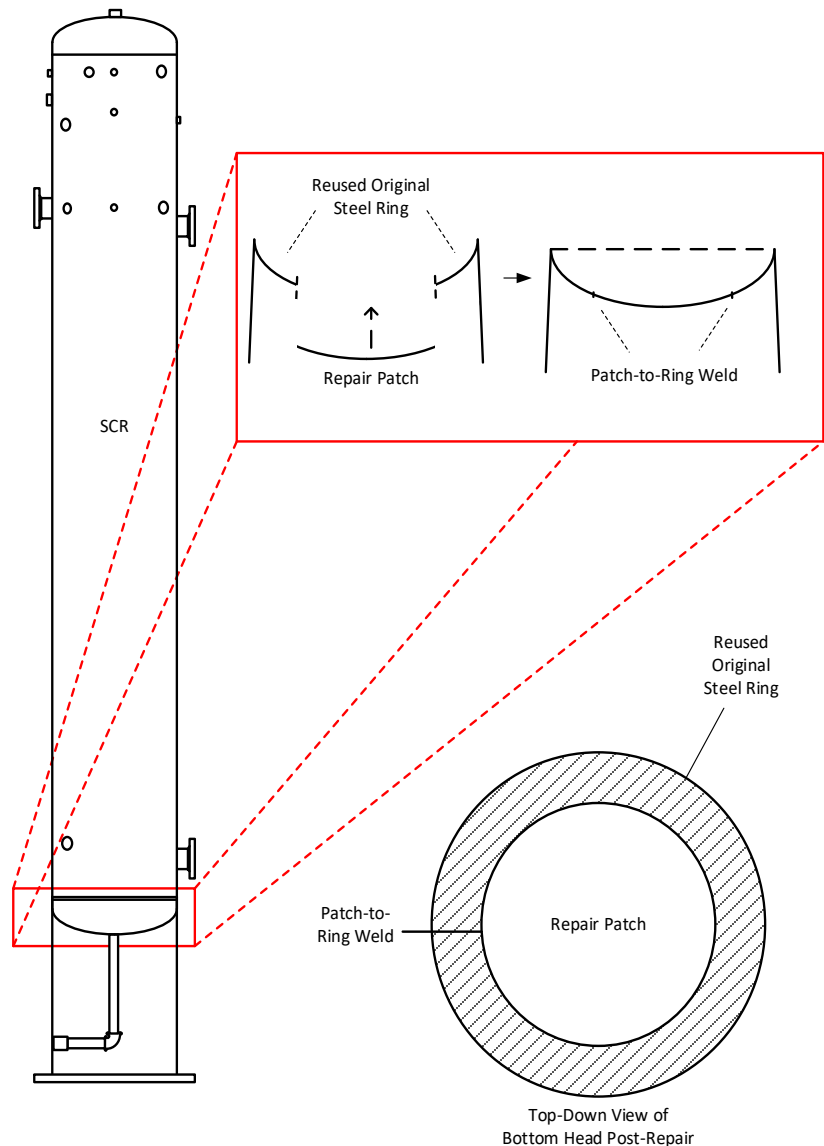
As illustrated in **Figure 7**, Kickham cut the SCR shell from the bottom head, leaving the bottom head attached to the skirt. With the bottom head and skirt removed from the SCR shell, Kickham inspected the inside surface of the SCR. A Kickham employee who oversaw the repair said Kickham observed pitting corrosion damage in the bottom head.

With access to the inside surface of the bottom head, Kickham cut out a circular portion of the center of the bottom head. According to a Kickham employee, the size of the circular portion was chosen to remove all the pitting and corrosion damage. The Kickham employee also told CSB investigators that the repair removed all corrosion damage in the SCR bottom head. In interviews, CSB investigators asked whether Kickham did any ultrasonic thickness (UT) measurement during the course of its repair. CSB investigators also asked whether Kickham inspected visually or used a micrometer.

**Figure 7.** Conceptual diagram showing repair made to SCR bottom head in 2012. (Credit: CSB)

When Kickham cut out a circular portion of the bottom head, it left a ring of the original head material still connected to the shell. This report calls this material the “reused original steel ring.” Kickham welded the new patch plate (termed the “repair patch” in the remainder of this report) to the reused original steel ring of the bottom head.<sup>a</sup> Kickham then rewelded the bottom head and skirt assembly to the SCR shell. Kickham told the CSB that when workers welded the patch in, the metal to which they were welding (the reused original steel ring) was of nominal thickness (0.250 inches). Kickham and Loy-Lange conducted a post-repair hydrostatic pressure test on the SCR prior to returning it to service. The test was conducted using water at 110 psig.

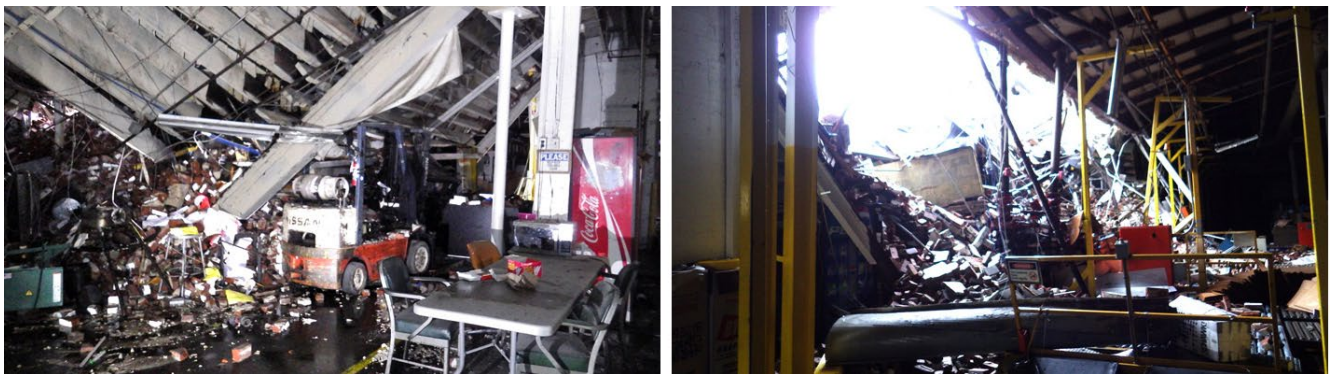
**Figure 10.** Photos of damage caused by SCR explosion. (Credit: St. Louis Fire Department)

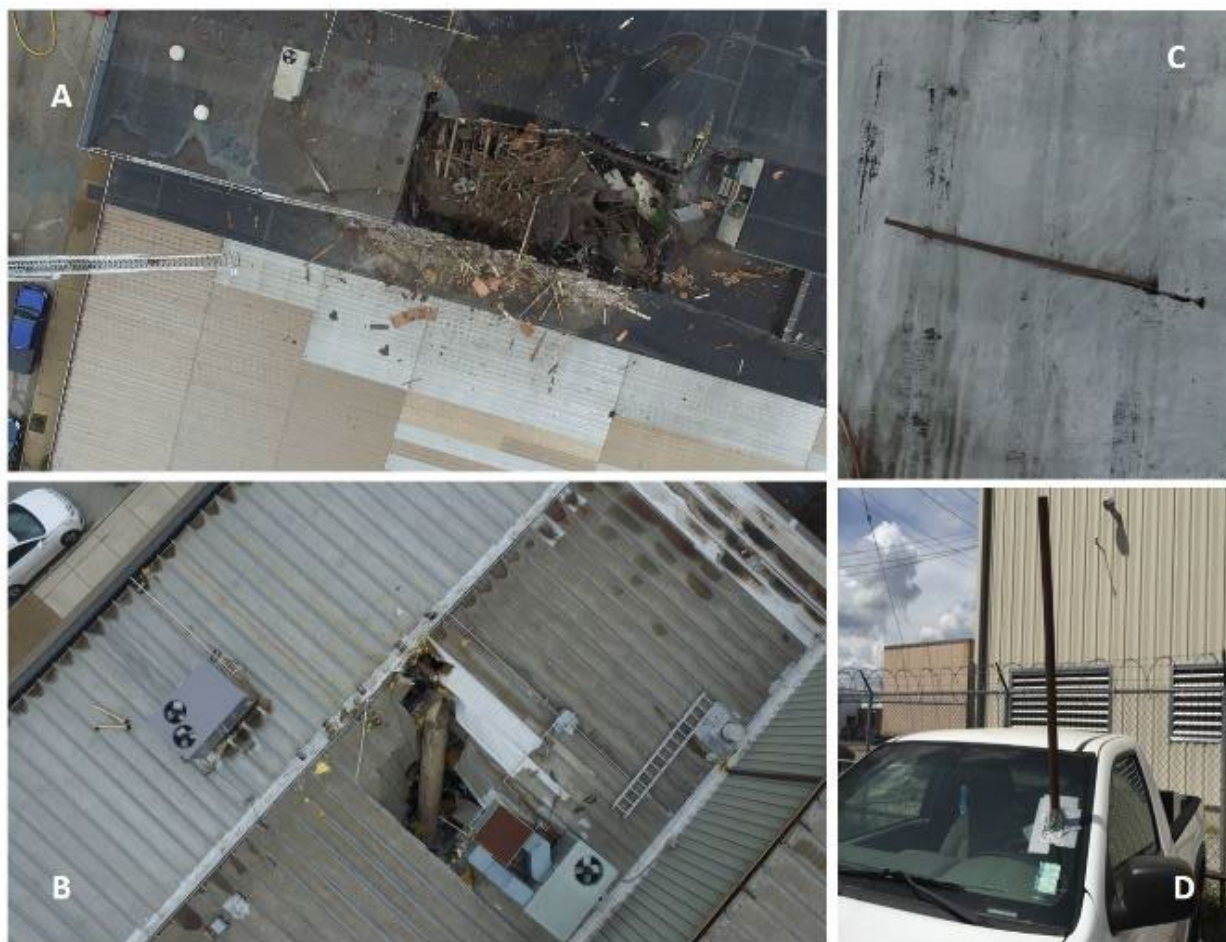
(**Figure 11C**). A section of 1.5-inch pipe approximately seven feet in length pierced the windshield and embedded in the dashboard and through the floorboard of an unoccupied pickup truck parked in the area (**Figure 11D**). A map of the debris field is shown in **Figure 12**. As a result of the incident, one stationary engineer at Loy-Lange was fatally injured. At Faultless Healthcare Linen, three employees were fatally injured when the SCR fell through the roof.

**Figure 11.** Damage from the incident. (Credit A-C: St. Louis Fire Department, D: CSB)

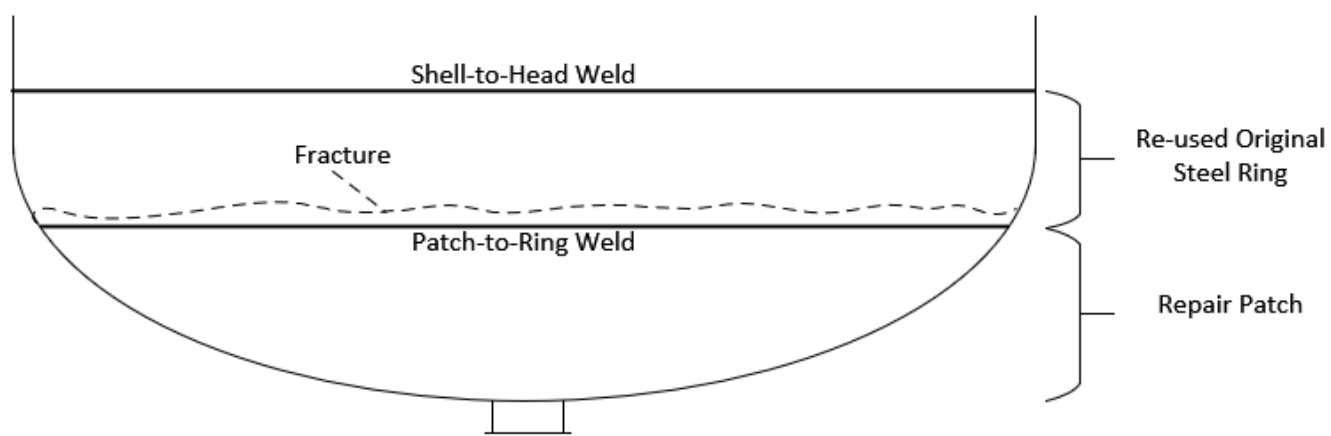
**Figure 14.** Conceptual illustration of fracture in SCR bottom head. (Credit: CSB)

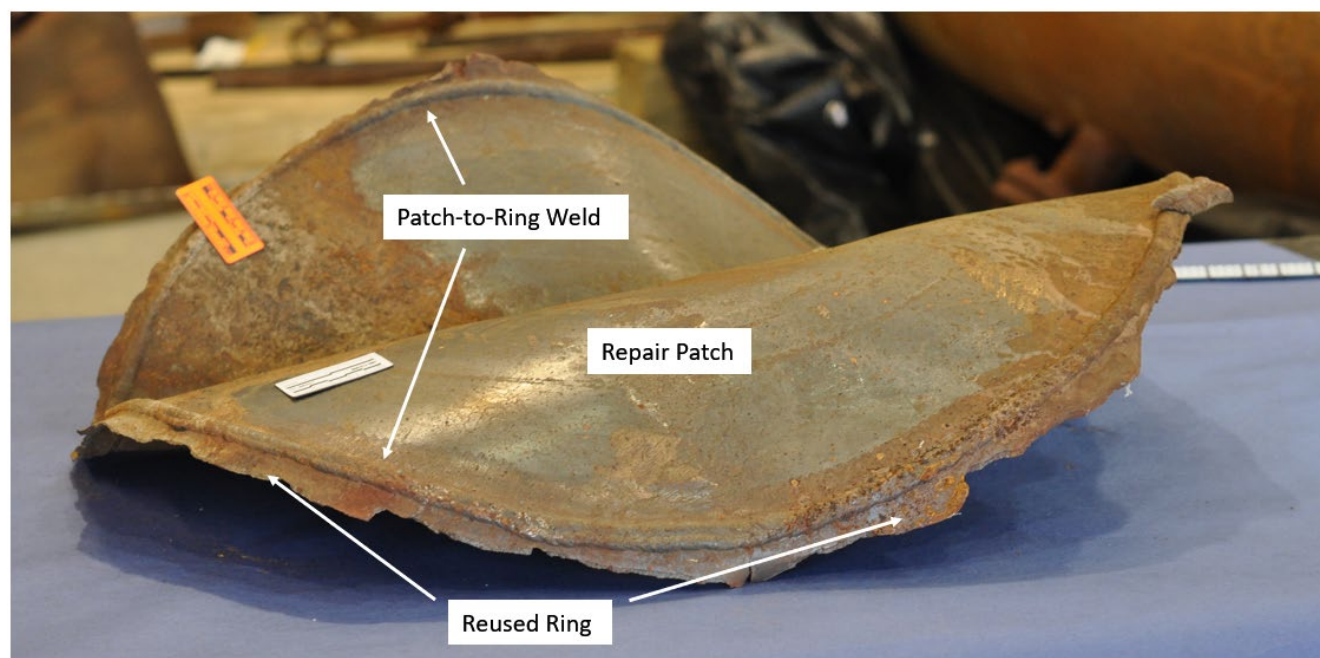
**Figure 15.** Photo of failed section of SCR bottom head. (Credit: CSB)

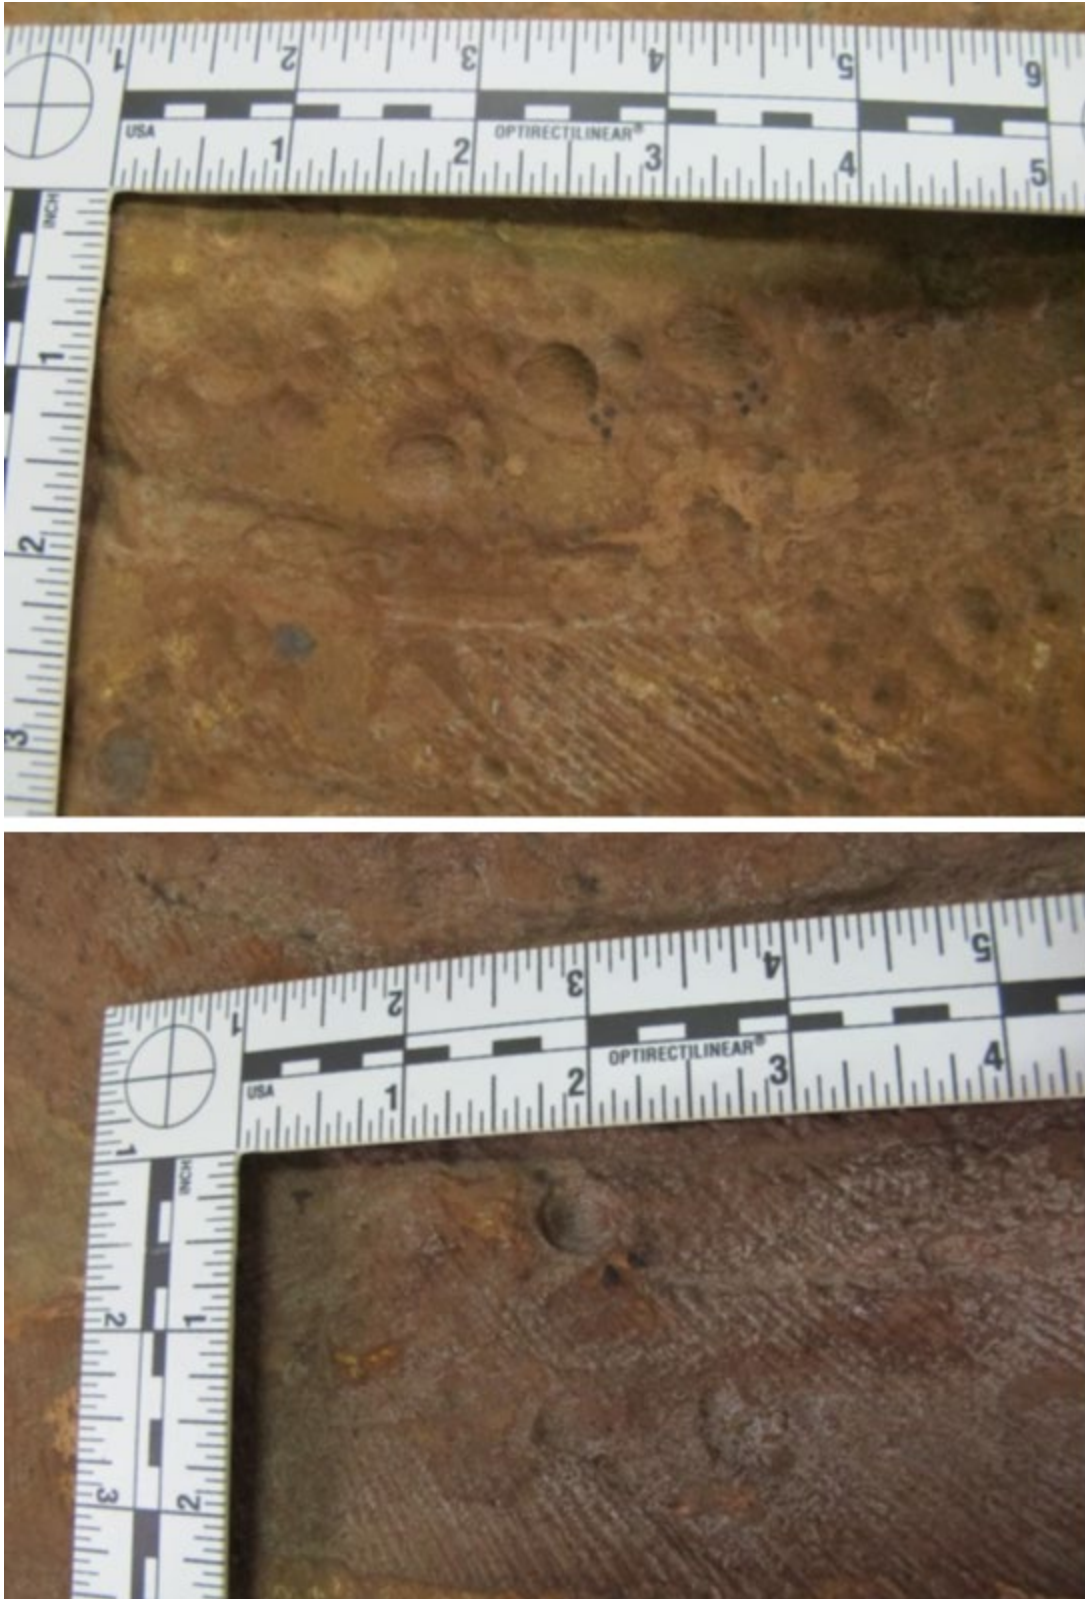
Extensive pitting and generalized corrosion damage (**Figure 16**) was found in both the separated portion of the bottom head and in the portion of the bottom head that remained attached to the SCR shell. This pitting and generalized corrosion damage is consistent with the appearance of oxygen pitting and corrosion damage. The shell and upper head were found to be relatively unaffected by corrosion damage, as pictured in **Figure 17**.

**Figure 16.** Pitting corrosion damage in SCR bottom head. (Credit: CSB)

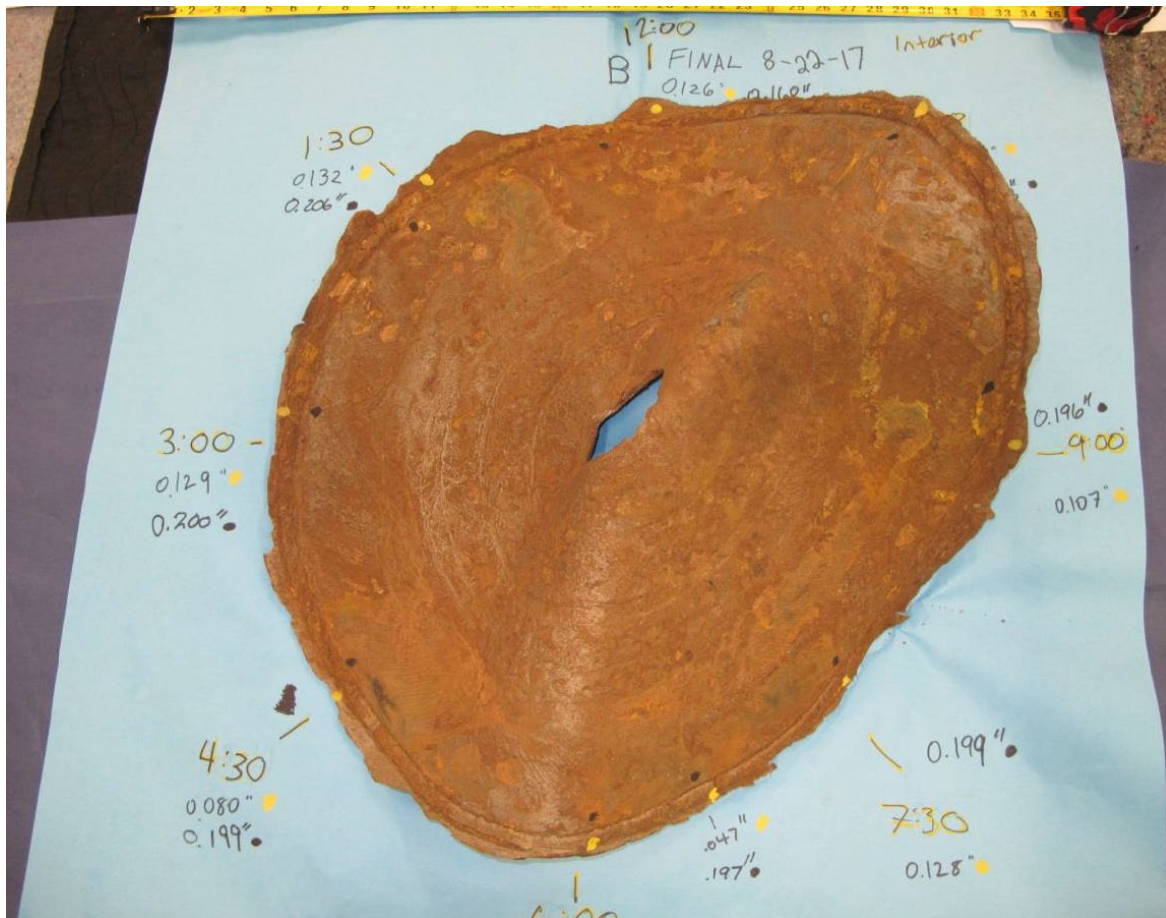
**Figure 19.** Thickness comparison on either side of patch-to-ring weld. (Credit: CSB)

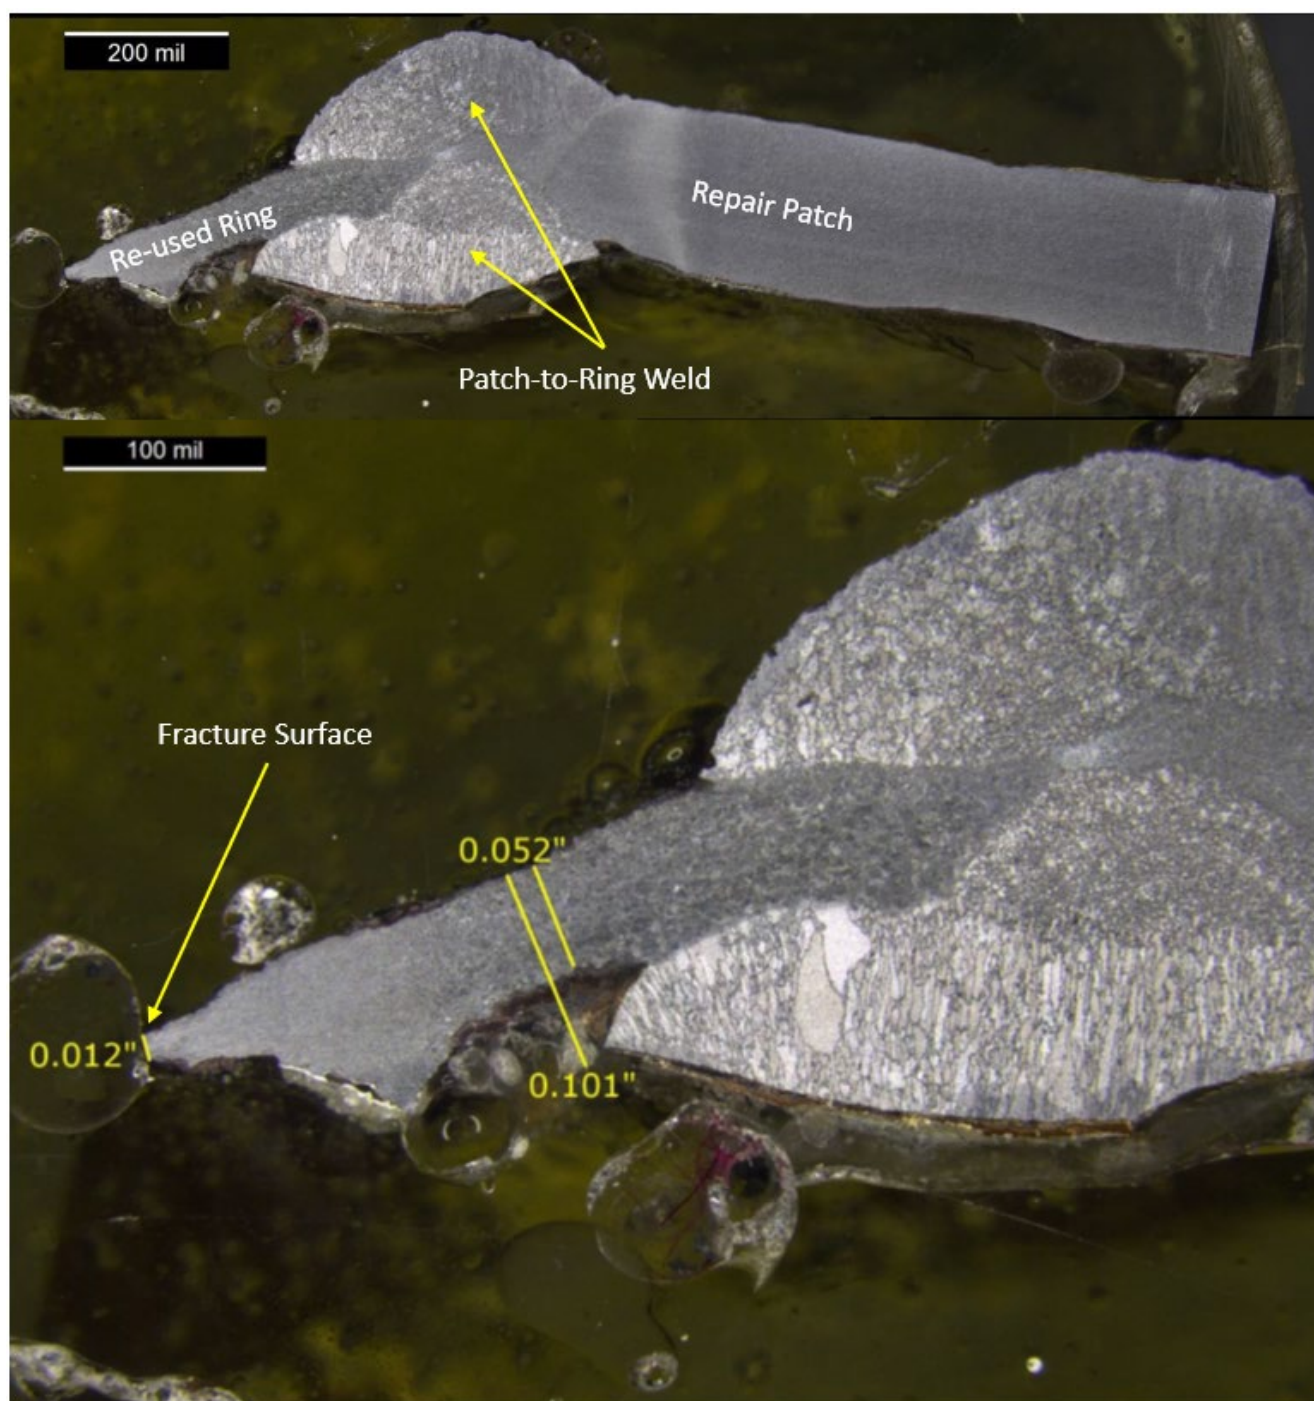
Destructive thickness examination found that corrosive attack reduced the nominally 0.250-inch steel to 0.012 inches at the thinnest spot measured, a thickness loss of 95 percent (**Figure 20**). The spot that measured 0.012 inches was at the fracture edge, in the re-used ring. The average post-incident thickness of the re-used ring around the periphery of the fracture, as measured by calipers, was 0.107 inches. The examination also discovered four weld repairs in the portion of the re-used ring that remained attached to the shell. These welds were cross-sectioned and examined. Three of the four welds were weld overlays, used to fill in thin spots from the inside of the vessel. The fourth was a plug weld, used to plug a full penetration through the thickness of the head. All four of these welds were made to the ring of bottom head material that remained attached to the SCR shell. A photo documenting one of the weld overlays is shown in **Figure 21**, and photos documenting the plug weld are shown in **Figure 22**.

**Figure 20.** Post-Incident metallurgical examination of patch-to-ring weld and fracture. (Credit: CSB)

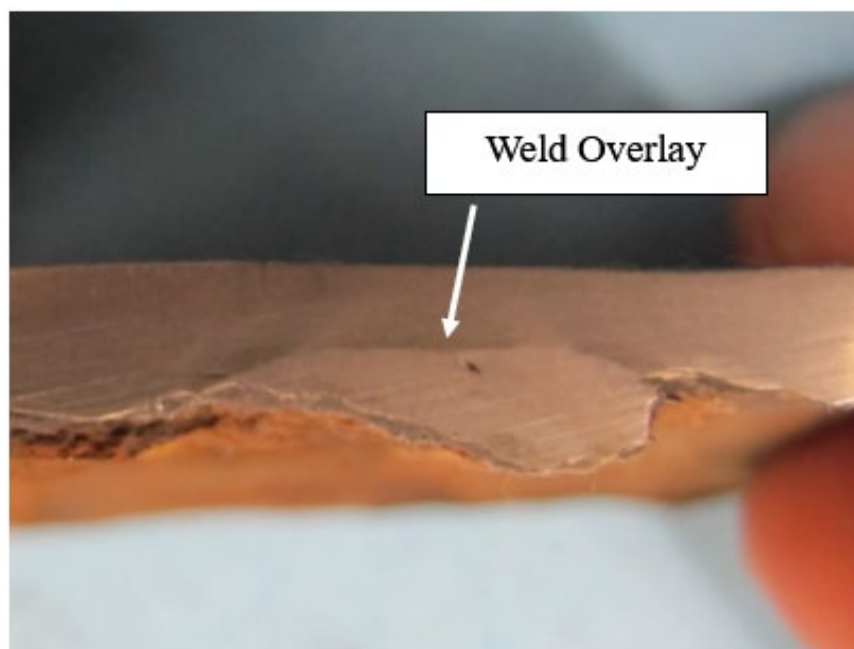
**Figure 21.** Weld overlay found in the ring of steel still attached to the shell, cross-sectioned. (Credit: CSB)

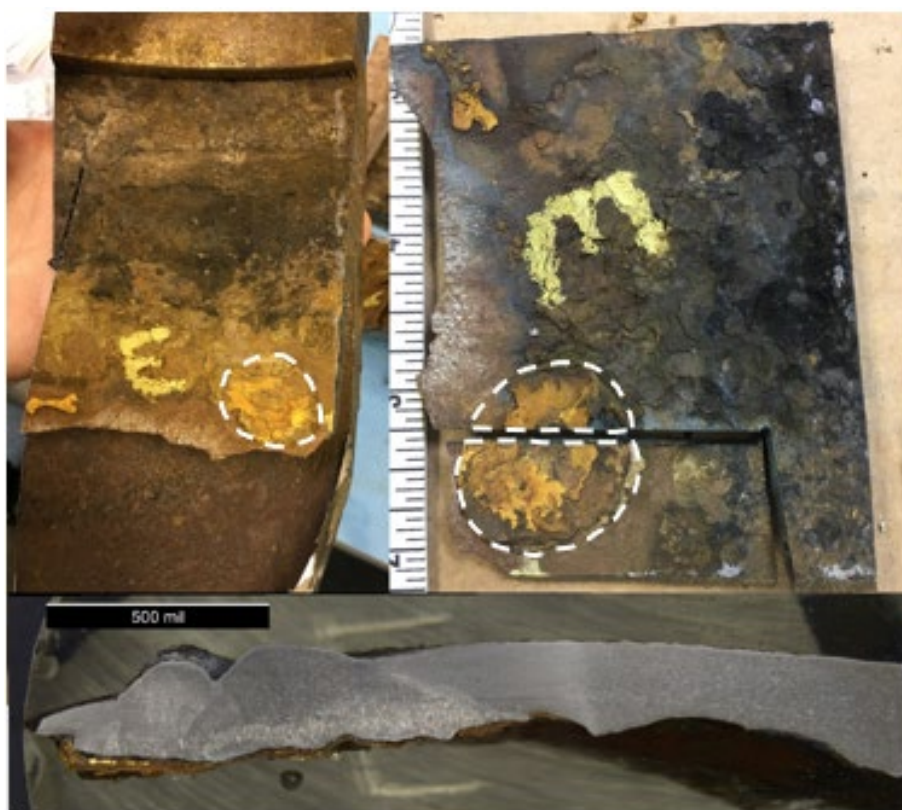
**Figure 22.** Plug weld found in the ring of steel still attached to the shell, cross-sectioned. (Credit: CSB)

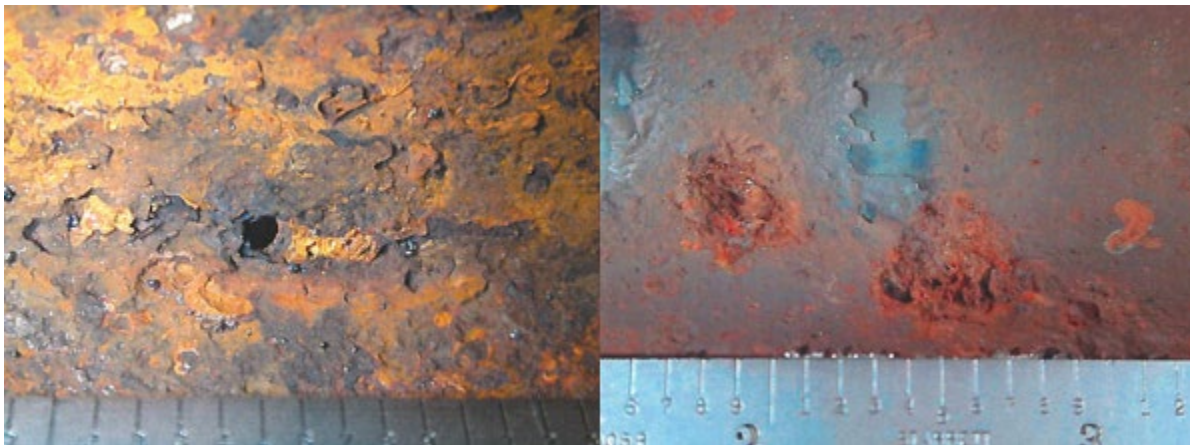
In addition to these leaks in the SCR, Loy-Lange experienced corrosion in other parts of the steam system. The CSB found documentation of one known steam separator leak and four generator coil failures.<sup>a</sup> **Figure 28** shows the oxygen pitting corrosion found in two of the four generator coil failures. The images were taken by Clayton after Loy-Lange submitted the failed coils to Clayton for warranty replacement consideration. The left image is of a 2002 coil failure and the right image is of a 2004 coil failure.

**Figure 28.** Pitting damage in two of Loy-Lange’s steam coils. (Credit: Clayton)

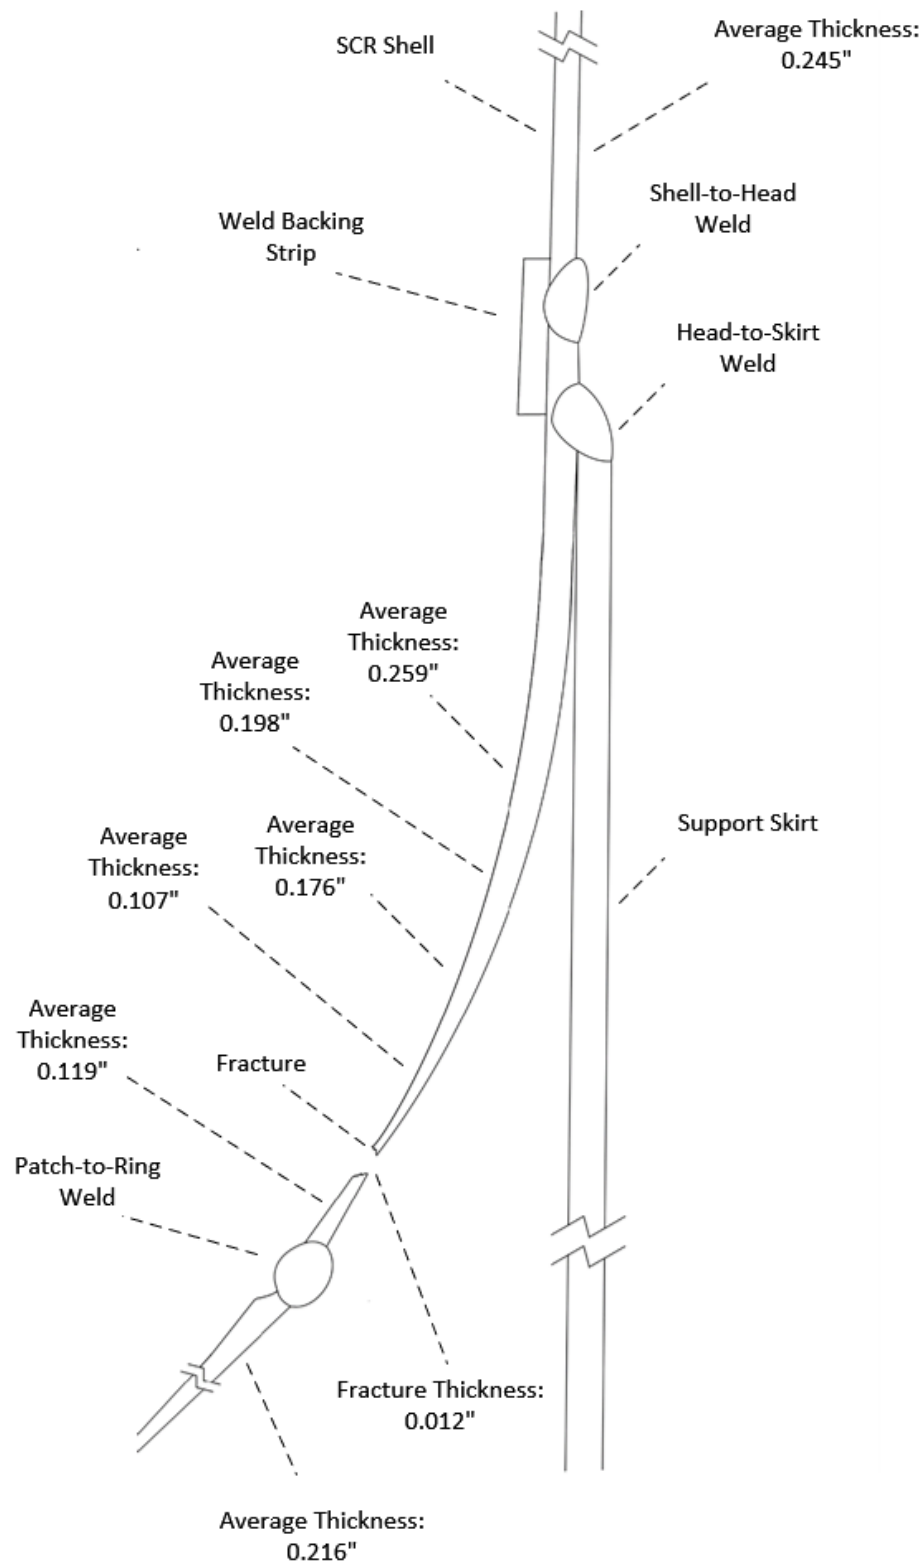
Nondestructive and destructive thickness measurement showed that corrosion primarily occurred in the SCR bottom head and was minimal elsewhere in the vessel (Section 1.6). **Figure 31** below shows a summary of some of the thickness findings:

**Figure 31.** Conceptual cross-sectional diagram of the SCR bottom head, showing examination findings. (Credit: CSB)

The minimum thickness of the SCR bottom head, specified on the vessel's U1A form, was 0.2204 inches. As shown above in **Figure 31**, the average thickness of nearly the entire SCR bottom head was thinner than the required thickness after the incident. The thinnest spot measured on the fracture surface, likely the fracture initiation point, was measured at 0.012 inches, and the average thickness near the patch to ring weld was roughly half the minimum required thickness.

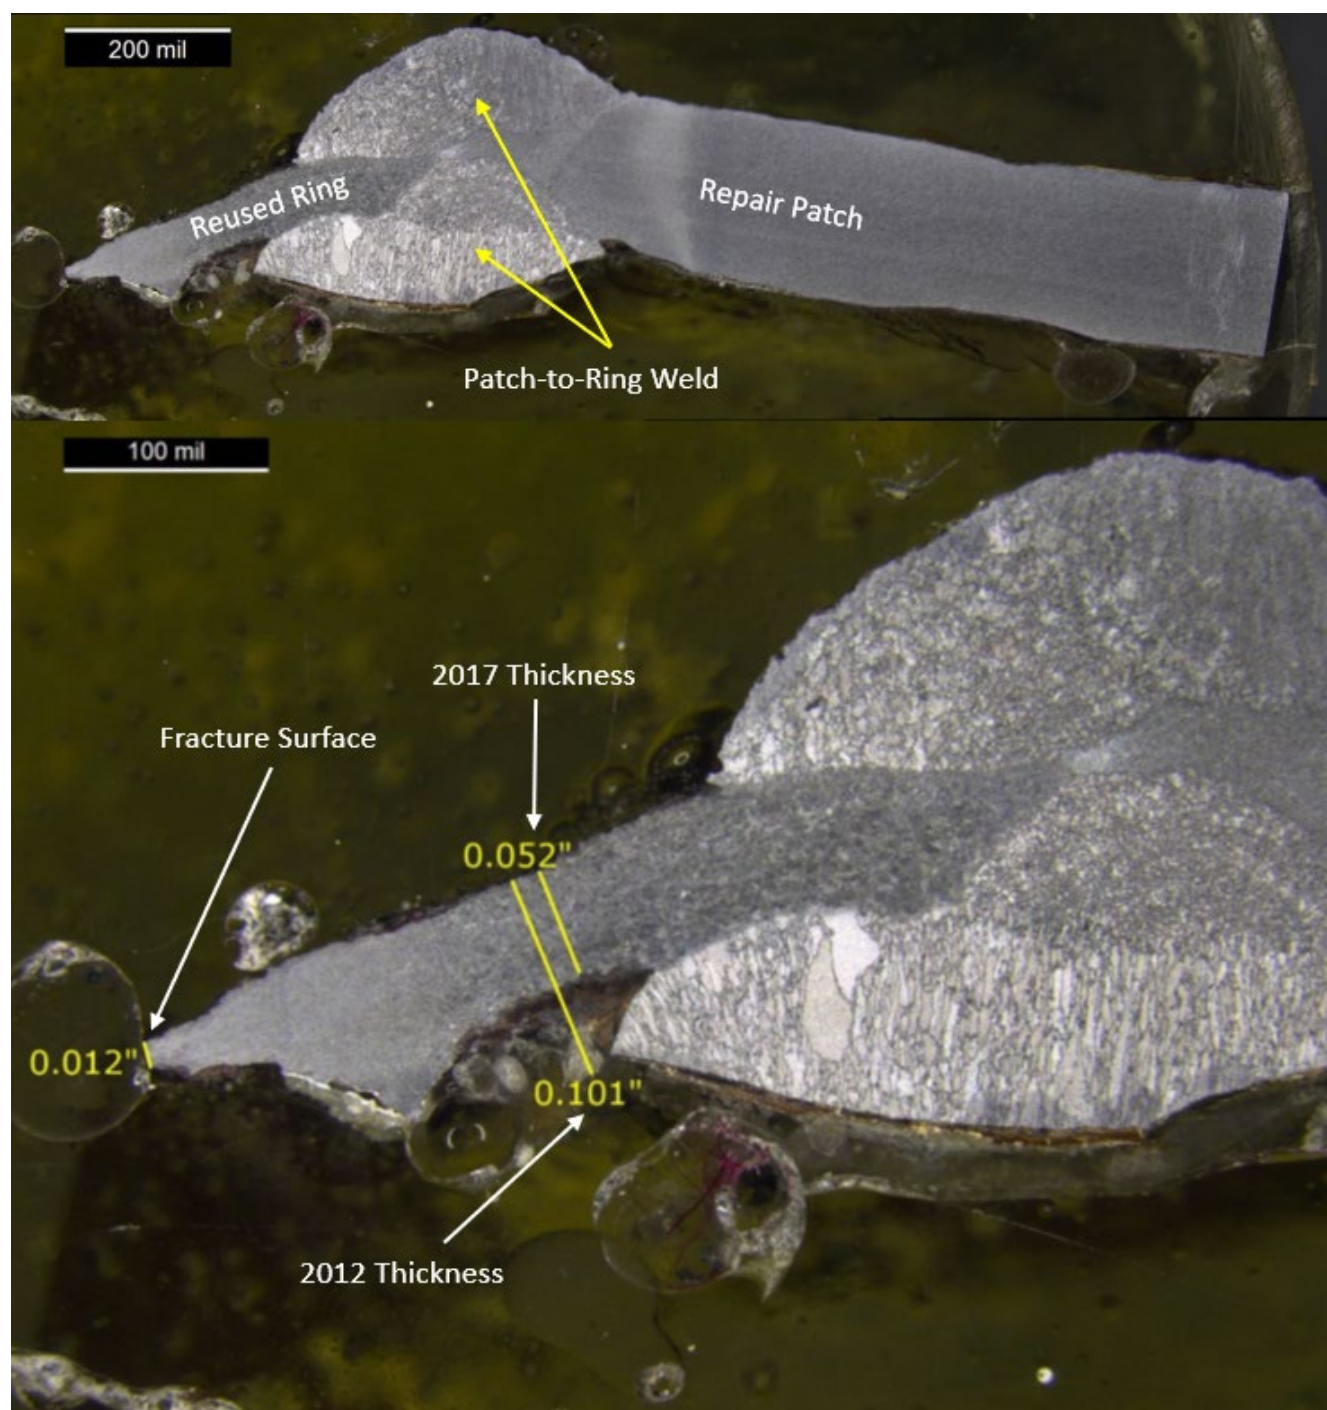
**Figure 33.** Metallurgical mount examination of a portion of the reused ring. (Credit: CSB)

Based on the metallurgical examination and corrosion calculations, there is evidence that the 2012 repair did not remove all existing corrosion damage. It is important to remove all corroded material that is too thin to meet the vessel's minimum thickness requirements because a decrease in thickness could impact the pressure retaining ability of the vessel. The CSB concludes that Kickham likely left thinned material in place when it repaired the SCR bottom head in 2012, and in so doing did not adhere to the requirements of *NBIC Part 3 Repair and Alterations*.

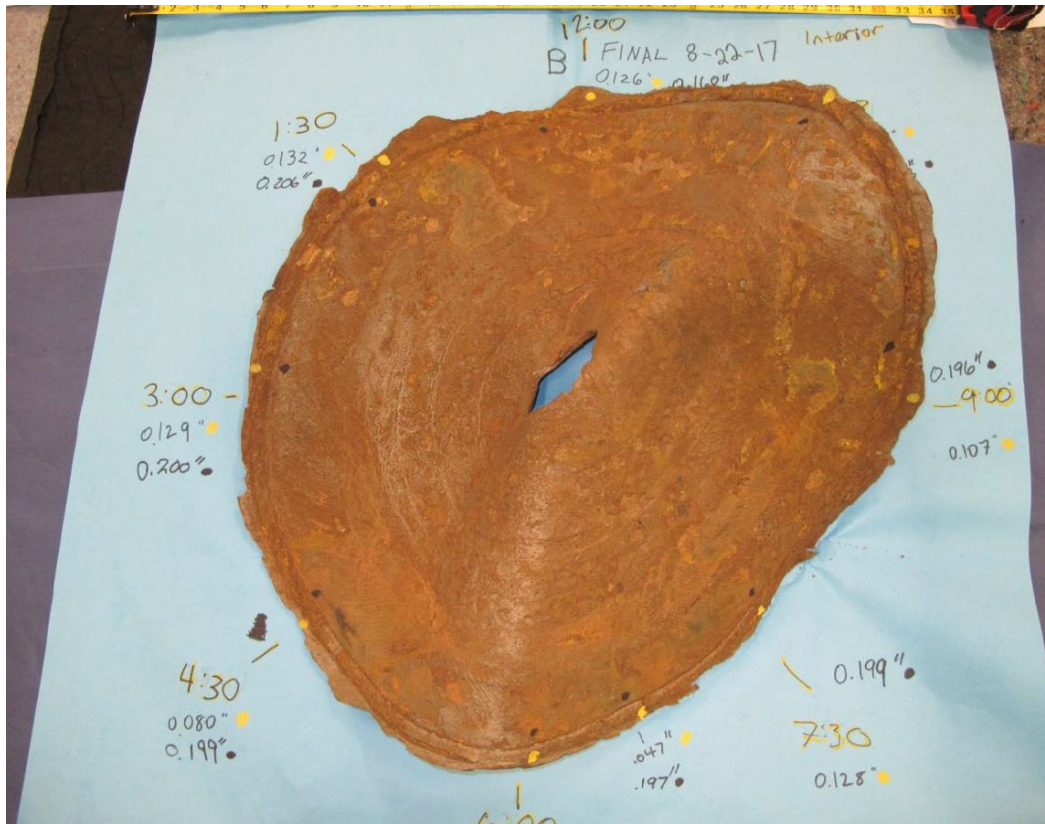
**Figure 34.** Thickness comparison on either side of patch-to-ring weld. (Credit: CSB).
