## Investigation Report

Published: December 2023

## U.S. Chemical Safety and Hazard Investigation Board

The April 2, 2019, explosion and fire at the KMCO facility in Crosby, Texas, fatally injured James Mangum.

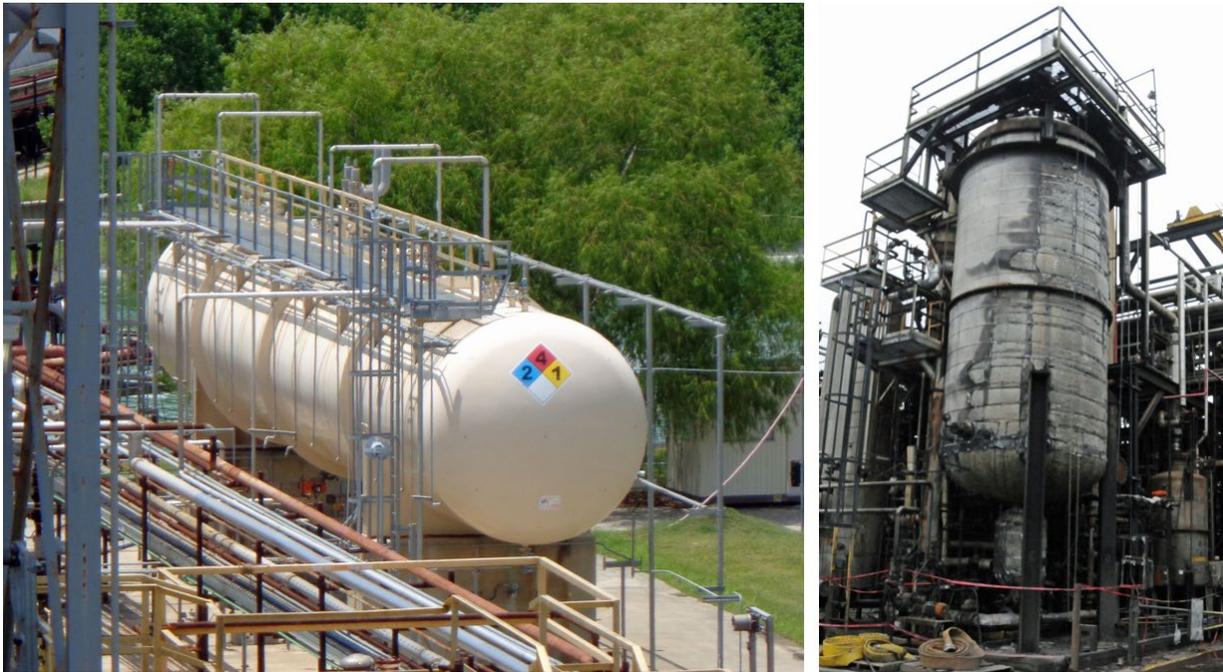
**Figure 2.** Post-Incident Photos of KMCO’s Isobutylene Storage Tank (left) and Batch Reactor System (right). (Credit: CSB)

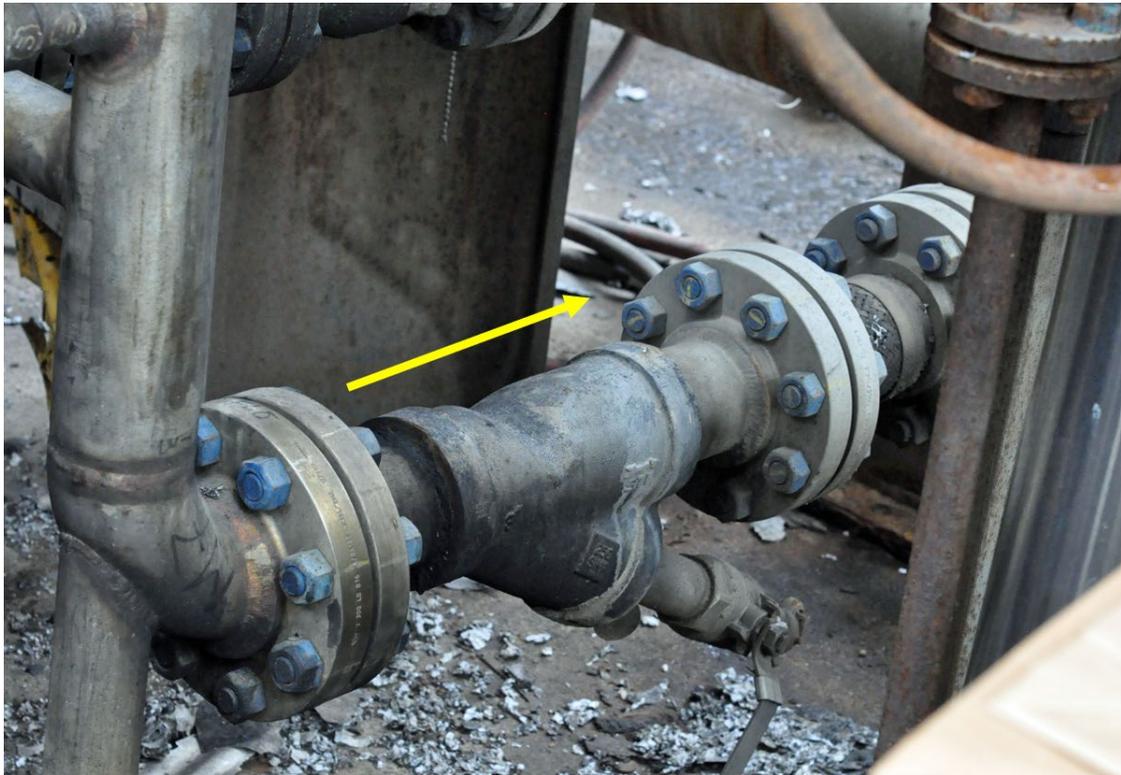
**Figure 4.** Y-Strainer (East Side). This post-incident photo shows the top and east sides of the 3-inch y-strainer in the inlet piping to the isobutylene charge pump. The orientation of the y-strainer was such that the straight-through flow was headed north. (Credit: CSB)

Post-incident, the source of the isobutylene release was identified as the 3-inch y-strainer on the inlet (suction) piping to the isobutylene charge pump. The y-strainer was found with a hole, which was roughly 3 inches by 5.5 inches, on its west side (**Figure 17**). Field Operator 1 confirmed that the location of this hole was consistent with where he saw the isobutylene escaping.

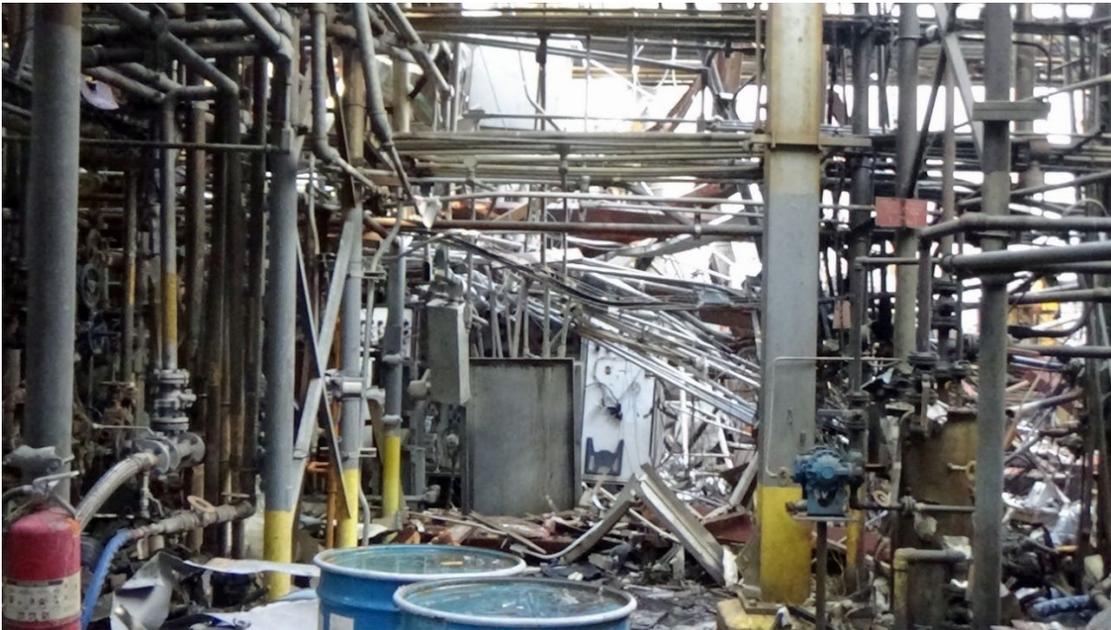
One of the responders described what the R2 Building looked like right after the incident, saying, “Shrapnel. ... There was nothing left of it. Wires, there was nothing there. There wasn’t a building there anymore” (**Figure 13**, **Figure 14**, and **Figure 15**).

**Figure 13.** R2 Building (North Side). This post-incident photo shows the path KMCO workers commonly took to enter the R2 Building. With process units on the left and right, this walkway led to the entrance on the north side of the R2 Building, where emergency responders found Board Operator 2. (Credit: CSB)

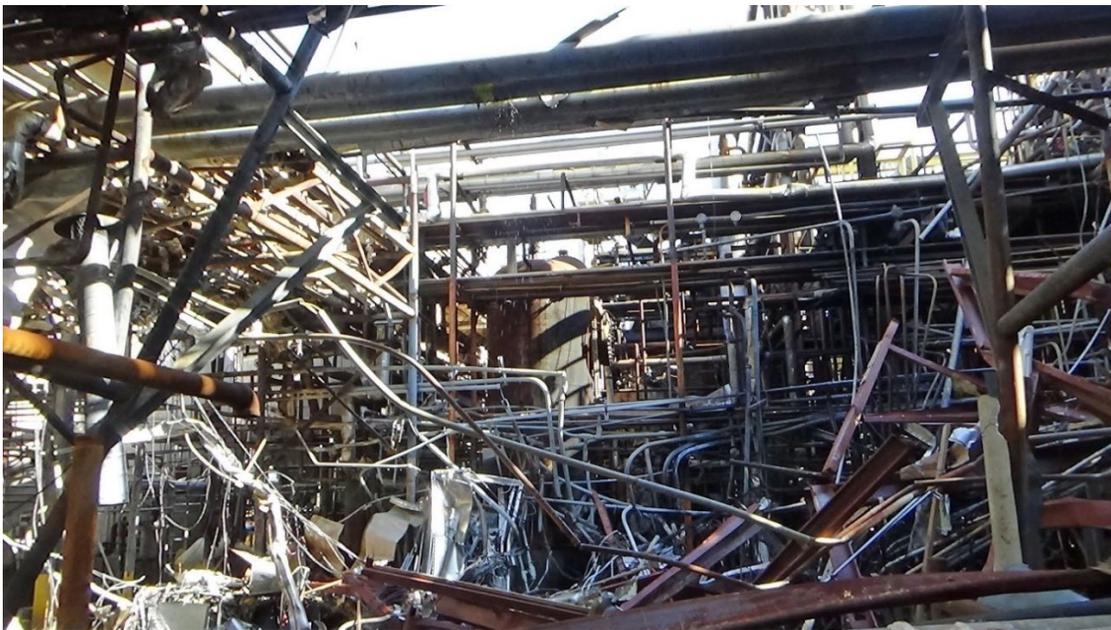
**Figure 14.** R2 Building (South Side). This post-incident photo shows the south side of the R2 Building. (Credit: CSB)

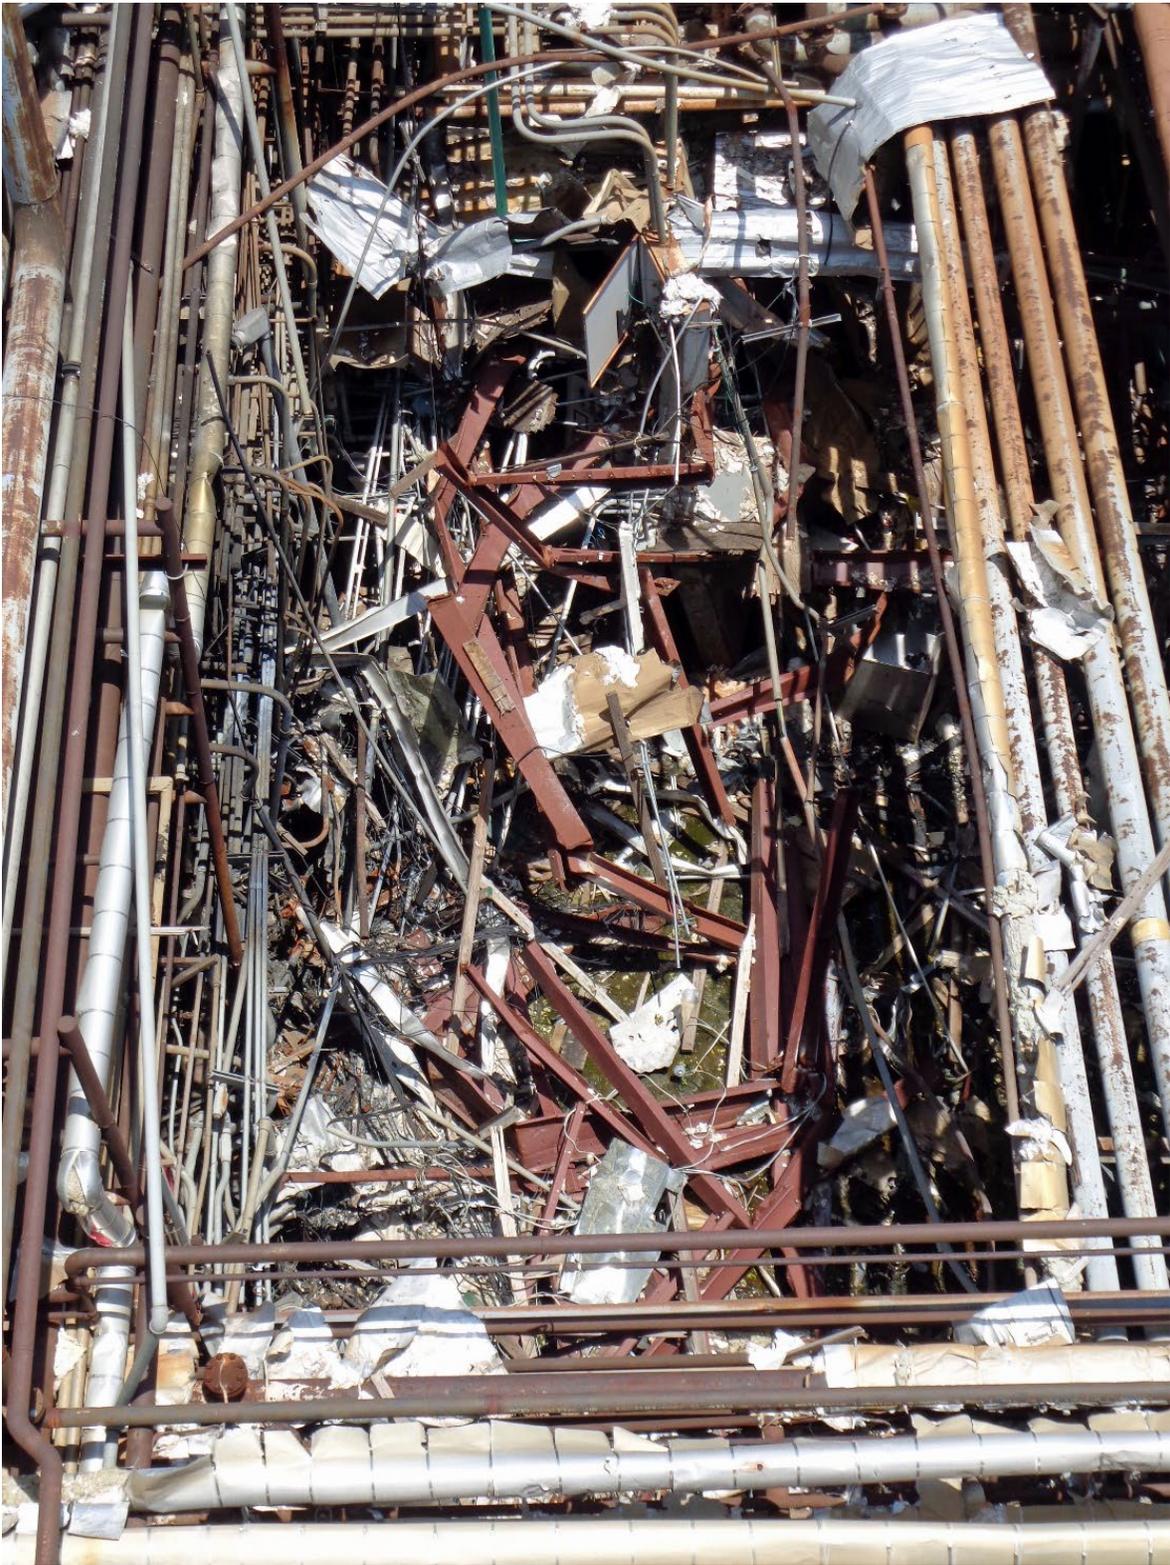
**Figure 15.** R2 Building (Top View). This photo, taken from the top of adjacent equipment, shows the post-incident condition of the R2 Building. (Credit: CSB)

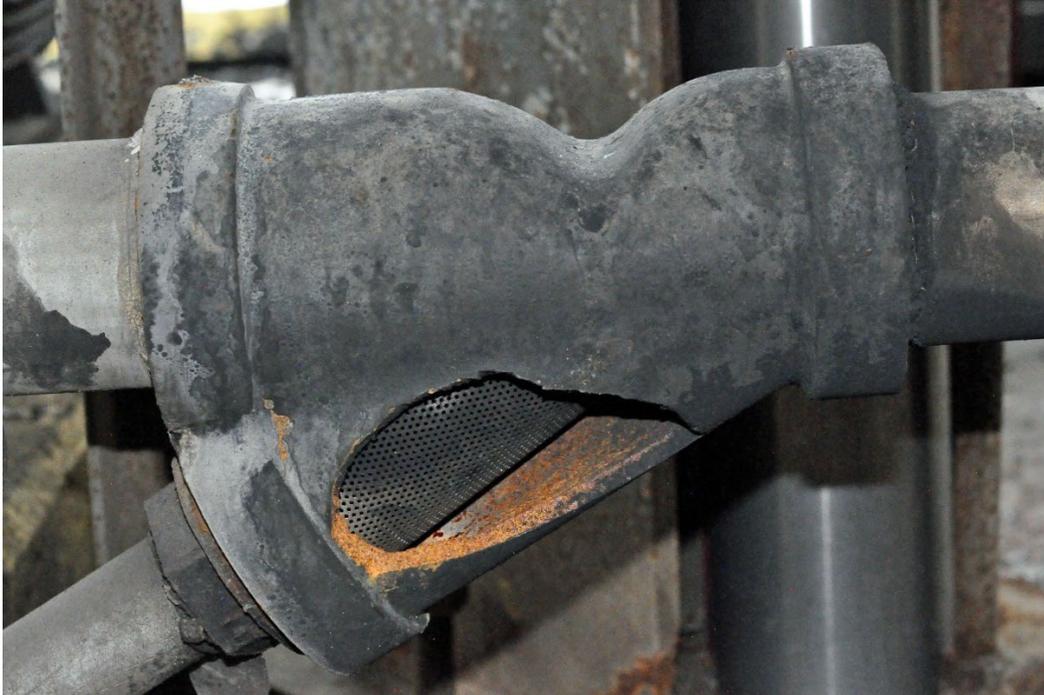
The CSB determined that the cause of the isobutylene release was a brittle overload fracture of the cast iron y-strainer driven by internal pressure. The y-strainer was installed in a segment of the isobutylene piping that was not protected from the high-pressure conditions that developed within this equipment, most likely from liquid thermal expansion. The isobutylene vapor cloud was most likely ignited by electrical equipment within a poorly sealed, nearby building.

**Figure 17.** Y-Strainer. This photo shows the west side of the failed y-strainer involved in the April 2, 2019, incident. (Credit: CSB)

that catastrophically failed on April 2, 2019, ruptured from a brittle overload fracture driven by internal pressure.

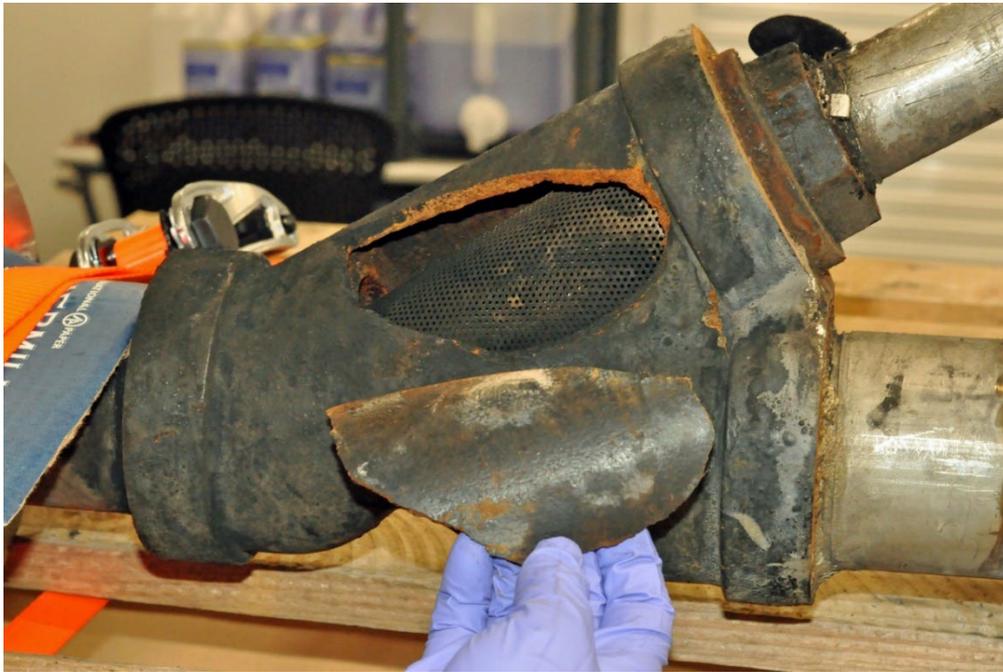
The metal fragment that broke away from the y-strainer was found on the ground, near the sulfurized isobutylene reactor and to the west of the y-strainer (**Figure 18**).

**Figure 18.** Y-Strainer Piece. This photo shows the single piece that broke away from the failed y-strainer. (Credit: CSB)

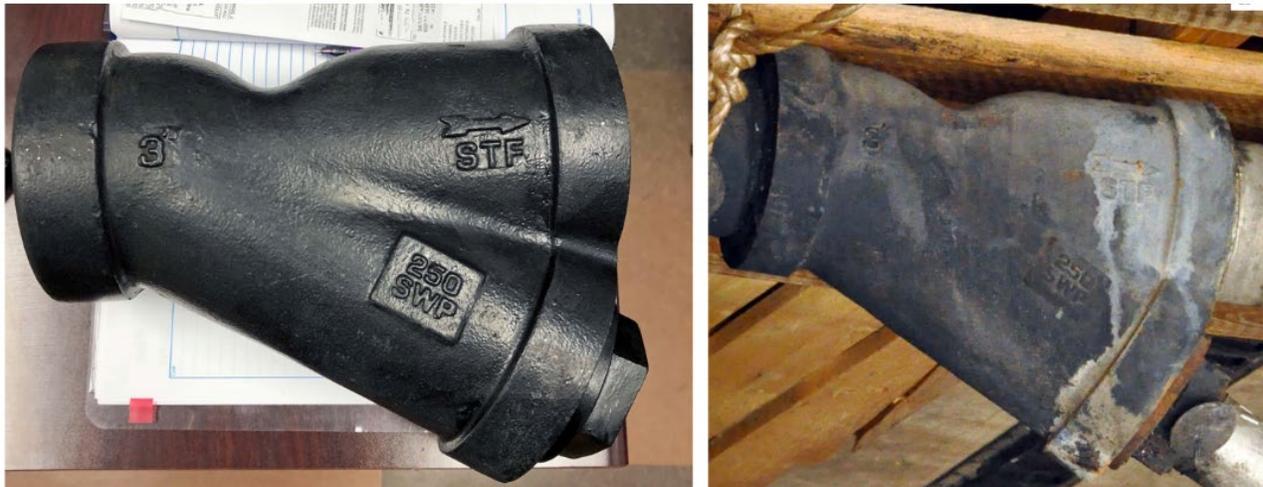
The y-strainer involved in the incident was the same make and model as the standard 3-inch gray iron y-strainer that KMCO stocked in its warehouse. Using the KMCO warehouse inventory information, the CSB purchased an exemplar y-strainer for \$171 that was the same make and model as the incident y-strainer (**Figure 19**). The CSB used this exemplar y-strainer in the metallurgical testing that determined why the incident y-strainer failed.

**Figure 19.** Exemplar Y-Strainer. The CSB purchased an exemplar y-strainer (left) using the inventory information available in KMCO’s warehouse. The image on the right shows the y-strainer involved in the incident. (Credit: CSB)

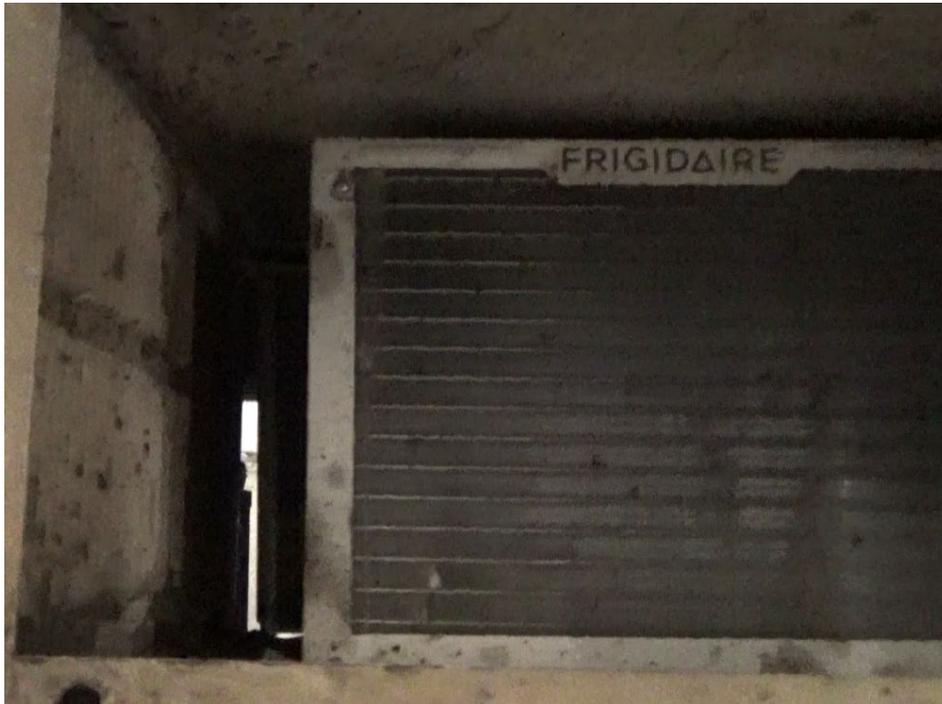
**Figure 21.** Wall-Mounted Air Conditioner. This photo, taken from outside of the PPE Room, shows an opening to the inside of the PPE Room. (Credit: CSB)

KMCO had identified the area where the R2 Building was located as a Class 1, Division 2 location, one of the hazardous classified locations under the National Fire Protection Association (NFPA) 70, *National Electrical Code*, where the possibility of fire or explosion hazards may exist under abnormal conditions because of the presence of flammable material, such as isobutylene [38, p. 350]. The CSB learned that the R2 Building likely did not meet the NFPA’s requirements because it contained unclassified electrical equipment, such as motor starters, and the building was not pressurized to prevent flammable vapor from entering the building.

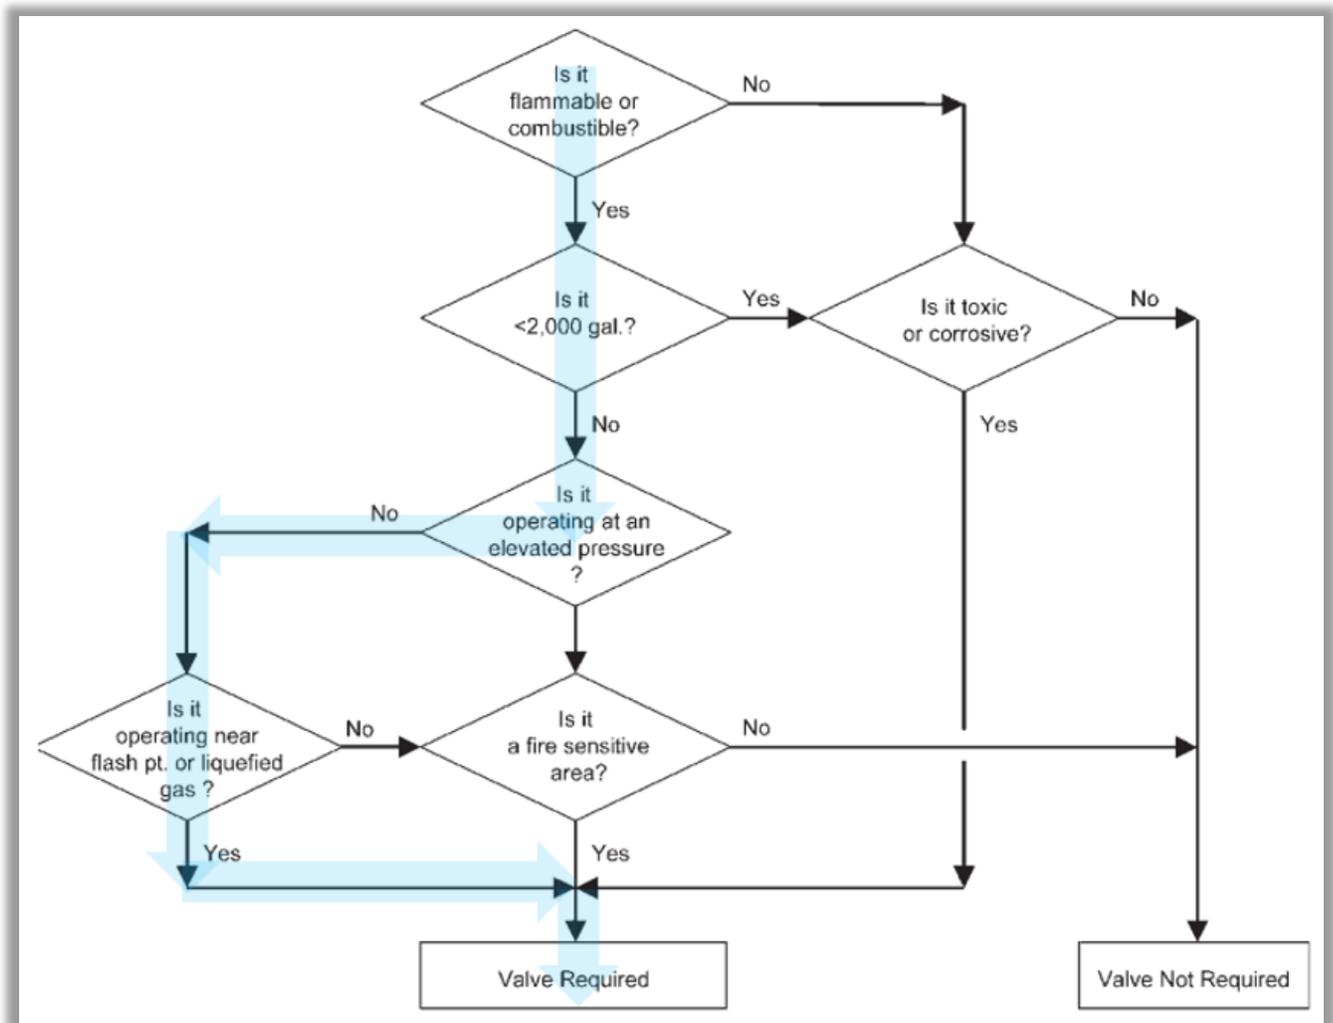
In addition, the CCPS provides a decision flowchart as an example of a tool that companies could use to decide where remote isolation equipment should be installed [55, p. 267]. As illustrated in **Figure 23**, applying this tool to KMCO's isobutylene system shows that remote isolation equipment should have been provided.

**Figure 23.** Remote Isolation Decision Flowchart. (Credit: CCPS, annotations by CSB)

The CSB concludes that although the need to provide workers with effective remote isolation capability has been well established by existing industry standards and good practice safety guidance documents, KMCO's isobutylene system remained unprotected. As a result, when the y-strainer ruptured on April 2, 2019, KMCO workers did not stop the isobutylene release remotely, from a safe location.<sup>a</sup> KMCO could have reduced the severity of its April 2, 2019, incident if the company had provided its Board Operators with the capability to remotely isolate the isobutylene release from within the blast-resistant Reaction Control Room—a safe location.
