U.S. Chemical Safety and Hazard Investigation Board

E.I. DuPont de Nemours & Co Inc.

Flammable Vapor Explosion

Welding on Tank Containing Vinyl Fluoride (1 Killed, 1 injured)

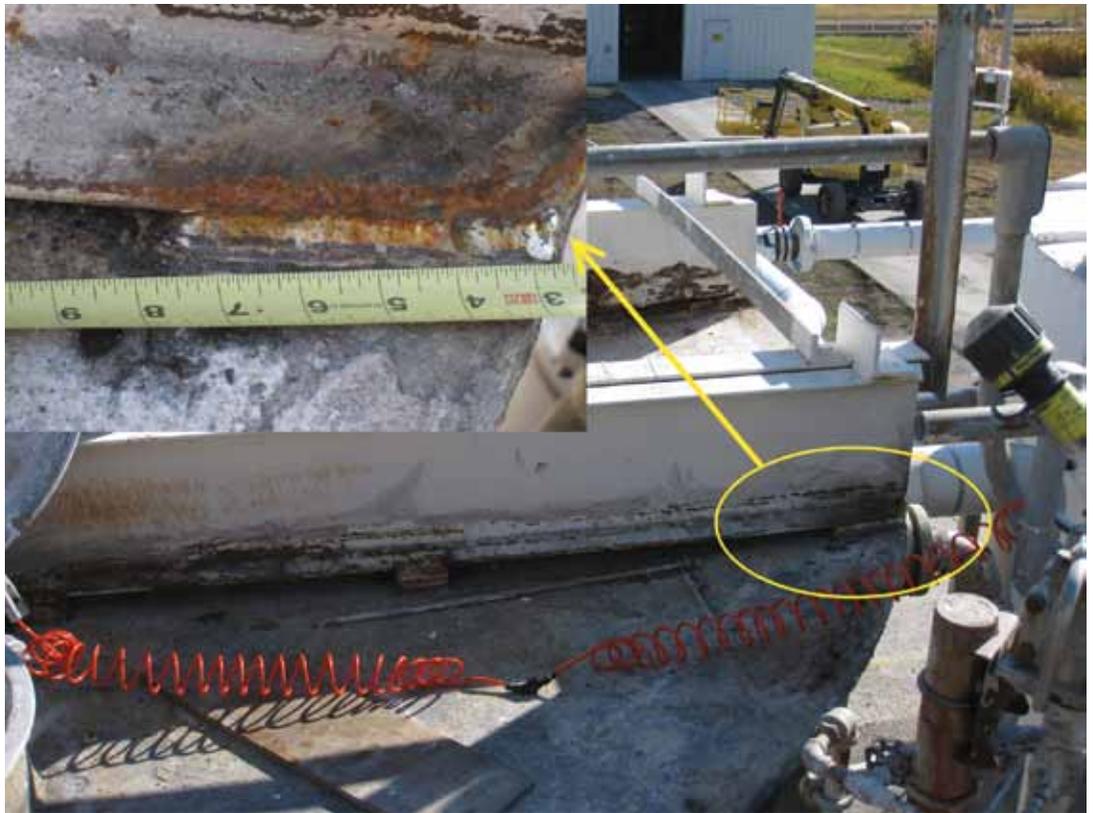
FIGURE 4.

On October 22, the slurry tanks were locked out⁷ by DuPont maintenance personnel so the tanks could be cleaned and entered. On October 29, DuPont discovered damaged agitator

Repair weld on agitator support beam to the slurry tank 2 top plate

support after the insulation was removed from the slurry tanks 1 and 2. A DuPont engineer wrote up a work order for the repair of the agitator supports and had the construction field engineer in charge of contractors begin writing a work scope and gather contractors and materials. DuPont hired Mollenberg-Betz to repair the agitator support based on the fact that they were already engaged in hot work on site and could be quickly made available.

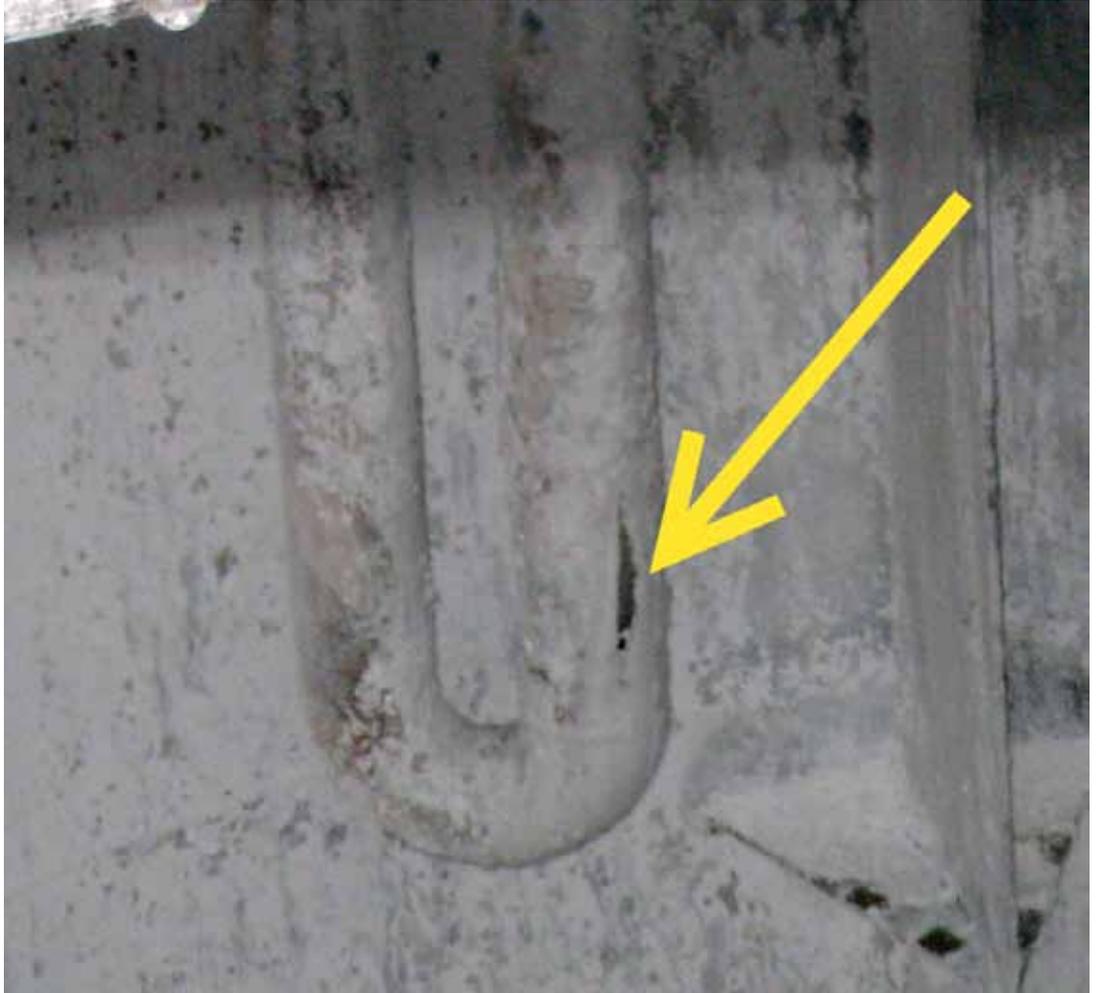
FIGURE 5.

During the tank 2 internal inspection on November 3, DuPont engineers discovered that the U-leg seal loop on the flash tank overflow line had a “fishmouth” split in the pipe (Figure 5), likely the result of the PVF water slurry freezing in the line. The engineers concluded that the slurry tank could be returned to service without repairing the split. DuPont engineers who saw the broken seal loop concluded its likely purpose was to limit steam in the flash tank from flowing into the slurry tanks. They further concluded that the operation was safe and that the broken seal loop presented no hazards. No acknowledgement was given to the fact that flammable VF gas had a pathway into the slurry tanks, an area classified as “low hazard” and not expected to contain any flammable materials. DuPont engineers scheduled a repair on this seal loop during the next planned unit outage. No management of change (Section 4.7.2) was carried out for the process to continue with this compromised seal loop.

Fishmouth split on seal loop pipe inside tank 2

the flash tank had an open path to slurry tank 2 through the cracked seal loop. VF from the flash tank was the main source of flammables on the day of the incident.

After DuPont personnel noticed the cracked seal loop, DuPont technical engineers decided not to repair the loop until the next turn around. If DuPont had included the slurry tanks and slurry flash tank overflow line in their PSM program they would have been required to fix the cracked seal loop before restarting the unit or ensure that the cracked seal loop posed no safety hazard.
