December Public Meeting

CSB Public Business Meeting

December 11, 2025

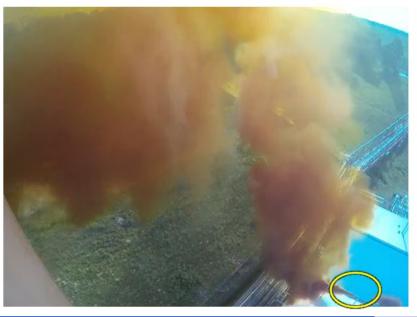
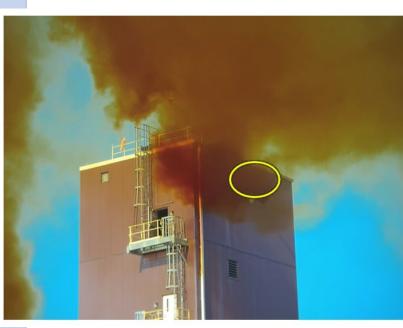
Incident Overview – Austin Powder Red Diamond

- McArthur, Ohio
- June 11, 2025
- Release of NO_x for over 3 hours
- Company-estimated release: 3,945 pounds of NO_x from emergency pressure relief valve (left) and process vent (right)
- 85% nitric acid tank overheated, creating NO_x gas
- Zaleski, Ohio evacuated and no-fly zone established
- No injuries were reported

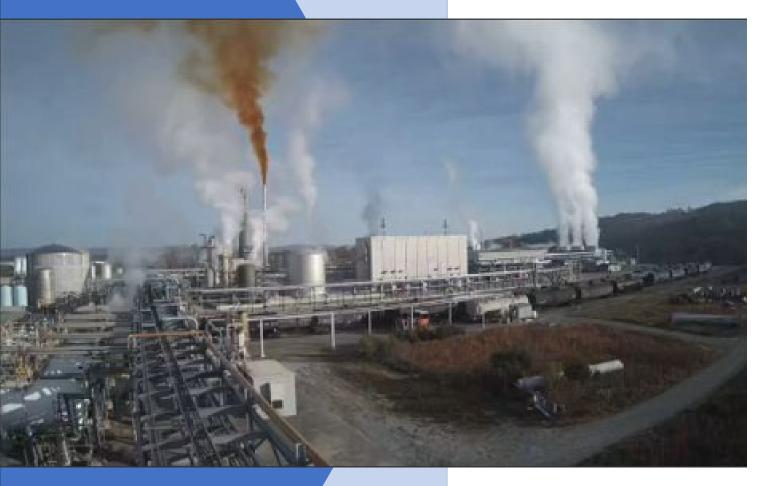
Incident Overview – U.S Nitrogen

- Midway, Tennessee
- November 24, 2024
- Subsidiary of Austin Powder
- Two releases of NO_x : 6:47 a.m. and 8:42 a.m.
- Company-estimated release: 910 pounds of NO_x from exhaust stack
- Both were failed startup attempts in the nitric acid production unit
- No injuries were reported

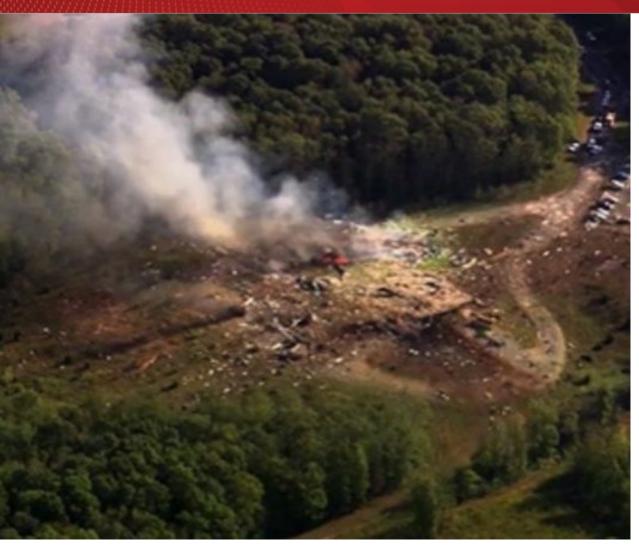
Incident Overview

- On October 10, 2025, at 7:47 a.m., approximately 23,000 pounds of explosives were involved in multiple detonations and fires in Building 602 at the Accurate Energetics Systems (AES) facility in McEwen, Tennessee
- AES manufactures explosives for commercial and military use
- Building 602 housed operations where explosives were melted and poured into booster charges

- The explosion fatally injured 16 AES employees
- 9 non-fatal injuries
- Complete destruction of Building 602

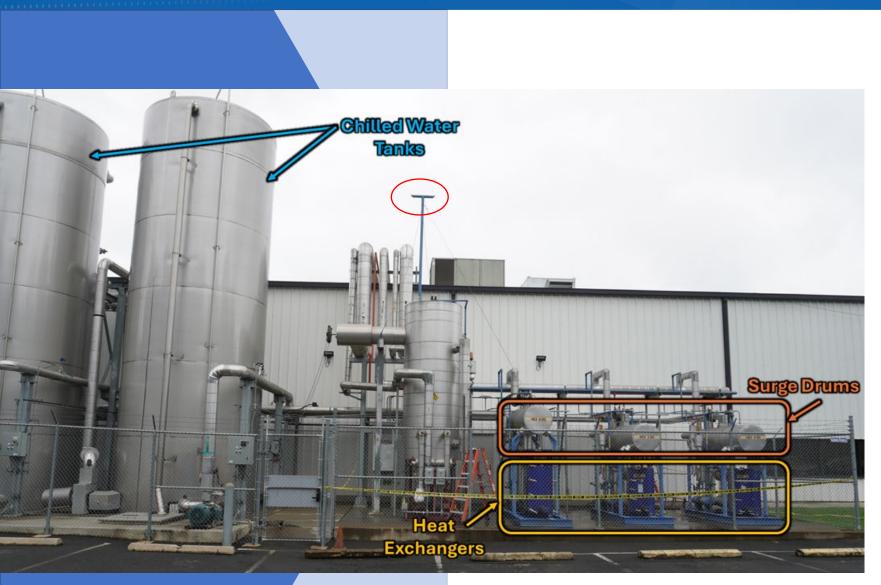
Incident Overview

- Refrigeration process upset
- Surge Drum overpressure
- Emergency pressure relief valve opened
- Ammonia reached ground level, some went over roof
- Some personnel impacted while evacuating

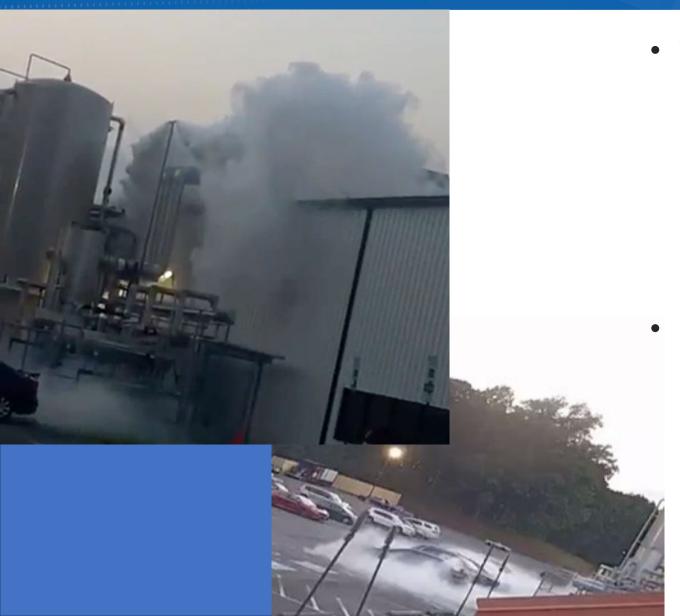
Two-Phase Atmospheric Relief

- The ammonia release contained liquid aerosol, causing a slumping ammonia cloud that reached ground level. The ground-level cloud likely contained immediately dangerous to life or health (IDLH) concentrations.
- The emergency pressure relief system did not account for potential liquid overfill, liquid entrainment, or aerosol release relief scenarios.

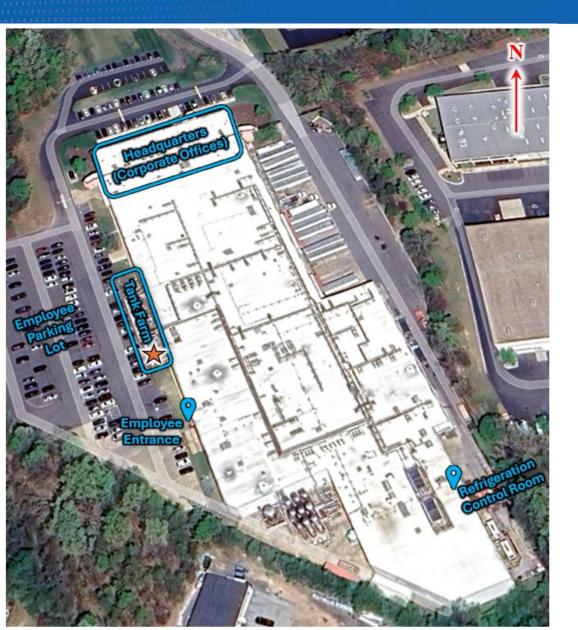
Discharging to a Safe Location

- Cuisine Solutions did not provide mitigation for liquid or two-phase ammonia relief, and did not ensure no harm to people.
- International Institute of All-Natural Refrigeration (IIAR) – Standard ANSI/IIAR 2: Standard for Design of Safe Closed-Circuit Ammonia Refrigeration Systems
- While ANSI/IIAR 2 contains several requirements for relief discharge piping to atmosphere, these requirements may not be sufficient to ensure that ammonia relief streams discharge to a safe location.

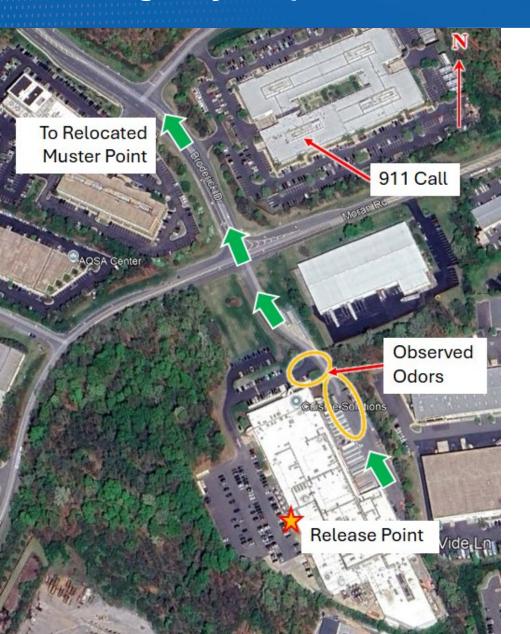
Emergency Preparedness

- Emergency Action Plan gaps:
 - Wind direction;
 - Indoor vs outdoor ammonia releases;
 - No written emergency shutdown procedures;
- Emergency preparedness gaps:
 - Ineffective planning and training on emergency shutdown;
 - Ineffective drills;
 - Ineffective communication; and
 - No evacuation alarm sounded.

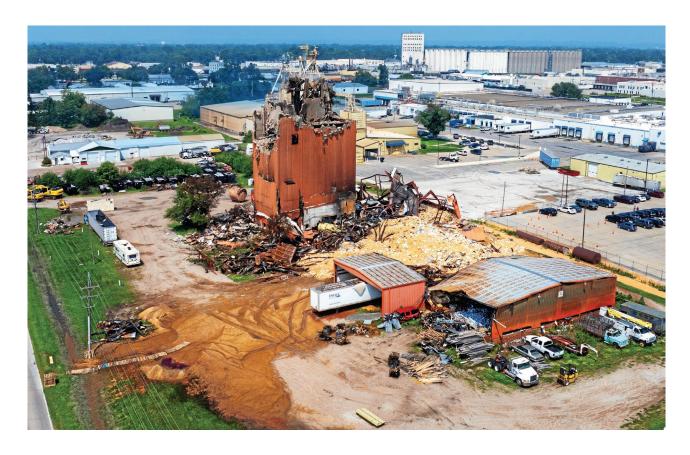
- July 29, 2025, approximately 11:56 a.m.
- Large explosion at the Horizon Biofuels,
 Inc. facility in Fremont, Nebraska
- Three people fatally injured—an operator and his two young daughters (aged 8 and 12)
- Several fires occurred and smoldering continued for more than a month
- Significant building and vehicle damage within the Horizon Biofuels property

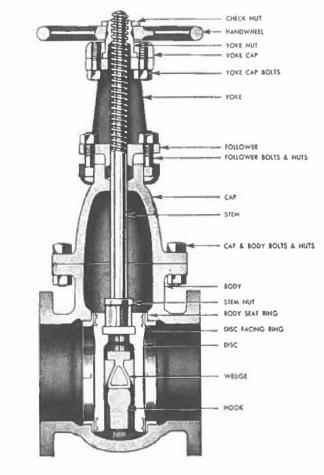
Illustration 20 Section through double disc iron body outside screw gate valve

- 18-inch cast iron double disc gate valve
- Markings on the valve's body indicate that Chapman fabricated it in 1953.
- The valve was rated for 50 pounds per square inch (psig).
- The valve had two cleanout ports directed at the valve seat, one on either side of the valve body.

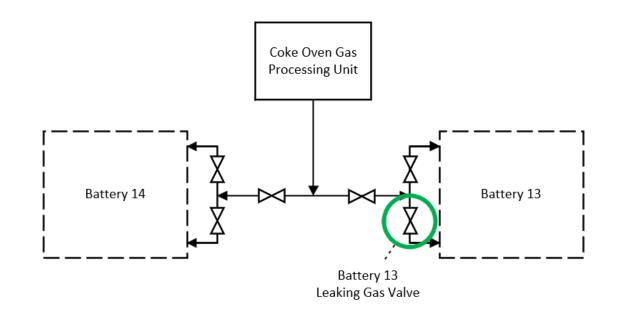
- July 8, 2025 leaking valve discovered downstream of the Battery 13 isolation valve.
- Valve cracked near flange
- Cracked valve temporarily repaired

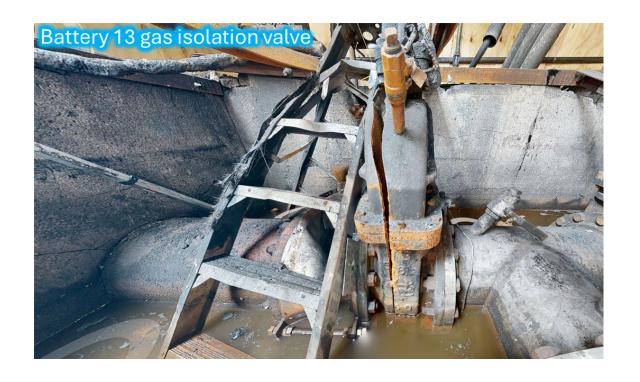
- Gas monitors alarmed
- Water observed leaking from bonnet flange
- Workers heard a "pop," one employee reported smelling gas
- Supervisor ordered evacuation of the area
- Other employees communicated evacuation of Batteries 13 and 14
- Explosion occurred at approximately 10:47 a.m., less than one minute after the workers made the radio evacuation call

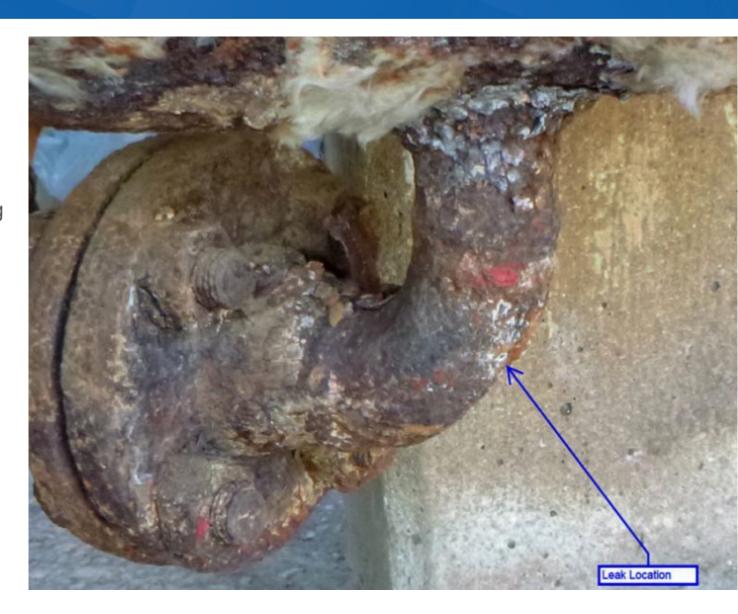
- Explosion and fire with \$50 million in property damage
- A 54-year-old piping segment had significantly corroded since the last inspection and was leaking
- A clamp was installed to stop the small LPG leak
- The piping segment failed (broke apart) when sealant was being added to the clamp
- LPG ignited with an explosion and fire

- Corroded piping broke while sealant was being injected into the repair clamp
- External insulation and equipment washing practices likely accelerated the corrosion

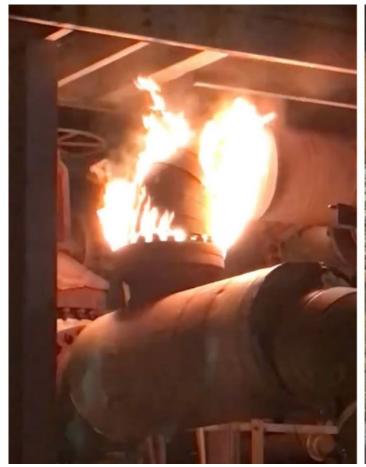
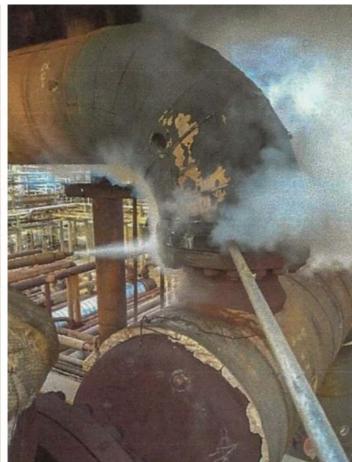
- Explosion and fire with four serious injuries and \$107 million in property damage
- A flange fire occurred two days before the incident, and steam lances were used to extinguish the fire
- Hot naphtha was leaking from the flange. To stop the leak, workers were installing injectable bolts as part of a wire wrap repair effort
- Hydraulic wrench applied localized force to a 59year-old, 14-inch elbow, rupturing the elbow and adjacent piping
- The elbow was thin from sulfidation corrosion

- Hydraulic wrench applied external force to a severely corroded piping elbow, initiating the rupture.
- Lack of an inspection that could have identified the thinned piping contributed to the incident

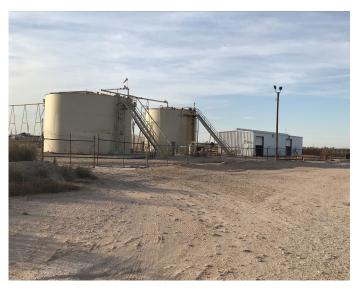
- Oct 26, 2019
- Aghorn employee responded to a pump oil level alarm at a waterflood station in Odessa, TX
- The pump was not isolated, kicked on, and released water containing H2S fatally injuring the employee
- The spoused investigated, also fatally injured

Develop and implement a site-specific security program to prevent unknown and unplanned entrance of those not employed by Aghorn, starting with access gates that lock upon entering and departing the facility.

- Aghorn developed a site security program to prevent the unplanned entrance of waterflood stations by nonemployees.
- Aghorn installed fences with locking access gates around its waterflood stations.

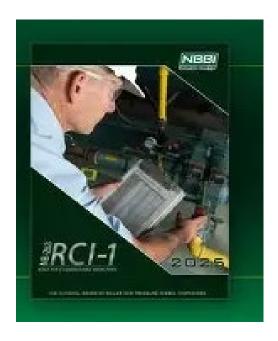
- April 3, 2017
- The bottom head of a pressure vessel (PV)
 catastrophically failed due to corrosion and an
 inadequate repair. The PV launched, crashing through
 the roof of a near by business.
- 3 members of the public were fatally injured

- Published 2025 Edition of NB-263, RCI-1, Rules for Commission Inspectors (NB-263) with an effective date of January 1, 2025
- Issued the 2025 Edition of the National Board Inspection Code (NBIC). Part 32 contains new requirements for evaluating flush patches/adjacent material
- Broadly publicized the events of the Loy Lange Box Company Pressure Vessel Explosion and other incidents
