March Public Meeting

U.S. Chemical Safety and
Hazard Investigation Board

Public Business Meeting
March 19, 2026

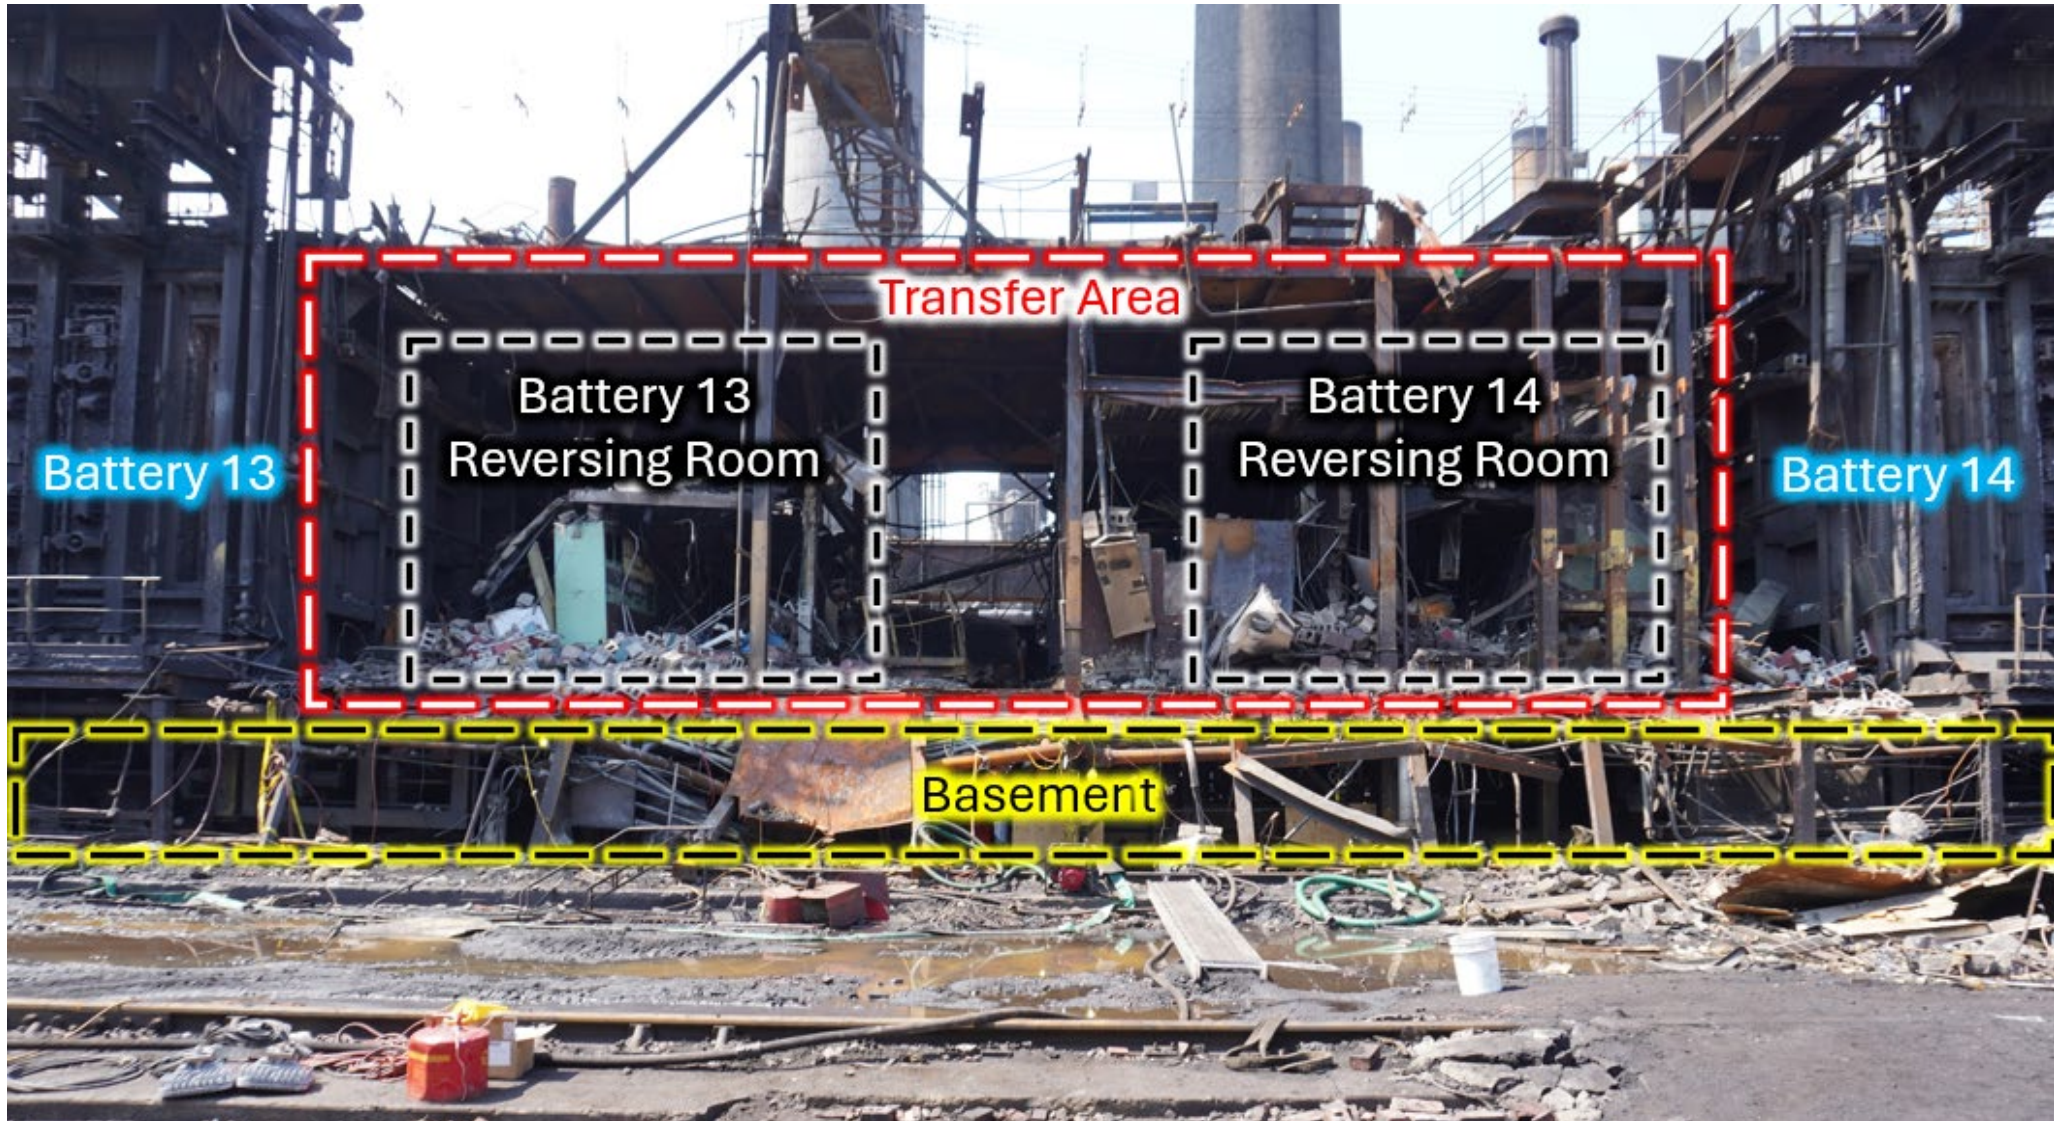
Battery 13/14 Transfer Area

- Prior to the incident, US Steel had not conducted a facility siting evaluation for Batteries 13 and 14
- US Steel conducted PHAs for its coke oven gas processes in 1998, 2003, 2008, 2013, and 2018.
- US Steel consistently chose not to evaluate facility siting
 - PHA documentation from 1998, 2003, and 2008 all clearly state that the PHA team did not consider facility siting
 - The 2018 PHA team claims to have considered facility siting, but the topic is not mentioned anywhere in the PHA documentation
- US Steel management rejected a recommendation from the 2003 PHA team to conduct a facility siting evaluation
- US Steel management believed that the OSHA PSM standard did not apply to the coke oven gas processes

- US Steel's decision not to address facility siting in its coke batteries increased the severity of this incident.
- After the incident, US Steel decided to relocate the workers stationed in the reversing rooms from the 13/14 transfer area to a different building
- US Steel has not conducted a facility siting evaluation to inform that decision
- US Steel has 6 coke batteries; all of them have routinely occupied buildings, that are not blast resistant, and which are located nearby coke oven gas piping and other potential hazard sources
- US Steel can reduce the severity of potential future incidents by evaluating and appropriately mitigating facility siting hazards at the Clairton facility

- CSB issued two interim recommendations:
- Conduct a facility siting evaluation for all occupied buildings at the Clairton facility in accordance with prevailing industry good practice guidance
- Appropriately address facility siting hazards according to the methods discussed in those industry guidance documents

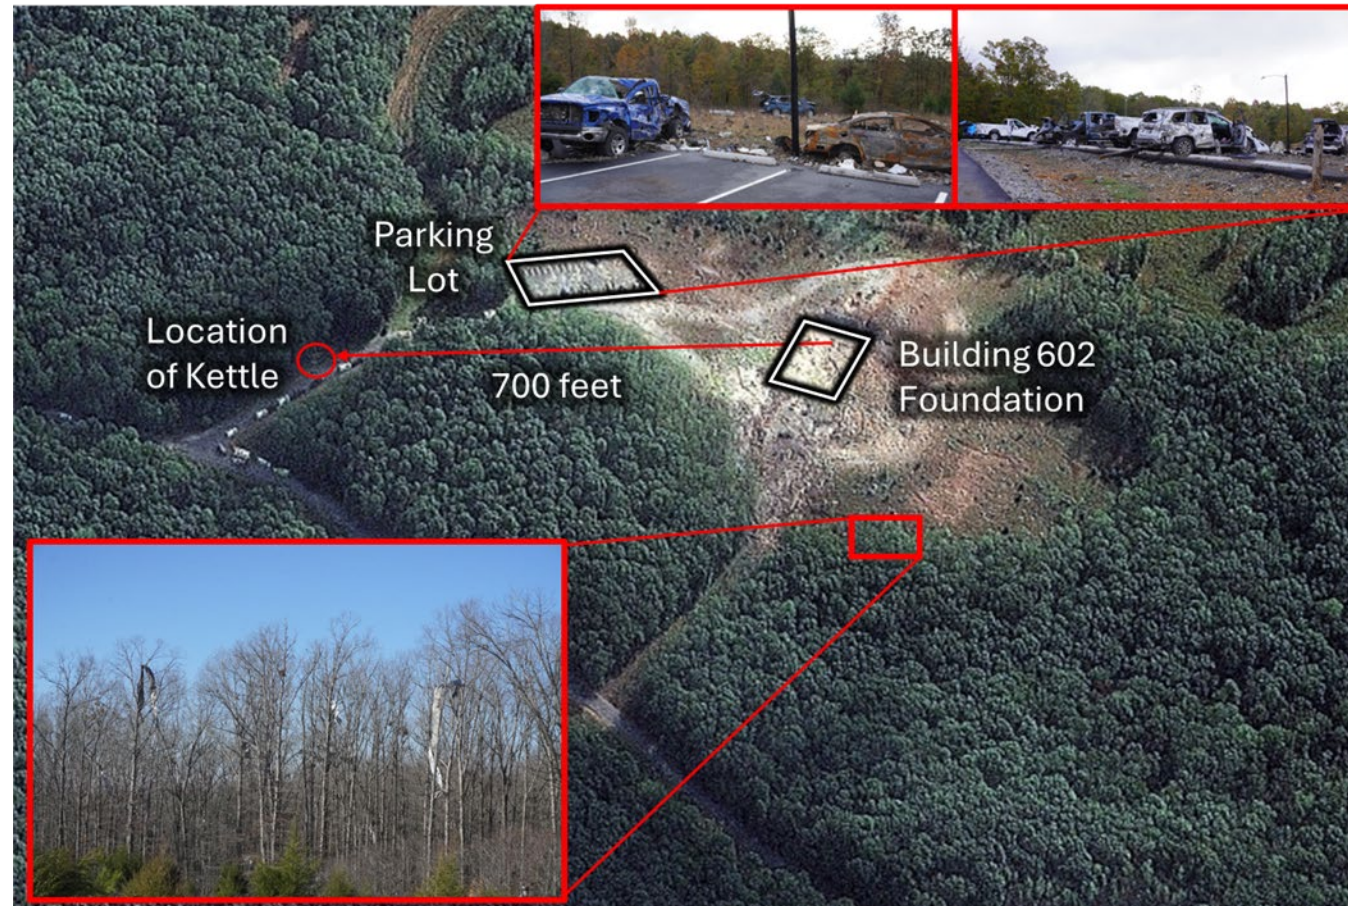
- Debris was launched from the building. Following the incident, one kettle was found approximately 700 feet away from the building. The explosion destroyed vehicles in the employee parking lot approximately 350 feet away.

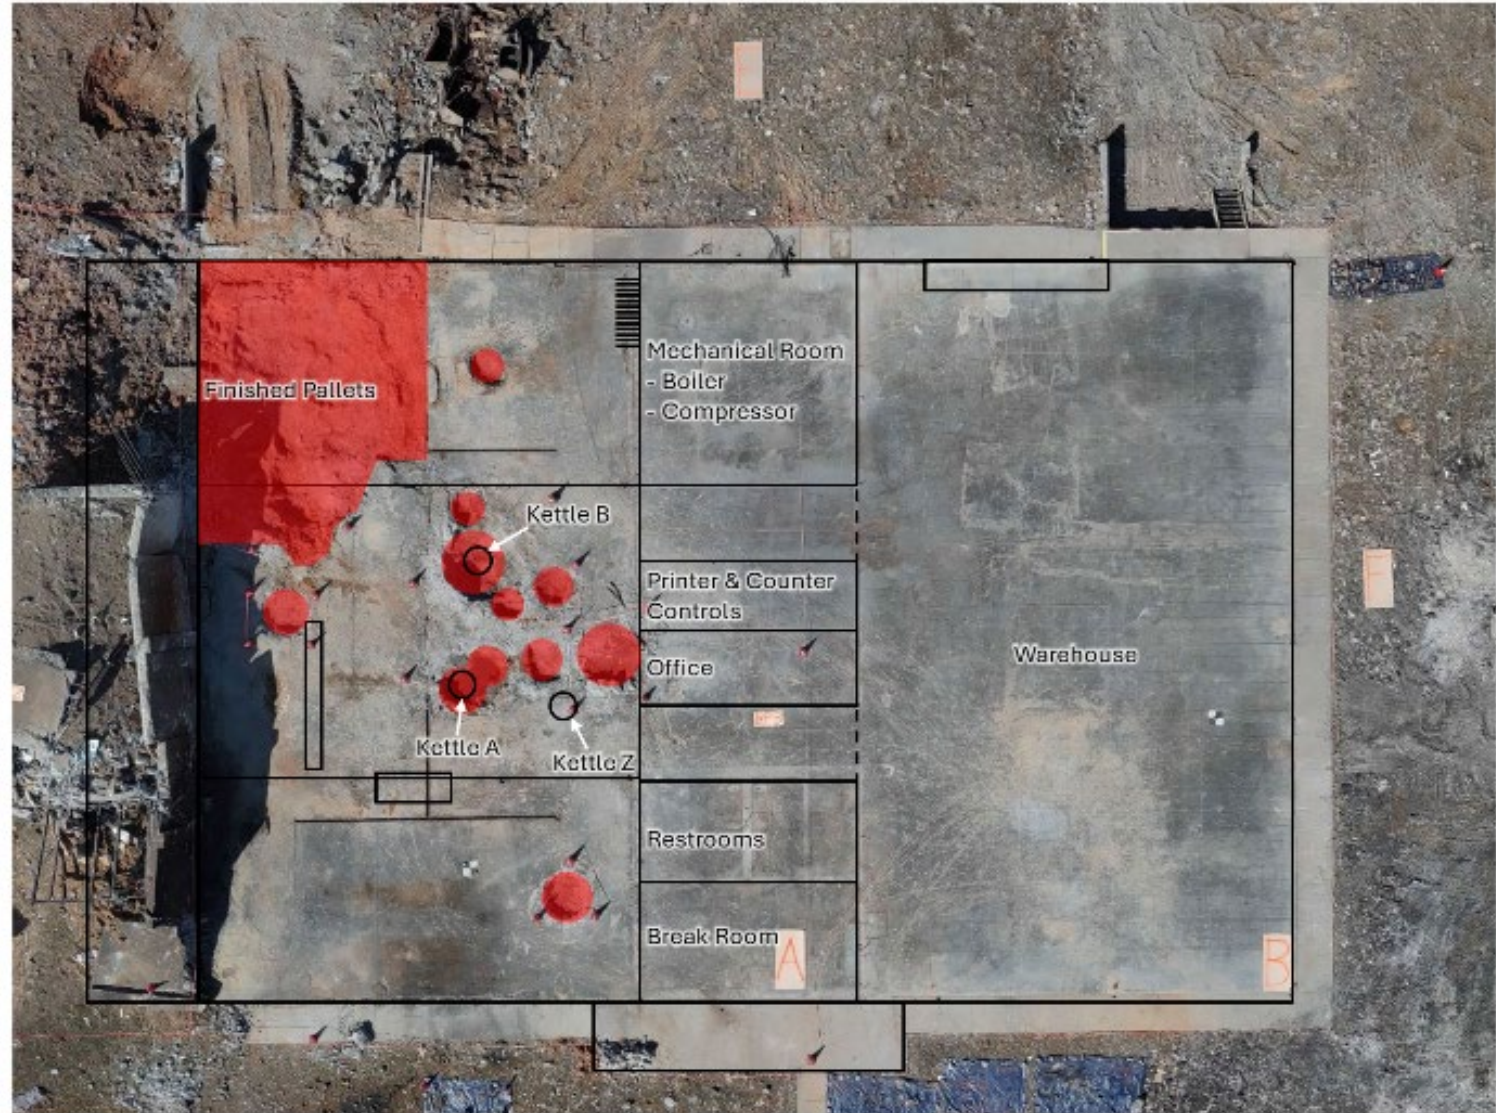
Crater Analysis

- At the time of the incident, 24,600 pounds of explosives were in Building 602.
- The first explosion likely occurred on the ground floor.
- Multiple explosions occurred following this initial explosion.
- The CSB has been able to identify the equipment and materials at each of these locations to aid in further analysis.

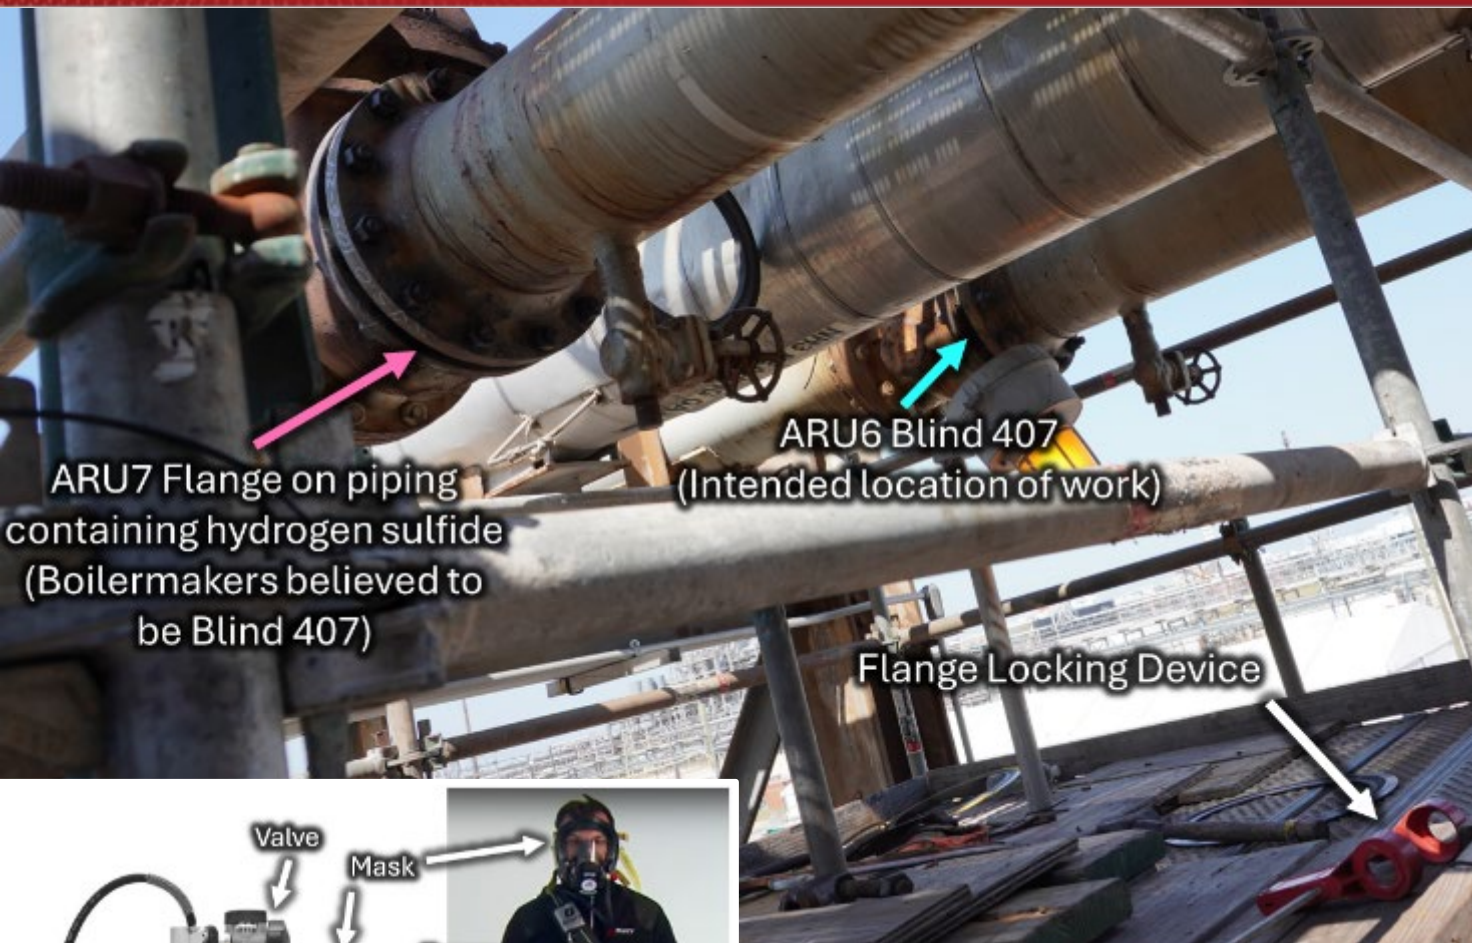
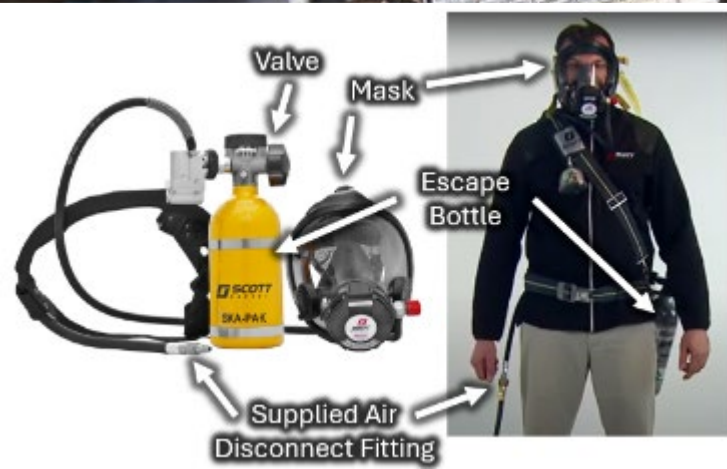
Acid Gas Blind Removal

- Boilermakers put on supplied air respirators with escape bottles and climbed to the platform to work on Blind 407.
- Boilermakers saw two identical piping segments located 5 feet apart—one contained acid gas on ARU7
- They did not see a blind tag, but did see a flange-locking device on ARU7, so they falsely believed it was the location of Blind 407.
- The Blind 407 tag was on the railing above the platform, and they did not see it

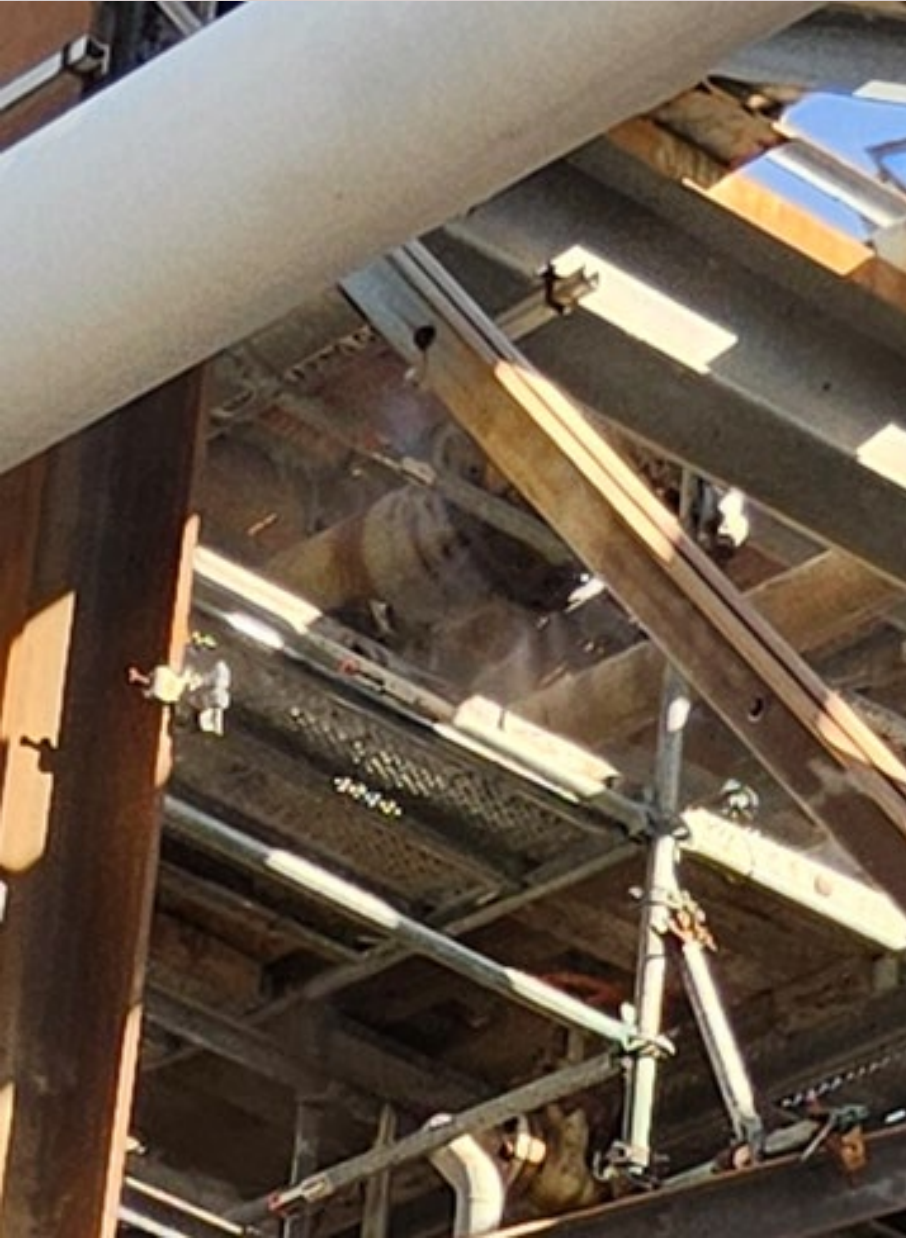
Hydrogen Sulfide Release and First Fatality

- Believing that they were working on Blind 407, the boilermakers removed bolts from the ARU7 flange.
- At 4:23 p.m., the flange opened and released toxic hydrogen sulfide.
- One boilermaker disconnected his air hose, but inhaled hydrogen sulfide and collapsed several feet away. Emergency responders later found him fatally injured from hydrogen sulfide poisoning.
- The fatally injured boilermaker was found with this respirator mask removed, lying next to him. The escape bottle was found with the strap wrapped around one leg, but not secured to his torso.
- The respirator regulator was found set to continuous flow.
- The escape bottle was empty at the conclusion of the incident.
- The other boilermaker safely escaped the release.

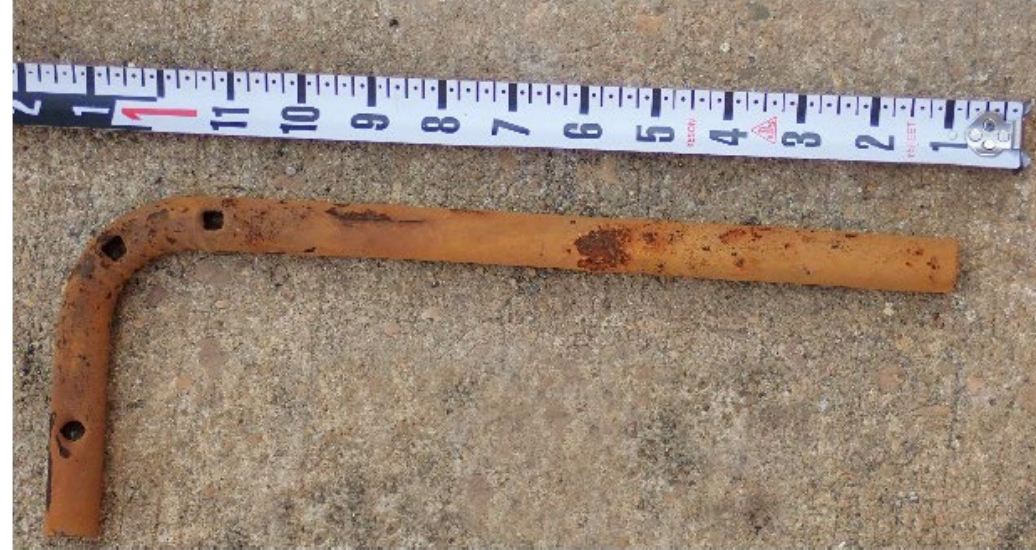
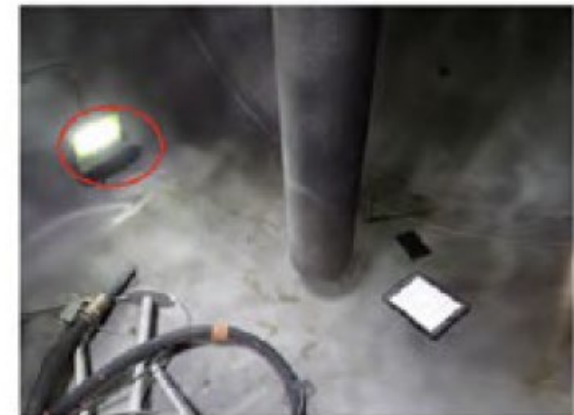
- Portable work lights were left in the reflux drum after the May 2023 turnaround work in the drum had concluded. Debris consistent with the work lights was found in the reflux drum, the downstream pumps, the product cooler, and the rupture disc after the incident.
- At the time of the incident, Dow's vessel closure process had no official procedure in place related to tracking equipment placed inside a vessel during maintenance and inspection activities requiring confined space entries.
- Dow's vessel closure process and practices did not adequately identify whether the reflux drum was clean and empty after maintenance was completed.

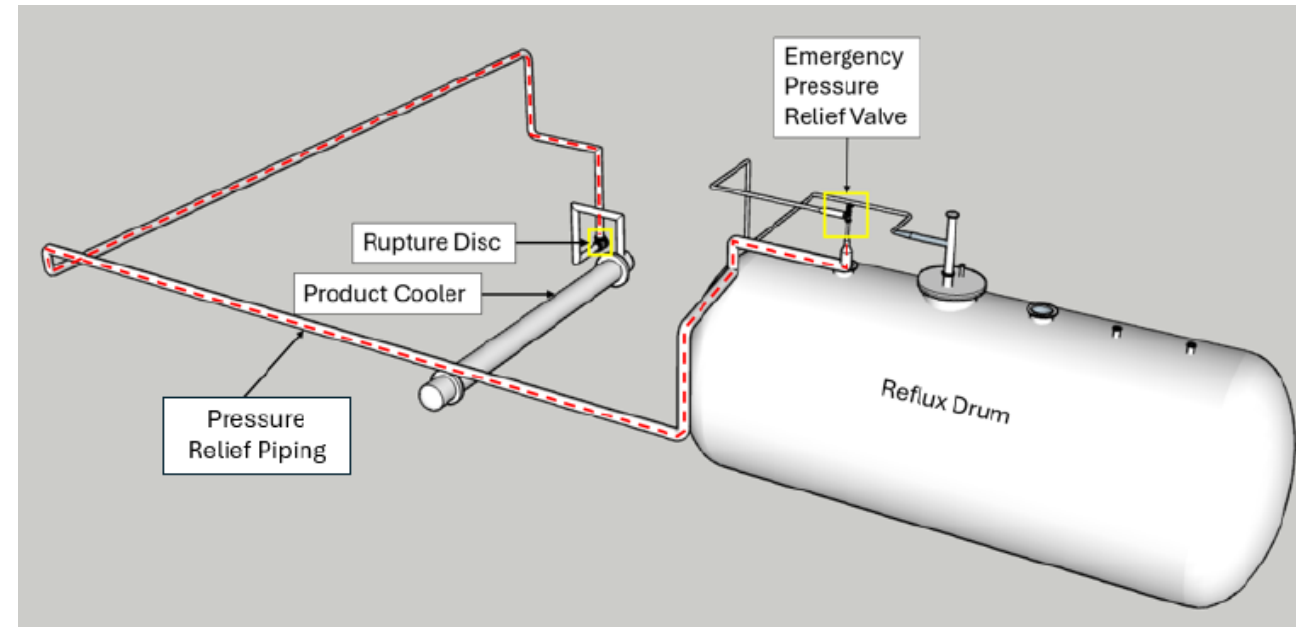
- Ethylene oxide liquid discharged into the vapor space of properly inerted equipment or piping will not carry sufficient energy to ignite the vapor in the absence of oxygen.
- At Dow's facility, nitrogen is one of the primary safeguards to ensure ethylene oxide equipment that contained a vapor phase would not react or combust in the vapor space.
- Prior to the incident, nitrogen would be manually charged into the pressure relief piping whenever the system was opened for maintenance or inspection, and no procedure required regular charging of nitrogen.
- There is no evidence that an operator or management official checked the pressure in the system in the two-plus years between rupture disc work in 2020 and the incident in 2023, or that any management system prompted them to do so.

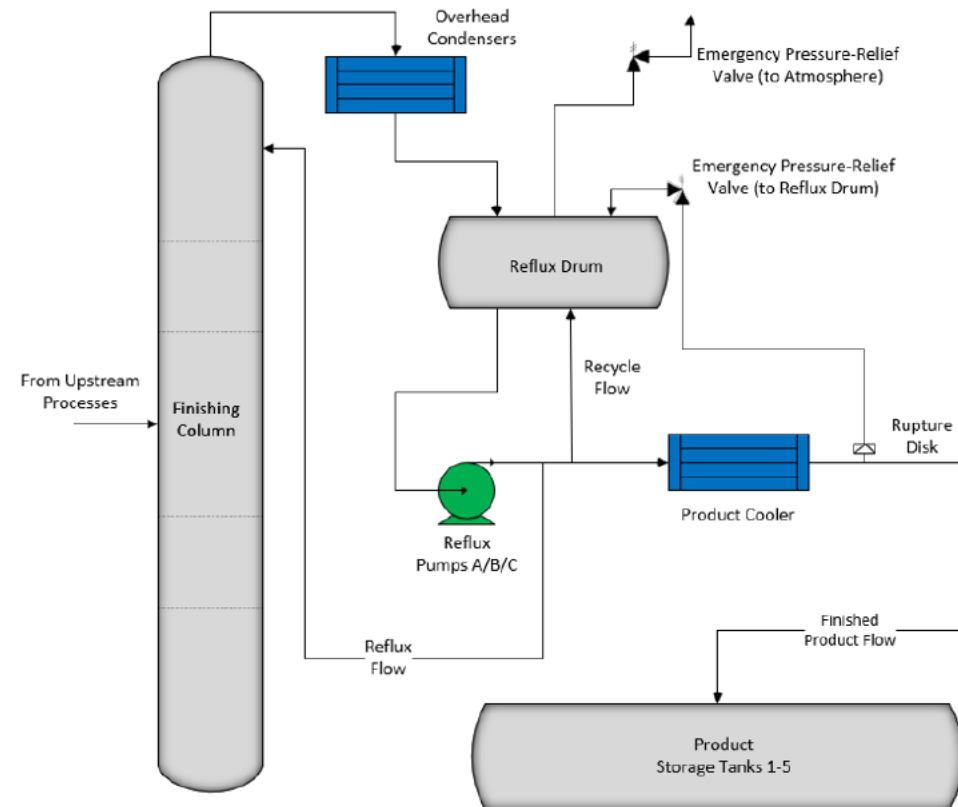
Pressure Relief System Design

- After the ethylene oxide ignited within the pressure relief piping, the flame front built pressure as it propagated toward the PRV and the reflux drum.
- When this flame front reached the reflux drum, it heated and ignited the large quantity of ethylene oxide present in the drum, which decomposed and significantly increased the severity of the incident when the reflux drum exploded.
- The product cooler was replaced in 2011. The pressure relief system between the product cooler and the reflux drum was put in place when the new product cooler system was installed. The new system changed the product cooler to eliminate certain overpressure scenarios but did not eliminate the need for the pressure relief piping completely.
- After the incident, the pressure relief piping from the product cooler into the reflux drum was eliminated completely
