U.S. Chemical Safety and  
Hazard Investigation Board

# Pressure Vessel Explosion at Loy-Lange Box Company

St. Louis, MO | Incident Date: April 3, 2017 | No. 2017-04-I-MO

## Investigation Report

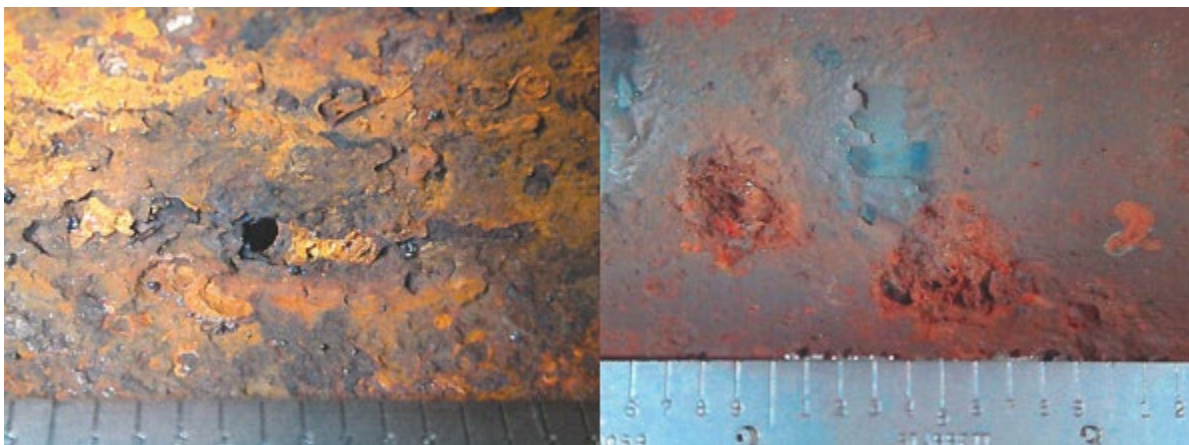
**Figure 28.** Pitting damage in two of Loy-Lange’s steam coils. (Credit: Clayton)

In addition to these leaks in the SCR, Loy-Lange experienced corrosion in other parts of the steam system. The CSB found documentation of one known steam separator leak and four generator coil failures.<sup>a</sup> **Figure 28** shows the oxygen pitting corrosion found in two of the four generator coil failures. The images were taken by Clayton after Loy-Lange submitted the failed coils to Clayton for warranty replacement consideration. The left image is of a 2002 coil failure and the right image is of a 2004 coil failure.
