U.S. Chemical Safety and
Hazard Investigation Board

NEWS RELEASE
U.S. CHEMICAL SAFETY BOARD
EMBARGOED UNTIL
10 a.m. EST – December 8, 2008

**CSB to Conduct Full Investigation of Causes of
Catastrophic Fertilizer Tank Collapse at Allied Terminals
in Chesapeake, Virginia; Issues Urgent Safety
Recommendations Citing Hazard to Public from Welding
Defects on Several Remaining Tanks**

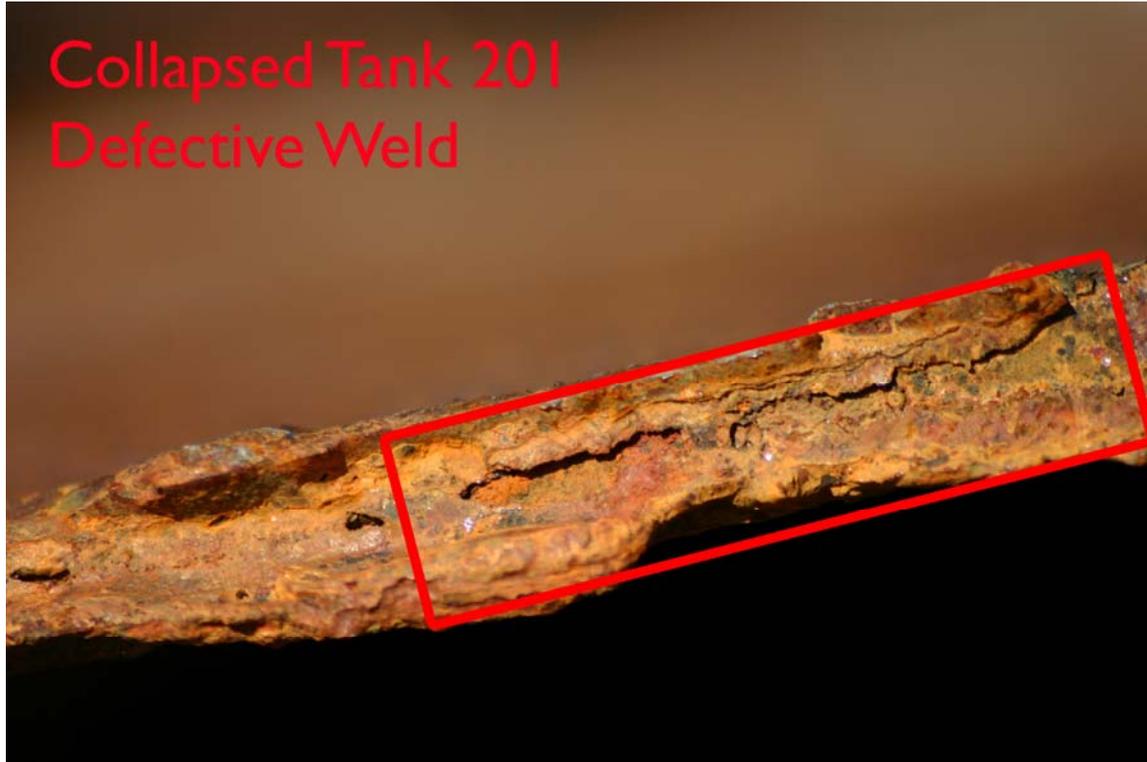
CSB investigators concluded that the November 12 collapse of Tank 201, which contained an aqueous solution of urea and ammonium nitrate fertilizer, likely resulted from defective welds on the tank wall. The welding was performed in 2006 as part of a project to strengthen four fertilizer tanks that were constructed around 1929 by replacing vertical riveted seams.

“We found a number of welding defects where the modifications were made, including incomplete penetration of the welding metal into the joints,” said CSB Lead Investigator Robert J. Hall, P.E. “These welding defects likely weakened Tank 201 and led to its failure when the liquid was raised to a level slightly below the tank's recommended safe fill height.”
