On May 19, 2018, at approximately 10:30 a.m., during preparations for startup activities following a turnaround,¹ a fire occurred at the Kuraray America EVAL facility in Pasadena, Texas. At the time of the incident, 266 employees and contract workers were onsite. During pre-startup pressure-testing activities of a chemical reactor, an abnormal high-pressure condition occurred and over 2,000 pounds of ethylene² were released to the atmosphere from a pressure relief valve. The ethylene vapors ignited (**Figure 1**), resulting in worker injuries. Twenty-one injured workers were transported to off-site medical facilities for treatment.³

The Kuraray America EVAL Plant (“EVAL Plant”) is a chemical production facility located in the Bayport Industrial District⁴ near Pasadena, Texas. The EVAL Plant produces ethylene-vinyl alcohol copolymers.⁵ This plant has four production lines. Production began in 1986 with two production lines, 1100 and 1200. The 1300 line began production in 1997. The fourth line, 1400, started commercial production in 2006. The 1200 production line, one of the original lines, was involved in the incident. Each of these production lines has a pressurized chemical reac

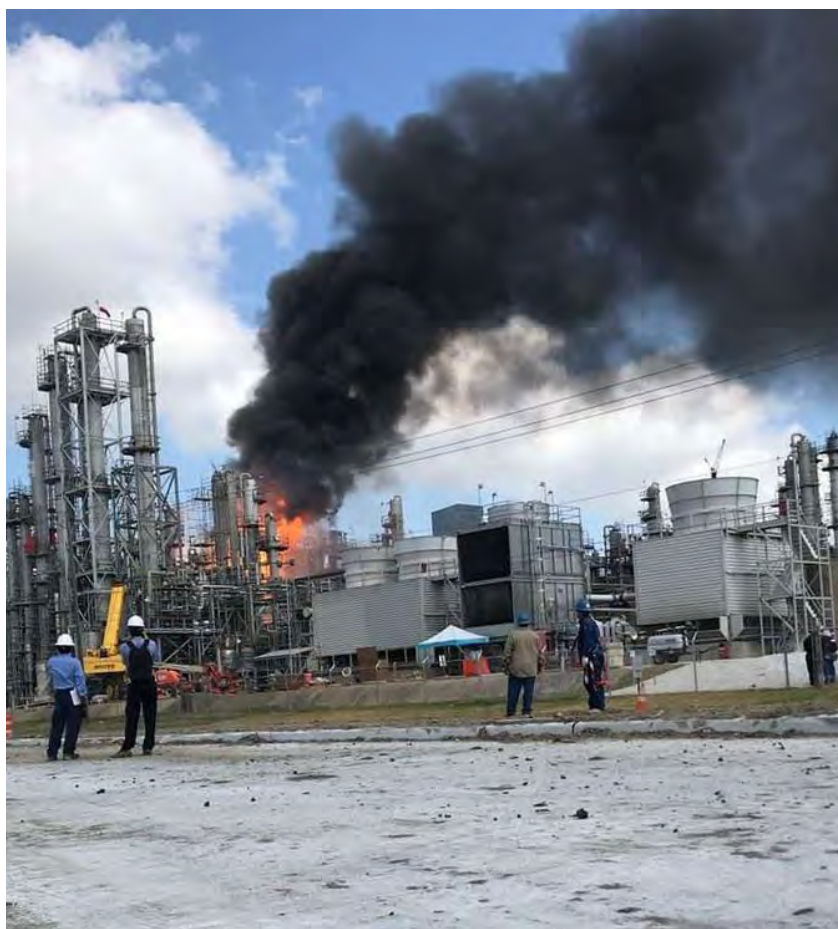
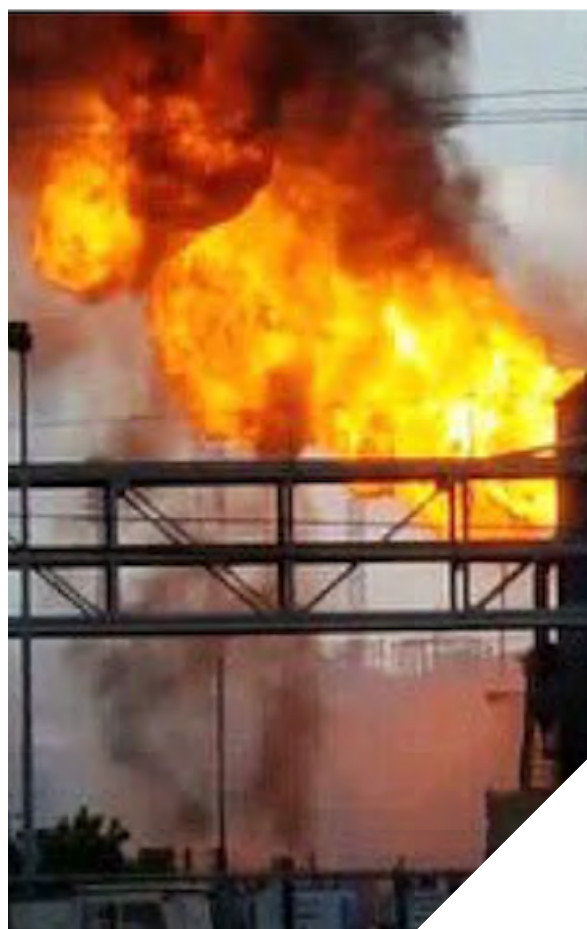
Figure 1. Fire at Kuraray EVAL Plant. The photo on the left shows the fire from a local road. The photo on the right is an image from a [video](#) of the fire. Credit: Houston Chronicle (left) Tiffany Craig, KHOU TV, courtesy of Edward Ross (right).

When the reactor’s pressure relief valve opened, reactor vapor ejected horizontally out of the relief valve’s atmospheric discharge piping, over a road adjacent to the reactor structure inside the EVAL Plant. The flammable gas ignited, resulting in a large flash fire,¹⁰ which then propagated back to the relief valve outlet and became a jet fire¹¹ (right photo **Figure 1**). The Harris County Fire Marshal

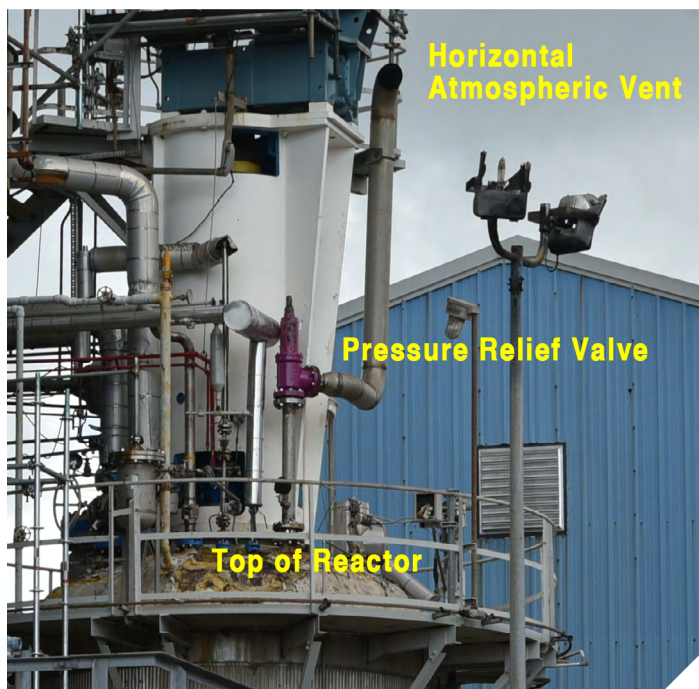
Figure 2. The pressure relief system that activated and discharged ethylene horizontally across the road. Credit: CSB.

After the day shift took over on the morning of May 19, 2018, at approximately 7:00 a.m., one of the supervisors checked on the status of the process. During this review, he recognized the low reactor temperature. The supervisor requested that the control room operator close the brine valves to stop circulating brine through the reactor coolers. In addition, the operations staff began to warm up the reactor contents by circulating steam-heated water through the reactor jacket. Closing the brine valves and adding heat to the reactor jacket began vaporizing the ethylene liquid in the reactor, increasing both the reactor temperature and pressure. Over the next three and one-half hours, Kuraray operators made a number of process adjustments, but at 10:28 a.m. the reactor pressure relief system⁹ (**Figure 2**) activated.

9 The reactor’s pressure relief system consists of a rupture disc and pressure relief valve. When the pressure relief system is activated, the disc will burst, opening a path to the relief valve. Then the relief valve will open, discharging vapor and/or liquid horizontally, until the pressure in the reactor decreases enough for the valve to close.

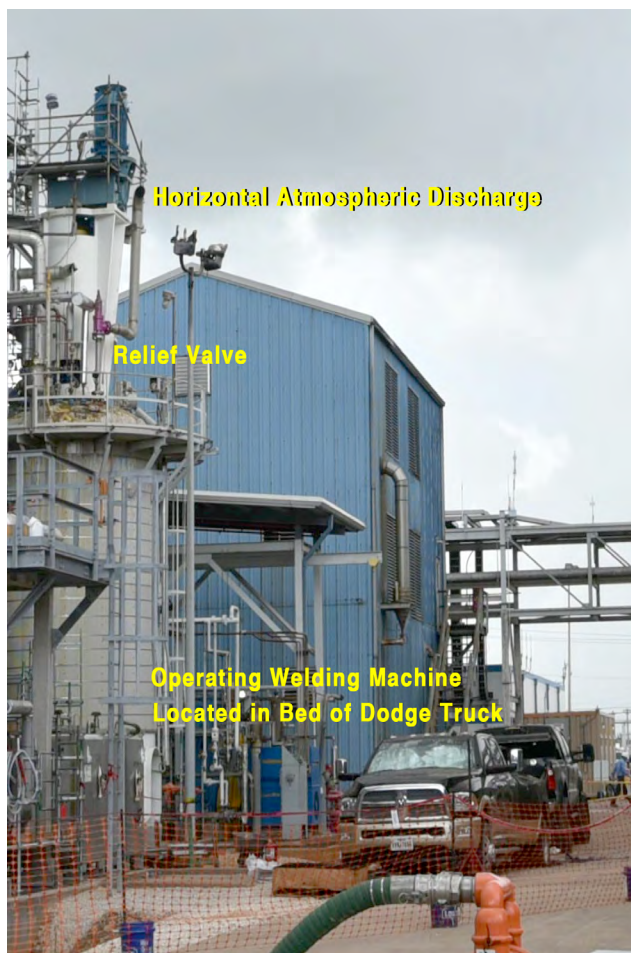
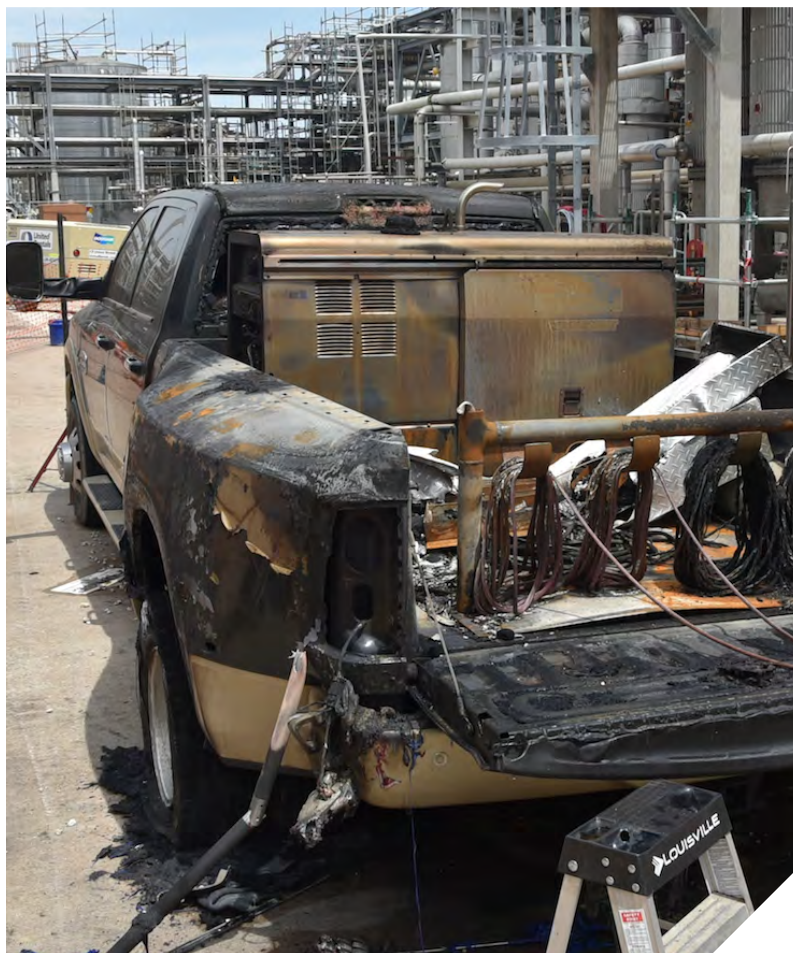
Figure 3. The welding machine that was the source of ignition, located under the relief valve's horizontal discharge. Credit: CSB.

Office identified the ignition source as “located in or around the operating welder [welding machine] located in the back of the Dodge pickup” (right photo in **Figure 3**), located adjacent to the reactor structure, under the relief valve discharge piping (left photo in **Figure 3**). Contract workers in the vicinity of the fire were performing a variety of activities including welding, insulating, and painting. These workers immediately evacuated when the fire erupted. Some workers suffered burns or were injured by jumping from heights or falling while running to escape the fire. The fire burned for
