U. S. Chemical Safety Board

SONAT INVESTIGATION

**Catastrophic Vessel
OVERPRESSURIZATION
(4 Deaths)**

- March 4, 1998, near Pitkin, LA
- Startup of Oil / Gas Separation Equipment
- Natural Gas Purge of Vessels and Pipeline
- Oil / Gas Separator Overpressurized
- Catastrophic Vessel Failure
- Four Operators Killed

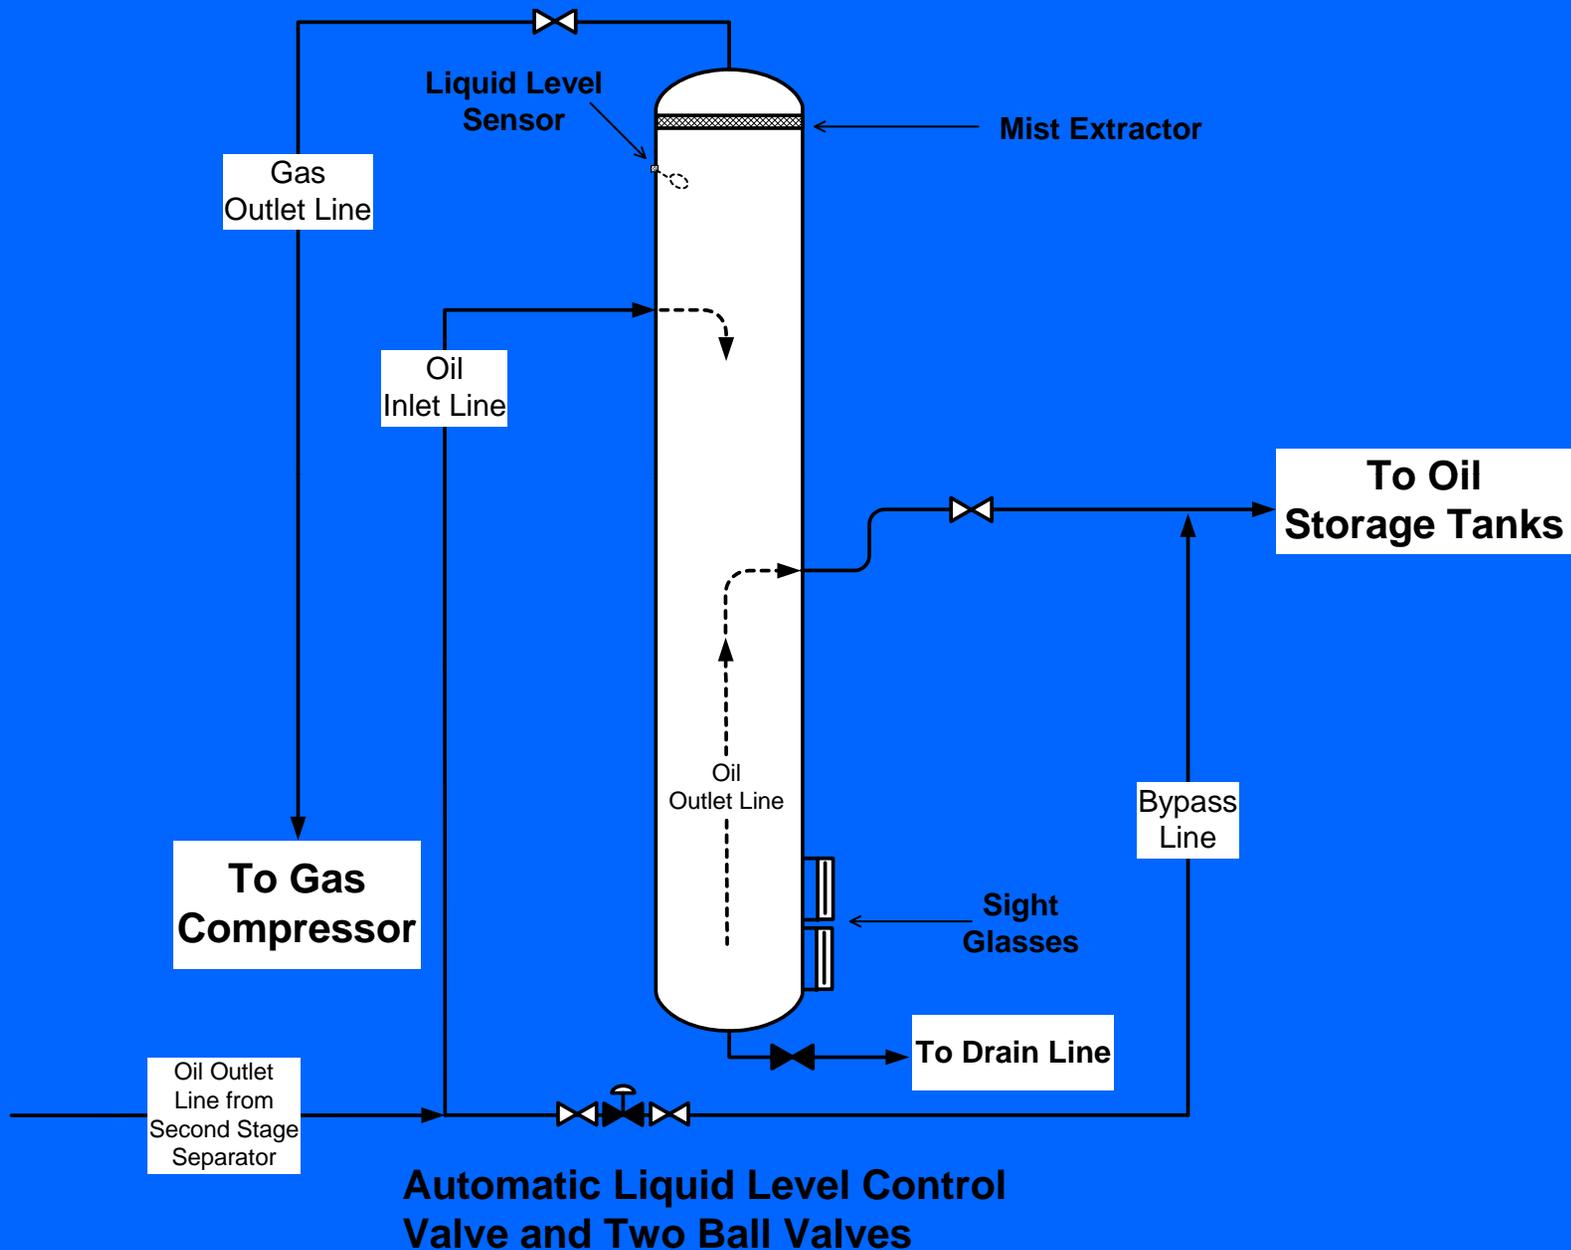
Third Stage Separator Schematic

- Separator had a single inlet line for oil/gas mixture but two separate outlet lines
- Separator was not designed for permanent oil storage
- Separator was positioned upstream of the storage tanks in series with the 1st and 2nd stage separators

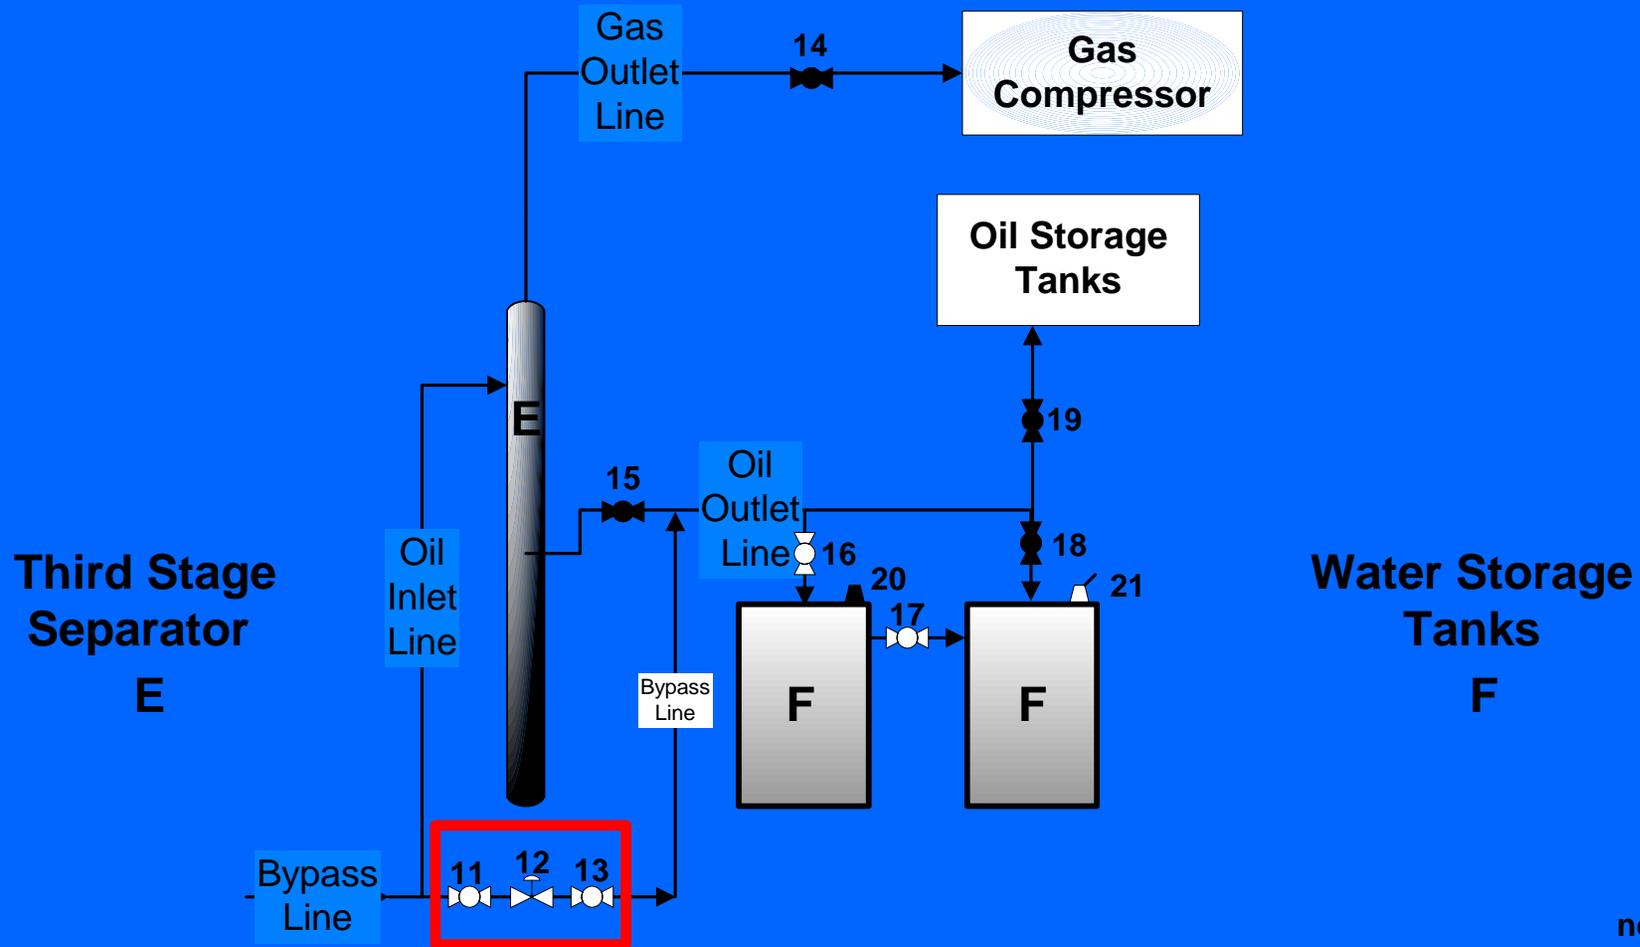
Intended Valve Positions after the Final Alignment

- The vessel that failed, a third stage separator, lacked an inlet valve and could not be isolated from an adjacent bypass line, which at the time of the incident contained high-pressure purge gases.

- At the time of the incident, two outlet block valves on the separator were closed, as were two block valves on the bypass line downstream of the separator. Accordingly the high-pressure purge gases could not be vented and the separator

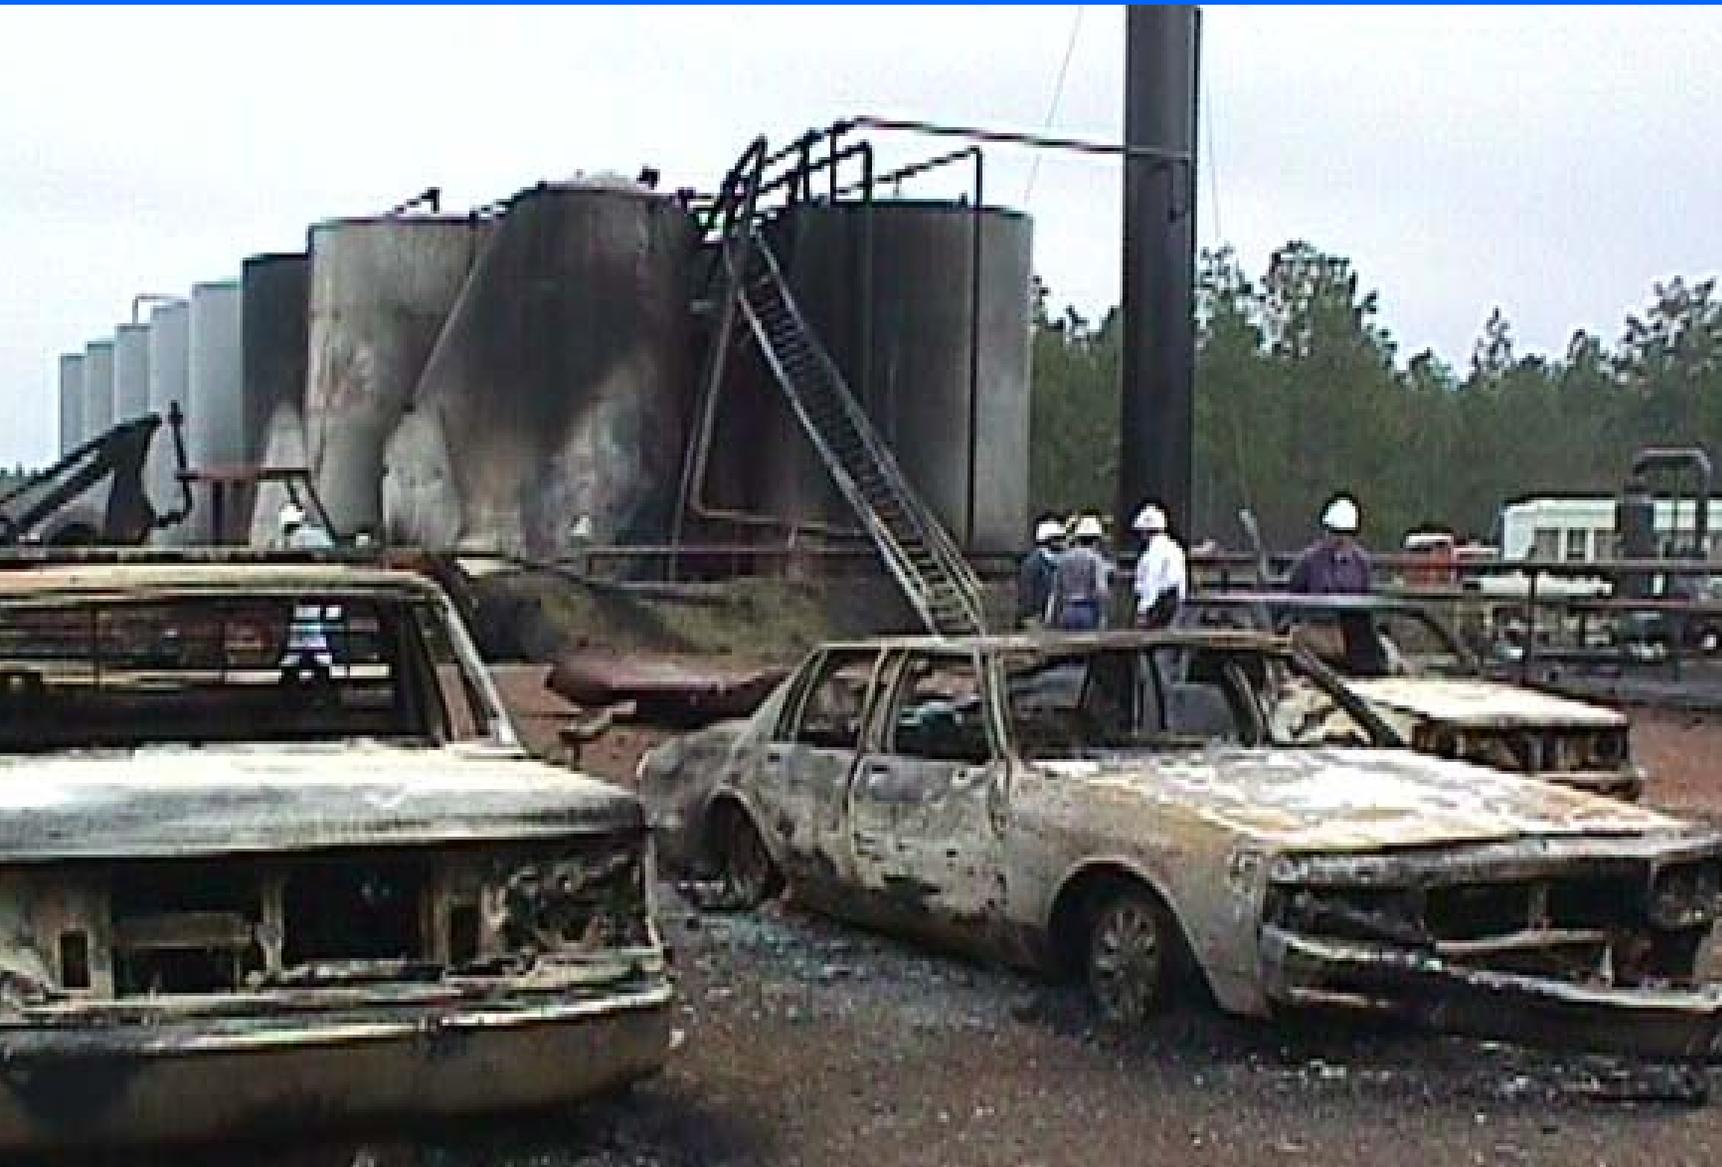
Damaged Vehicles and Storage Tanks

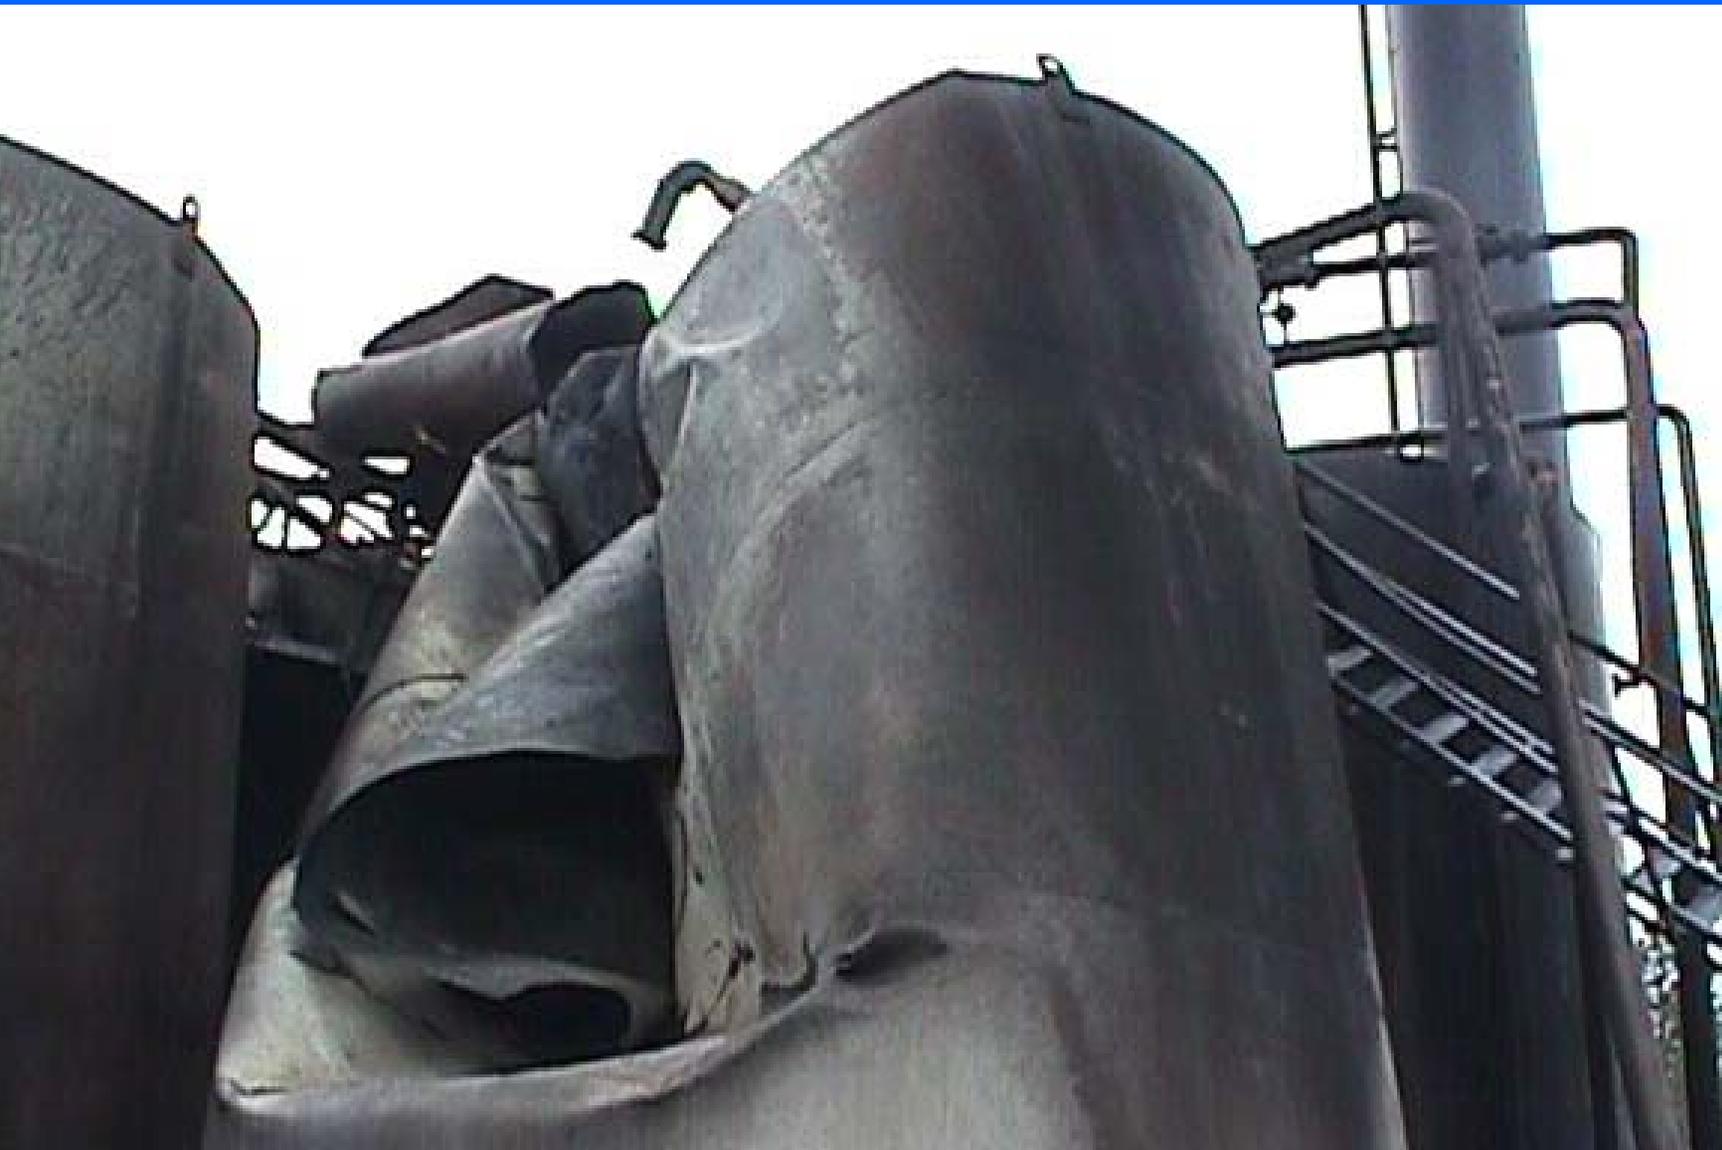
Damaged Water Storage Tank
