**API 653
Inspection Report**

Report Prepared For
**U.S. CHEMICAL SAFETY AND HAZARD INVESTIGATION BOARD
FREEDOM INDUSTRIES**

4-METHYLCYCLOHEXANEMETHANOL (MCHM)

Tank Number
397

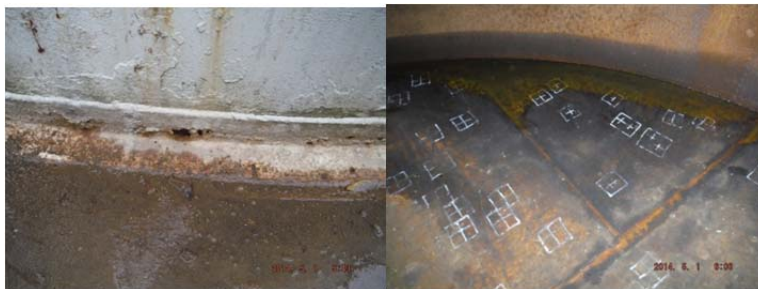
Muddy Conditions around the base of the tank and debris inside tank

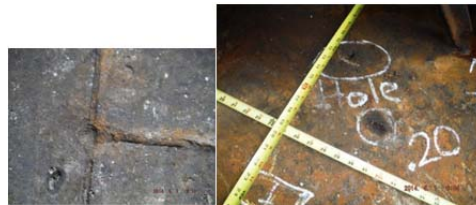
- 1.2. **Product Side Visual Bottom Inspection:** At the time of the inspection a series of deep isolated product side pits were identified on the bottom. A hole through the bottom from product side corrosion was present under the water draw out near the shell. However, because of the debris along the bottom it is very likely that other existing leak paths are present. Product side pits as deep as 0.200-in were identified ($0.25-0.200=0.05$ -in remaining thickness) as well as surrounding pits with depths measuring 0.08-in. Most of these pits are located in the API 653 designated critical zone (3-in from shell of the inside edge of the shell, measured radially inward).

**Pits on bottom**

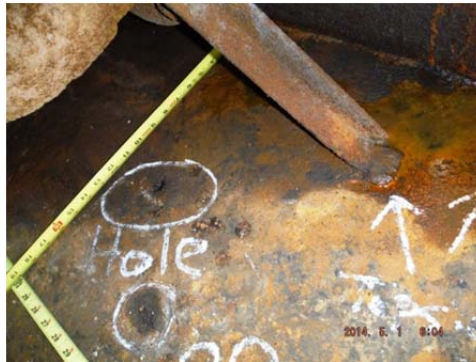
**Hole on bottom from product side pitting**

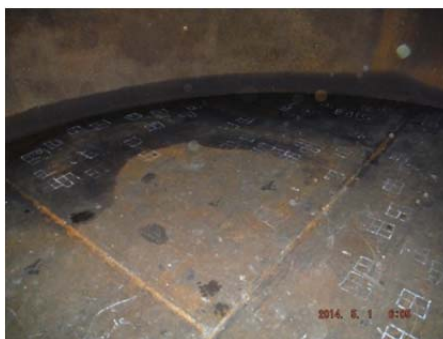
- 1.3. **Soil Side Bottom Inspection:** The 0.250-in thick bottom was inspected for soil-side corrosion utilizing the MFE 2412 Mark II scanner. Extensive magnetic flux differential indications were recorded on every bottom plate. Some of these indications most likely result from soil side corrosion damage. Unfortunately, (in order to preserve the condition of the bottom as close to the conditions at the time of the product leakage) at the time the inspection the bottom was muddy and dirty. (see photo below)

Note: It is the inspector's experience that it is unlikely that all the indications are from soil side corrosion damage. In addition to soil side corrosion the MFE 2412 scanner can indicate on 'old weld-ments', mechanical dents, bottom plate warp age, debris or dirty plates, and rough areas of corrosion scale or pitting loss. In order to properly classify and quantify these indications precisely, the bottom would need to have been sand blasted and immaculately clean.

**Bottom Conditions at Time of Inspection**

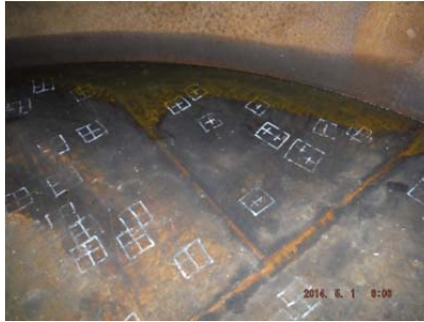
- 1.4. During the MFE 2412 bottom scan each significant MFE indication was marked on the bottom with "Mark-a-l® Paint stick".

**MFE Bottom Indication Marks
(Immediately after marking)**

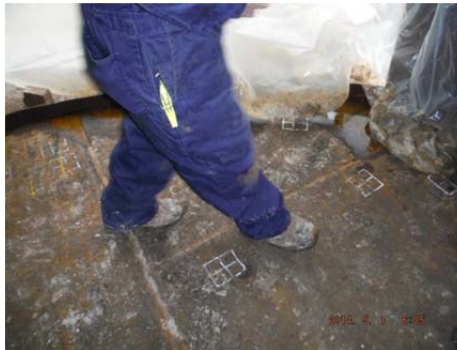
- 1.5. The marks were quickly obscured by dirt and mud.

**MFE Bottom Indication Marks
(shortly after marking)**

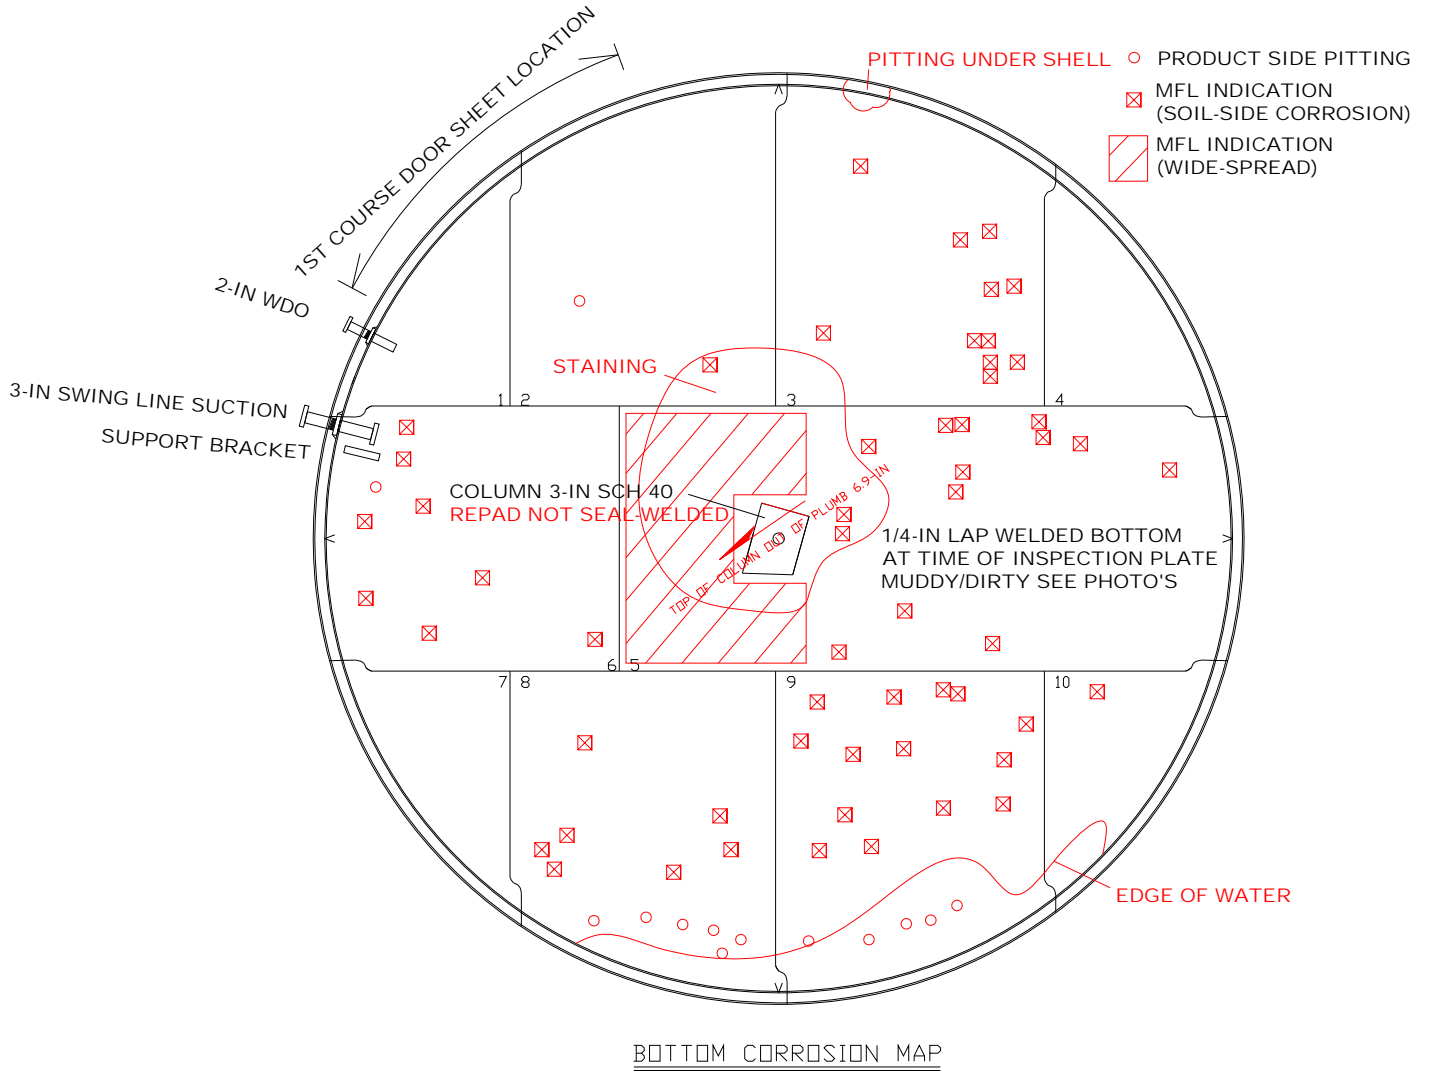
- 1.6. Limited prove-up of the MFE indications resulted in remaining UT thickness of 0.18-in or a loss of 0.25-0.18=0.07-in). Note it is the inspector's opinion that the limited UT prove up did not identify the worst are of soil side corrosion. In order to conduct this type inspection at a minimum a full inspection blast of the bottom to remove all scale/dirt and debris would need to be conducted.
- 1.7. Soil side corrosion rate. 0.07-in loss/25 years age of bottom = 0.0028-in/year.

1.8. In the Bottom Corrosion Map the MFE indications are marked with red X's.

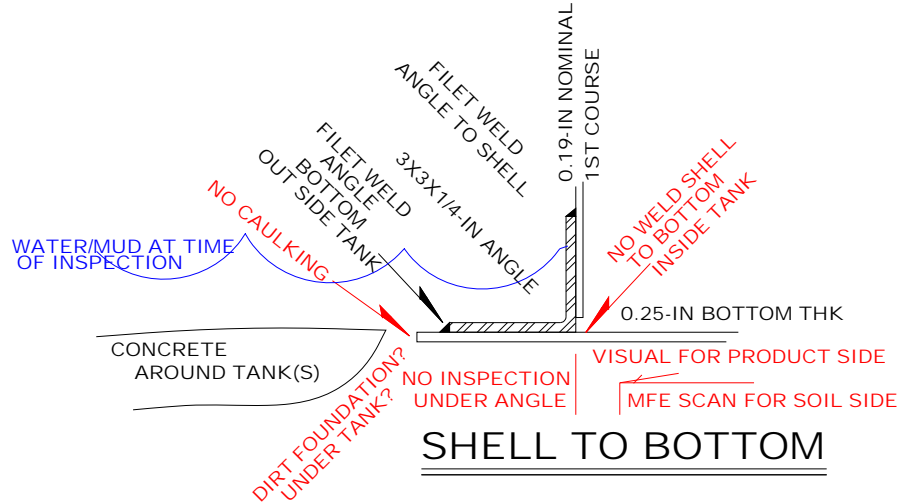
2.1. There is a possibility that significant undetected bottom corrosion is present under non API 650 tank shell to bottom joint. This joint is formed with a 3 x 3 x 1/4-in angle as illustrated. Note: Inspection of the bottom plate under the shell and extending outward is almost impossible short of excavating around the base of the tank and utilizing mirrors to view the bottom condition in this area.

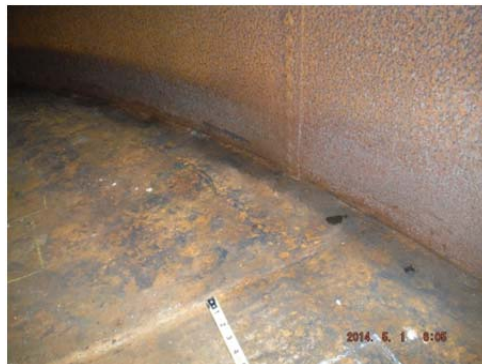
2.2. There may be existing cracks or weld defects in the existing bottom butt welds. The lap welded bottom is 1/4-in nominal thick plate with an under the shell bottom breakdown detail (as illustrated) that transitions from a lap weld to a butt weld. This joint is susceptible to cracking and is located in the API 653 area of the bottom called the "Critical Zone" or CZ. Most of the CZ joint is obscured from inspection by the shell to bottom angle detail.

Photo of typical crack location

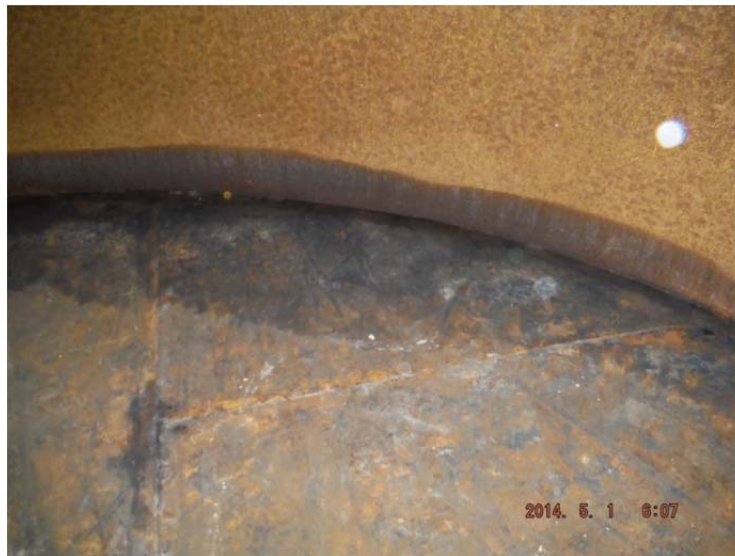
Photo of typical lap weld to butt weld transition

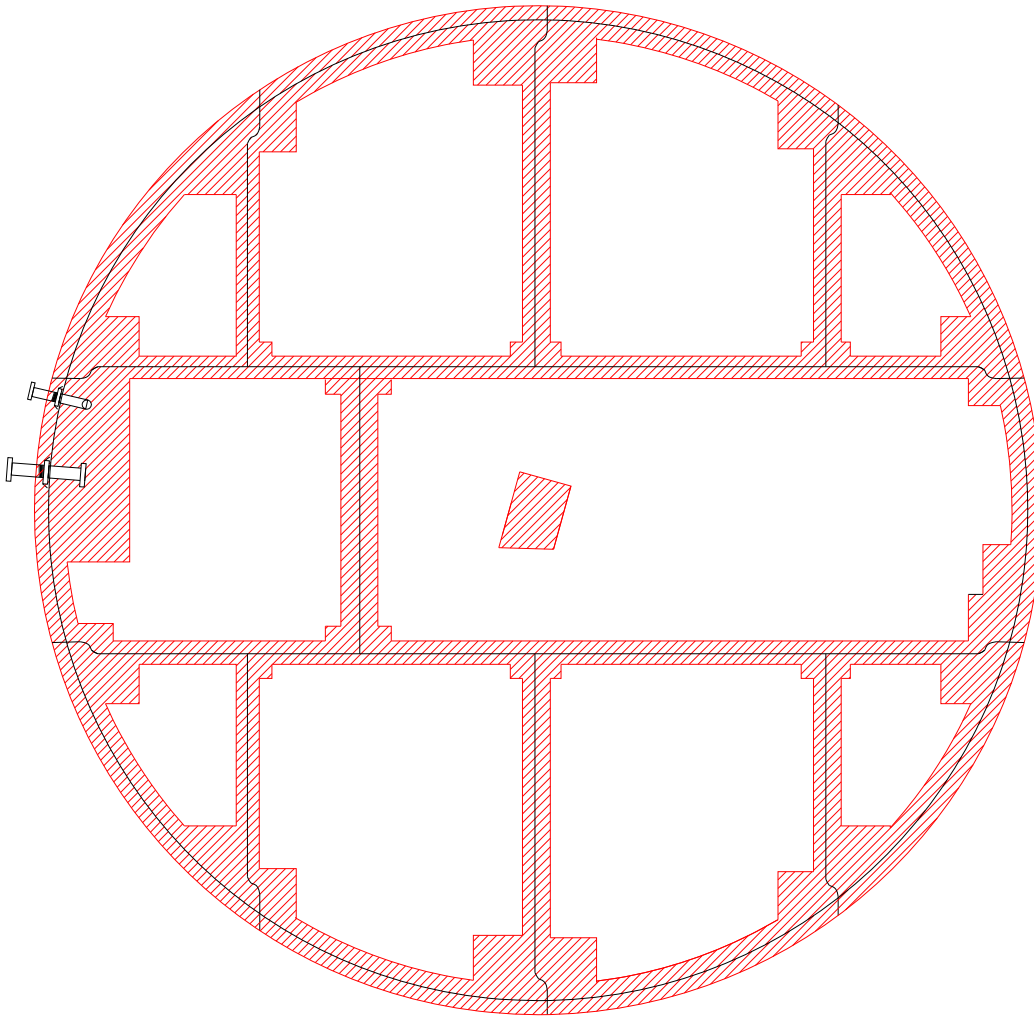
MFE SCAN COVERAGE

- 2.3. **There may be significant soil side corrosion in the areas of the bottom difficult for access with the MFE 2412 scanner.** The MFE coverage was limited to approximately 75% of the bottom area and indicated in the next drawing. Under normal conditions the scanner coverage near the bottom to shell joint is plus or minus 1 to 2-in, at the square plate intersections plus or minus 4-in, around nozzles plus or minus 3 to 12-in, and near the triangular corners of sketch plates plus or minus 6 to 12-in. In addition on this tank the shell to bottom detail eliminates from MFE coverage, the outer 4 inches of the bottom that extends under the shell.

- 2.4. These areas that were difficult to reach with the scanner (<2-in from the corner weld, tight angled bottom plates, under columns and base plates, around supports, and under low shell nozzles). If conditions were optimal Ultrasonic thickness testing or UT would be performed in these areas, however because of the rough and dirty bottom conditions, effective UT of these areas was not possible.

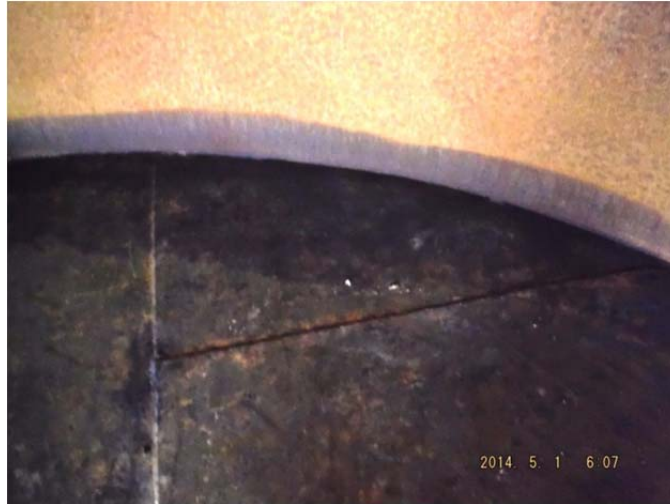
- 2.5. In addition to visual inspection the bottom lap welds are typically tested with a Vacuum Box, during an API 653 bottom inspection. Unfortunately the conditions did not allow for affective inspection by either method.

Typical Bottom Lap Weld

- 2.6. Several support components are attached directly to the bottom without seal welded repads.
- 2.7. Extensive corrosion damage is also present along visually accessible lap welds.

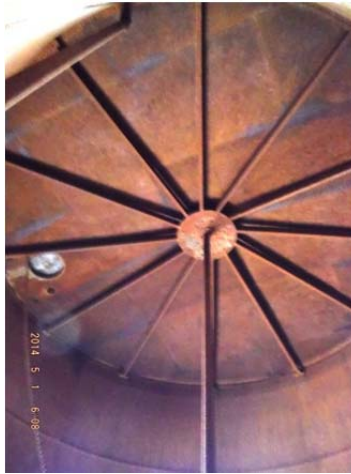
- 3.4. **Roof Support Rafters.** Several of the roof deck support rafters appear to be in fair condition.

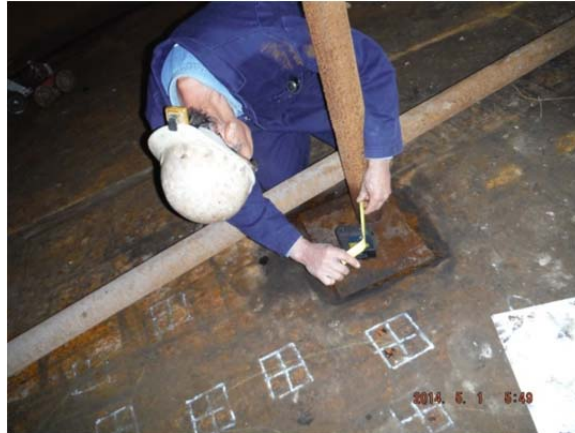
- 3.5. **Roof Support Column.** The roof support column is a pipe design and is susceptible to undetected internal corrosion damage.
- 3.6. **Column Base.** The base of the column does not appear to be restrained from lateral movement. A repad is present under the column but is not seal welded. There is a risk that an undetected leak path is present underneath the column. The column is out of plumb 4-in.

Base of Column

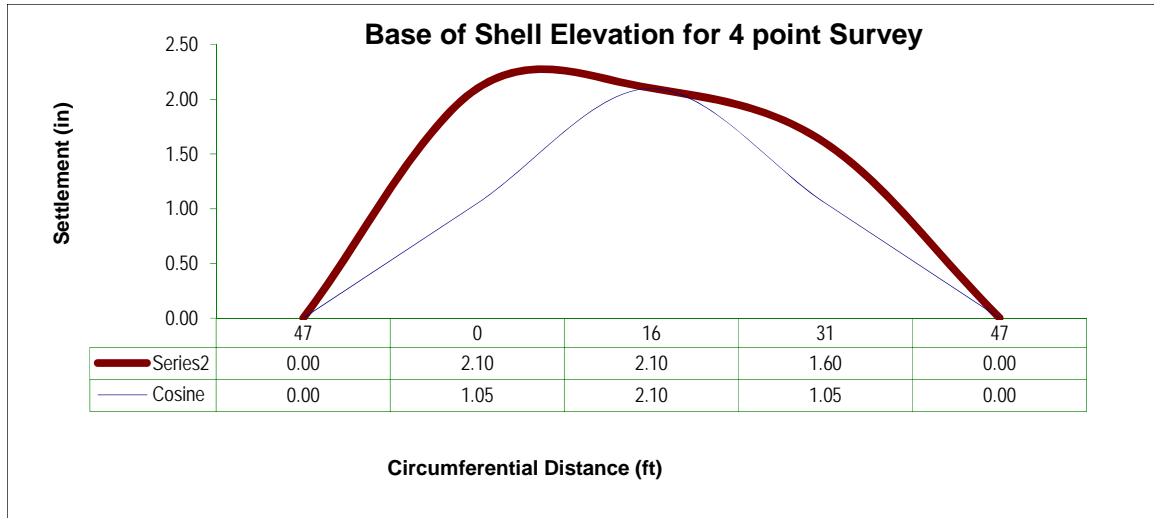
- The settlement for the tank is planer or roughly approximates the shape of a cosine curve.
- The evaluation of this “out-of-levelness” or settlement, utilizing the criterion for “out-of-plane distortion” as described in API 653 Appendix B.3.2, indicates that the settlement **outside** the acceptable limits.

Results:	Allowable	<	Actual	
Differential (ft)	0.070	<	0.088	Fail
(in)	0.842	<	1.050

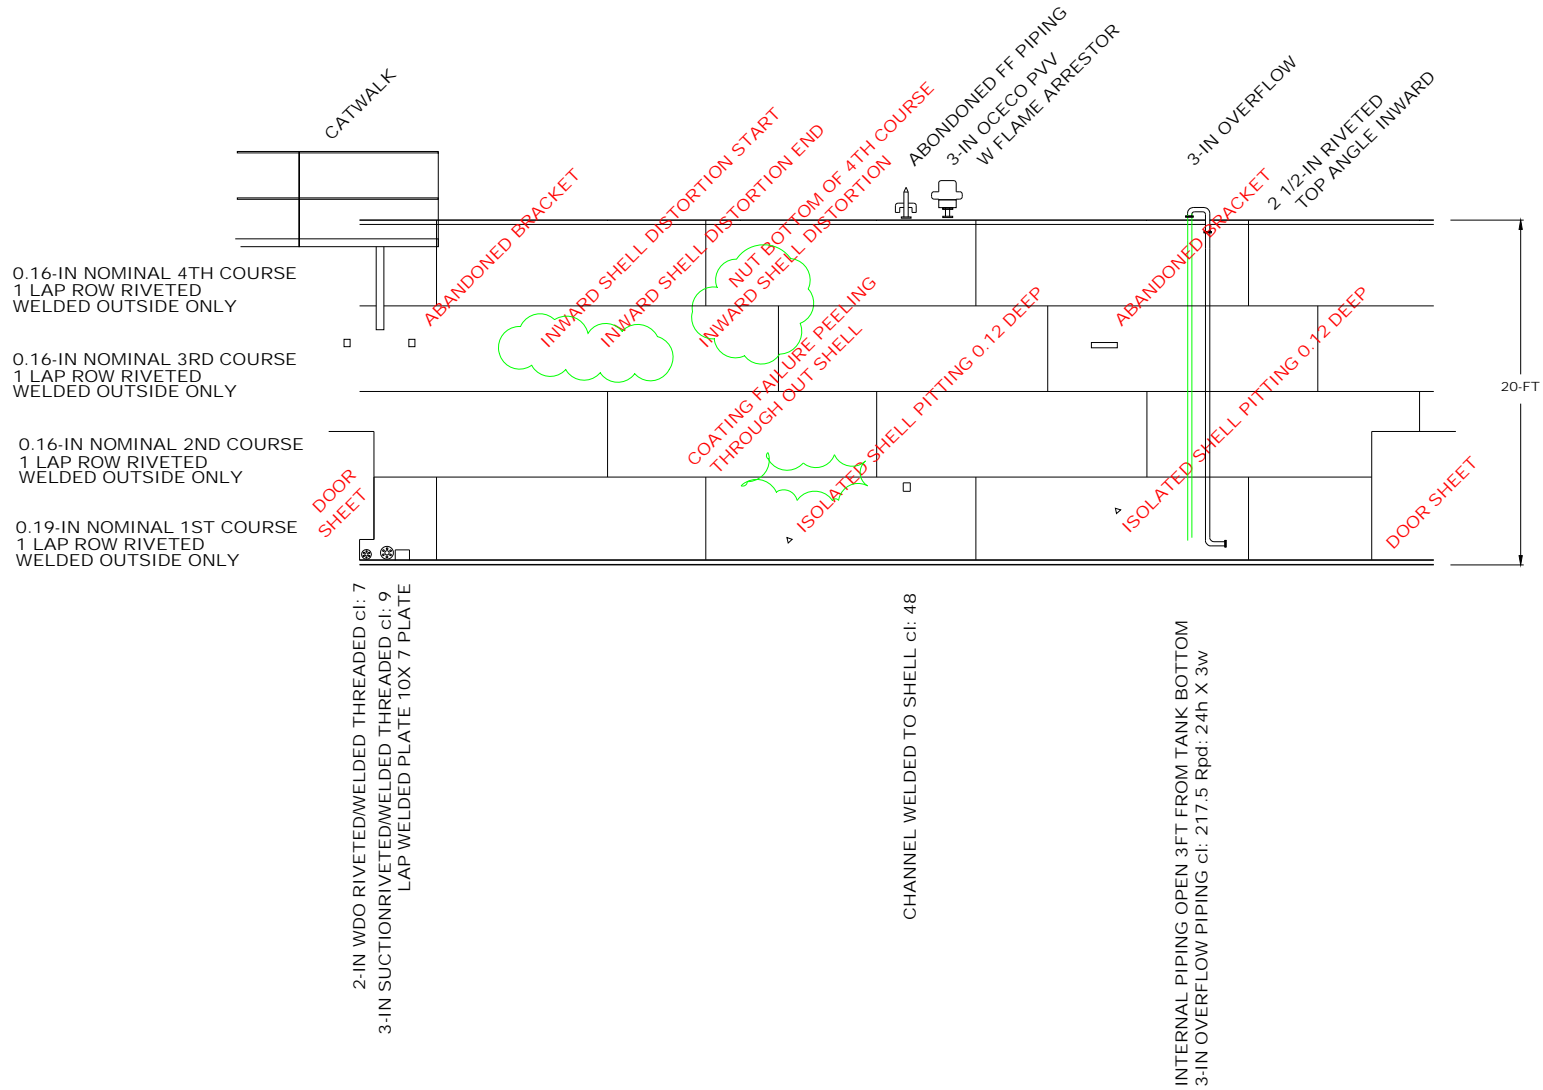
SHELL ROLLOUT VIEW

- 3.2. **Shell Verticality.** The shell has some existing cosmetic dents and minor deformation. (see shell roll out drawing and photos)
- 3.3. **Access Structure.** The roof access is via a common catwalk servicing all 3 tanks. The vertical handrail support and connection to the catwalk is poorly designed allowing deflection of the handrail.

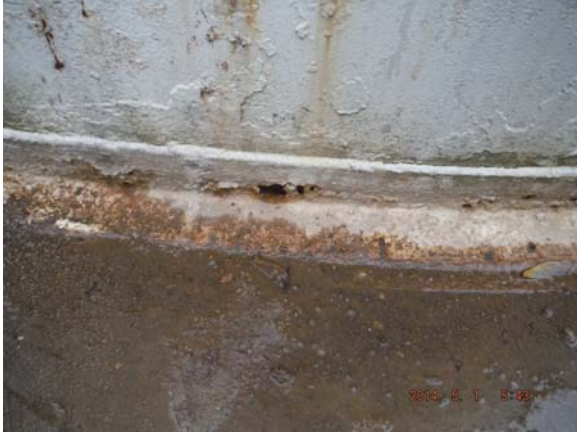
B. FOUNDATION
COATING FAILURE ALONG THE BOTTOM ANGLE

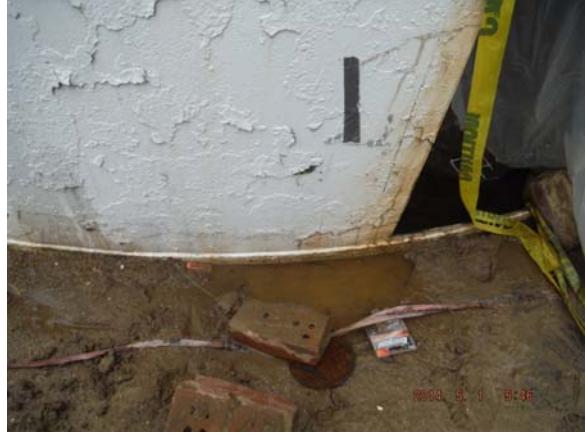
B. FOUNDATION
WATER IN CONTACT WITH BOTTOM PLATES

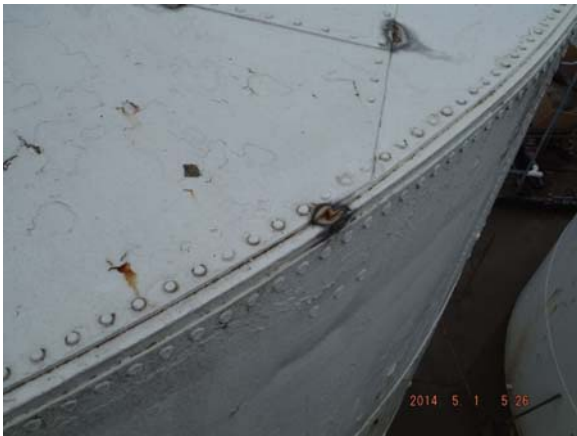
D. ROOF
COATING FAILURE AND CORROSION ALONG UPPER ANGLE

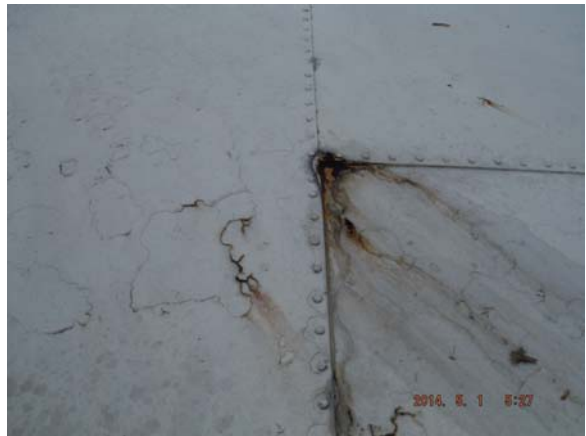
D. ROOF
CORROSION ALONG THE ROOF DECK

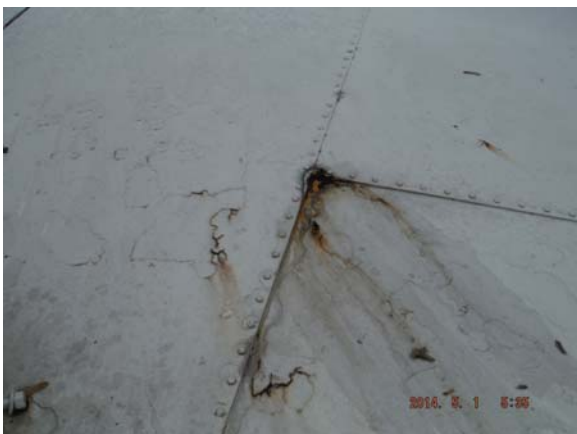
D. ROOF
COATING FAILURE AND CORROSION ALONG ROOF DECK

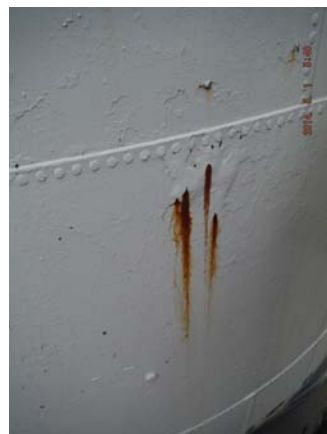
E. SHELL
COATING FAILURE AND CORROSION ALONG SHELL PLATES

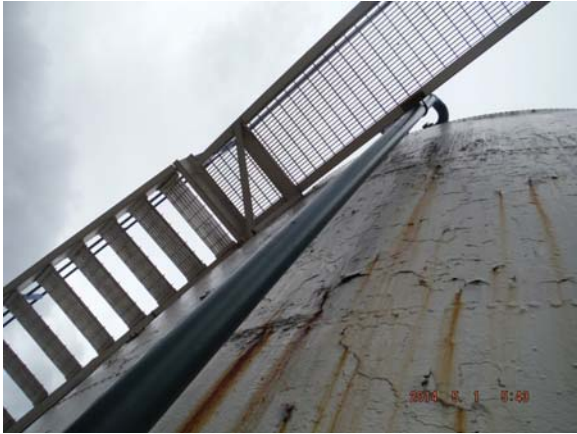
E. SHELL
COATING FAILURE ALONG THE SHELL

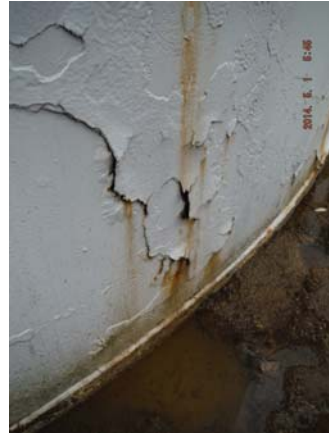
E. SHELL
COATING FAILURE AND CORROSION ALONG SHELL PLATES

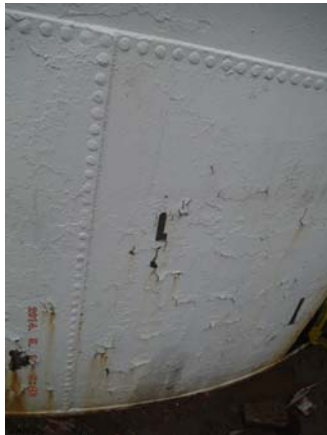
E. SHELL
COATING FAILURE ALONG EXTERIOR SHELL

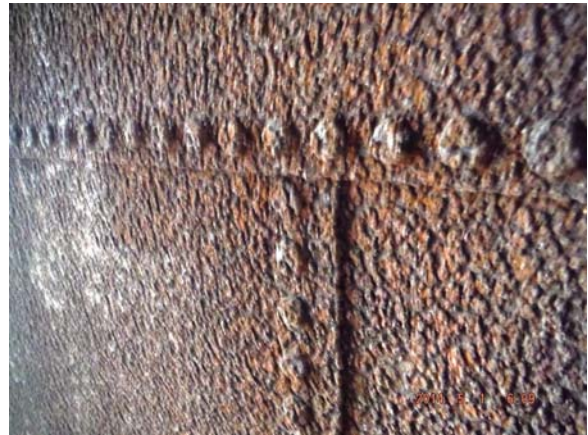
E. SHELL
CORROSION ALONG THE INTERIOR SHELL PLATES

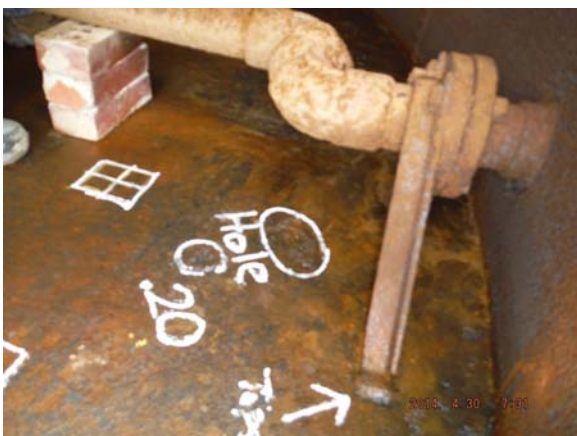
F. BOTTOM
0.200-IN PITTING AND THROUGH HOLE CORROSION ON THE BOTTOM PLATES

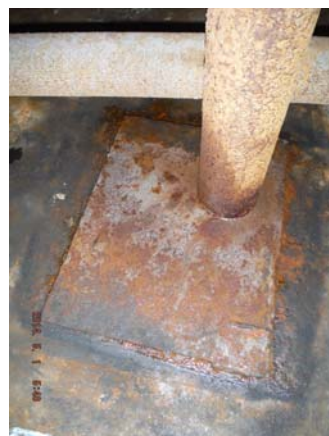
F. BOTTOM
REPAD NOT SEAL-WELDED TO BOTTOM: COUND NOT INSPECT UNDERNEATH

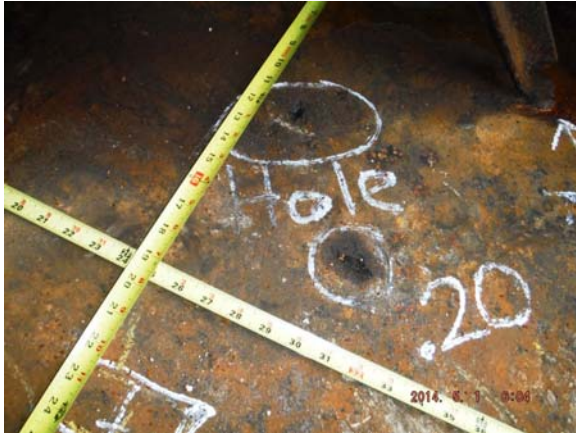
F. BOTTOM
THROUGH-HOLE CORROSION AND 0.200-IN DEEP PITTING
ALONG BOTTOM PLATES

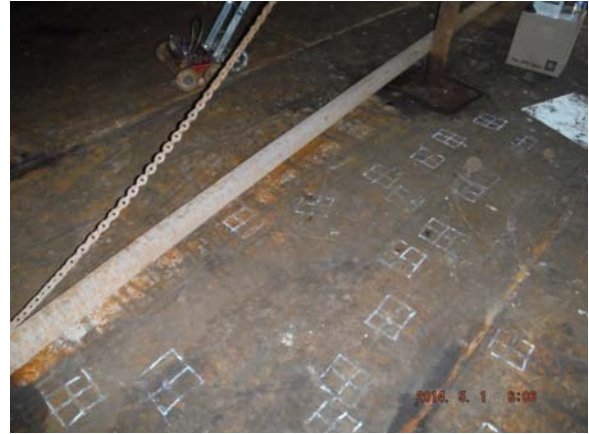
F. BOTTOM
WIDE SPREAD MFL INDICATIONS OF SOIL-SIDE
CORROSION

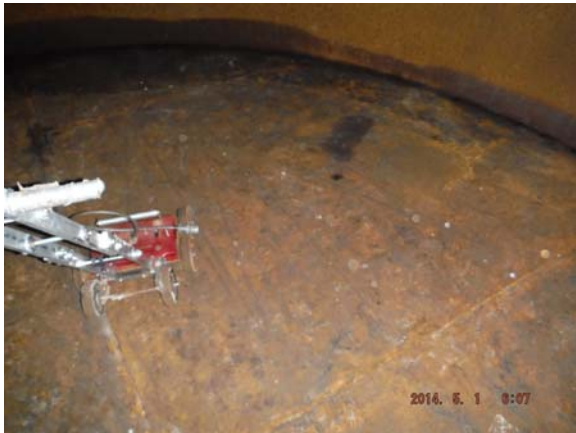
F. BOTTOM
WATER AND DIRT PREVENTED ACCURATE UT PROVE-UP
OF MFL INDICATIONS

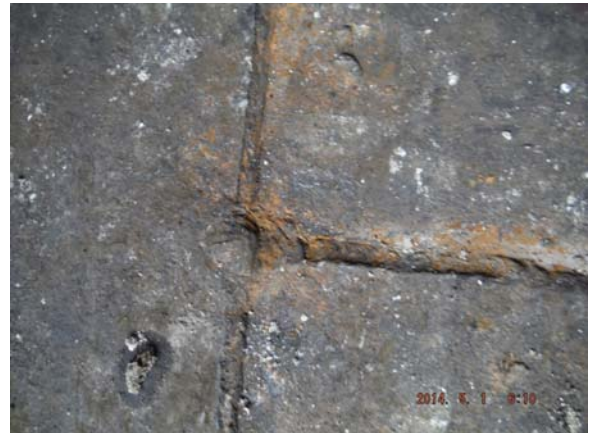
F. BOTTOM
PITTING ALONG BOTTOM PLATES

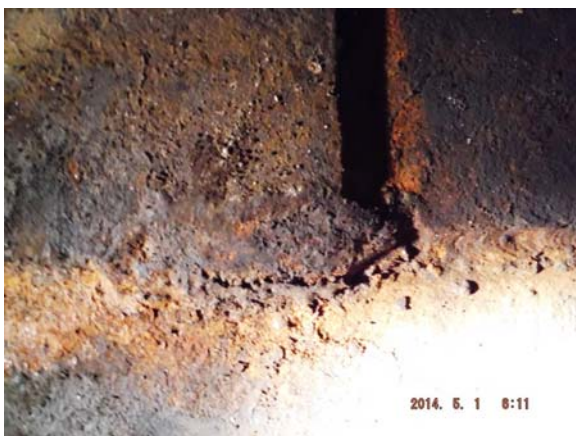
F. BOTTOM
PRODUCT-SIDE CORROSION ALONG BOTTOM PLATES

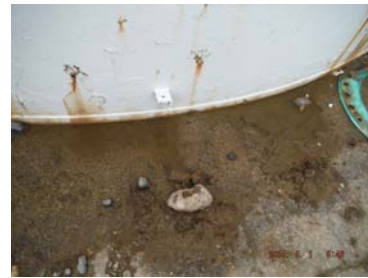
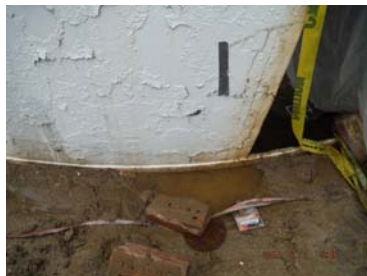
WATER IN CONTACT WITH BOTTOM PLATES

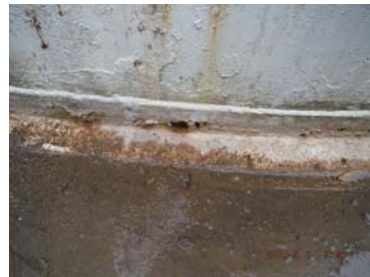
DSCF5741.JPG

COATING FAILURE ALONG THE BOTTOM ANGLE

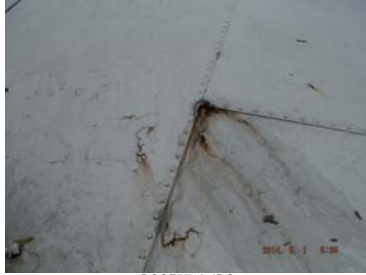
DSCF5718.JPG

COATING FAILURE AND CORROSION ALONG ROOF DECK

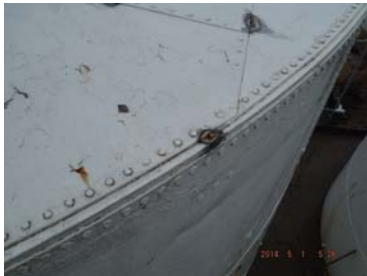
DSCF5693.JPG

COATING FAILURE AND CORROSION ALONG UPPER ANGLE

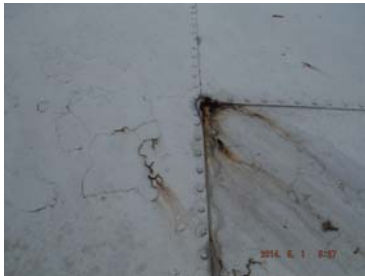
CORROSION ALONG THE ROOF DECK

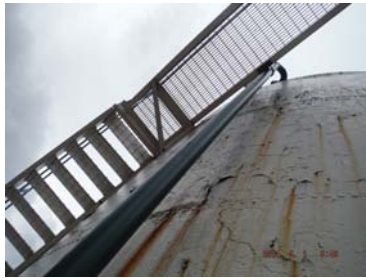
DSCF5739.JPG

COATING FAILURE ALONG THE SHELL

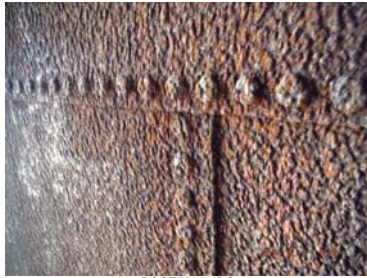
DSCF5809.JPG

CORROSION ALONG THE INTERIOR SHELL PLATES

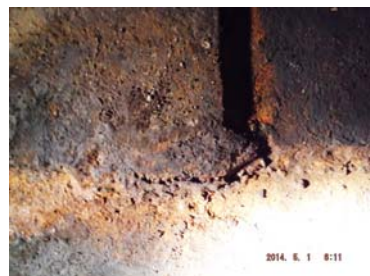
DSCF5813.JPG

PRODUCT-SIDE CORROSION ALONG BOTTOM PLATES

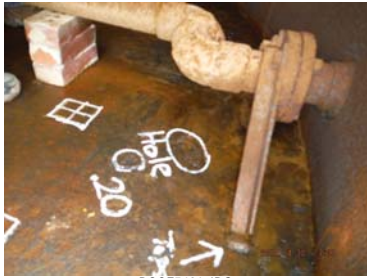
DSCF5420.JPG

0.200-IN PITTING AND THROUGH HOLE CORROSION
ON THE BOTTOM PLATES

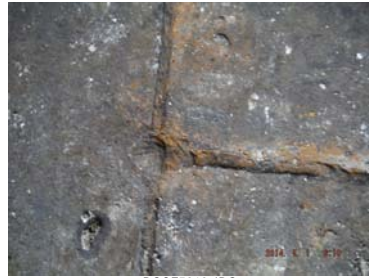
DSCF5812.JPG

PITTING ALONG BOTTOM PLATES

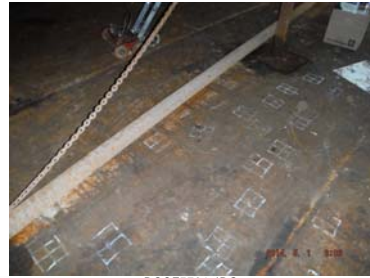
DSCF5791.JPG

WIDE SPREAD MFL INDICATIONS OF SOIL-SIDE CORROSION

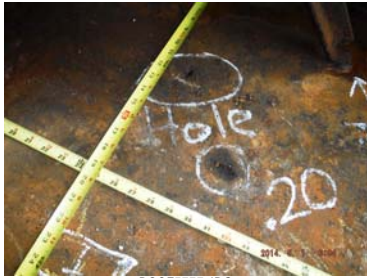
DSCF5777.JPG

THROUGH-HOLE CORROSION AND 0.200-IN DEEP PITTING ALONG BOTTOM PLATES
