BETA LAB NO. M10198, TESORO LS2 AND LS2/CS2 TEE FINDINGS PART: 6600-E HEAT EXCHANGER, LS2 22 IN, 36.5 IN MOUNTS, LS2 T2L SEM FRACTOGRAPHY AND PART 22 LS2-CS2 TEE FINDINGS PARTS 16-1 AND 22	TESORO REFINING AND MARKETING COMPANY ANACORTES REFINERY 10200 W. MARCH POINT ROAD T91WA4428 ANACORTES, WA 98221	CUSTOMER P.O. No.: 4501667904
		DATE: OCTOBER 13, 2010
		PAGE 1 OF 56

LABORATORY REPORT

This report is the tenth of a series of the reports on the failed parts of the 6600E heat exchanger. The LS# and CS# refer to longitudinal and circumferential weld seams respectively, while the part number refers to the chain of custody number. Below is the list of the previously issued reports:

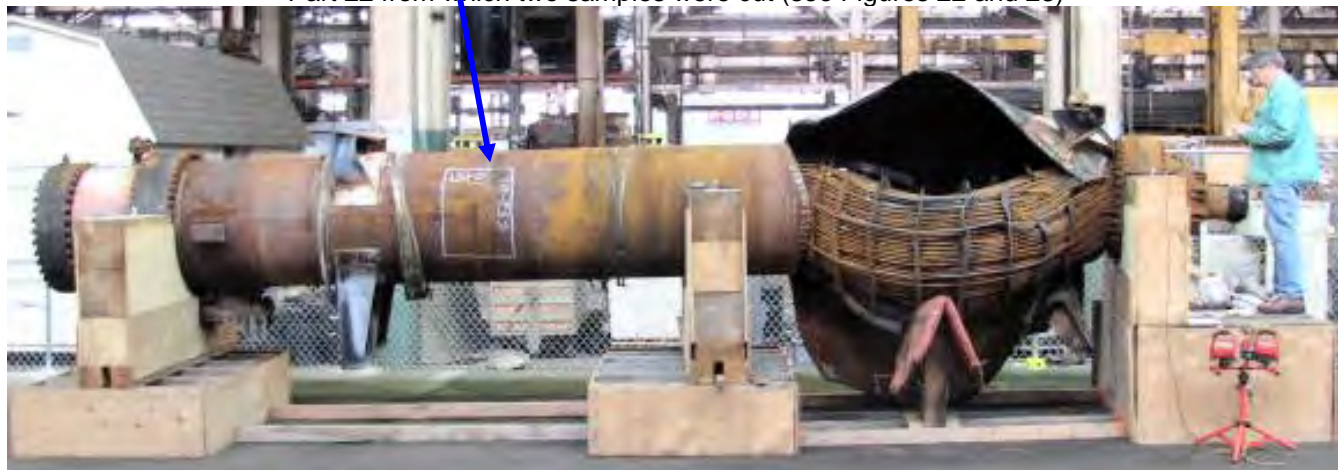
Figure 1 Un-packed main heat exchanger

Overall main heat exchanger with "fish mouth" rupture primarily along LS3 and CS4

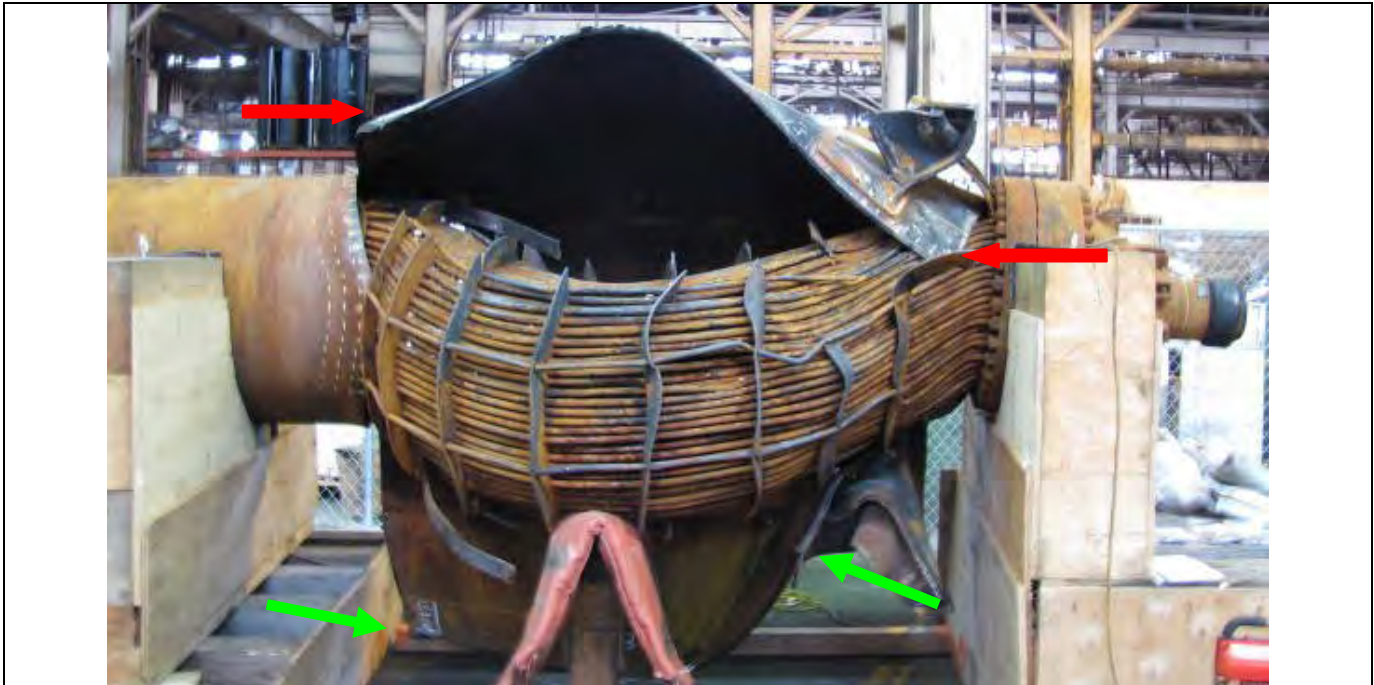
Figure 2 Photo showing the fracture along LS3 where an approximate 6 inch wide portion was removed

Fracture along LS3 seam between the green arrows for the bottom part of the fracture, and for the LS3 top – between the red arrows

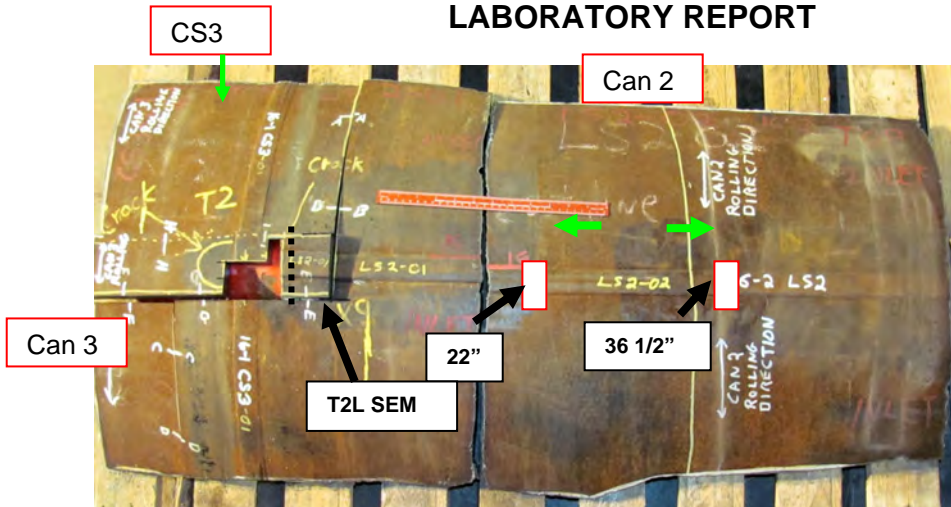
Part 16-1 with locations for the 22 inch, 36.5 inch mounts, and the part the T2L SEM was cut out (black dotted line).

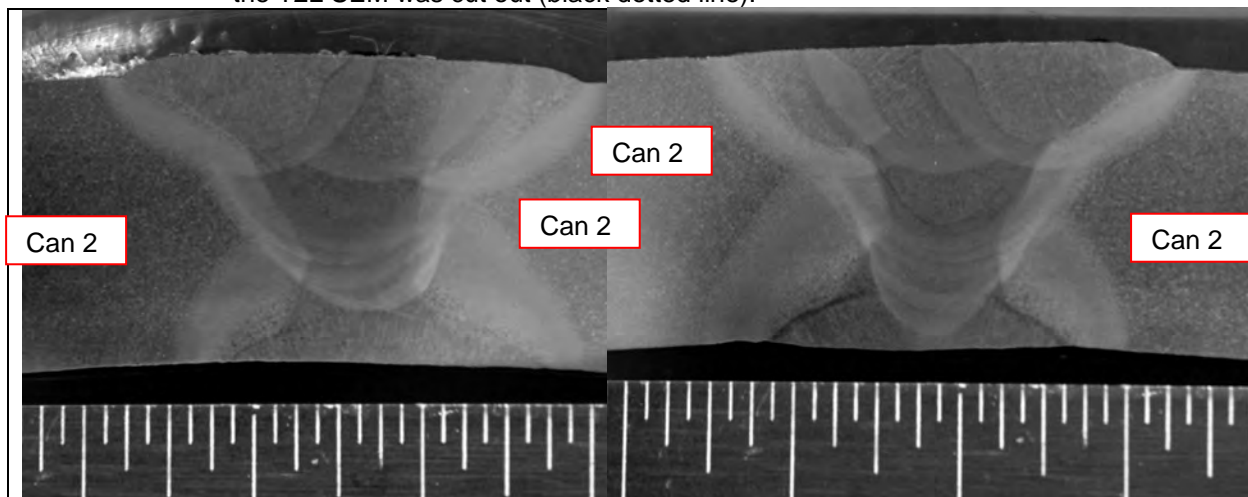
Photomicrograph of 22 inch sample-ID on bottom, scale mark is 1/16 inch

Photomicrograph of 36.5 inch sample-ID on bottom, scale mark is 1/16 inch

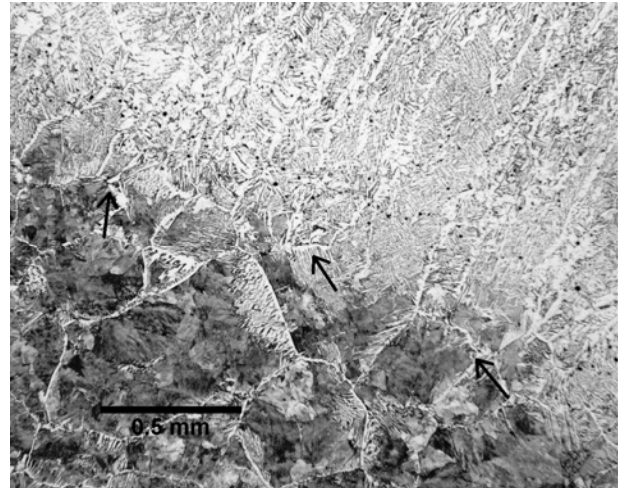
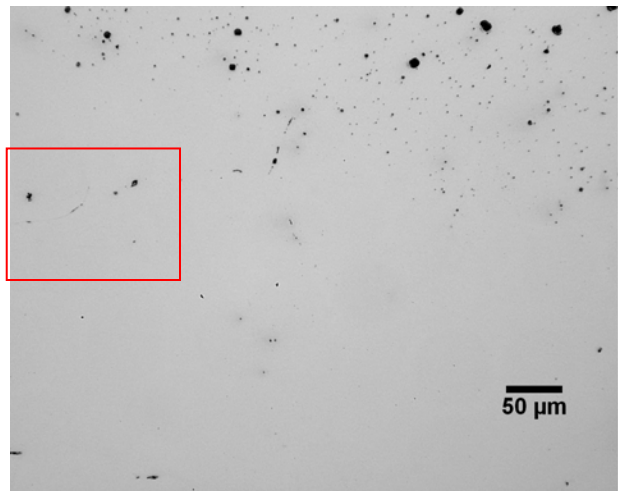
Figure 14

A. HAZ-Weld metal interface 3.28 mm down from ID. Un-etched

C. Same 3.28 mm level, different area. Un-etched

D. Same area as at left, enlarged. See marked area on Figure 15A below. Un-etched

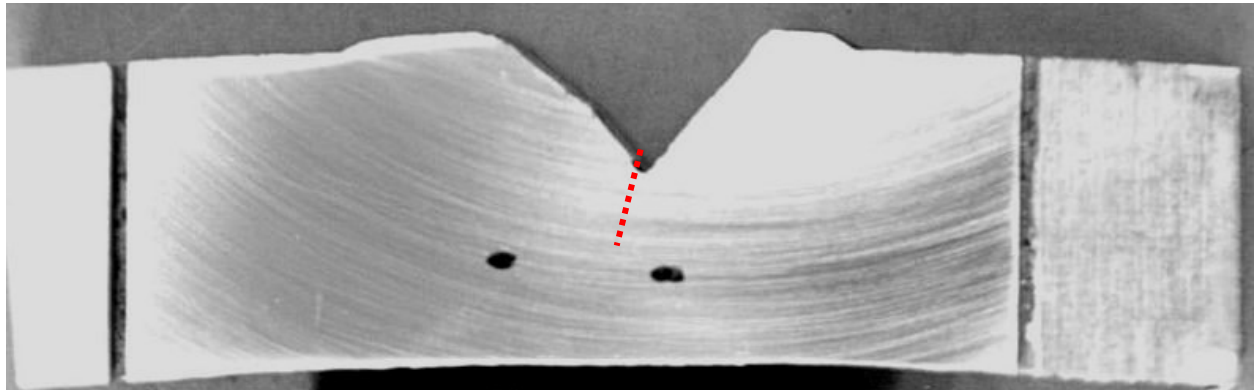
Figure 18

T2L SEM sample before break. The dotted line shows approximate location of the saw cut to facilitate the break. Two black dots are markers of approximate location of the crack tips.

Fracture surfaces of the T2L sample after break. The sample on the right was evaluated in the SEM.

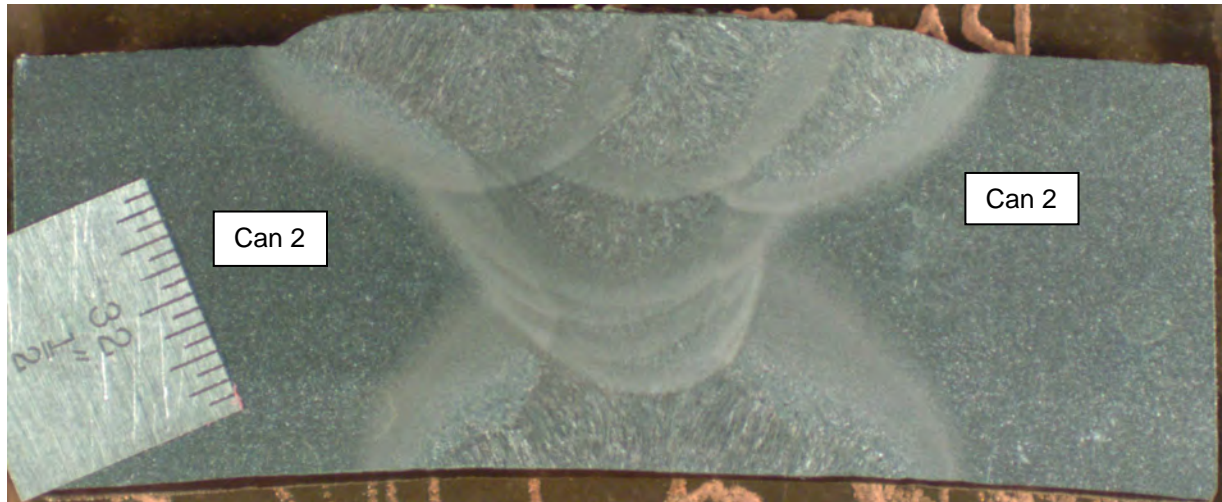
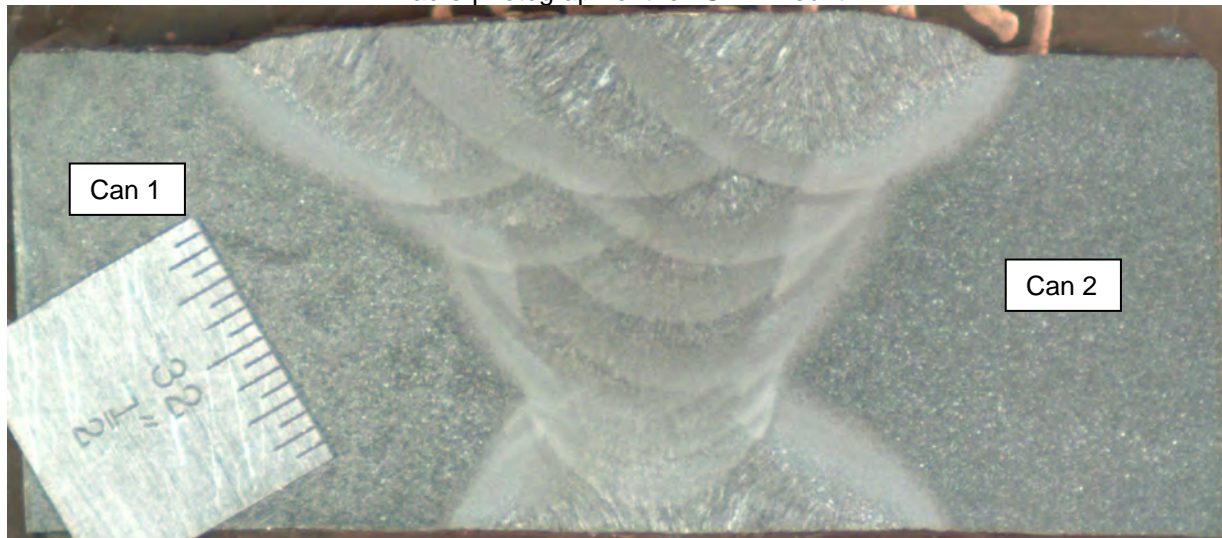
Figure 24

The largest depth of the damage penetration in the LS2-A sample was measured as 2.68 mm from I.D.

Macro-photograph of the LS2-A mount

Macro-photograph of the CS2-A mount

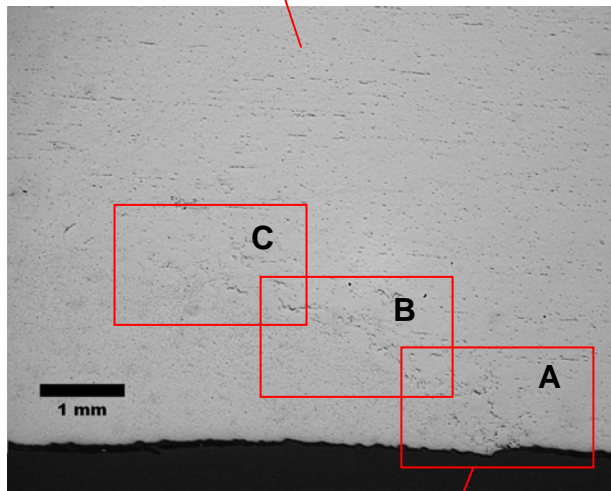
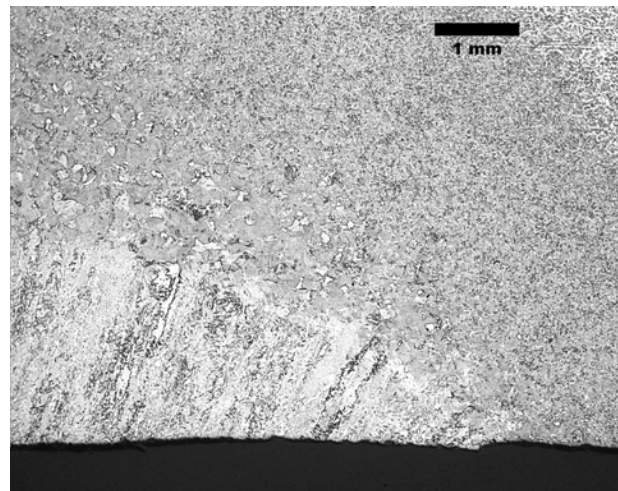
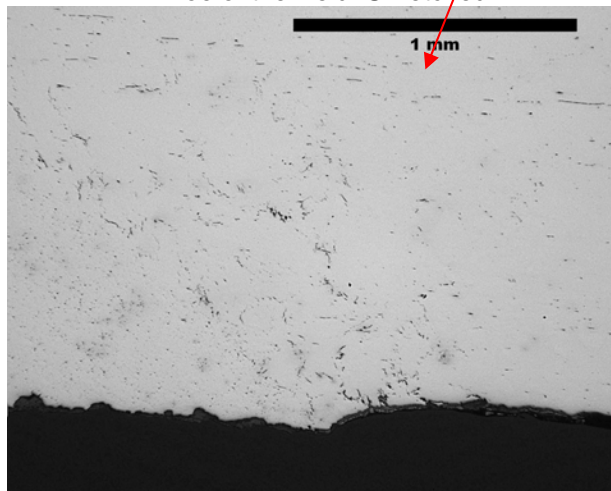
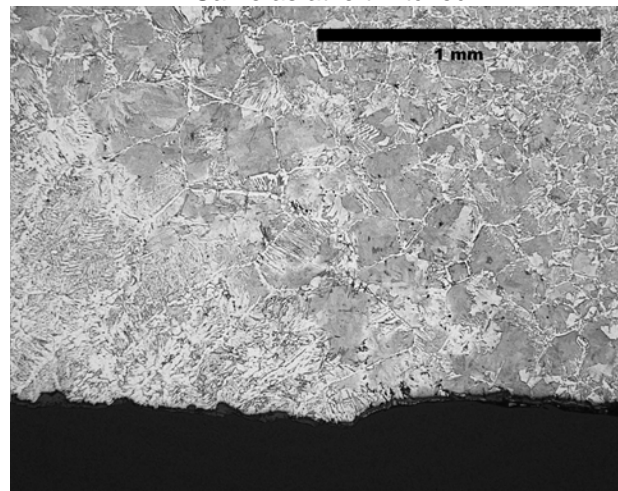
Figure 25. Enlarged areas in the rectangles are shown on Figure 26 A&B, and 26 C&D. Locations are approximate.

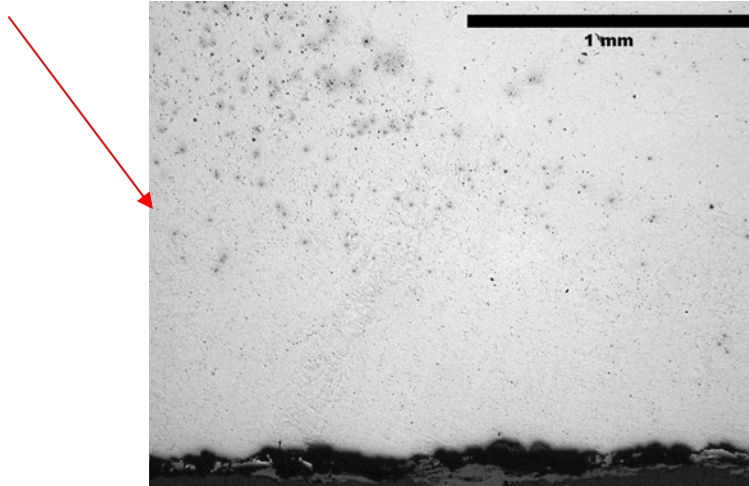
Toe of the weld. No damage found on CS2-A mount. Typical. Un-etched

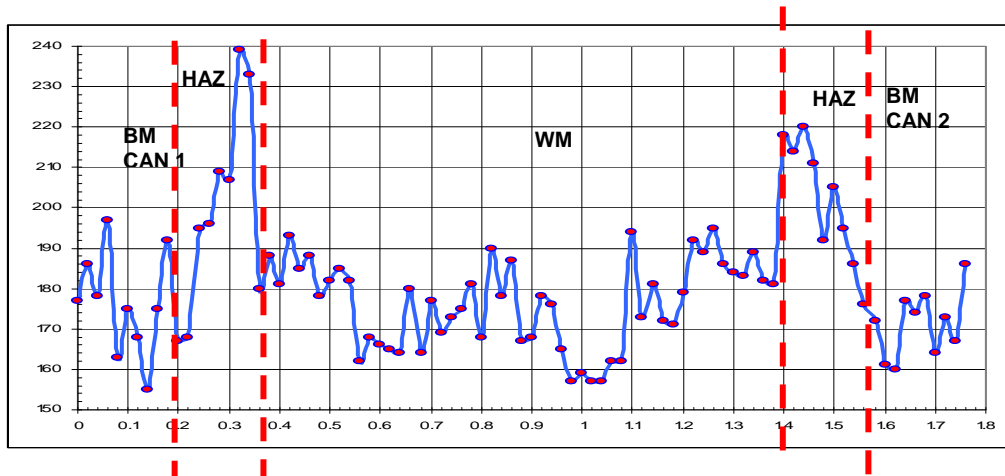
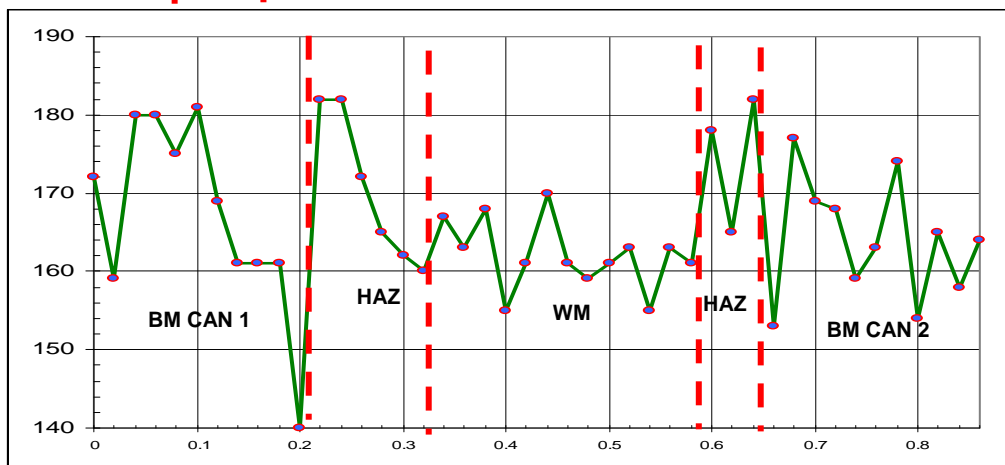
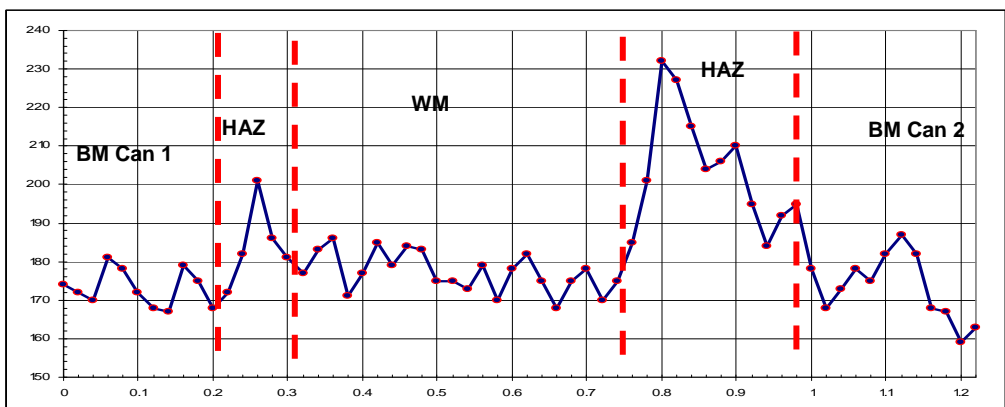
BM – Base Metal, HAZ – Heat Affected Zone, WM – Weld Metal
Figure 31. CS2-A hardness measurements results.
