BETA LAB No.M10198- CS4-01/ LS3 BOTTOM, REV. 1	TESORO REFINING AND MARKETING COMPANY ANACORTES REFINERY 10200 W. MARCH POINT ROAD T91WA4428 ANACORTES, WA 98221	CUSTOMER P.O. NO.: 4501667904
PART: 6600-E HEAT EXCHANGER CS4 01/BOTTOM PART 18/14		DATE: SEPTEMBER 20, 2010
PAGE 34 OF 55

LABORATORY REPORT-CS4-01/ LS3 Bottom

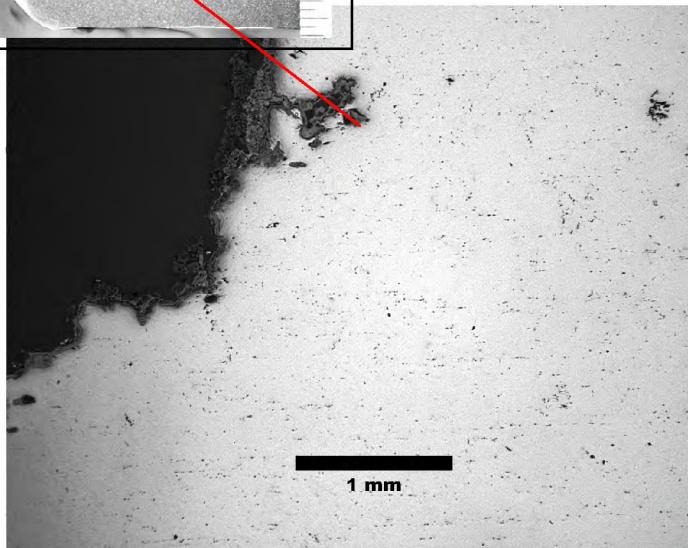
A. Fracture edge near HAZ. Un-etched

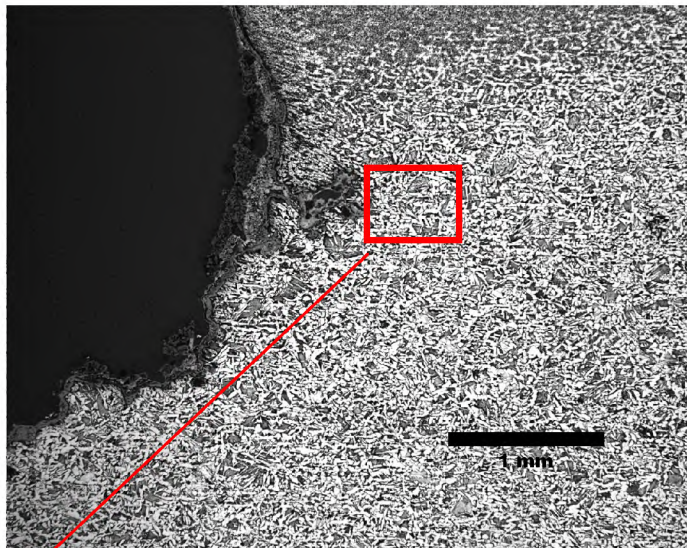
B. Fracture edge near HAZ. Etched

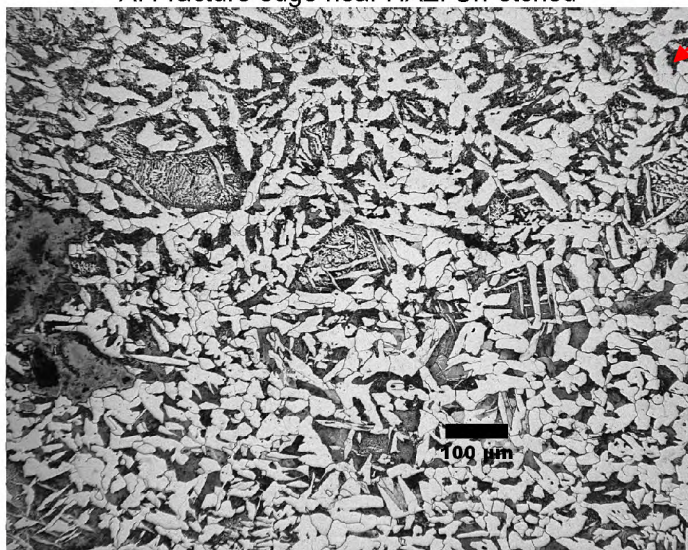
Figure 28- OD on top

C. . Fracture edge near HAZ at higher magnification.
 Etched

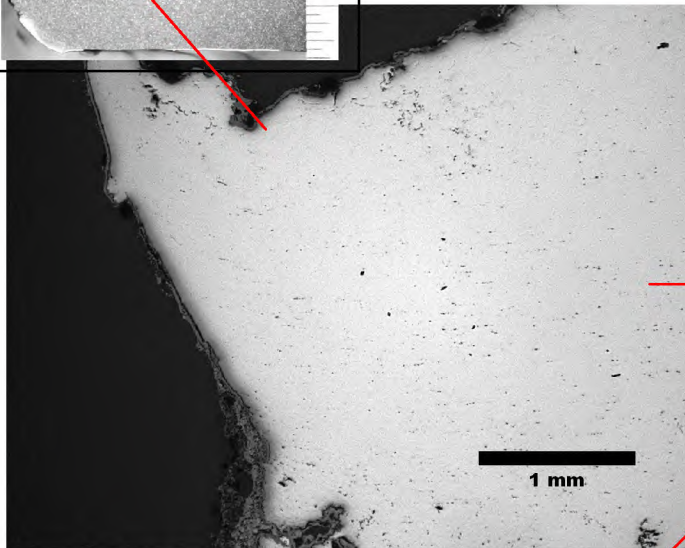
A. Fracture edge at the tip of HAZ. Un-etched

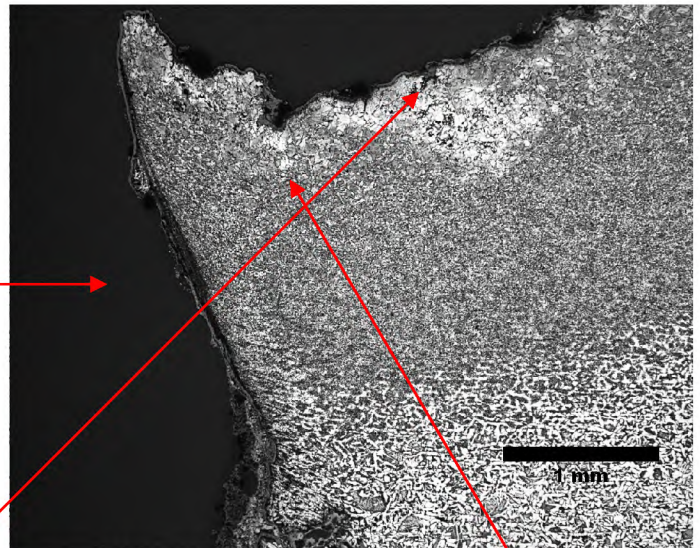
B. Fracture edge at the tip of HAZ. Etched

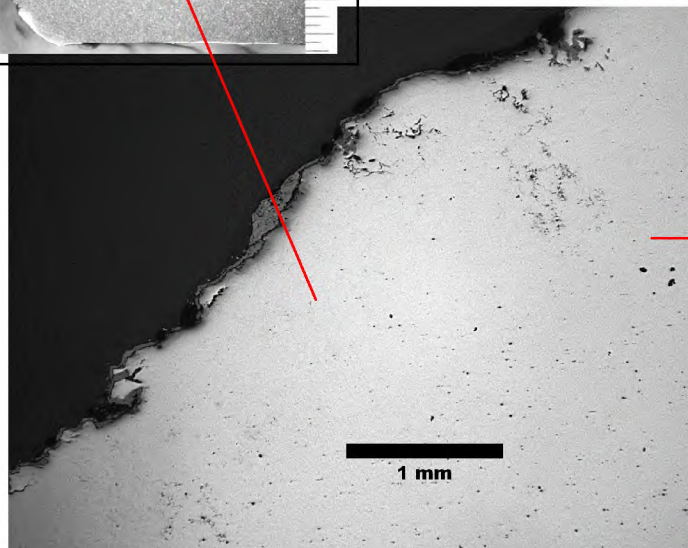
A. Fracture edge. Un-etched

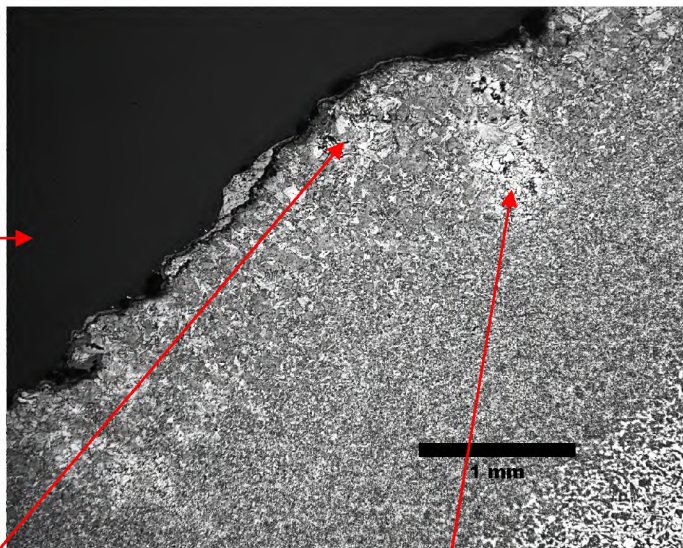
B. Fracture edge. Etched

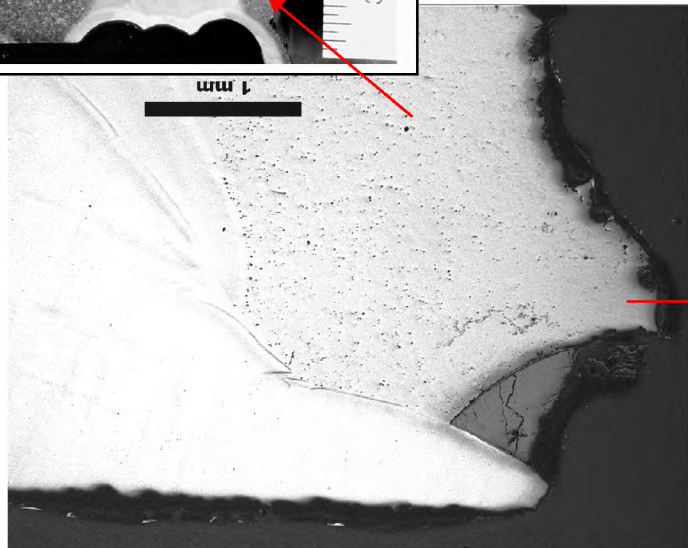
A. SS weld toe. Un-etched

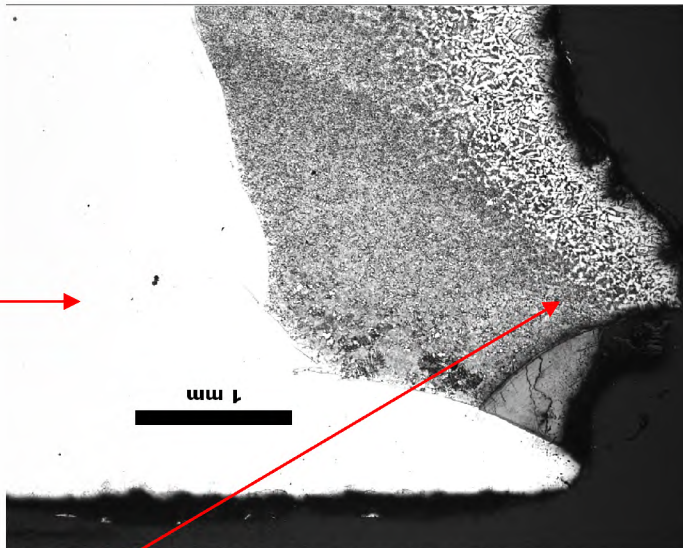
B. SS weld toe. Etched

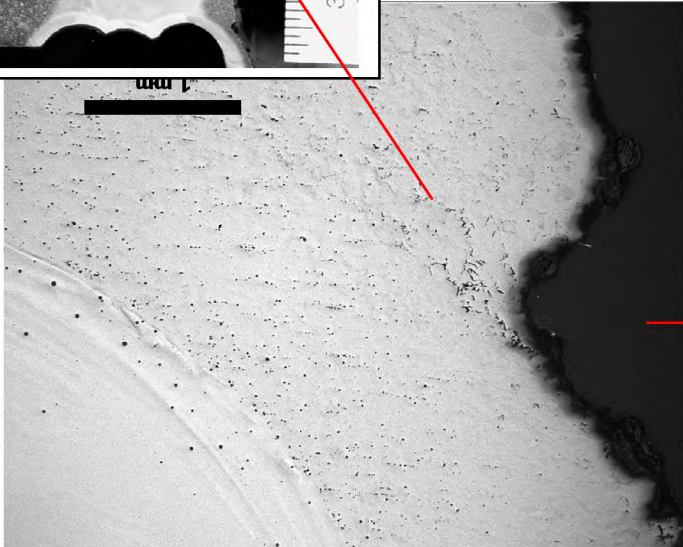
A. Fracture edge at indicated location. Un-etched

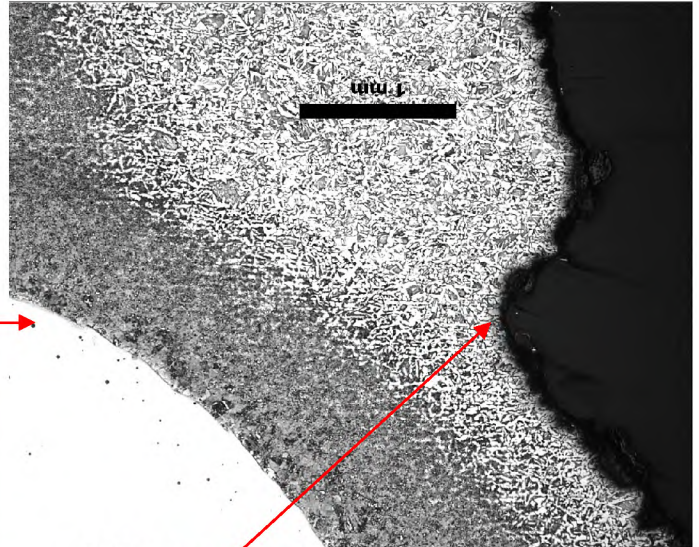
B. Fracture edge at indicated location. Etched

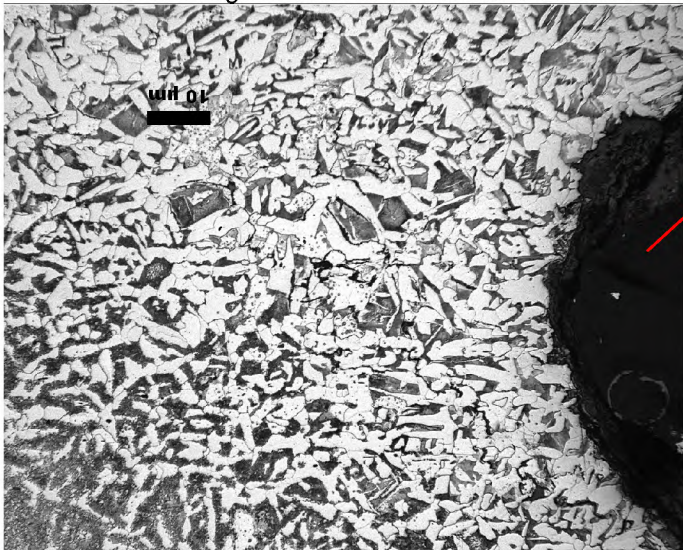
Figure 32

C. Fracture edge at indicated location at higher magnification.

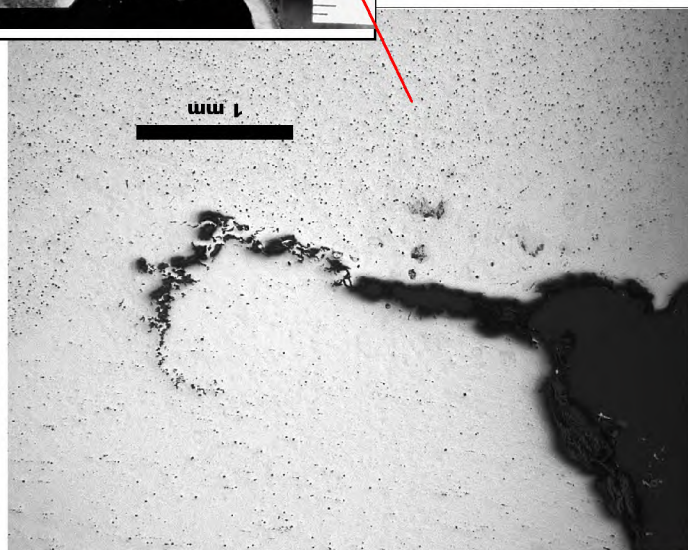
A. Fracture edge under the weld cap.

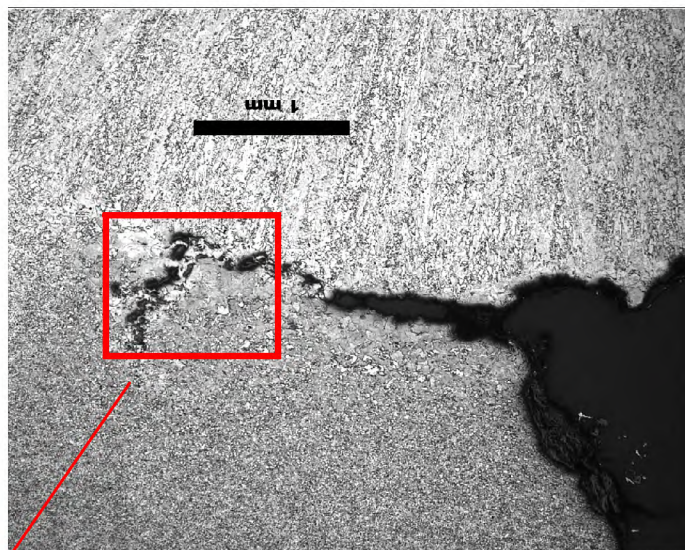
B. Fracture edge under the weld cap. Etched

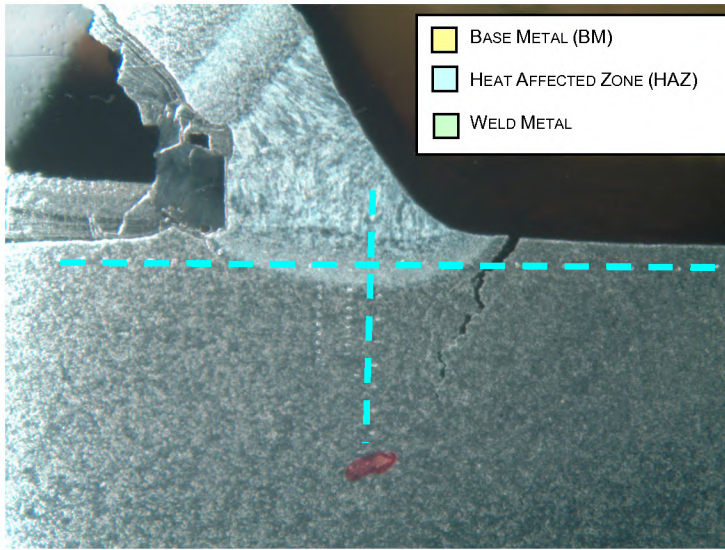
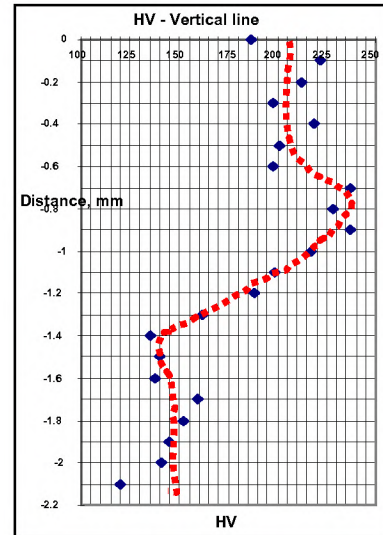
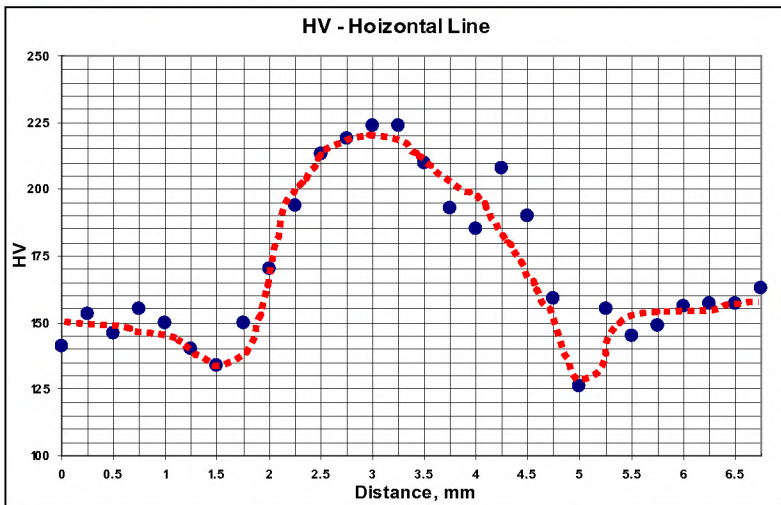
Figure 34

HORIZONTAL		VERTICAL	
Dist. mm	HV @ 500g	Dist., mm	HV @ 500g
0	141	0	187
0.25	153	0.1	222
0.5	146	0.2	212
0.75	155	0.3	198
1.00	150	0.4	219
1.25	140	0.5	201
1.50	134	0.6	198
1.75	150	0.7	237
2.00	170	0.8	228
2.25	194	0.9	237
2.50	213	1.0	217
2.75	219	1.1	199
3.00	224	1.2	188
3.25	224	1.3	162
3.50	210	1.4	135
3.75	193	1.5	140
4.00	185	1.6	138
4.25	208	1.7	159
4.50	190	1.8	152
4.75	169	1.9	145
5.00	126	2.0	141
5.25	155	2.1	120
5.50	145		
5.75	149		
6.00	156		
6.25	157		
6.50	157		
6.75	163

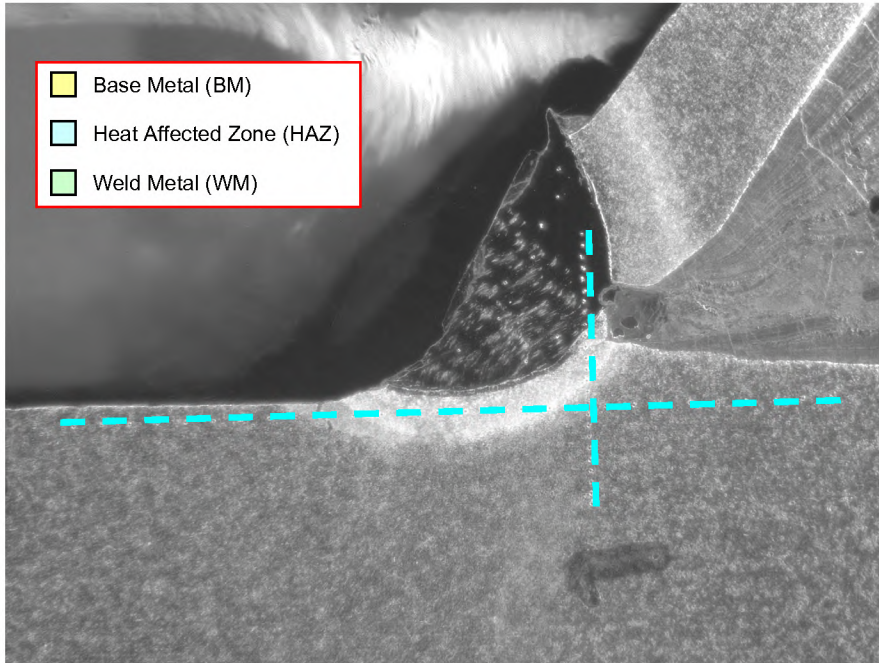
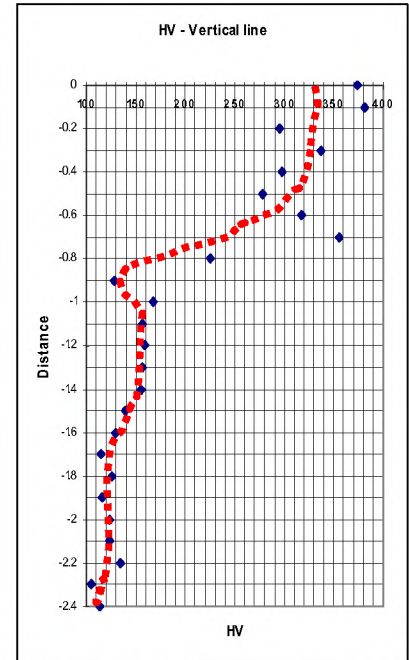
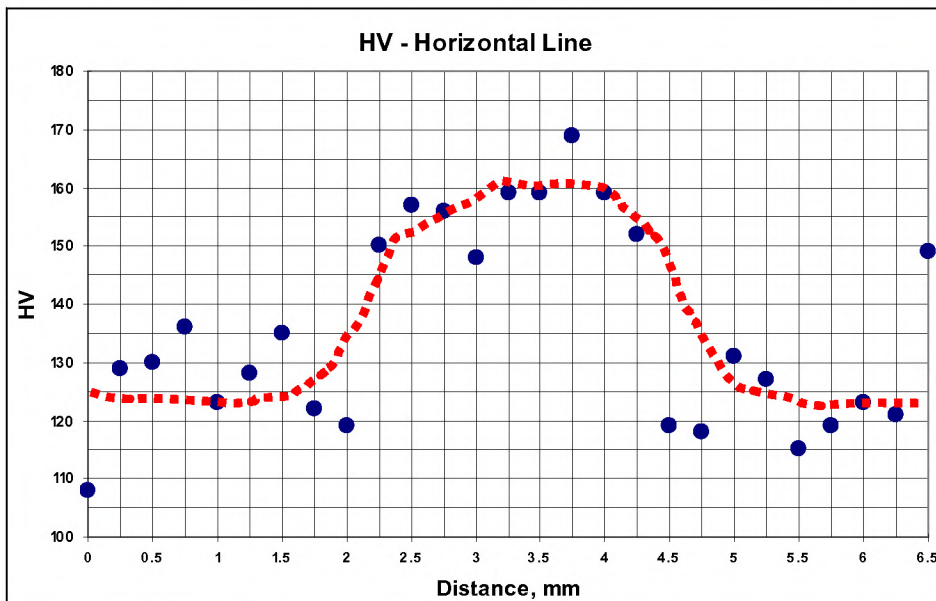
Figure 35

HORIZONTAL LINE	
DIST., MM	HV @ 500G
0	108
0.25	129
0.50	130
0.75	136
1.00	123
1.25	128
1.50	135
1.75	122
2.00	119
2.25	150
2.5	157
2.75	156
3.00	148
3.25	159
3.50	159
3.75	169
4.00	169
4.25	152
4.50	119
4.75	118
5.00	131
5.25	127
5.50	115
5.75	119
6.00	123
6.25	121
6.50	149

VERTICAL LINE	
DIST., MM	HV @ 500G
0	374
0.1	381
0.2	295
0.3	337
0.4	298
0.5	278
0.6	318
0.7	356
0.8	226
0.9	128
1.0	168
1.1	156
1.2	159
1.3	157
1.4	155
1.5	139
1.6	129
1.7	115
1.8	126
1.9	116
2.0	123
2.1	123
2.2	135
2.3	105
2.4	113
