BETA LAB NO.M10198- CS4-02	TESORO REFINING AND MARKETING COMPANY ANACORTES REFINERY 10200 W. MARCH POINT ROAD T91WA4428 ANACORTES, WA 98221	CUSTOMER P.O. NO.: 4501667904
PART: 6600-E HEAT EXCHANGER CS4 PART 19 & 20		DATE: AUGUST 5, 2010
PAGE 15 OF 57

LABORATORY REPORT-CS4

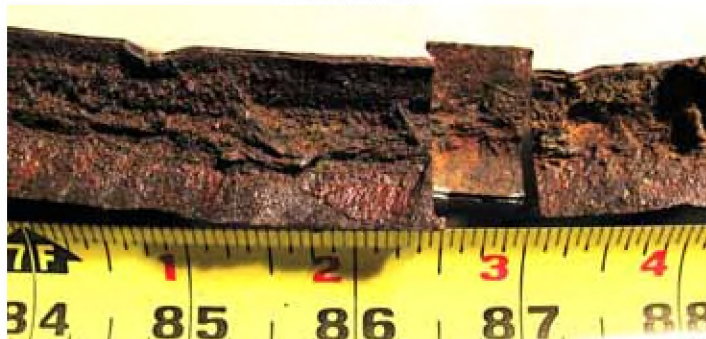
Location 25-notice the M4 cuts

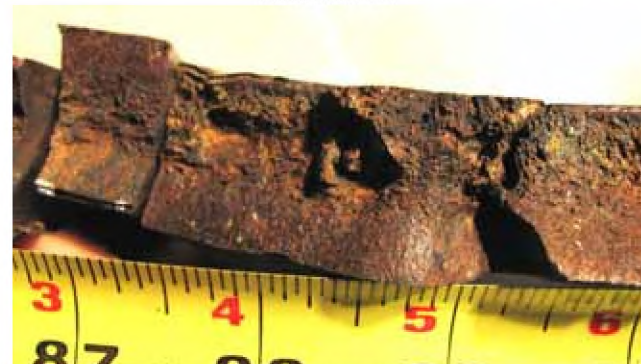
Location 26-notice the M4 cuts

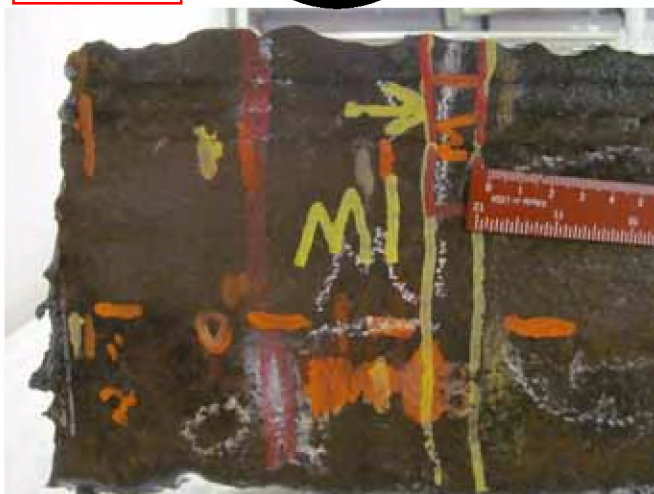
Looking at OD surface CS4 top and Can 4 at bottom

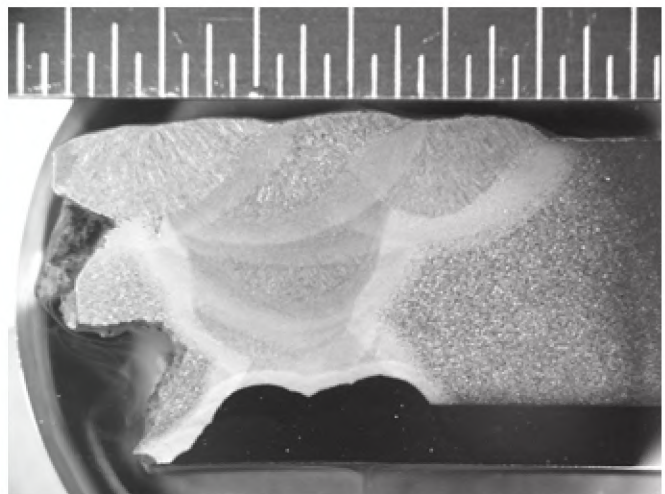
Mount M1 transverse through CS4 can 3 fracture on left and can 4 on right – ID on bottom- Black is clad or stainless steel weld

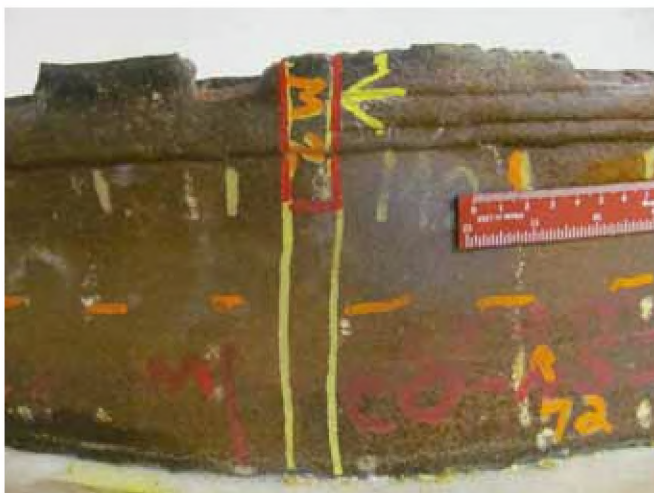
Looking at OD surface CS4 top and Can 4 at bottom

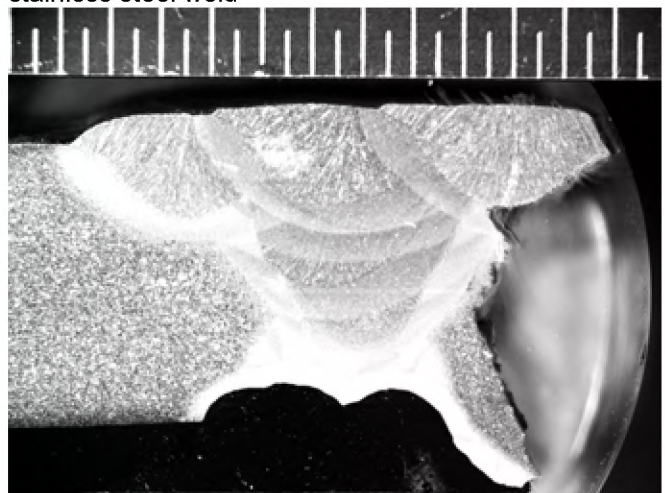
Mount M 2 transverse through CS4 can 4 on left and can 3 fracture on right- ID on bottom- Black is clad or stainless steel weld

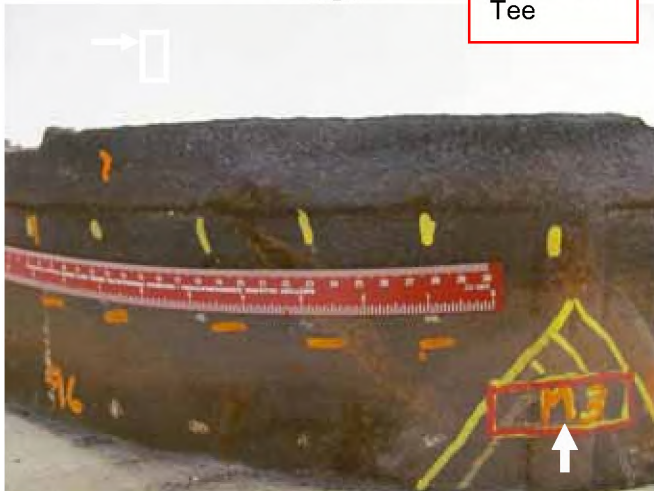
Looking at OD surface CS4 top with LS4 the vertical weld at the Tee into CS4

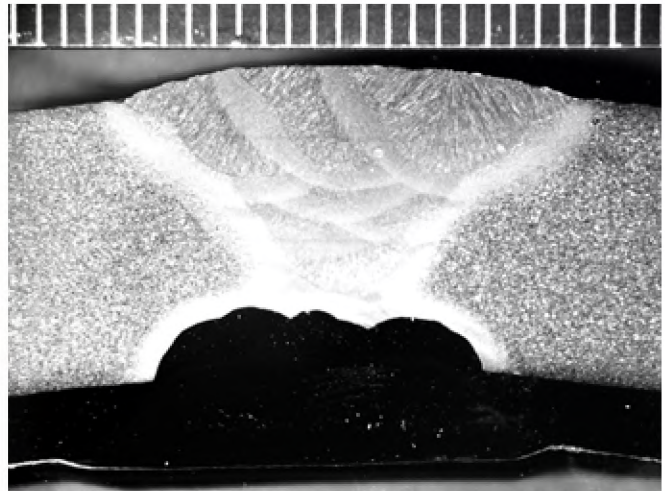
Mount M3 transverse through LS4 can 4 on both sides – ID on bottom- Black is clad and stainless steel weld

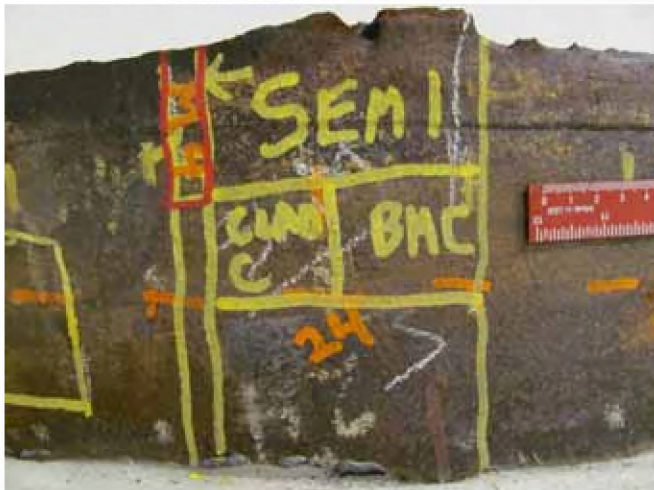
Looking at OD surface CS4 top at junction of LS3

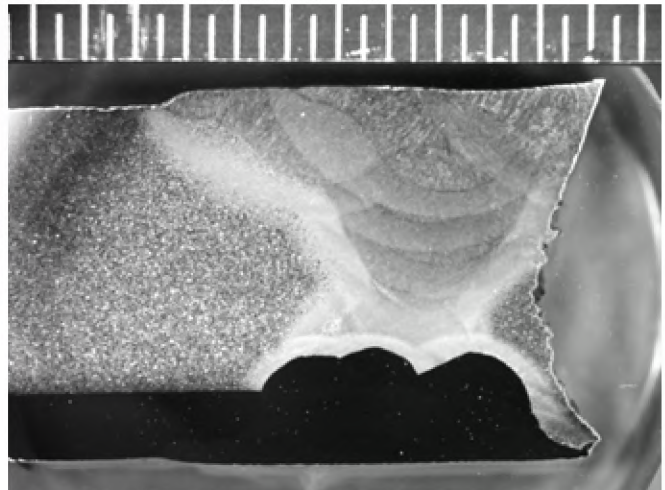
Mount M4 transverse through CS4 can 3 fracture on right and can 4 on left – ID on bottom- Black is clad and stainless steel weld

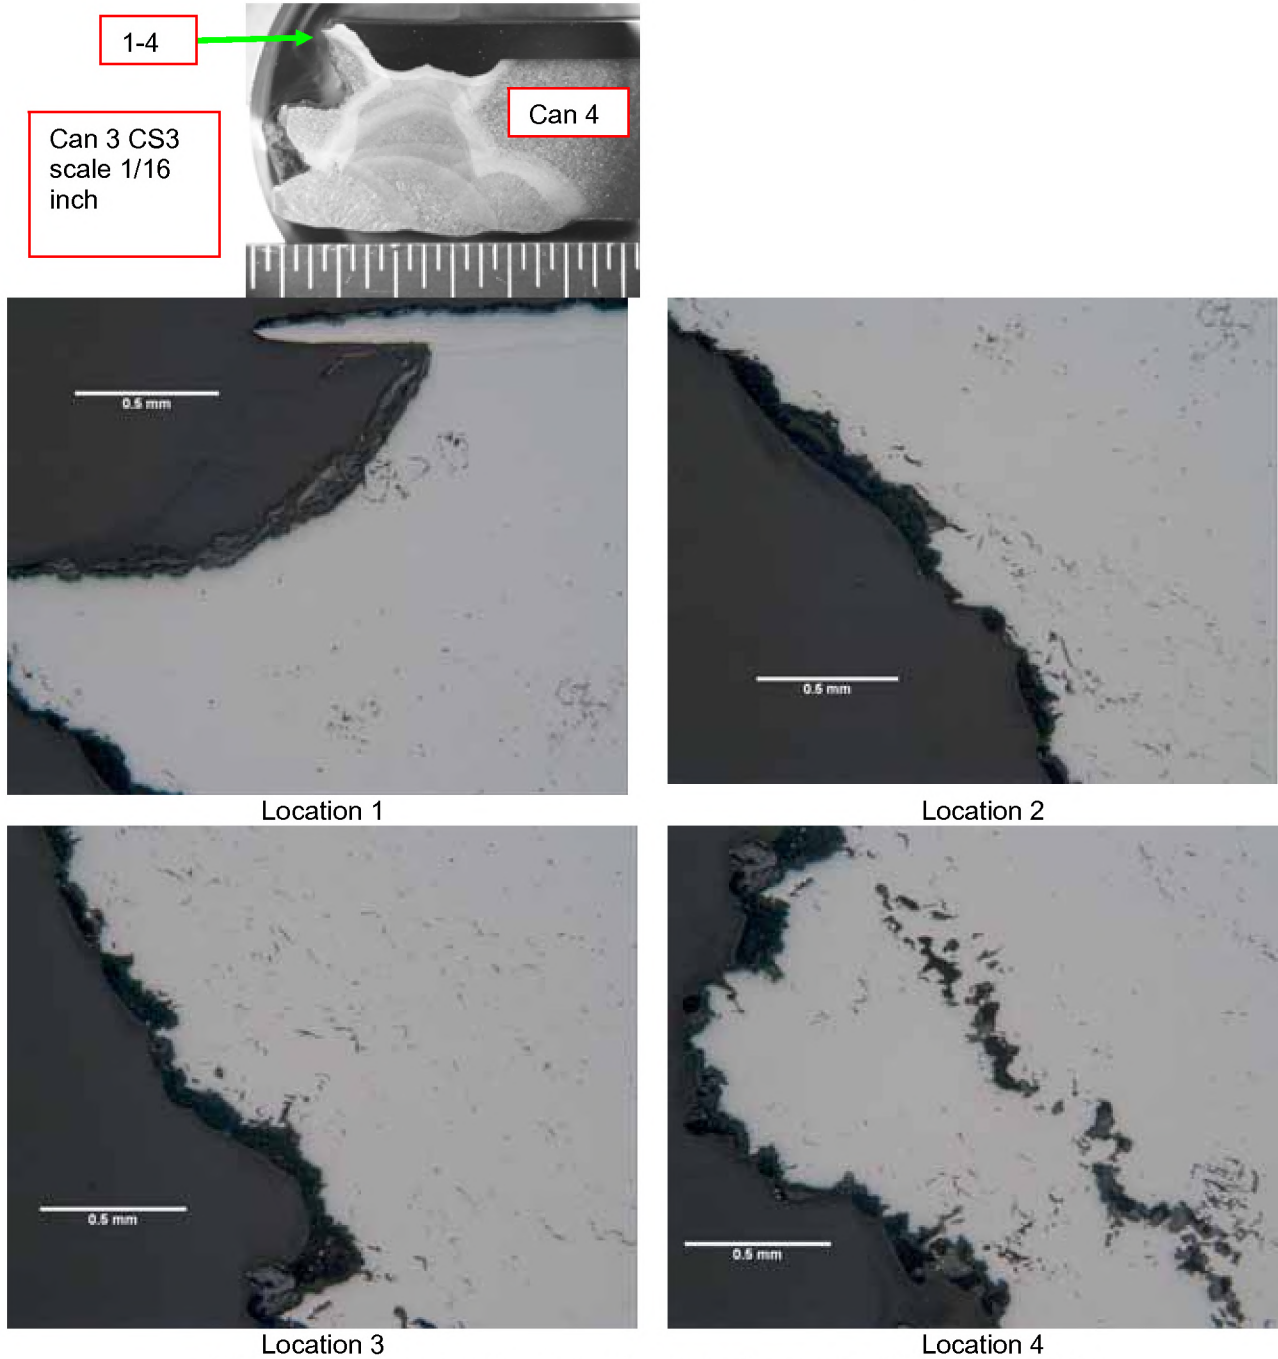
FIGURE 11 Un-etched fracture edge from ID towards OD for mount M1

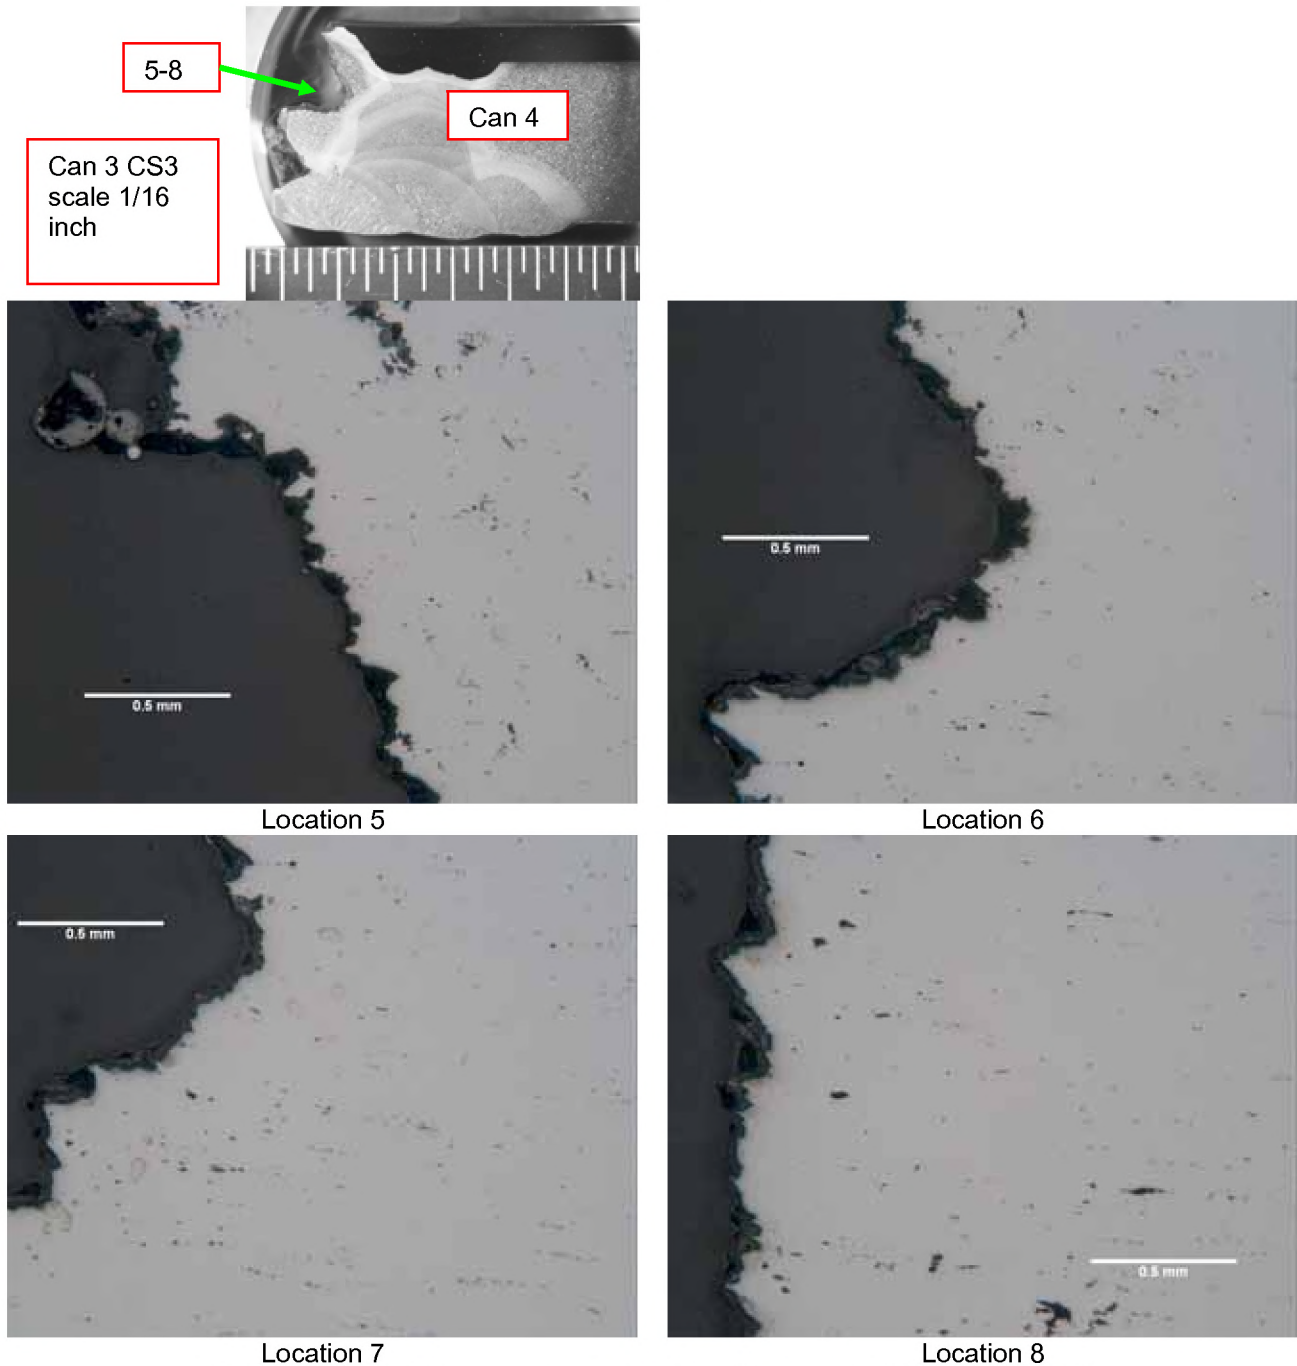
FIGURE 12 Un-etched fracture edge from ID towards OD for mount M1

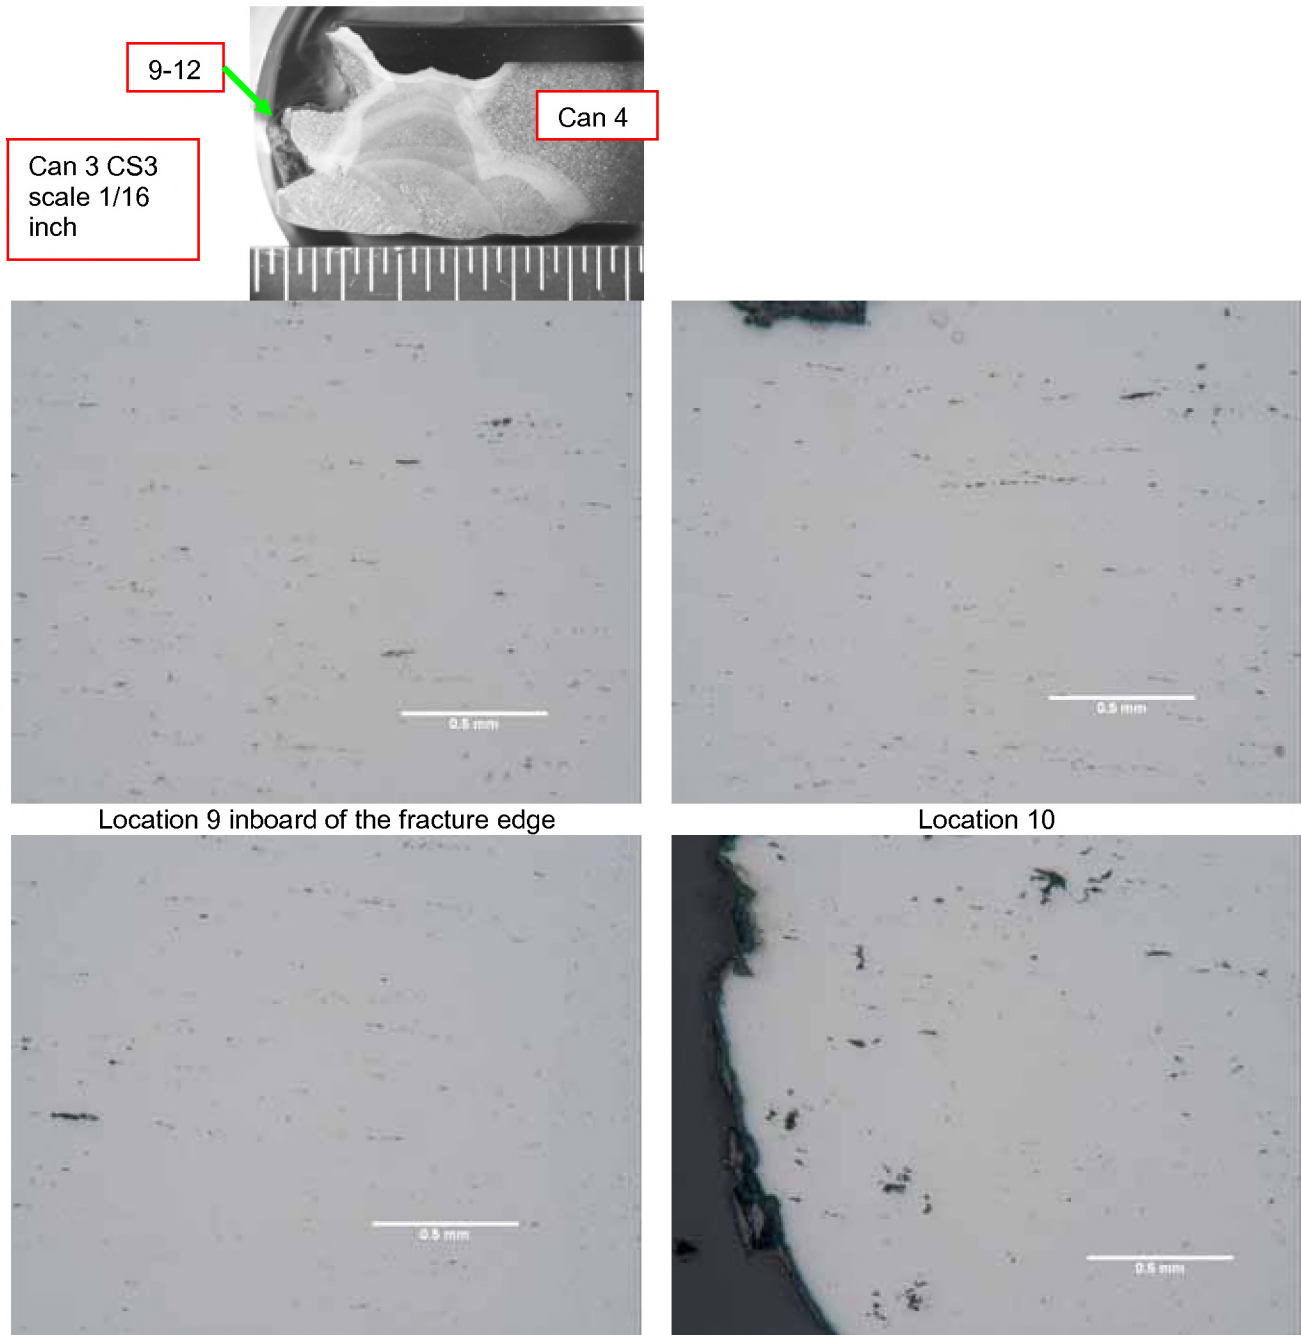
FIGURE 13 Un-etched fracture edge from ID towards OD for mount M1

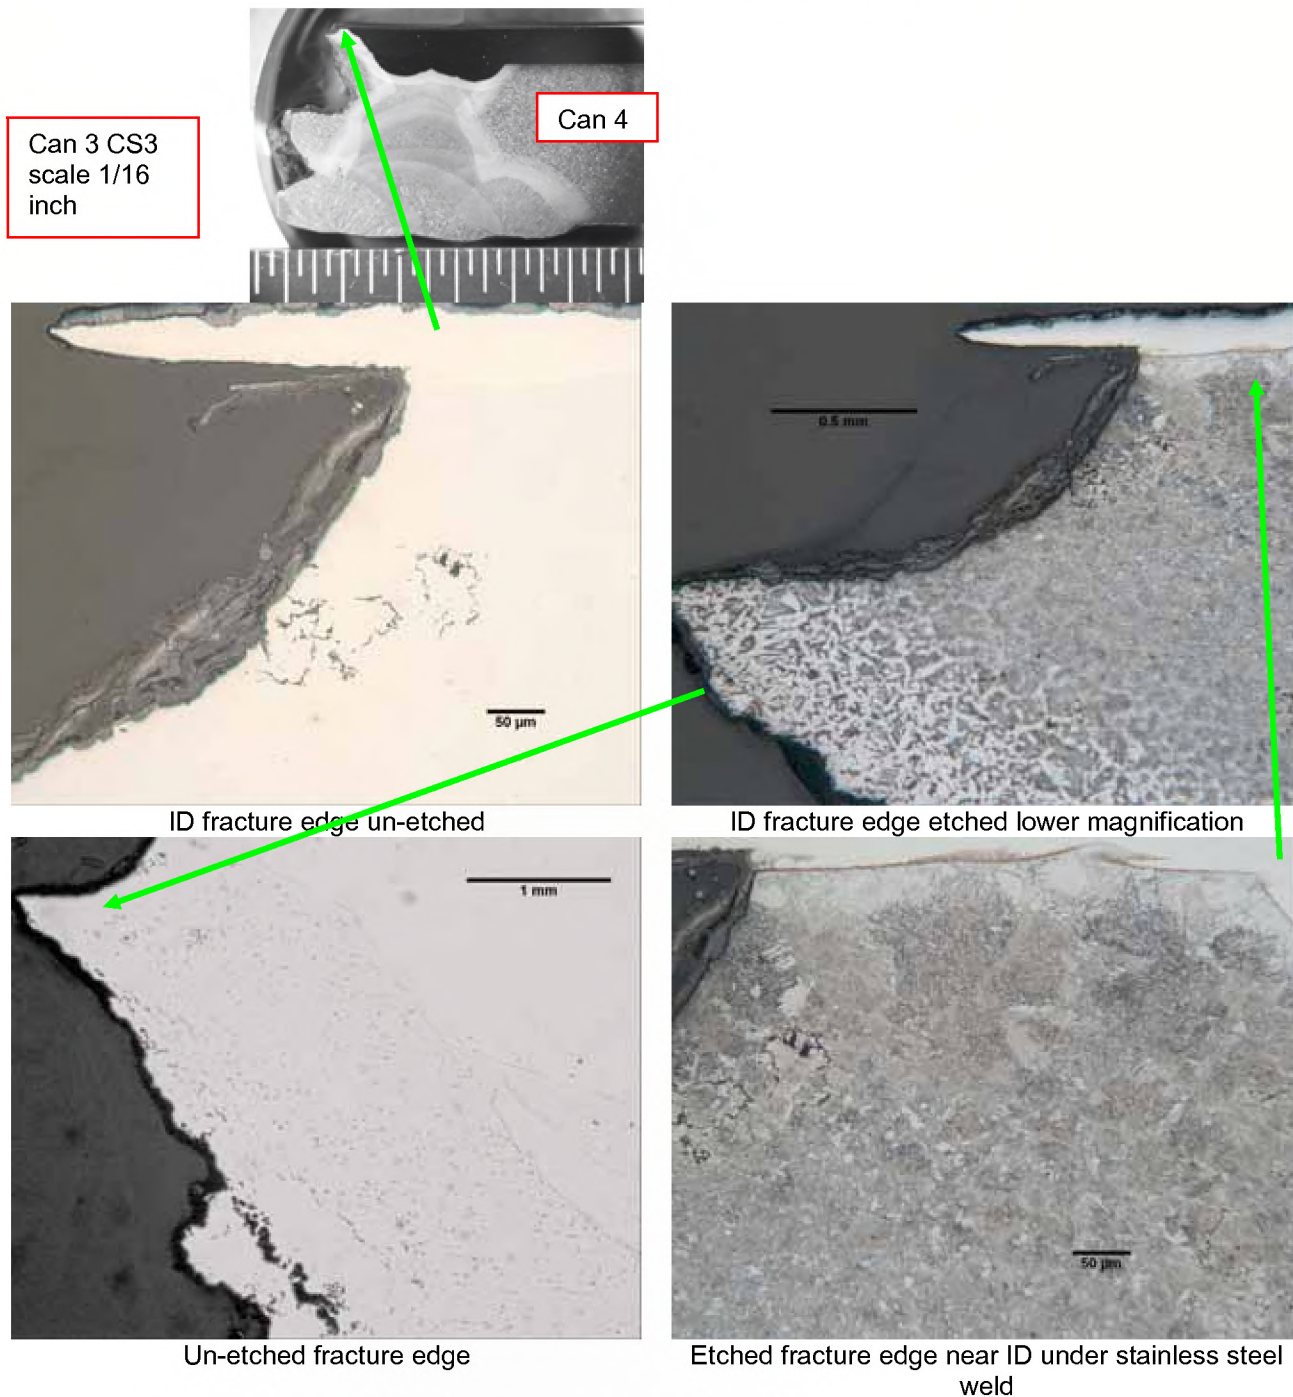
FIGURE 16 Un-etched and etched fracture edge near ID and under stainless steel weld for mount M1

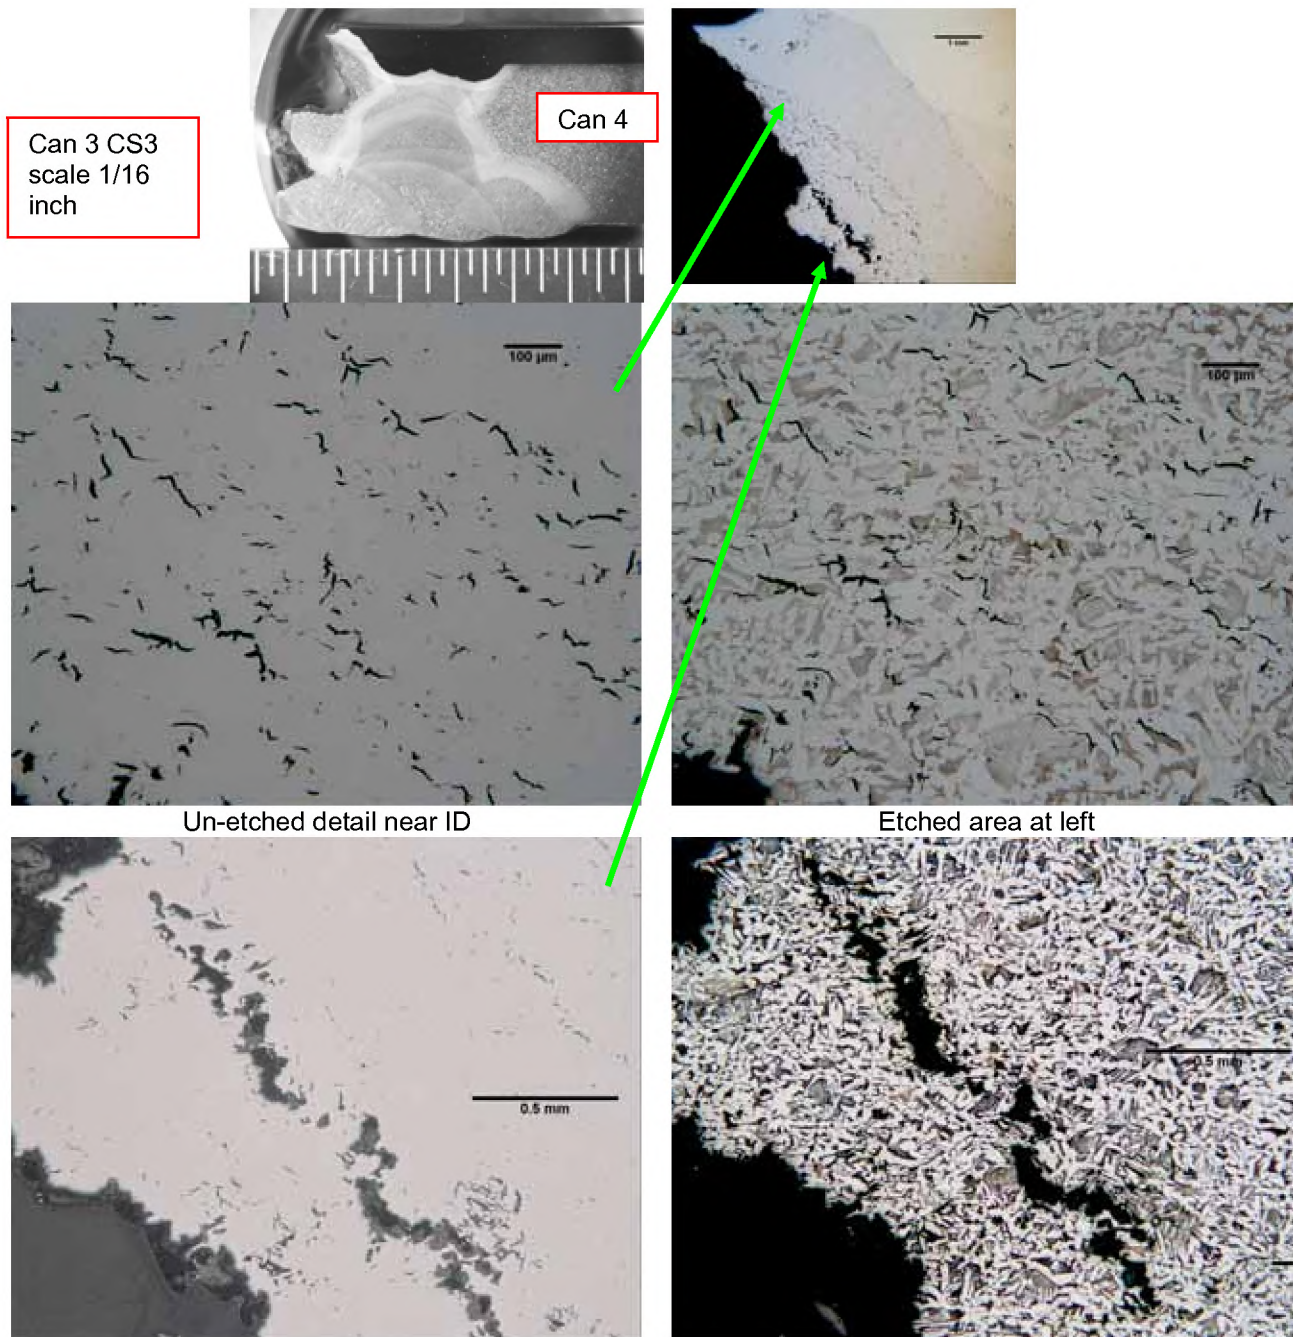
FIGURE 18 Un-etched and etched fracture edge proceeding along the fracture surface for mount M1

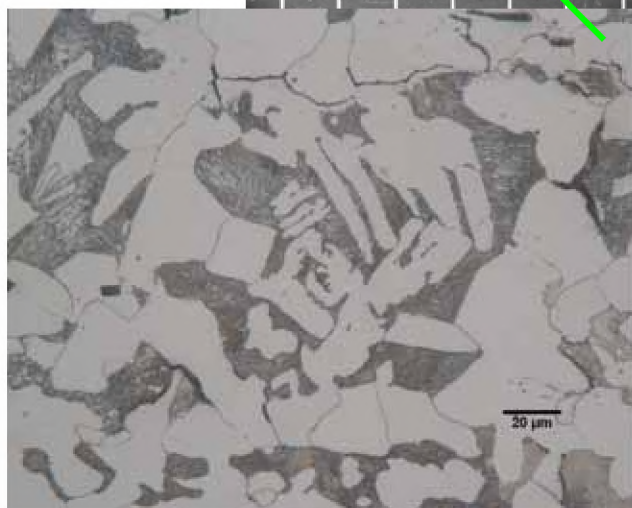
Etched area about 1/3 from ID

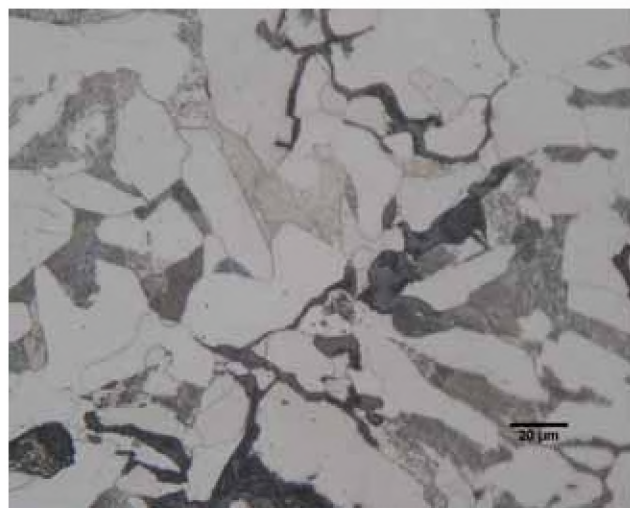
Etched area about 1/3 from ID

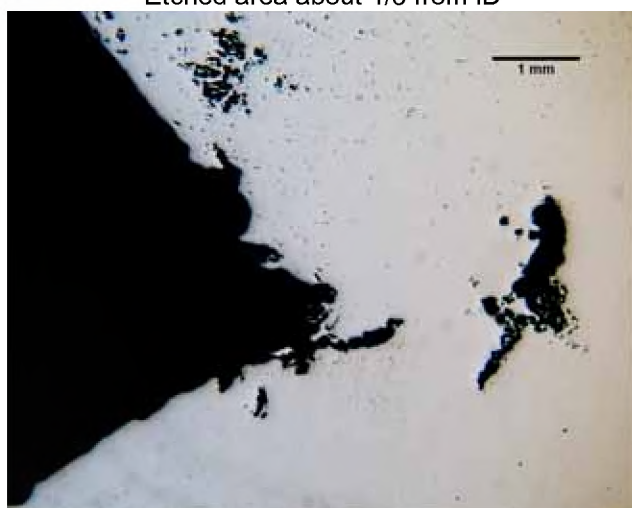
Un-etched near OD fracture edge, under OD cap
