BETA LAB NO.M10198- CS4-02	TESORO REFINING AND MARKETING COMPANY ANACORTES REFINERY 10200 W. MARCH POINT ROAD T91WA4428 ANACORTES, WA 98221	CUSTOMER P.O. NO.: 4501667904
PART: 6600-E HEAT EXCHANGER CS4 PART 19 & 20		DATE: AUGUST 5, 2010
PAGE 29 OF 57

LABORATORY REPORT-CS4

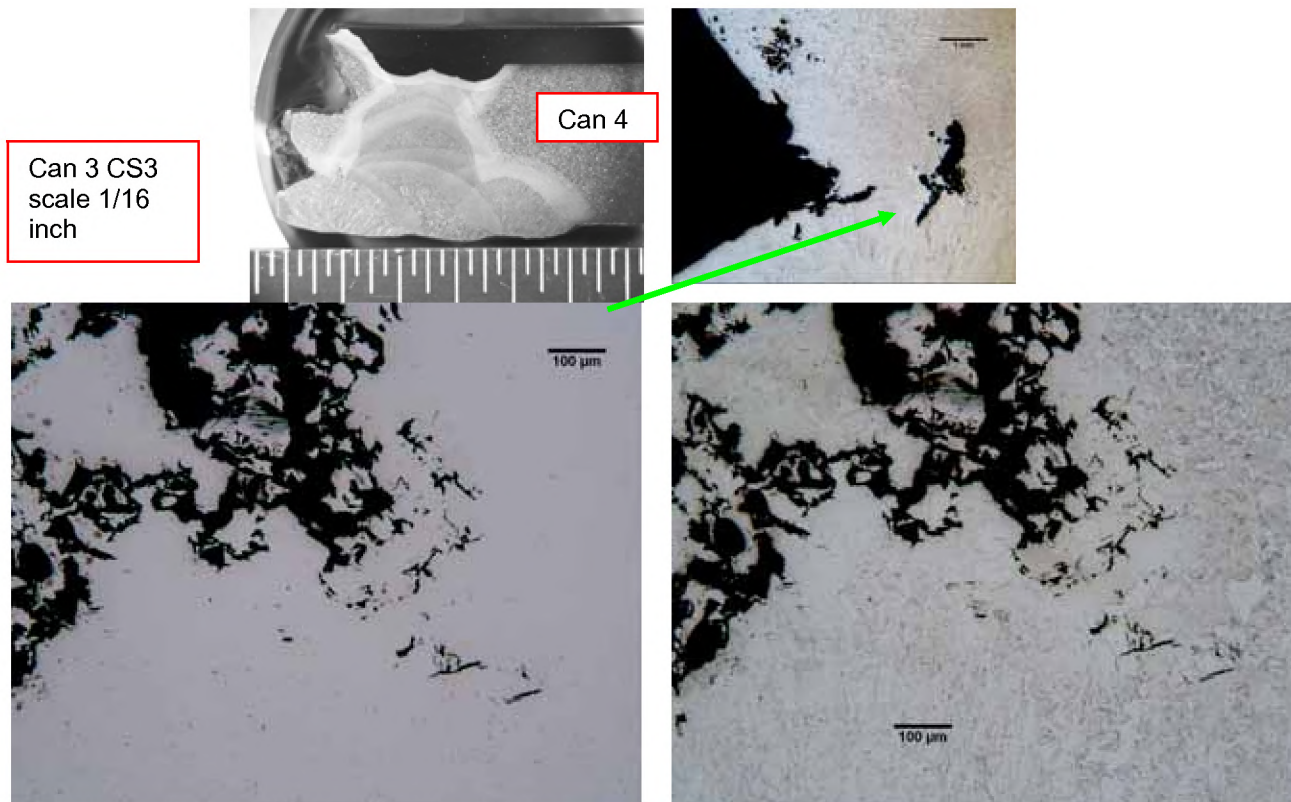
Un-etched detail near OD under OD cap

Etched detail near OD under OD cap

FIGURE 20 Un-etched and etched details of are in Figure 18 for mount M1

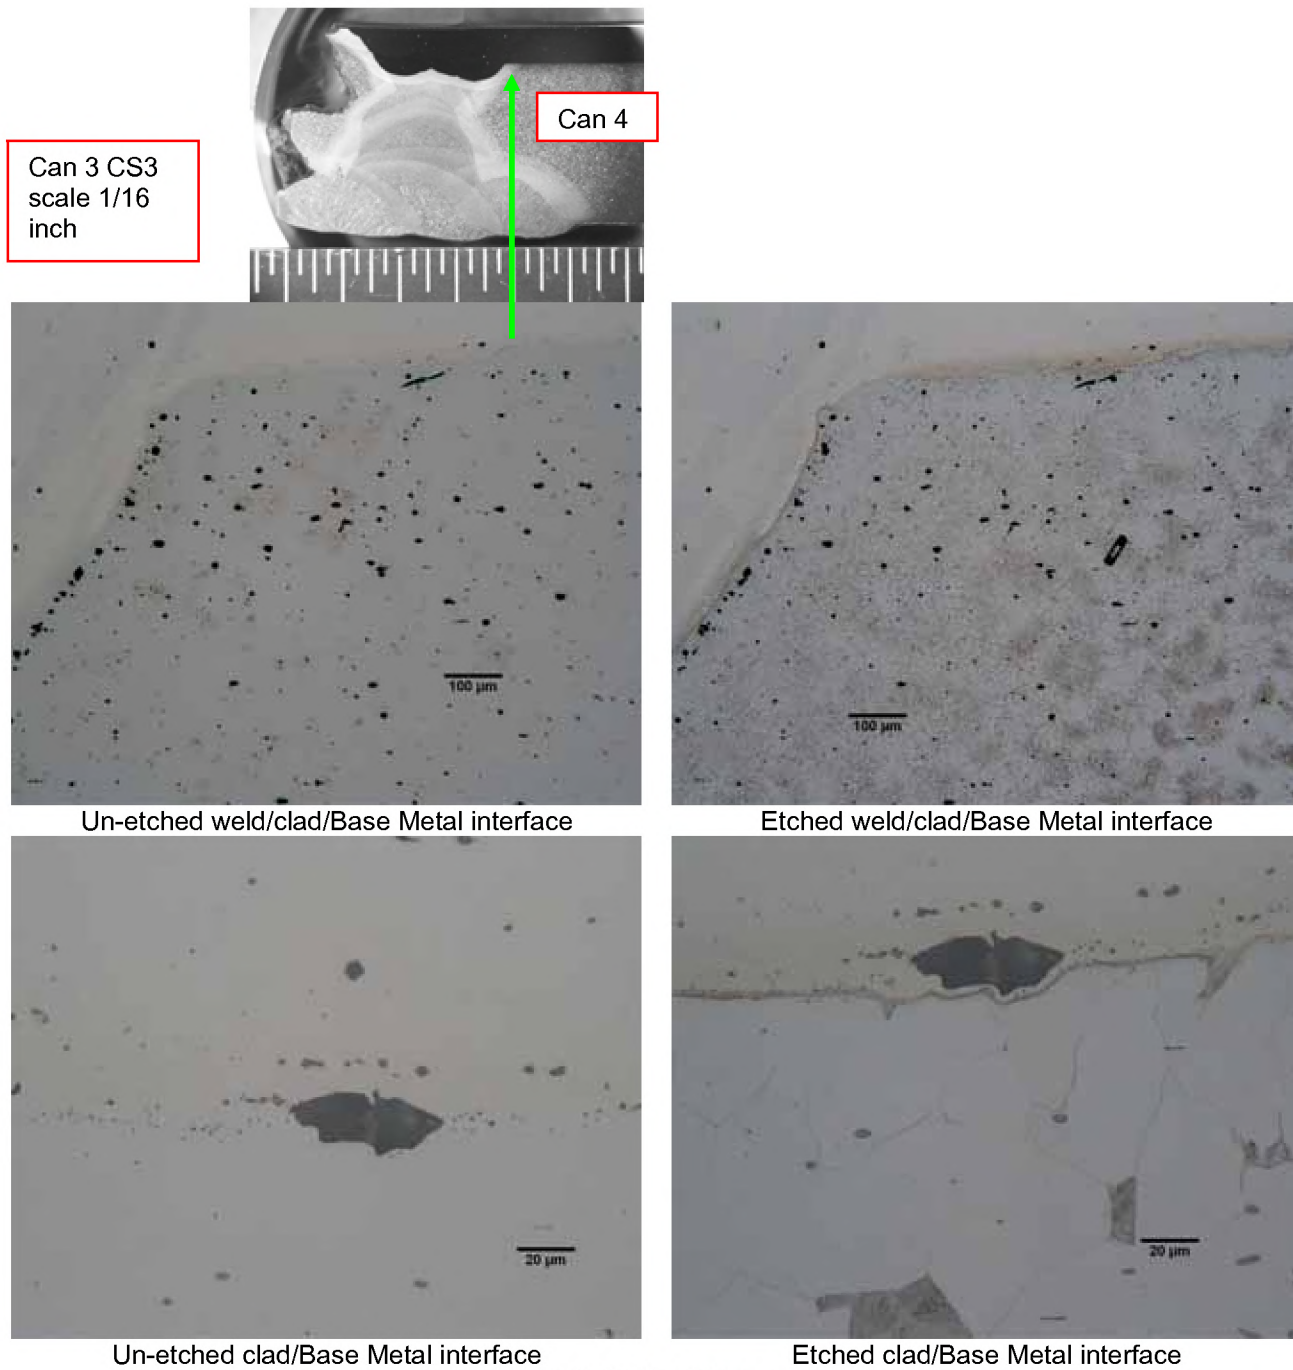
FIGURE 21 Un-etched and etched clad/weld/base metal interface for mount M1

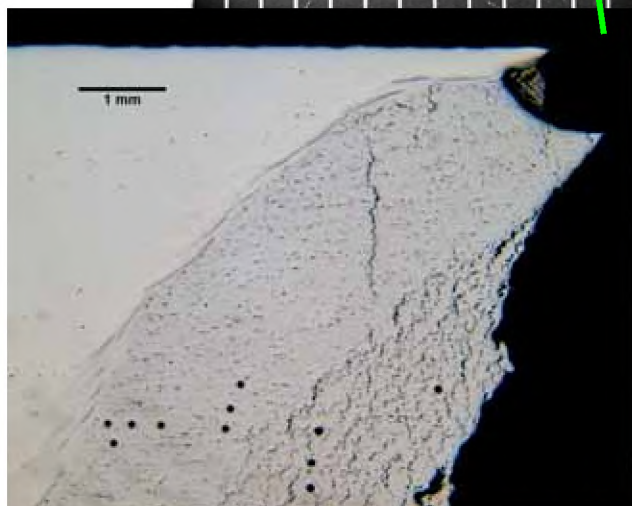
Un-etched at ID- note Vickers hardness impressions

FIGURE 22 Un-etched and etched ID for mount M2

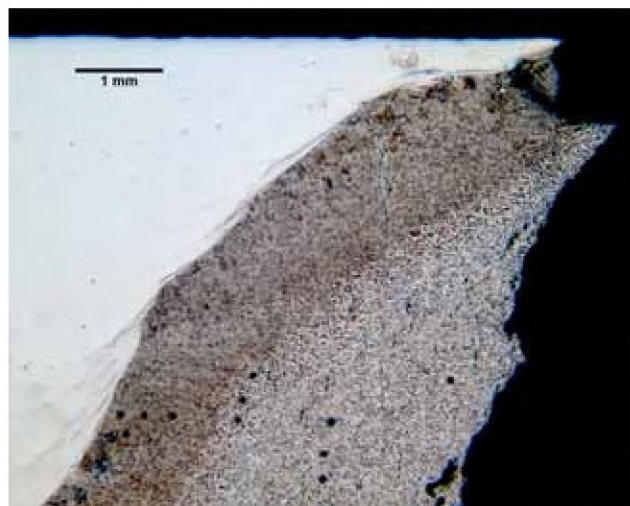
Etched at ID- note Vickers hardness impressions

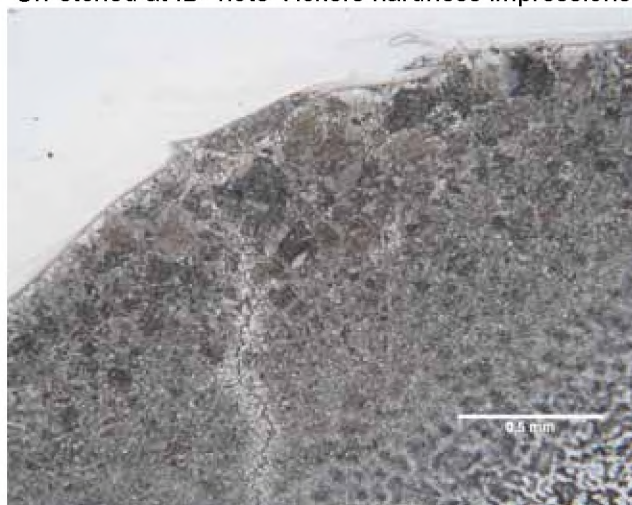
Etched under stainless steel weld from above

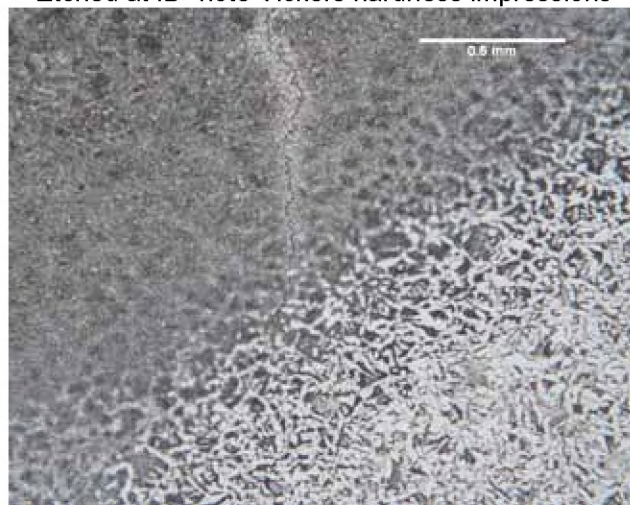
Etched under stainless steel weld at tip from above

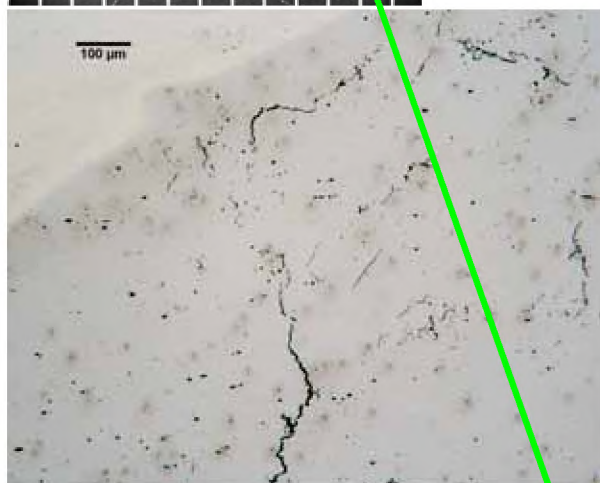
Un-etched under stainless weld metal-brown are artifacts

FIGURE 23 Un-etched and etched fracture edge progressing from ID toward the OD for mount M2

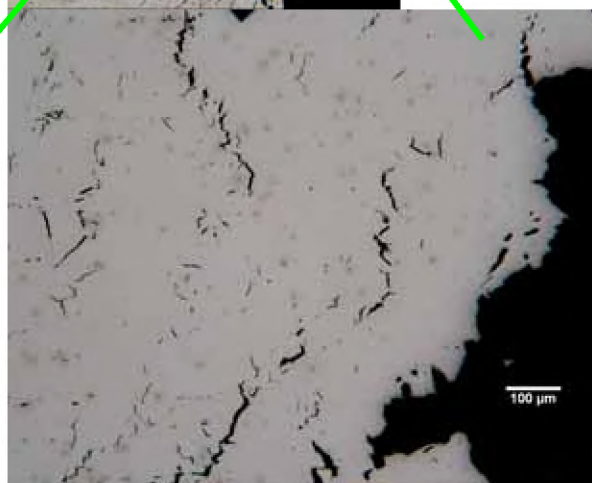
Un-etched along fracture edge

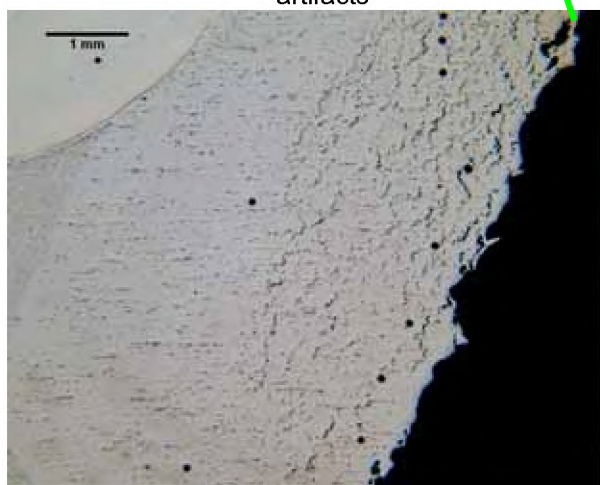
Un-etched further along the fracture edge-note Vickers hardness impressions

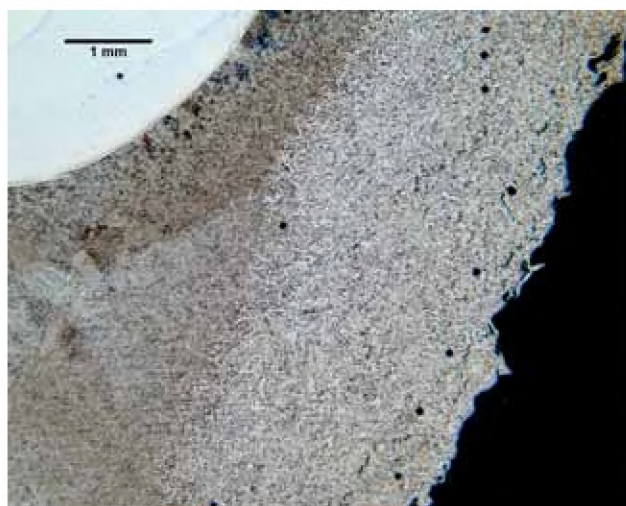
Etched area at left

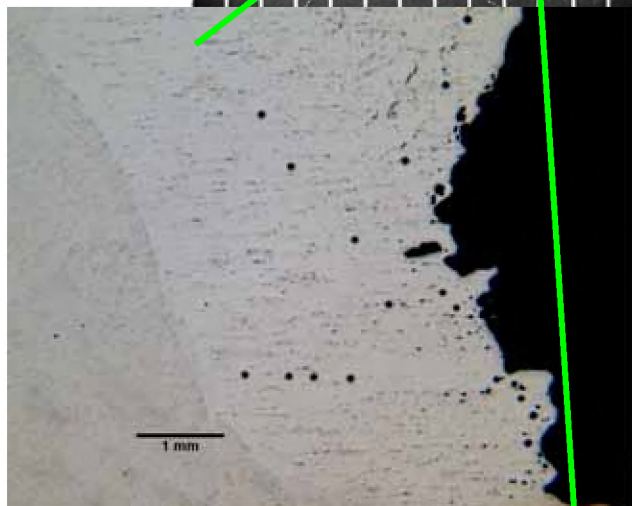
Un-etched further along the fracture edge near OD

FIGURE 24 Un-etched and etched fracture edge towards OD for mount M2

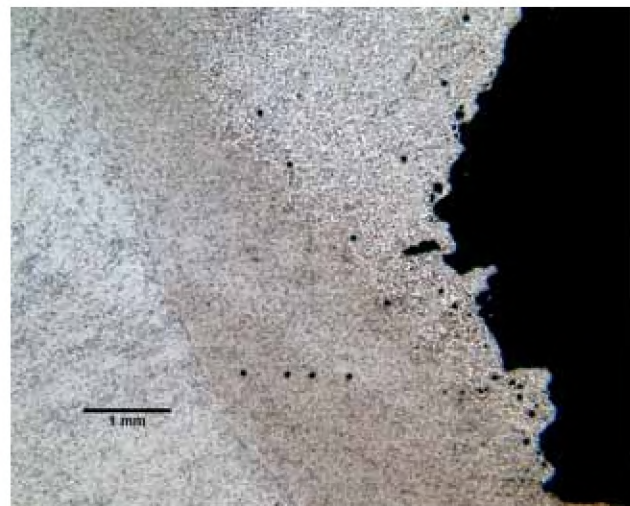
Etched further along the fracture edge near OD

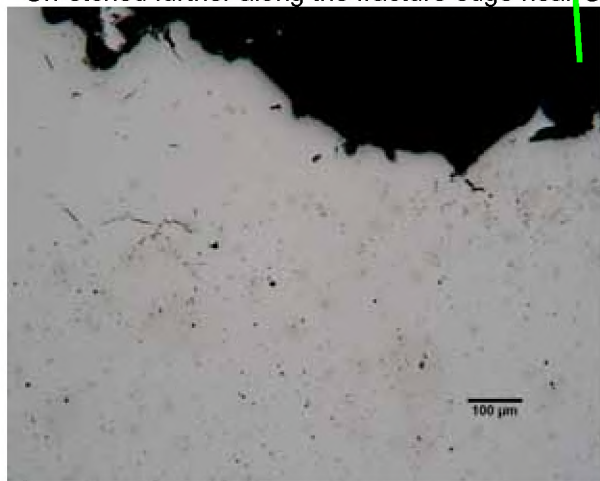
Un-etched under OD cap pass

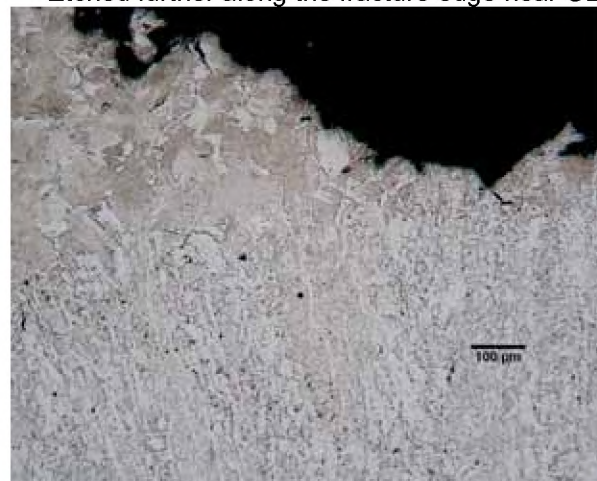
Etched under OD cap pass

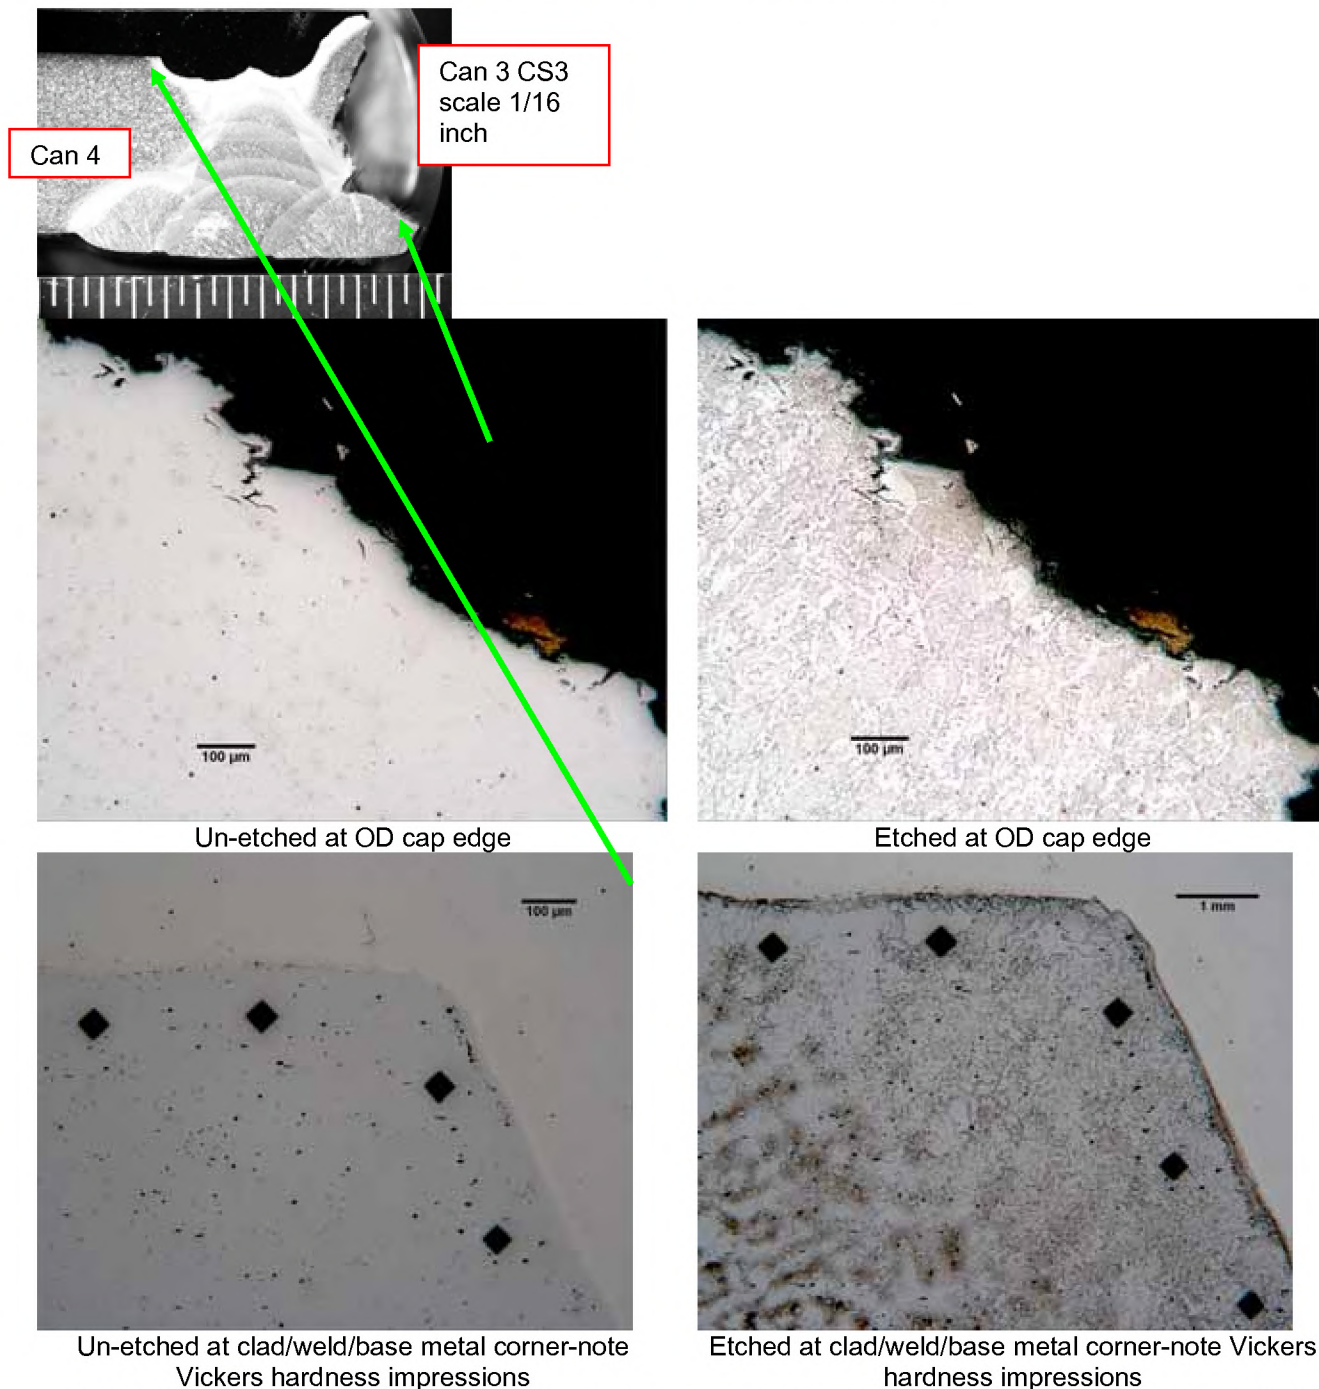
FIGURE 25 Un-etched and etched fracture edge progressing from ID toward the OD for mount M2

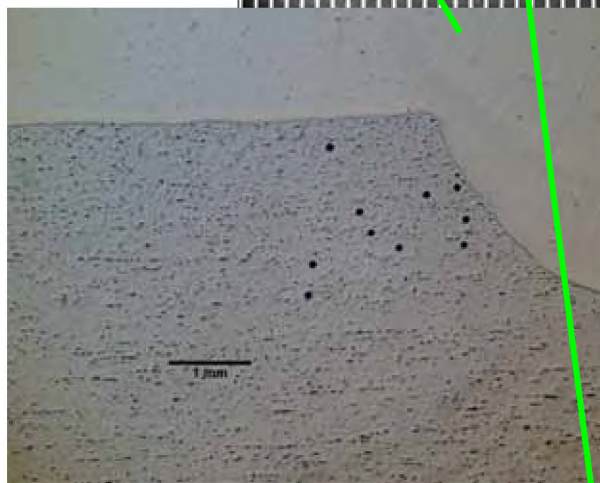
Un-etched at weld/clad/base metal interface- note Vickers hardness impressions

FIGURE 26 Un-etched and etched weld and clad interfaces for mount M3

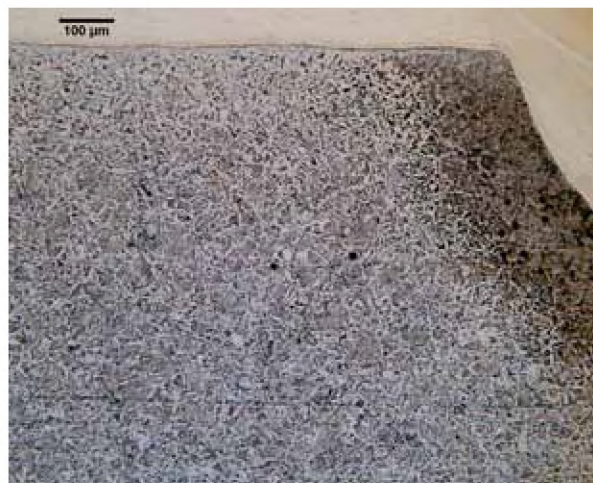
Etched at weld/clad/base metal interface- note Vickers hardness impressions

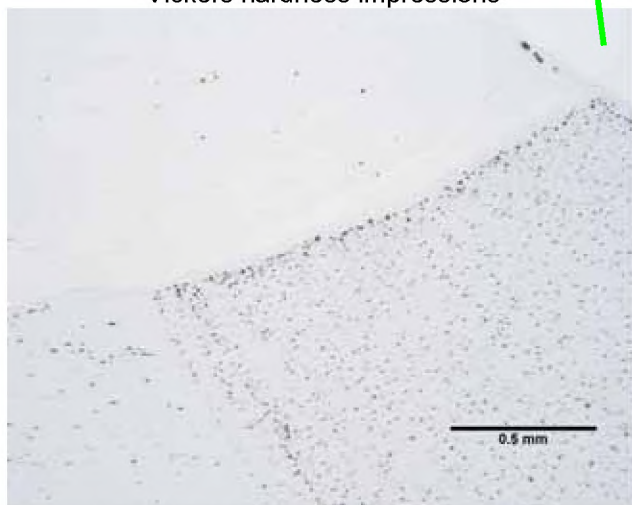
Un-etched at weld/base metal interface

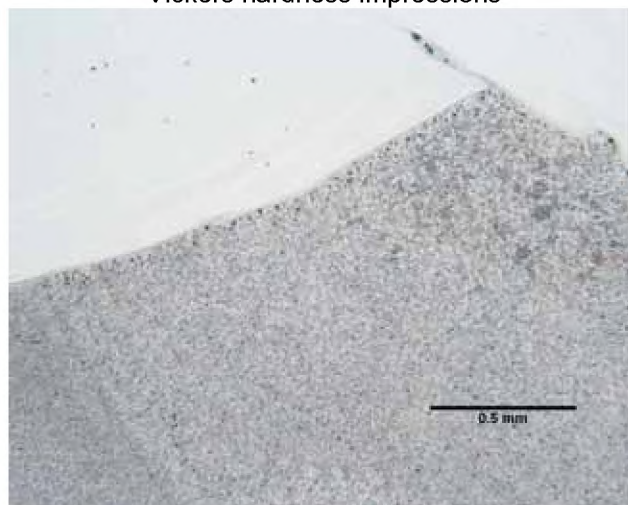
Etched at weld/base metal interface

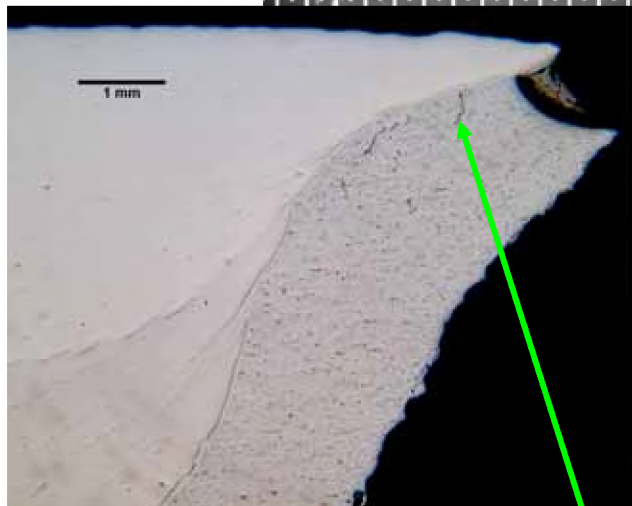
Un-etched at ID fracture edge

FIGURE 27 Un-etched and etched at ID and along the fracture edge for mount M4

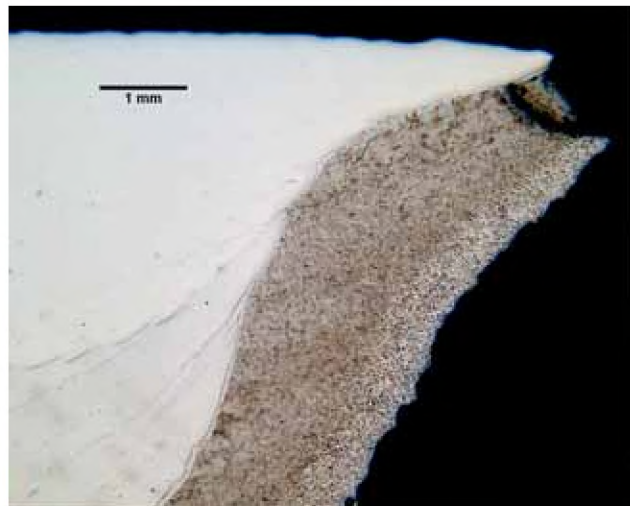
Etched at ID fracture edge

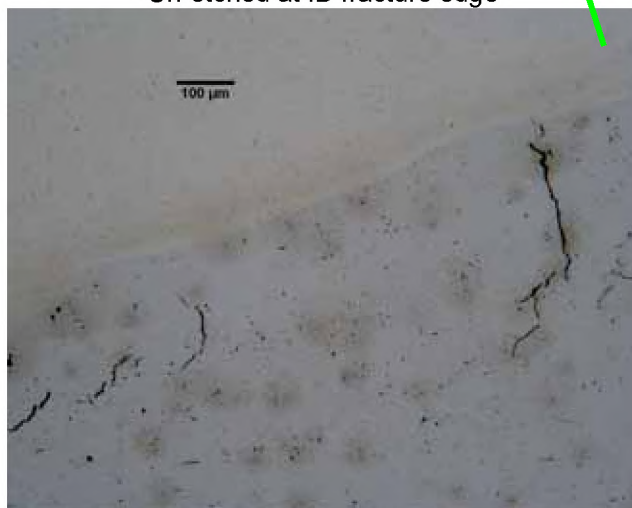
Un-etched under weld near ID-brown are artifacts

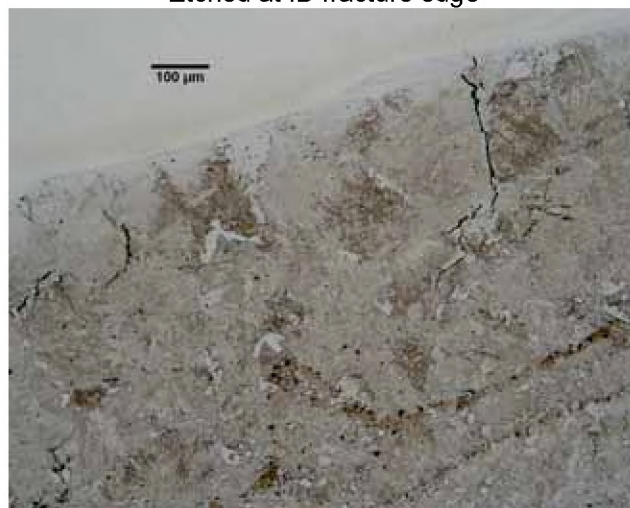
Etched under weld near ID

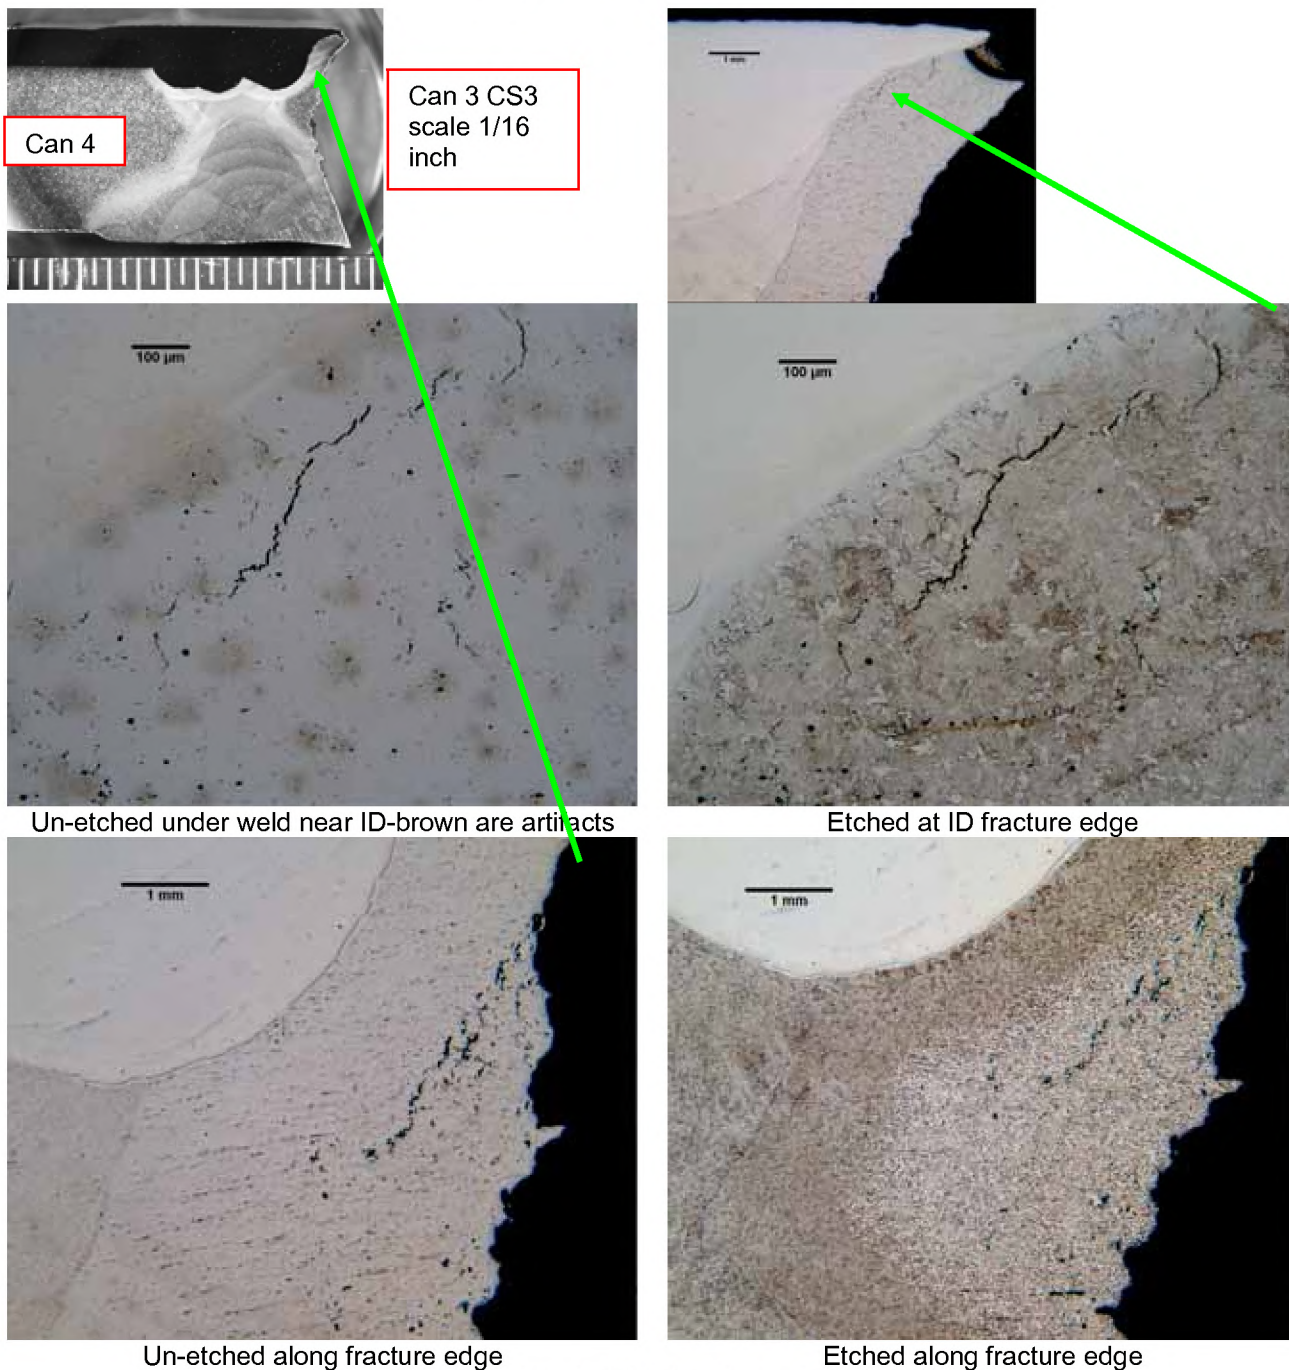
FIGURE 28 Un-etched and etched under weld near ID mount M4

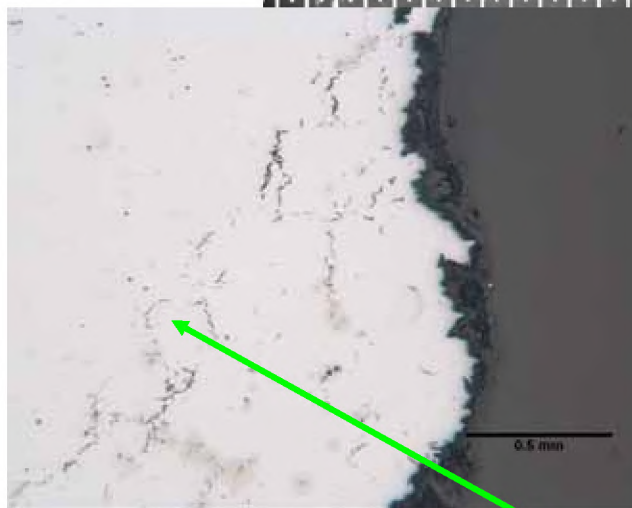
Un-etched along fracture edge

FIGURE 29 Un-etched and etched at ID and along the fracture edge for mount M4

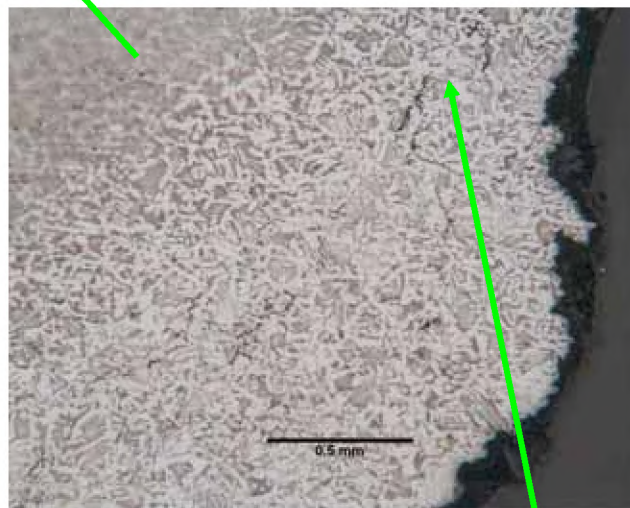
Etched along fracture edge

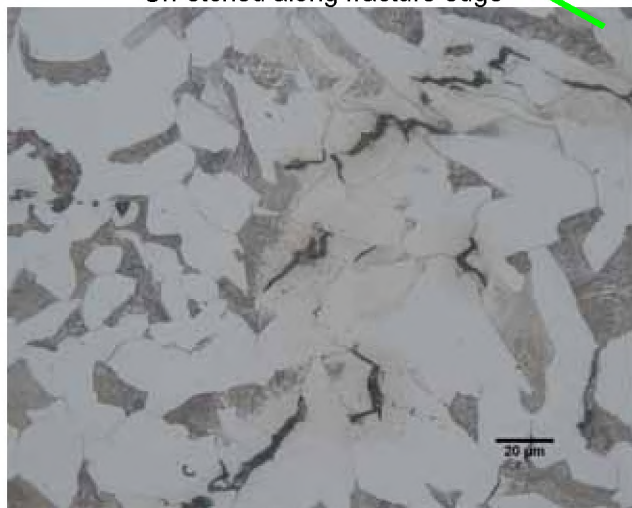
Etched detail of above

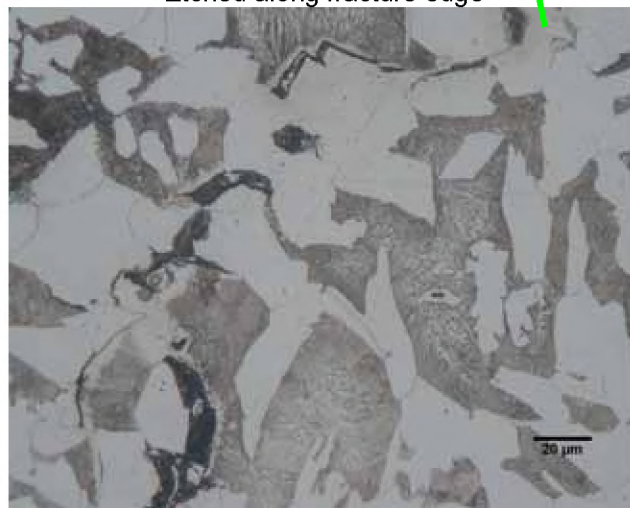
Etched detail of above

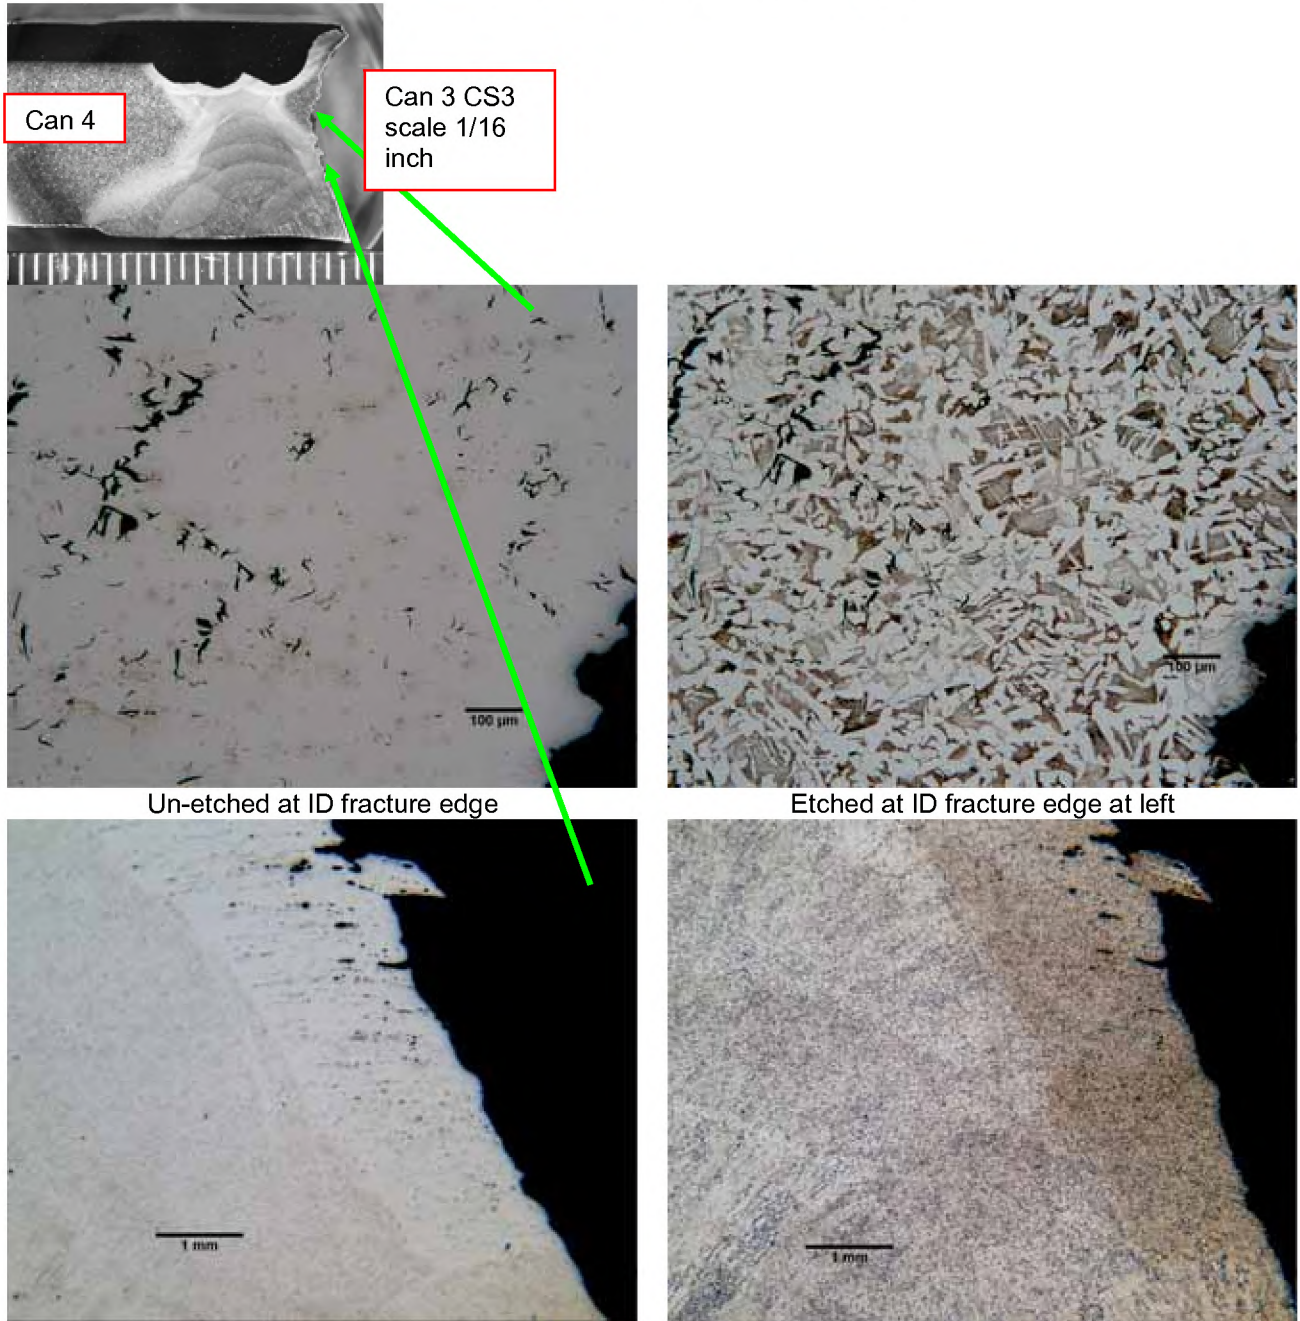
Un-etched at ID fracture edge

Etched at ID fracture edge at left

Un-etched along fracture edge

Etched along fracture edge

FIGURE 30 Un-etched and etched along fracture edge for mount M4

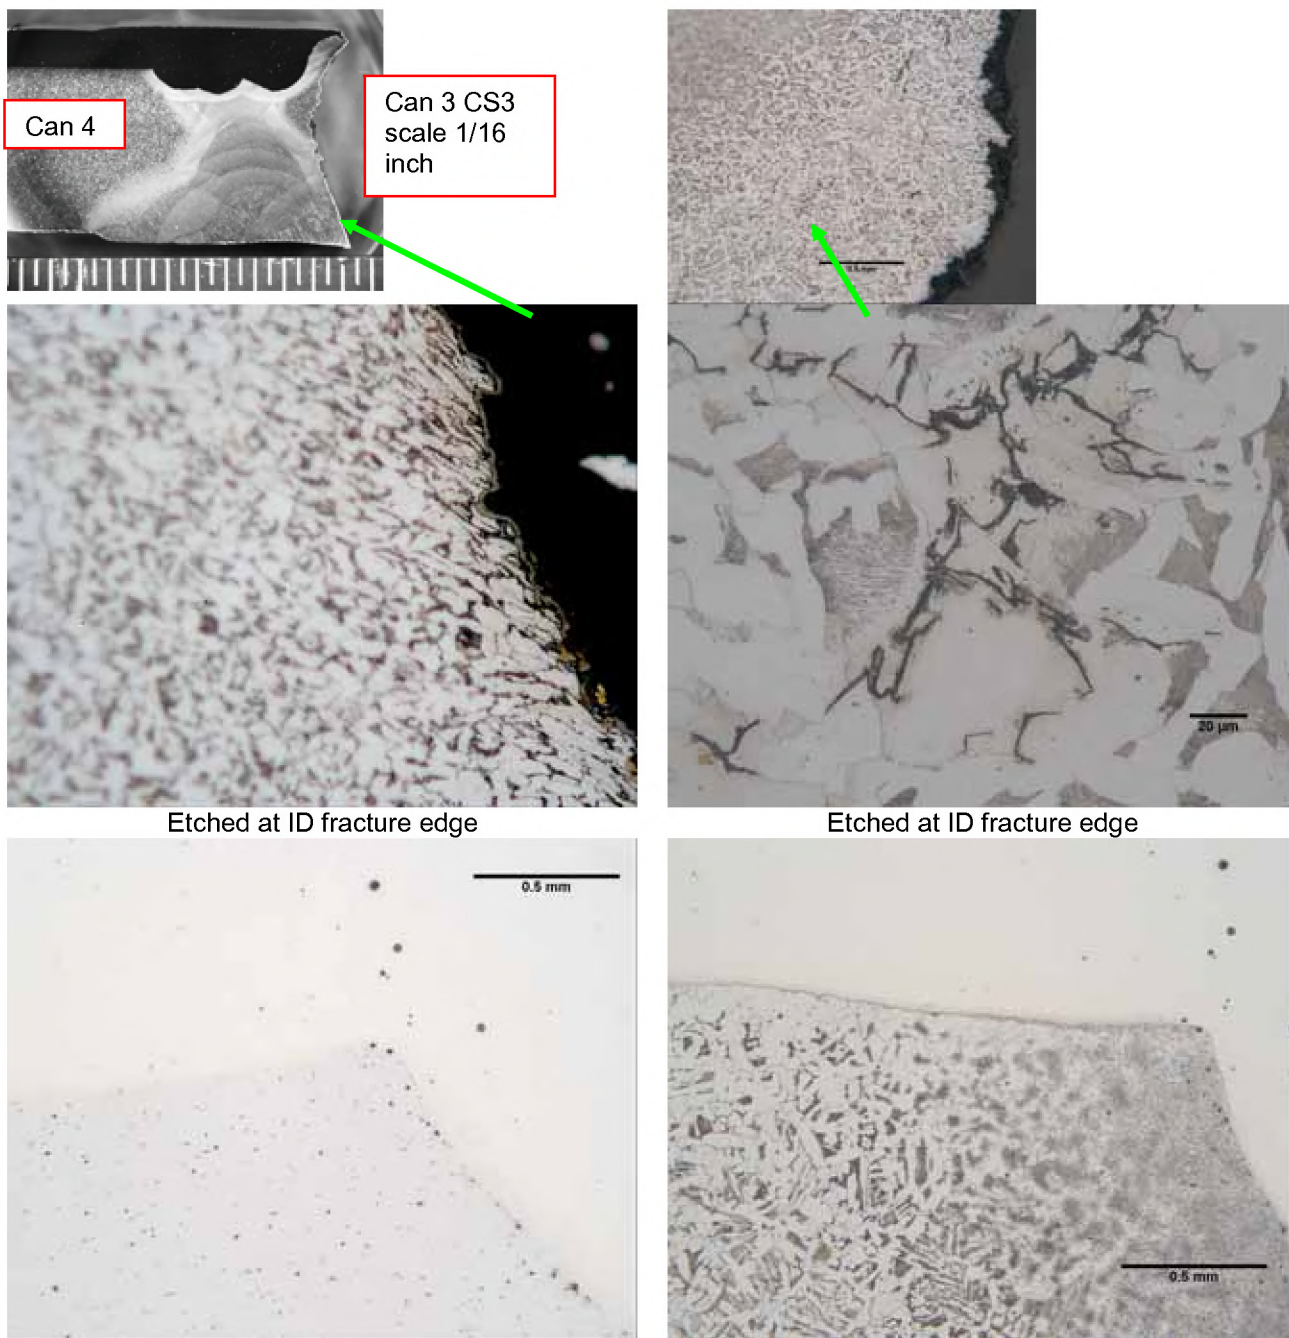
Etched at ID fracture edge

Un-etched at clad/weld/base metal interface

Etched at clad/weld/base metal interface

FIGURE 31 Un-etched and etched along fracture edge for mount M4

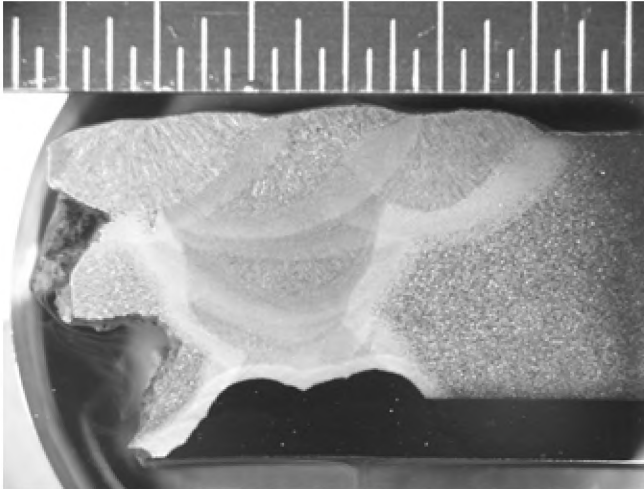
Mount M1 transverse through CS4 can 3 fracture on left and can 4 on right – ID on bottom- Black is clad and stainless steel weld- NO HARDNESS TESTS REQUESTED

FIGURE 32 Photo macrographs with green lines where the micro-hardness traverses were made. hardness values are given in Table 5-7

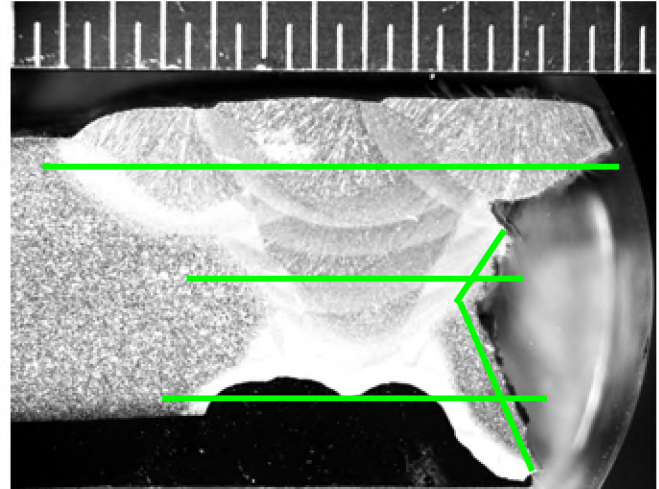
Mount M2 transverse through CS4 can 4 on left and can 3 fracture on right- ID on bottom- Black is clad and stainless steel weld-

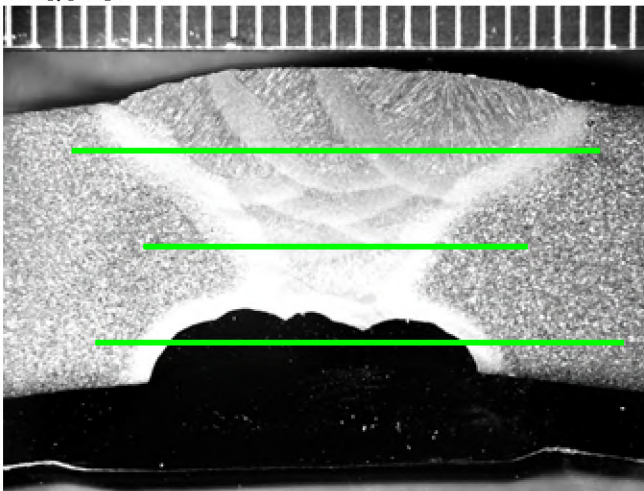
Mount M3 transverse through LS4 can 4 on both sides – ID on bottom- Black is clad and stainless steel weld

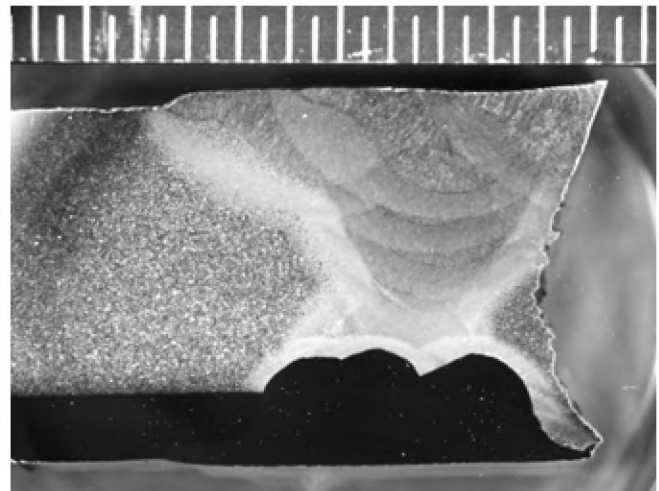
Mount M4 transverse through CS4 can 3 fracture on right and can 4 on left – ID on bottom- Black is clad and stainless steel weld- NO HARDNESS TESTS REQUESTED

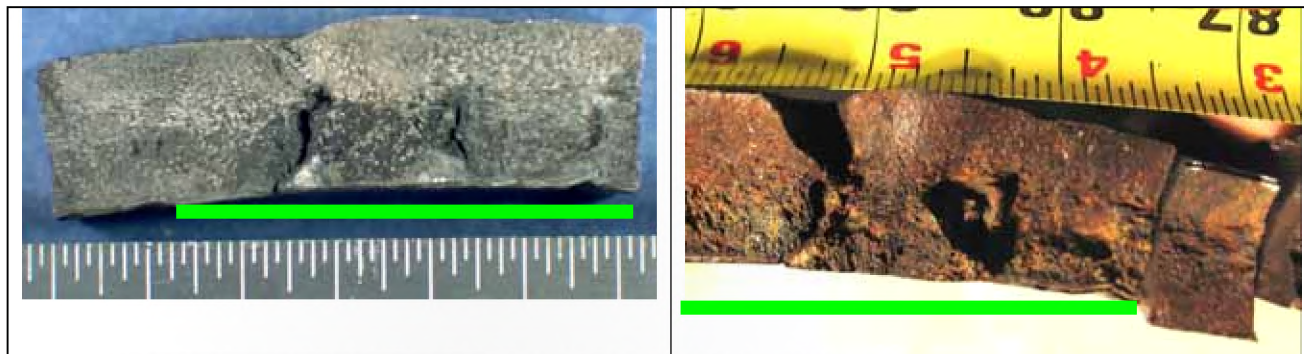
Straight down photo, ID bottom and OD top-scale is 1/16 inch—left after cleaning and right before cleaning

FIGURE 33 Photo of SEM 1 sample before and after cleaning

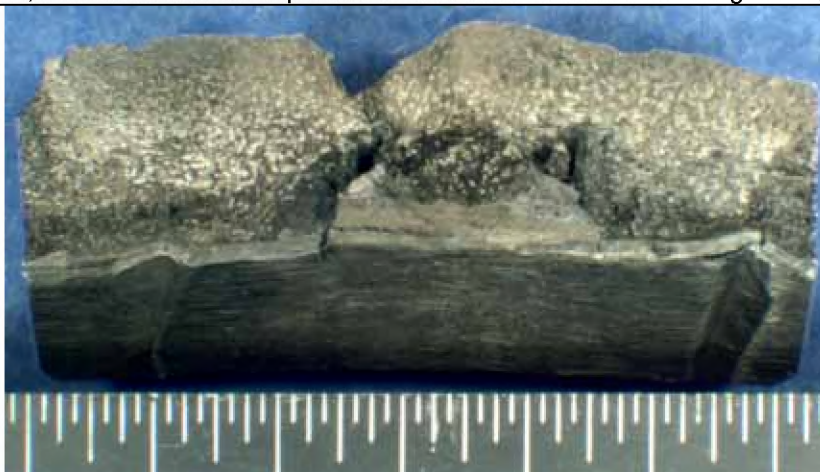
Tilt to show ID corner- scale is 1/16 inch

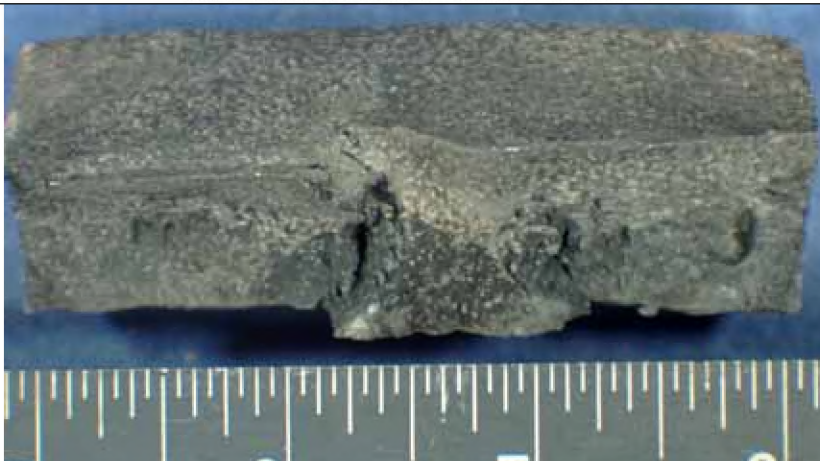
Tilt to show OD corner- scale is 1/16 inch
