BETA LAB No.M10198- LS3 BOTTOM	TESORO REFINING AND MARKETING COMPANY ANACORTES REFINERY 10200 W. MARCH POINT ROAD T91WA4428 ANACORTES, WA 98221	CUSTOMER P.O. NO.: 4501667904
PART: 6600-E HEAT EXCHANGER LS 3 BOTTOM PART 14		DATE: JULY 30, 2010
PAGE 1 OF 88

**LABORATORY REPORT-LS3 BOTTOM**

This report is the first of a series on the failed parts of the 6600E heat exchanger. The LS# and CS# refer to longitudinal and circumferential weld seams while the part number refers to the chain of custody number.

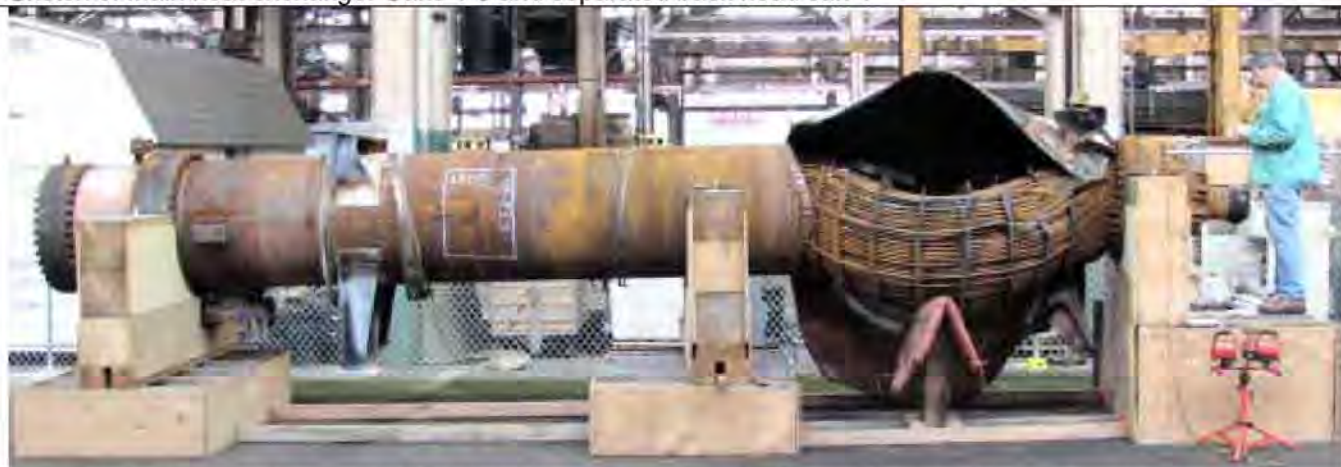
**FIGURE 1 Un-packed main heat exchanger**

Sketch of main heat exchanger Cans 1-3 and separated back head can 4

Overall main heat exchanger with "fish mouth " rupture primarily along LS3 and CS4 as shown by green box above

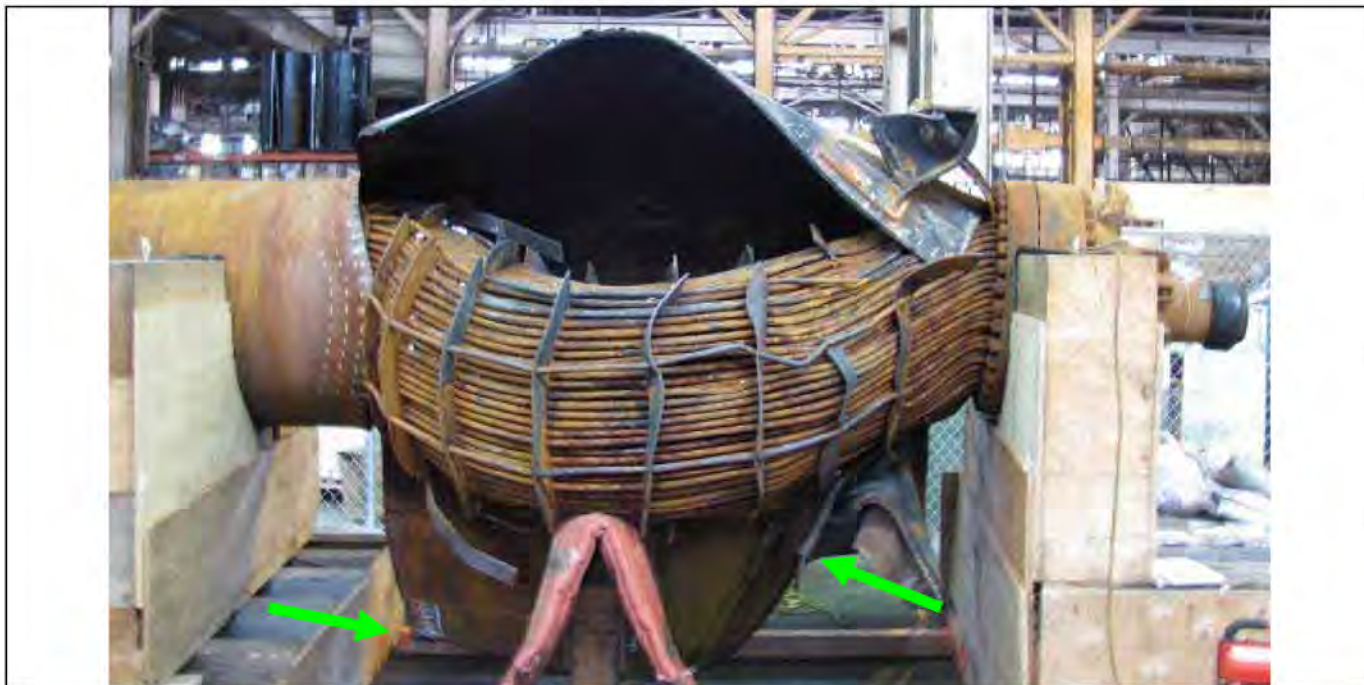
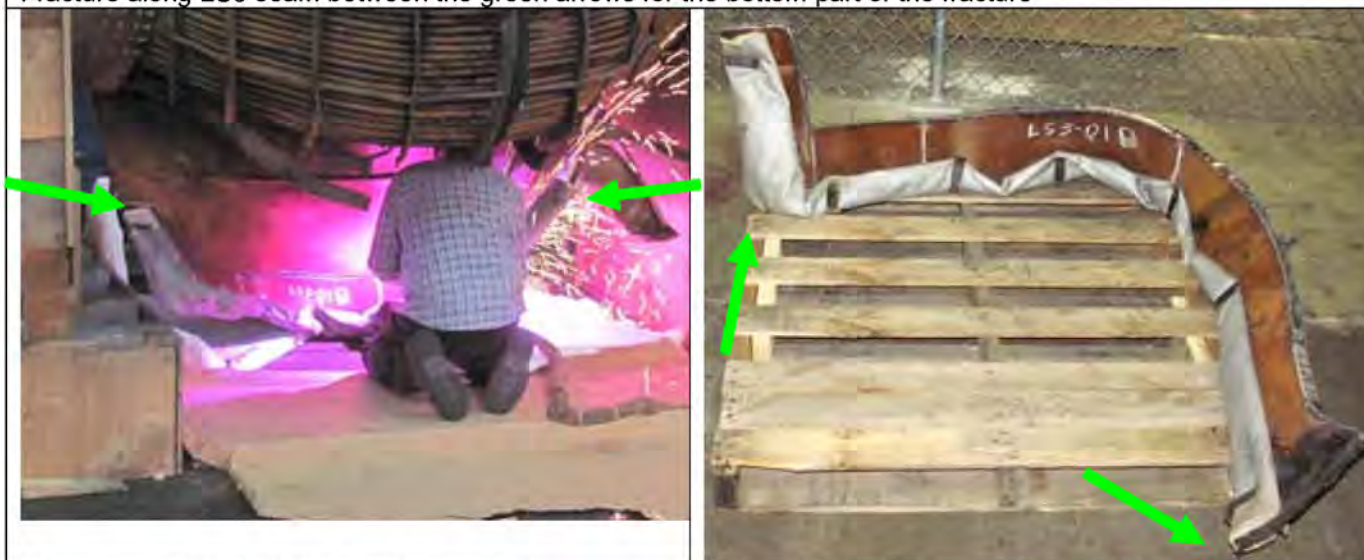
Fracture along LS3 seam between the green arrows for the bottom part of the fracture

Plasma arc cutting LS3 bottom fracture out

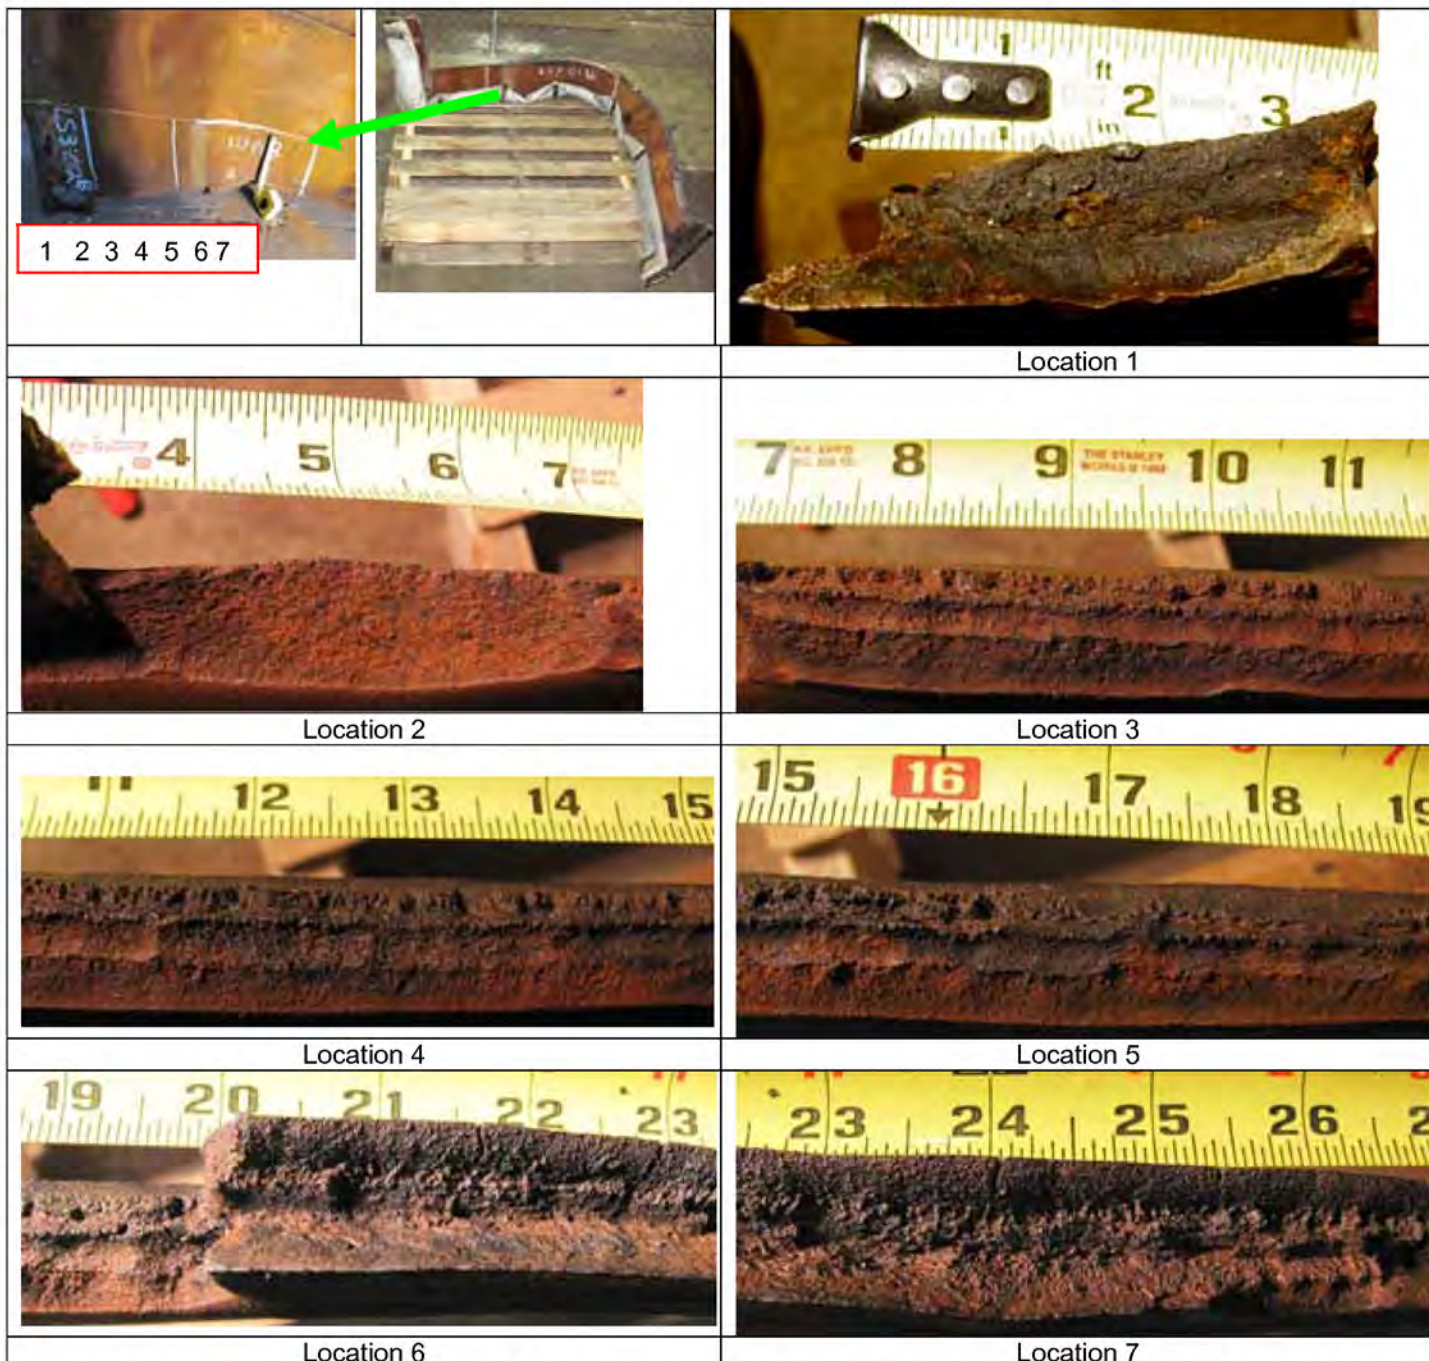
**FIGURE 4** Photos of the fracture along LS3 from CS3 corner with the locations as shown in the upper left (ID on top)

**TEST RESULTS:** The heat exchanger weld seams had been previous labeled as shown in Figure 1 and the same labeling was used for this report. A piece labeled 14 (LS3 Bottom) contained the complete LS 3 bottom fracture and about 20 and 13 inches of the fracture in CS3 and CS4 respectively, as shown in Figure 2 was received at BETA Lab for testing. The visual appearance of the CS3 fracture edge is shown in Figure 3. The approximately 84 inches of the LS3 fracture edge are shown in Figures 4-8. Figure 9 shows the fracture edge of CS4.

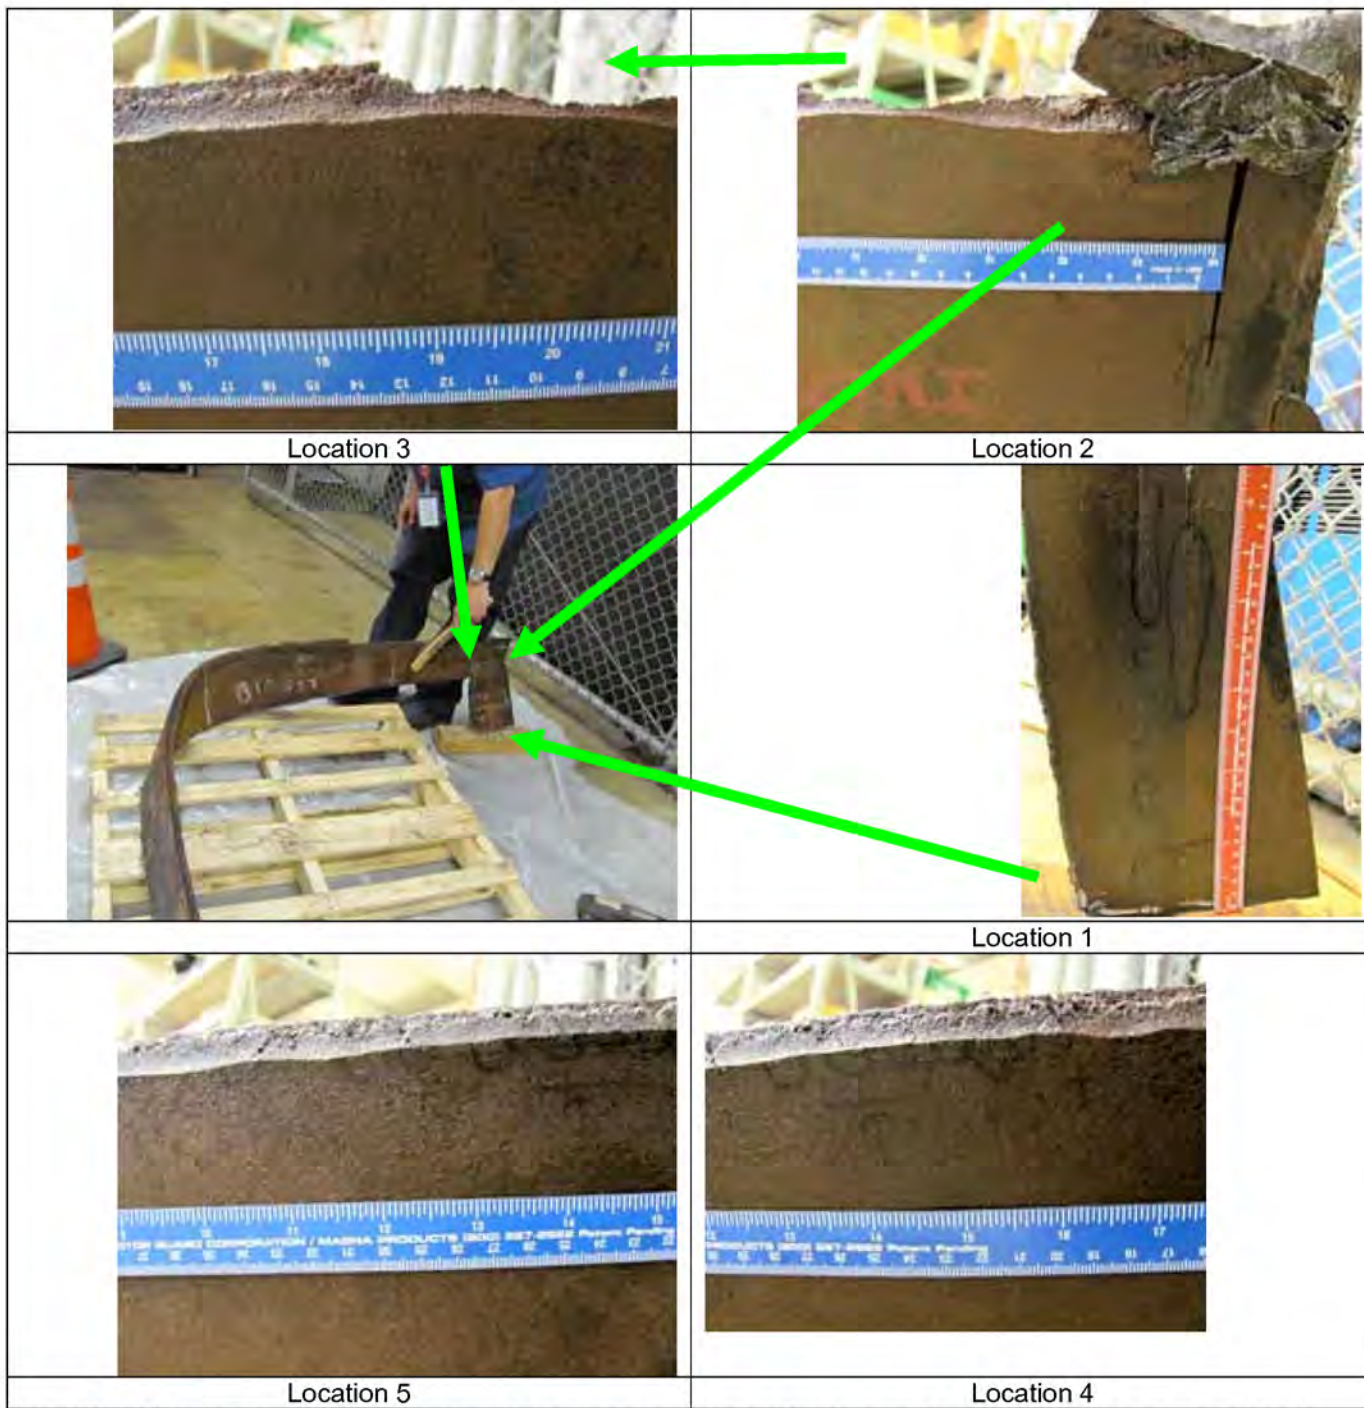
The ID surface of part 14 was wet fluorescent magnetic particle inspected by others and numerous indications were found. The Indications are circled in Figures 10-13.

**FIGURE 10 Magnetic Particle inspection indications circled (fracture on top and looking at ID surface)**

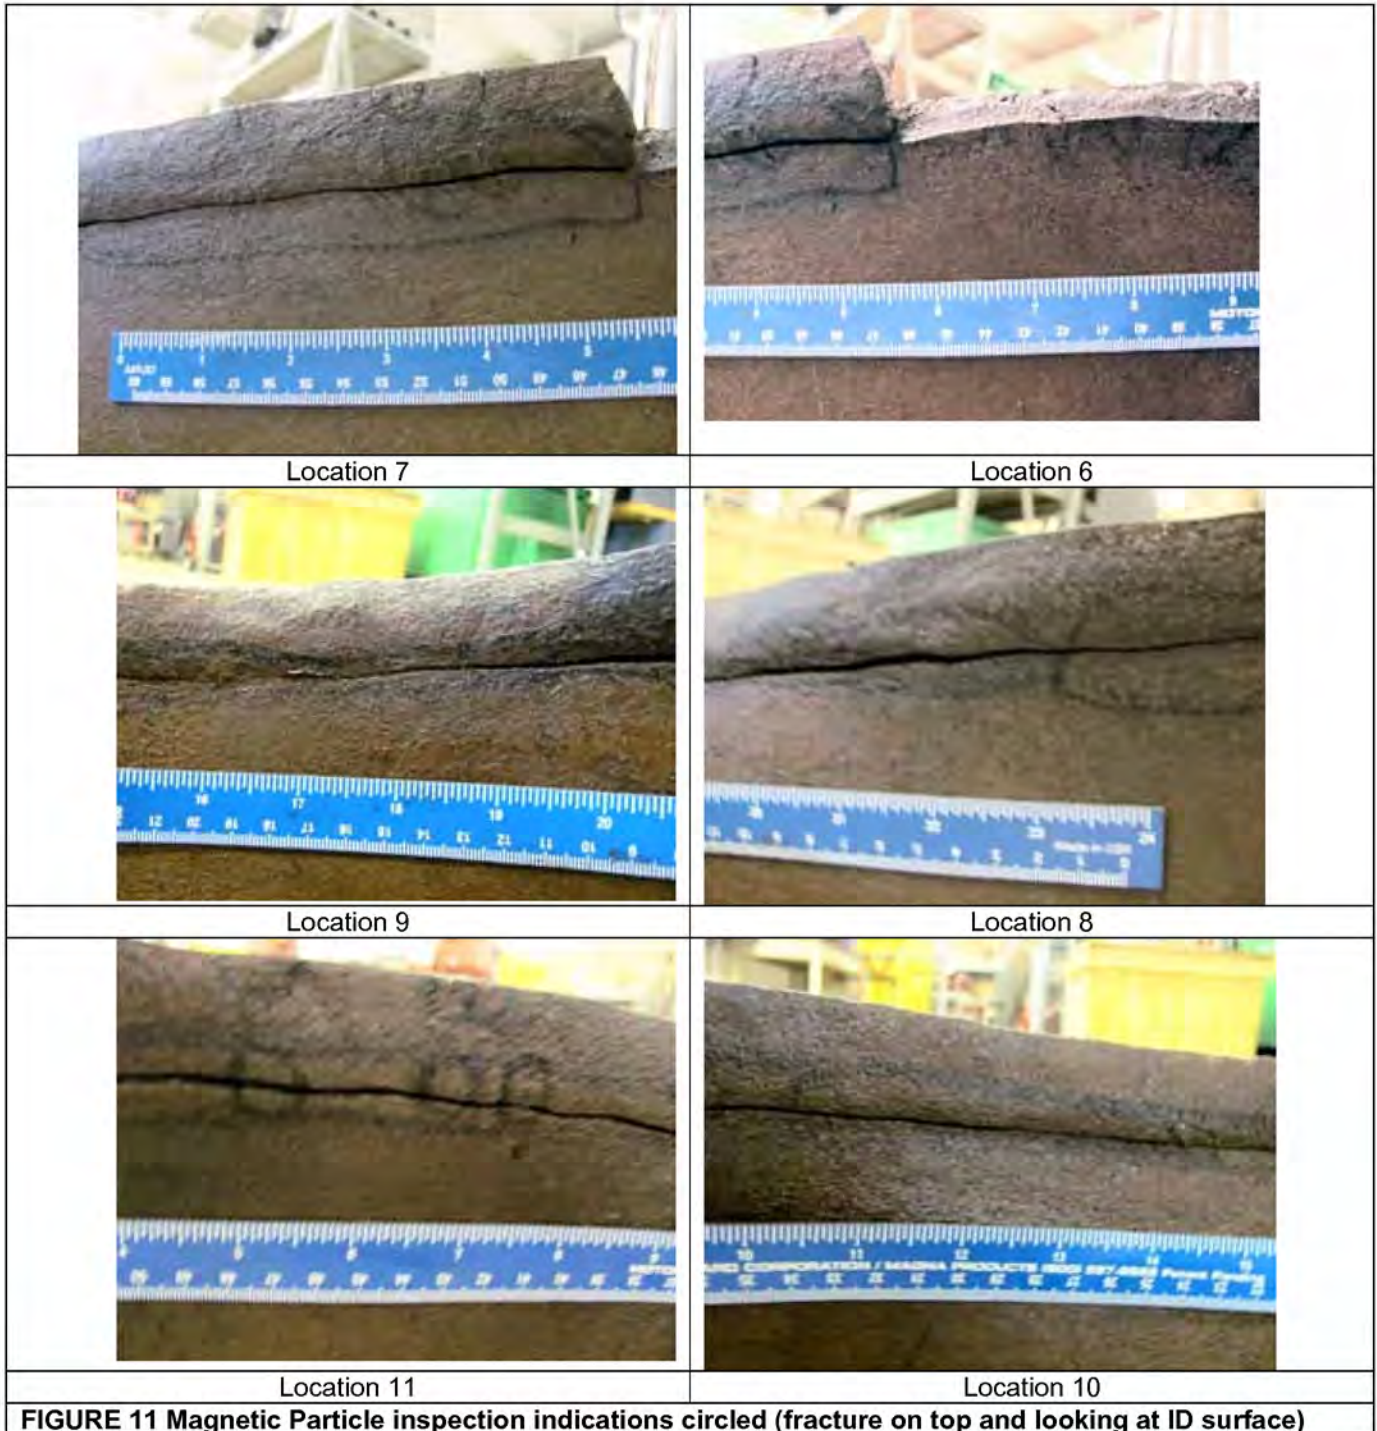
**FIGURE 11 Magnetic Particle inspection indications circled (fracture on top and looking at ID surface)**

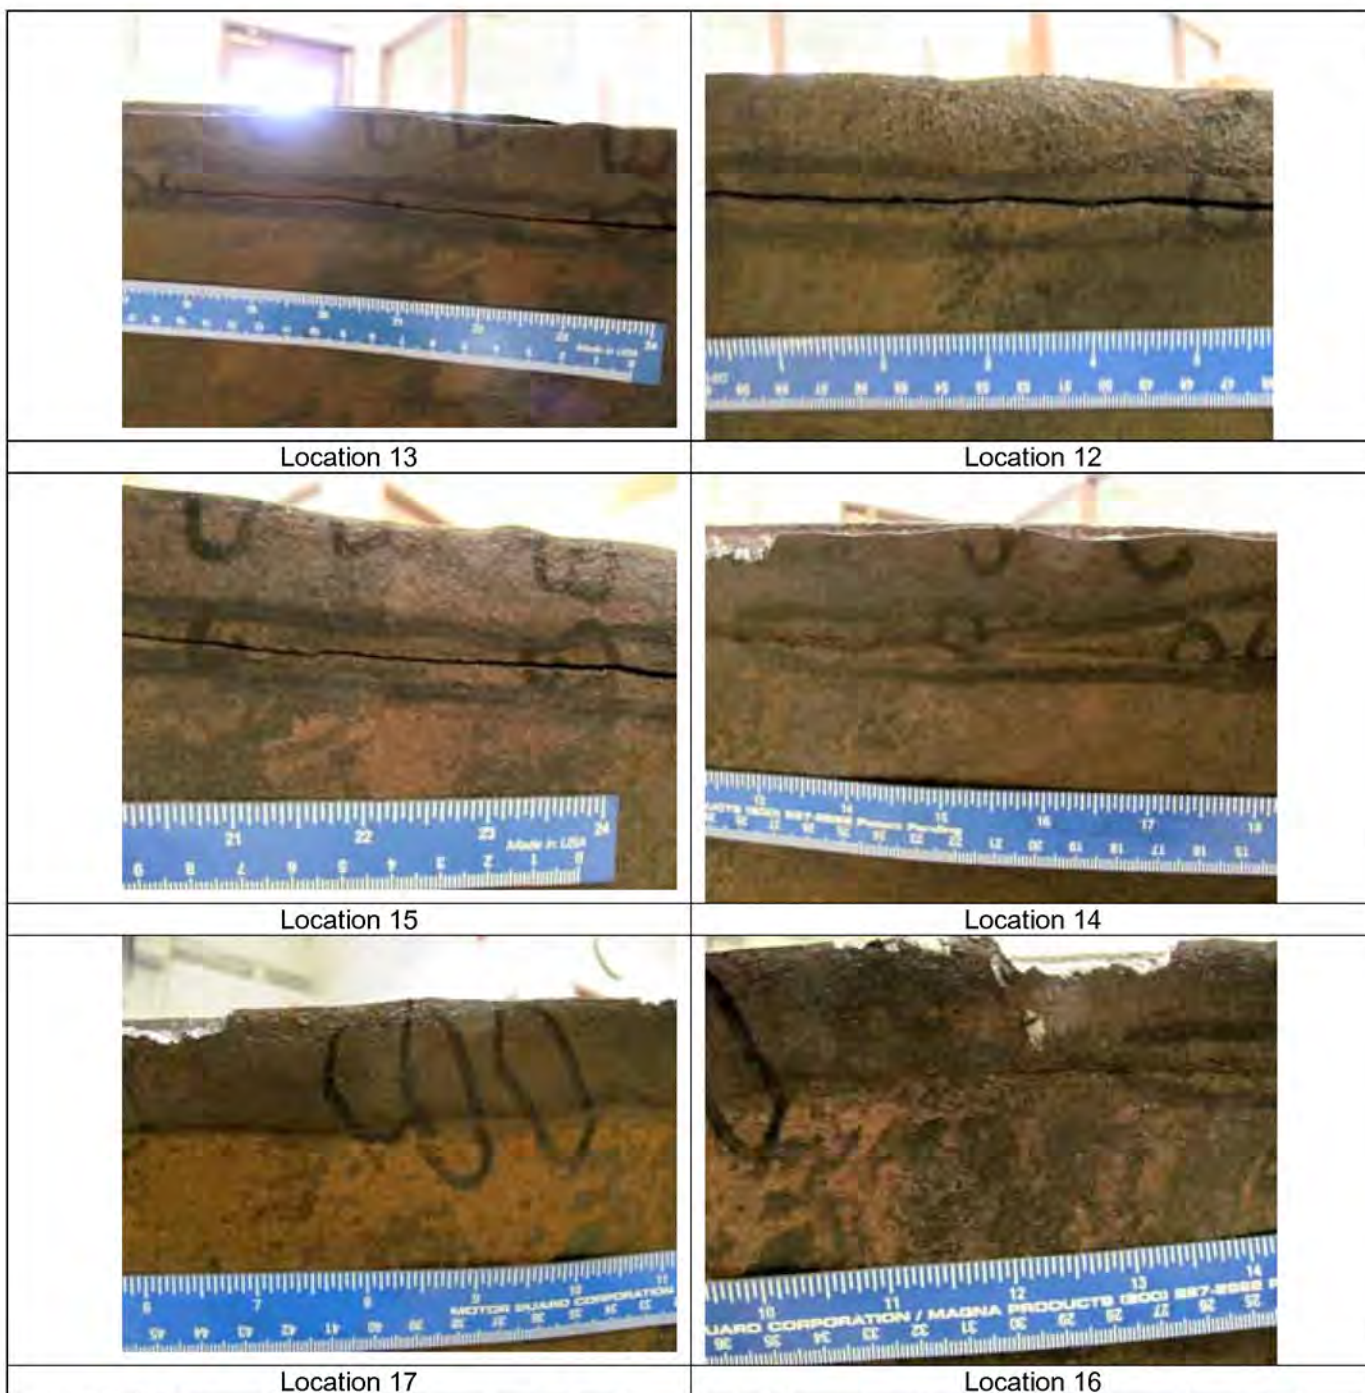
**FIGURE 12 Magnetic Particle inspection indications circled (fracture on top and looking at ID surface)**

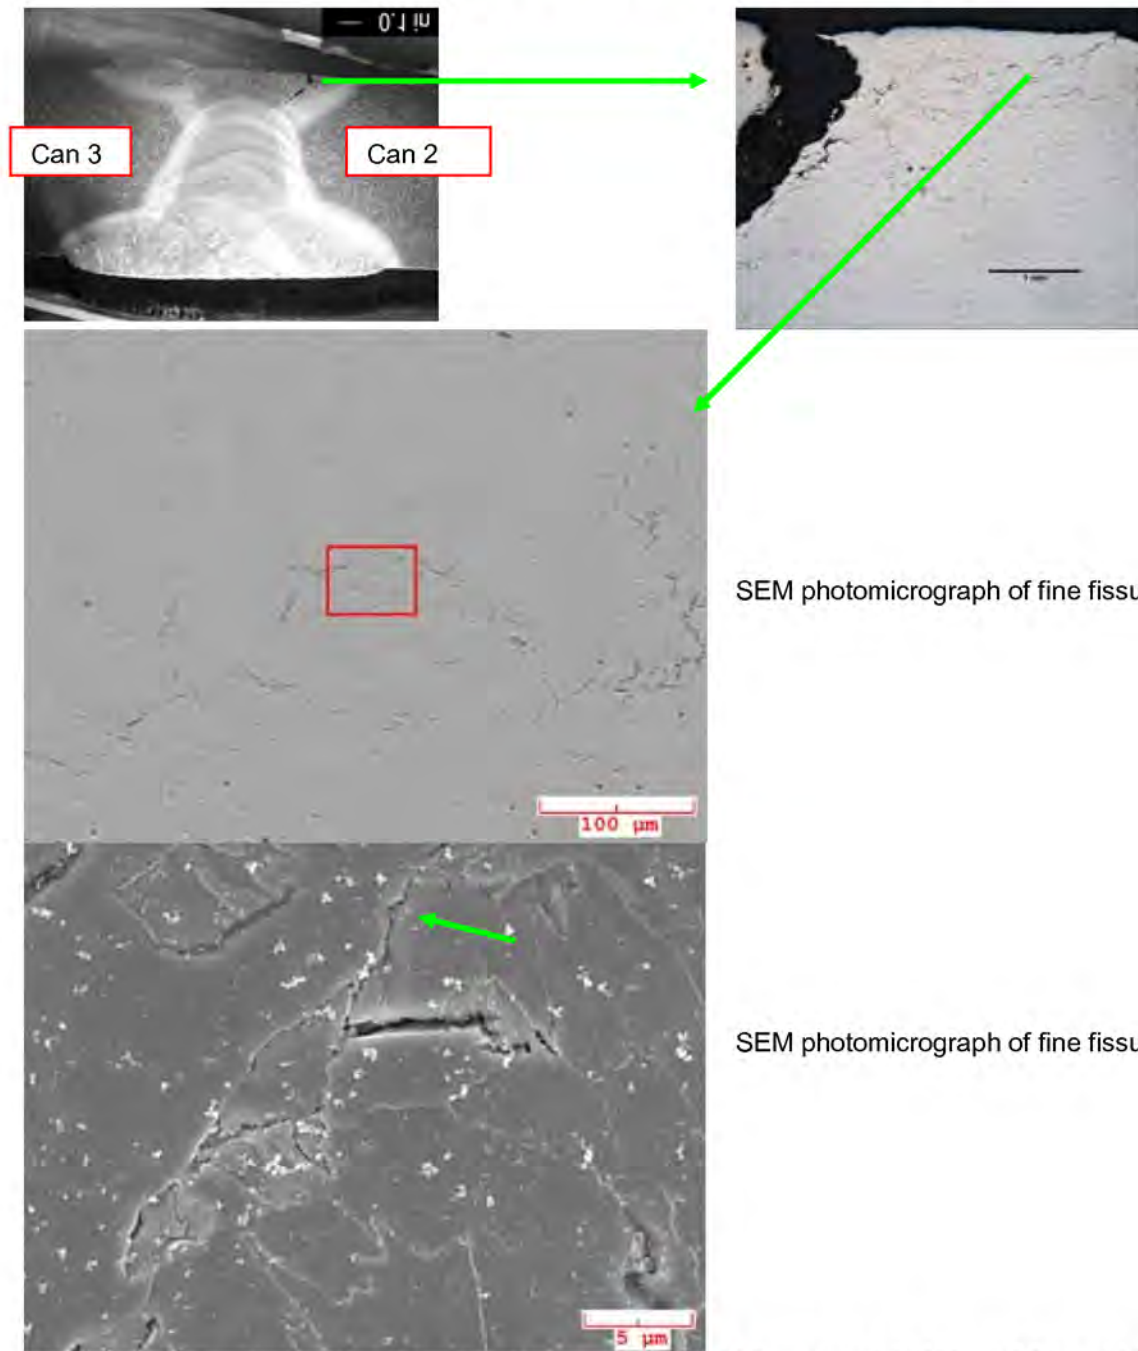
SEM photomicrograph of fine fissures

SEM photomicrograph of fine fissures-

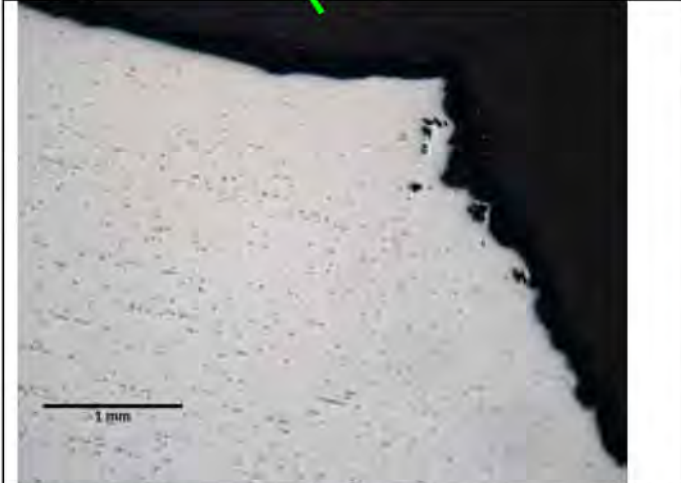
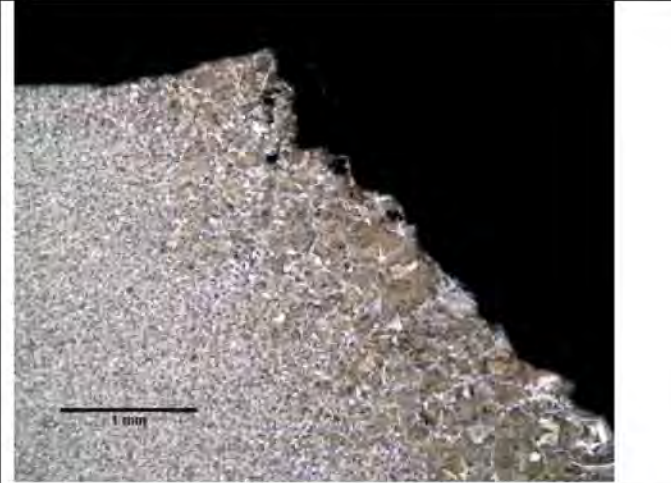
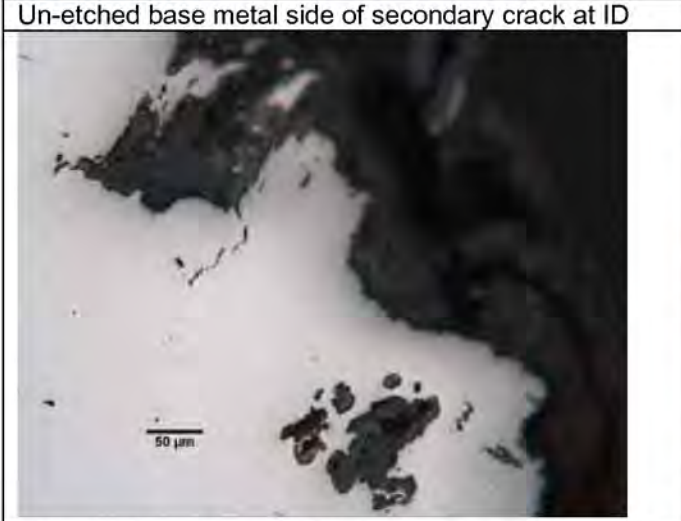
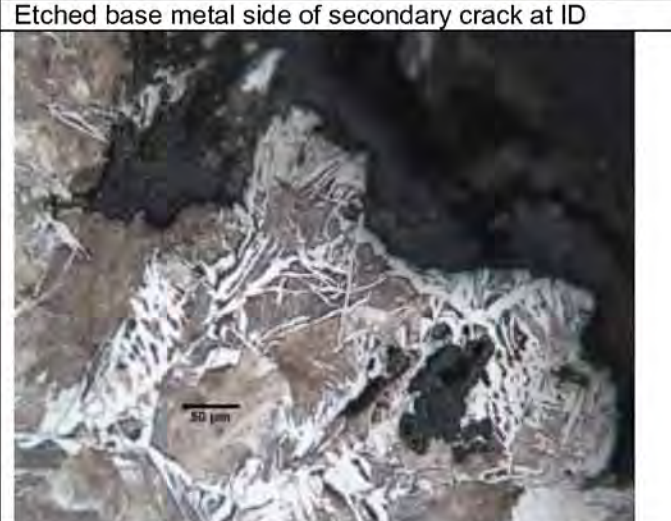
<p><b>FIGURE 28 Secondary crack in M3 on base metal side can 3 on LS3 fracture</b></p>

<p>Un-etched base metal side of secondary crack near ID</p>

<p>Etched base metal side of secondary crack at ID</p>

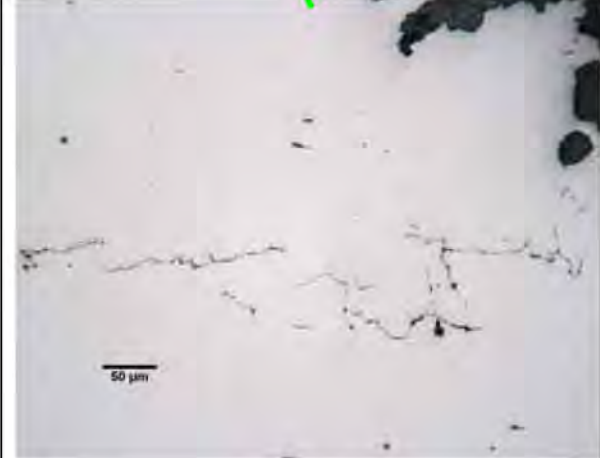
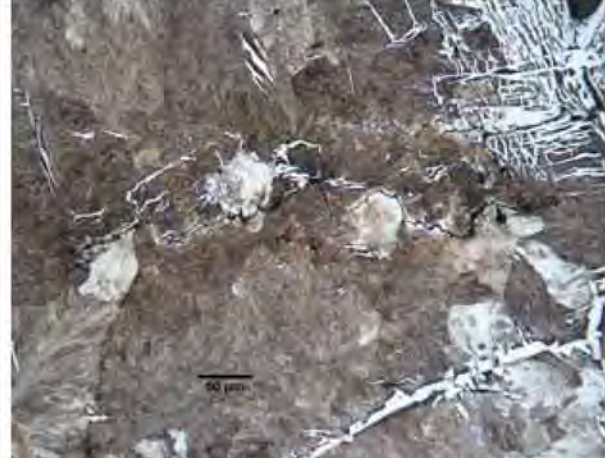
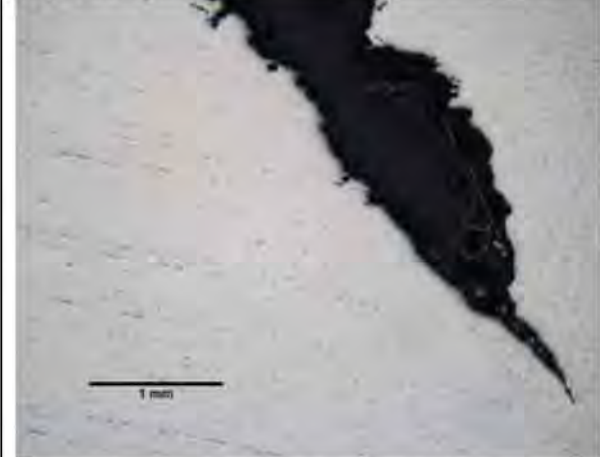
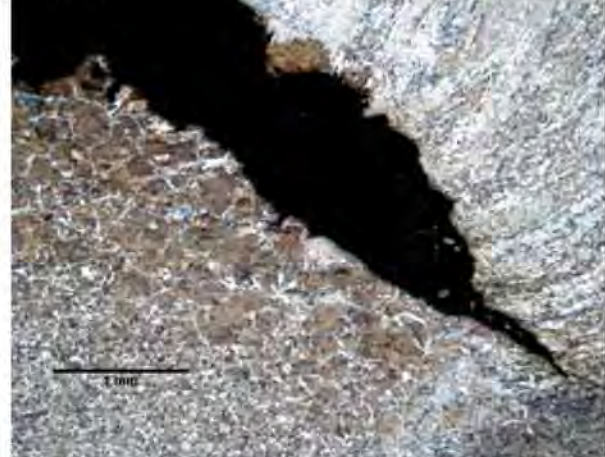
<p>Un-etched base metal side of secondary crack at <math>\frac{3}{4}</math> depth of crack</p>	<p>Etched base metal side of secondary crack at <math>\frac{3}{4}</math> depth of crack</p>

<p>Un-etched base metal side of secondary crack tip</p>	<p>Etched base metal side of secondary crack tip</p>
<p><b>FIGURE 30 Secondary crack in M3 on base metal side can 3 on LS3 fracture</b></p>

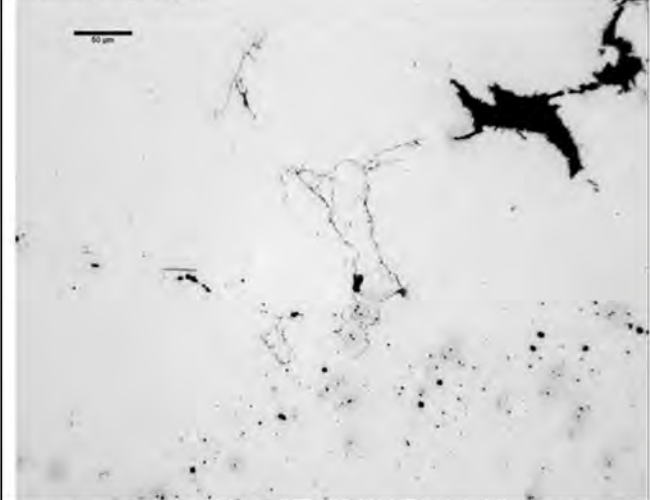
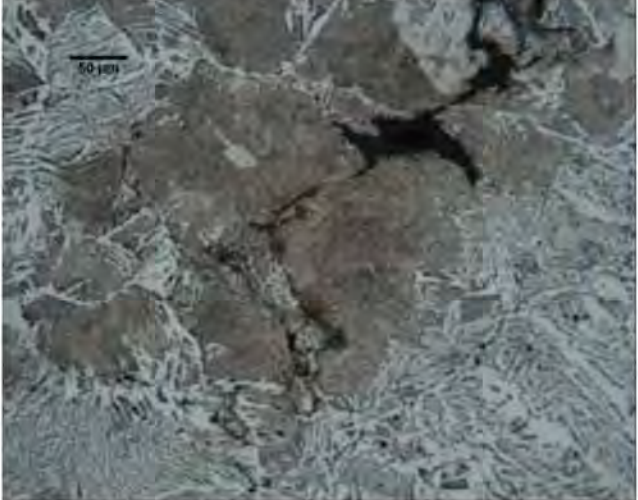
<p>Un-etched cusp</p>	<p>Etched cusp</p>

<p>Detail of Un-etched cusp- brown circles are artifacts</p>	<p>Detail of etched cusp</p>
<p><b>FIGURE 32 Secondary crack in M3 on base metal side can 3 on LS3 fracture</b></p>

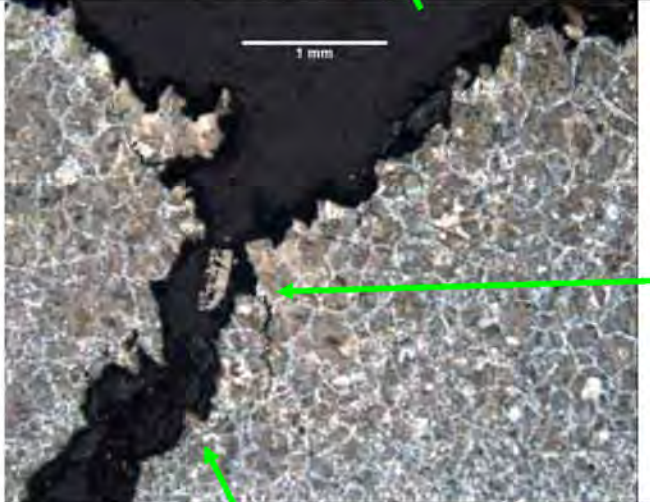
<p>Etched right side</p>	<p>Details of transverse secondary cracks</p>

<p>Details of transverse secondary cracks</p>	<p>Details of transverse secondary cracks</p>	
<p><b>FIGURE 34 ID surface polished for M4, fracture surface at top on LS3 fracture</b></p>

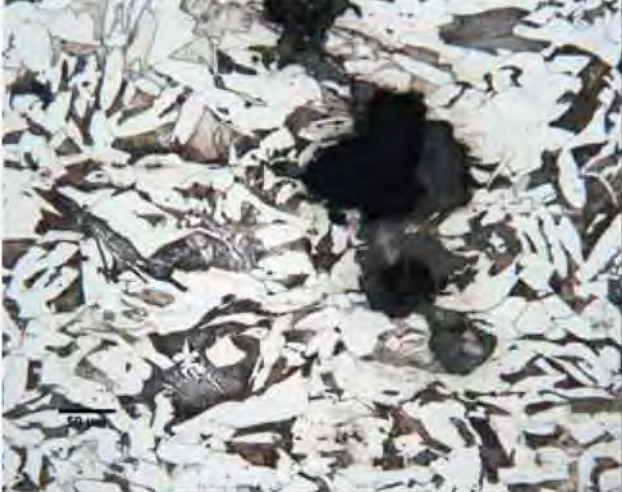
<p>Un-Etched secondary crack tip</p>	<p>Etched secondary crack tip</p>

<p>Detail of Etched secondary crack tip</p>	
<p><b>FIGURE 45 Transverse M6 mount on CS3 weld</b></p>

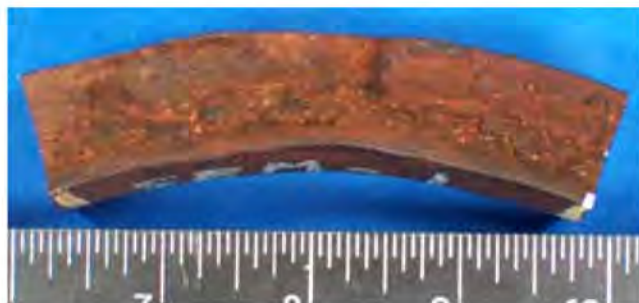
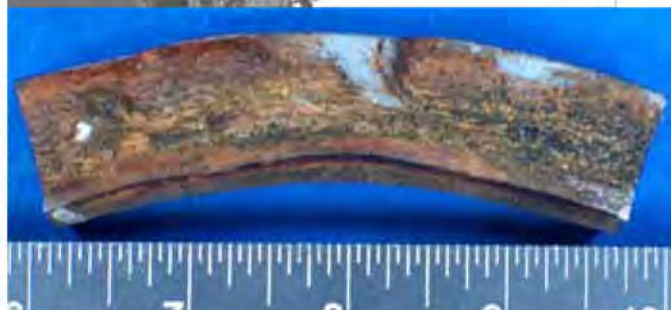
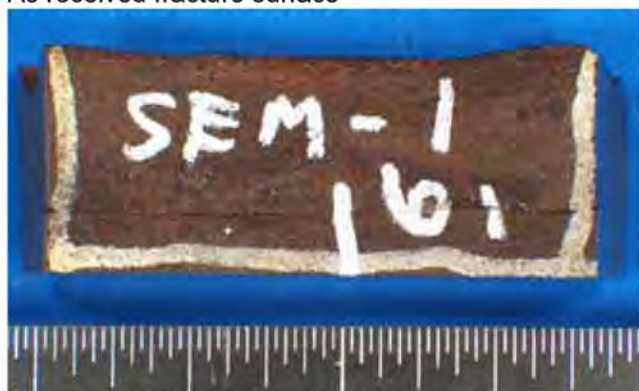
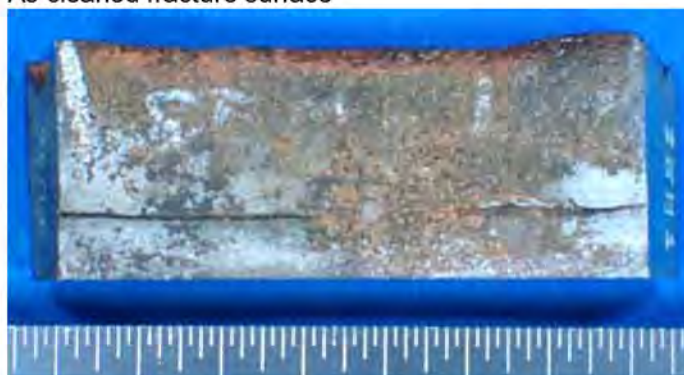
**FIGURE 52 Sample selected for SEM fractography in as received and partial cleaning condition-SEM1**

Four locations were selected for SEM fractography but the fracture surface was very heavily coated with scale/corrosion product, as shown in Figure 52-55. The fracture surfaces of 14-SEM1, SEM2 and SEM3 were cleaned with the following procedure and the as cleaned surfaces are shown in Figures 52-55.

As received fracture surface

As cleaned fracture surface
