BETA LAB NO.M10198- MECHANICAL PROPERTY TESTING	TESORO REFINING AND MARKETING COMPANY ANACORTES REFINERY 10200 W. MARCH POINT ROAD T91WA4428 ANACORTES, WA 98221	CUSTOMER P.O. NO.: 4501667904
PART: 6600-E HEAT EXCHANGER 17 (LS1- CS2), 16-1 & 2 (LS2- CS3) AND 19 (CS4)		DATE: AUGUST 27, 2010
PAGE 1 OF 54

LABORATORY REPORT- MECHANICAL PROPERTY TESTING

SAMPLE DESCRIPTION: A heat exchanger failed and a test protocol was developed for the failure analysis of the component. This test protocol and its addendum, as of this date and contained in Attachment 1, were developed and signed by Tesoro Companies, Division of Occupational Safety and Health and U.S. Chemical Safety Board. FirstEnergy BETA Laboratory was selected as the referee test laboratory to perform the testing requirements of test protocol. The test protocol was not specific as to the test samples to be removed from the heat exchanger or the test locations/test parameters for each specific test within the test sample. Therefore it was agreed

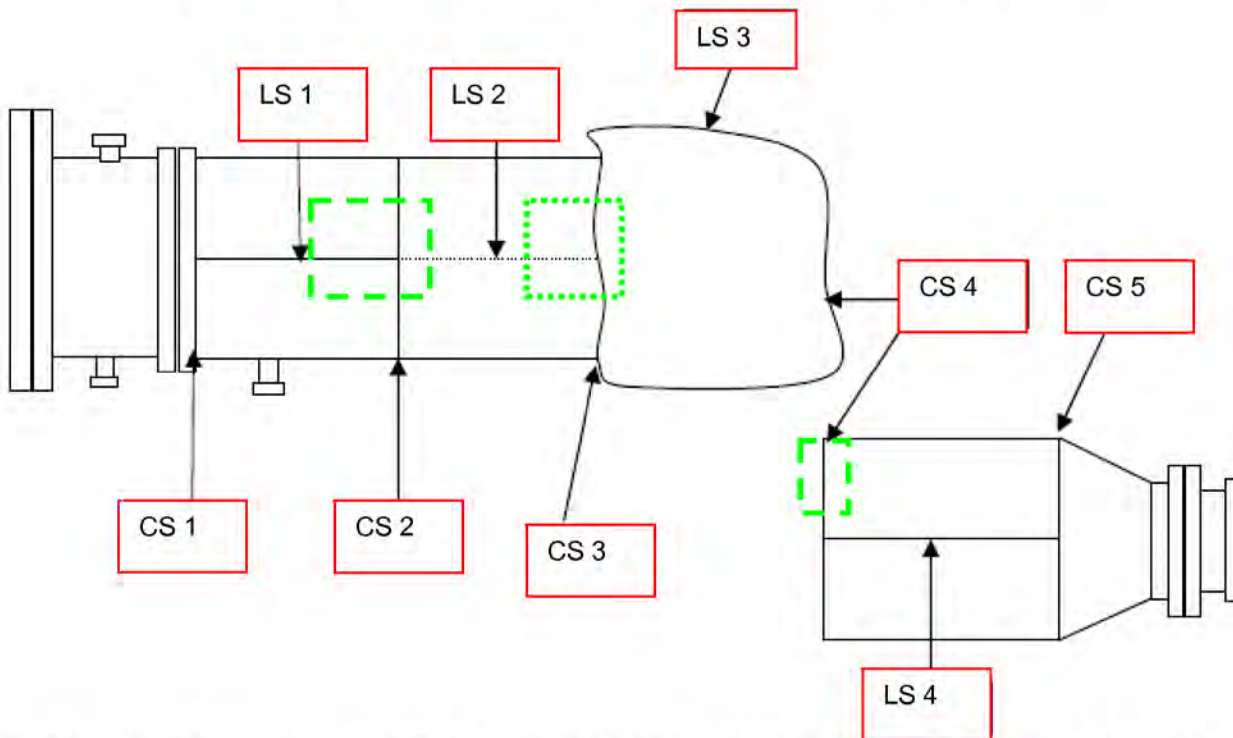
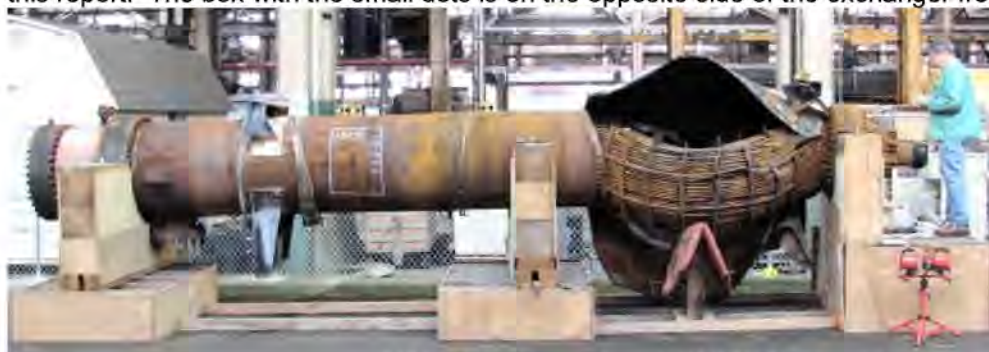
FIGURE 1 Un-packaged 6600E heat exchanger

Sketch of main heat exchanger Cans 1-3 and separated back head Can 4- green dotted line are the items for this report. The box with the small dots is on the opposite side of the exchanger from the of the leak

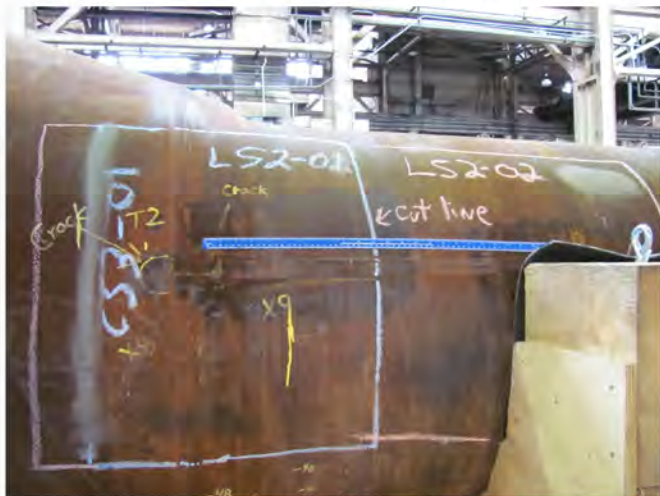
Marking on shell- note tee at T2 location

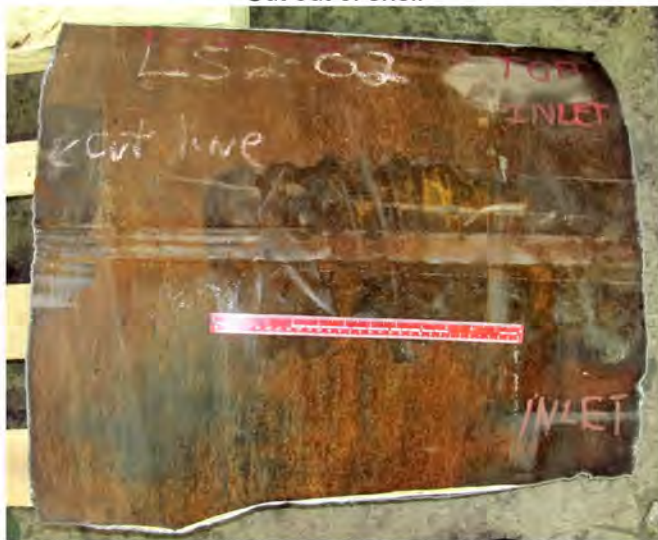
Part 16-2 cut out ready for shipment-curved edge is due to location where wood cribbing was located

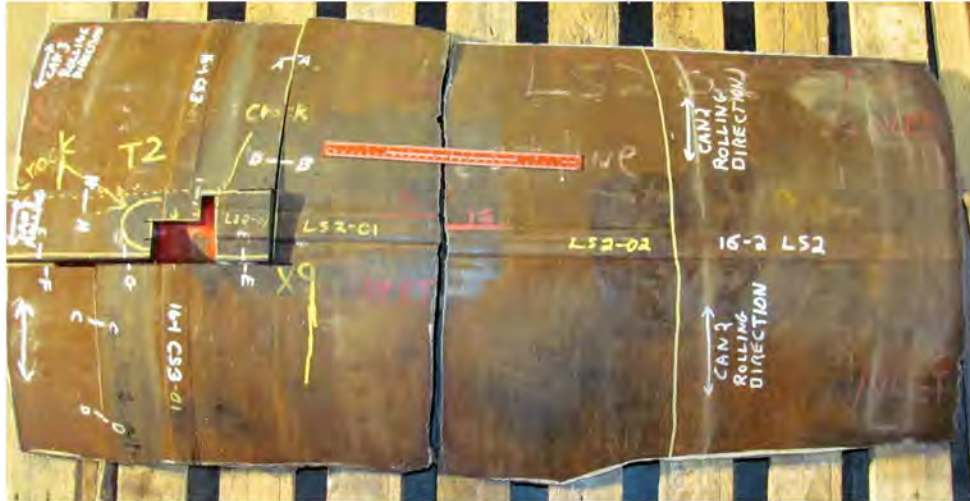
Arrows denote the determined rolling direction for each can- the missing areas are where T2, T2C, T-2L mounts were taken and reported on in a previous report
