BETA LAB NO.M10198- RECEIPT INSPECTION	TESORO REFINING AND MARKETING COMPANY ANACORTES REFINERY 10200 W. MARCH POINT ROAD T91WA4428 ANACORTES, WA 98221	CUSTOMER P.O. NO.: 4501667904
PART: 6600-E HEAT EXCHANGER INITIAL RECEIPT		DATE: JULY 29, 2010
PAGE 1 OF 8

RECEIPT INSPECTION REPORT

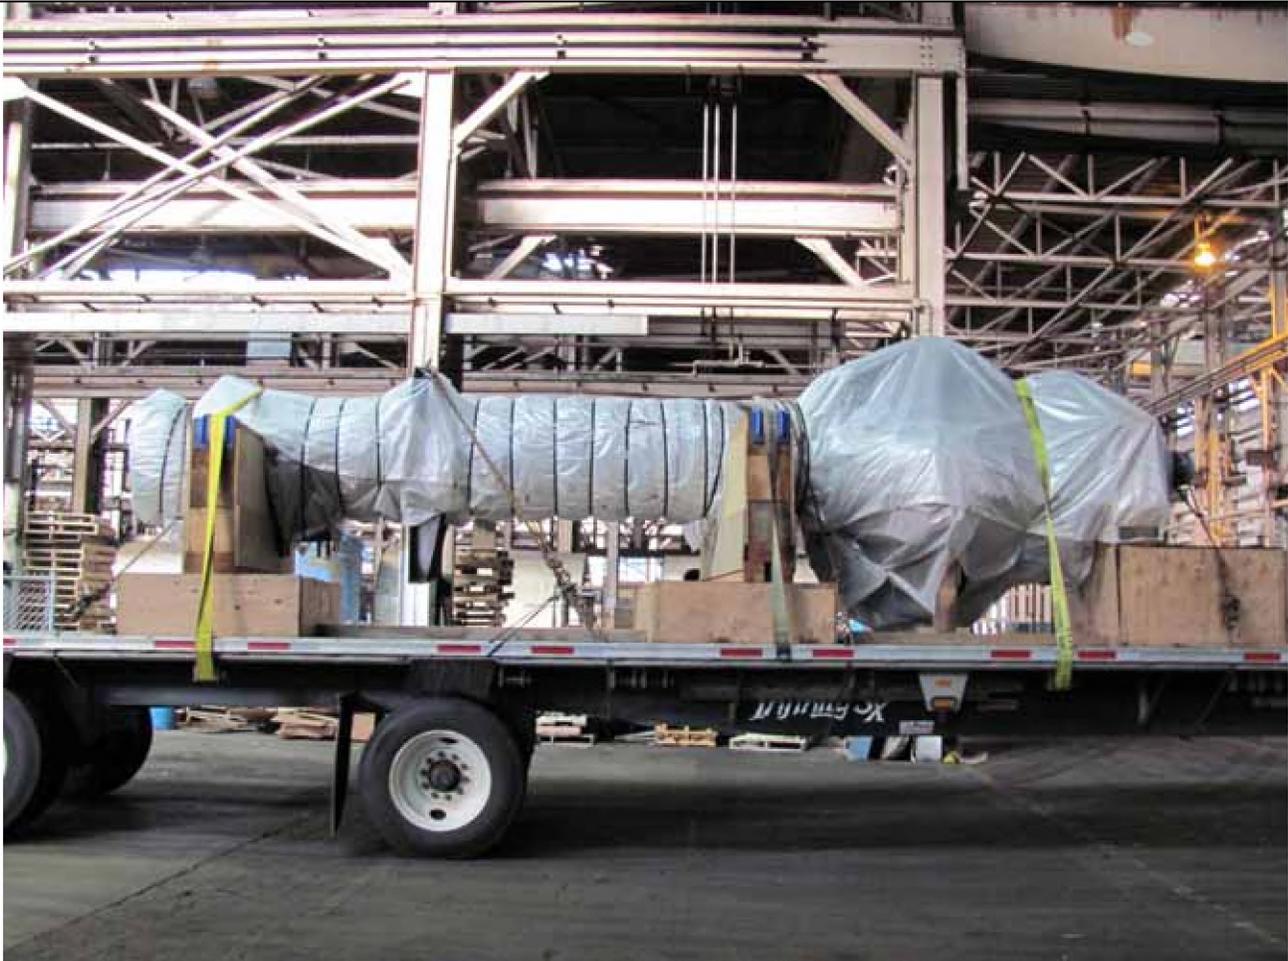
FIGURE 1 As received parts on the truck

Figure 1 shows the two parts on the truck. Each part was wrapped in a plastic type material and bound to the truck body. The main heat exchanger had three wood cradle supports and a wood leg for the bundle support. The back head was positioned on wood rails. Figures 2 and 3 shows the general condition of the wrap and attachment materials. Figure 4 details some areas where the wrap did not totally cover the heat exchanger parts.

6600-E Exchanger Damaged shell and bundle Tag # ABSC- R070

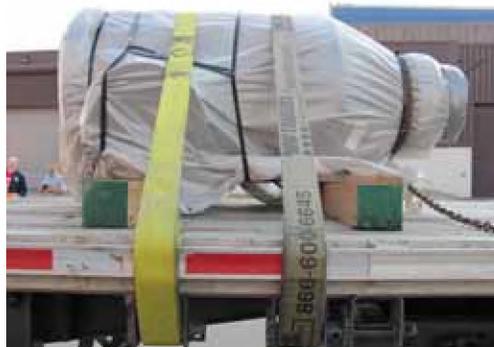
6600-E Back head Damaged back head Tag # ABSC-R073

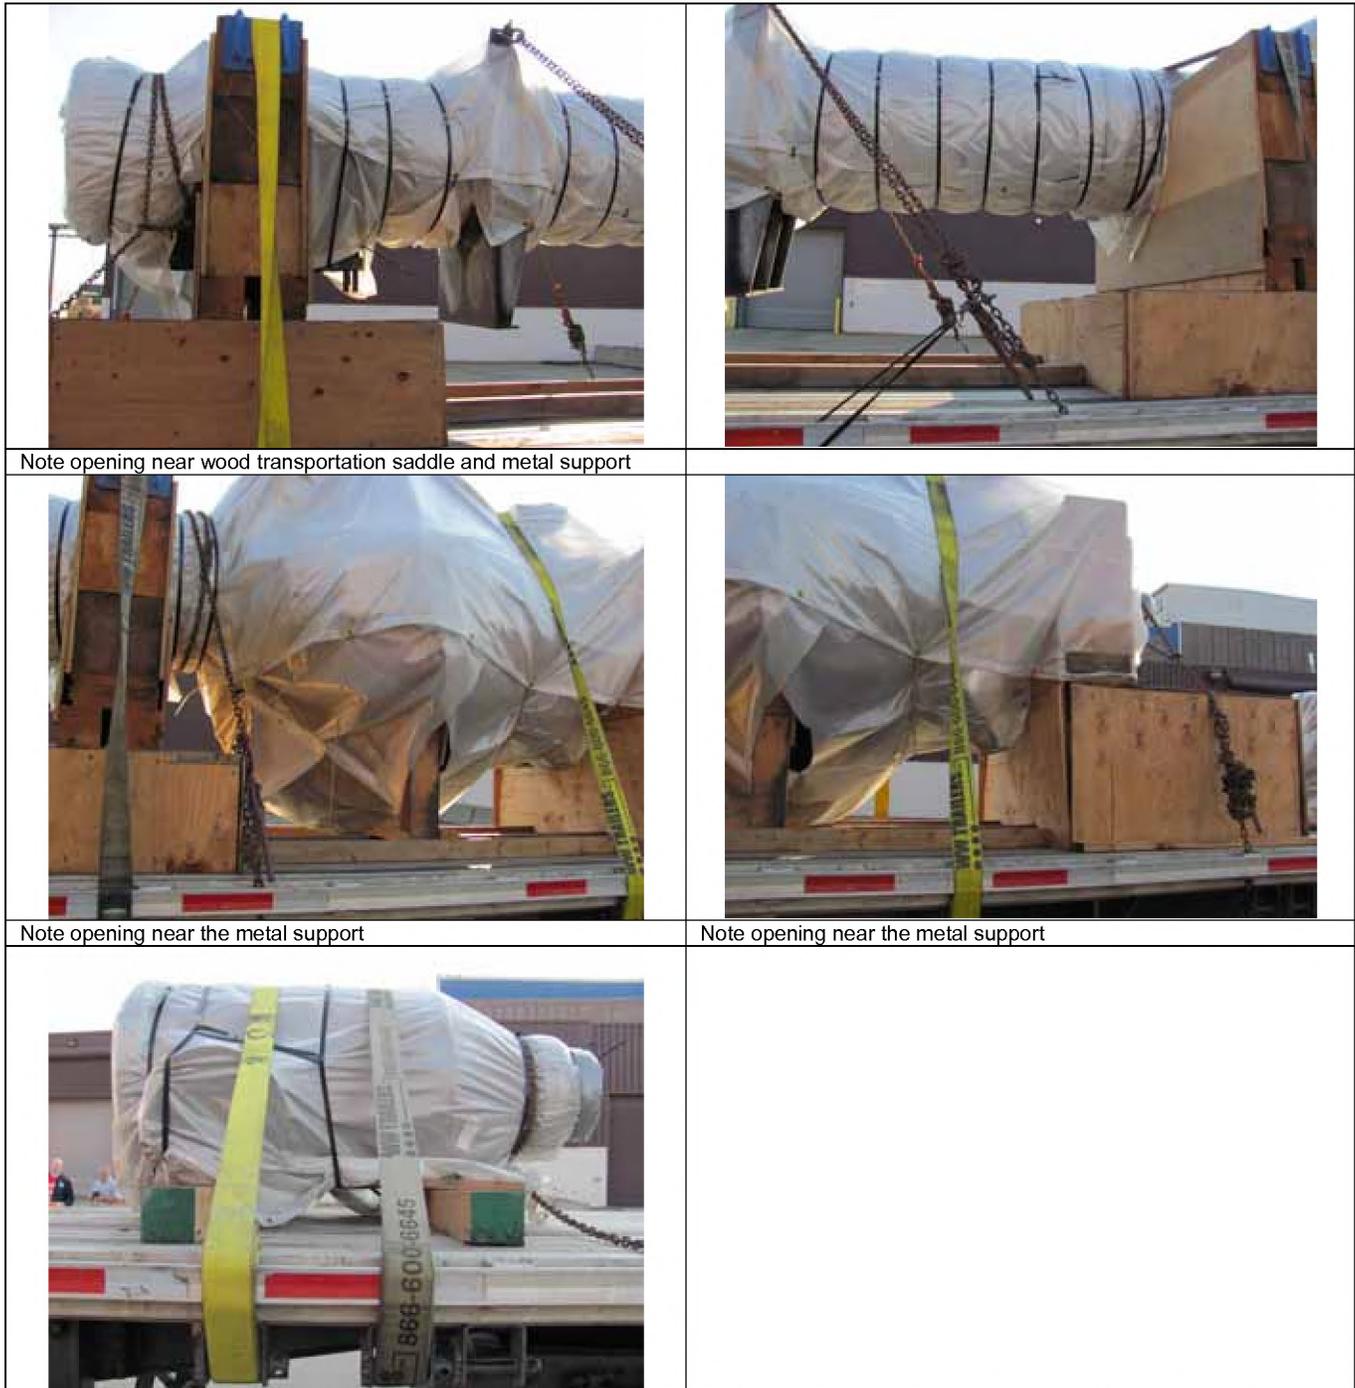
FIGURE 2 As received details of drivers side of truck, front to back is top to bottom respectively

Note opening near wood transportation saddle and metal support

Note opening near the metal support

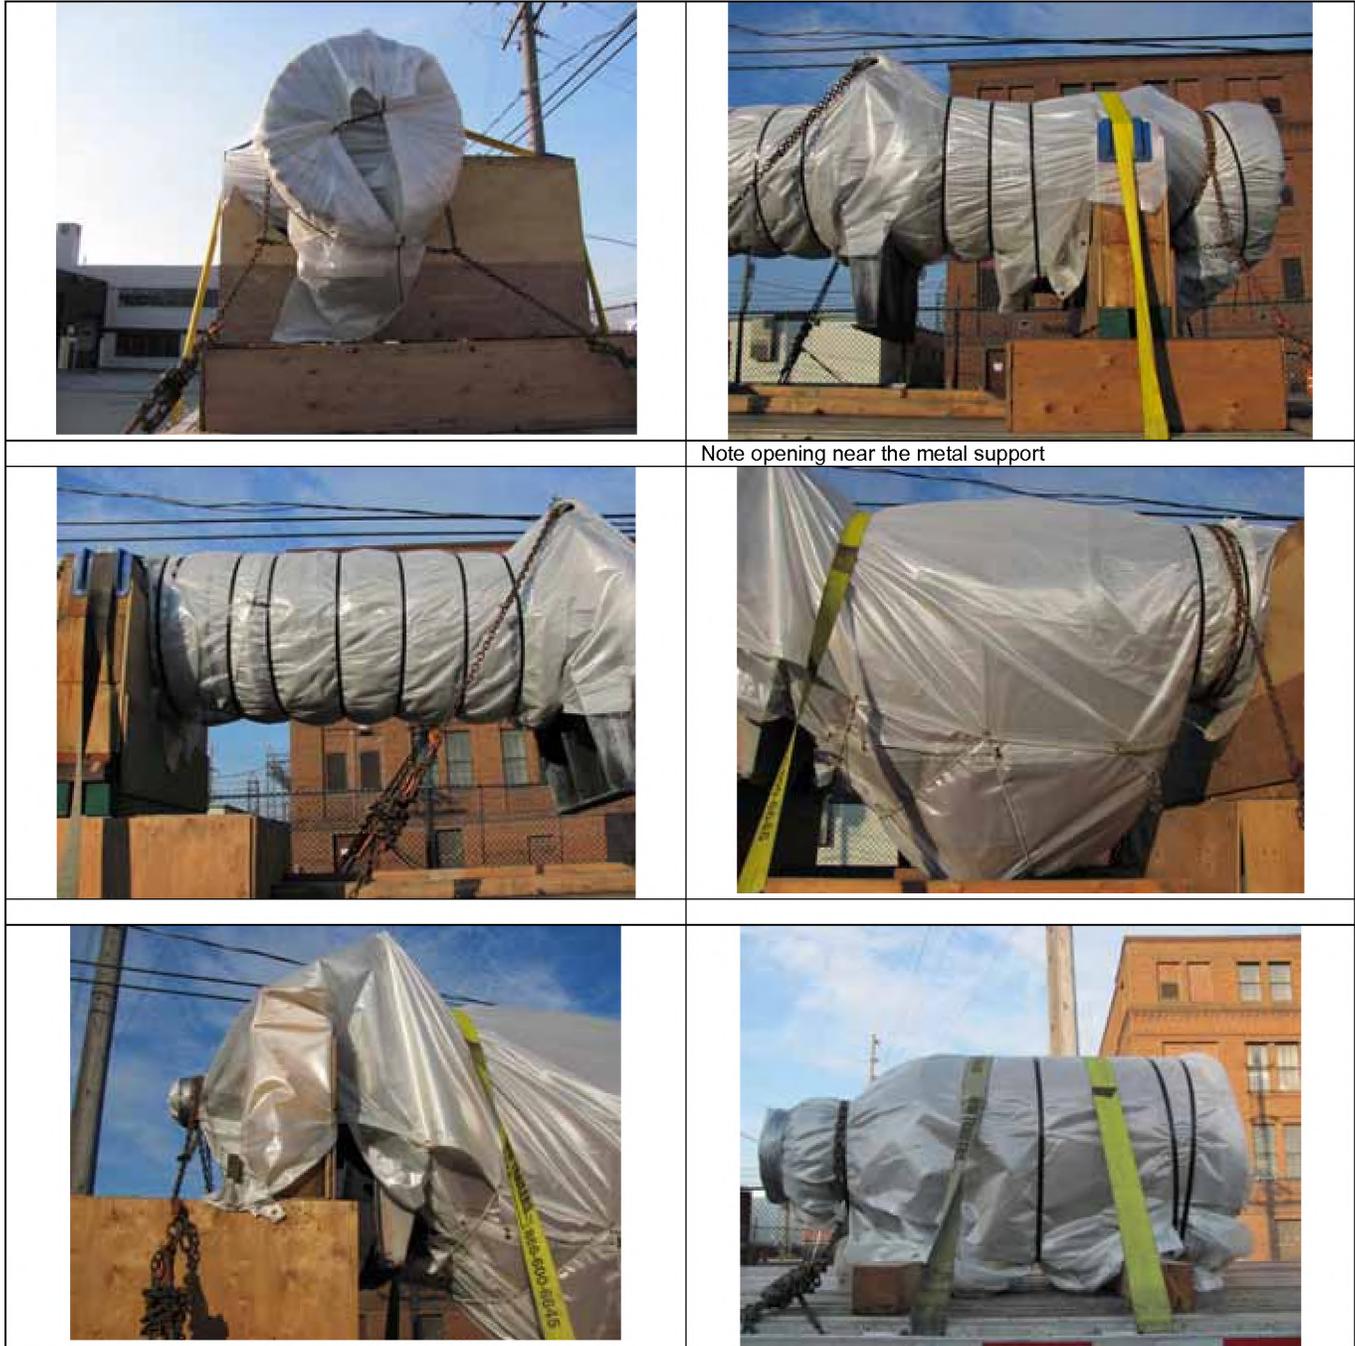
FIGURE 3 As received details of front and passengers side of truck, front to back, top to bottom respectively

Note opening near the metal support

Note opening near wood transportation saddle and metal support

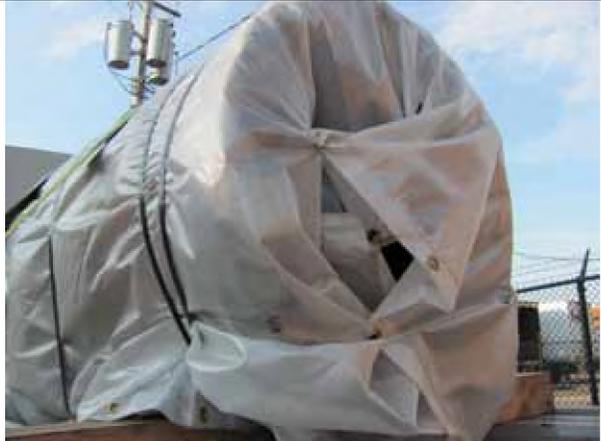
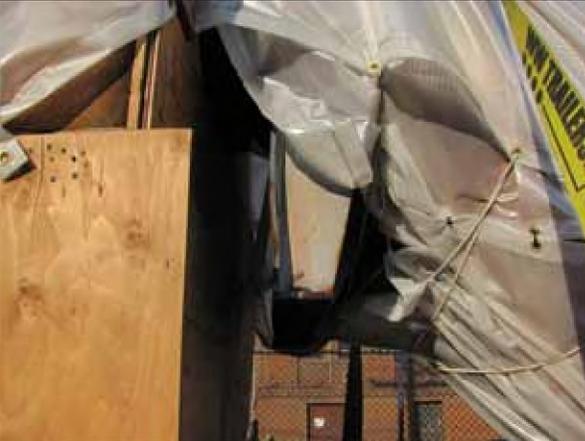
FIGURE 4 As received details of specific areas

Note opening at the end of the back head	Note opening near wood transportation saddle and metal support

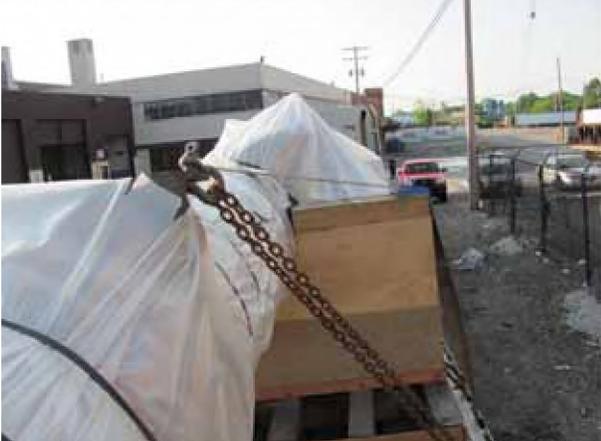
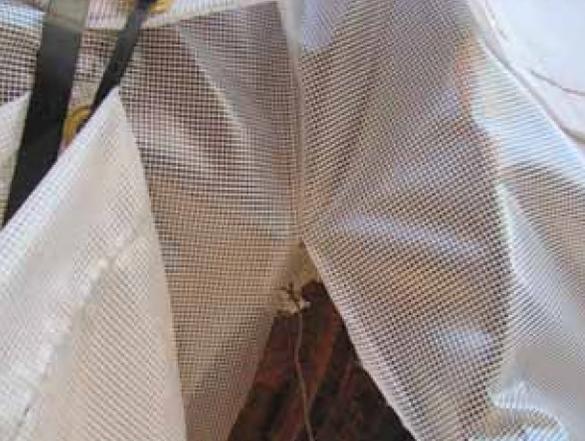
Note opening near anchor bracket	Note opening

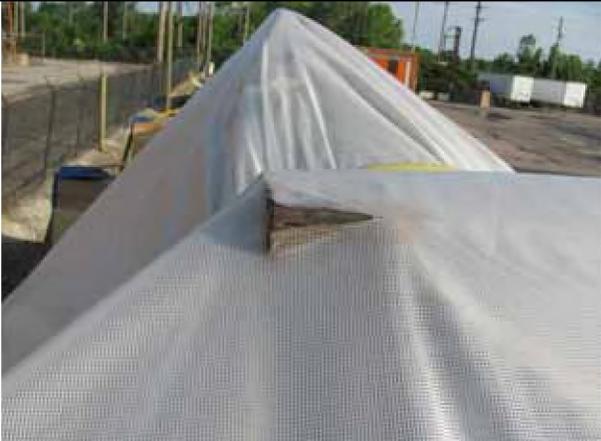
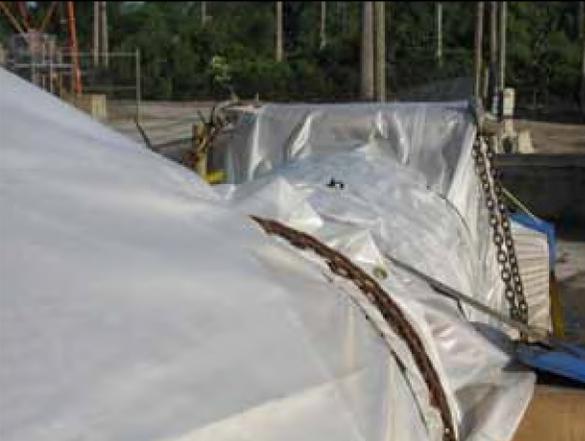
Note tear at top corner

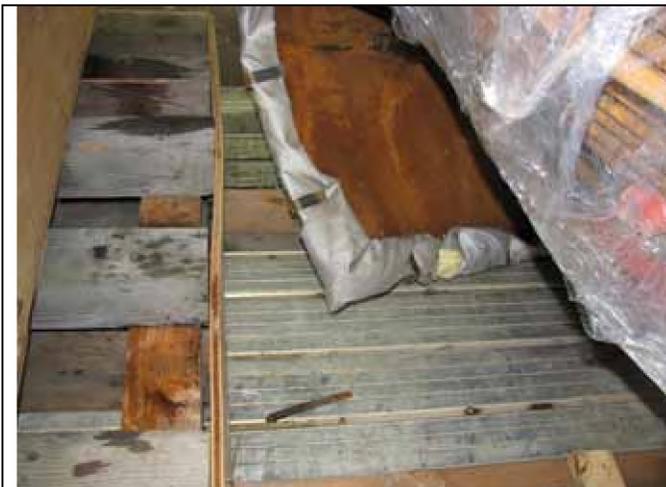
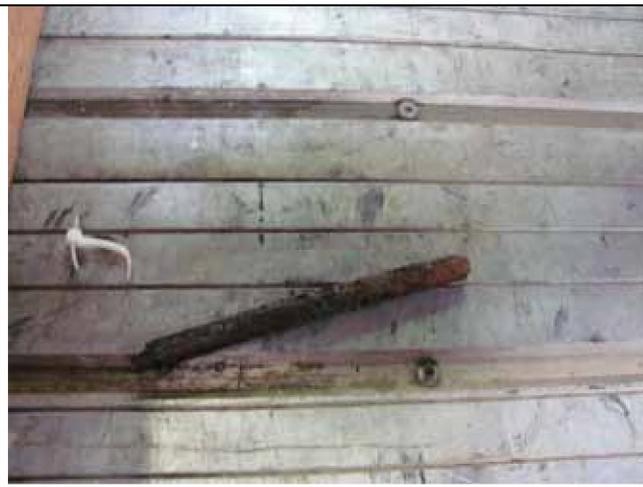
FIGURE 7 materials found on truck bed after lifting the components off the truck all were bagged for evidence

Inspection of the truck bed after the lift disclosed some debris which is shown in Figure 7. The materials were bagged and logged into evidence for potential examination.

Rod found under bundle on truck bed

Details of rod on truck bed

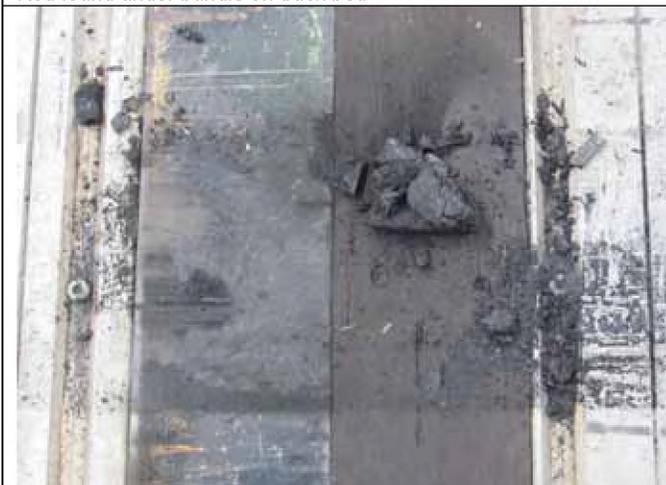
Debris on truck bed at about 130 inch from front of truck

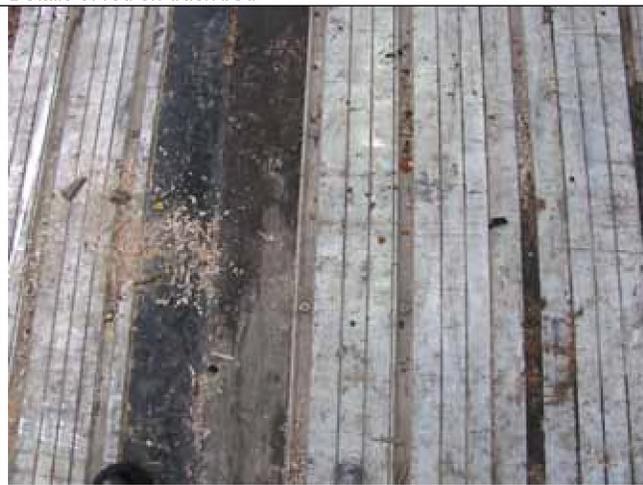
Debris on truck bed at about 147 inch from front of truck
