BETA LAB NO.M10198- LS2-CS3 TEE INDICATIONS	TESORO REFINING AND MARKETING COMPANY ANACORTES REFINERY 10200 W. MARCH POINT ROAD T91WA4428 ANACORTES, WA 98221	CUSTOMER P.O. NO.: 4501667904
PART: 6600-E HEAT EXCHANGER LS2-CS3 TEE INDICATIONS PART 16-1		DATE: AUGUST 13, 2010
PAGE 23 OF 45

LABORATORY REPORT- LS2-CS3 TEE INDICATIONS FINDINGS

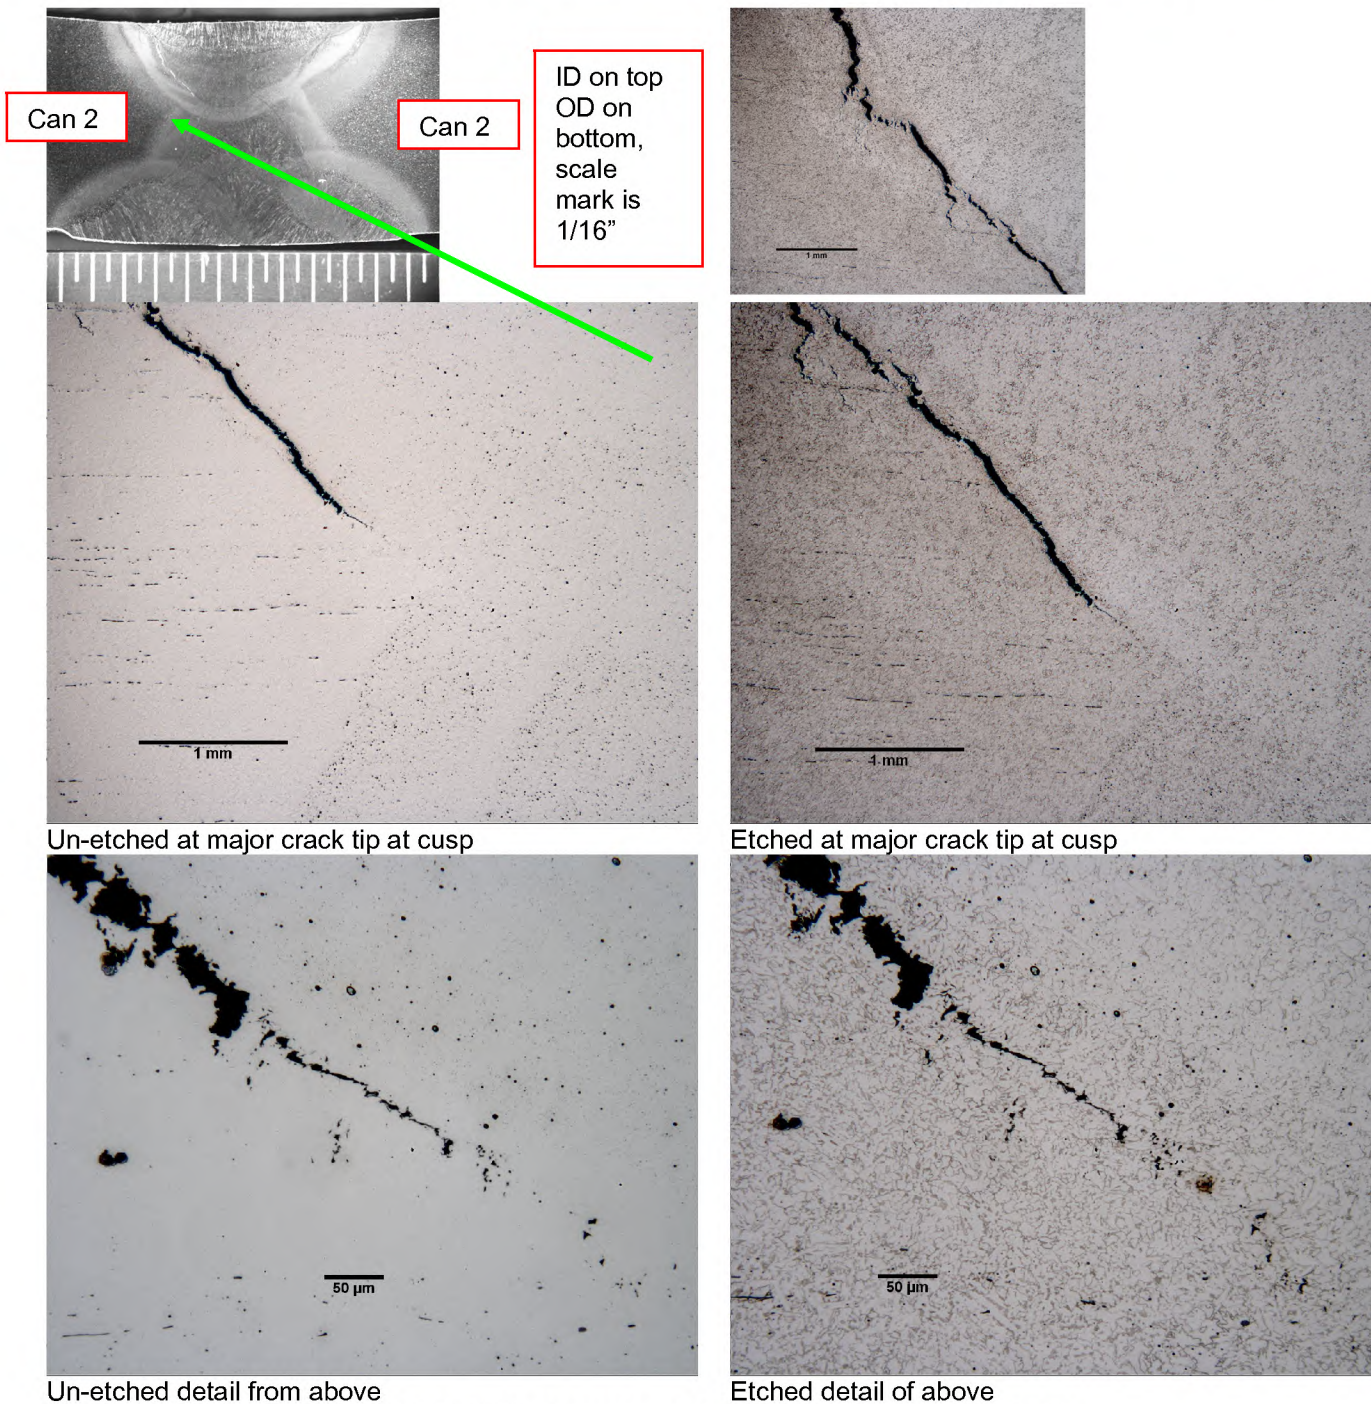
FIGURE 17 Photomicrographs of Mount T2L at ID left side

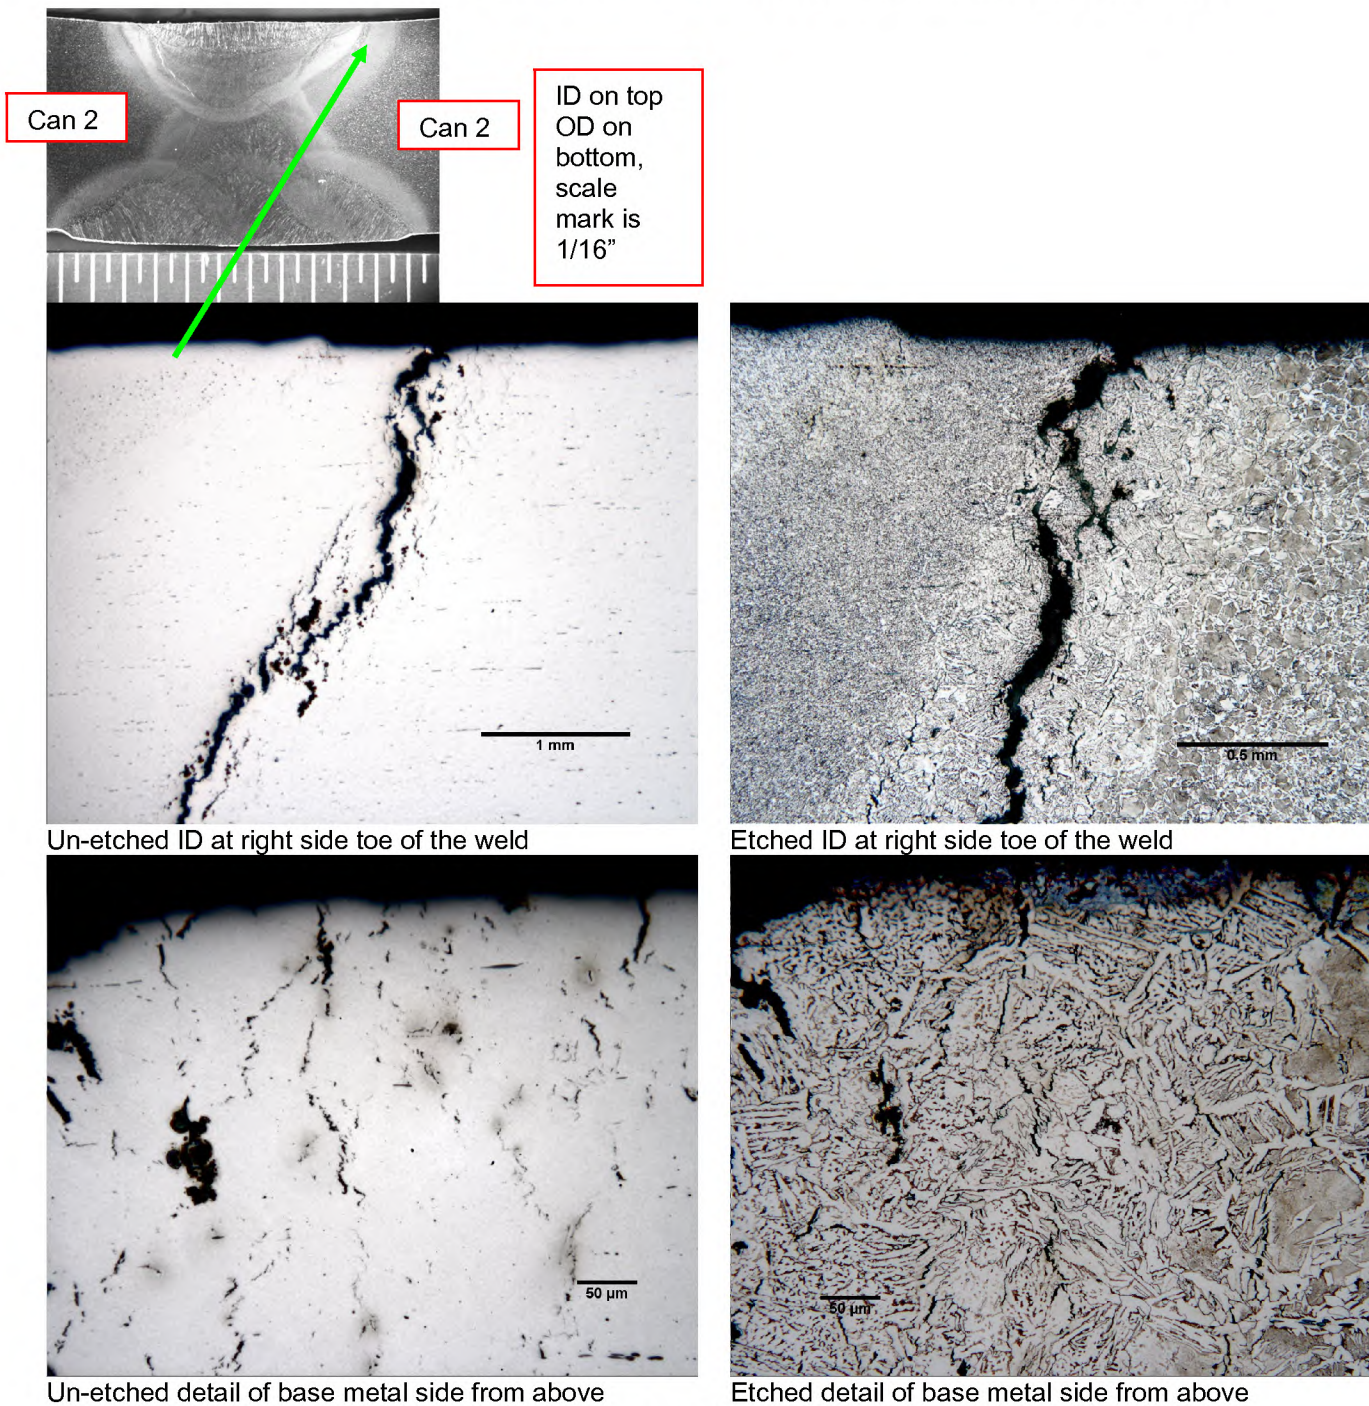
FIGURE 18 Photomicrographs of Mount T2L at right side

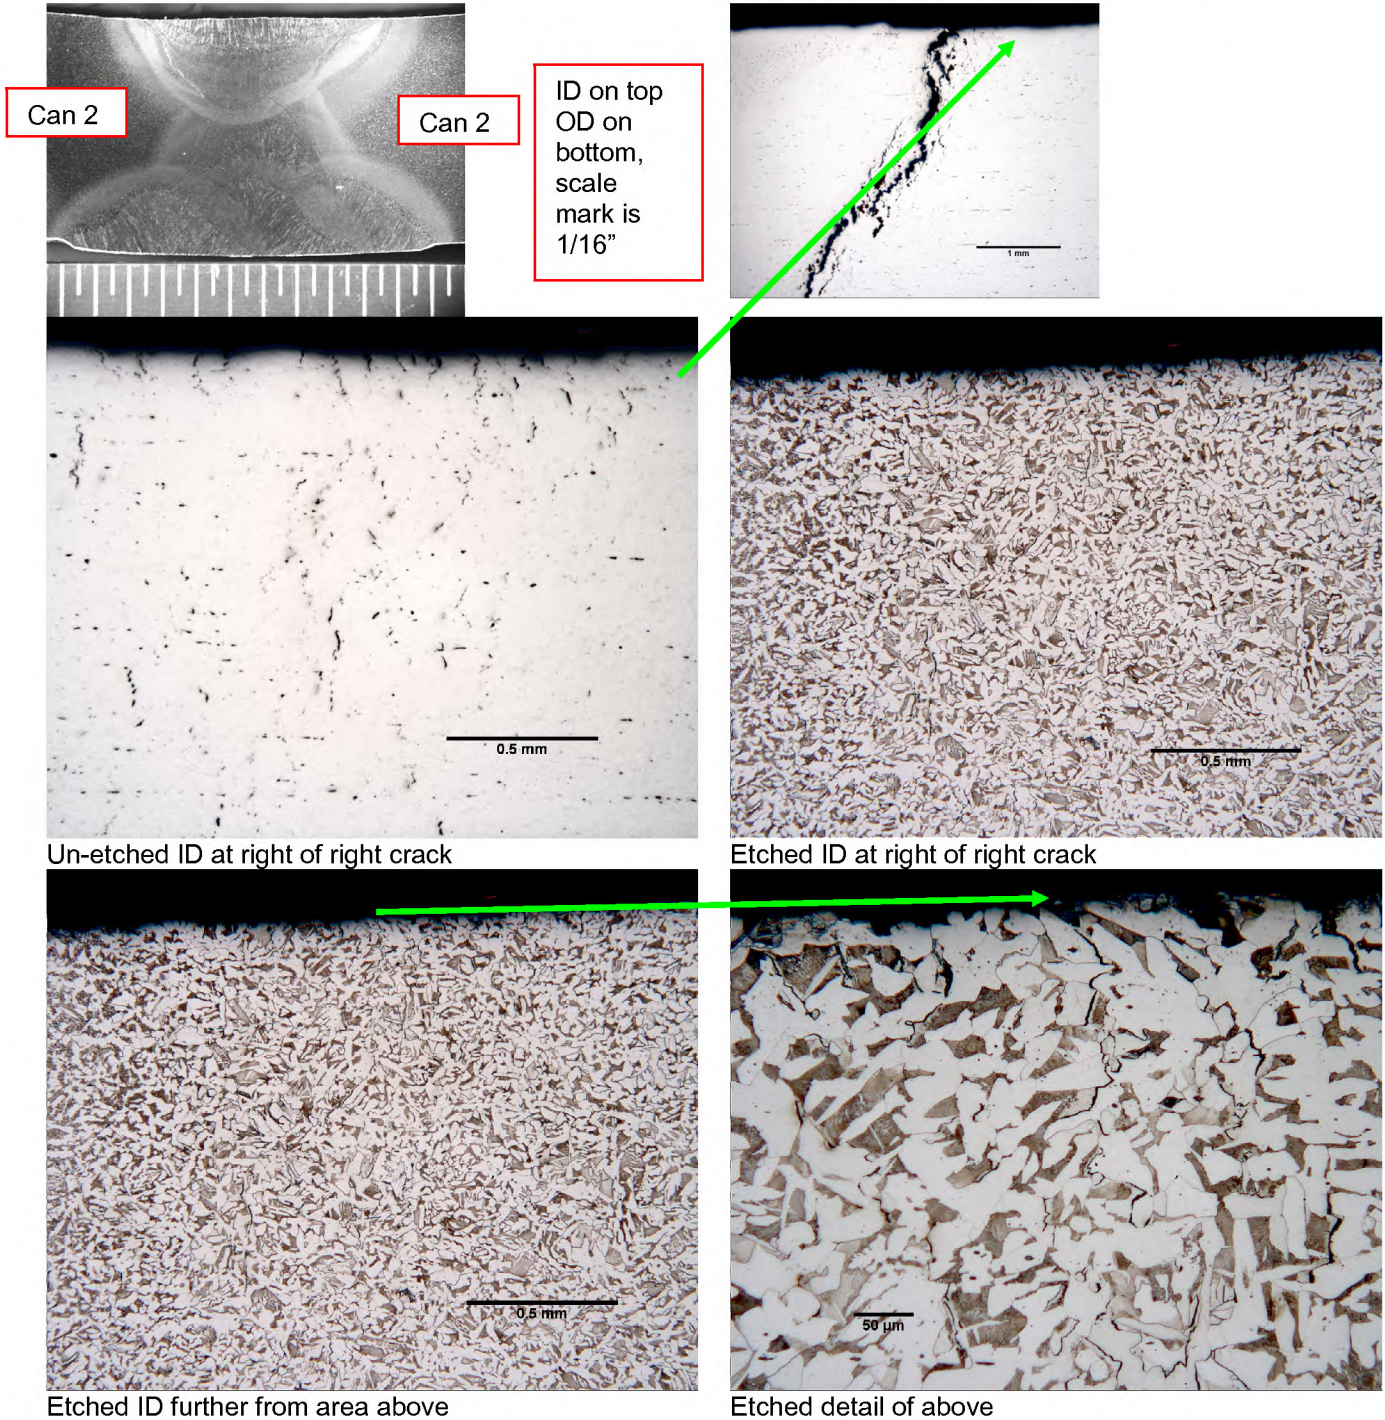
Un-etched ID at right of right crack

Etched ID at right of right crack

Etched ID further from area above

Etched detail of above

FIGURE 19 Photomicrographs of Mount T2L at right side Base Metal side of crack

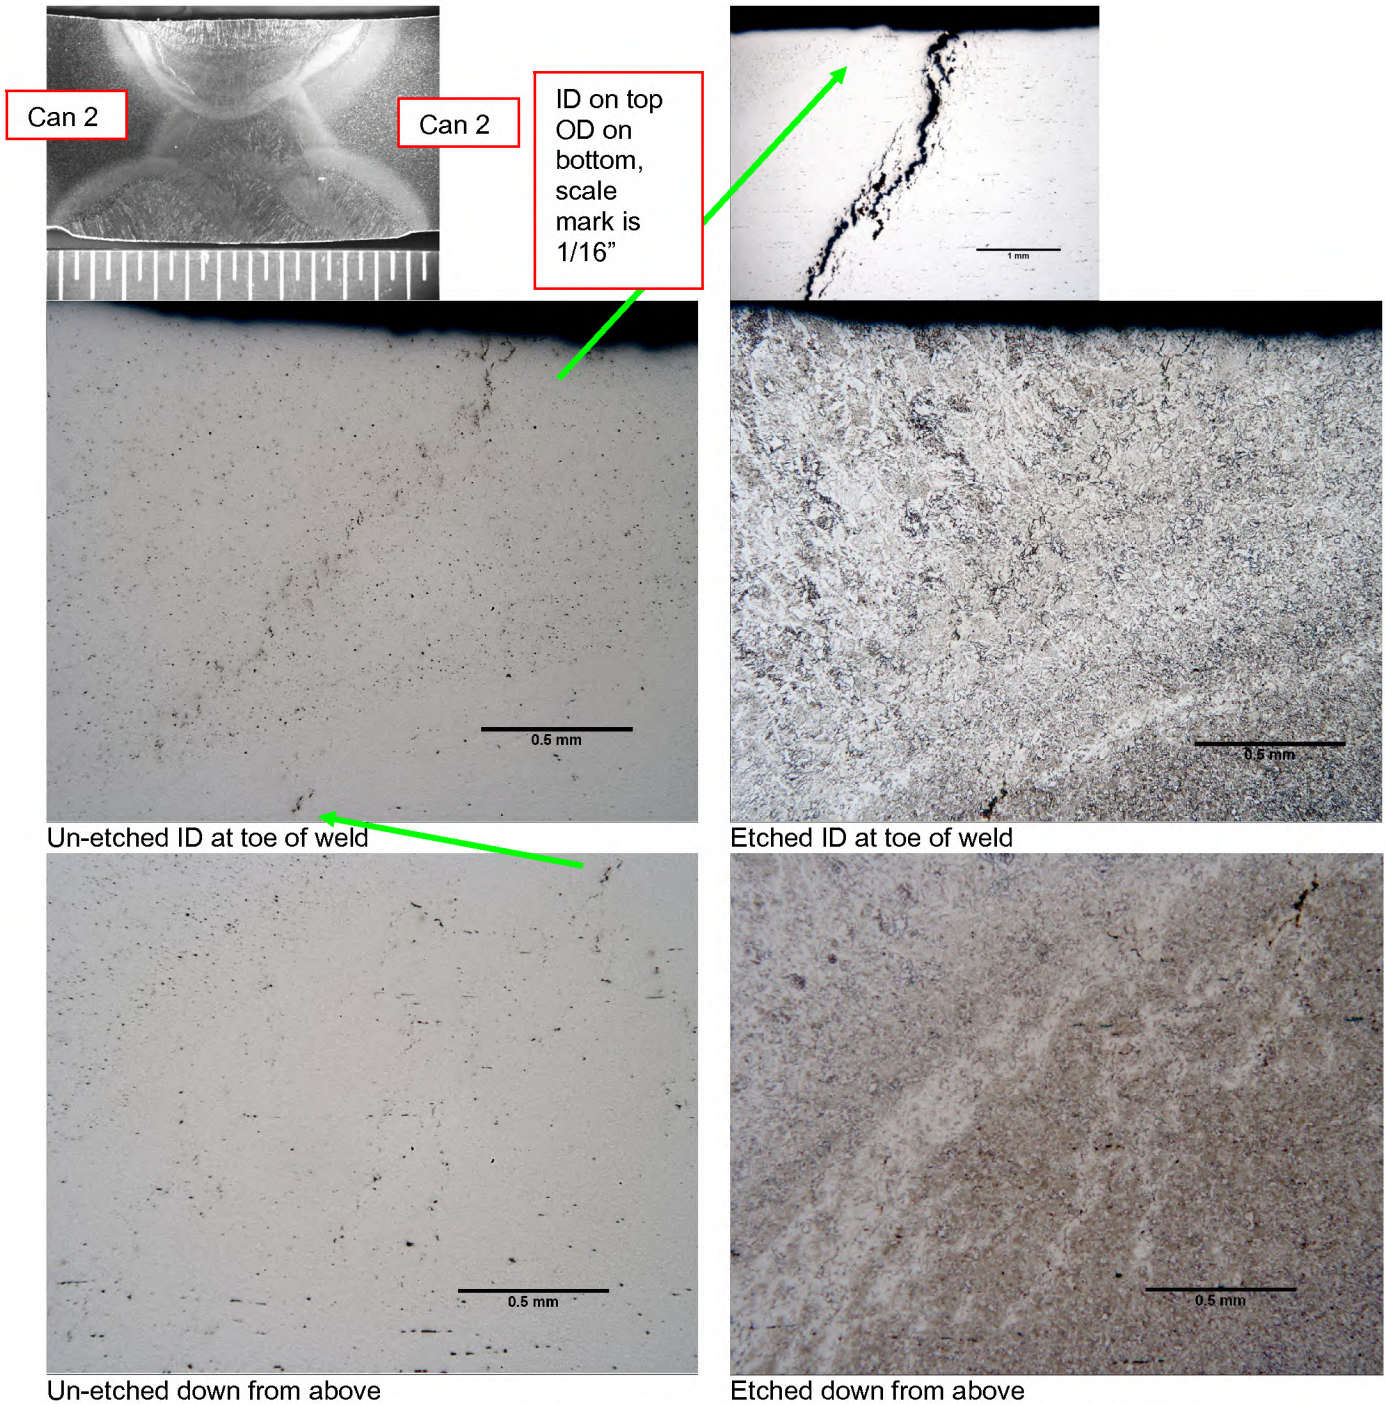
FIGURE 21 Photomicrographs of Mount T2L at right side Weld Metal side of crack

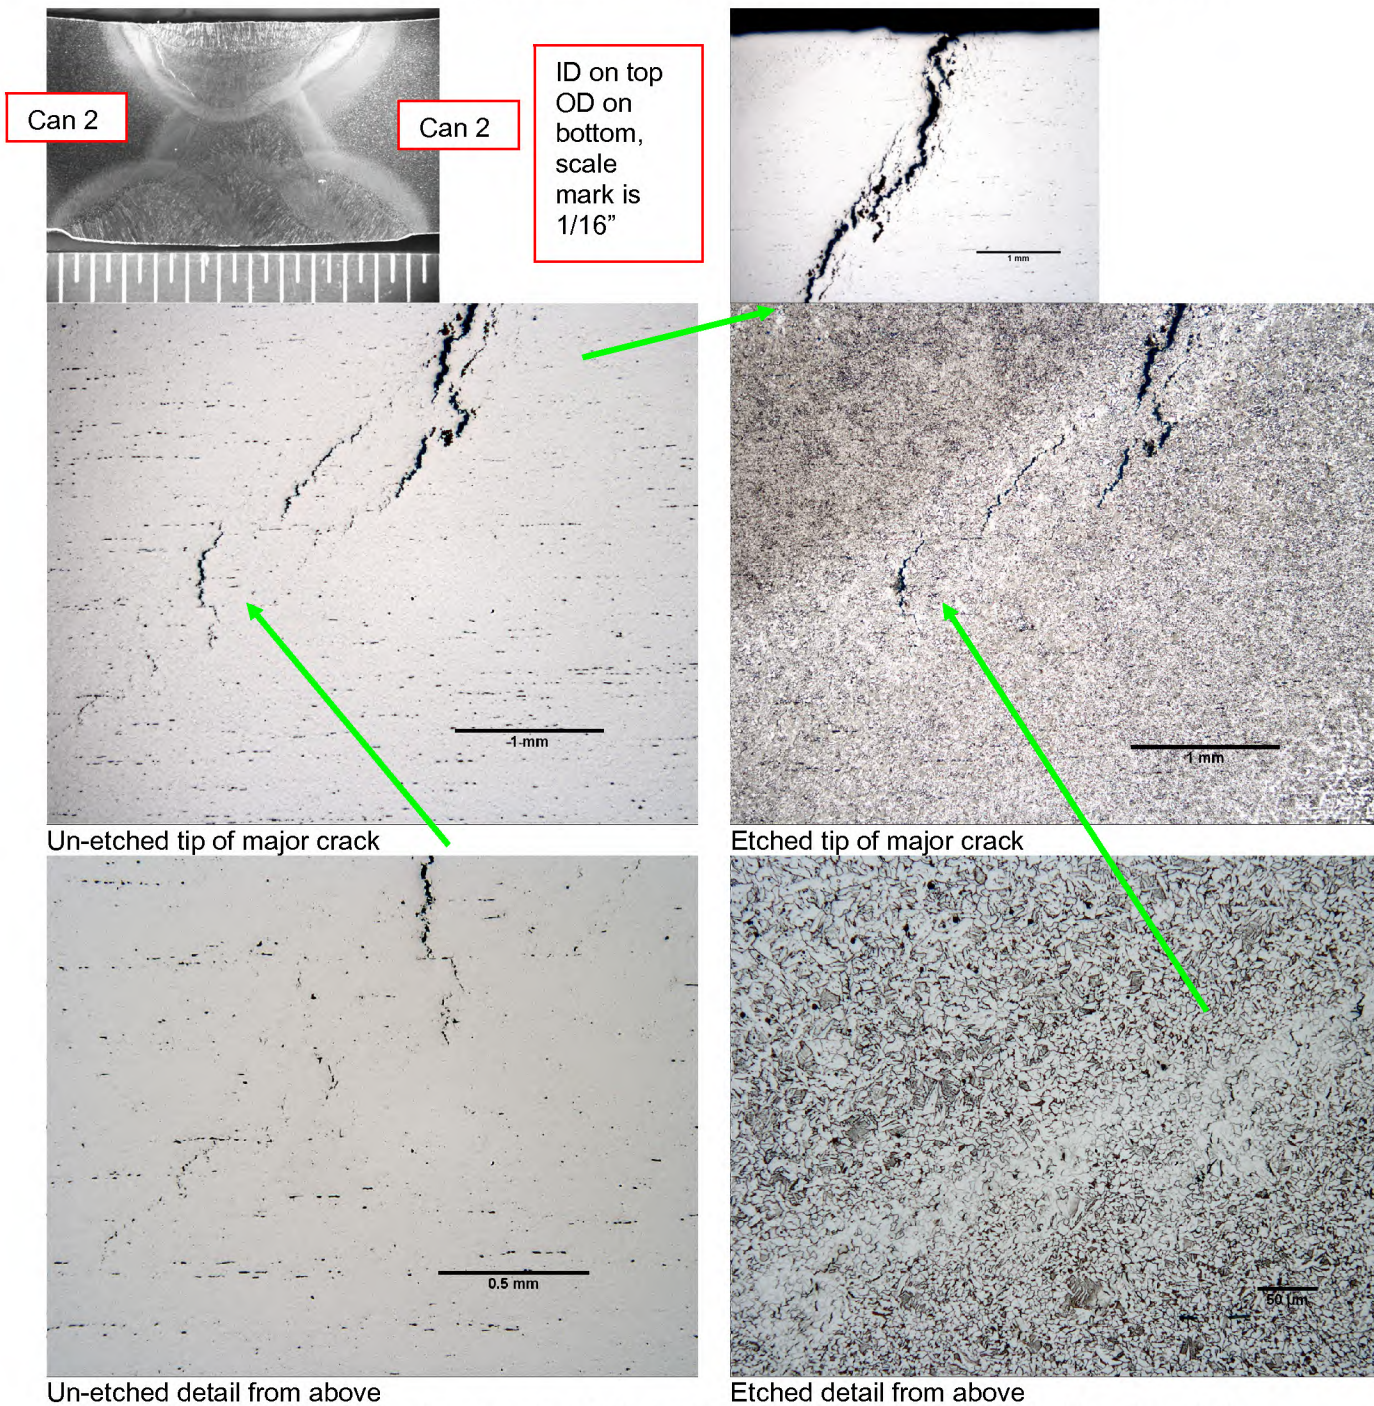
FIGURE 22 Photomicrographs of Mount T2L at right side Weld Metal side of crack tip

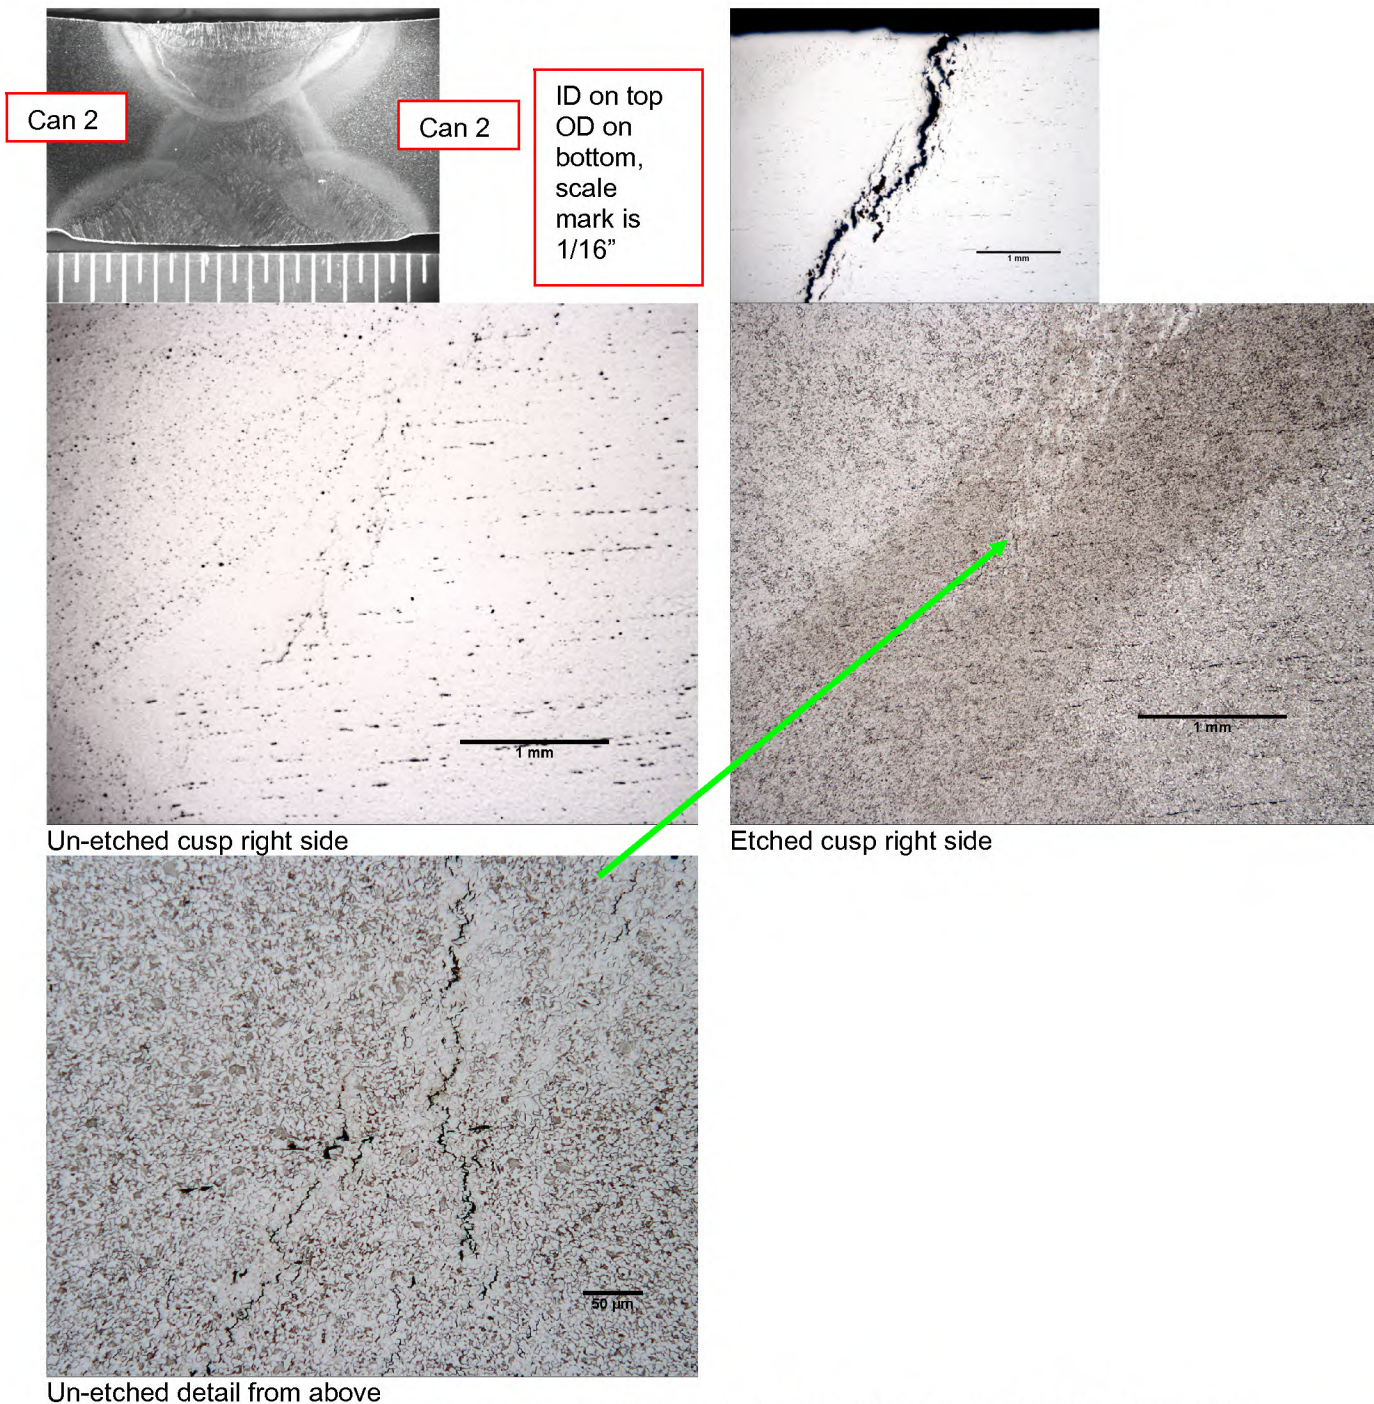
FIGURE 23 Photomicrographs of Mount T2L at right side Weld Metal side of crack tip

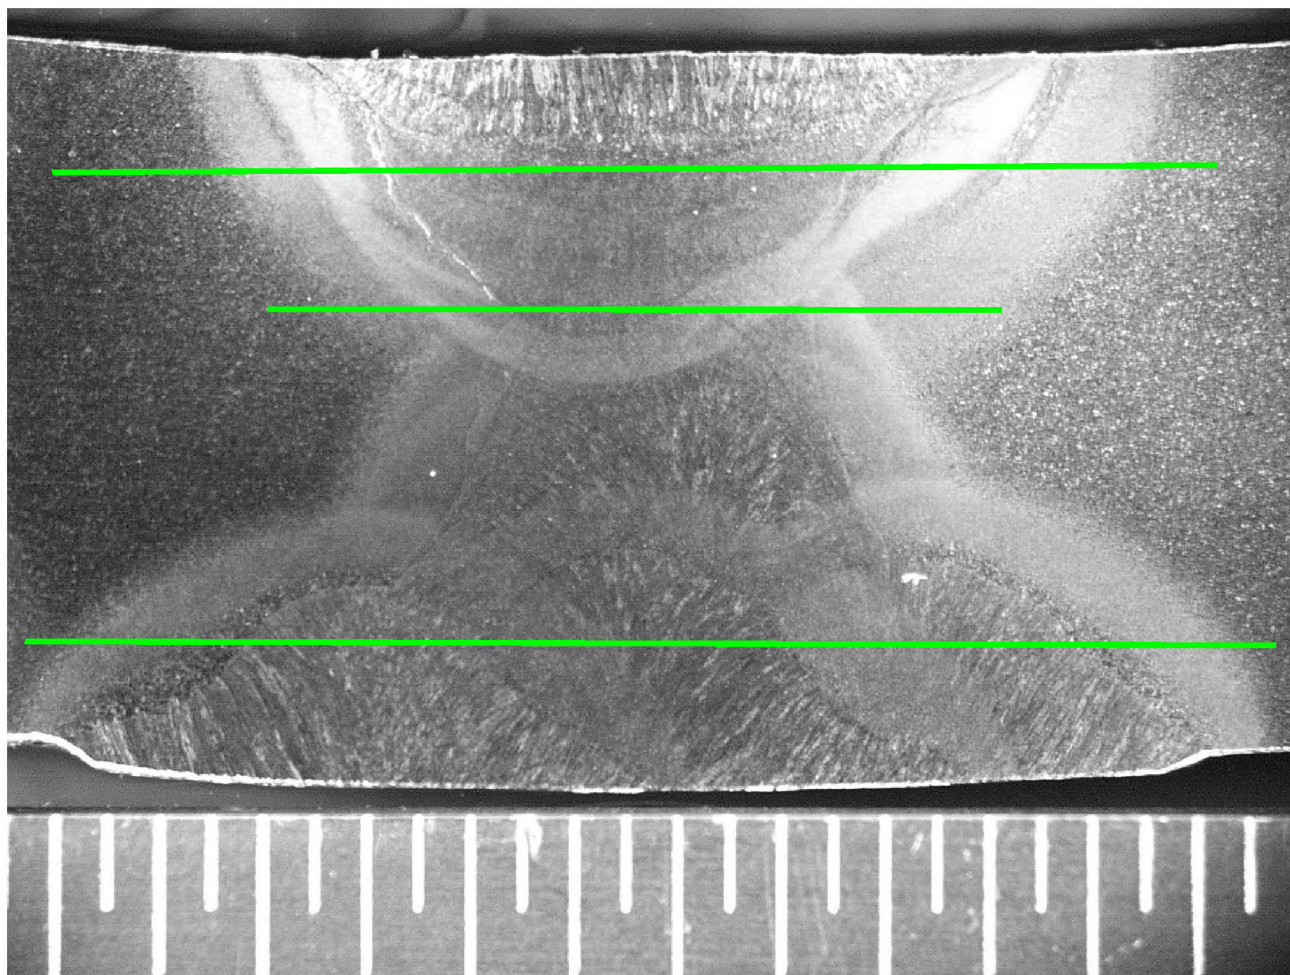
Mount T2L transverse through -

FIGURE 24 Photo macrographs with green lines where the micro-hardness traverses were made. Hardness values are given in Table 4 & 5. The scale marks are 1/16inch.
