BETA LAB No.M10198- LS3 TOP	TESORO REFINING AND MARKETING COMPANY ANACORTES REFINERY 10200 W. MARCH POINT ROAD T91WA4428 ANACORTES, WA 98221	CUSTOMER P.O. No.: 4501667904
PART: 6600-E HEAT EXCHANGER LS 3 TOP PART 15		DATE: SEPTEMBER 20, 2010
PAGE 1 OF 53

LABORATORY REPORT-LS3 TOP

This report is the seventh of a series on the failed parts of the 6600E heat exchanger. The LS# and CS# refer to longitudinal and circumferential weld seams while the part number refers to the chain of custody number.

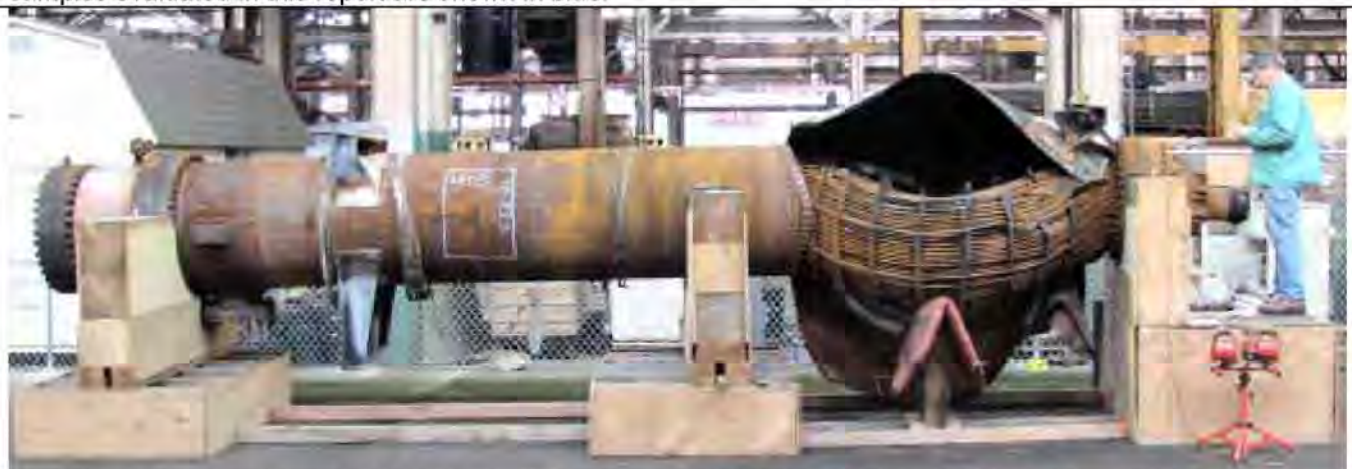
Figure 1 Un-packed main heat exchanger

Overall main heat exchanger with "fish mouth " rupture primarily along LS3 and CS4 as shown by green box above

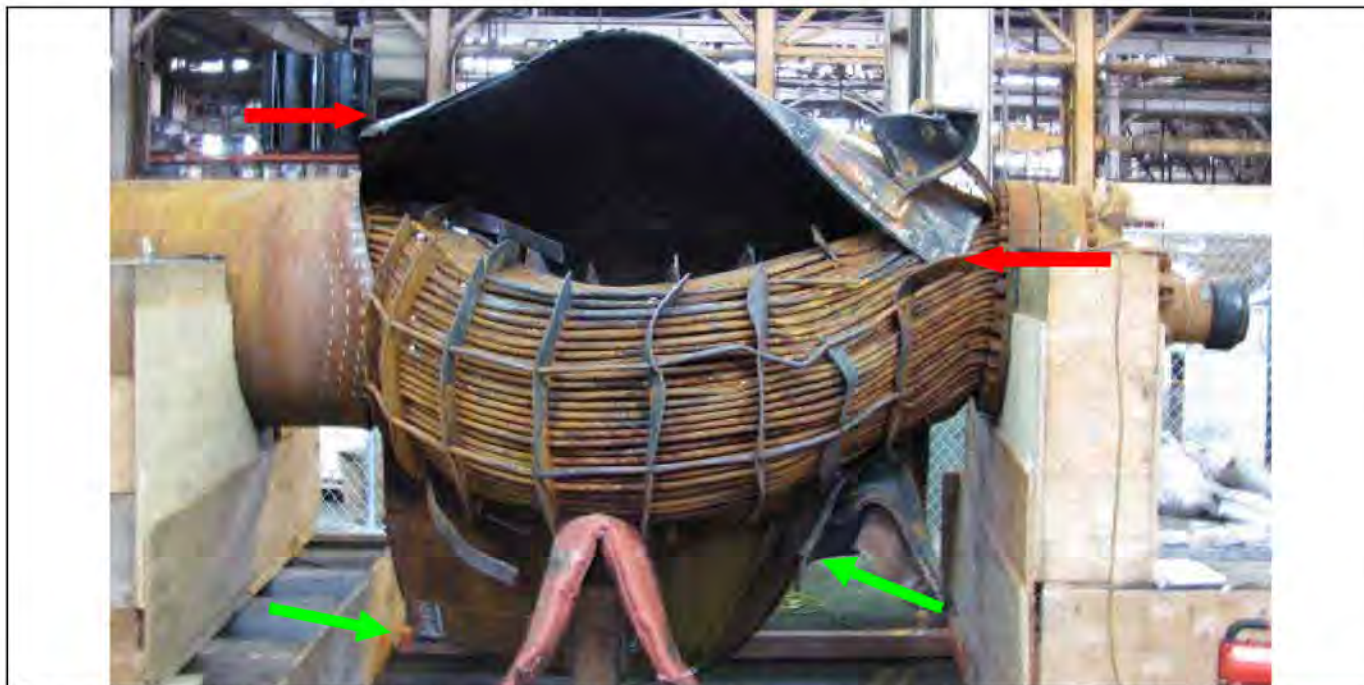
Fracture along LS3 seam between the green arrows for the bottom part of the fracture, and for the LS3 top – between the red arrows

Figure 2 Photo showing the fracture along LS3 where an approximate 6 inch wide portion was removed

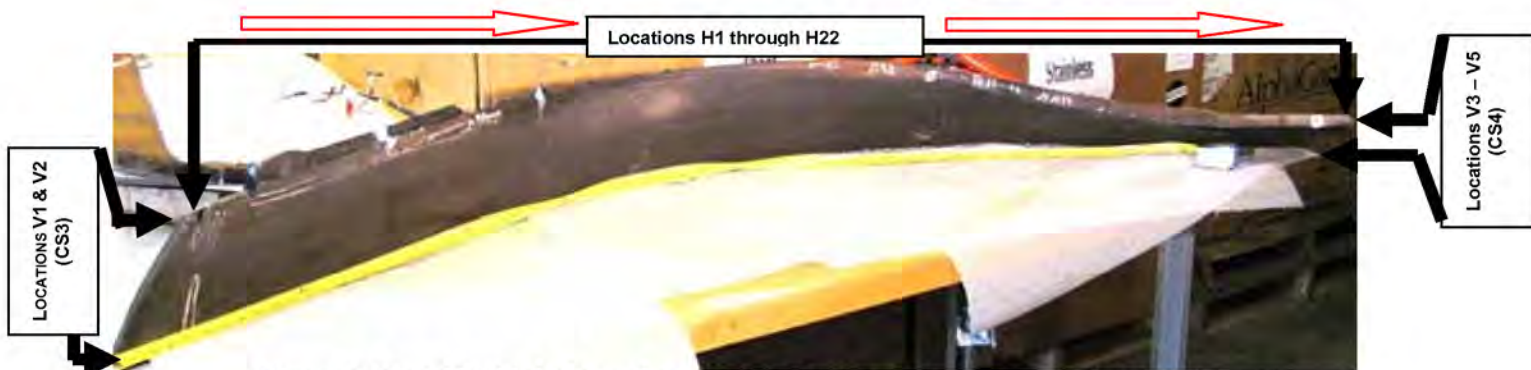
Figure 3. Part 15 with LS-3 and parts of CS-3 (left end) and CS-4 (right end).

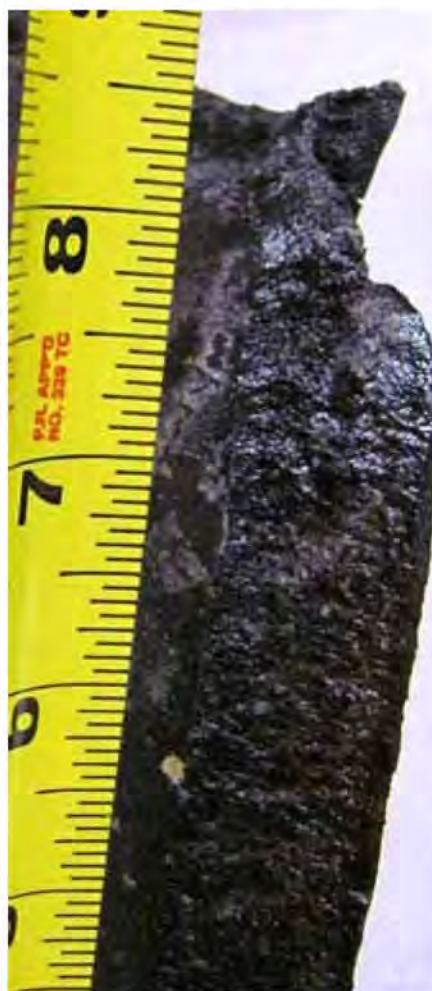
Figure 4. Fracture surfaces along the CS4 weld. ID is on the right.

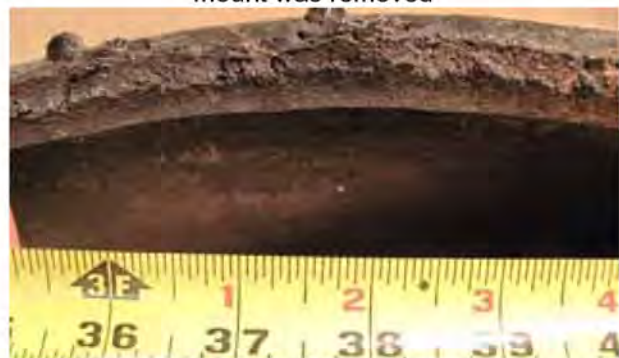
Figure 5. Fracture surfaces along the LS3 weld. ID is on the bottom, where the measure tape is located.

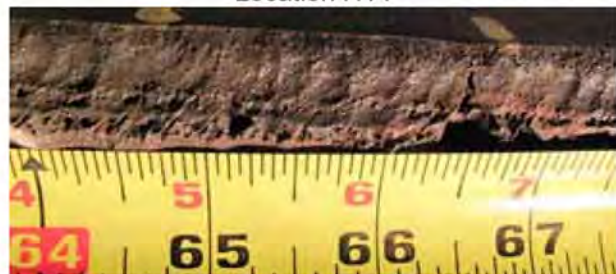
Figure 6. Fracture surfaces along the LS3 weld. ID is on the bottom, where the measure tape is located.

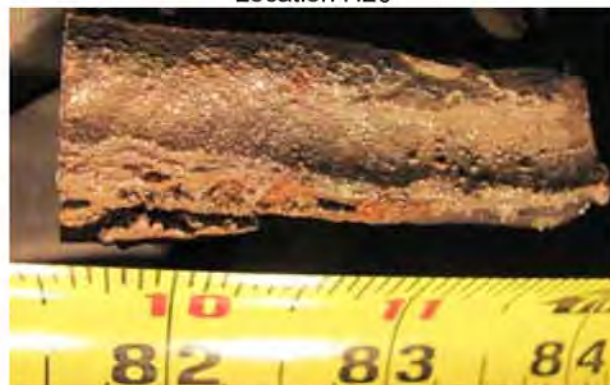
Figure 7. Fracture surfaces along the LS3 weld. ID is on the bottom, where the measure tape is located.

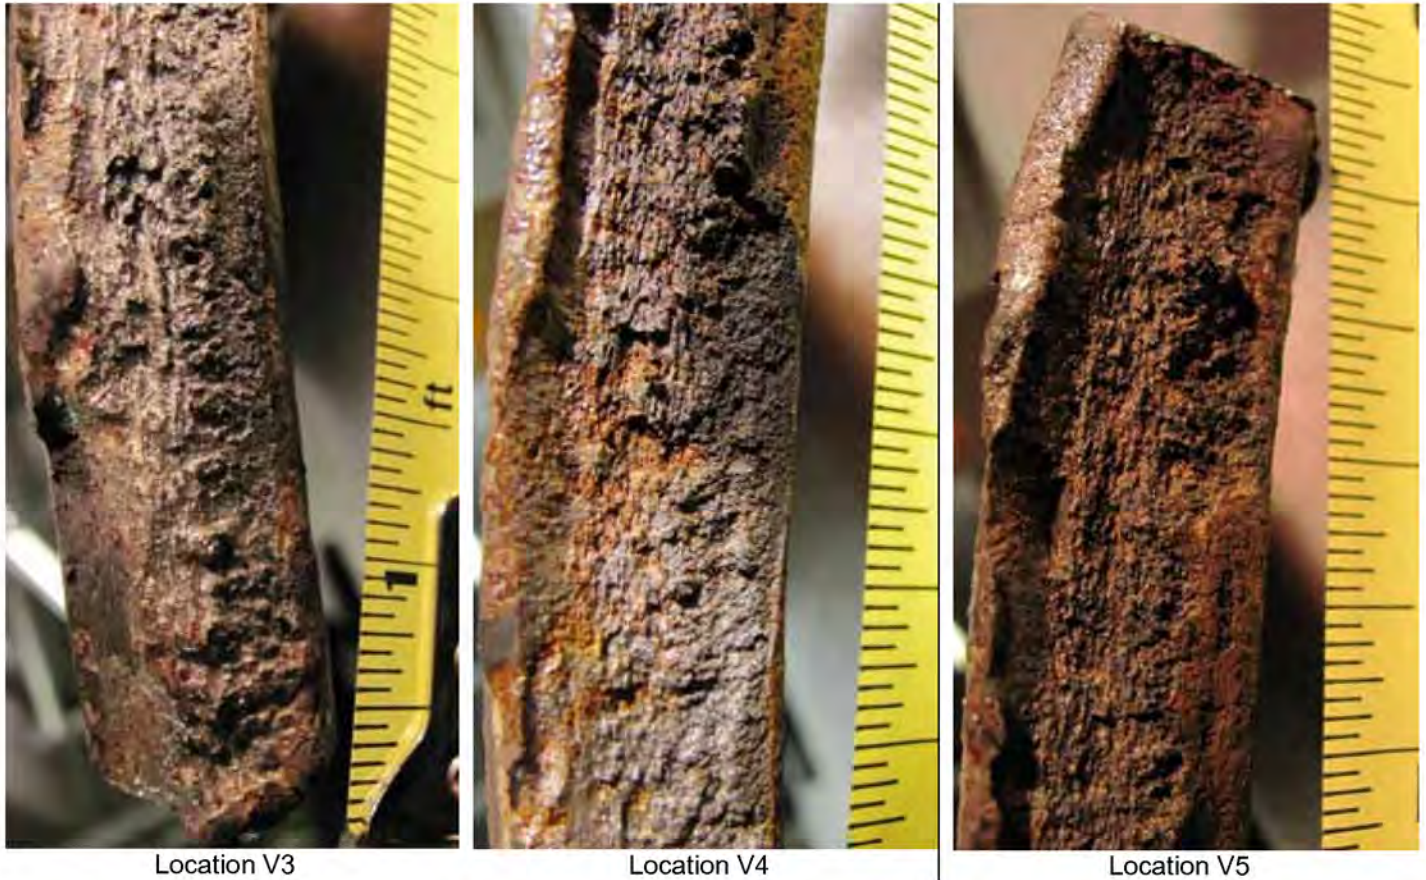
Figure 8. Fracture surfaces along the CS4 weld. ID is on the right, where the measure tape is located.

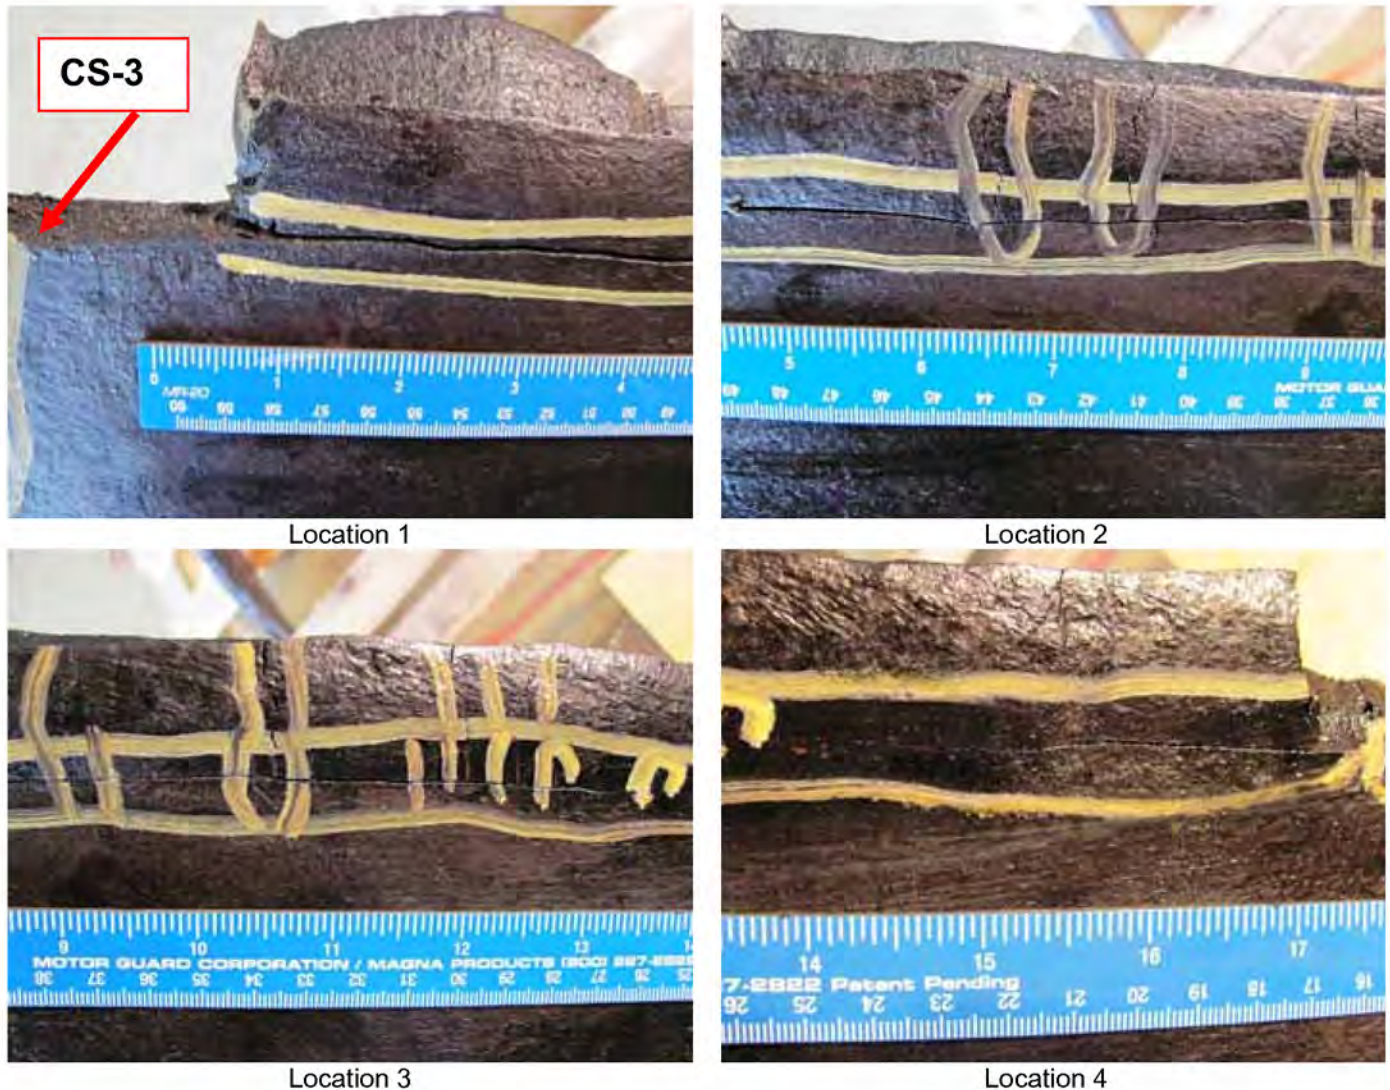
Figure 9. Magnetic Particle Inspection. Indications circled (fracture on top and looking at ID surface)

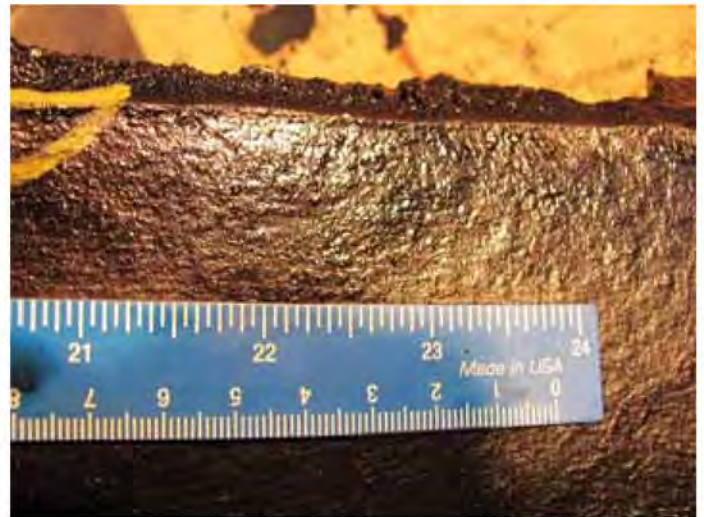
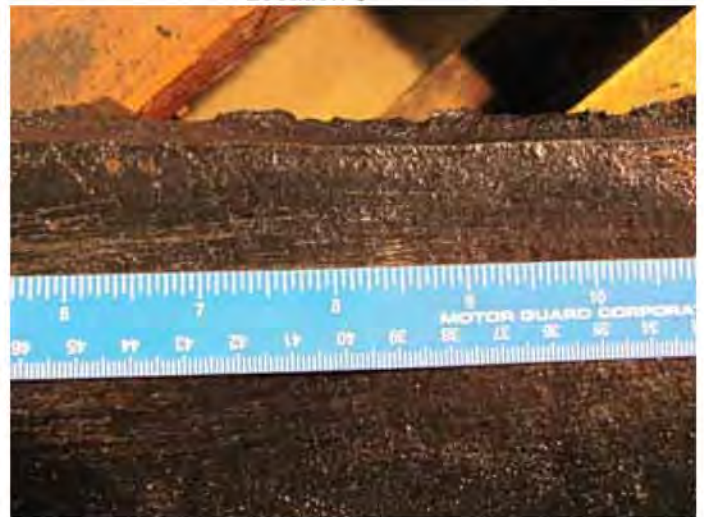
Figure 10. Magnetic Particle inspection. Indications circled (fracture on top and looking at ID surface)

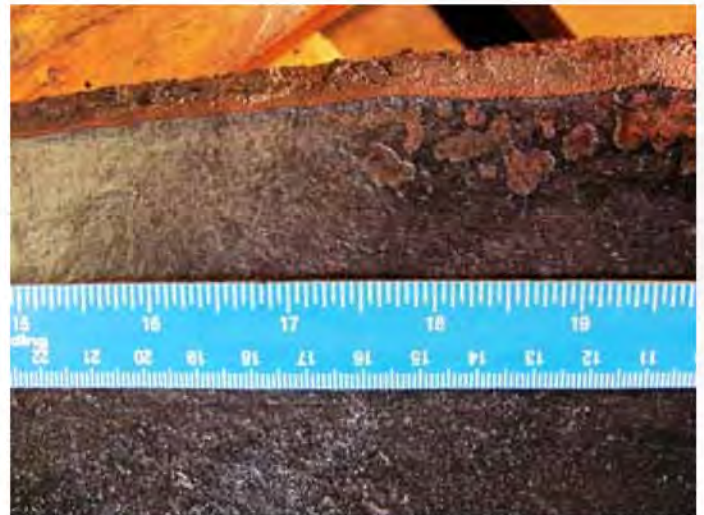
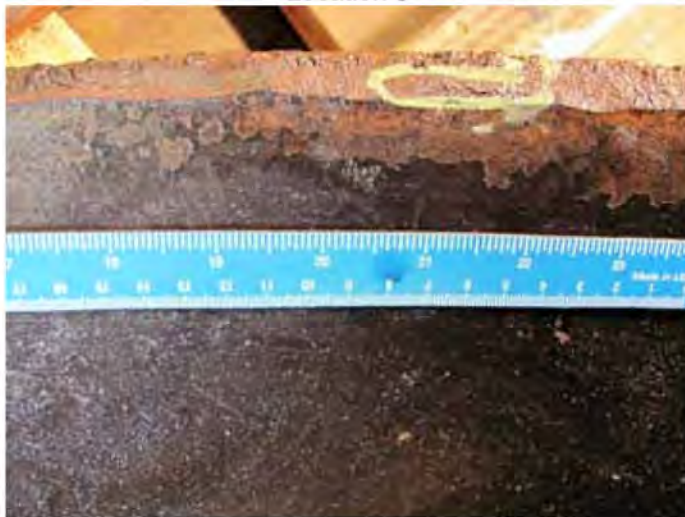
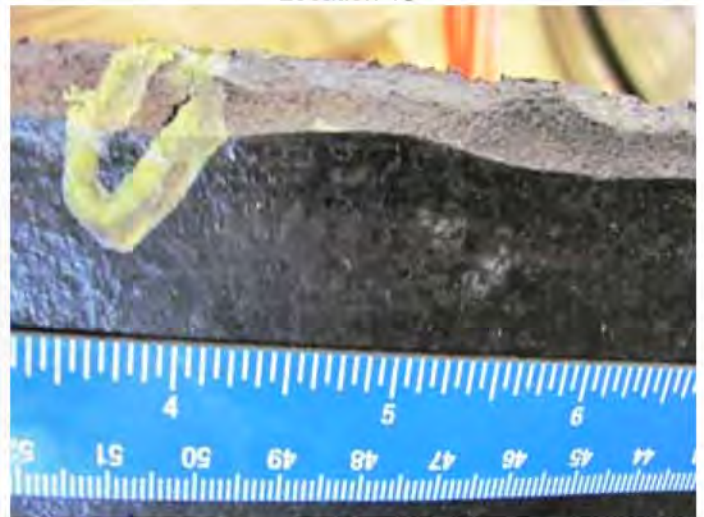
Figure 11. Magnetic Particle inspection. Indications circled (fracture on top and looking at ID surface)

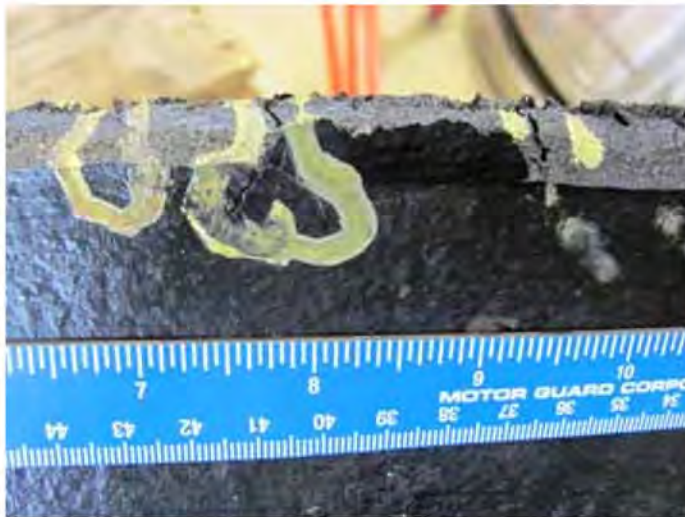
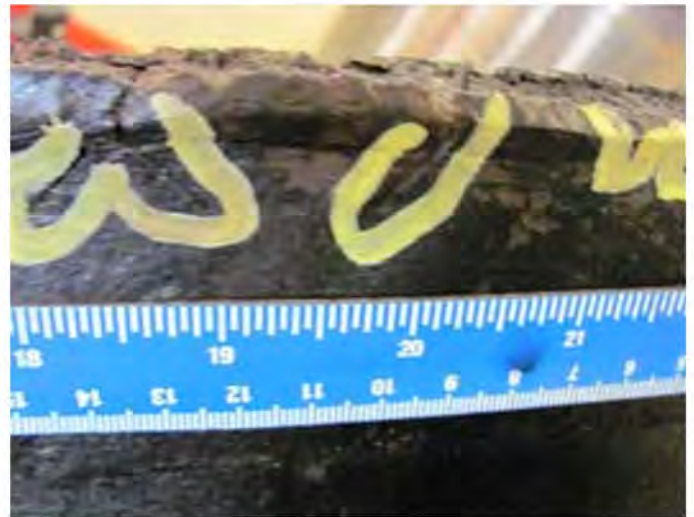
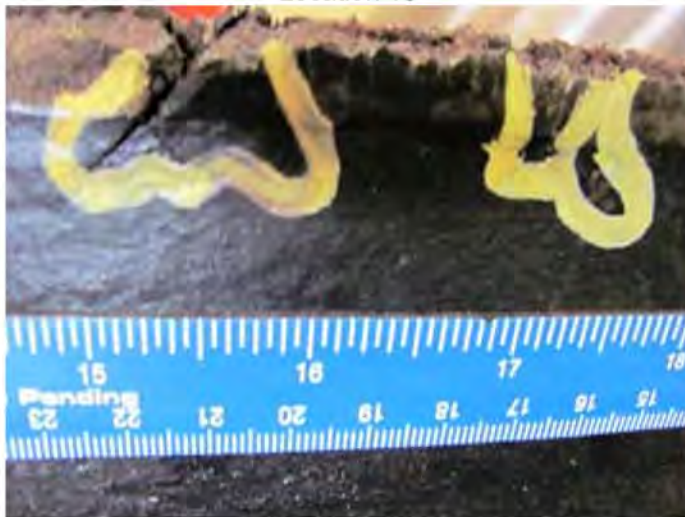
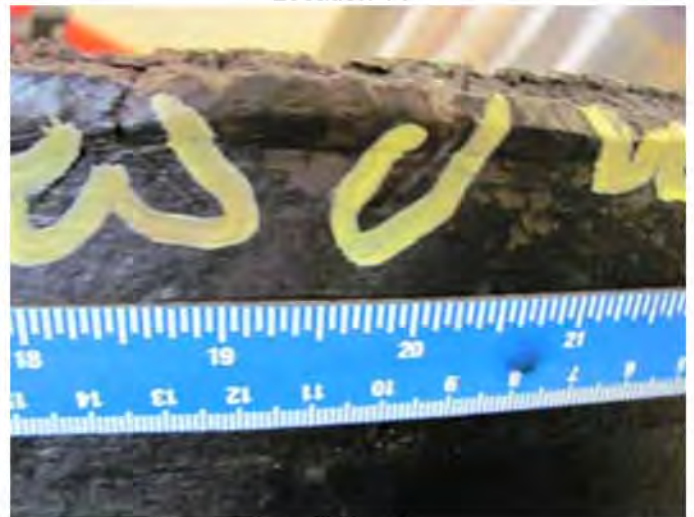
Figure 12. Magnetic Particle inspection. Indications circled (fracture on top and looking at ID surface)

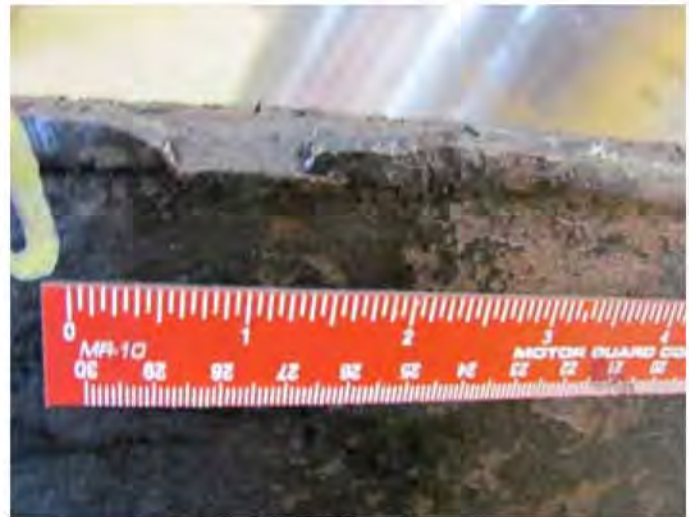
Figure 13. Magnetic Particle inspection. Indications circled (fracture on top and looking at ID surface)

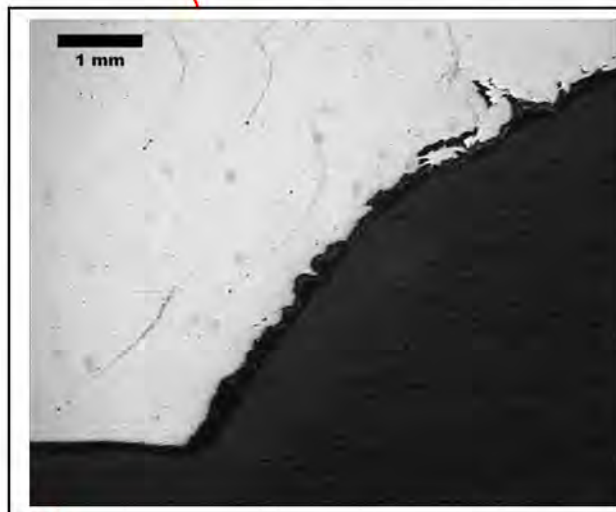
Fracture at ID corner, un-etched

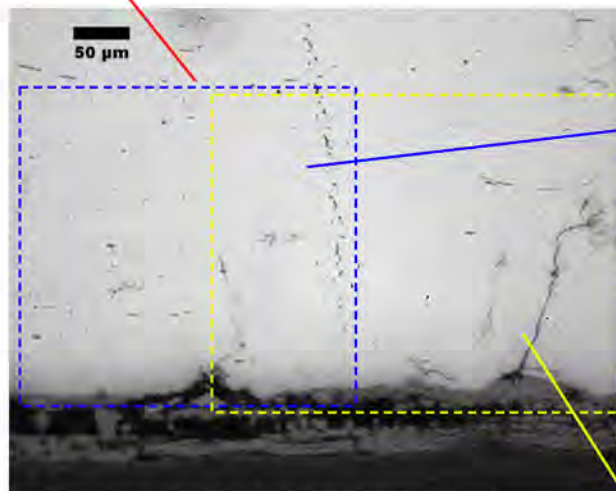
Area near the crack, un-etched

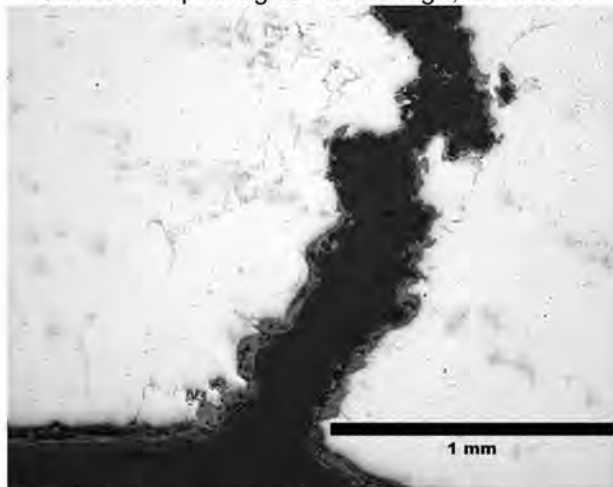
Both sides of the crack at ID. Un-etched

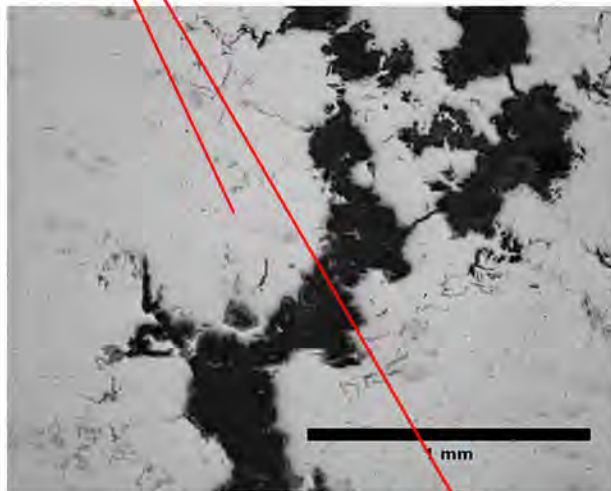
Crack, up from the ID. Un-etched

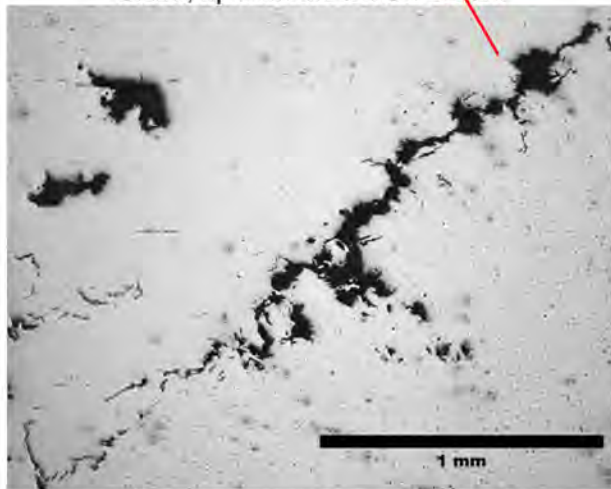
Tip of the crack along fusion line, un-etched

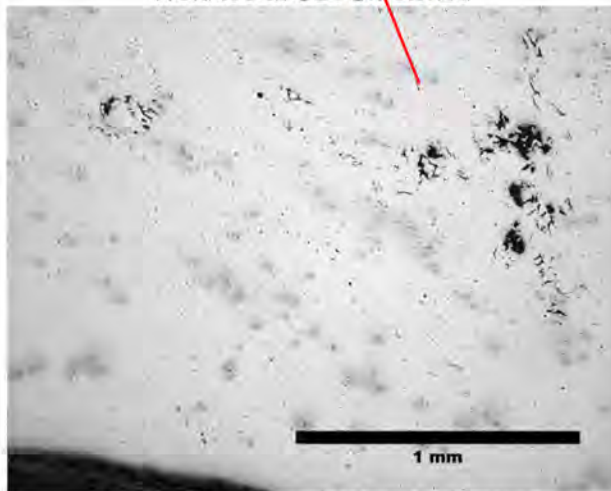
Cracks in the Weld Metal, un-etched

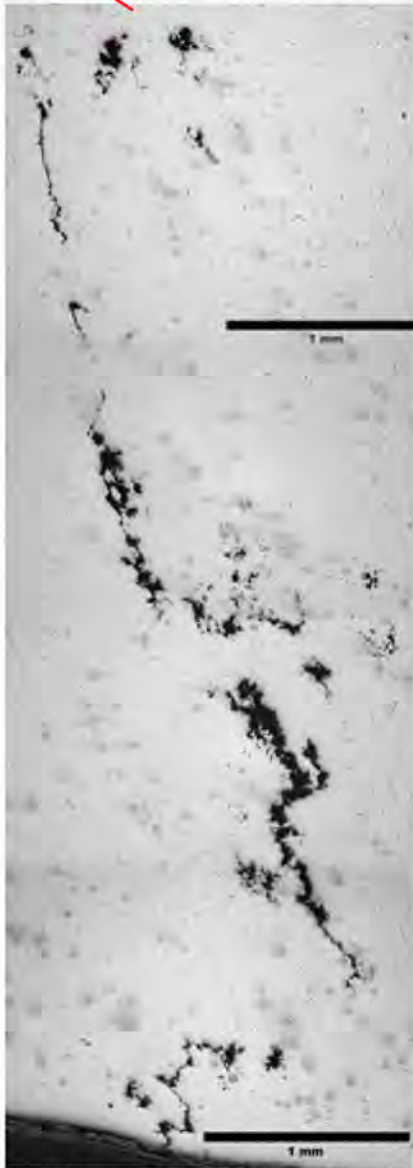
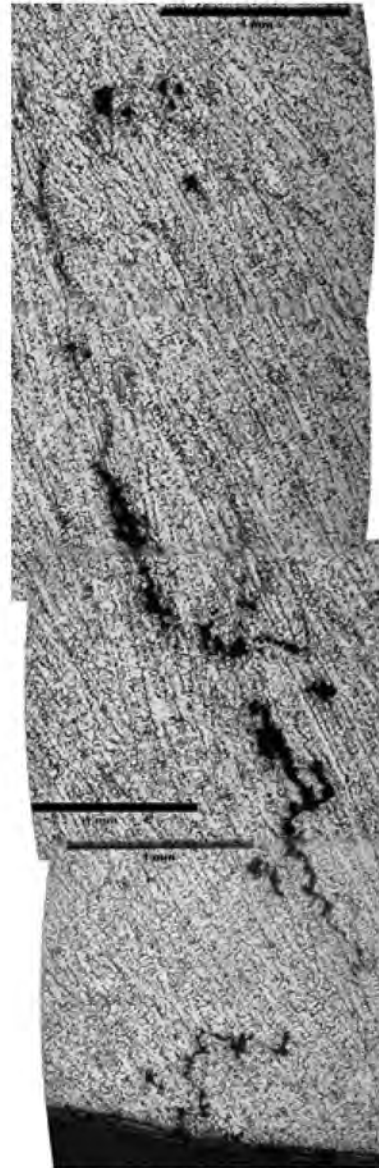
One of the cracks in the Weld Metal. Four microphotographs stitched together. Un-etched
